San Jose Incident Investigation Report

SAFETY AND ENFORCEMENT DIVISION
GAS SAFETY AND RELIABILITY BRANCH

May 23, 2024
Final Report

Report Date:	May 23, 2024
Investigators:	Hengyao Chen
Incident Number:	G20230608-3539
Date incident reported to CPUC	June 8, 2023
Utility:	Pacific Gas and Electric Company (PG&E)
Date and Time of the Incident:	June 8, 2023 at 0300 hours
Location of the Incident:	15630 Alum Rock Ave San Jose, CA, Santa Clara County

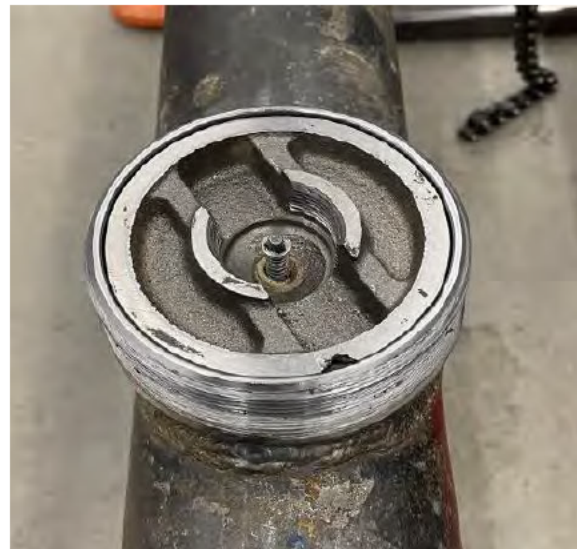
Figure 4. Post Incident Photo- 4” Mueller Line Stopper with damage completion plug but no cap on (top view)

Examination of Damaged Completion Plug: Completion plug damage was noted measuring 0.41" wide and .18" deep at approximately 12 o'clock position (12 o'clock position was determined as closest linear point near damage; see Figure 3). Noted minor deformation on leading thread from 3 o'clock position extending to 5:30 position (see Figure 4).

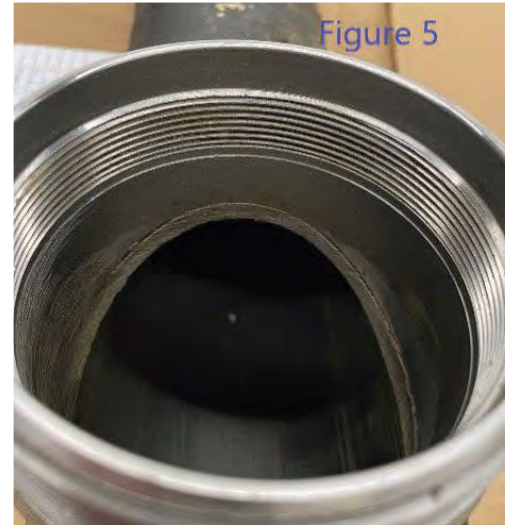
Examination of Mueller H-17190 4" M2 Fitting: Minor damage noted on leading internal completion plug thread between 12 o'clock and 2 o'clock positions (see Figure 5).

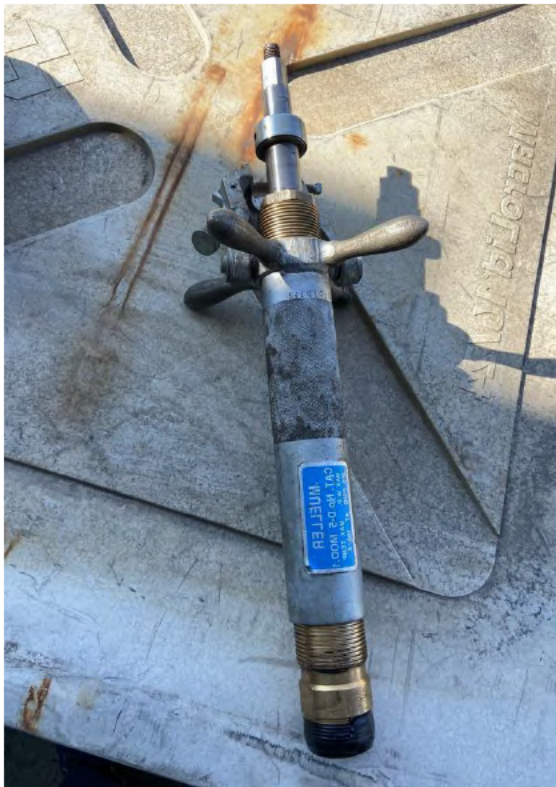
Figure 1. Mueller D-5 machine involved in the incident.

Inspection of D-5 Machine: Inspected all components, no issues found.
