**CALIFORNIA PUBLIC UTILITIES COMMISSION**  
**Safety and Enforcement Division**  
**Wildfire Safety and Enforcement Branch**

**Incident Investigation Report**

**Incident Number:** E20220819-01 (Ridge Fire)

**Regulated Utility Facilities Involved:** Jarvis 12kV Distribution Circuit

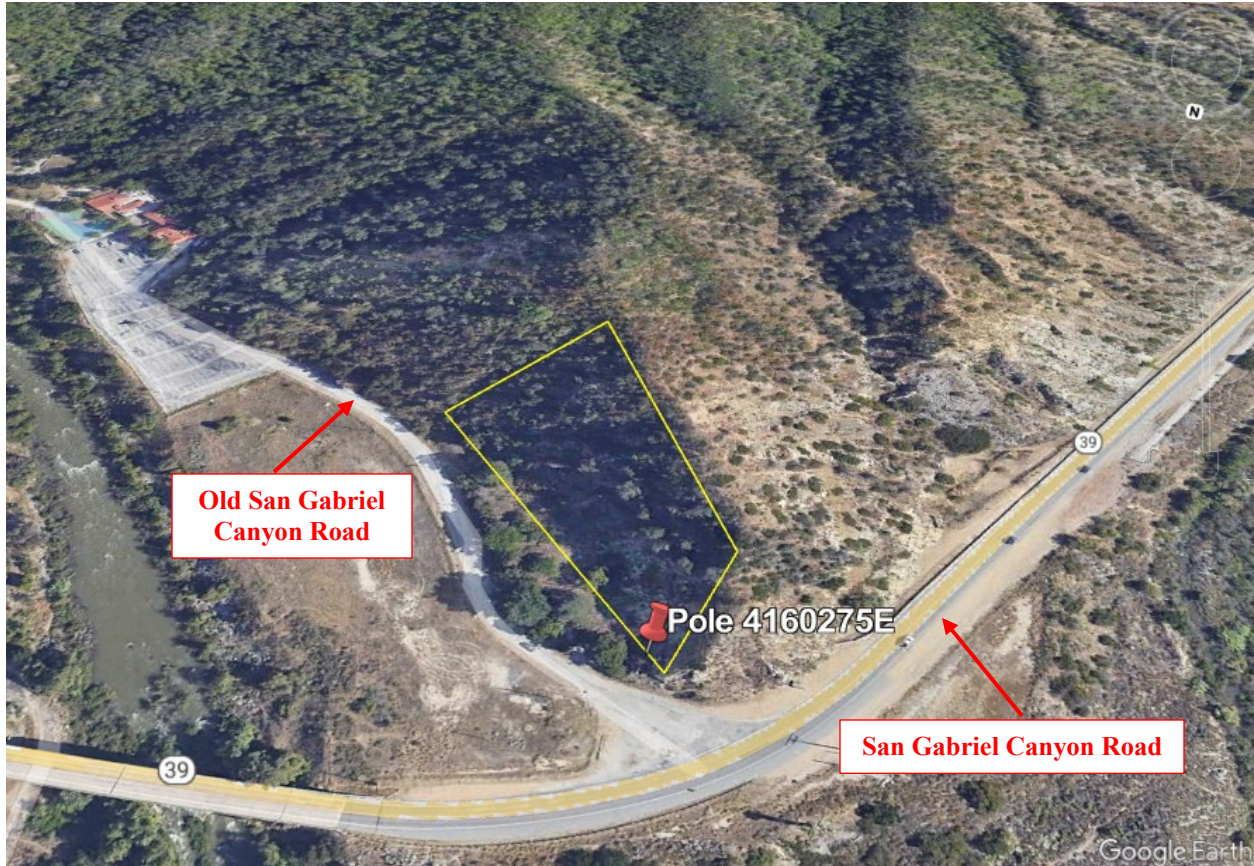
**Figure 2.** A close-up view of the burned area from north of San Gabriel Canyon Road.

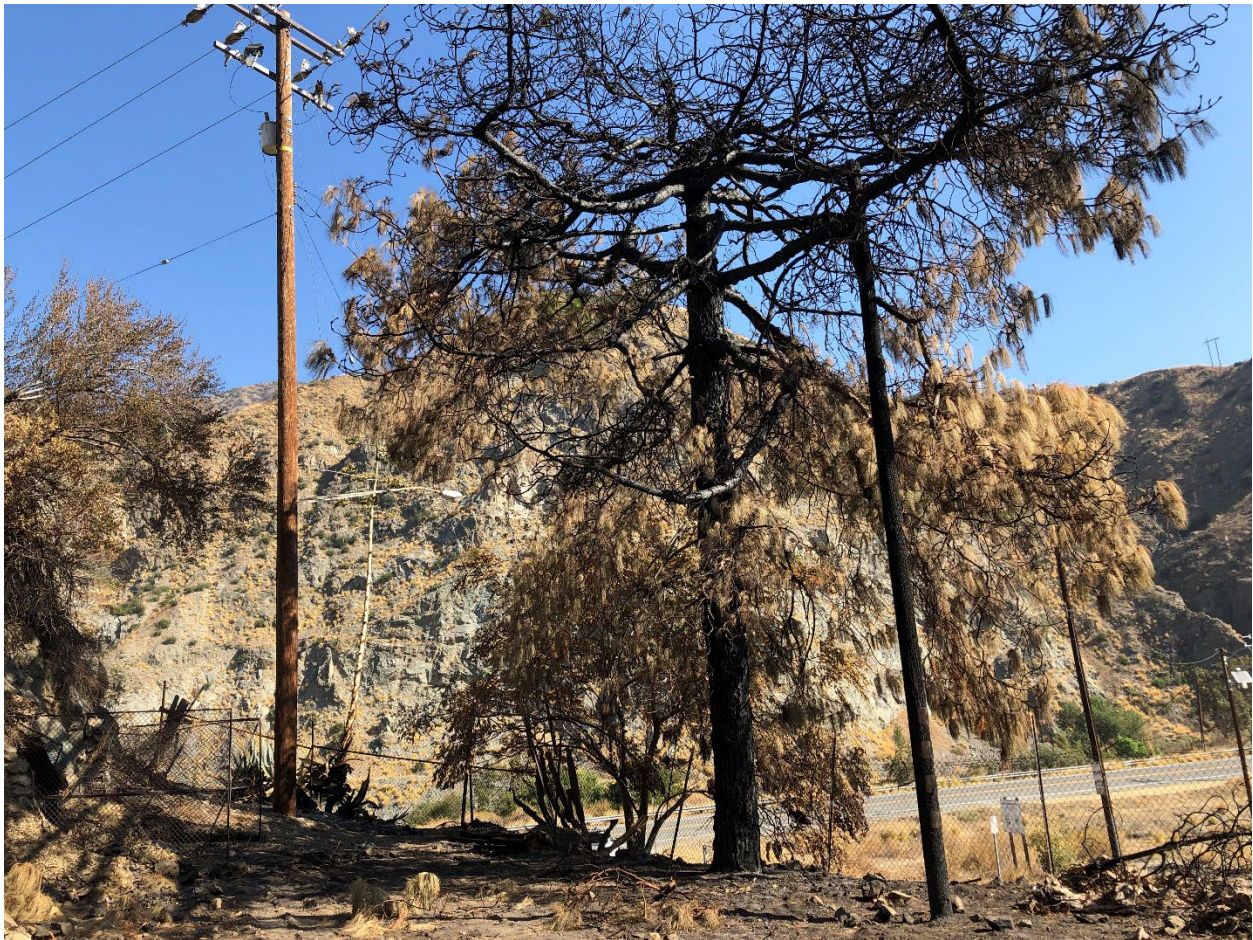
(See Figure 3.) A closer examination led investigators to the specific area of origin, approximately four to five feet northwest of the power pole.<sup>8</sup>

**Figure 3.** The plateau area was identified by the LACoFD as the area of origin. The specific area of origin was determined to be four to five feet northwest of the pole in the area, Pole 4160275E.

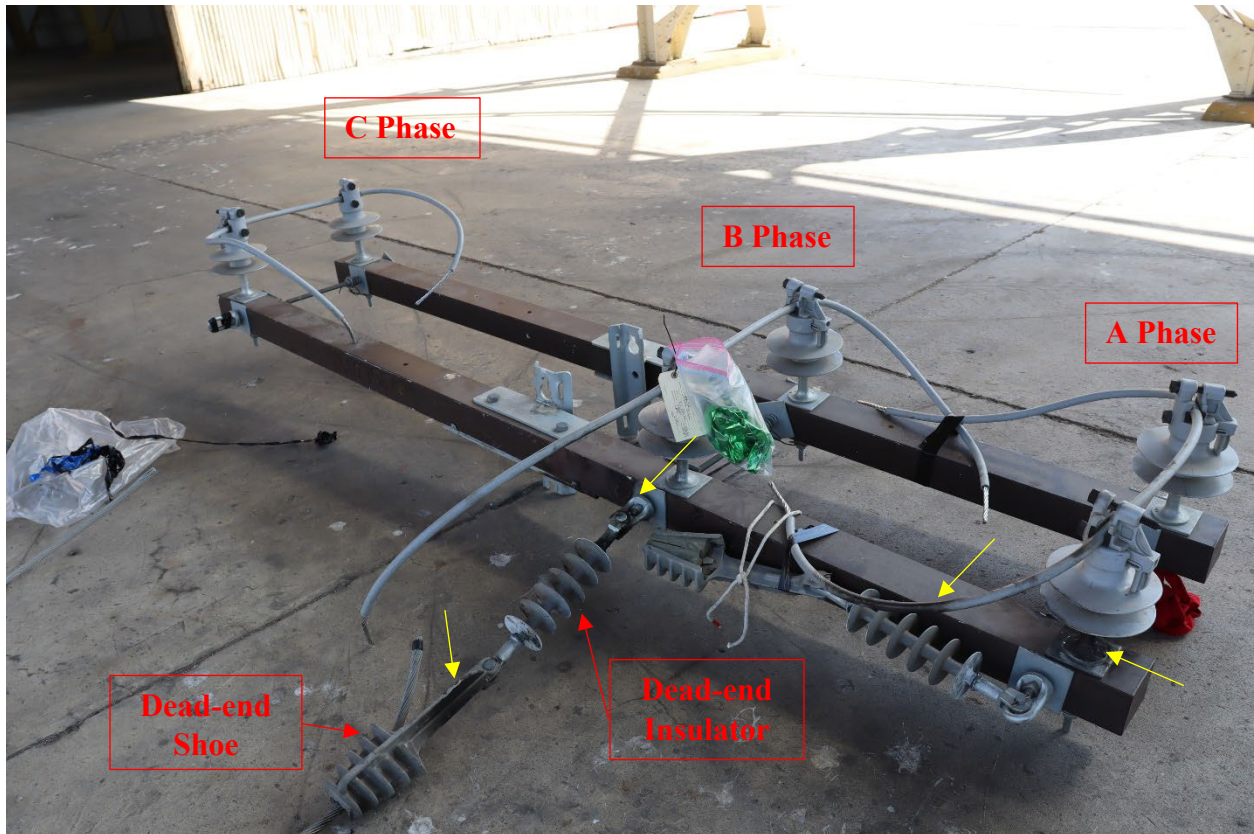
**Figure 7.** This figure shows the cross arm removed from Pole 4160275E with the associated insulator hardware and jumper wires displaying burn marks, as indicated by yellow arrows in the photo. Remnants of mylar balloons can be seen on the ground and in the Ziploc bag attached to the “B” phase jumper wire.

The burn marks on the insulator hardware on the “A” and “B” phases and the “A” phase jumper wire appear to be an indication of an arc flash between the two phases. Mylar balloons have the capability of conducting electricity due to their metallic coating.

SCE stated that the fault event of August 19, 2022, was a phase-to-phase fault involving “A” and “B” phases,<sup>22</sup> which is consistent with SED’s observation of burn marks on the “A” and “B” phase equipment at Pole 4160275E during the site visit. The recorded fault current for “A” and “B” phases were 1380 amps and 1401 amps, respectively.<sup>23</sup> Just prior to the fault event, the recorded current for “A” and “B” phases were 263 amps and 170 amps, respectively.<sup>24</sup> RAR

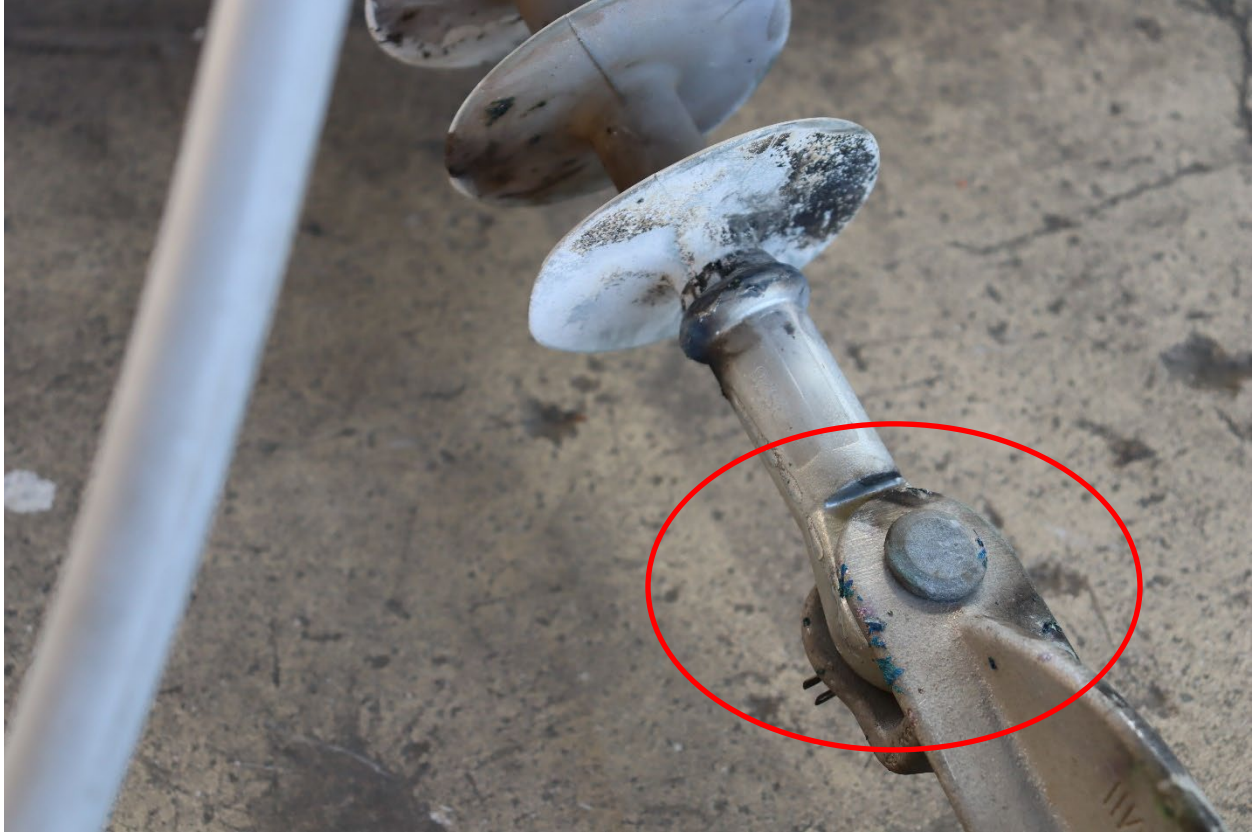
**Figure 8.** Mylar balloon marks on the B phase dead-end insulator/shoe assembly.

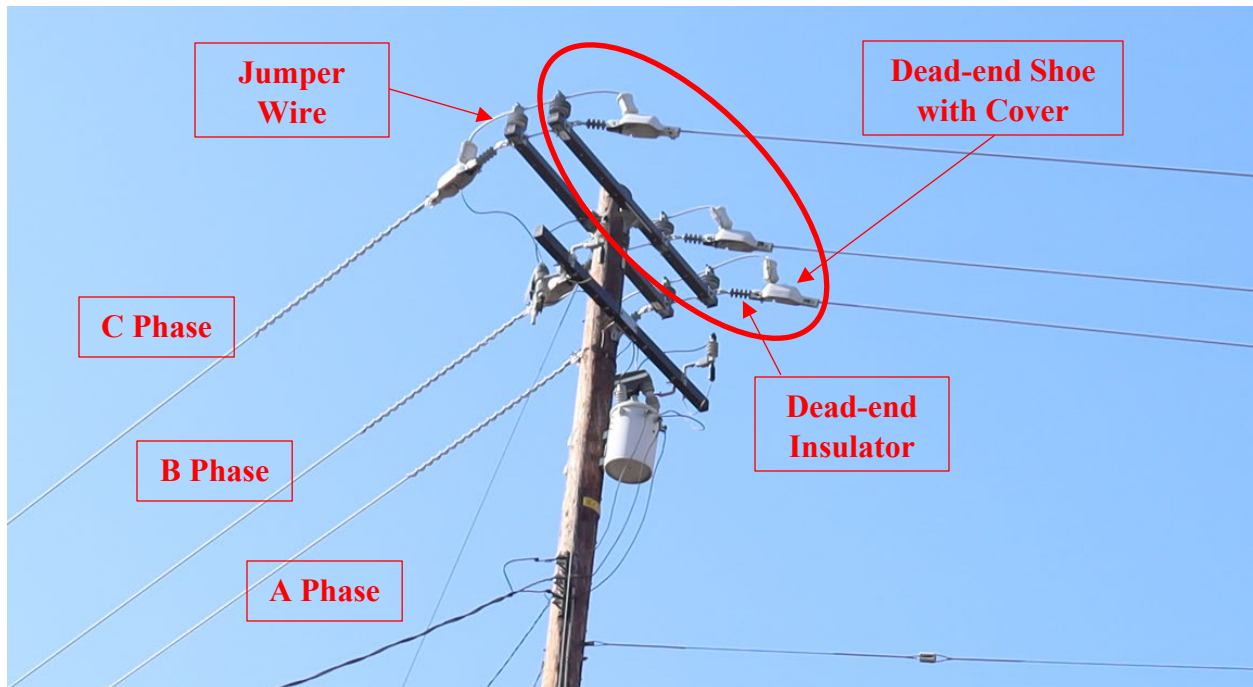
**Figure 9.** Figure 9 shows the various hardware and jumper wires at Pole 4160275E after the repair. The jumper wires are connected to the conductors at the dead-end shoes. The red ellipse shows the location of the section damaged in the incident.

Map says 1/0 ATW but is actually 336 wire. Crew will be out Saturday to make repairs and put in covered conductor.<sup>26</sup>
