Incident Investigation Report  
Supporting Documents  
SED Incident E20220819-01 RIDGE FIRE  
(Ridge Fire)

**Southern California Edison**  
**NDDR Non-Docketed Data Request**

**DATA REQUEST SET S E D - R i d g e - 0 0 2**

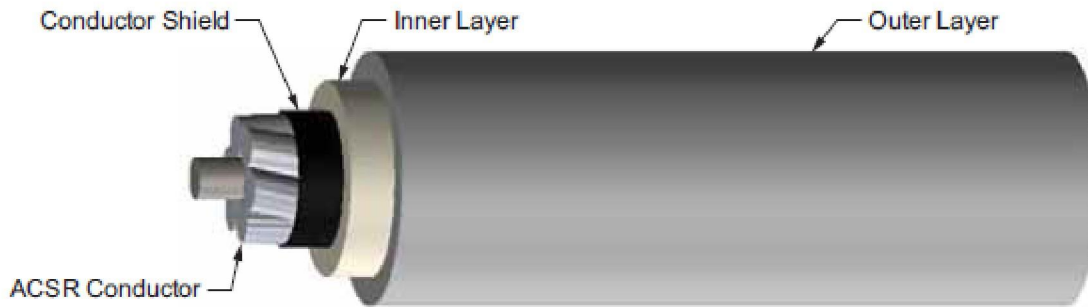
iii: The protective coating is made up of three layers. As shown in the figure below, the first layer is the conductor shield, which is a semiconducting thermoset polymer. The inner layer is crosslinked low density polyethylene and the outer layer is a crosslinked high-density polyethylene.

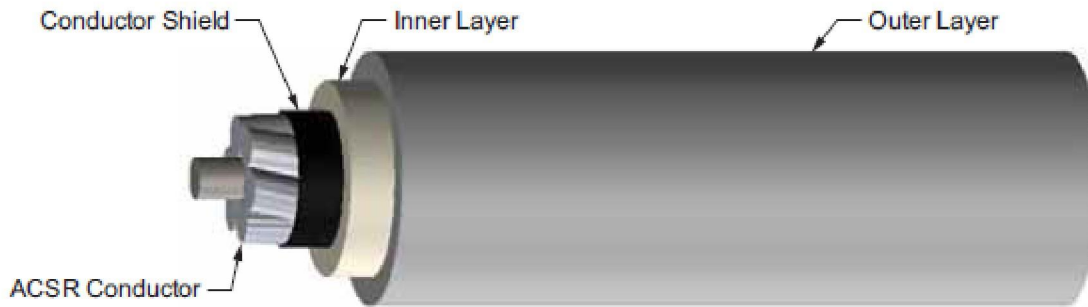
iii: The protective coating is made up of three layers. As shown in the figure below, the first layer is the conductor shield, which is a semiconducting thermoset polymer. The inner layer is crosslinked low density polyethylene and the outer layer is a crosslinked high-density polyethylene.
