# San Jose Incident Investigation Report

SAFETY AND ENFORCEMENT DIVISION  
GAS SAFETY AND RELIABILITY BRANCH

Final Report

<b>Report Date:</b>	May 23, 2024
<b>Investigators:</b>	Hengyao Chen
<b>Incident Number:</b>	G20230608-3539
<b>Date incident reported to CPUC</b>	June 8, 2023
<b>Utility:</b>	Pacific Gas and Electric Company (PG&E)
<b>Date and Time of the Incident:</b>	June 8, 2023 at 0300 hours
<b>Location of the Incident:</b>	██████ Alum Rock Ave San Jose, CA, Santa Clara County

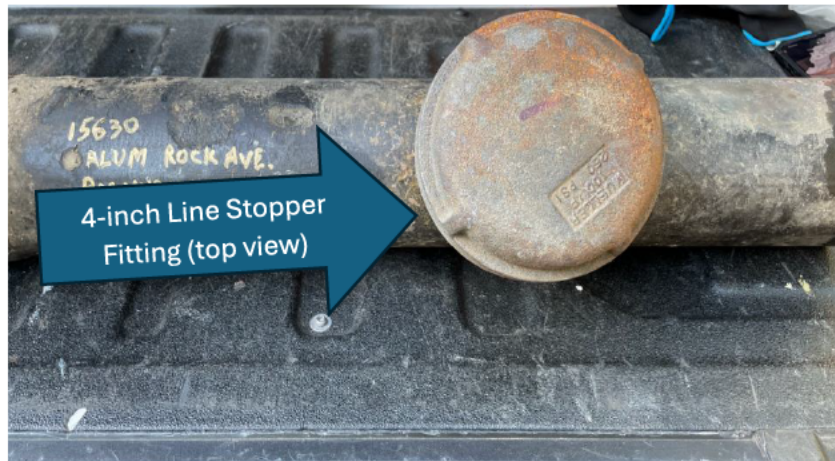
Figure 2. Post Incident photo – 4” Mueller Line Stopper with cap on (top view)

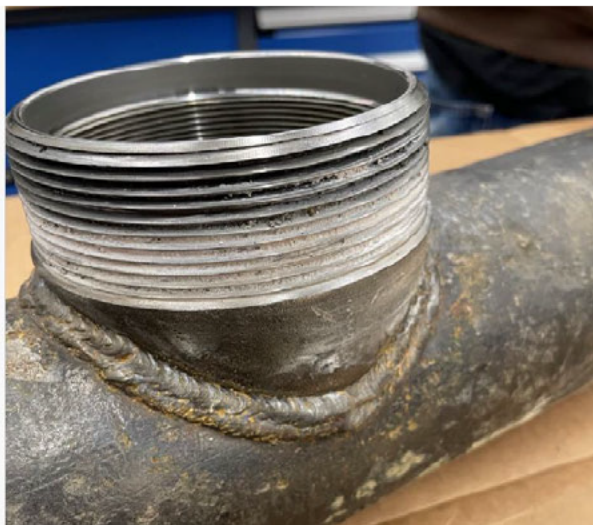
Figure 3. Post Incident Photo- 4” Mueller Line Stopper without installed cap and completion plug (side view)

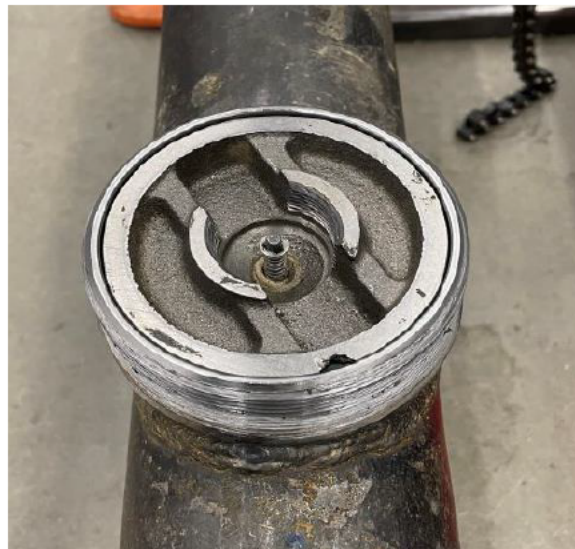
Figure 4. Post Incident Photo- 4” Mueller Line Stopper with damage completion plug but no cap on (top view)

*Examination of Damaged Completion Plug: Completion plug damage was noted measuring 0.41" wide and .18" deep at approximately 12 o'clock position (12 o'clock position was determined as closest linear point near damage; see Figure 3). Noted minor deformation on leading thread from 3 o'clock position extending to 5:30 position (see Figure 4).*

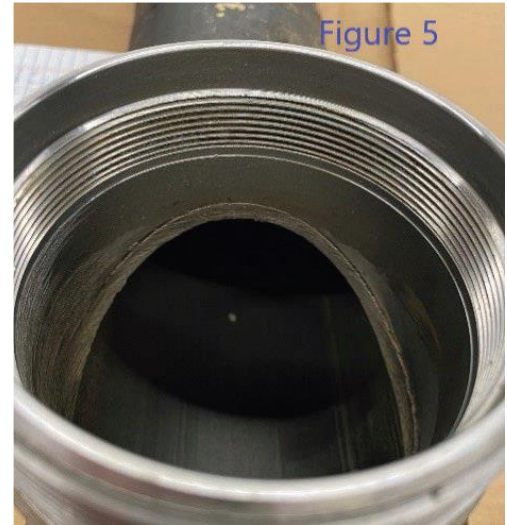
*Examination of Mueller H-17190 4" M2 Fitting: Minor damage noted on leading internal completion plug thread between 12 o'clock and 2 o'clock positions (see Figure 5).*

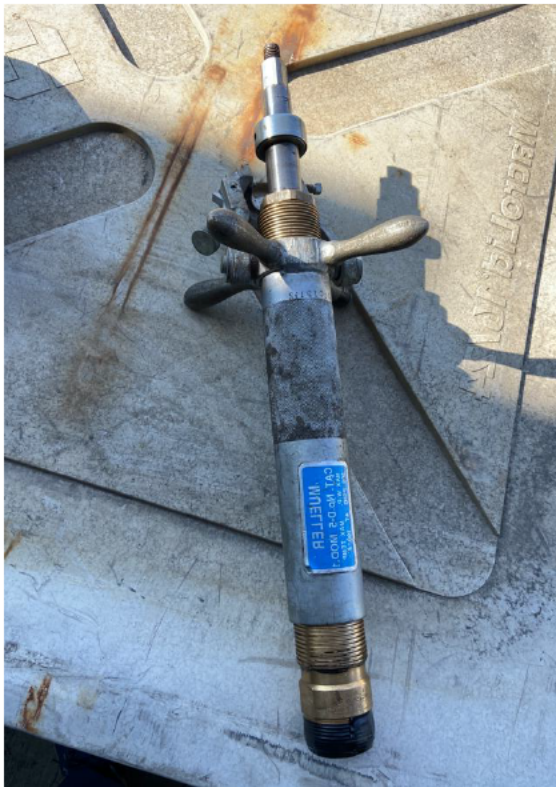
Figure 1. Mueller D-5 machine involved in the incident.

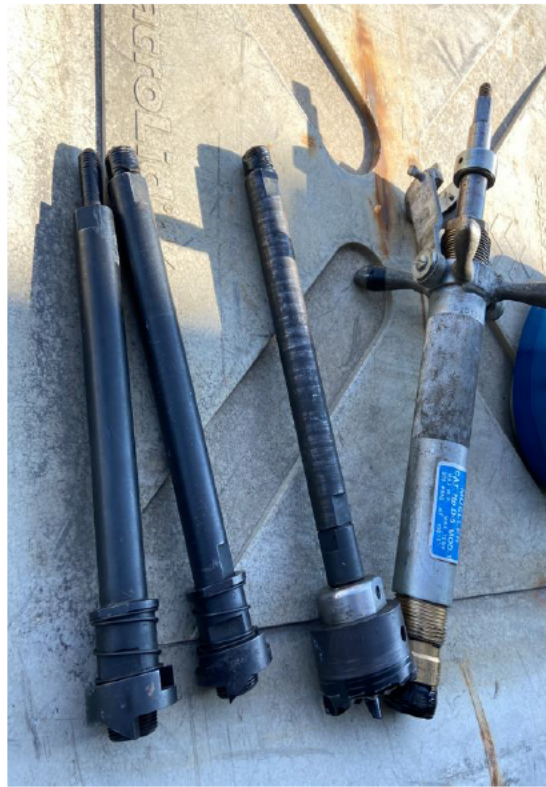
Figure 2. Mueller D-5 machine and inserting tool involved in the incident.
