CALIFORNIA PUBLIC UTILITIES COMMISSION
Consumer Protection and Safety Division
Utilities Safety and Reliability Branch
Incident Investigation Report

Incident Number: E 20081115-03

Utility: Southern California Edison (SCE)

Location of the Incident: 13000 Sayre Road
Sylmar, CA
County: Los Angeles

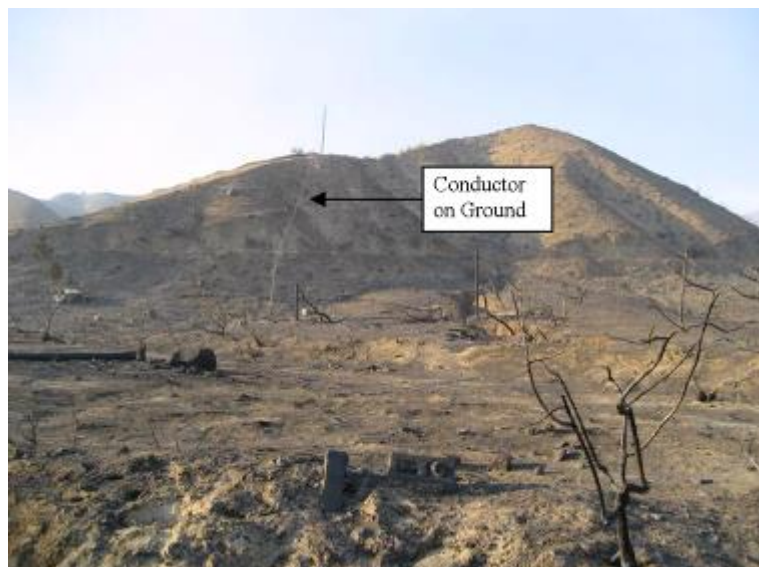
On November 15, 2008, I met with Paul Pimentel of SCE and representatives from the Los Angeles County Fire Department at the site of the fire and discovered numerous conductors on the ground and damaged poles (See Photos 1 and 2 titled *Burn Area* and *Damaged Cross-arm*, respectively). I took photos of area that was accessible and cleared by the Fire Department.

Photo 1
Burn Area

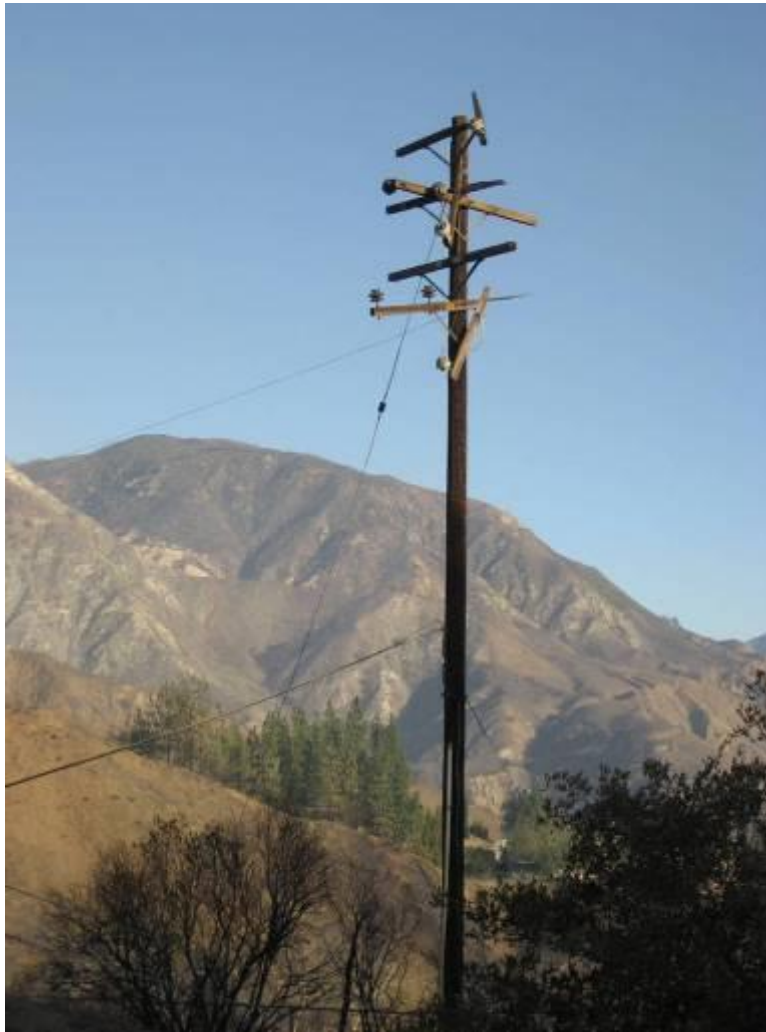
Photo 2
Damaged Cross-arm

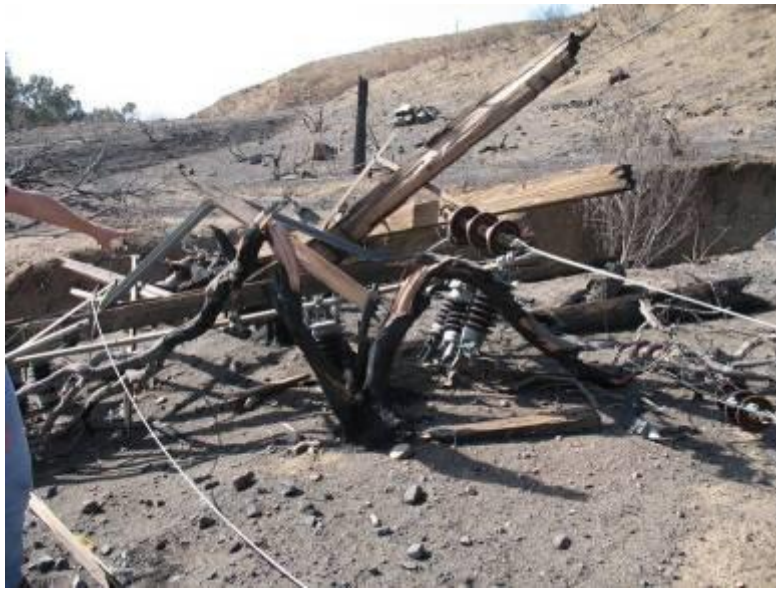
On November 20, 2008, I met with the U.S. Forest Service, Mark J. Felling (U.S. Forest Service Consultant), staff from the Los Angeles County Fire Department Arson Unit, and SCE staff at the fire location. I took photos, observed numerous destroyed and damaged SCE facilities (See Photo 3, titled *Damaged SCE Facilities*) and a line of metal fragments (See Photos 4 and 5 titled *Line of Metal Fragments #1 and #2*, respectively), believed to be aluminum, on the ground from the north phase conductor of the Veterans Circuit. This was the only conductor of three fallen conductors for this circuit within the subject span between poles 1154864E and 1154863E that sustained damage (See Photo 6, titled *Subject Conductors*). The conductor melted as a result of the heat and/or fire. The center and south phase conductors were attached with tie wire on post-type insulators. The north phase conductor was attached by a clamp-type insulator. The Los Angeles Arson Unit staff stated to me that they believe SCE's overhead facilities are located where the fire originated.

Photo 3
Damaged SCE Facilities

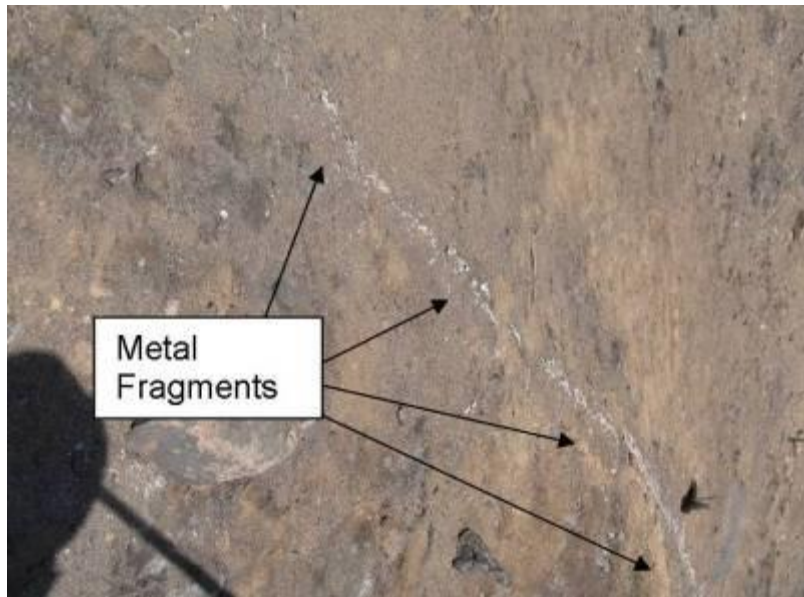
Photo 4
Line of Metal Fragments #1

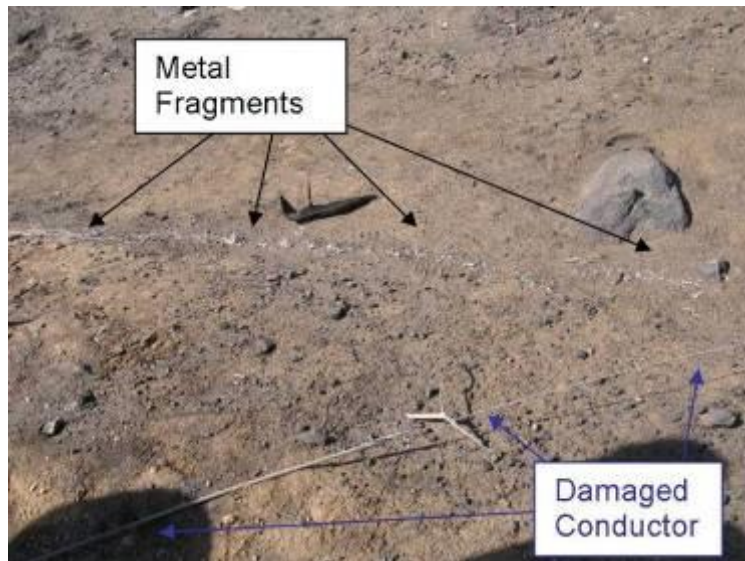
Photo 5
Line of Metal Fragments #2

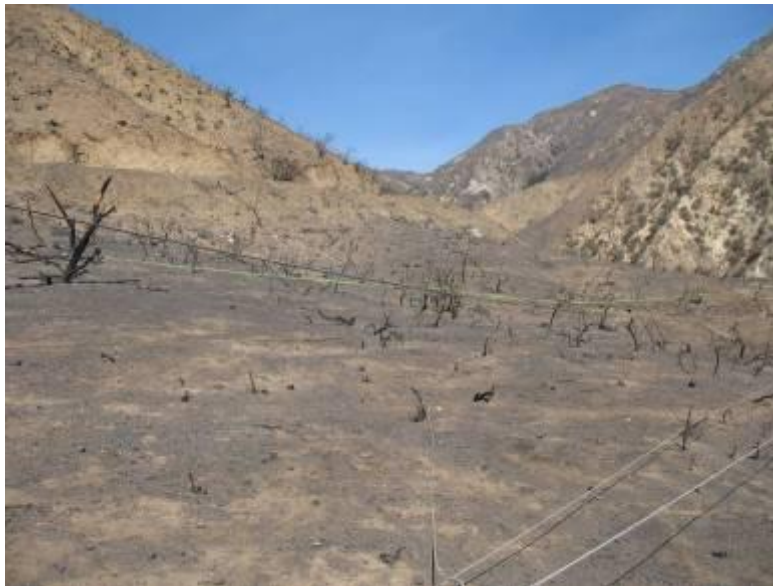
Photo 6
Subject Conductors

SCE’s facilities sustained fire damage to several poles and conductors. SCE determined that numerous conductors between pole numbers 1154861E and 4717630E fell to the ground subsequent to the poles burning. The conductors within the subject span of pole numbers 1154864E and 154863E were still attached to the cross-arm at pole number 1154863E after the pole broke and partially burned but one (north phase) of the three conductors was melted. See Figure 2, titled *Pole Line Map* for an overview of facilities near the incident site. SCE is the sole owner of the poles, but at one time General Telephone Company was a joint owner of some of the damaged poles.

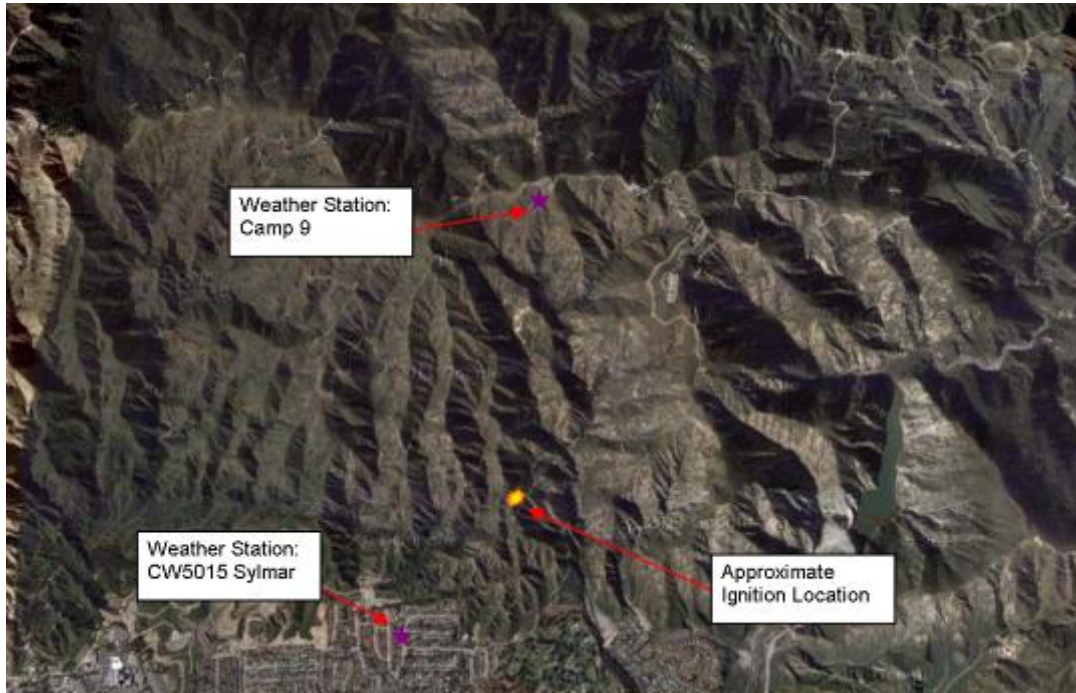
Figure 1
Weather Station Map

Weather Station Camp 9 (CNIC1) on top of a hill at an elevation of approximately 4000 feet and approximately 1.5 miles northeast of the incident site, recorded wind speeds 19-23 mph with gust up to 61 mph around the time of the start of the fire. Weather Station CW5015 Sylmar (C5015) in a residential area at an elevation of approximately 1650 feet and approximately one mile southwest of the incident site, recorded wind speeds 9-13 mph with gust up to 32 mph around the time of the start of the fire. See Figure 1, titled *Weather Station Map* for an overview of the weather station locations relative to the fire location. According to the City of Los Angeles Fire Department, the winds were blowing steadily at approximately 50-60 mph and gusting 70-80 mph. According to the Los Angeles County Fire Department the winds were blowing steadily at 40 mph with gusts up to 70 mph.
