CALIFORNIA PUBLIC UTILITIES COMMISSION
Safety and Enforcement Division
Electric Safety and Reliability Branch

Incident Investigation Report

Incident Number: E 20191011-01

Utility Facilities involved: 220 kV Gold-Sylmar Circuit

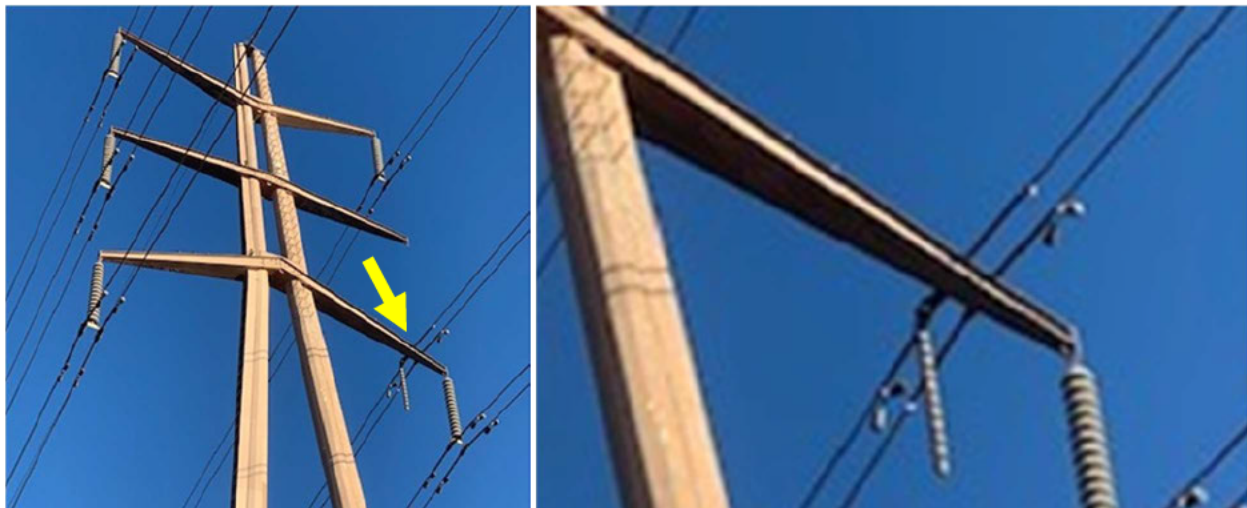
On October 10, 2019, at approximately 8:57 PM, the insulator Y-clevis end fitting supporting the B phase conductor of the 220 kV Gould-Sylmar circuit failed. This caused the B phase conductor to fall onto the underbuilt steel arm supporting the C phase conductor of the 220 kV Gould-Sylmar circuit (see Figure 3). The contact between the B phase conductor and the steel tower caused a B-phase-to-ground fault on the 220 kV Gould-Sylmar circuit, which in turn caused the

Figures 2 and 3: A photograph of tower M5-T2 showing the middle B phase conductor that fell onto the lower supporting arm on October 11, 2019 (source: Enrique Camacho of OWR Nursery, 14220 Tyler Street, Sylmar). The yellow arrow was added to identify the contact location of the 220 kV conductor and the lower tower arm.

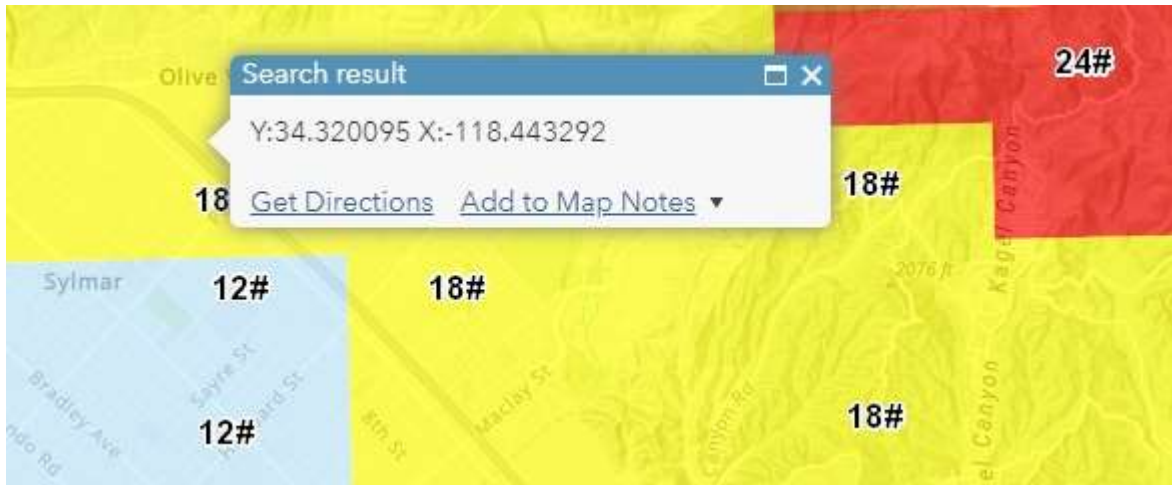
SCE Tower M5-T2 was constructed and designed in 1970 with a wind load of 8 pounds per square foot (psf) as defined in General Order (GO) 95, Rule 43.2: Light Loading. However, SCE provided a wind load map used for pole loading that indicated that tower M5-T2 was in a known 18 psf wind load area at the time of the incident (Figure 4). In its response to data request response no. 2, question 11, SCE stated, “Tower 5/2 is located in the Yellow = 18# - 84 mph wind loading tier. The yellow tier is the second highest of the five wind loading tiers.” While this wind load map was not used for towers, it should be noted that wind speeds generally increase with height above ground due to reduced friction with the ground. As a result, conductors installed on towers are usually exposed to higher wind speeds than conductors installed on poles.

Figure 4: SCE wind loading map used for pole loading with GPS coordinates of tower M5-T2.

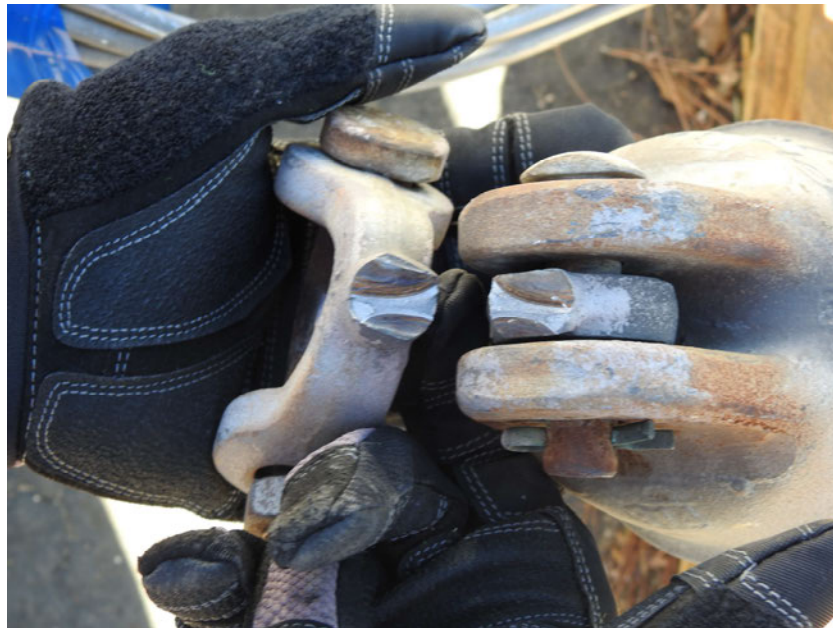
On October 25, 2019, ESRB inspected evidence at an SCE service yard. One of the items collected was the Y-clevis end fitting that was used to hold the ceramic string insulator onto the B-phase arm of tower M5-T2. The broken ends of the Y-clevis end fitting showed signs of fatigue, e.g., beach marks, and corrosion on the fracture surface (see Figure 5). SCE indicated that it believes that the Y-clevis end fitting, likely a Lindsey brand fitting forged from galvanized steel, was installed in 1970 and had an expected service life of 100+ years.

Figure 5: a photograph taken on October 25, 2019, at the evidence inspection at the SCE service yard, shows corrosion on the failed section of Y-clevis that supported the B-phase 220 kV conductor on tower M5-T2.

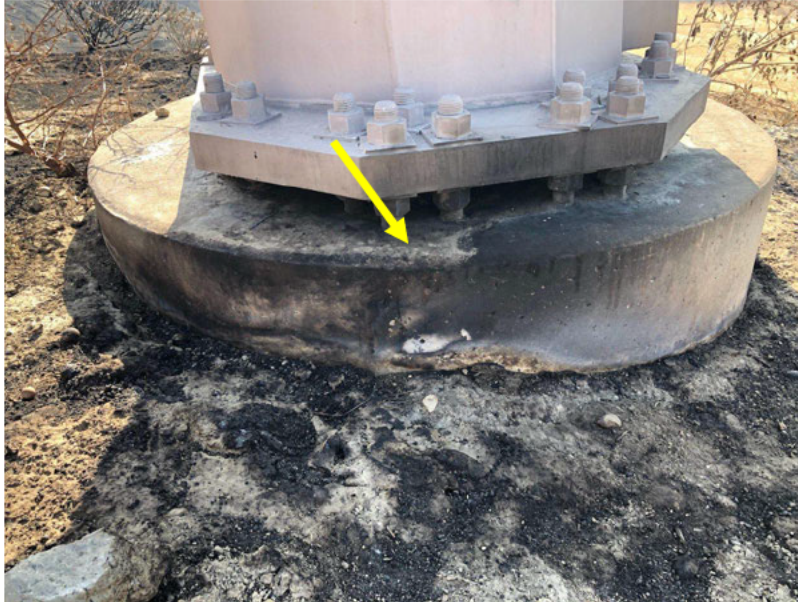
Another piece of evidence that ESRB considered from a photograph from the Los Angeles Fire Department (see Figure 6). The photograph shows unusual burning on the footing on Tower M2-T4, which is one tower away from Tower M2-T5¹.

¹ LAFD Fire Investigation Report No. 2019-10-0664 states, “additional towers were surveyed for damage. At Tower 2/4, I observed high heat burn patterns at its base including spalling of the concrete. These patterns did not appear to be consistent with the fuel load and fuel arrangement in this area. It is possible the damage may be related to the catastrophic failure at Tower 5/2.”

Figure 6: LAFD photograph showing evidence of unusual burning on one of the footings on Tower M2-T4.

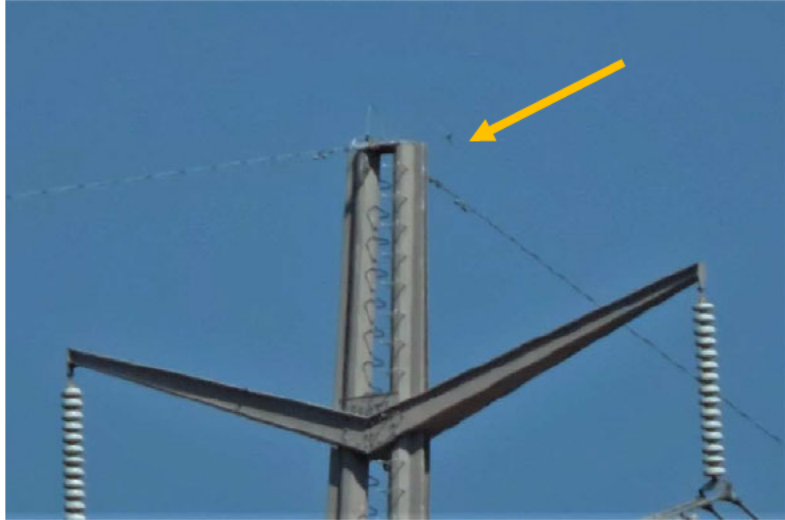
1. **Broken skyline jumper wire on M2-T6**: The photograph in Figure 7, taken on October 12, 2019, of tower M2-T6, located just east of M2-T5, showed a broken skyline jumper wire. The "skyline" (alternatively referred to as a "static line" or "shield wire") has multiple functions, including directing lightning strikes to ground, contributing to the grounding system during a fault event, and supporting communications cables. After the incident, SCE discovered and repaired the broken skyline jumper wire. SCE indicated that a skyline jumper wire provides an optimal path but is not necessary when there are no insulators on the skyline. However, because SCE chose to install a jumper wire on the skyline, SCE is required to ensure that the jumper is maintained. SCE is in violation of GO 95, Rule 31.1 for failing to design, construct, and maintain the skyline jumper wire so that it will not break under normal operating conditions. Additionally, SCE is in violation of GO 95, Rule 44.3 for failing to ensure that the skyline jumper wire maintained a minimum safety factor of 1.33.

Figure 7: A photograph of Tower M2-T6 with an arrow pointing to the detached skyline on the top of the tower.
