**Pacific Gas and
Electric Company®**

Response to CPUC 2020 audit inspection findings report of PG&E's Cupertino
Substation Headquarters

**CPUC AUDIT FINDINGS OF PG&E CUPERTINO
SUBSTATION HEADQUARTERS
JULY 6-10, 2020**

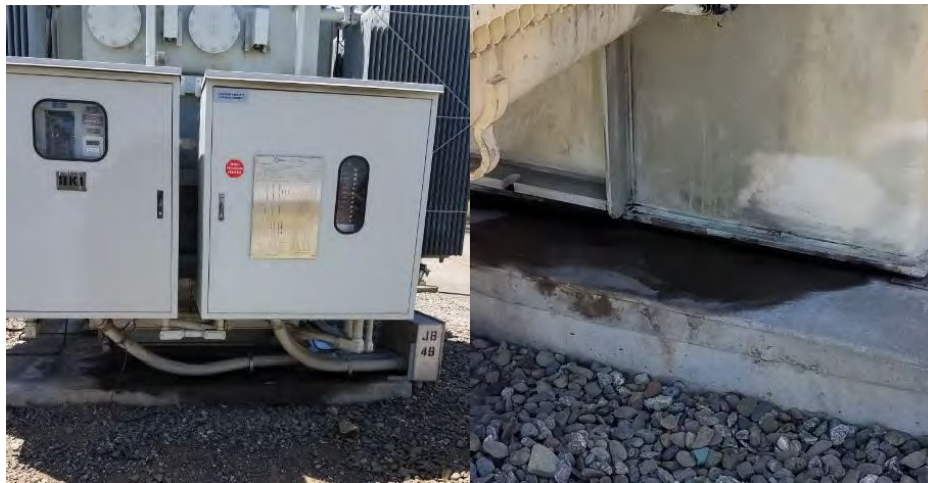
1.1. There are oil leaks at Transformer #1 and Transformer #2.

PG&E Response: Both oil leaks have been corrected:

- Wolfe Substation Transformer Bank #1 oil leaks were corrected, and the areas impacted was cleaned. Work was completed on 7/28/2020 under Notification 119363519.
- Wolfe Substation Transformer Bank #2 oil leaks were corrected, and the area impacted was cleaned. Work was completed on 8/09/2020 under Notification 119571993.

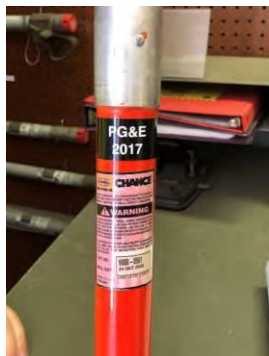
- 1.2. A hot stick has a 2017 sticker. This is in violation of PG&E Utility Standard TD-3322S, which requires testing of hot sticks every two years.

PG&E Response: PG&E’s Inspection, Care and Testing of Live-Line Tools policy is covered by Utility Procedure TD-2008P-01 (Attachment 1_TD-2008P-01.pdf). This utility procedure establishes requirements and processes for inspecting, caring for and testing of live-line tools every two years. Section 6.1 covers “Test Verification Stickers” which validates the year the tool was last tested and directs the user to “Never use a hot stick/live-line tool that does not have a current date test sticker.”

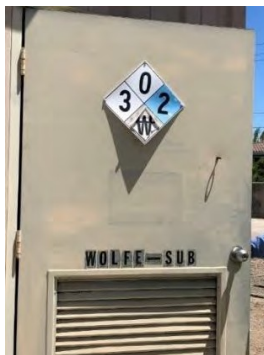
- 1.3 The National Fire Protection Association (NFPA) 704 Diamond on the door for the control room is faded and needs to be replaced.

PG&E Response: The faded NFPA sign on the control room door at Wolfe Substation was replaced as part of the August Station Inspection. No corrective notification was created to remove and replace the sign.

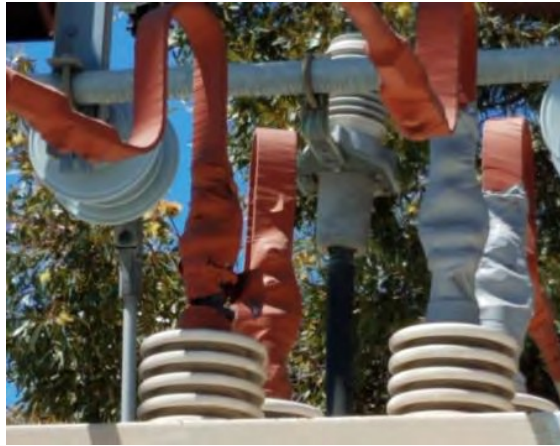
- 2.4. The animal abatement on CB (Circuit Breaker) 1113/2 is damaged.

PG&E Response: As responded in CPUC Data Request #2 (CPUC Reference Number: SA2020-870), in response to Question 1.b., PG&E representatives noted the animal abatement “flagging” observed on CB 1113/2 specifically on 1113/1 ‘A’ phase drop to the breakers bushing. This observation poses no immediate risk and will be bundled with the next planned breaker maintenance that requires an electrical clearance to be completed before the end of Q1 2021.

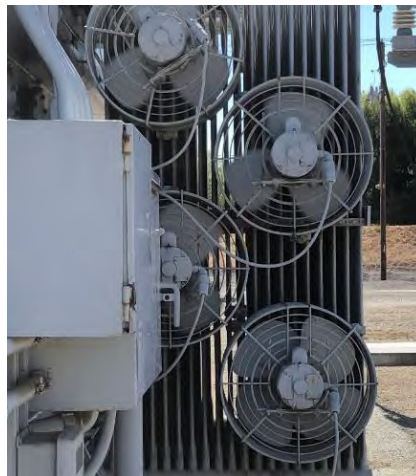
3.2. Transformer #1 has a fan that is not operating, which is in violation of PG&E's TD-3350P-12.

PG&E Response: Notification 119551290 was created to remove and replace the non-operating fan on Ames Transformer #1. This work was completed on 8/02/2020.

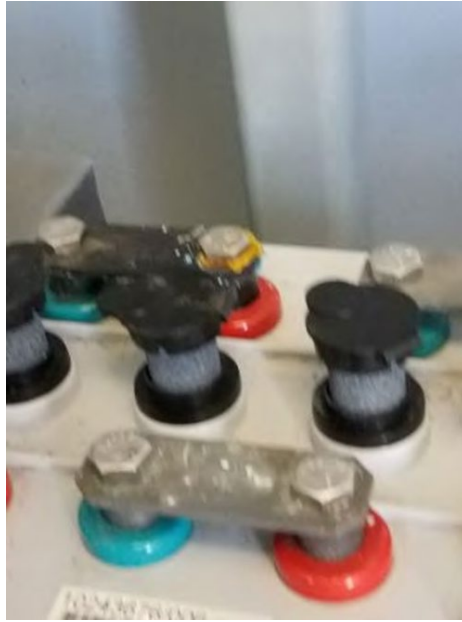
3.3. The substation battery #2 has corrosion.

PG&E Response: Notification 119582030 was created to remove the corrosion observed on battery cell #2 of the Ames Substation DC system. This work was completed on 8/09/2020.

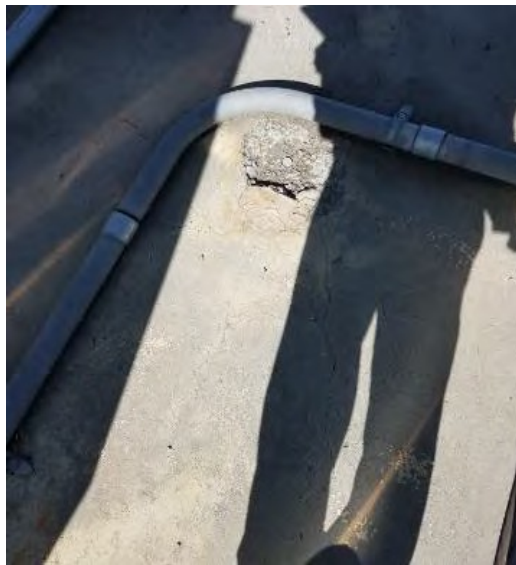
4.1. There is concrete damage by CB 1108/2.

PG&E Response: Notification 119581435 was created to assess all concrete foundations at Lawrence Substation. The assessment from Substation Civil Engineering for this foundation deemed this damage superficial and nonstructural with no further action required at this time. Substation will continue to monitor for further degradation and take corrective actions if necessary.

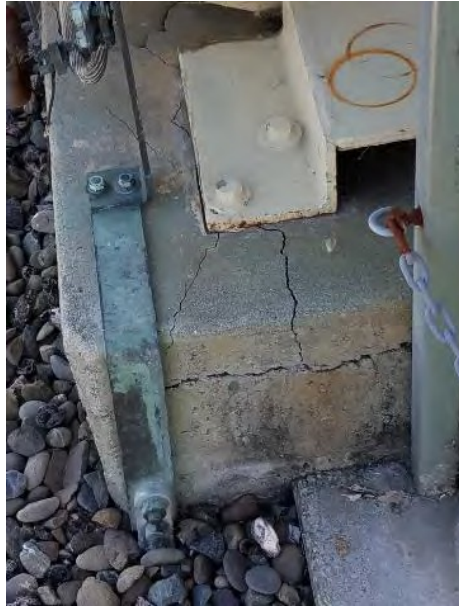
4.2. There are cracks in the concrete foundation for Transformer #1/A.

PG&E Response: Notification 119581435 was created for Substation Civil Engineering to evaluate the cracked foundation observed for Lawrence Transformer Bank #1/A. The assessment from the civil engineer recommended epoxy injections into all cracks present to prevent any further degradation of the foundations. This Transformer Bank is still undergoing an extensive evaluation for repair versus replacement. If the Transformer Bank is replaced, new foundations will have to be installed to accommodate the larger footprint for the new bank.

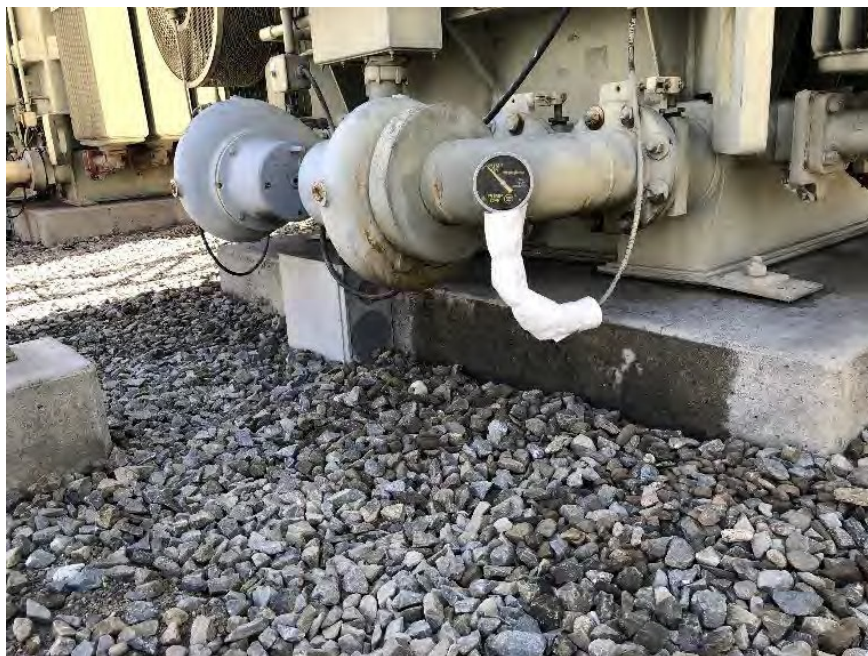
4.5. There is a leak at Transformer #1/C.

PG&E Response: Lawrence Transformer Bank #1 is still undergoing an extensive

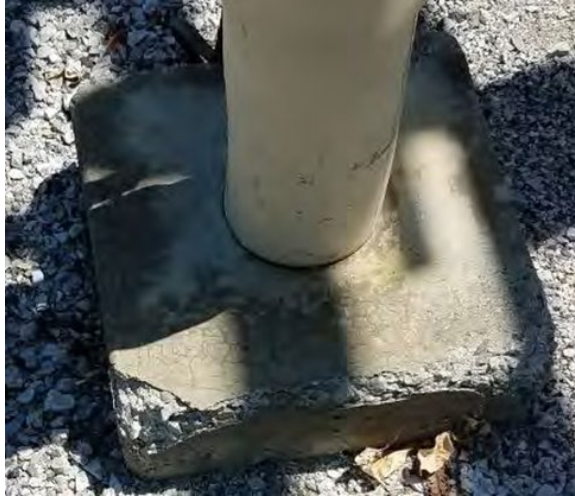
5.1. There is concrete damage at risers by CB1107/2 and by 1108 bus

PG&E Response: Notification 119571995 (CB 1107 riser) and Notification 119571997 (CB 1108 bus) were created for Substation Civil Engineering to evaluate the cracked foundation observed for Trimble CB 1107 riser near the 1108 bus. The assessments completed on 8/12/2020 recommended repair. This work is currently under bid with an approved civil contractor to be completed before the end of Q1 2021.
