SA2022-1004

**SUBJECT:** Electric Substation Audit of PG&E's Concord Headquarters

**CPUC SUBSTATION AUDIT FINDINGS**  
**PG&E CONCORD HEADQUARTERS**  
**April 4 – 8, 2022**

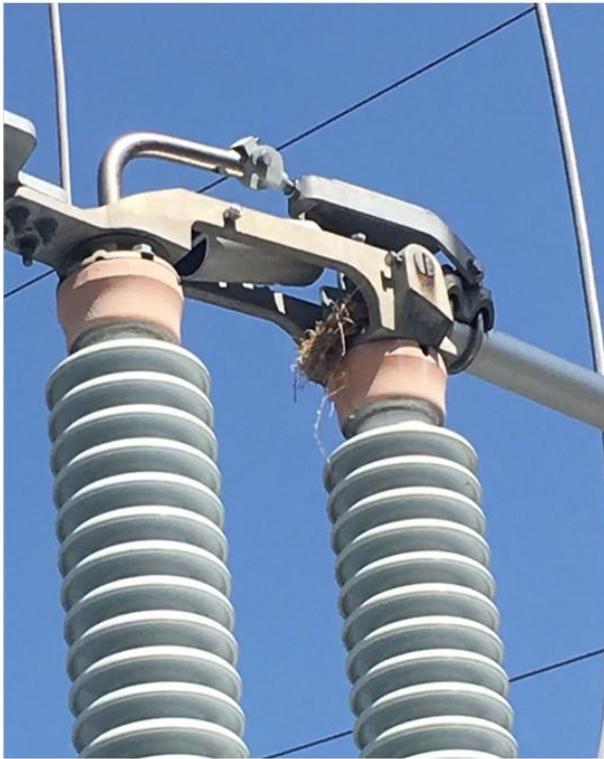
<b>Substations</b>	<b>Findings</b>	<b>Notes</b>
Christie01	A bird's nest at Switch 1215 for Christie-Sobrante line	PG&E Notification #: 123182915
Clayton01	Missing delineator	
Clayton02	Hanging light cover	
Clayton03	Damaged light pole foundation	
Clayton04	Abandoned cooling water hose at the transformer bank cooling fans	
ContraCosta02	Lean and damaged light pole	PG&E Notification #: 123201518
Franklin01	Broken light	PG&E Notification #: 122980381
Pittsburg01	Spare transformer paint peeling	PG&E Notification #: 123216486
Pittsburg02	Tripping hazard	After that audit, PG&E said it corrected this deficiency. PG&E needs to provide photos showing the correction.
PittsburgPP01	Foundation erosion	PG&E Notification #: 123175449
Sobrante02	Abandoned annunciator	
ValleyView01	Missing cover on light pole foundation	
ValleyView02	Leaning light pole	PG&E Notification #: 123206191
WillowPass01	At 21 kV yard - missing cover on light pole foundation	After the audit, PG&E said it corrected this deficiency. PG&E needs to provide photos showing the correction.

Christie01: A bird's nest at Switch 1215

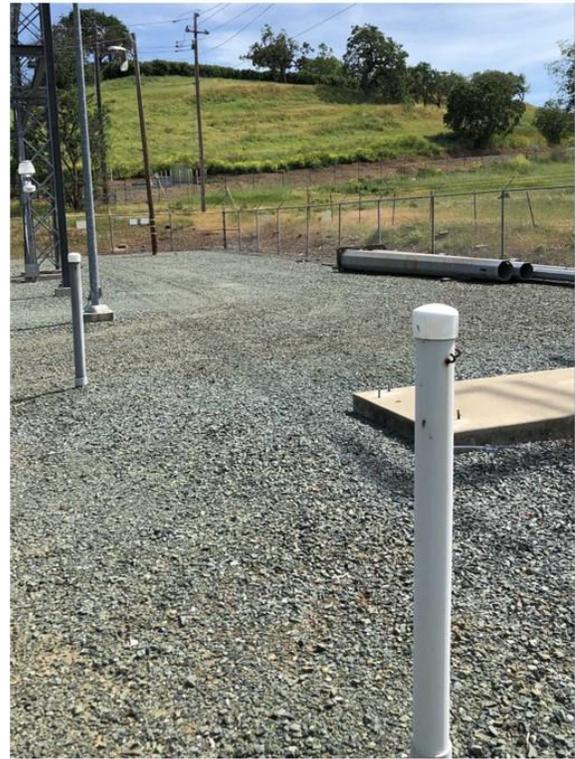
Clayton01: Missing delineator

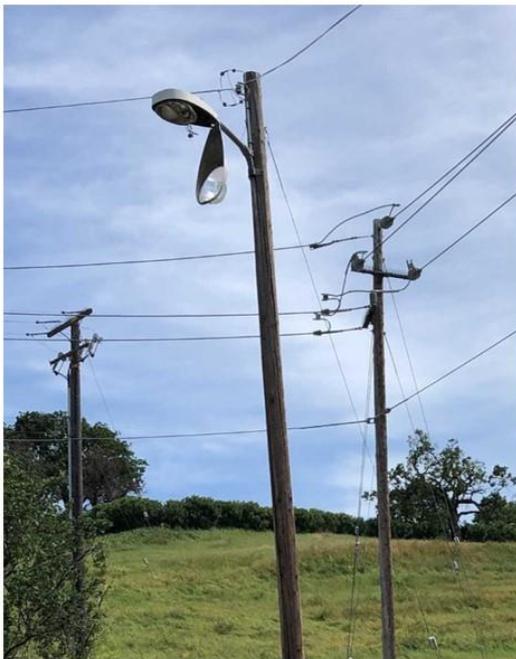
Clayton02: Hanging light cove

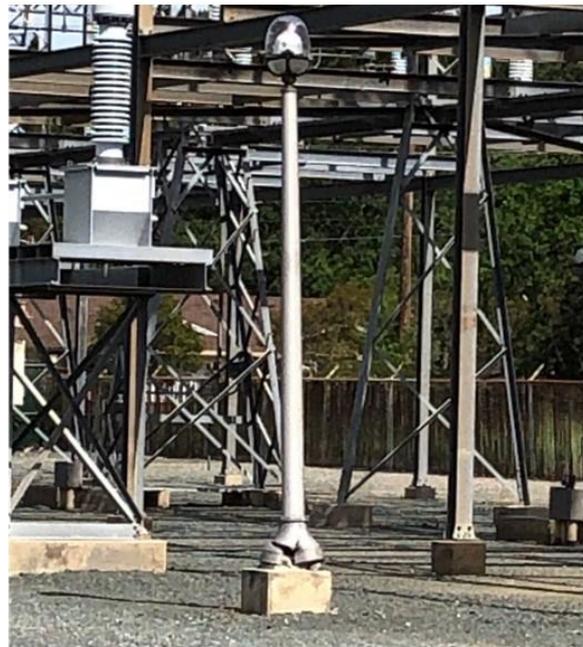
Clayton03: Damaged light pole foundation

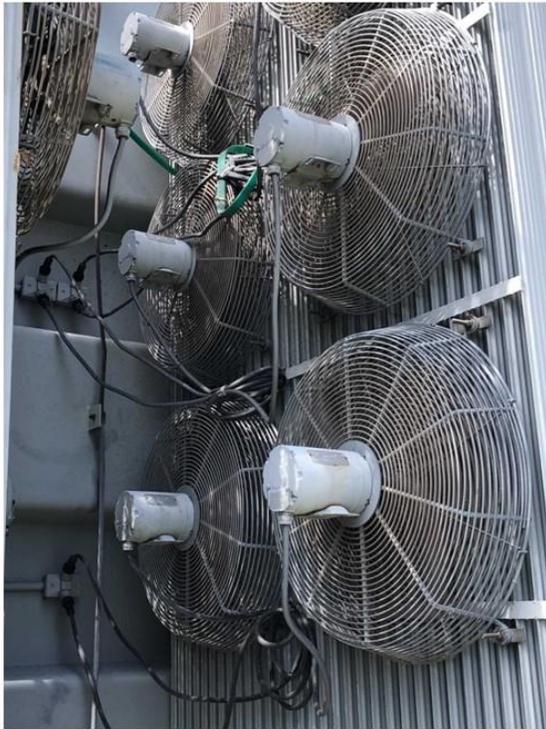
Clayton04: Abandoned cooling water hose at the transformer bank cooling fans

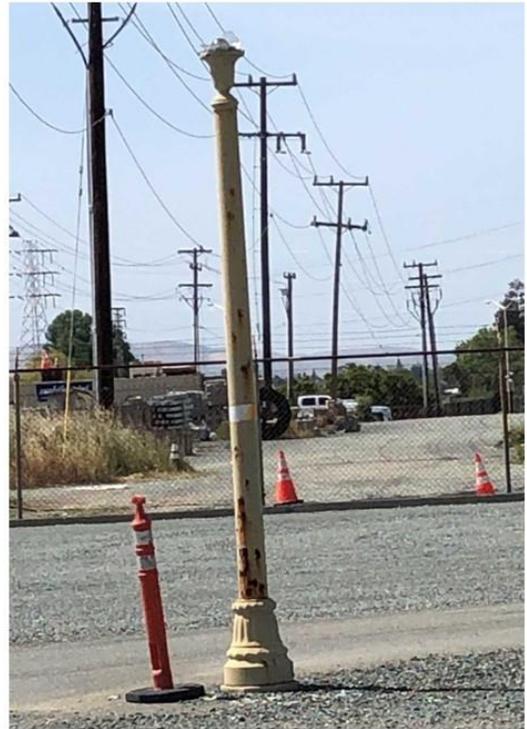
ContraCosta02: Lean and damaged light pole

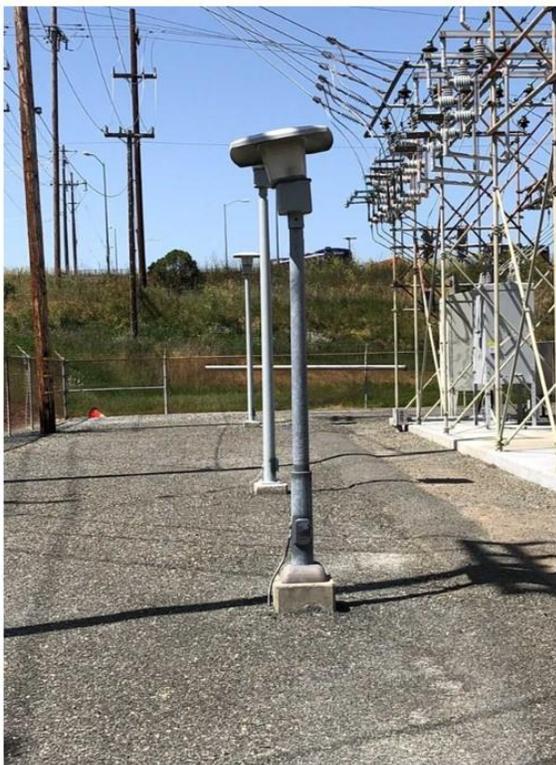
Franklin01: Broken light

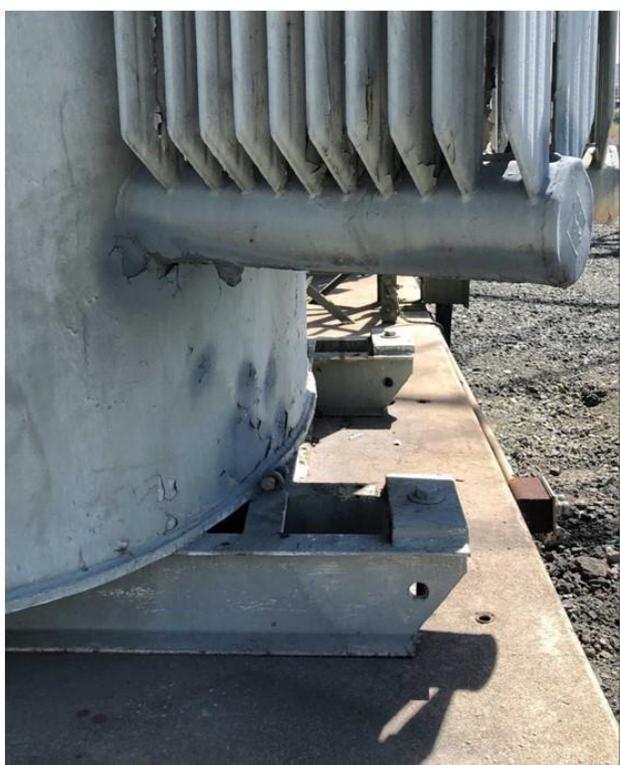
Pittsburg01 Spare transformer paint peeling

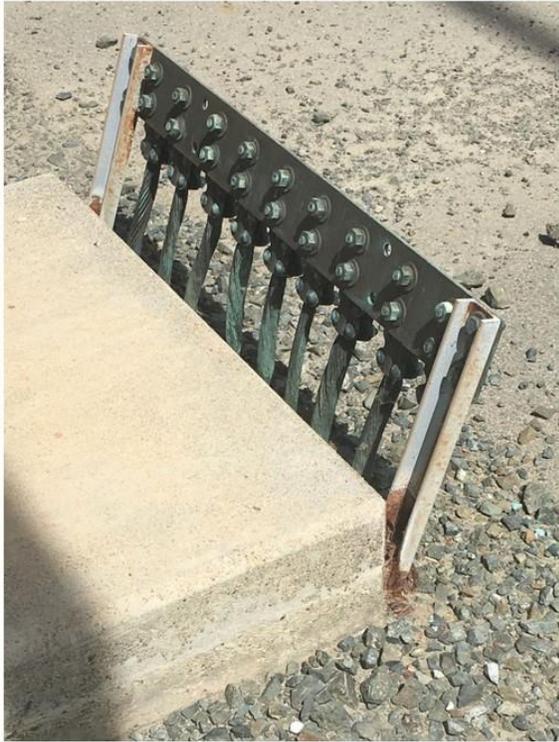
Pittsburg02: Tripping hazard

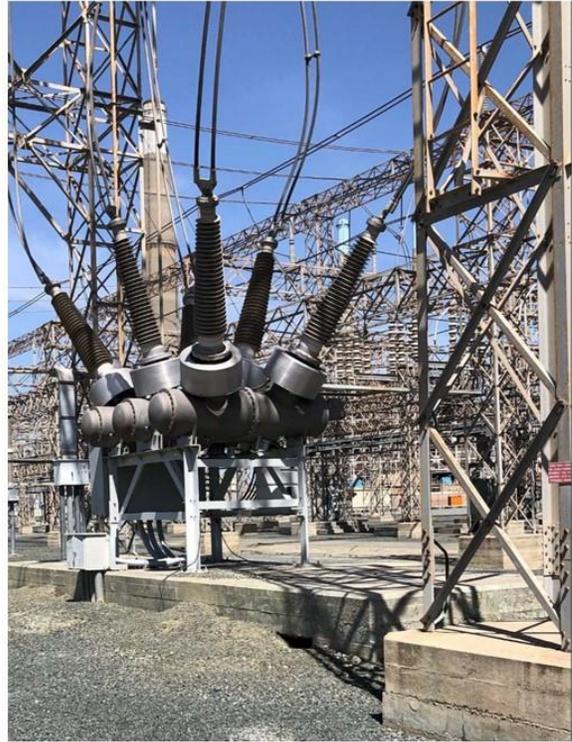
PittsburgPP01: Foundation erosion

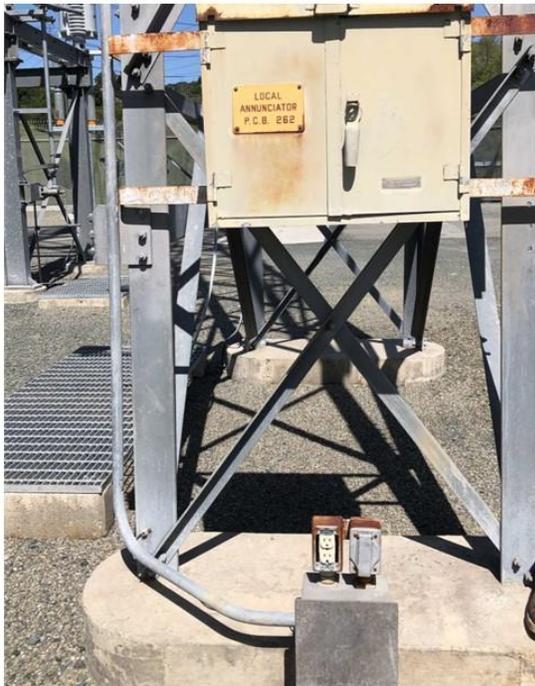
Sobrante02: Abandoned annunciator

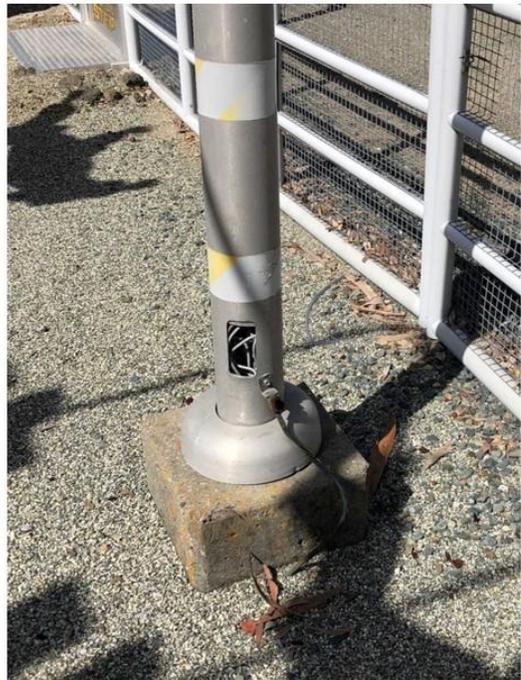
ValleyView01: Missing cover on light pole foundation

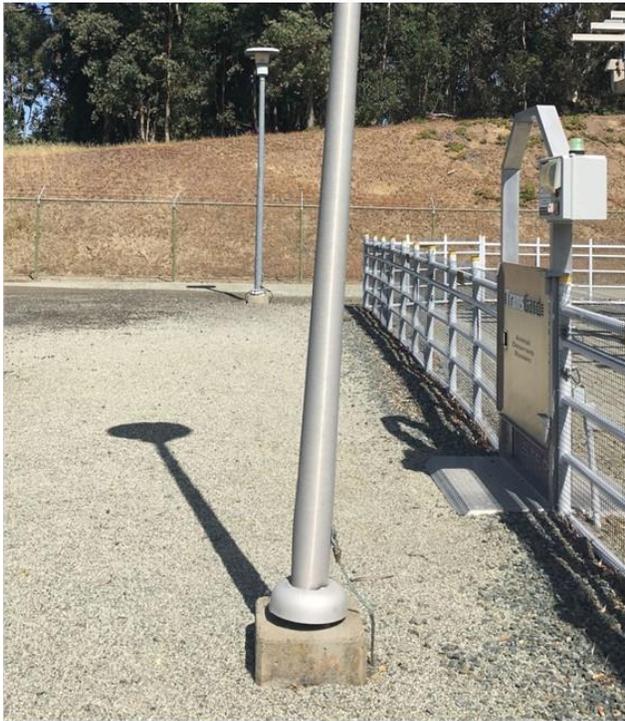
ValleyView02: Leaning light pole

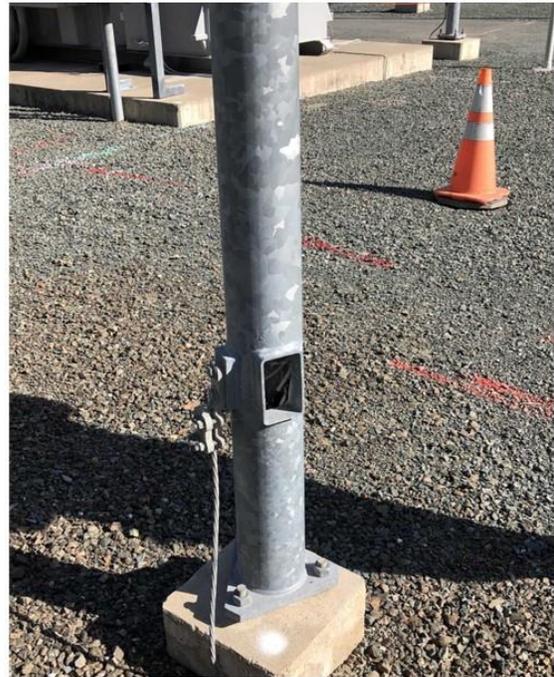
WillowPass01: At 21 kV yard - missing cover on light pole foundation

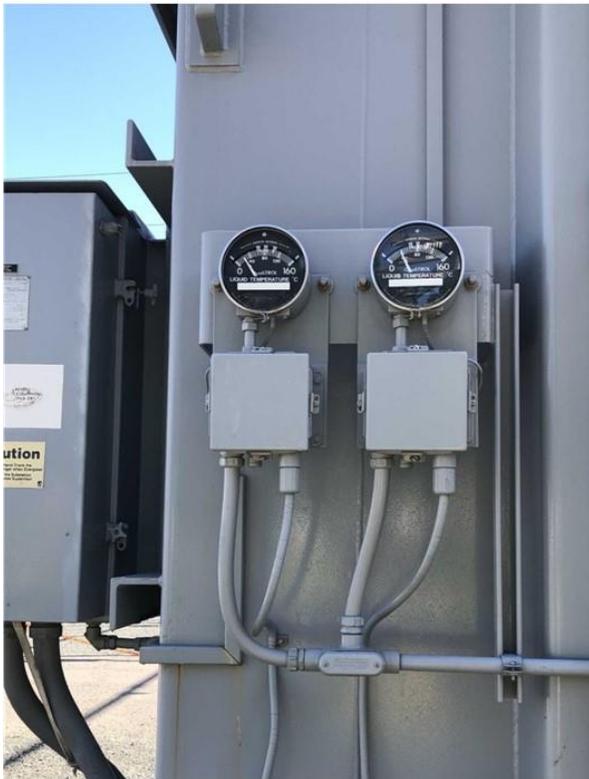
WillowPass02	Faded gauge labels at Bank 3	After that audit, PG&E said it corrected this deficiency. PG&E needs to provide photos showing the correction.
WillowPass04	The "High" is missing in the "High Voltage" sign

WillowPass02 Faded gauge labels at Bank 3

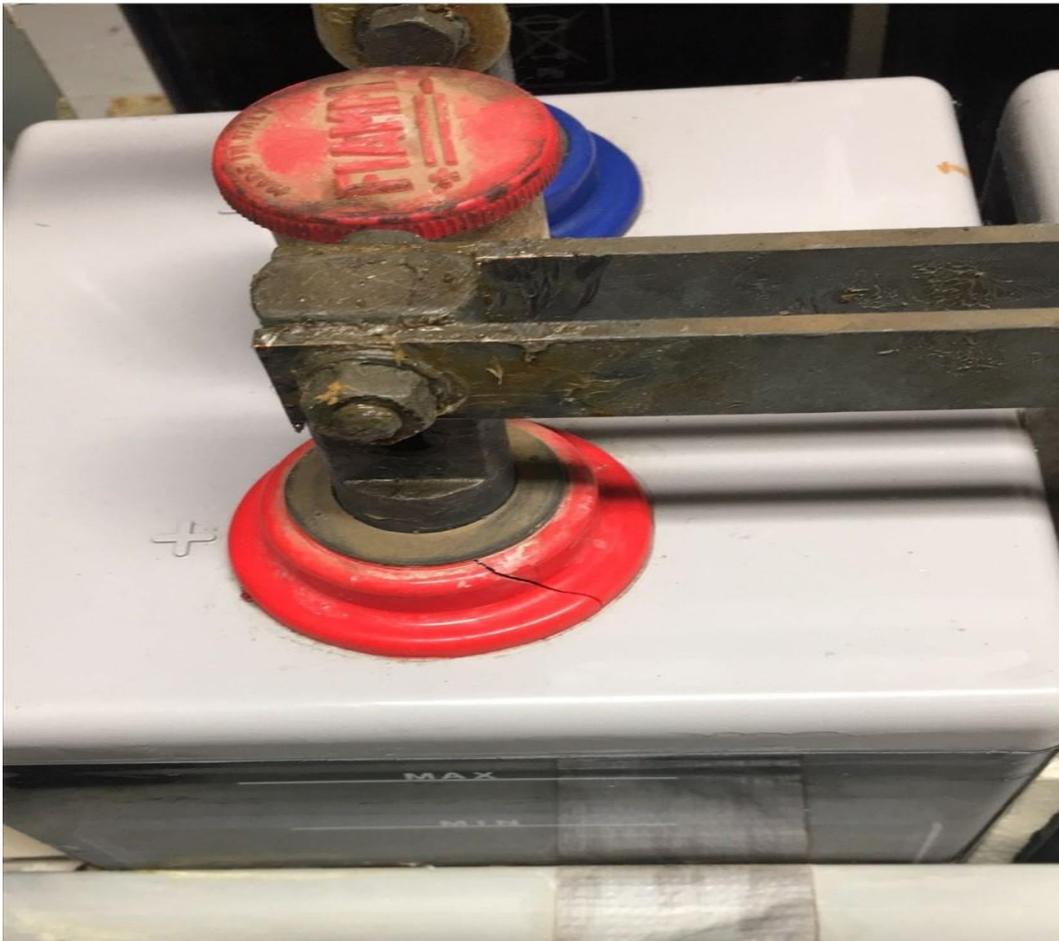
**Figure 5: TD-3322M Substation Batteries Subsection II.D.1 Finding**

*“While performing battery maintenance, inspect all battery cell jars, terminal posts, and racks for corrosion, electrolyte leaks, damage, cracks, and bulging cases.”*

<b>Substation</b>	<b>Finding</b>	<b>Notes</b>
ContraCosta01	Cracking cap at the battery terminals	PG&E Notification #: 120849300

ContraCosta01: Cracking cap at the battery terminals

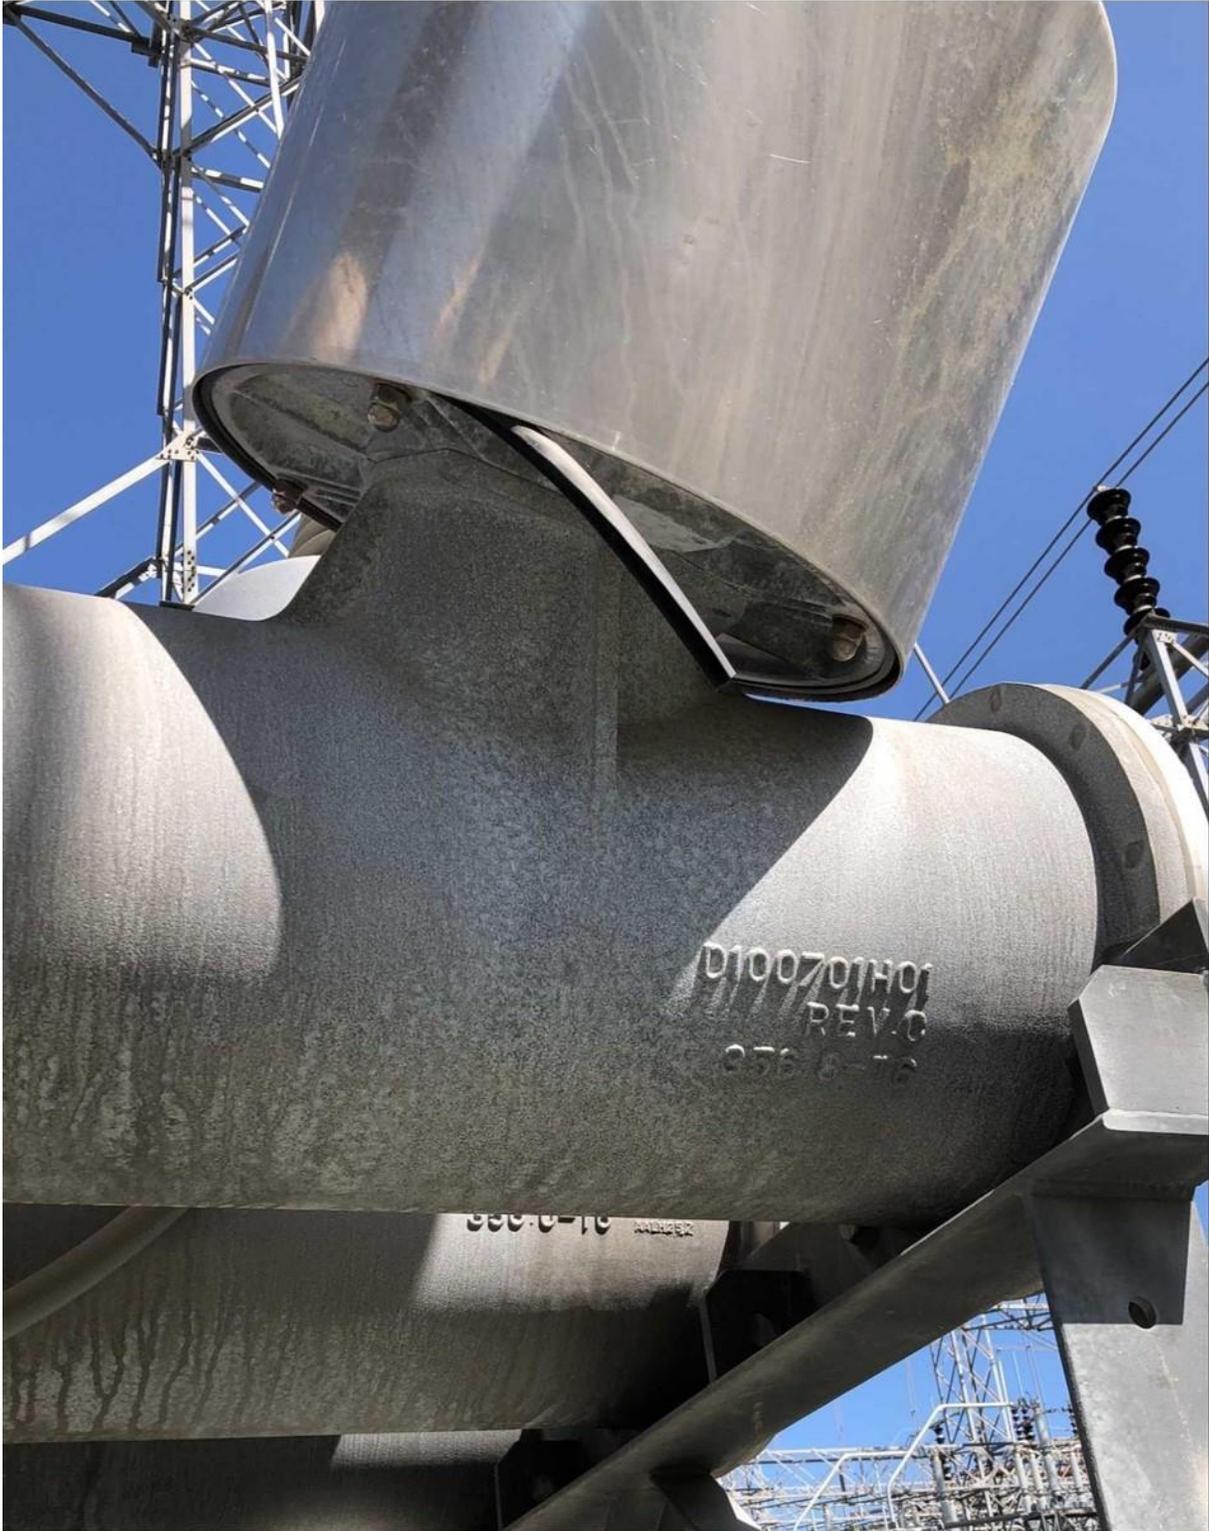
**Figure 6: TD-3322M Substation Inspection Manual, Subsection V.J.11 Finding**

<b>Substation</b>	<b>Finding</b>	<b>Notes</b>
Moraga01	Loose gasket on Circuit Breaker (CB) 372	After that audit, PG&E said it corrected this deficiency. PG&E needs to provide photos showing the correction.

Moraga01: Loose gasket on Circuit Breaker (CB) 372

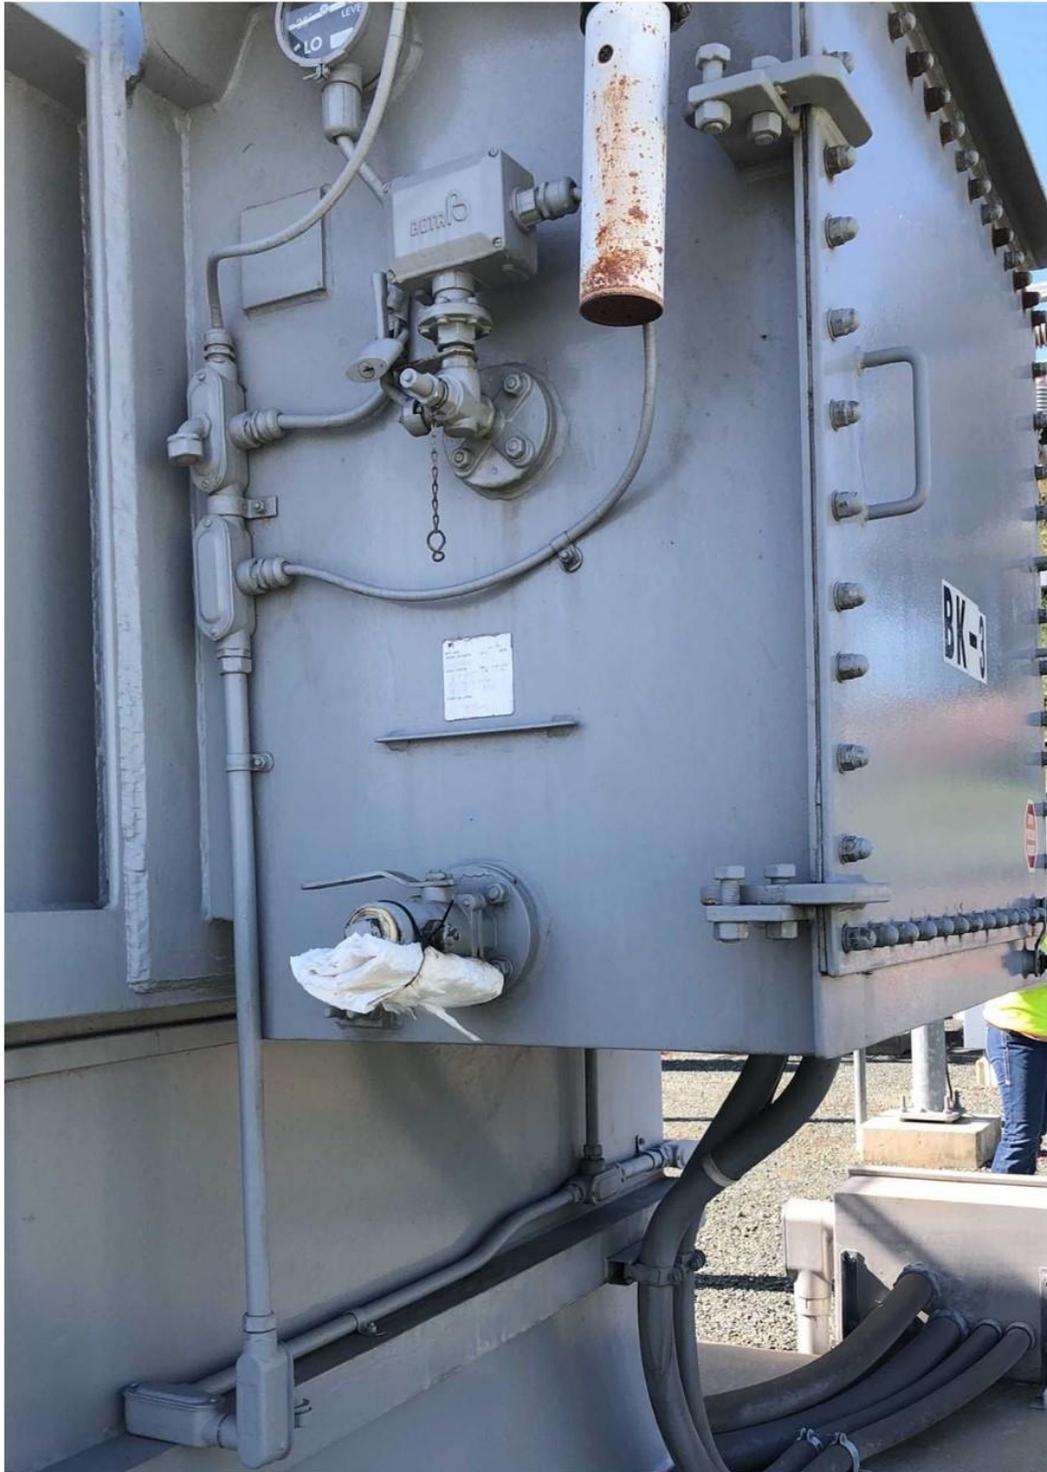
**Figure 7: TD-3322M Substation Inspection Manual, Subsection V.I. Finding**

<b>Substation</b>	<b>Finding</b>	<b>Notes</b>
WillowPass03	Leaking oil at LTC	PG&E Notification #: 121677014

WillowPass03: Leaking oil at the LTC

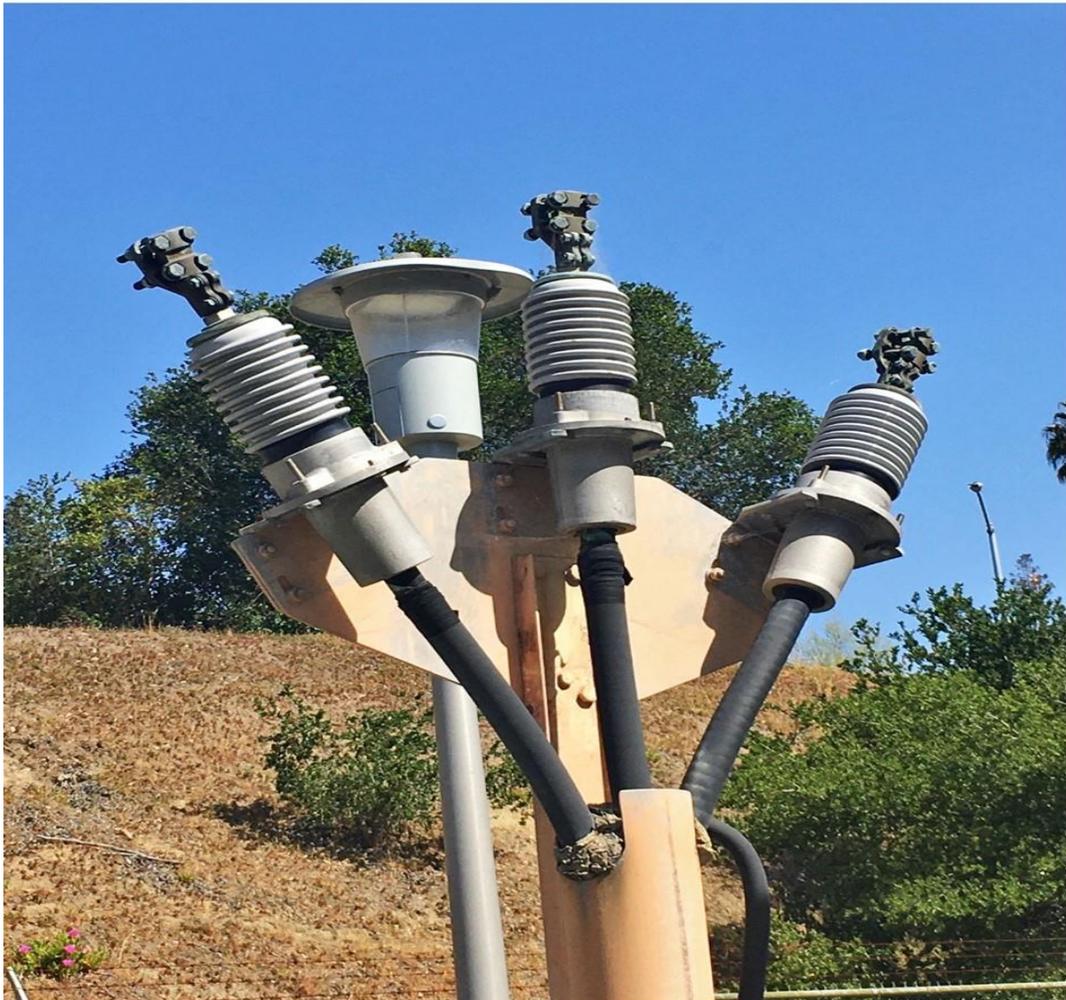
**Figure 8: TD-3322M Subsection V.A.6 Finding**

*“Ensure that stored equipment is grounded properly in accordance with the procedures in the Protective Grounding Manual.”*

<b>Substation</b>	<b>Finding</b>
ValleyView04	An underground cable that is not in use is not grounded

ValleyView04: An underground cable that is not in use is not grounded

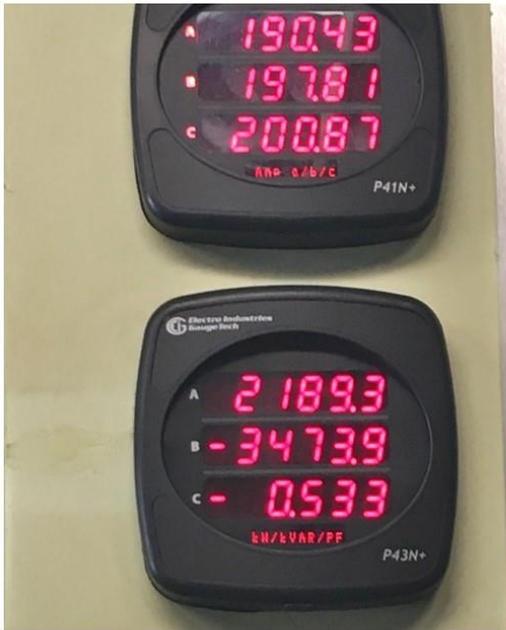
In the electric power industry, the good utility practice is to maintain the power factor for a substation in the range of 0.85 leading to 0.85 lagging (or -0.85----+0.85) to provide adequate services to interconnected customers. ESRB’s observations are listed in the Table 8:

ValleyView03: Power Factor = -0.533

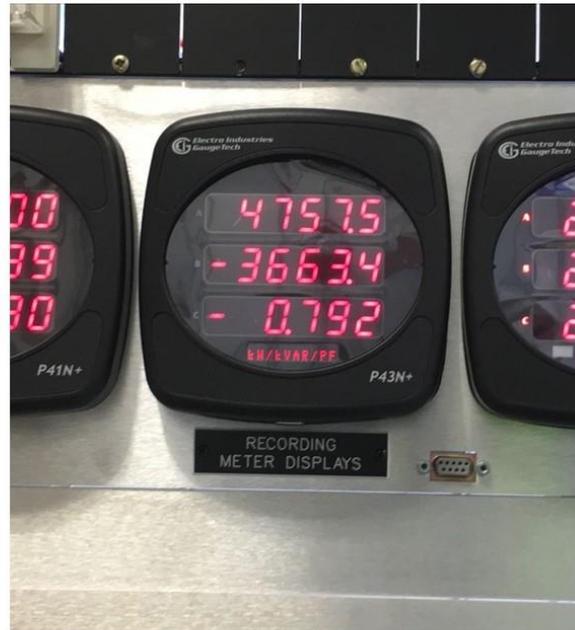
WillowPass04: Power Factor = -0.792

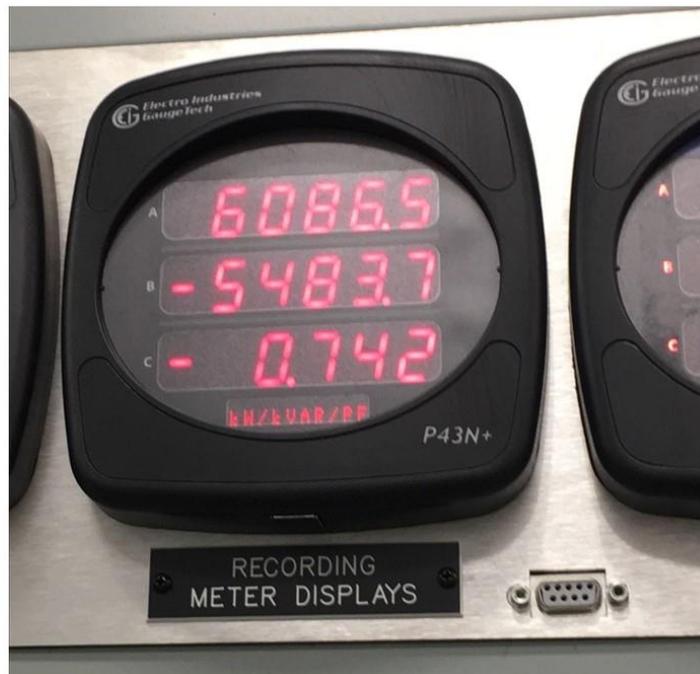
LoneTree01: the Power Factor = -0.742
