## PUBLIC UTILITIES COMMISSION

**SUBJECT:** Facilities Audit of PacifiCorp's Klamath Falls Substations

**PACIFICORP, KLAMATH FALL HEADQUARTERS  
SUBSTATION AUDIT FINDINGS  
AUGUST 12-16, 2024**

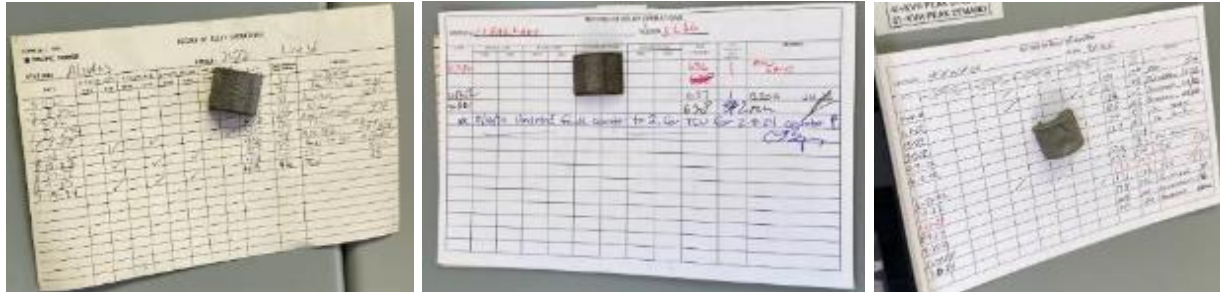
circuit breaker/relay card.”<sup>11</sup> Incorrect entries with missed fault counts were recorded at (see Figure 1 a, b, c):

- i. Alturas Substation, Feeder 2L22
- ii. Clear Lake Substation, Feeder 5L66
- iii. Newell Substation, Transmission Circuit Breaker 3L25

Figures 1 a, b, c. Counter card entry errors for Alturas, Clear Lake, and Newell Substations

ESRB notes that the Relay Operations cards at each site were corrected in the field.

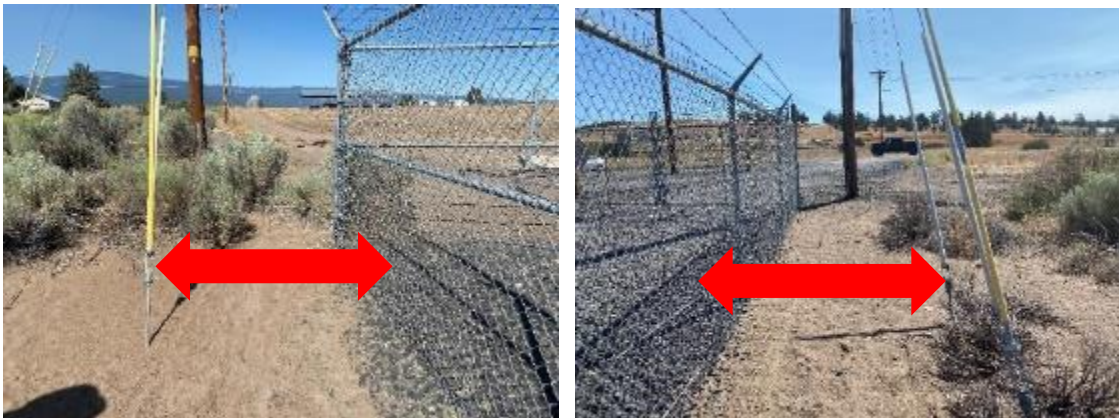
- 1.1. Touch potential between down guy and fence. Down guys are within 5 feet of station perimeter fence. No evidence that exterior structures are attached to the station ground grid.<sup>21 22</sup>

<sup>21</sup> PacifiCorp's Engineering Handbook 6B.6 section 4.2.1 calls for the peripheral ground conductors to be installed four feet outside the fence, parallel with the fence. The down anchors noted here are within touch potential and outside the peripheral ground.

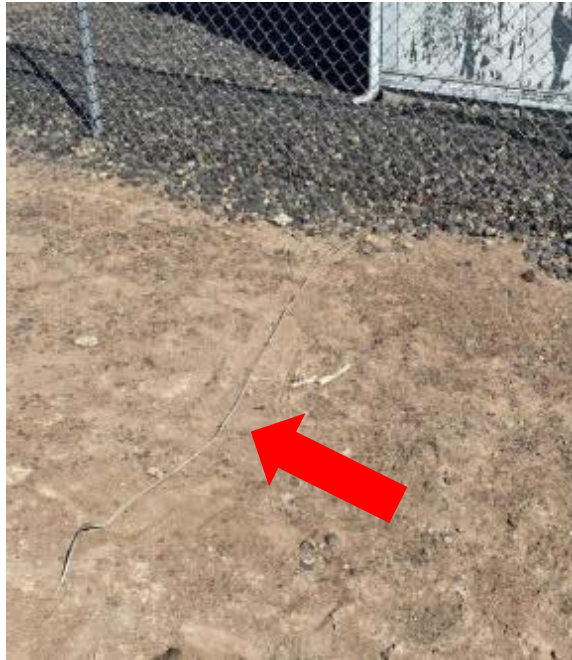
1.2. Station fence has an unattached ground wire.

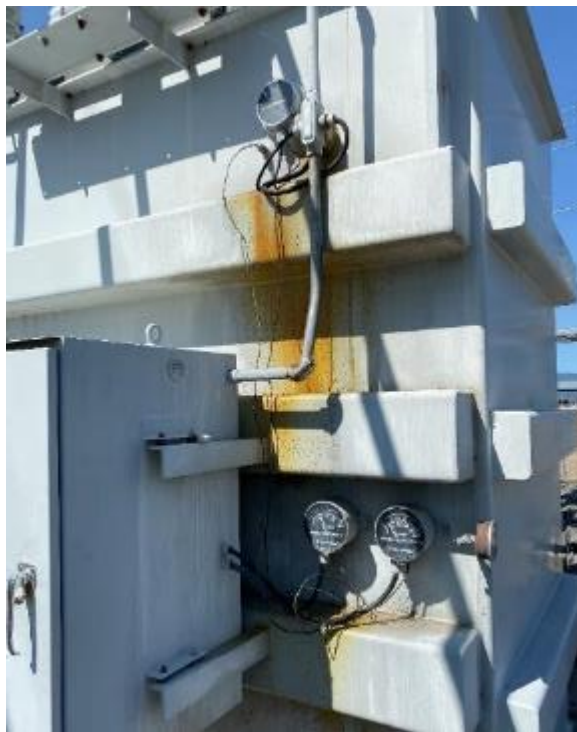
1.3. Transformer 3520 has an oil leak.<sup>23</sup>

<sup>23</sup> PacifiCorp notes that work orders were opened and closed for cleaning the leak, but not to repair the leak.

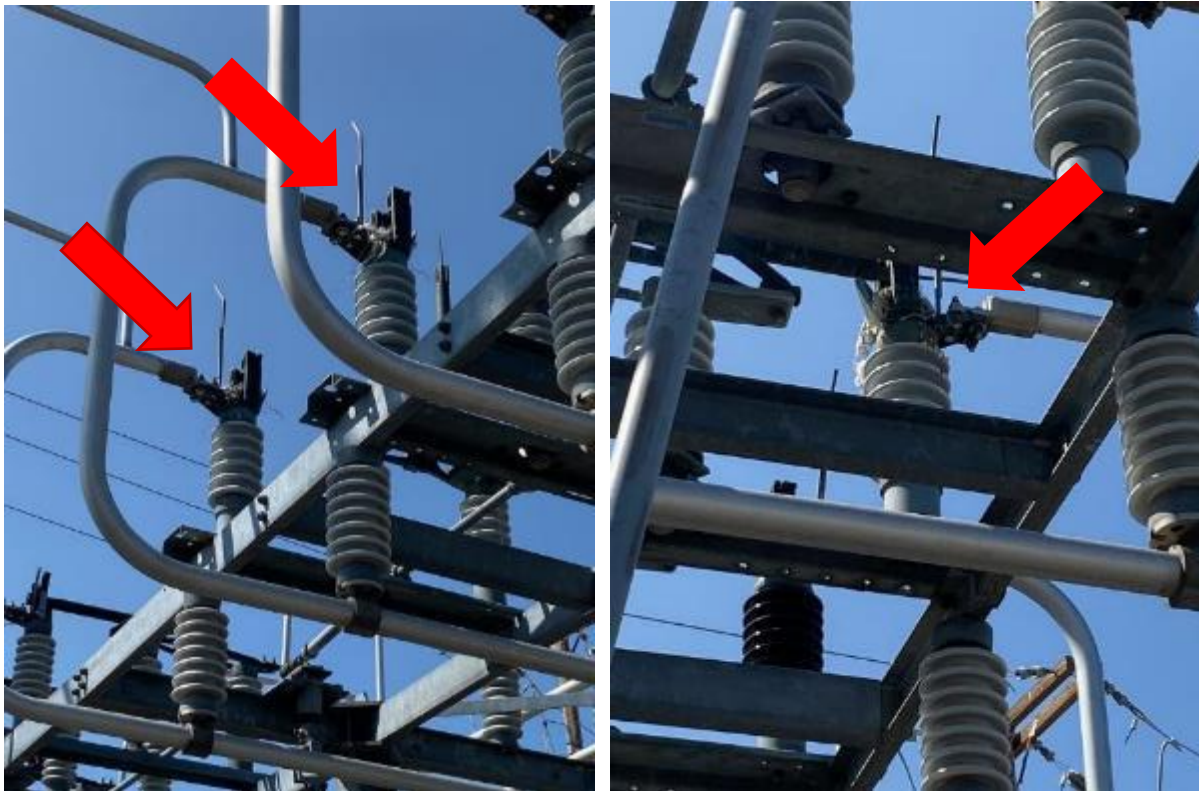
1.4. Switch 4L4 phases A and B have bird nests. Switch 4L5 phase B has a bird nest.

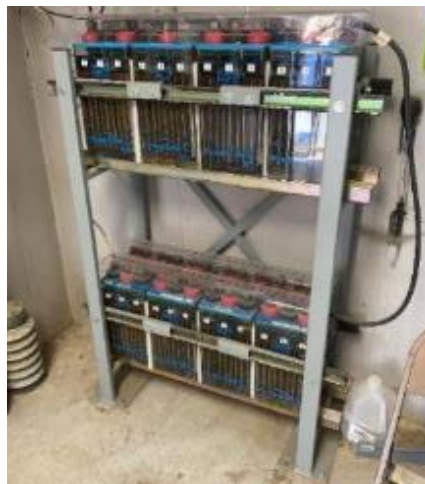
1.5. Station batteries have no provision for containing spilled electrolytes, and the metal battery rack is not grounded.<sup>24</sup>

<sup>24</sup> National Electric Safety Code (NESC 2017), Part 1 Section 14, Item 143. Racks, states in part, “Racks made of metal shall be grounded.”

ESRB notes that Berkshire Hathaway Energy (BHE, parent company of PacifiCorp) has no requirement for secondary containment for batteries.<sup>25</sup> National Electric Safety Code calls for provisions to contain spilled electrolytes.<sup>26</sup> Containing electrolytes be accomplished by secondary containment, dams, absorbent materials, or spill pillows.

Additionally, BHE's Substation Equipment—Flooded Lead-Acid Stationary Batteries EBU-BT-S01 states, "Racks shall have holes or brackets suitable for fastening the rack unit to the wall and ground surfaces. The battery rack shall have provisions for grounding".<sup>27</sup> PacifiCorp states that the rack was installed prior to the issuance of EBU-BT-S01 (Dec 2020) and believes the grounding requirement should be grandfathered.<sup>28</sup> As the NESC requirement for battery rack grounding predates the BHE document, prior revisions of the Flooded Lead-Acid Stationary Batteries rack standard should require grounding of the battery rack. No installation date of the battery rack was provided.

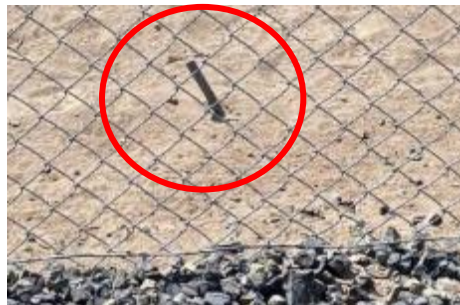
- 1.6. Station has abandoned ground rod causing a tripping hazard 1 foot outside fence perimeter. The rod may also be a touch potential hazard.

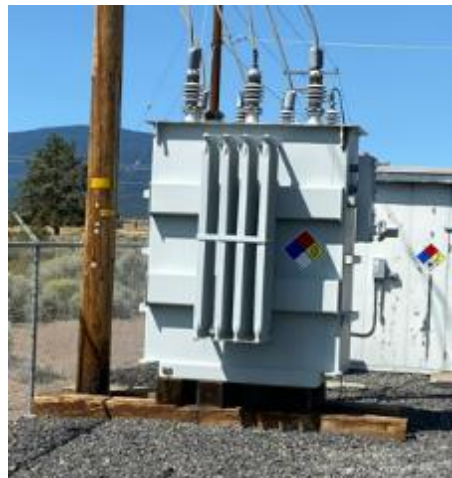
- 1.7. 12/20 kV Transformer placed on temporary timbers and not secured onto a foundation.

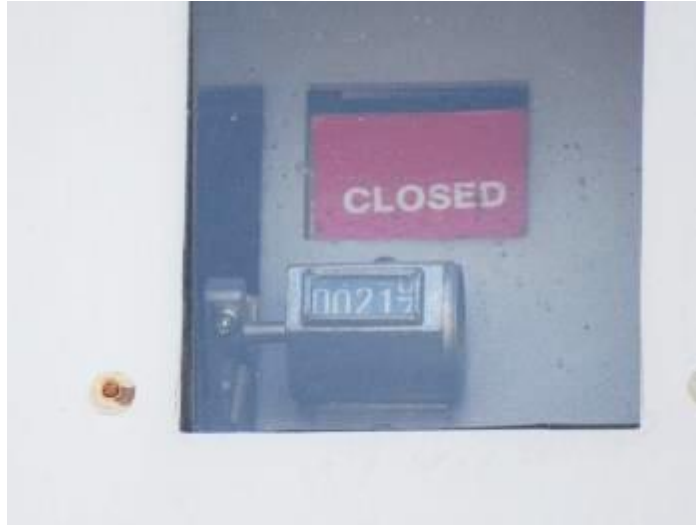
2.1. Counter on 5L64 does not properly index, resulting in unclear readings.

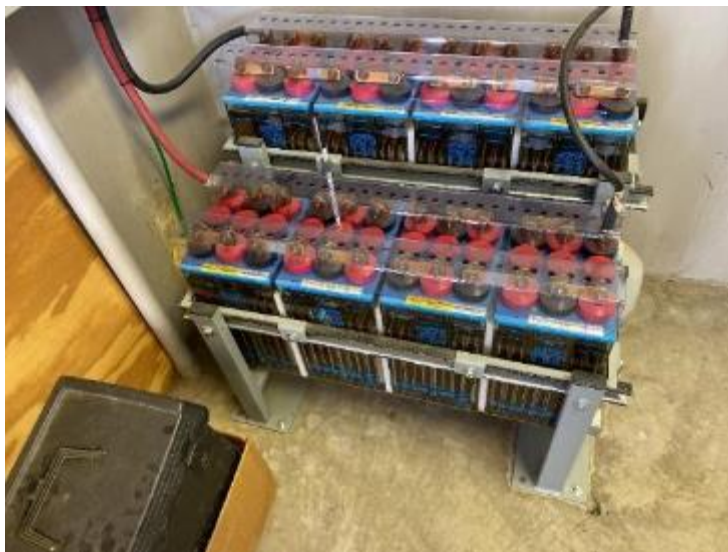
3.1 Station batteries have no provision for containing spilled electrolytes, and the metal battery rack is not grounded.<sup>29</sup>

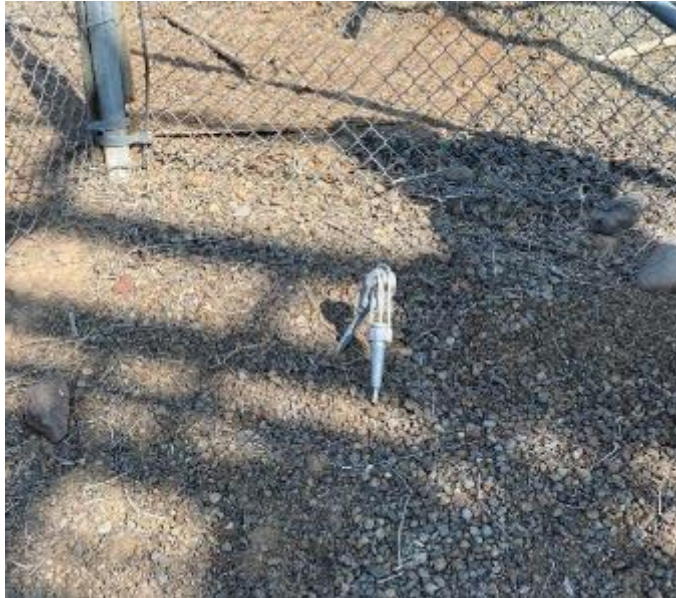
3.2 Station has an abandoned down guy anchor, an unmarked trip hazard.

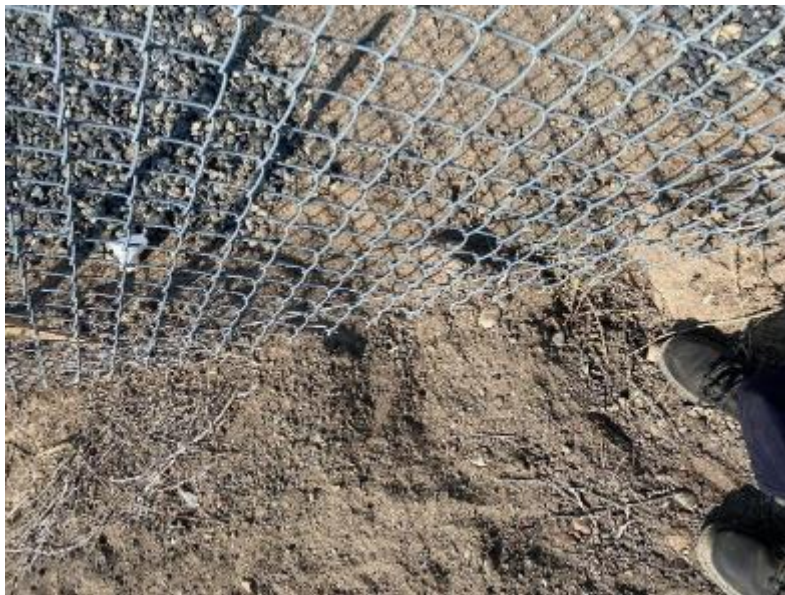
3.3 Station has a greater than 4-inch gap under the security fence.

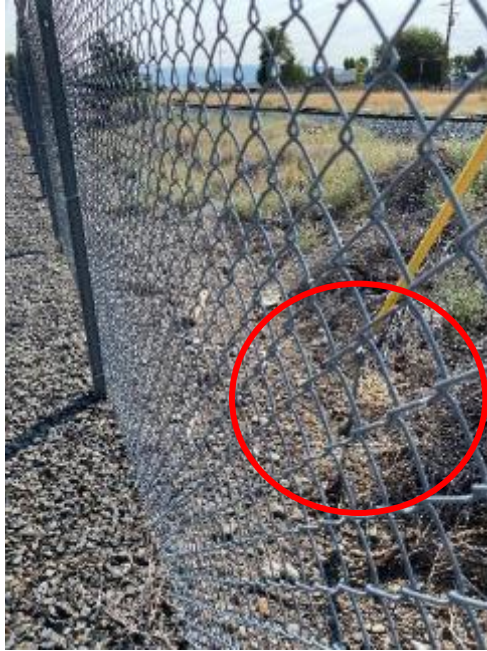
3.4 Touch potential between down guy and fence. Down guys are within 4 feet of station perimeter fence. No evidence that exterior structures are attached to the station ground grid.<sup>30</sup>

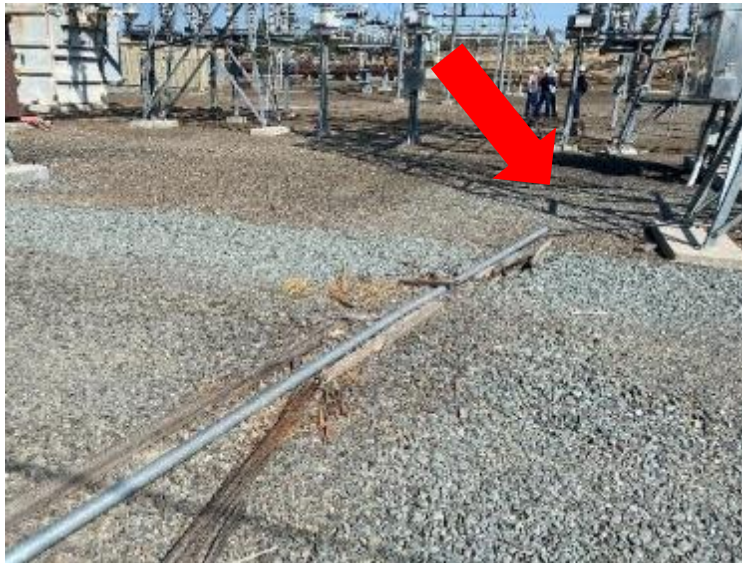
3.5 Station has debris and unmarked tripping hazards within the yard. Secondary service lines on ground.

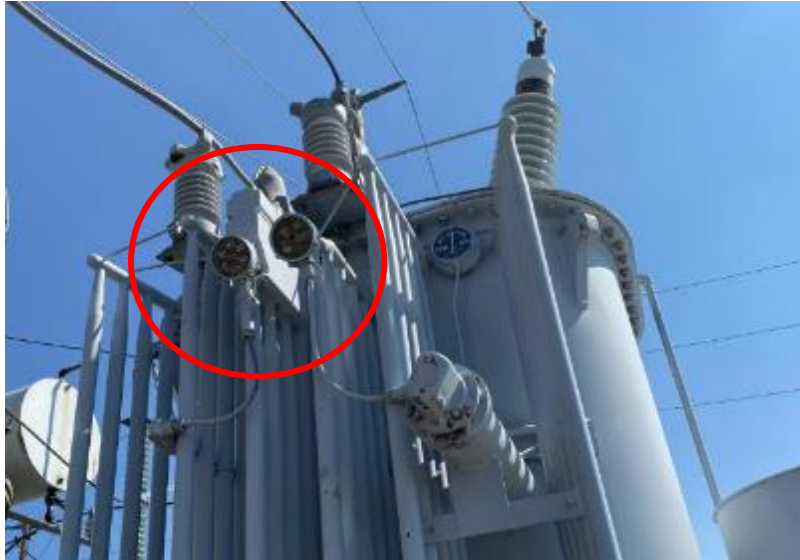
3.6 115/69 kV Transformer Phase A temperature gauges are inaccurate: fluid temperature is higher than winding temperature.

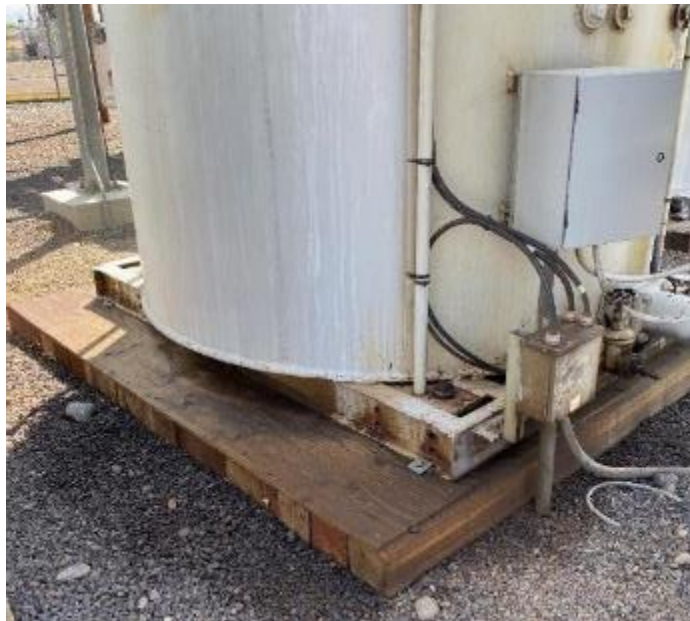
3.7 Transformer 2954 Phase B is leaking.

ESRB acknowledges that PacifiCorp has an open work order (#10071240, created 31 Jan 2020) to replace the transformer bank.

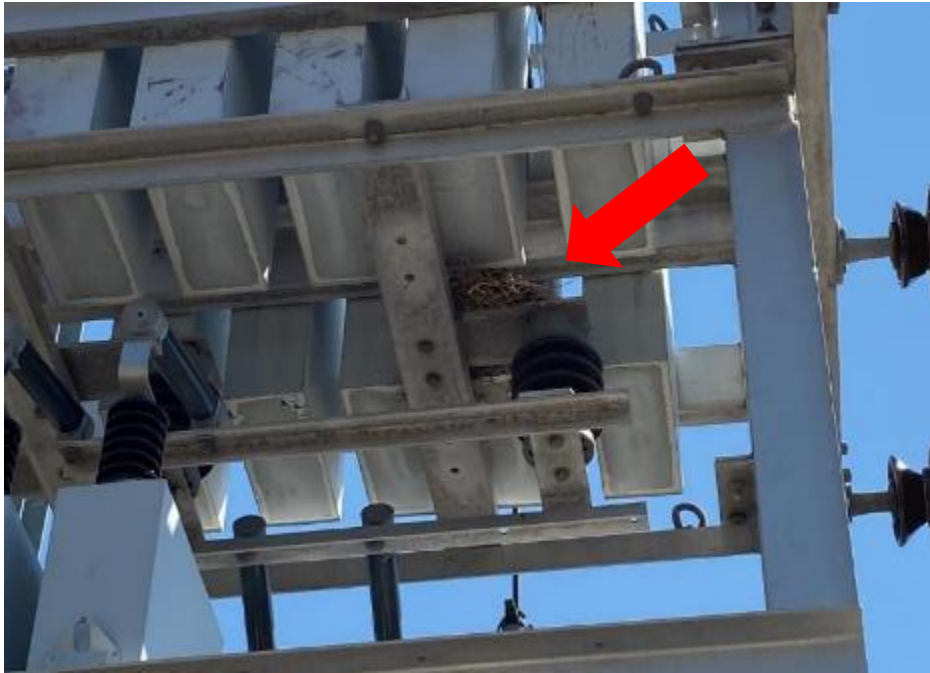
3.8 Capacitor bank 238 has a bird nest.

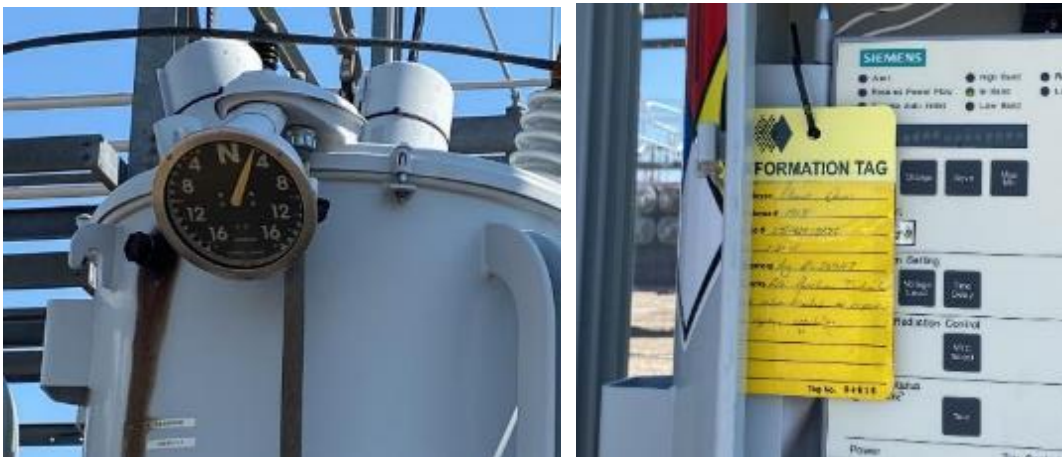
3.9 Regulator 368117 has a broken position indicator. Issue was marked by an information tag in 2015.

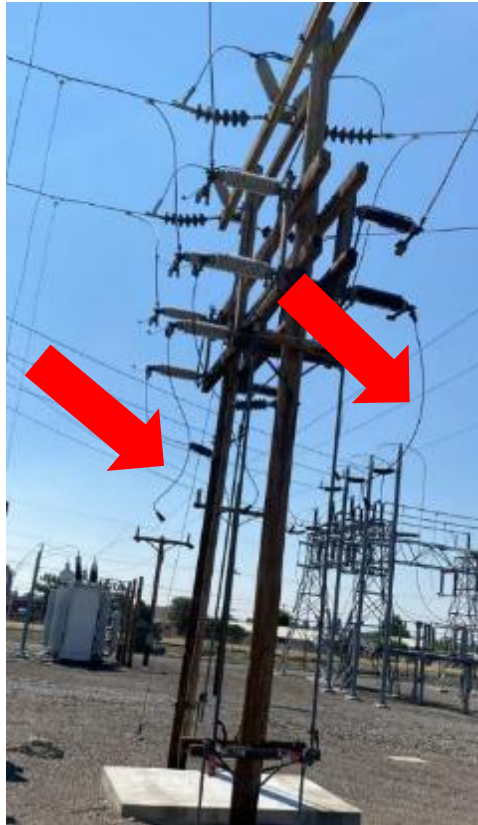
3.10 Unrestrained 69kV conductors, formerly attached to equipment.

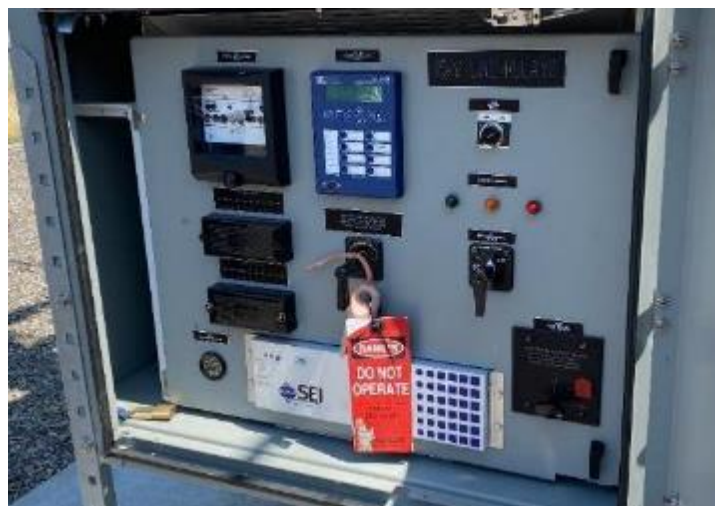
4.1. “Do Not Operate” tag was improperly used to indicate fire mode enabled.<sup>31</sup>

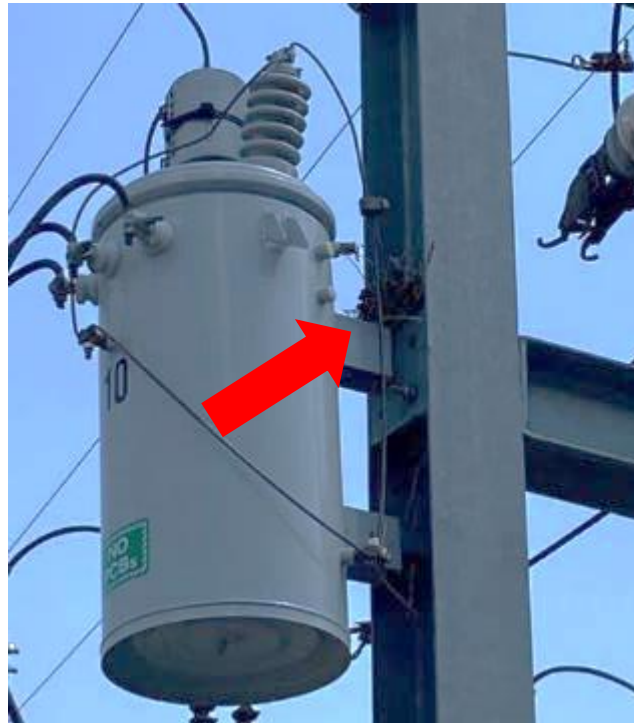
4.2. Station has a bird nest on framing near the station transformer.

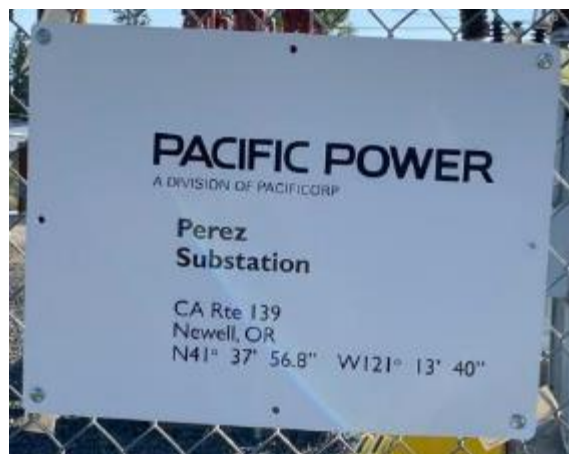
5.1. Station sign incorrectly states location as Newell, OR.<sup>32</sup>

<sup>32</sup> Station is in California rather than Oregon; Newell is 17 miles north of this station. Latitude and longitude are approximately correct.

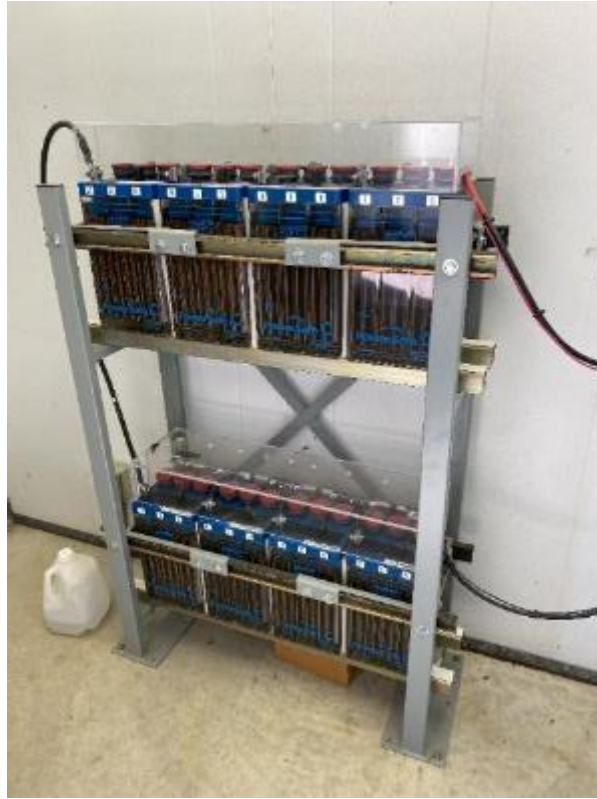
6.1. Station batteries have no provision for containing spilled electrolytes, and the metal battery rack is not grounded.<sup>33</sup>

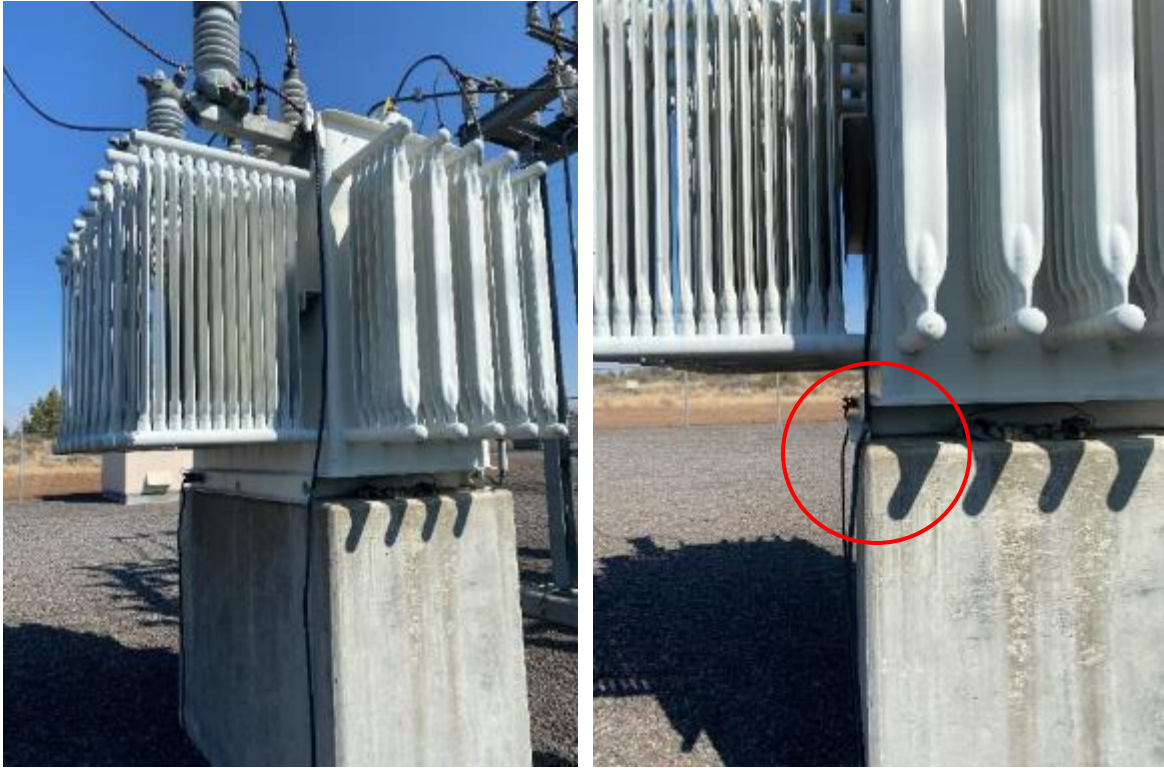
6.2. Foundation is not appropriately sized for Transformer 33-8306. The footing of the transformer extends beyond the base. Transformer is not secured onto the foundation. The elevated position of the transformer puts this at an increased risk of catastrophic failure in the event the transformer shifts in a seismic event.

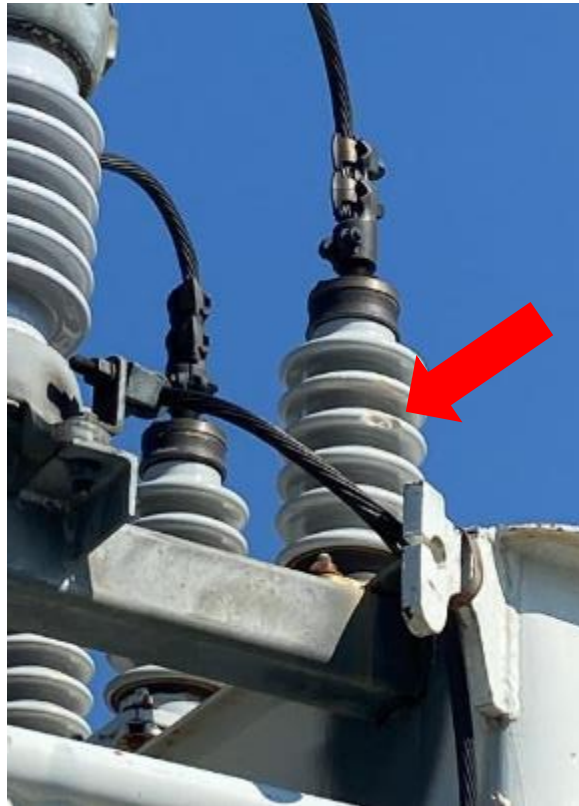
6.3. Transformer 33-8306 has a chipped insulator.

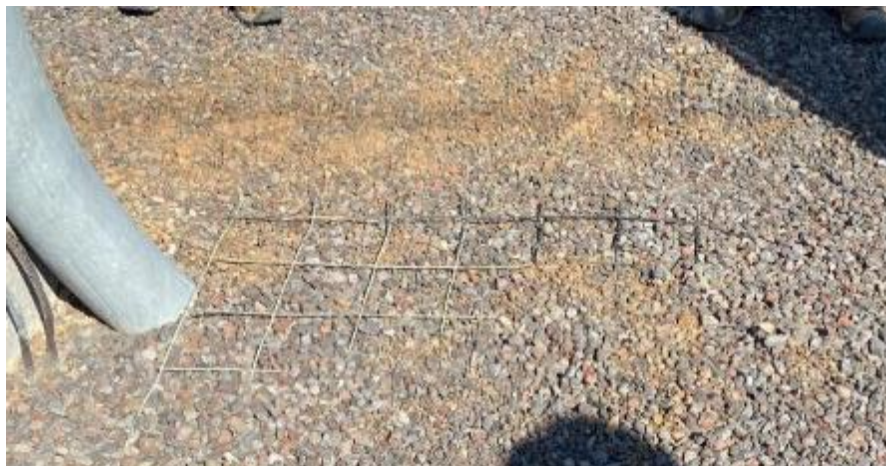
6.4. Part of the grounding grid is exposed inside the station. Exposed grounding grid also poses as a potential trip hazard.

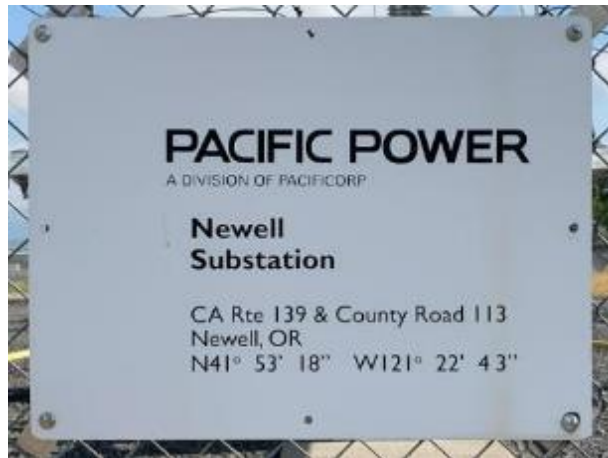
7.1. Station sign incorrectly states location as Newell, OR.<sup>34</sup>

<sup>34</sup> Station is in California rather than Oregon; latitude and longitude are approximately correct.

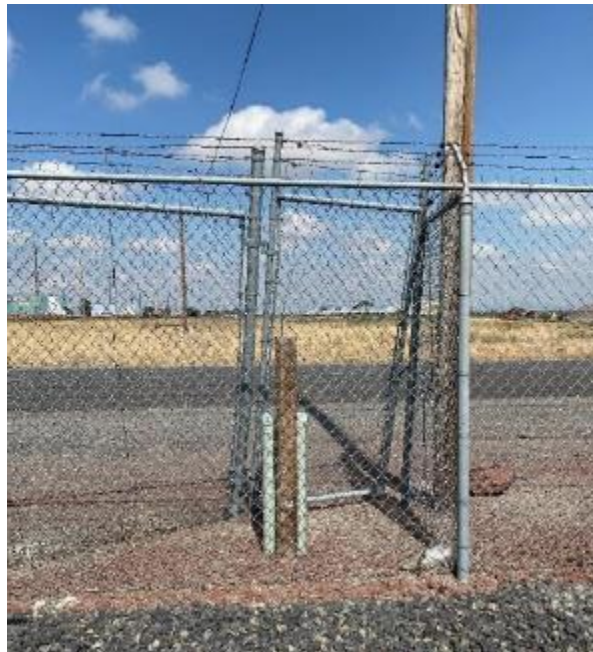
7.2. Unsecured fence surrounding phone pedestal, reducing effective fence height.

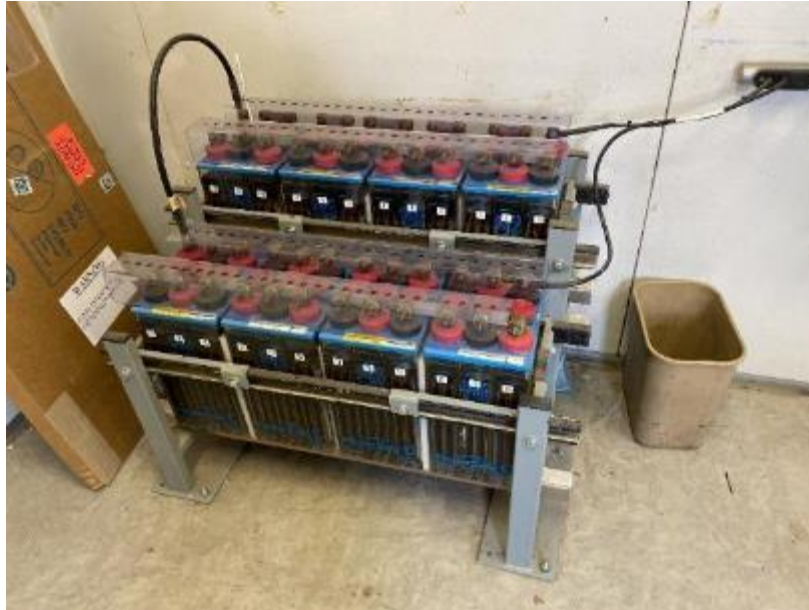
7.3. Station batteries have no provision for containing spilled electrolytes, and the metal battery rack is not grounded.<sup>35</sup>

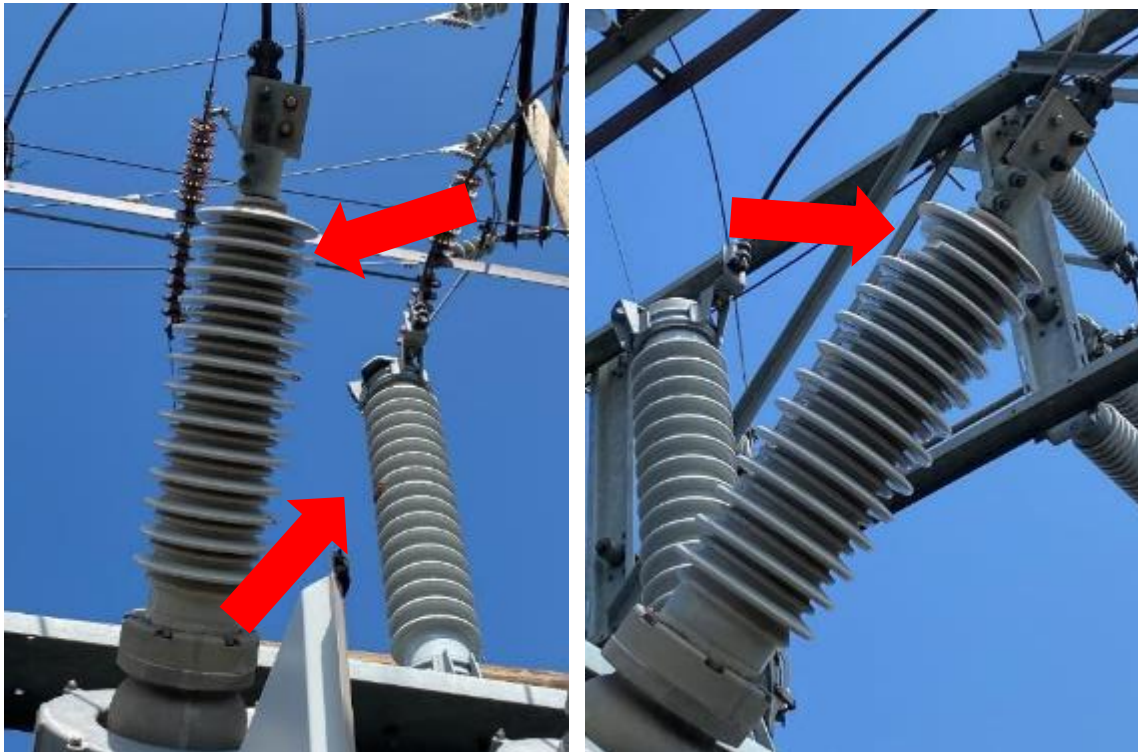
7.4. Circuit breaker 3L25 has chips on three bushing insulators.

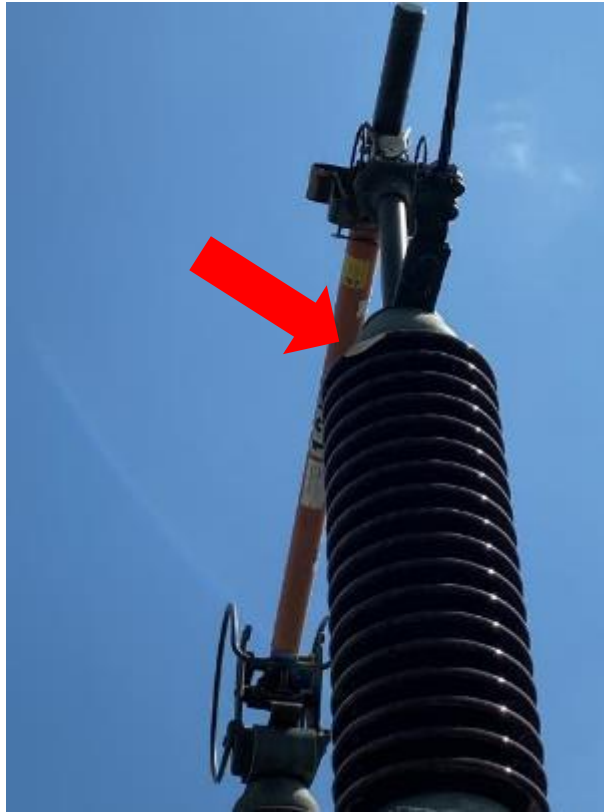
7.5. Transmission fuse 3L26 has a chipped insulator.

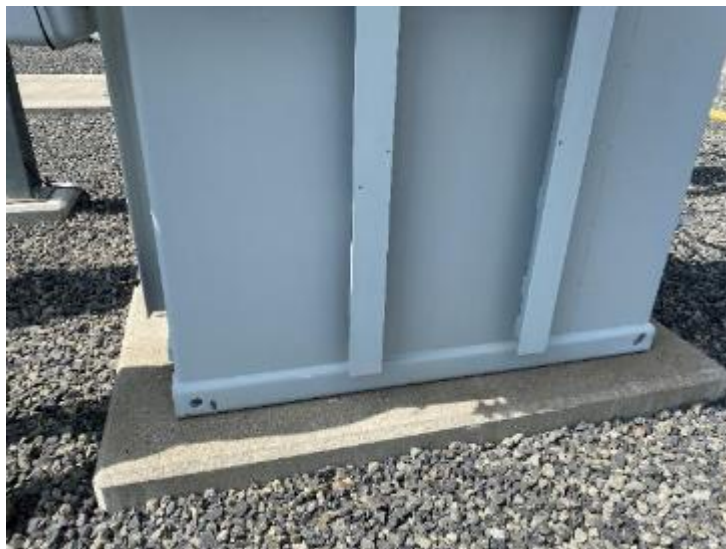
7.6. Regulator 1454 is not secured onto the foundation.

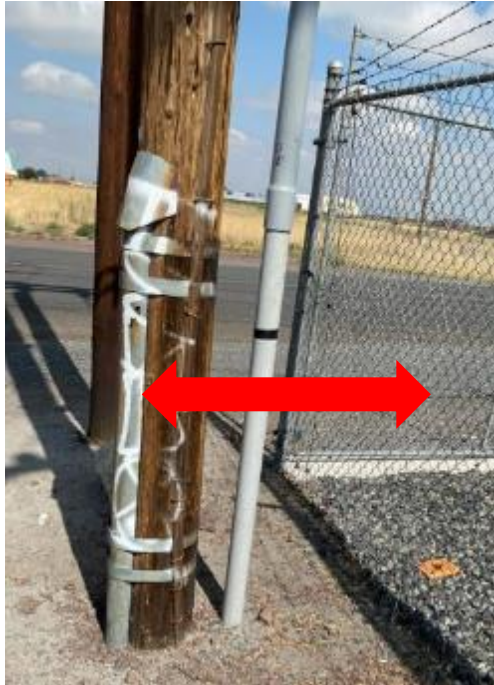
7.7.Touch potential between exterior pole reinforcement and fence. No evidence that exterior structures are attached to the station ground grid.

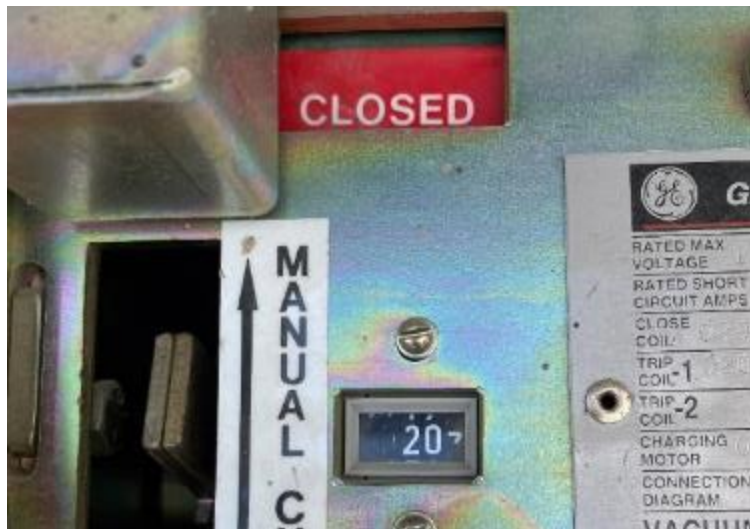
7.8.Circuit breaker 3L68 has a faded counter.

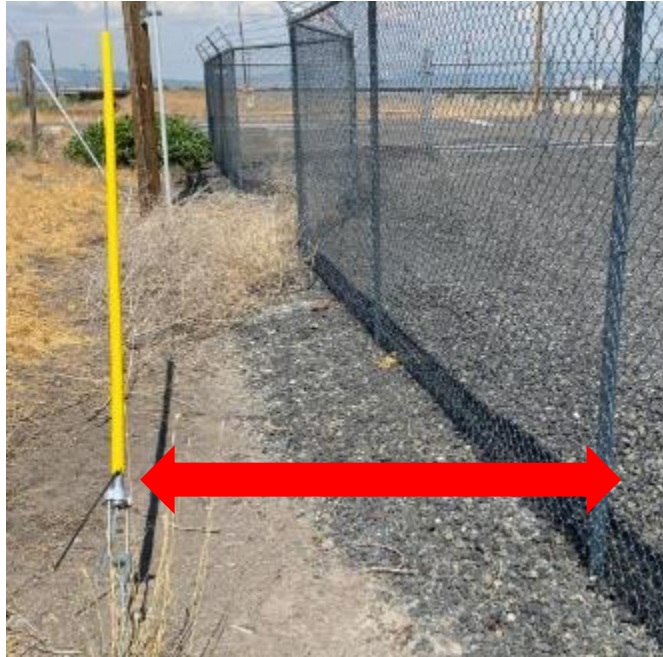
8.1.Touch potential between down guy and fence. No evidence that exterior structures are attached to the station ground grid.

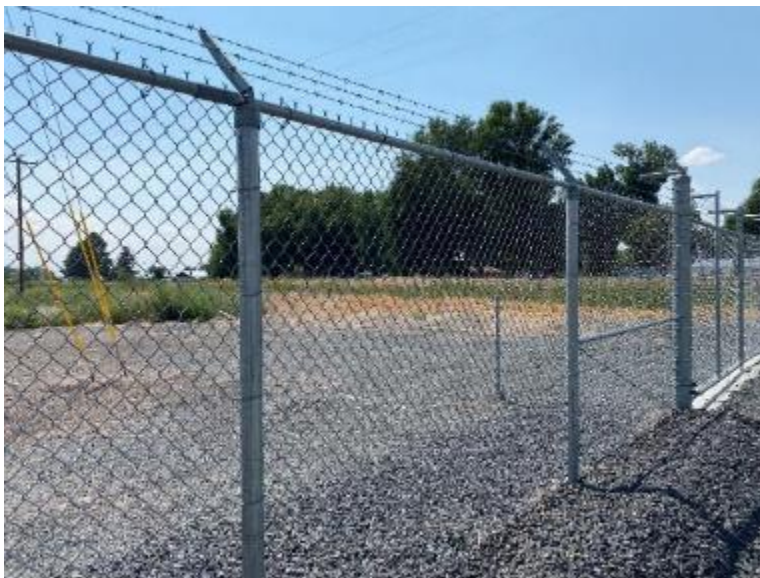
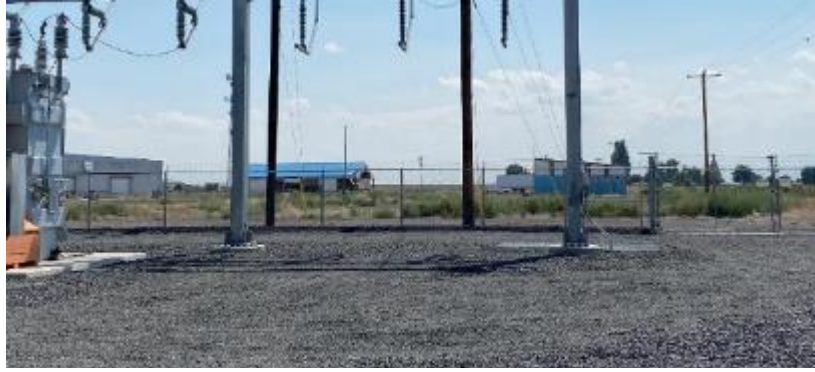
8.2.Ground wires on fence distanced approximately 70 feet apart, exceeds PacifiCorp standard for perimeter fence grounding of 50 feet. <sup>36</sup>

<sup>36</sup> PacifiCorp Engineering Handbook 6B.6 section 4.2.3

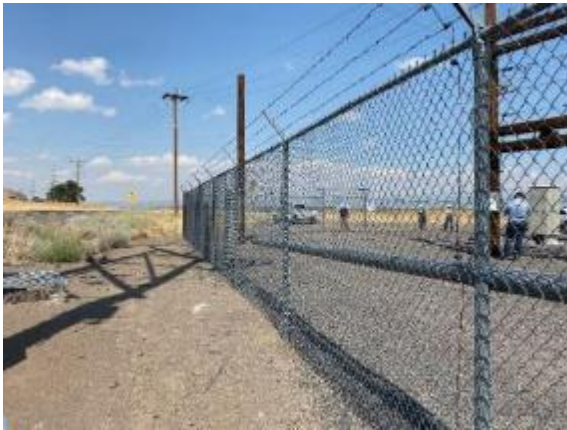
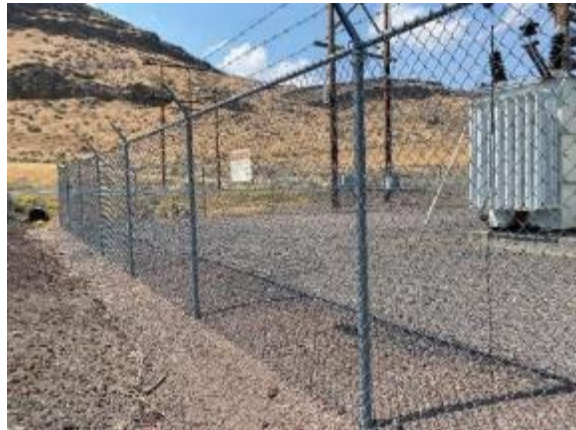
9.1. Ground wires on fence distanced approximately 60-70 feet apart, exceeds PacifiCorp standard for perimeter fence grounding of 50 feet.<sup>37</sup>

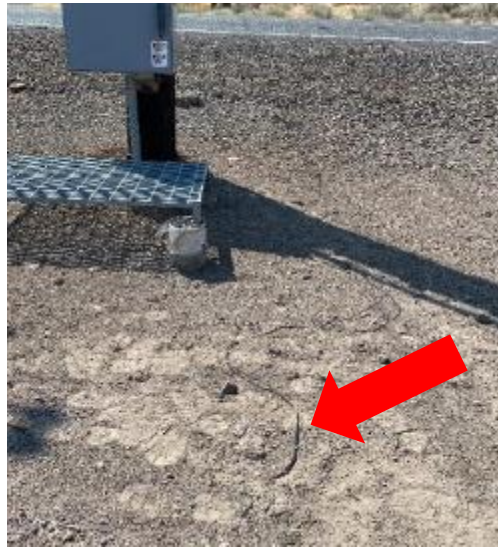
9.2. Unknown exposed conductor wire outside fence near interior phone box.

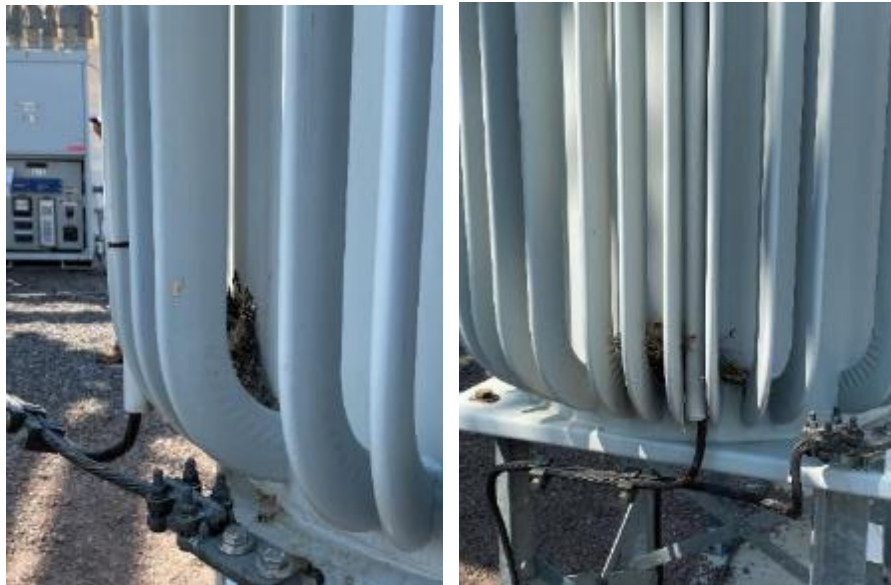
9.3. Regulators 372544 and 370510 have bird nests in the cooling fins.

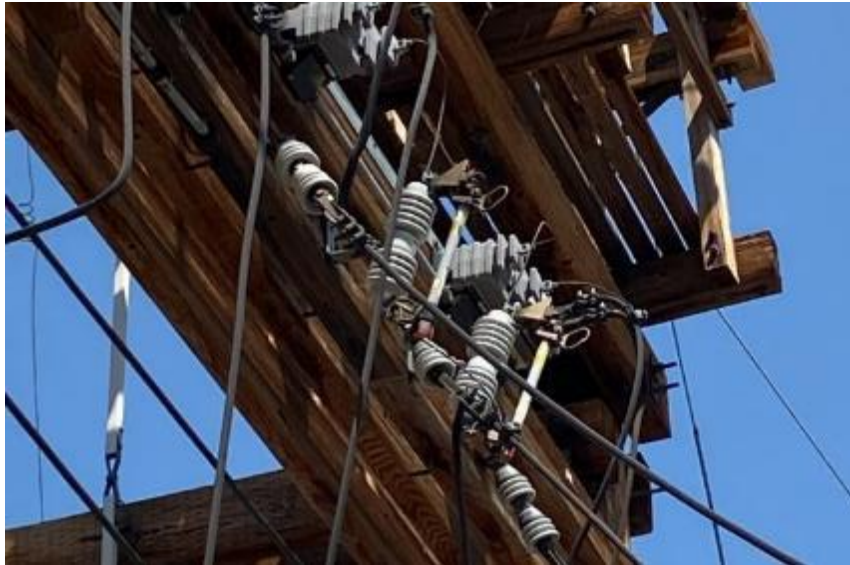
9.4. Station is missing spare replacement PT fuses. Image below is of fuses in service at station without replacements on hand.

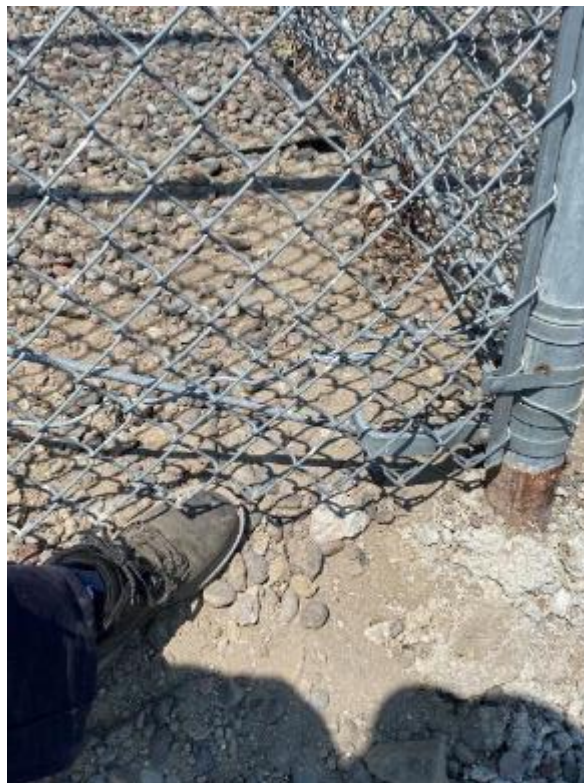
9.5. Grade below fence is eroding, causing a 3-inch gap.

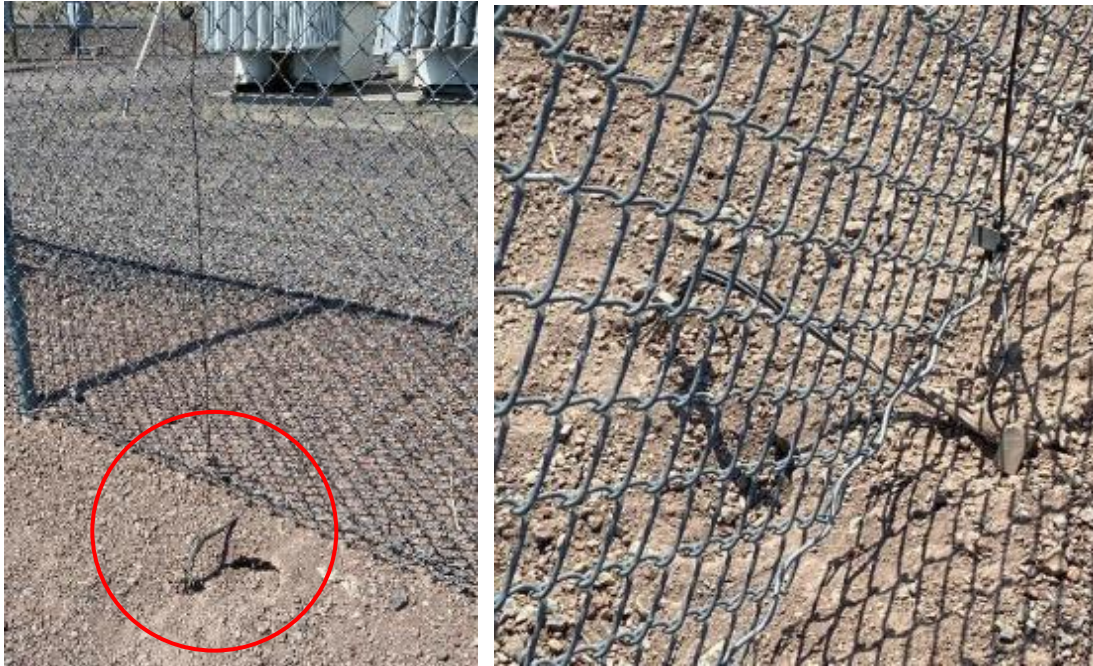
9.6. Station exterior has an exposed ground conductor attached to the fence creating a trip hazard.

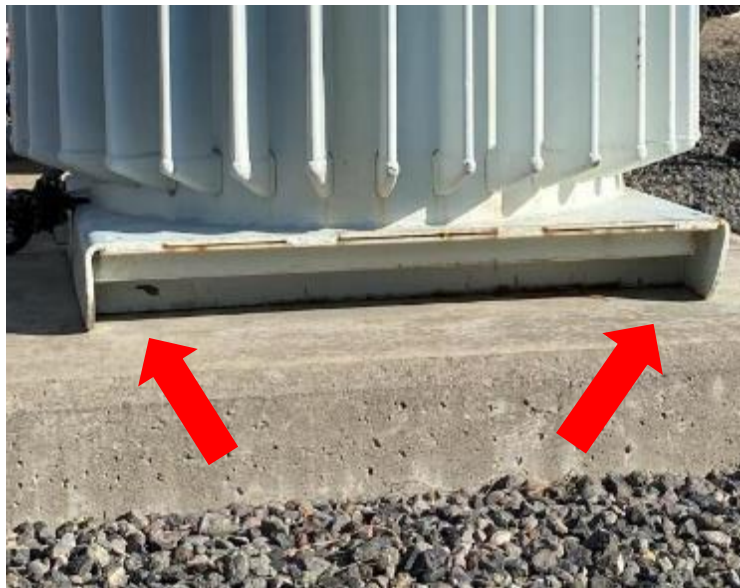
1.1. Transformers 2819, 2818, and 2817 are not secured onto foundation.

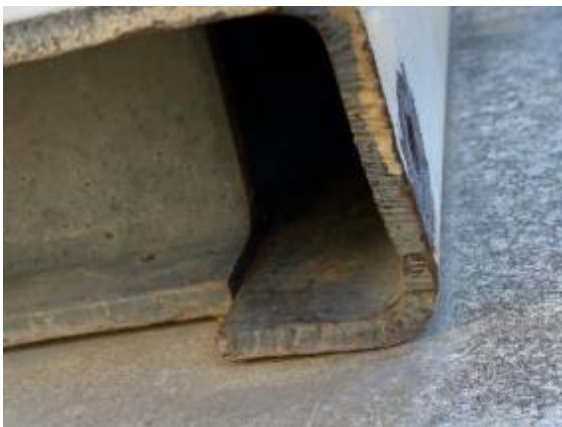
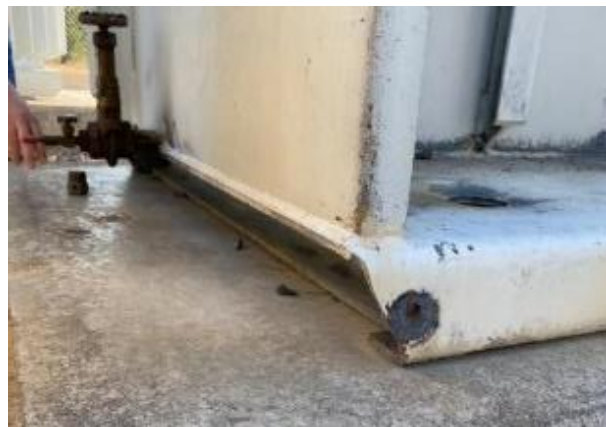
1.2. Regulator 1212 is not secured onto the foundation.

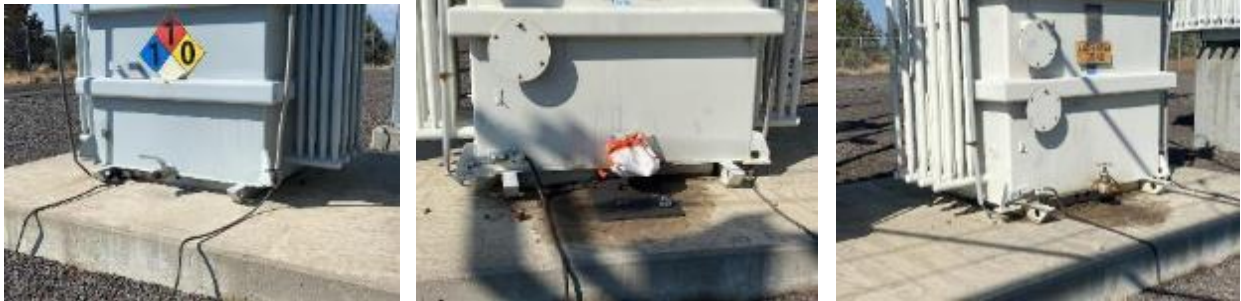
2.1. Transformer 2970, 3045, 3046 is not secured onto the foundation.

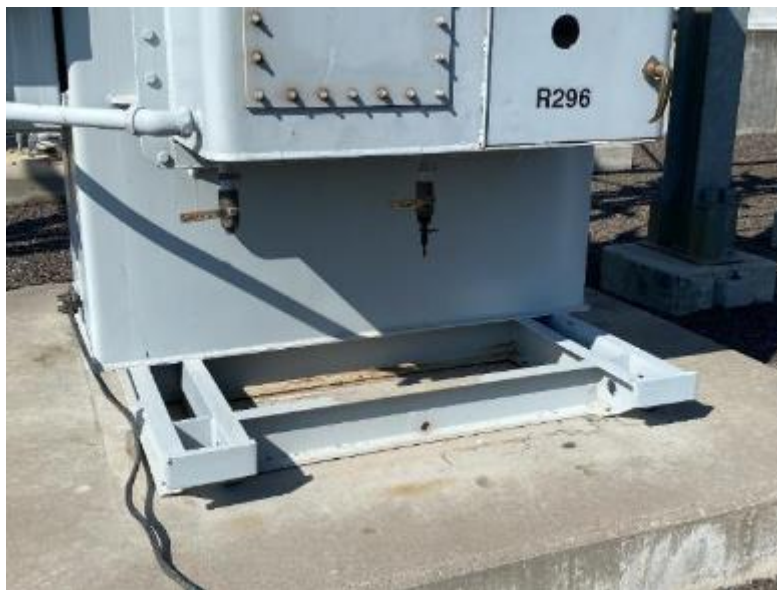
2.2. Regulator 296 is not secured onto the foundation.

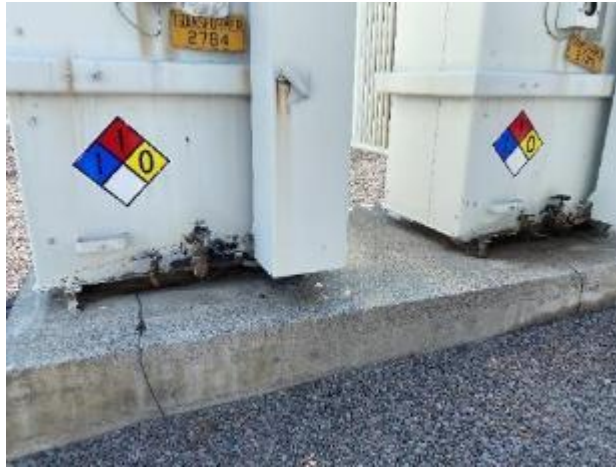
3.1. Transformers 2784, 2785, and 2786 are not secured onto the foundation.
