## PUBLIC UTILITIES COMMISSION

**SUBJECT:** Facilities Audit of PacifiCorp's Klamath Falls Substations

**PACIFICORP, KLAMATH FALL HEADQUARTERS  
SUBSTATION AUDIT FINDINGS  
AUGUST 12-16, 2024**

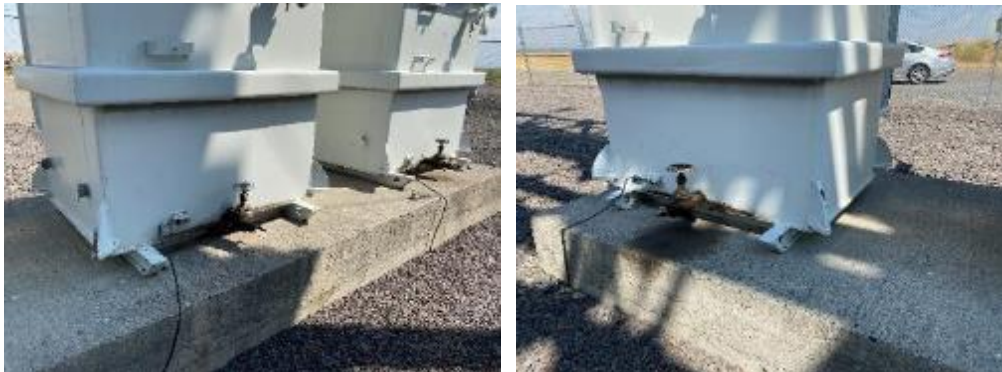
3.2. Transformers 2942A, 2941B, and 2949C are not secured onto the foundation.
