## PUBLIC UTILITIES COMMISSION

EA2025-1252/TA2025-1317/SA2025-1316

**SUBJECT:** Electric Facilities and Substation Audit of Shasta Lake Electric Utilities (Shasta)

**SHASTA LAKE ELECTRIC UTILITIES (SHASTA)  
ELECTRIC DISTRIBUTION, TRANSMISSION, AND SUBSTATION AUDIT  
FINDINGS  
MAY 5 – 9, 2025**

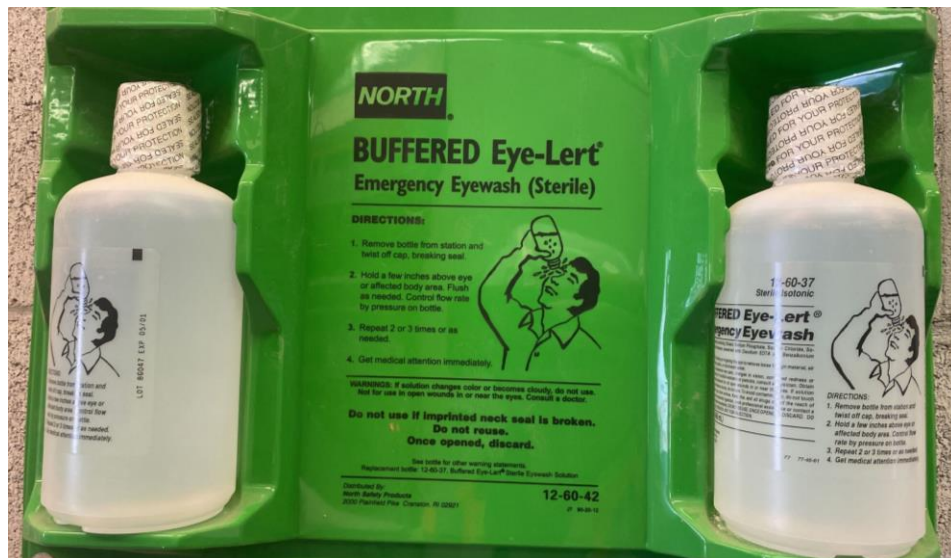
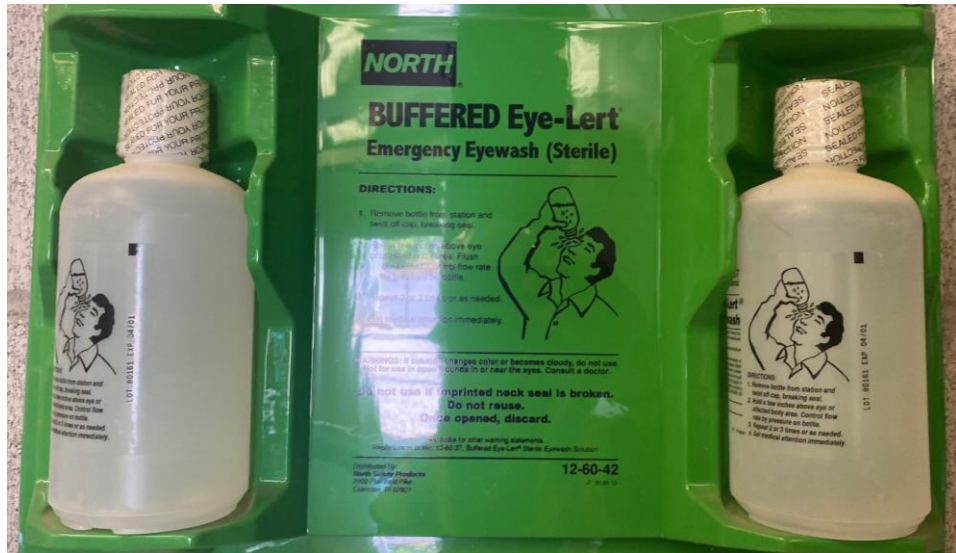
### 1. Knauf Substation

1.1. Two eyewash stations in the control room are expired.

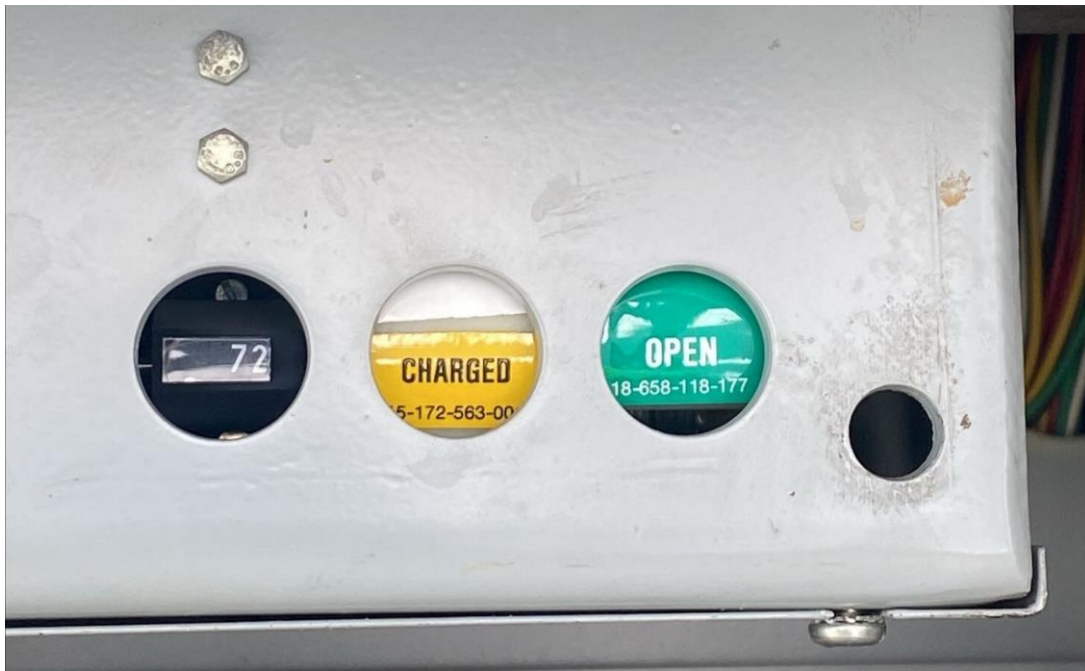
## 2. Central Valley Substation

2.1. Circuit Breaker DB72 has a faded counter.

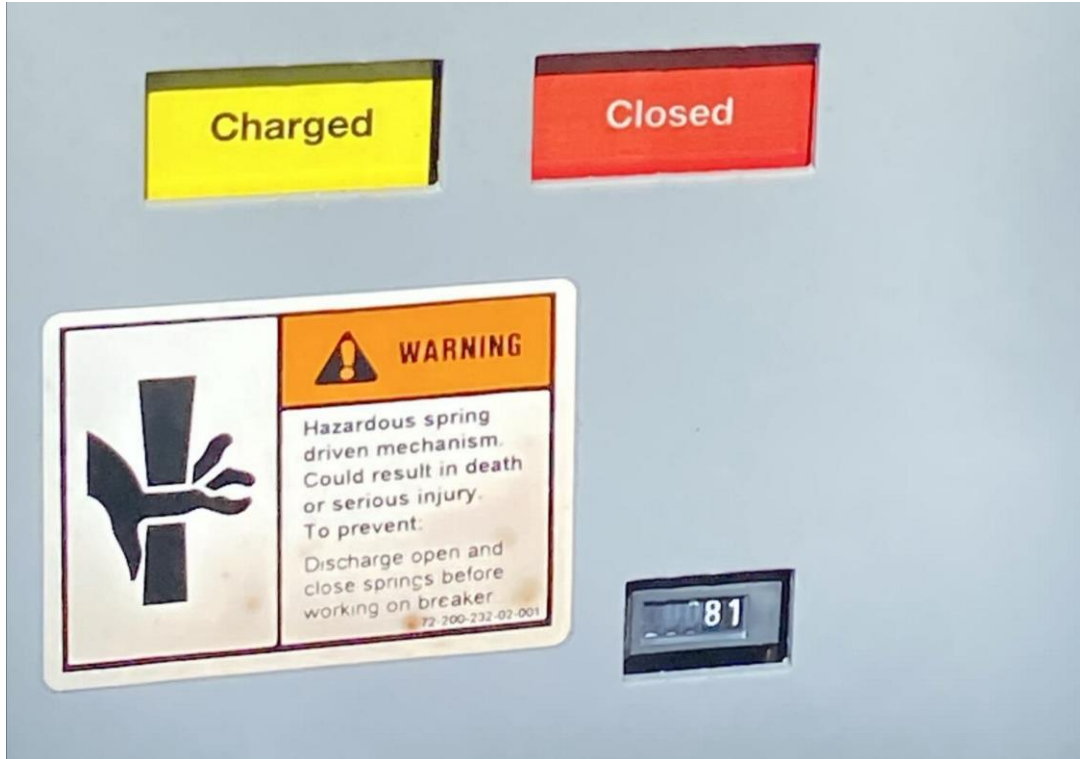
2.2. Circuit Breaker DB52 has a faded counter.
