## PUBLIC UTILITIES COMMISSION

EA2025-1245

**SUBJECT:** Electric Distribution Audit of PG&E's Central Coast Division

**PG&E CENTRAL COAST DIVISION**  
**ELECTRIC DISTRIBUTION AUDIT FINDINGS**  
**April 21-25, 2025**

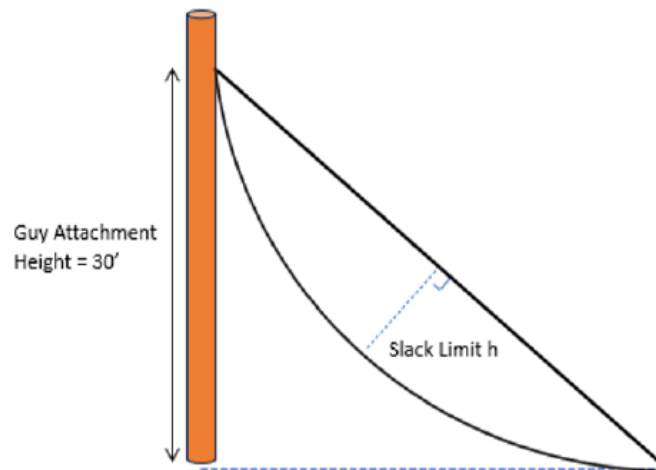
Figure 3: Guy slack limit, TD-2305M-JA02

PG&E’s TD-2305M-JA02, Job Aid: Overhead Assessment, Rev. 14, Effective January 14, 2025 Miscellaneous Other Compelling Abnormal Conditions, Guy Broken/Slack/Corroded states, *“Pole must be straight with Guy no more than an arm’s length (3ft) from taut, that does not have significant impact on the structural integrity of the pole.”* See Figure 3.

Per GO 95, Rule 56.2, guys are to be maintained taut. PG&E’s TD-2305M-JA02 allows a deviation from taut by as much as 3 feet without regard to length or angle of attachment.

PG&E’s TD-2305M-JA02, Job Aid, Miscellaneous Other Compelling Abnormal Conditions, Guy Broken/Slack/Corroded needs revision to comply with GO 95, Rule 56.2 requiring guys to be maintained taut in all circumstances.
