PUBLIC UTILITIES COMMISSION

EA2025-1323

SUBJECT: Electric Distribution Audit of PG&E's Peninsula Division

PG&E PENINSULA DIVISION
ELECTRIC DISTRIBUTION AUDIT FINDINGS
August 25-29, 2025

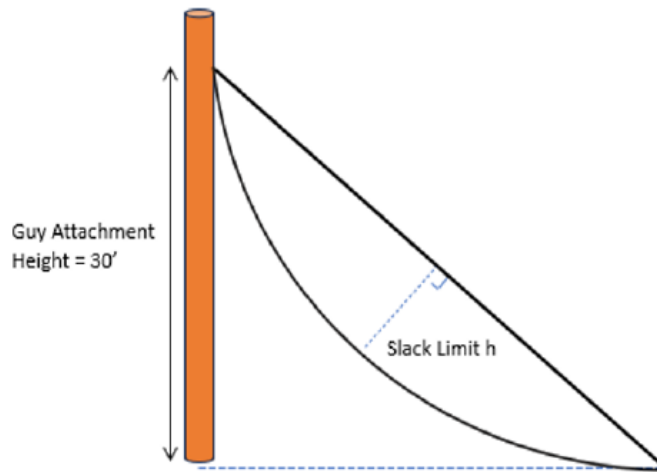
Figure 3: Guy slack limit, TD-2305M-JA02

PG&E’s TD-2305M-JA02, Job Aid: Overhead Assessment, Rev. 14, Effective January 14, 2025 Miscellaneous Other Compelling Abnormal Conditions, Guy Broken/Slack/Corroded states, *“Pole must be straight with Guy no more than an arm’s length (3ft) from taut, that does not have significant impact on the structural integrity of the pole.”* See Figure 3.

Per GO 95, Rule 56.2, guys are to be maintained taut. PG&E’s TD-2305M-JA02 allows a deviation from taut by as much as 3 feet without regard to length or angle of attachment.

PG&E’s TD-2305M-JA02, Job Aid, Miscellaneous Other Compelling Abnormal Conditions, Guy Broken/Slack/Corroded needs revision to comply with GO 95, Rule 56.2 requiring guys to be maintained taut in all circumstances.
