**CPUC SUBSTATION AUDIT FINDINGS REPORT RESPONSE**  
**PG&E Cupertino Headquarters**  
**January 27 – 31, 2025**

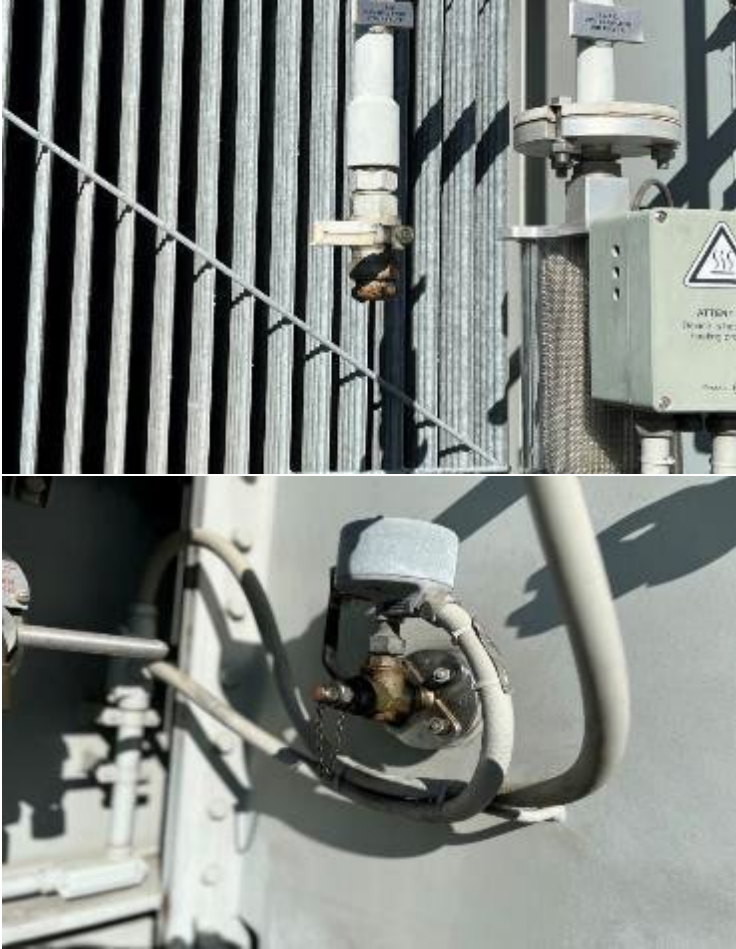
1.4 Transformer Bank 2 had Additional Oil Leaks at Load Tap Changer Conservator Tank Drain Valve and Fault Pressure Device Drain Valve.

The cited violation pertains to Bank 1, not Bank 2. We agree with the finding of oil residue on Transformer Bank 1 Load Tap Changer (LTC) oil conservator at Wolfe Substation. This issue was corrected onsite by PG&E QEW on the day of the field audit.

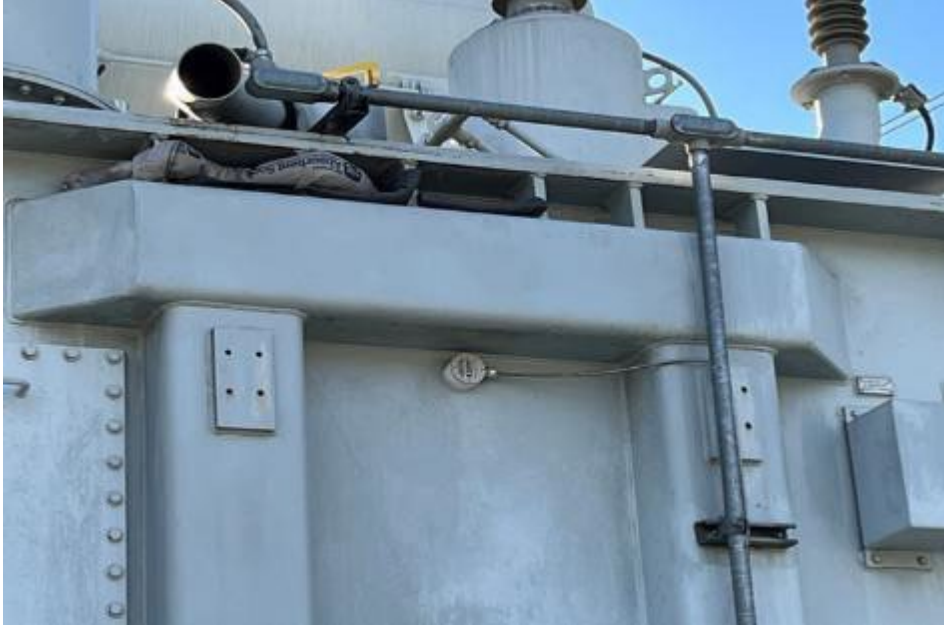
5.18 Transformer Bank 2 Phase A Oil Leak Top Flange Existing LC Tag#130783075.

The previously provided LC notification, 130783075, was cancelled because it was a duplicate of LC notification 130783072. We agree that Transformer Bank 2 A-Phase has an oil leak at the top of flange at Metcalf Substation. This nonconformance has a pre-existing LC notification, 130783072, that was established in our system of record, SAP, prior to the field audit. We do not agree that this finding qualifies as a violation of GO 174, Rule 12 since this LC notification is being worked in accordance with our maintenance procedures and is not past due.

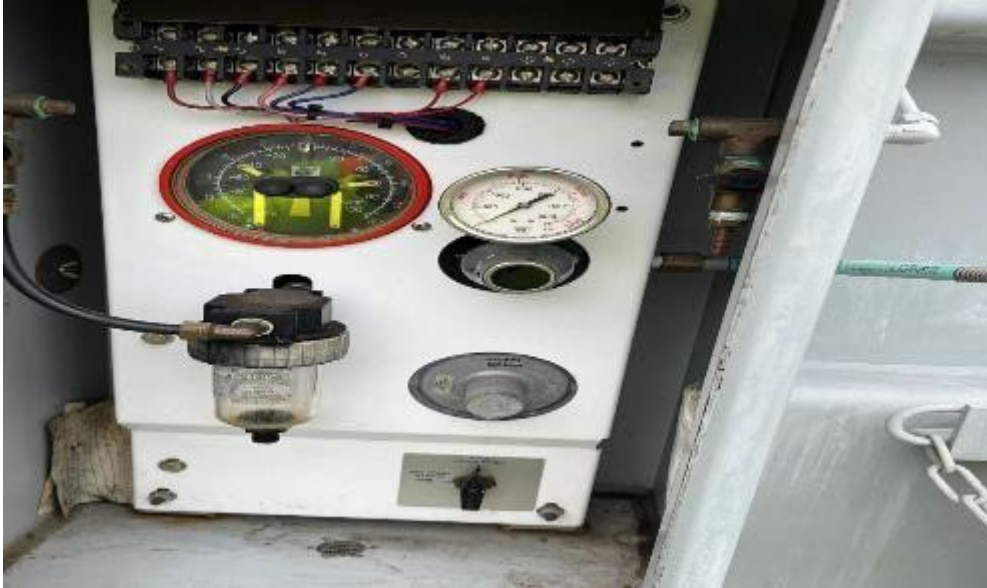
6.1 The Nitrogen Bottle for Transformer Bank 1 was Empty and no Nitrogen pressure at transformer top. PG&E replaced the Empty Bottle and Fixed in Field.

We agree with the finding that the nitrogen bottle for Transformer Bank 1 was empty and there was no nitrogen pressure at the top of the transformer at Metcalf Substation. This issue was corrected onsite by PG&E QEW on the day of the field audit.

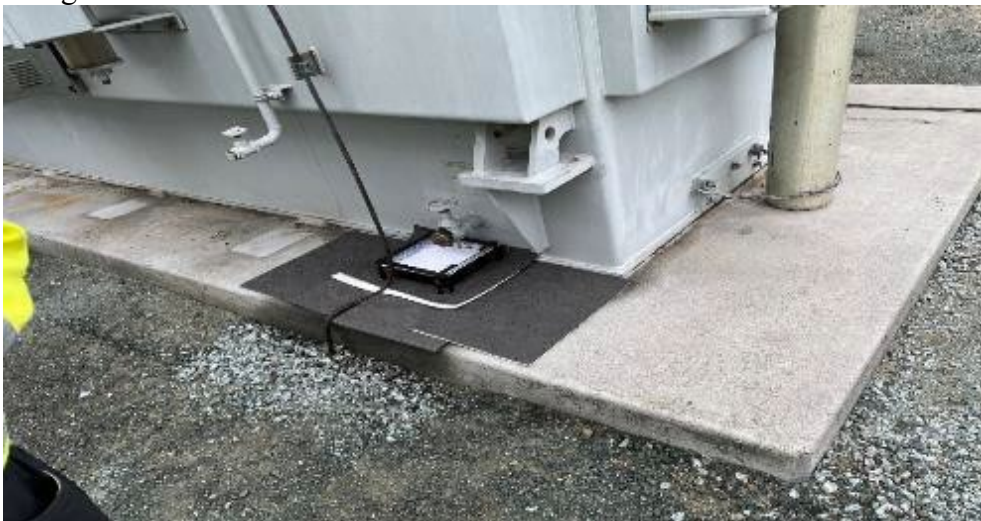
6.2 Transformer Bank 1 Sample Drain Valve Oil Leak Mitigation Existing LC Tag#129692374.

We agree that Transformer Bank 1 sample drain valve had an oil leak at El Patio Substation. This nonconformance had a pre-existing LC notification, 129692374, that was established in our system of record, SAP, prior to the field audit. We do not agree that this finding qualifies as a violation of GO 174, Rule 12 since this LC notification was worked in accordance with our maintenance procedures and completed on February 14, 2025.

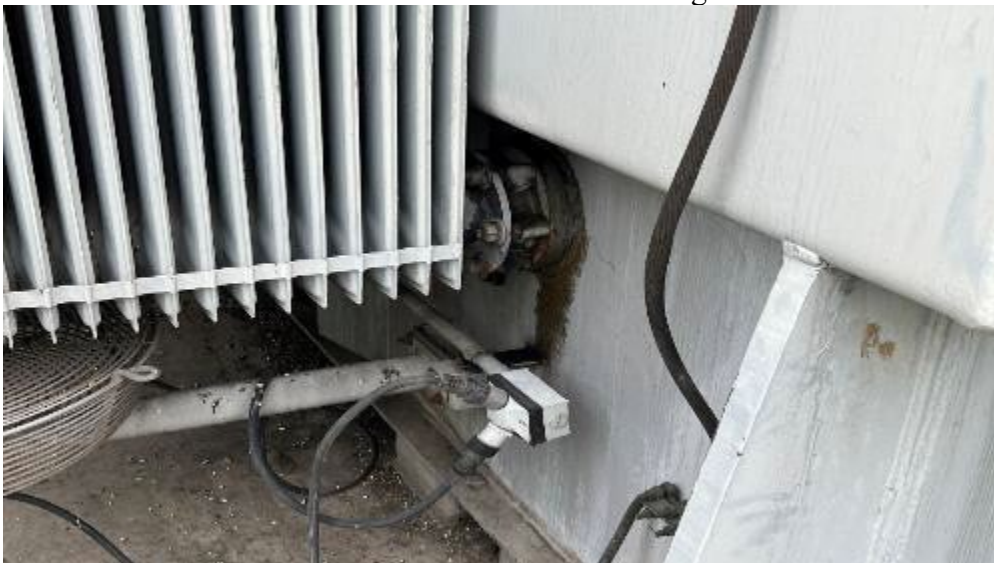
**6.4 Transformer Bank 2 Oil Leak at Lower Flange**

We agree with the finding of the oil stain on the lower flange at Transformer Bank 2 at El Patio Substation. We created LC notification 130804603, added it to the workplan and will be completed based on current work prioritization and material availability.

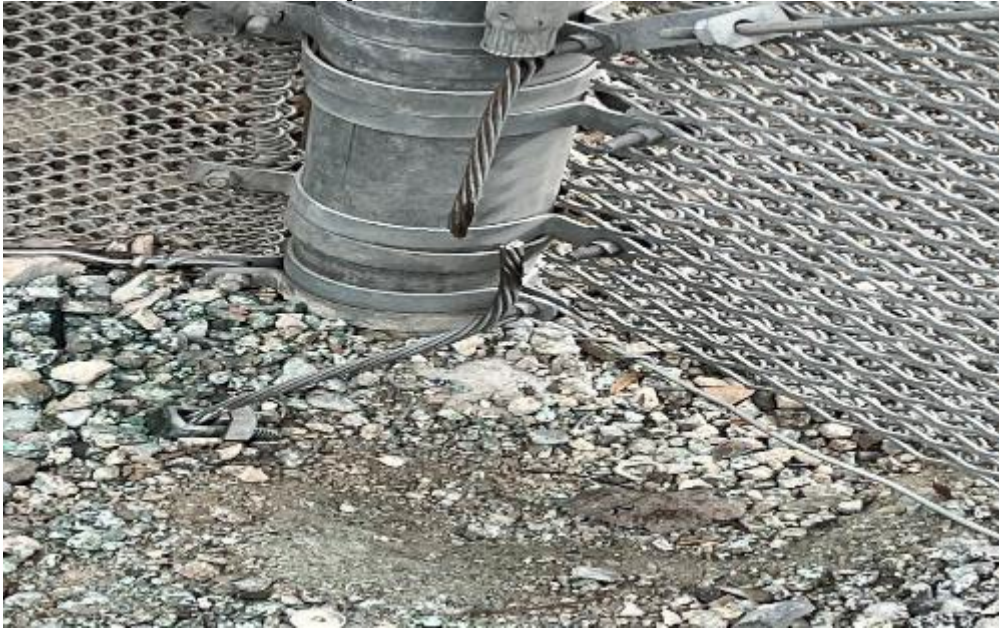
6.5 Perimeter Security Fence had Cut Ground Connection Due to Recent Vandalism

We agree with the finding of the cut ground at the perimeter security fence at El Patio Substation. We created LC notification 130804581, added it to the workplan and will be completed based on current work prioritization and material availability.

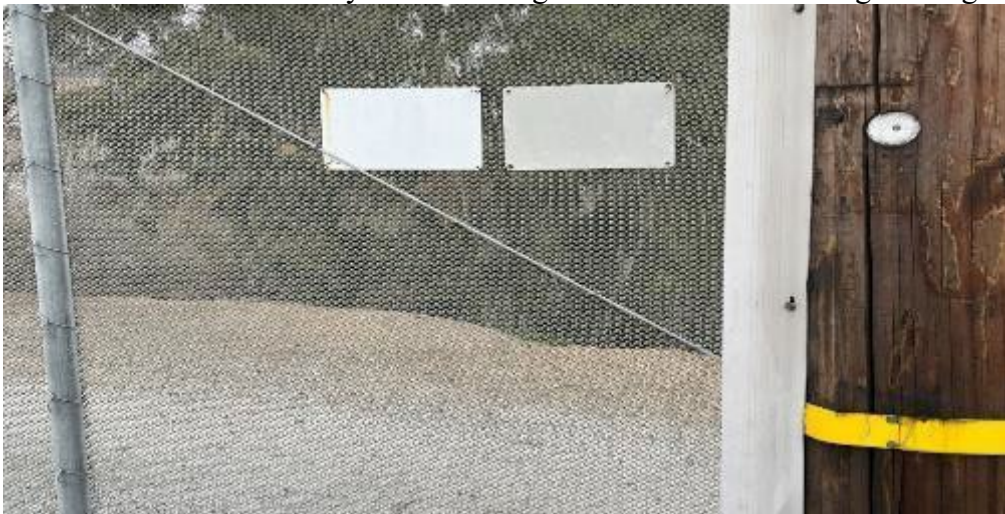
6.6 Perimeter Security Fence has Signs Posted Inside Existing LC Tag#130739987.

We agree that the perimeter security fence has signs posted inside at El Patio Substation. This nonconformance has a pre-existing LC notification, 130739987, that was established in our system of record, SAP, prior to the field audit. We do not agree that this finding qualifies as a violation of GO 174, Rule 12 since this LC notification is being worked in accordance with our maintenance procedures and is not past due.

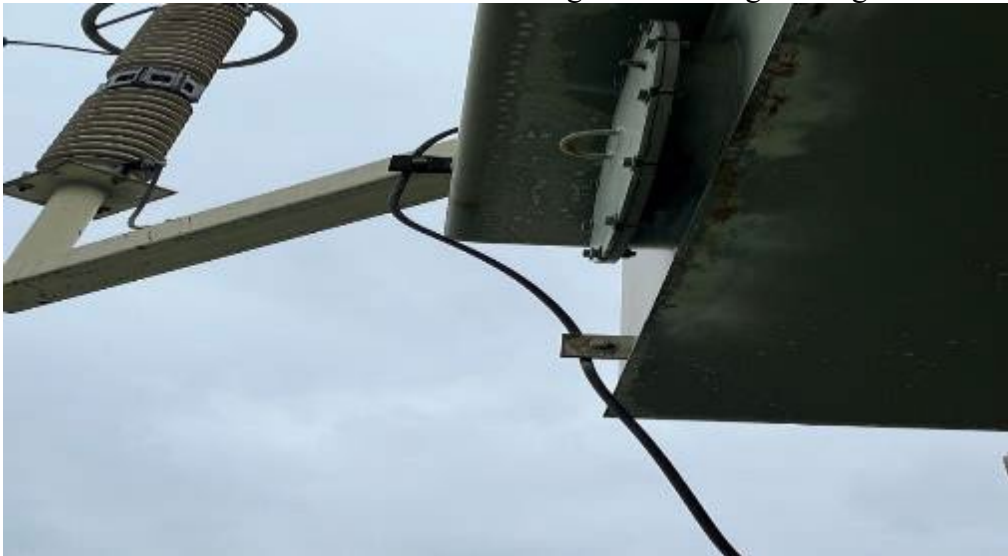
### 7.2 Transformer Bank 1 Oil Leak Mitigation Existing LC Tag#130535753.

We agree that Transformer Bank 1 has an oil leak at Hicks Substation. This nonconformance has a pre-existing LC notification, 130535753, that was established in our system of record, SAP, prior to the field audit. We do not agree that this finding qualifies as a violation of GO 174, Rule 12, since this LC notification is being worked in accordance with our maintenance procedures and is not past due.

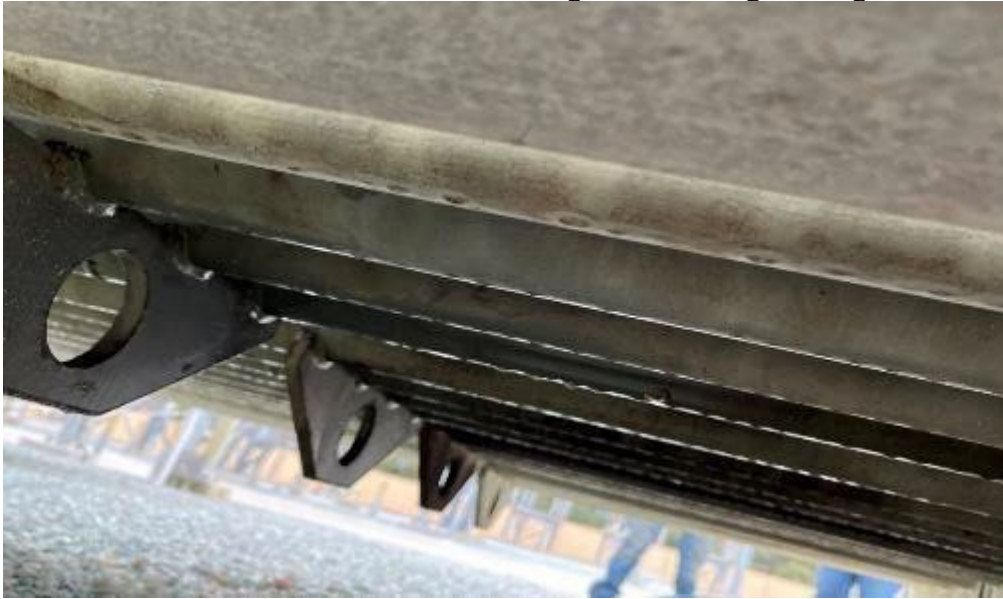
7.3 Transformer Bank 4 Oil Leak Mitigation Existing LC Tag#130535750.

We agree that Transformer Bank 4 had oil leak mitigation at Hicks Substation. This nonconformance had a pre-existing LC notification, 130535750, established in our system of record, SAP, prior to the field audit. We do not agree that this finding qualifies as a violation of GO 174, Rule 12 since this LC notification was worked in accordance with our maintenance procedures and completed on March 5, 2025.

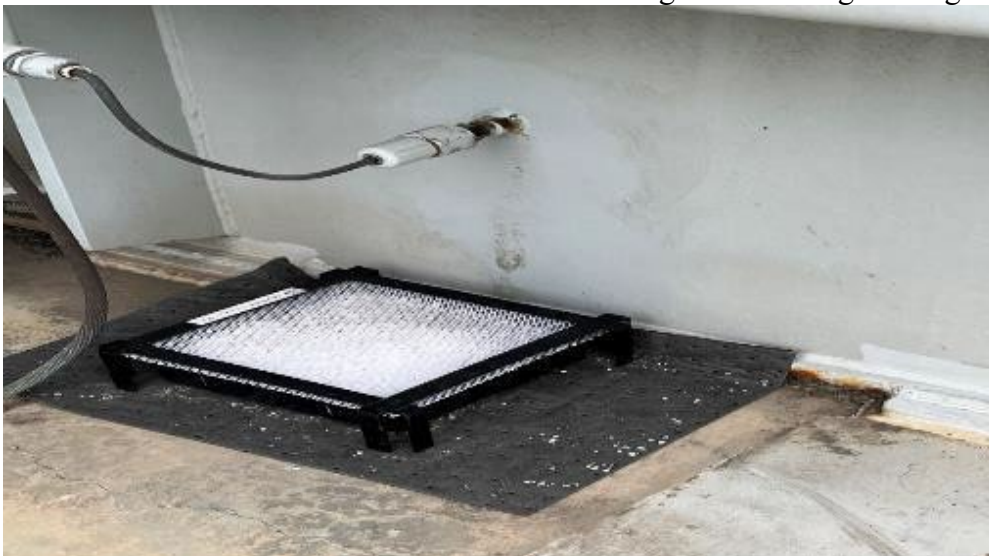
7.4 Transformer Bank 2 had an Oil Leak Mitigation Existing LC Tag#130535749.

We agree that Transformer Bank 2 had an oil leak mitigation at Hicks Substation. This nonconformance had a pre-existing LC notification, 130535749, that was established in our system of record, SAP, prior to the field audit. We do not agree that this finding qualifies as a violation of GO 174, Rule 12 since this LC notification was worked in accordance with our maintenance procedures and completed on February 14, 2025.

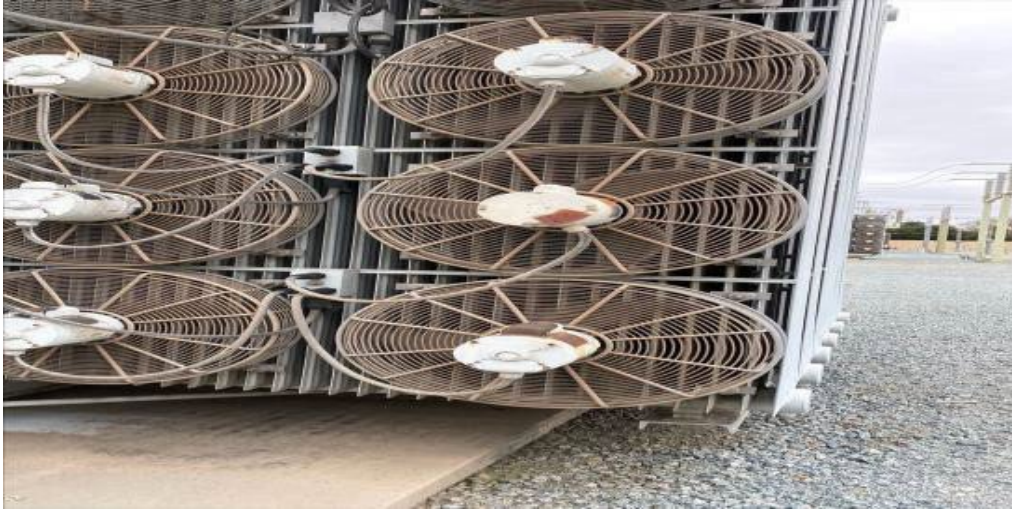
7.5 Transformer Bank 3 One Fan Not Working. PG&E Fixed in Field.

We agree with the finding that one fan on Transformer Bank 3 was not working at Hicks Substation. This issue was corrected onsite by PG&E QEW on the day of the field audit.

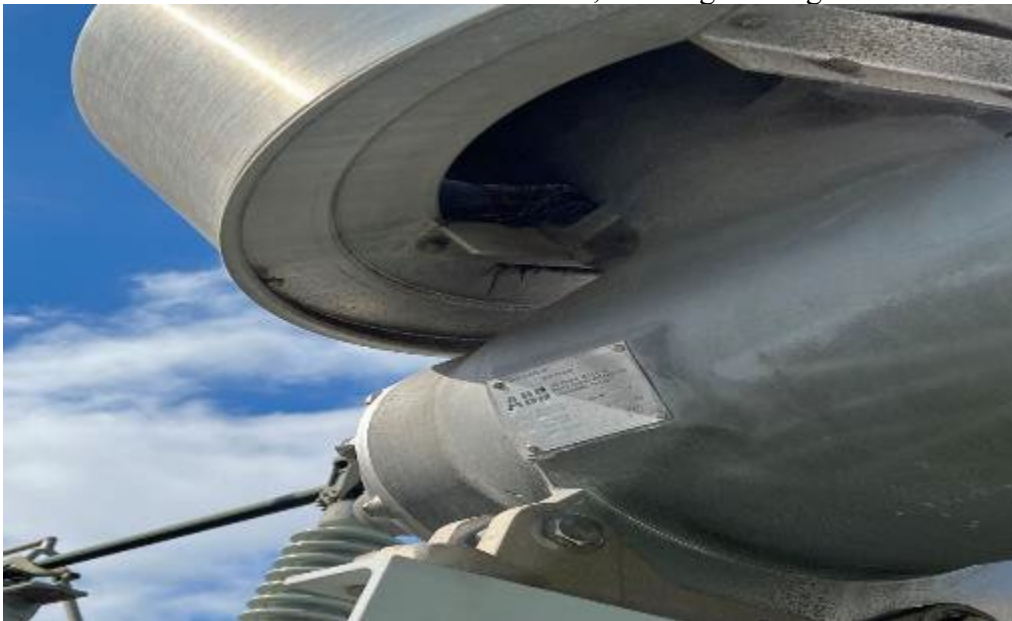
8.1 Circuit Breaker 162 Had a Bird Nest, Existing LC Tag#130791806.

We agree a bird's nest was present on circuit breaker 162 at Edenvale Substation. This nonconformance had a pre-existing LC notification, 130791806, that was established in our system of record, SAP, prior to the field audit. We do not agree that this finding qualifies as a violation of GO 174, Rule 12 since this LC notification was worked in accordance with our maintenance procedures and completed on February 3, 2025.

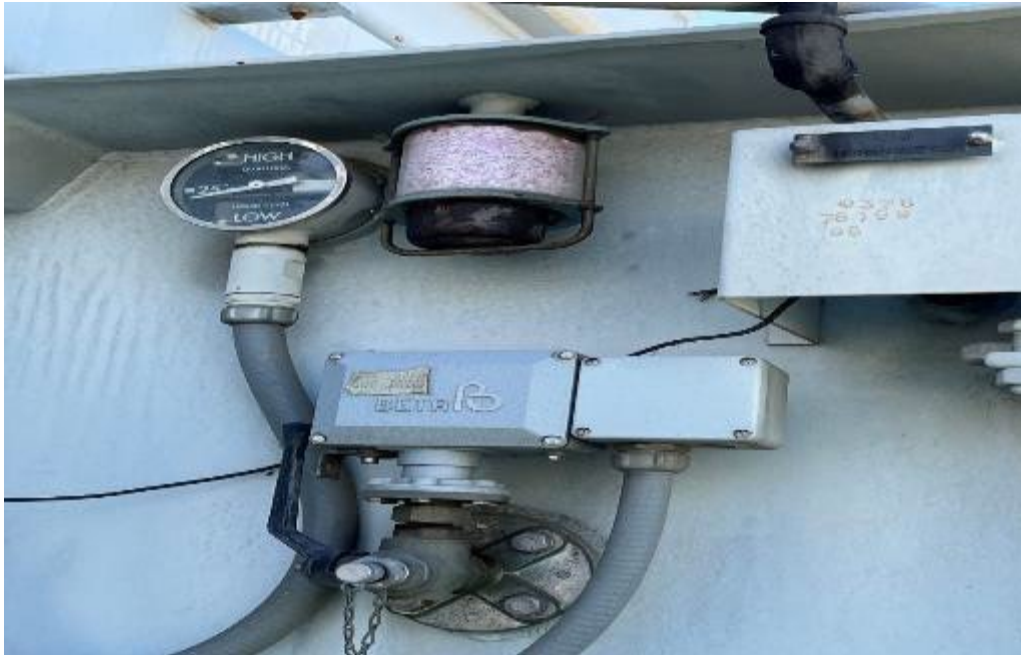
8.2 Transformer Bank 4 Desiccant Needs to be Replaced.

We agree with the finding that the desiccant needed replacement on Transformer Bank 4 at Edenvale Substation. We created LC notification 130804605, added it to the workplan and it was completed on March 17, 2025.

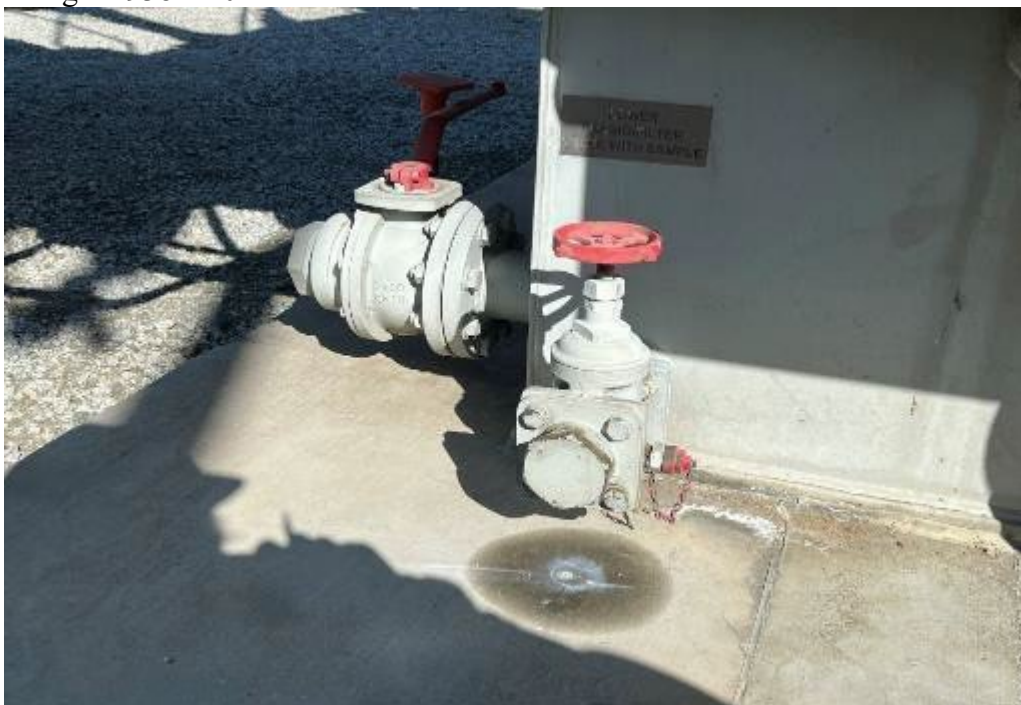
8.3 Transformer Bank 3 has Oil Leak at Lower Sampling Valve, Existing LC Tag#129384420.

We agree that oil was present below the sampling valve on Transformer Bank 3 at Edenvale Substation. We do not agree that this finding qualifies as a violation of GO 174, Rule 12 since we believe the oil present on the ground was only residual from a recent TDA sample that was completed on LC notification 129384420 on January 15, 2025.

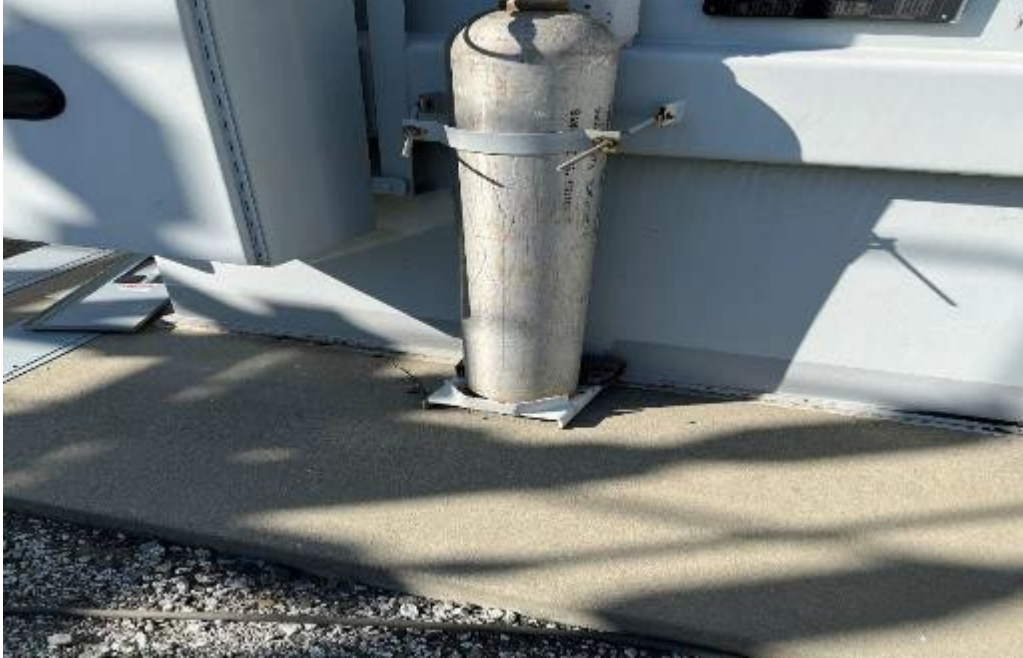
8.4 Transformer Bank 2 Nitrogen Bottle Needs 2nd Strap. PG&E Fixed in Field.

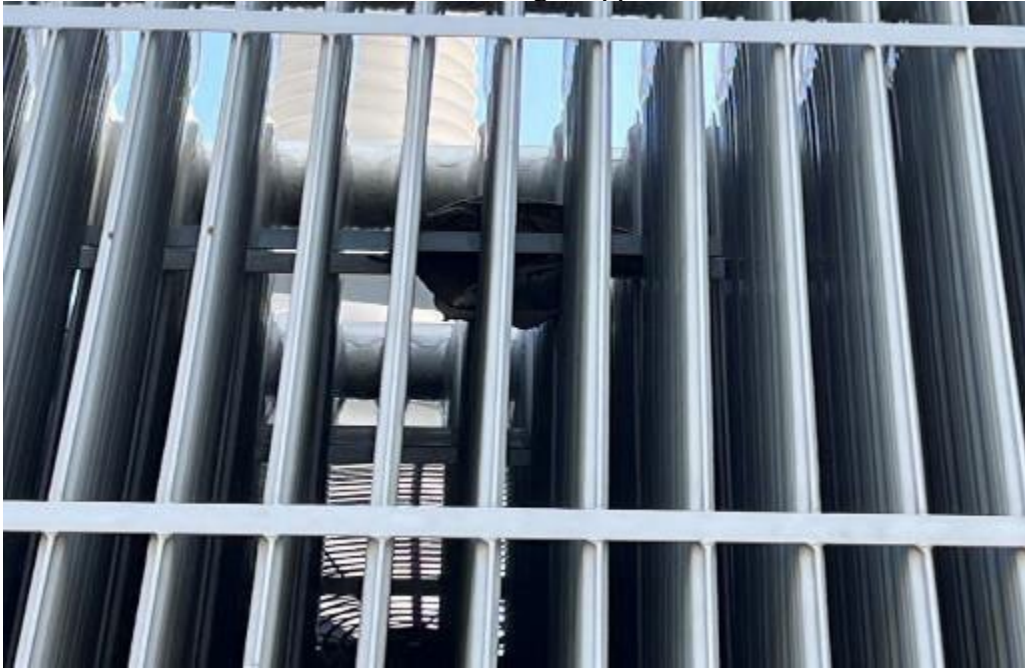
8.5 Transformer Bank 2 Fan has Rag Trapped in Radiator Fins. PG&E Fixed in Field.

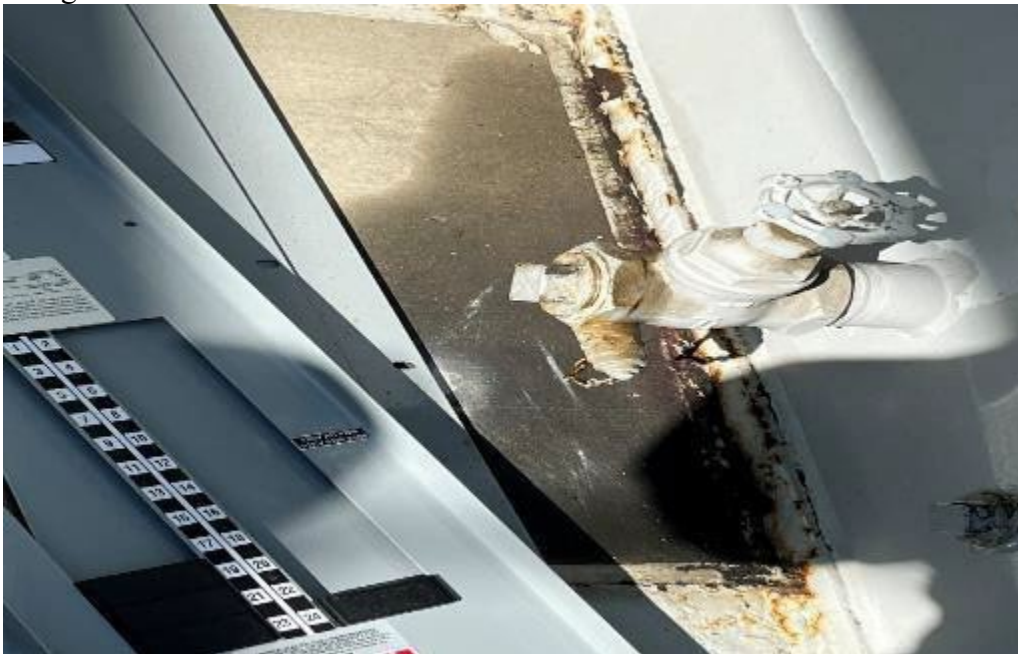
8.6 Transformer Bank 2 has Oil Leak Mitigation at Sample Valve. Existing LC Tag#130791809.

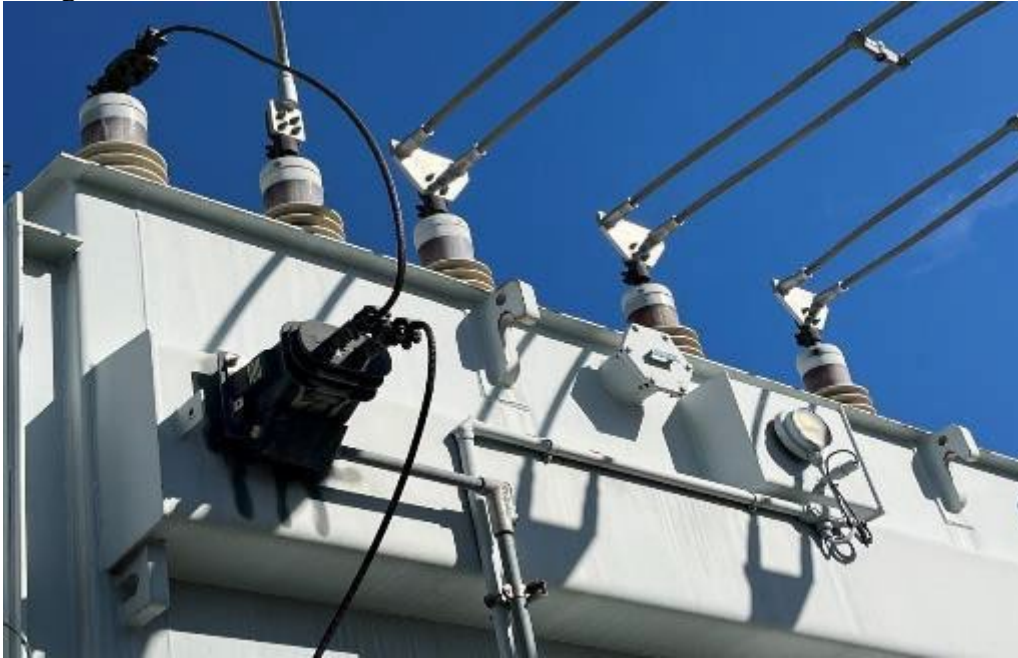
8.7 Transformer Bank 2 Need Animal Protection Tape at Bushing. Existing LC Tag#130791886.

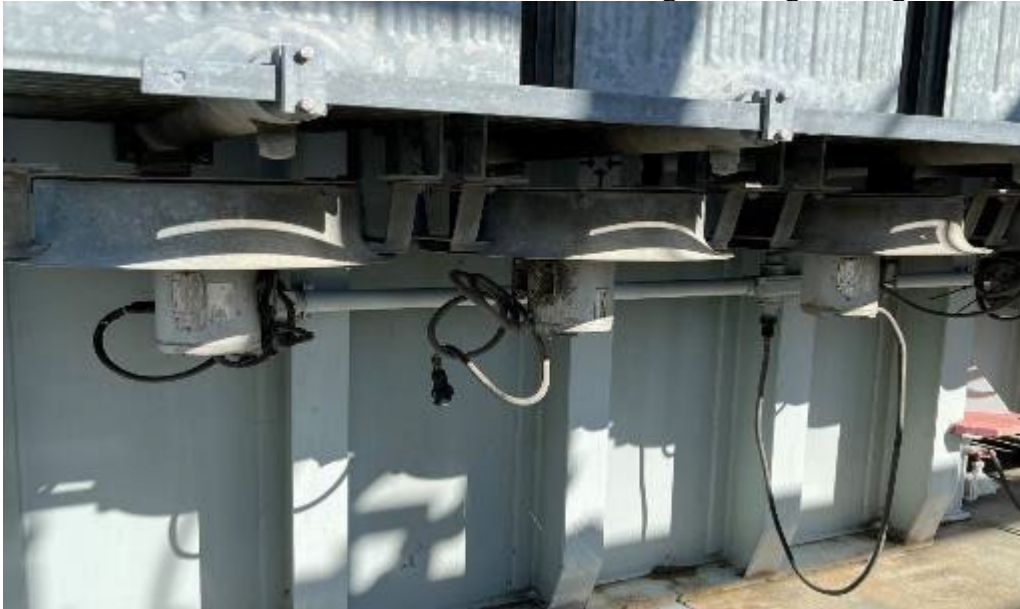
8.8 Transformer Bank 1 One Fan Not Working. Existing LC Tag#129632500.

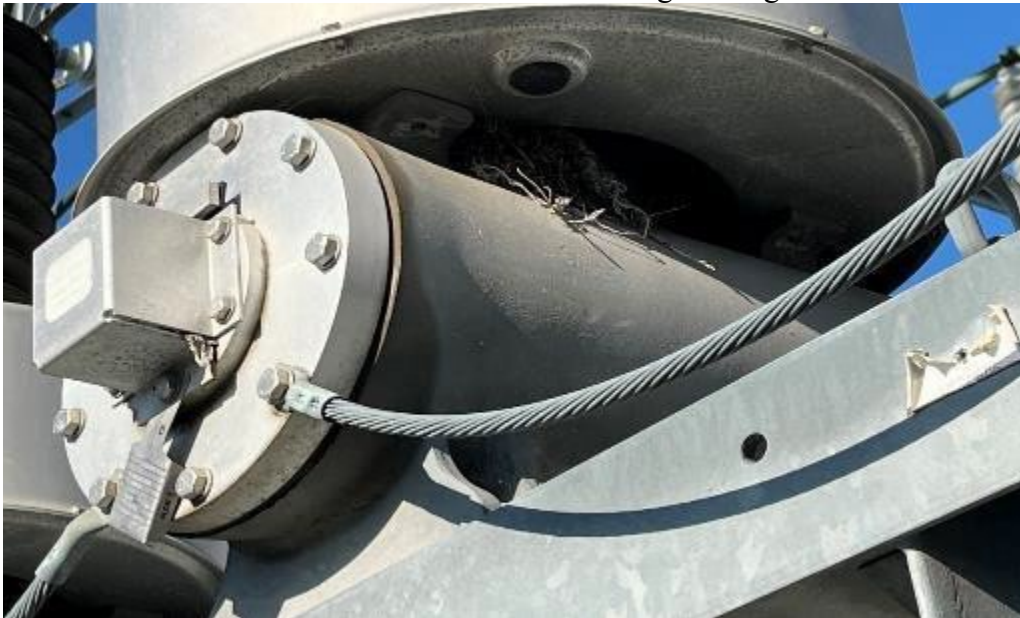
9.1 Circuit Breaker 32 Has Bird Nest. Existing LC Tag#129590697.

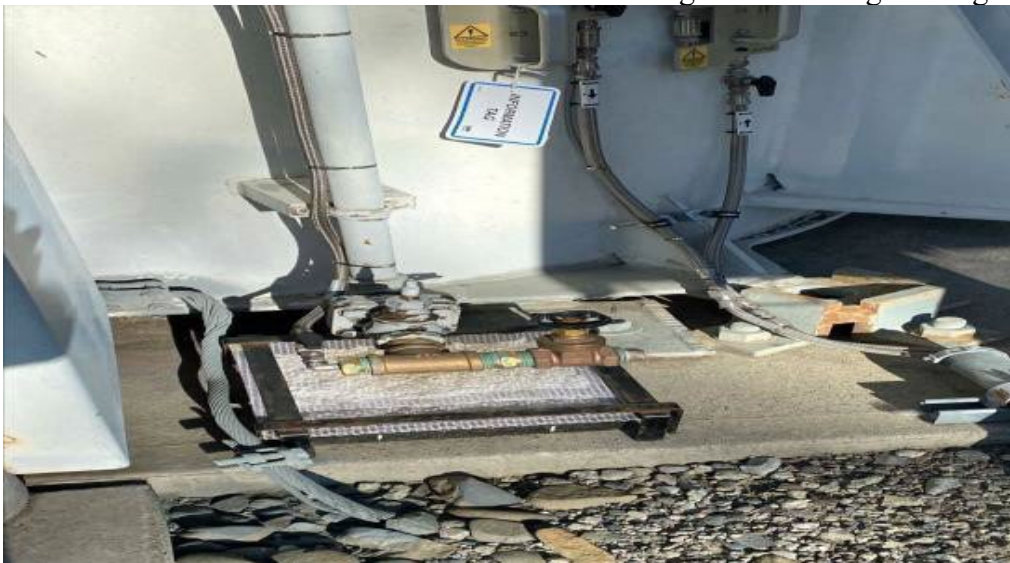
9.3 Transformer Bank 1 Phase B Oil Leak Mitigation. Existing LC Tag#129590535.

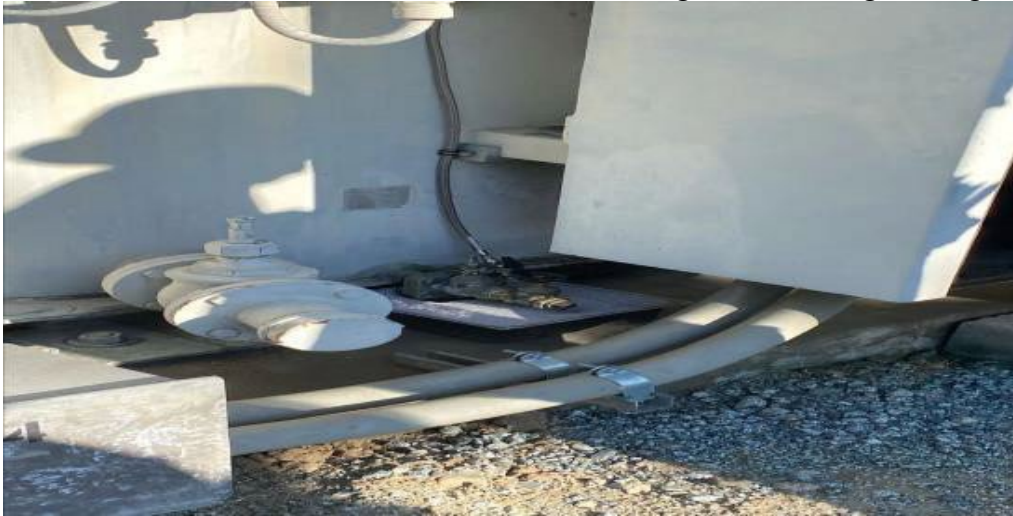
9.4 Transformer Bank 1 Phase A Oil Leak Mitigation. Existing LC Tag#129590535.

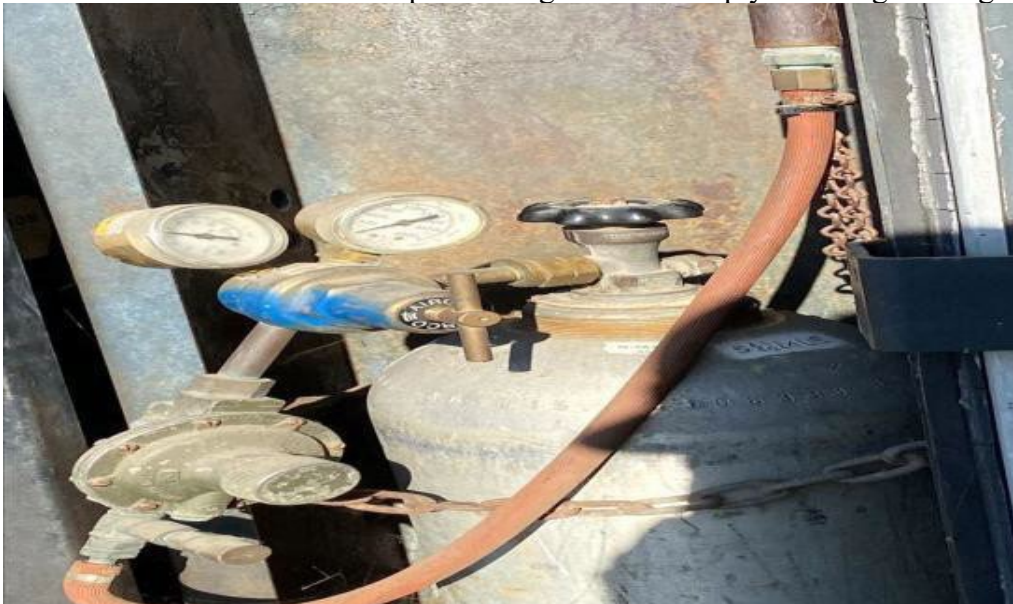
9.5 Transformer Bank 1 Spare Nitrogen Bottle Empty. Existing LC Tag#129590535.

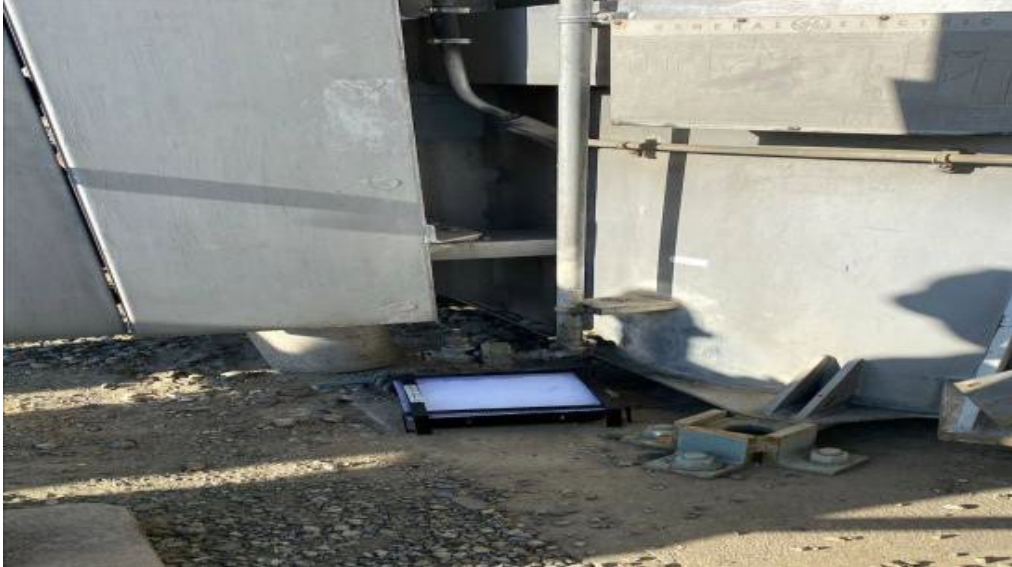
9.6 Transformer Bank 1 Spare Oil Leak Mitigation. Existing LC Tag#129590535.

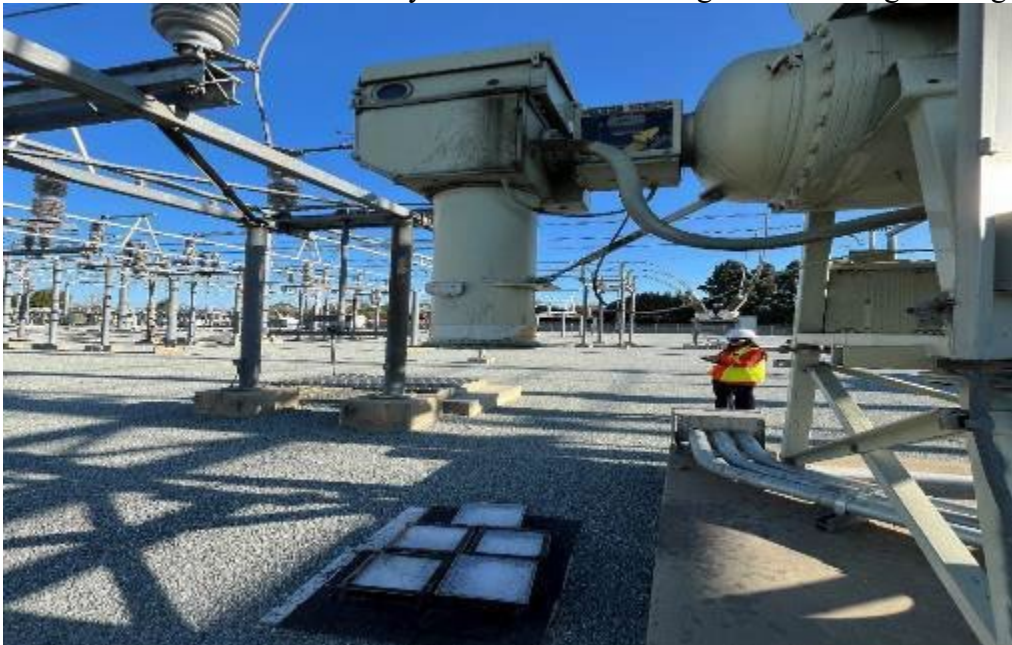
9.7 Circuit Breaker 172 Hydraulic Oil Leak Mitigation. Existing LC Tag#129590532.

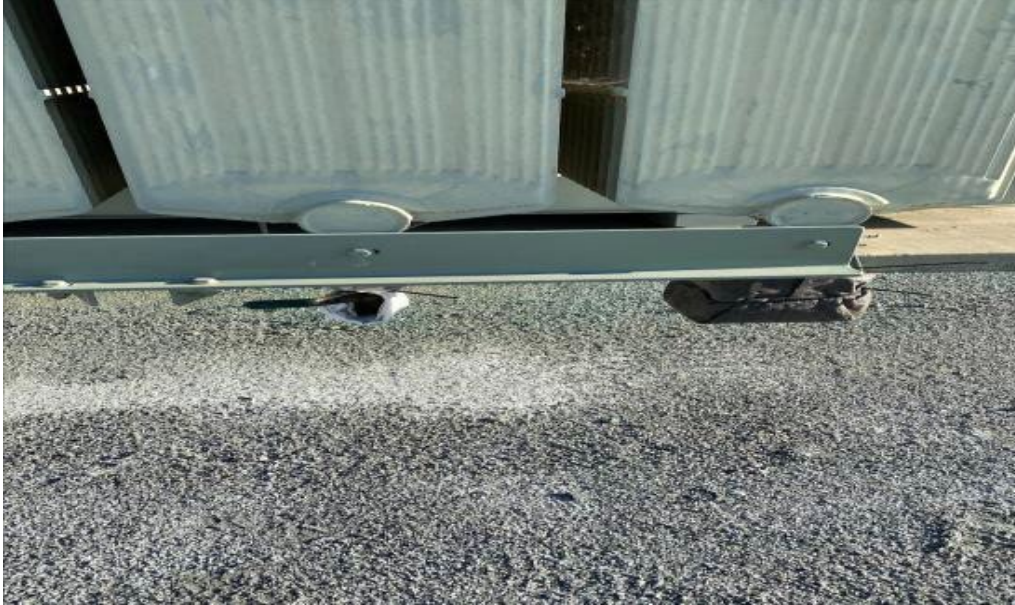
9.8 Transformer Bank 3 Oil Leak Mitigation. Existing LC Tag#129590690.

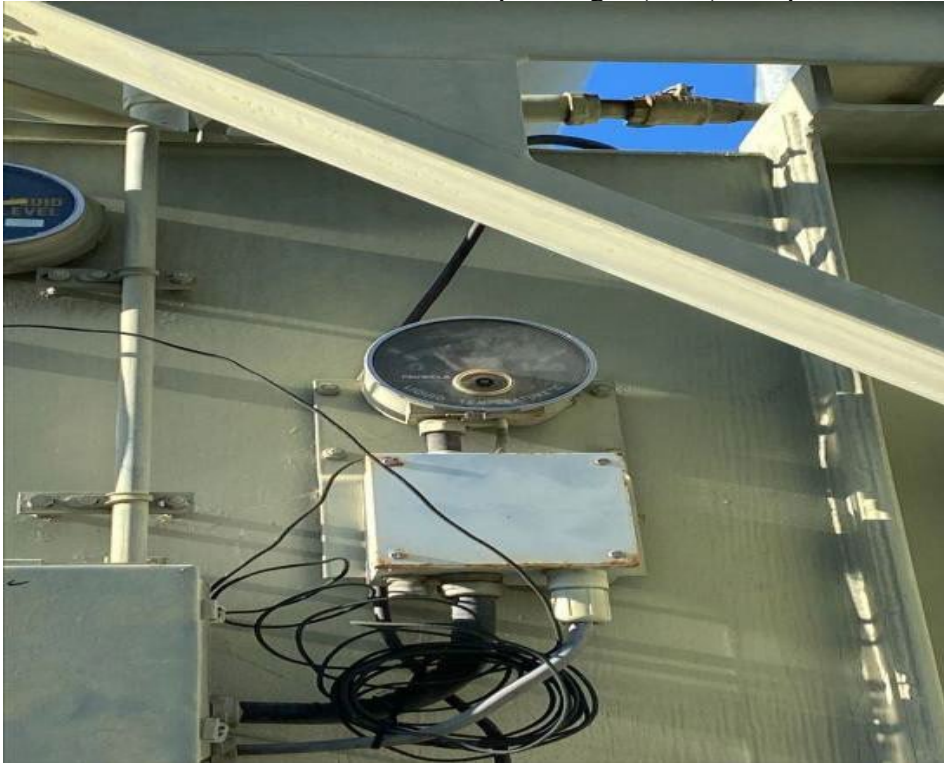
9.9 Transformer Bank 2 Load Tap Changer (LTC) Temperature Gauge Hard to Read.

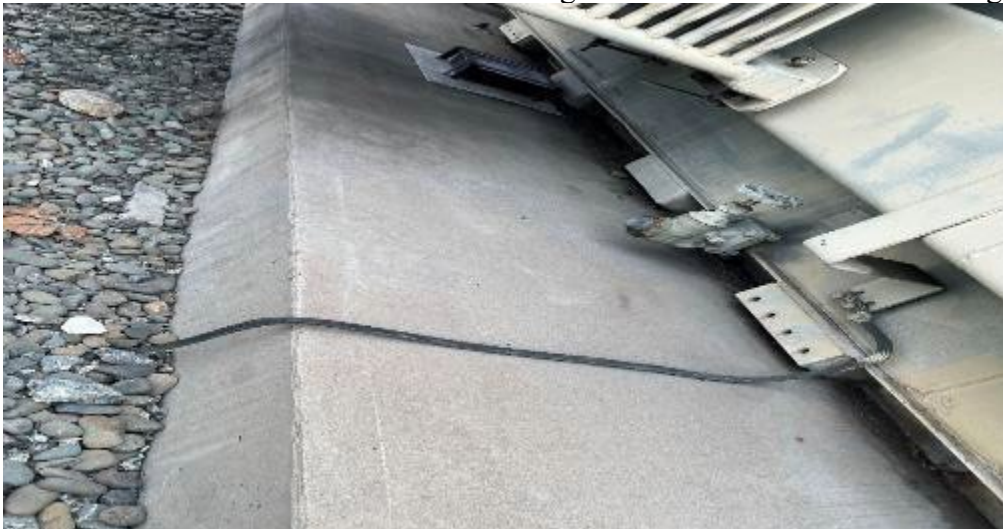
### **10.2 Transformer Bank 2 Oil Leak Mitigation at Main Oil Valve. Existing LC Tag#130718285.**

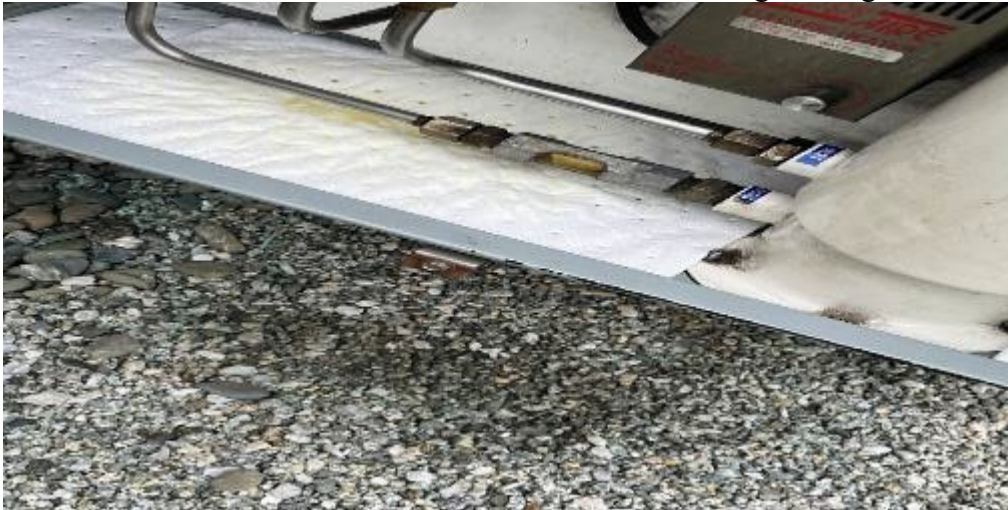
10.3 Transformer Bank 2 Oil Filter Line Leak. Existing LC Tag#130718286.

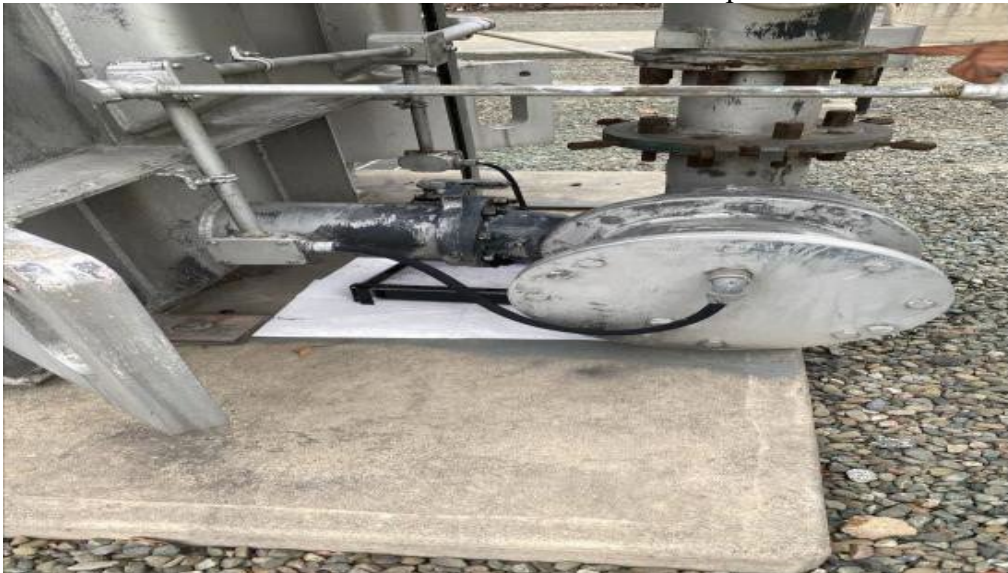
10.4 Transformer Bank 1 Oil Leak at Main Oil Pump Valve.

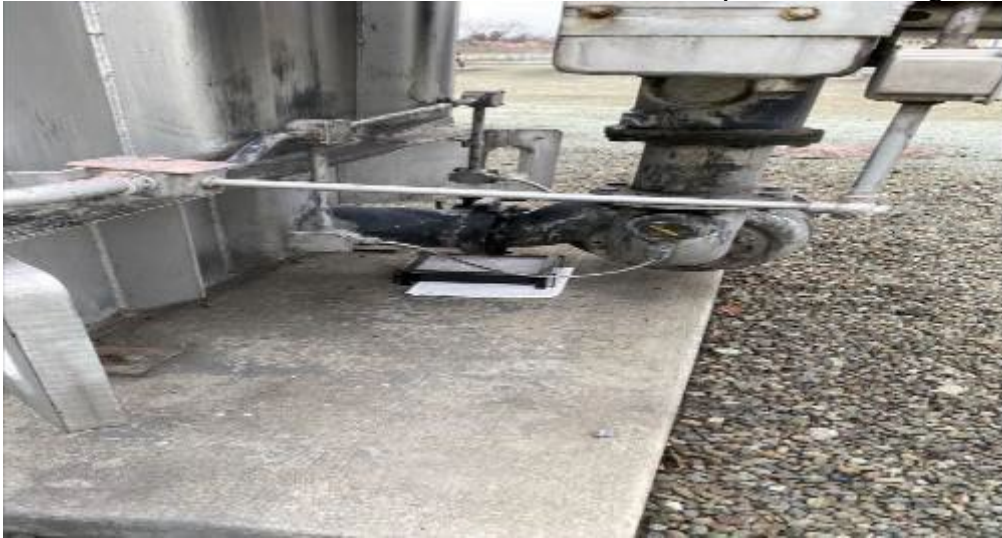
10.7 Transformer Bank 2 Oil Leak at Main Oil Pump Valve. Existing LC Tag#130718282.

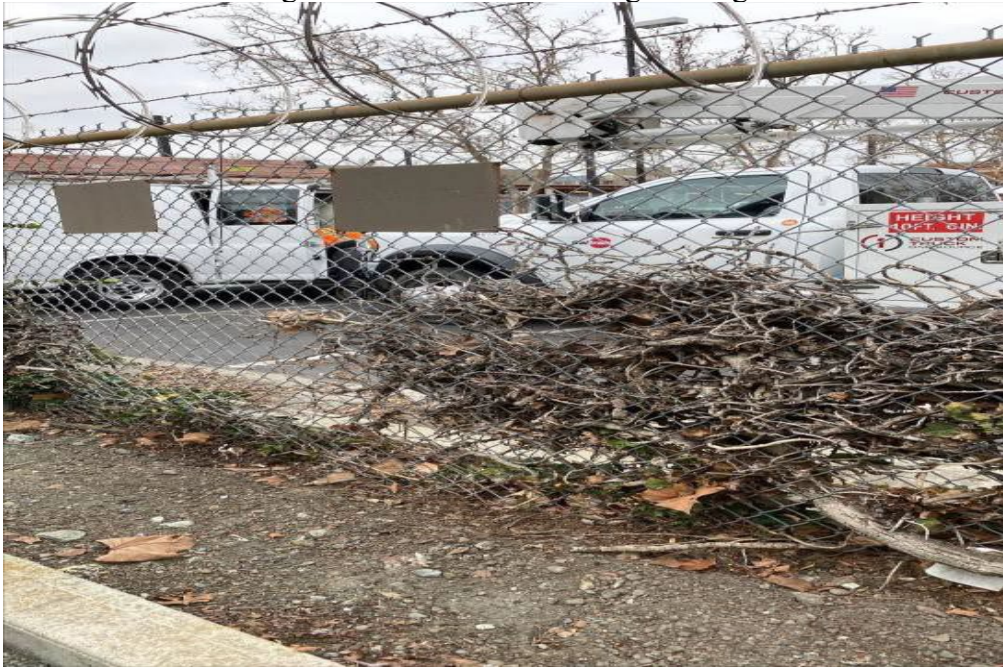
10.9 Perimeter Security Fence Signs Installed Inside Fence Existing LC Tag#130719763, Ground Rod Missing Northeast Corner Existing LC Tag#129390970.

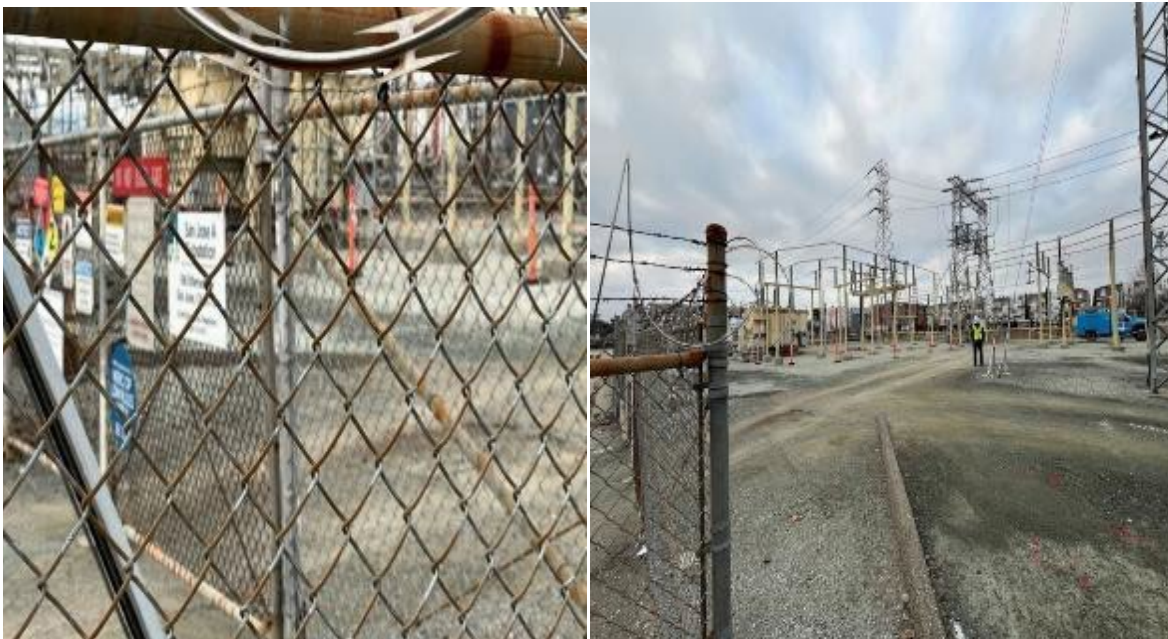
10.10 Ground Rod Missing Entrance Gate Left Side Post

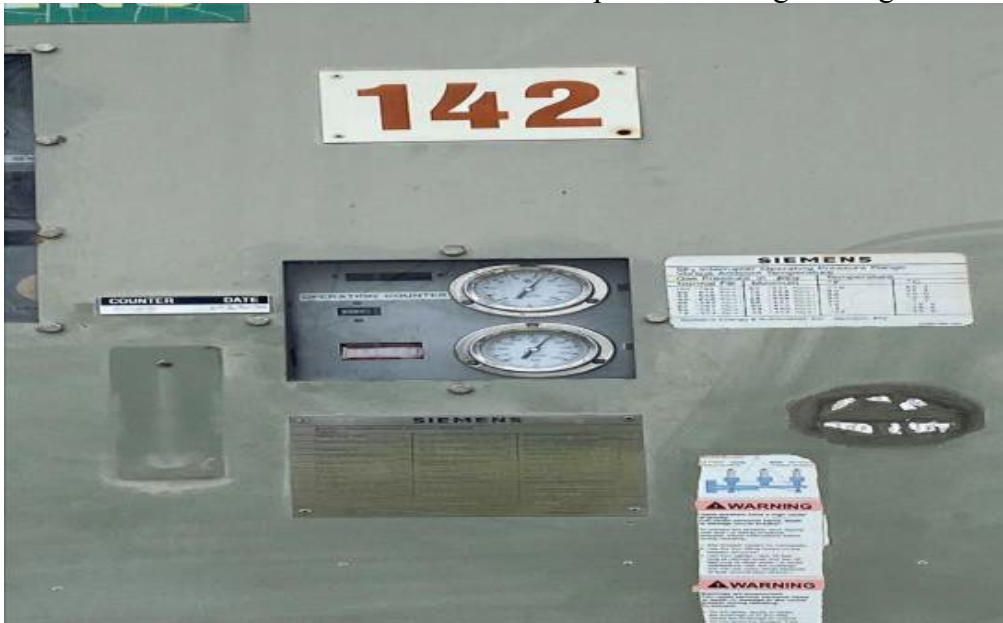
11.1 Circuit Breaker 142 has Faded Semaphore. Existing LC Tag#130791452.
