**CPUC SUBSTATION AUDIT FINDINGS REPORT RESPONSE**  
**PG&E Cupertino Headquarters**  
**January 27 – 31, 2025**

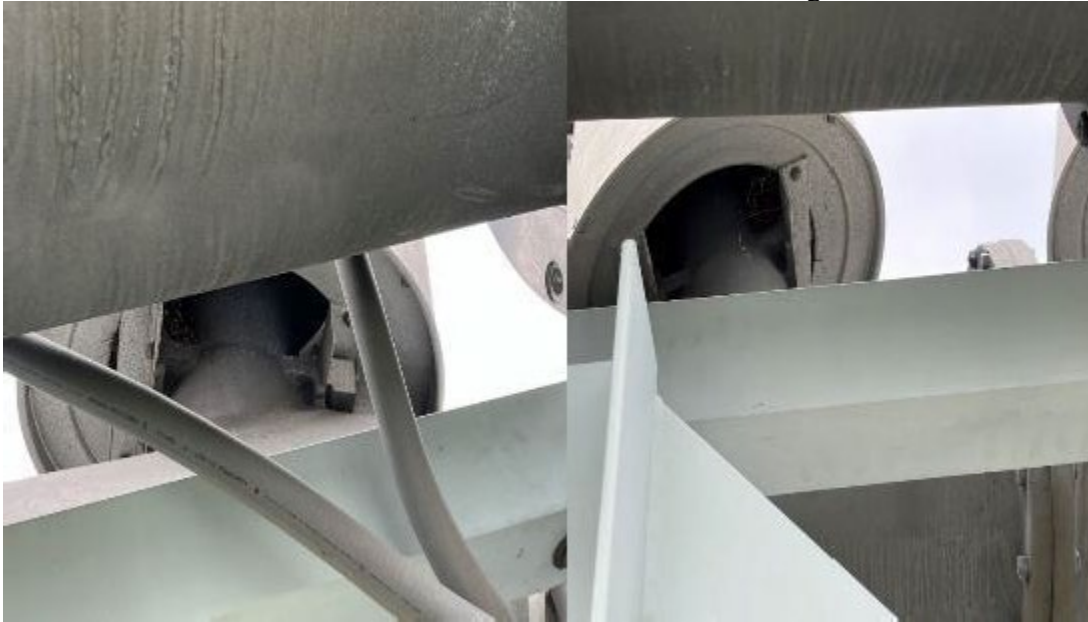
11.2 Circuit Breaker 182 has 2 Birds Nests Middle Bushing. PG&E Fixed in Field.

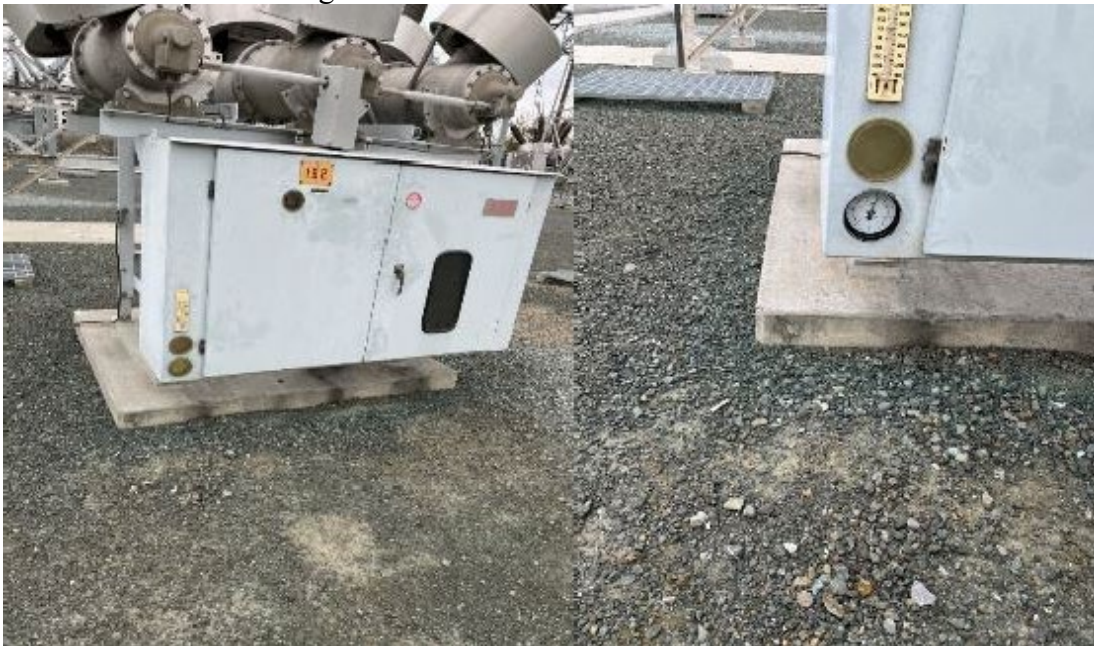
11.3 Circuit Breaker 162 Pressure Gauges Were Not Readable. Existing LC Tag#130791449 to Reinstall Pressure Gauges.

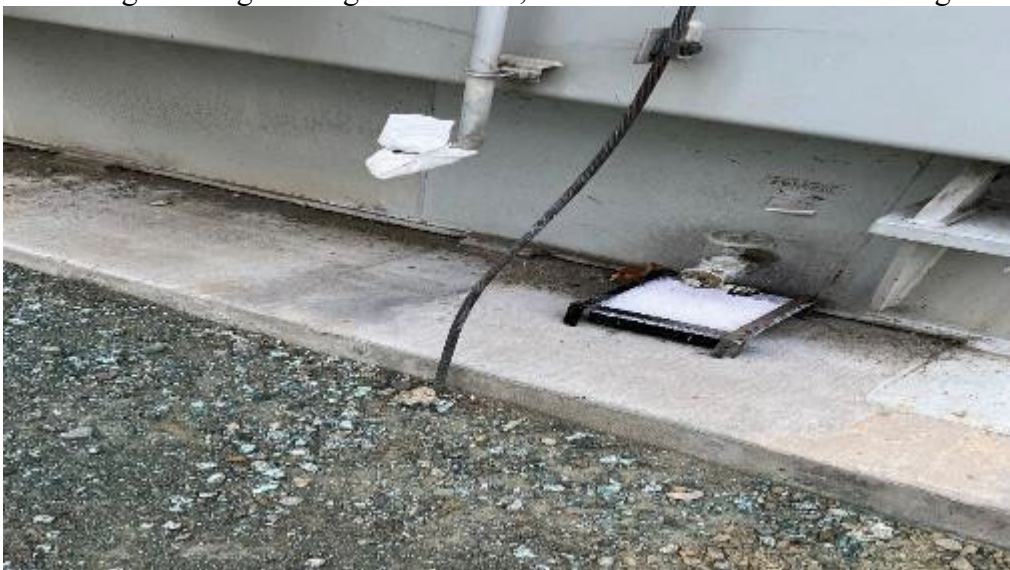
11.7 Transformer Bank 2 Oil Leak Mitigation Existing LC Tag#130791408, Oil Filter Not Running Existing LC Tag#129391900, Oil Residue on Conduit Existing LC Tag#129389768.

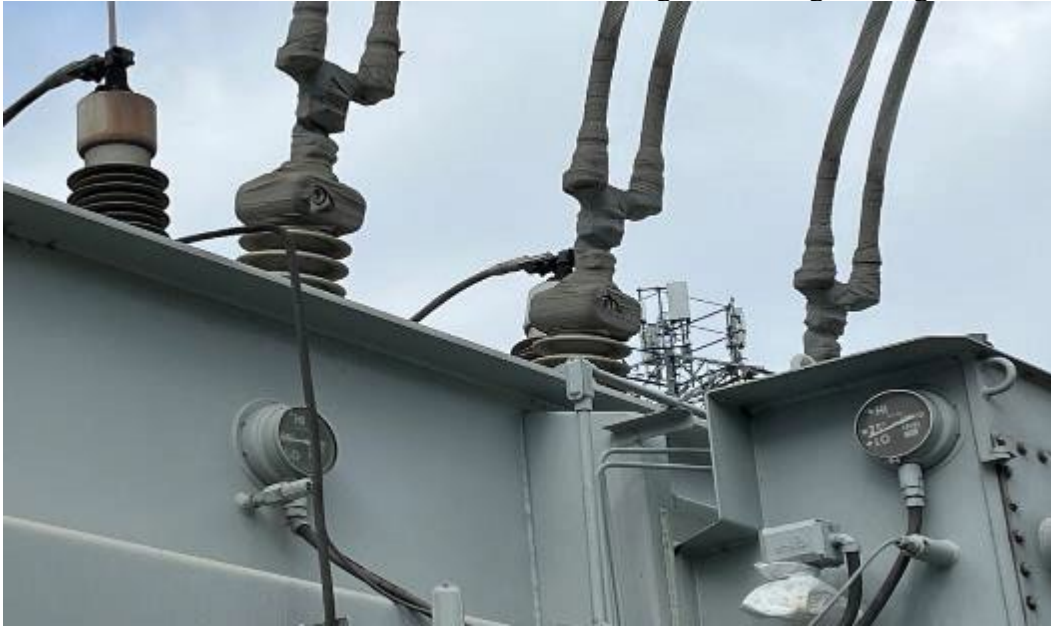
11.8 Transformer Bank 2 Animal Guard Damaged. Existing LC Tag#129390991.

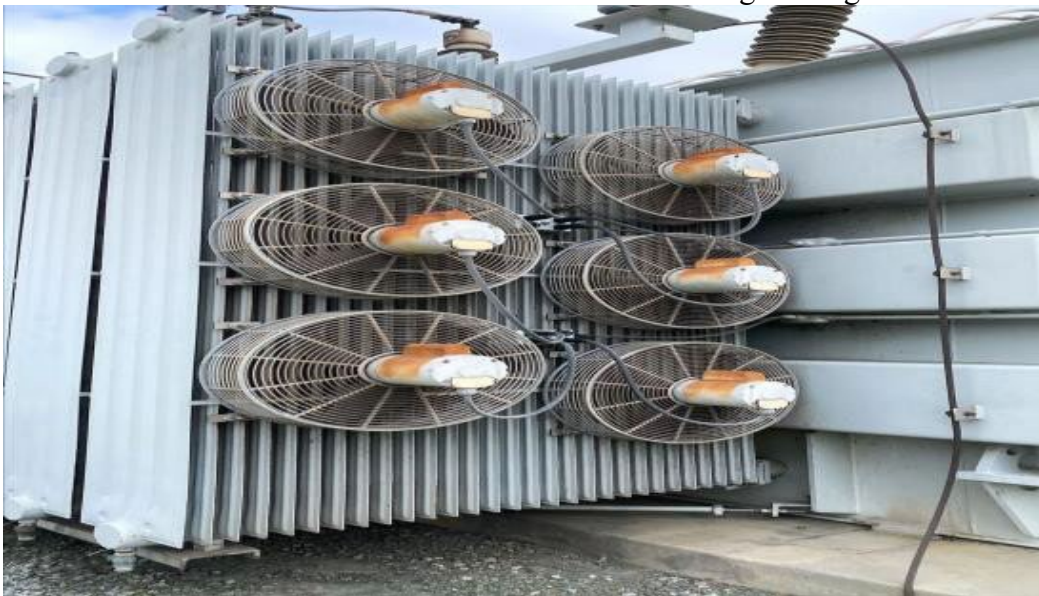
11.9 Transformer Bank 2 Fan Covers Rusted. Existing LC Tag#129389760.

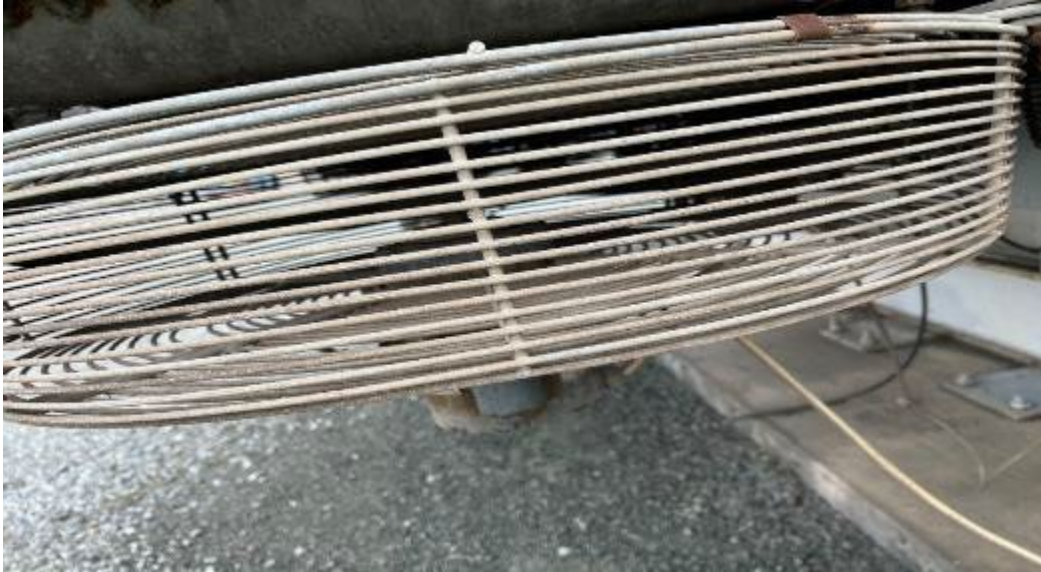
11.10 Transformer Bank 3 Fan Not Working. Existing LC Tag#130791434.

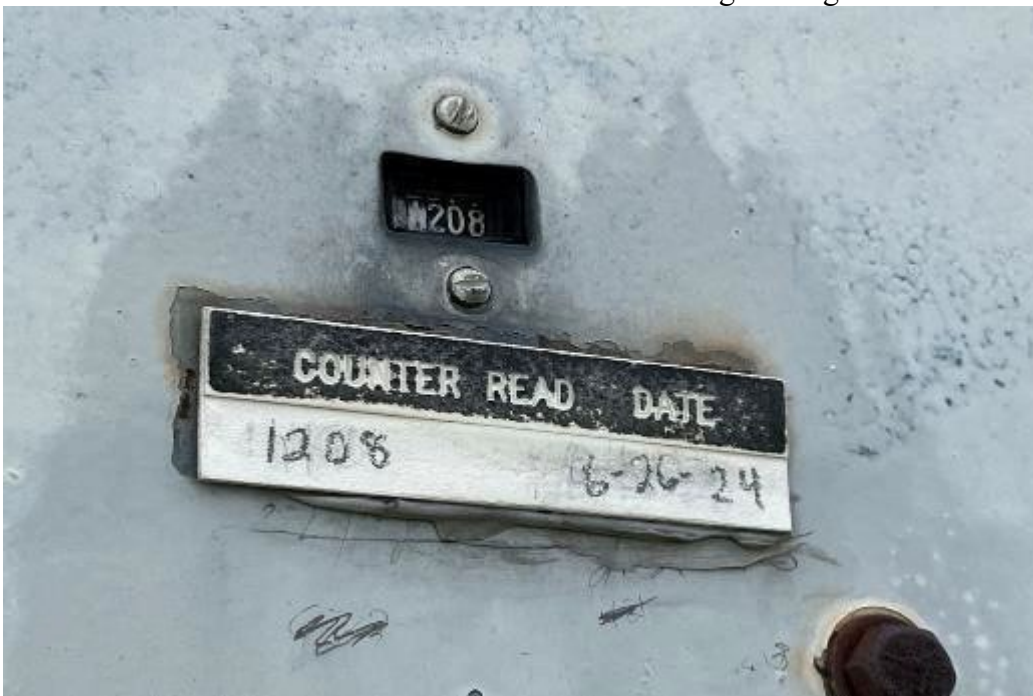
11.11 Circuit Breaker 1110/2 Faded Counter. Existing LC Tag#128451938.

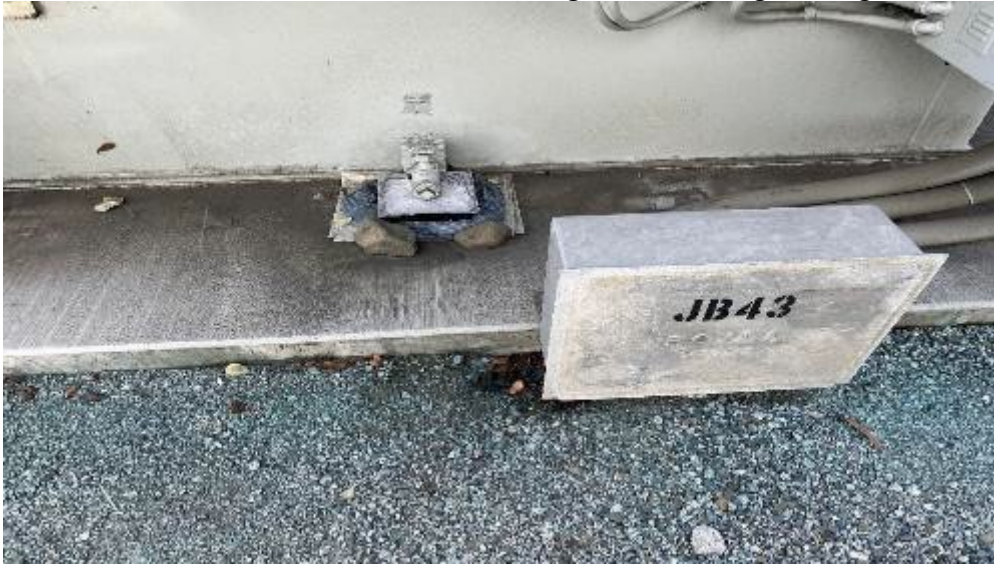
12.1 Transformer Bank 2 Oil Leak Mitigation. Existing LC Tag#130535745.

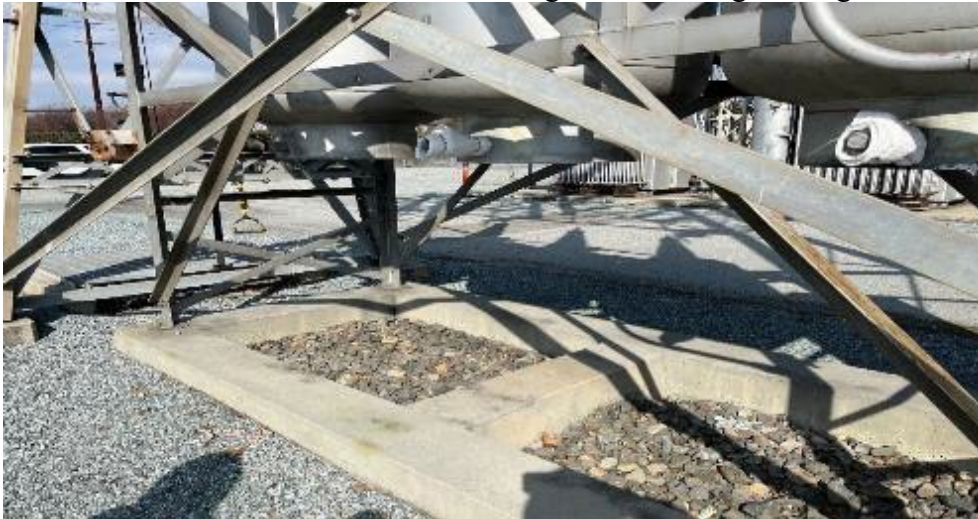
12.2 Circuit Breaker 72 Oil Leak Mitigation. Existing LC Tag#129395916.

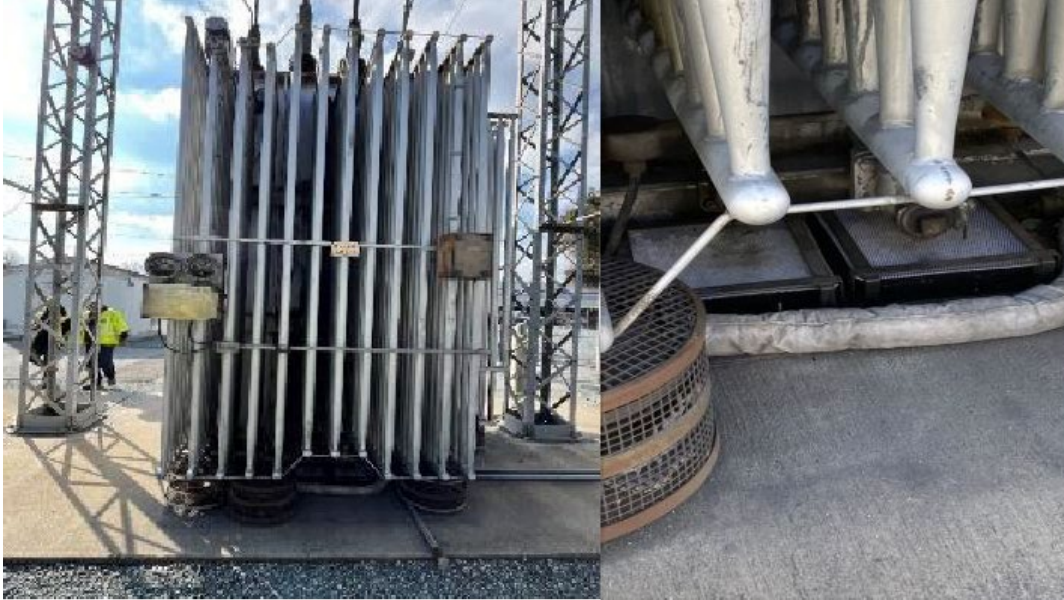
12.3 Transformer Bank 1 Phase C Oil Leak Mitigation. Existing LC Tag#130732652.

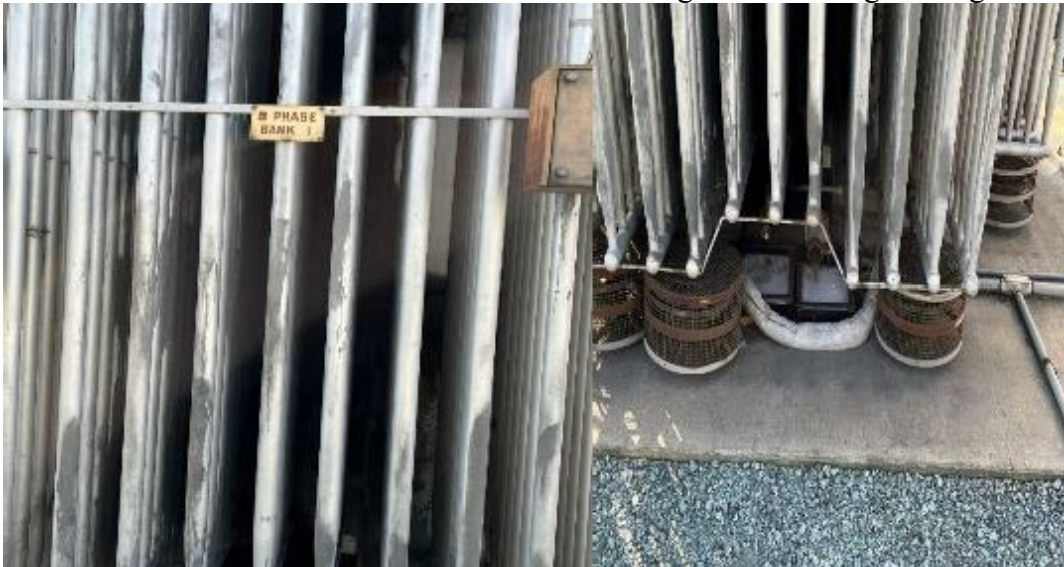
12.4 Transformer Bank 1 Phase B Oil Leak Mitigation. Existing LC Tag#130732701.

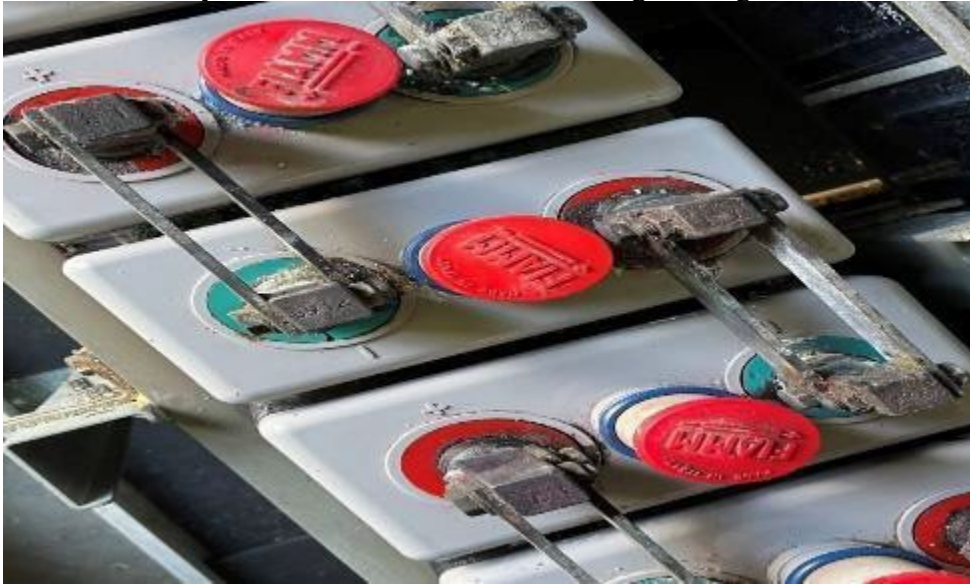
12.7 Battery Room Corrosion on Cells. Existing LC Tag#130713366.

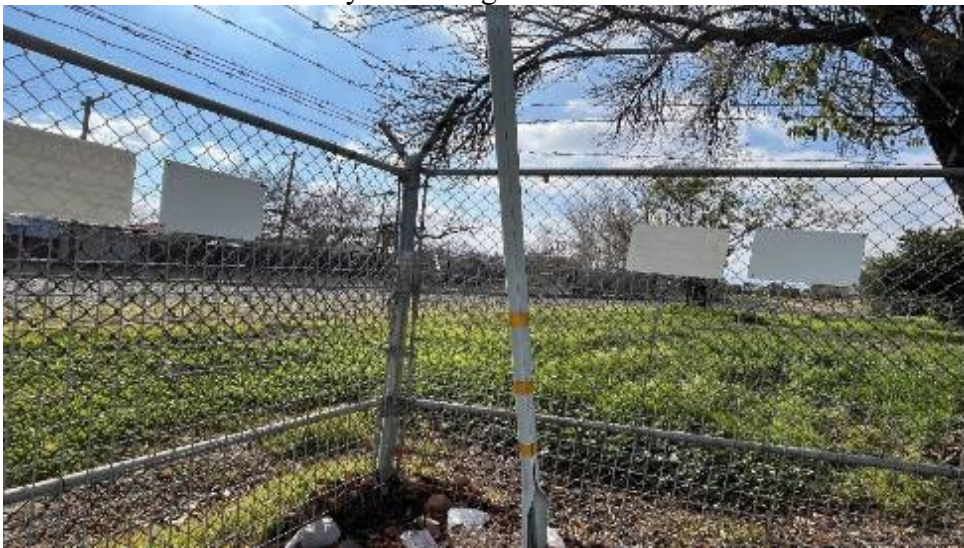
12.8 Perimeter Security Fence Signs Installed Inside Fence.

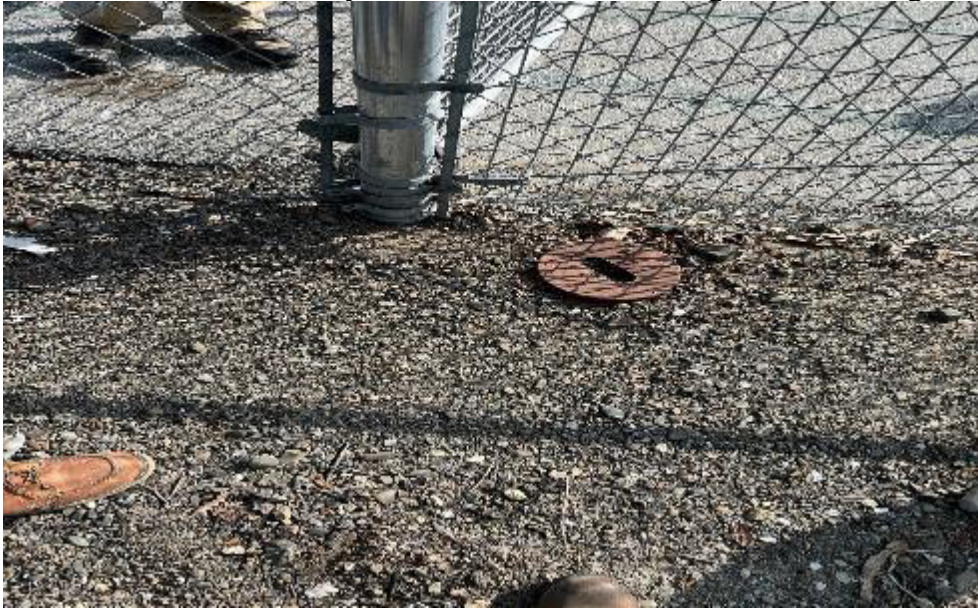
12.9 Perimeter Security Fence Ground Rod Missing Front Gate Right Side Post.

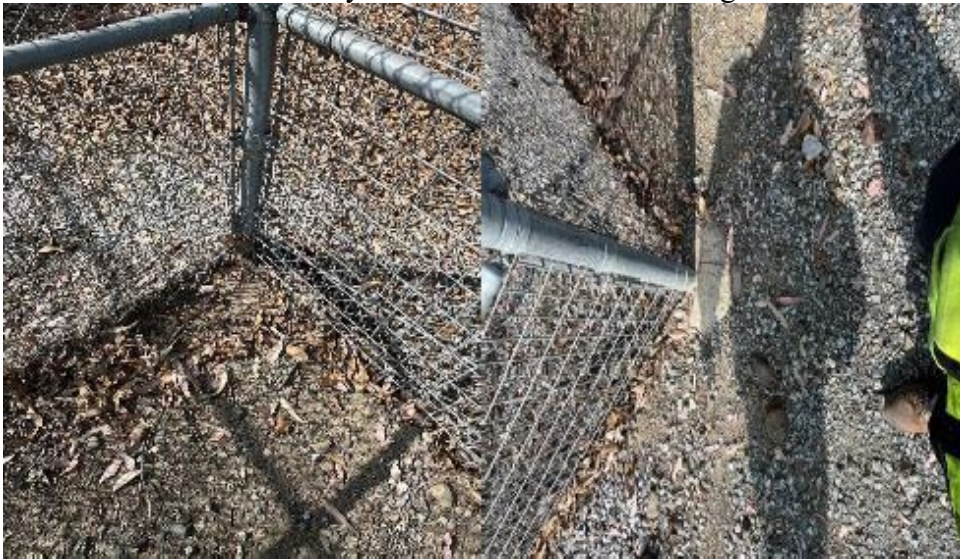
12.10 Perimeter Security Fence Ground Rods Missing at Substation Back Corner Posts.

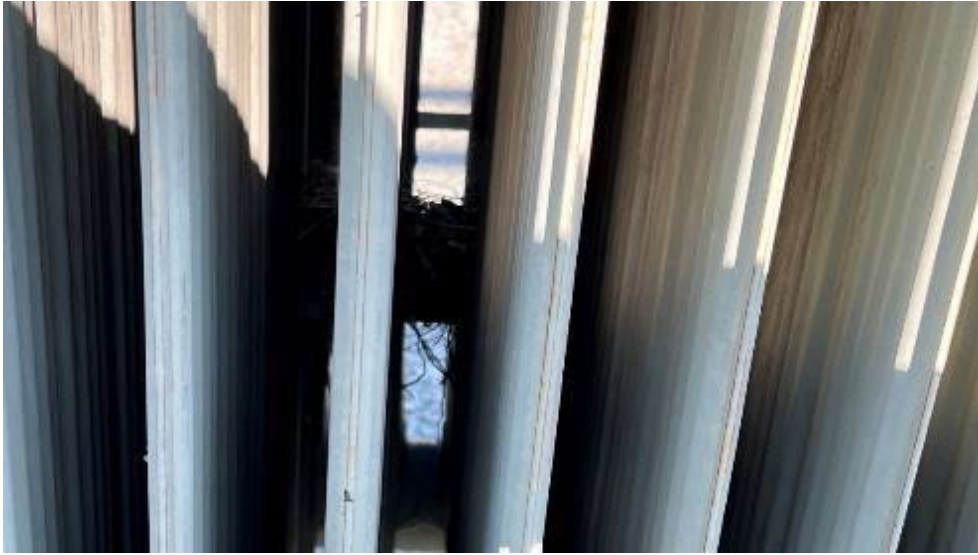
13.3 Transformer Bank 5 Birds Nest in Radiator. PG&E Fixed in Field.

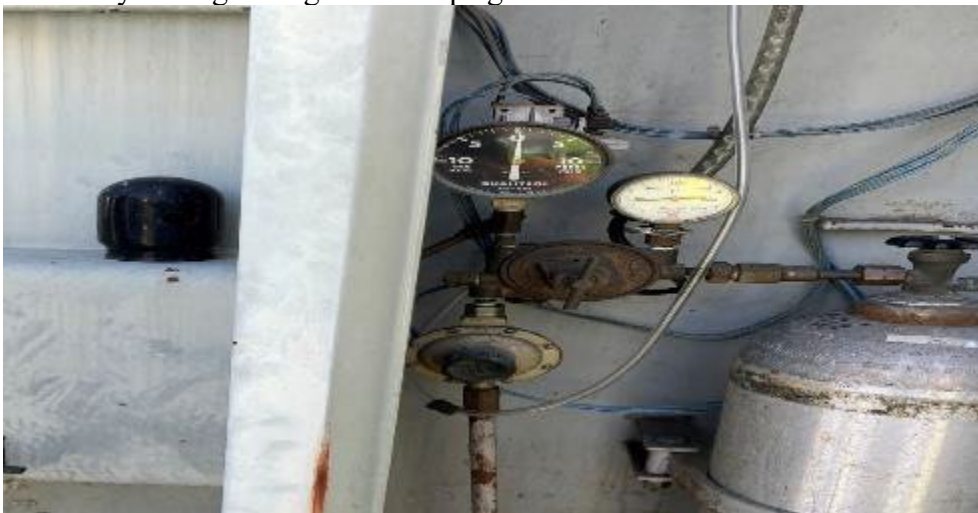
13.4 Transformer Bank 3 Low Nitrogen Pressure. Existing LC Tag#130712672 PG&E Fixed in Field by adding Nitrogen to 0.5 psig.

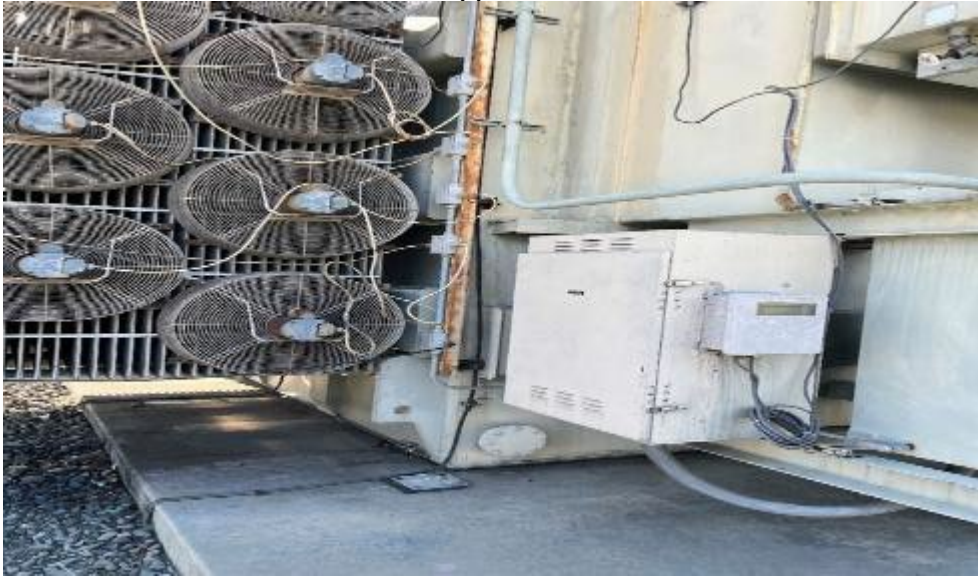
### 13.5 Rust on Fan Cover and Support Structure

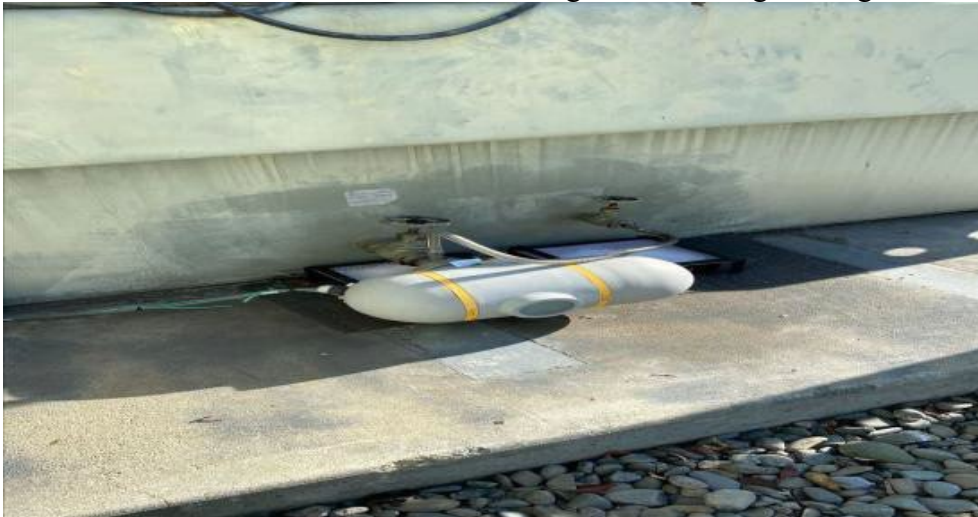
### 13.6 Transformer Bank 3 Oil Leak Mitigation. Existing LC Tag#130703901.

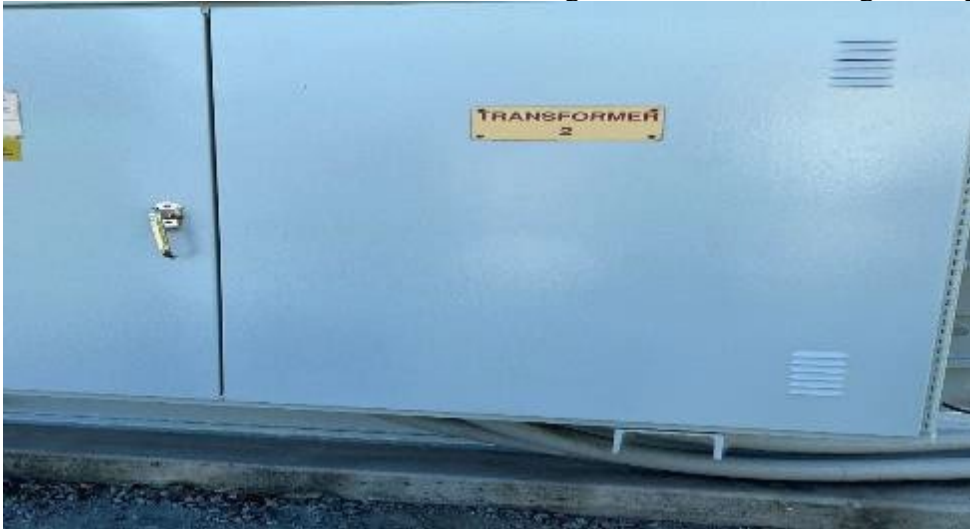
13.7 Transformer Bank 2 Oil Leak Mitigation at Filter. Existing LC Tag#130712699.

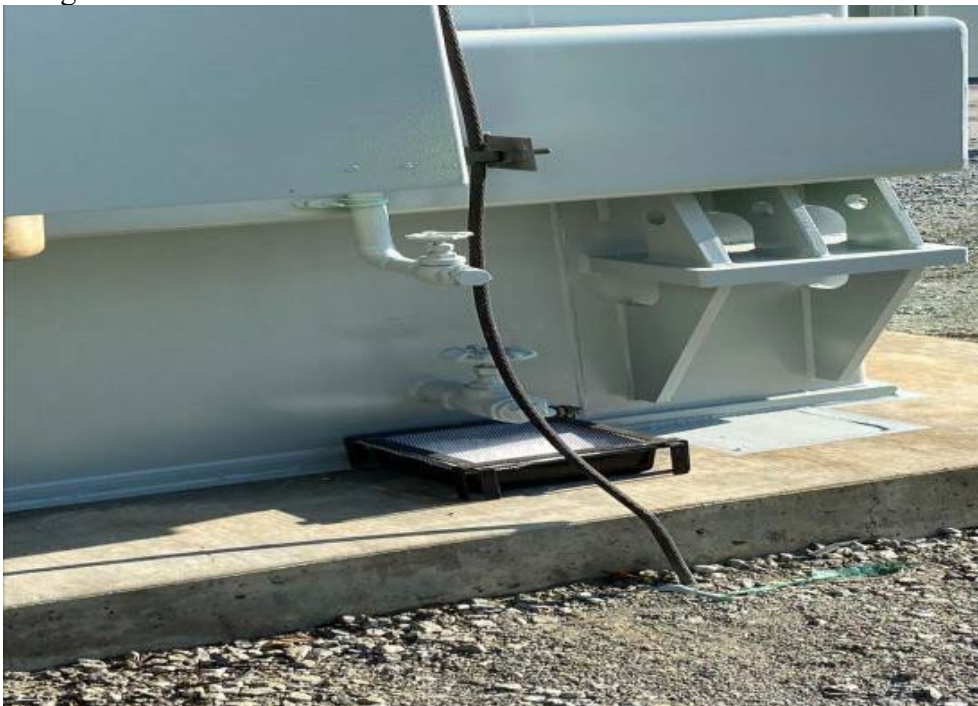
13.8 Transformer Bank 1 Oil Leak Mitigation at Main Drain Valve. Existing LC Tag#130712698.

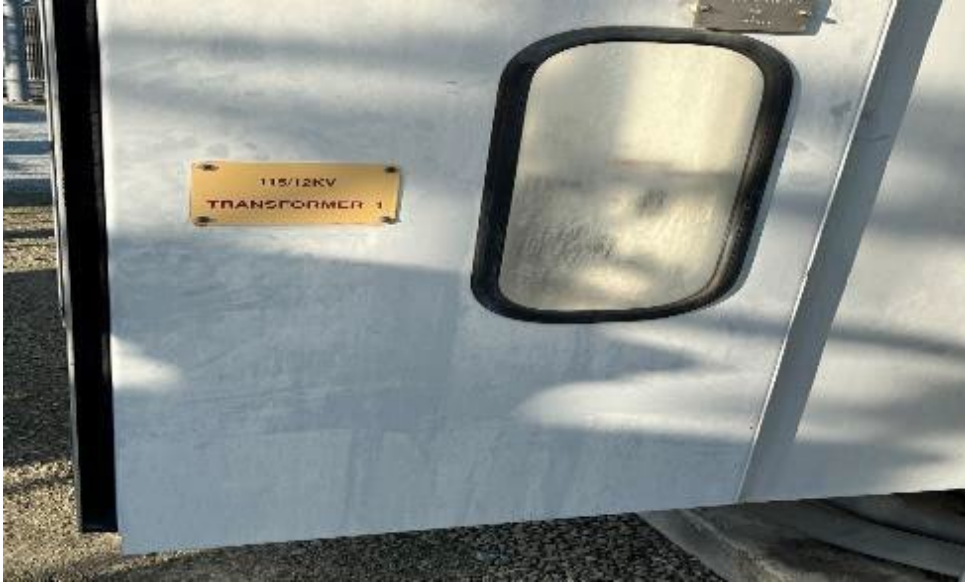
14.1 Transformer Bank 1 Oil Leak Mitigation. Existing LC Tag#130712698.

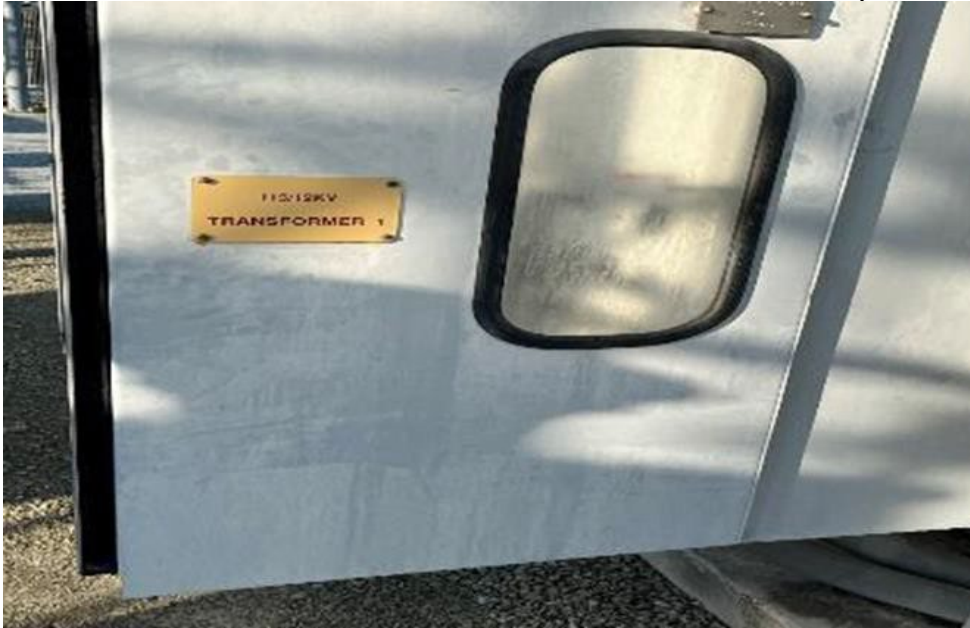
#### 14.2 Transformer Bank 1 Desiccant Near End of Life Need Replacement

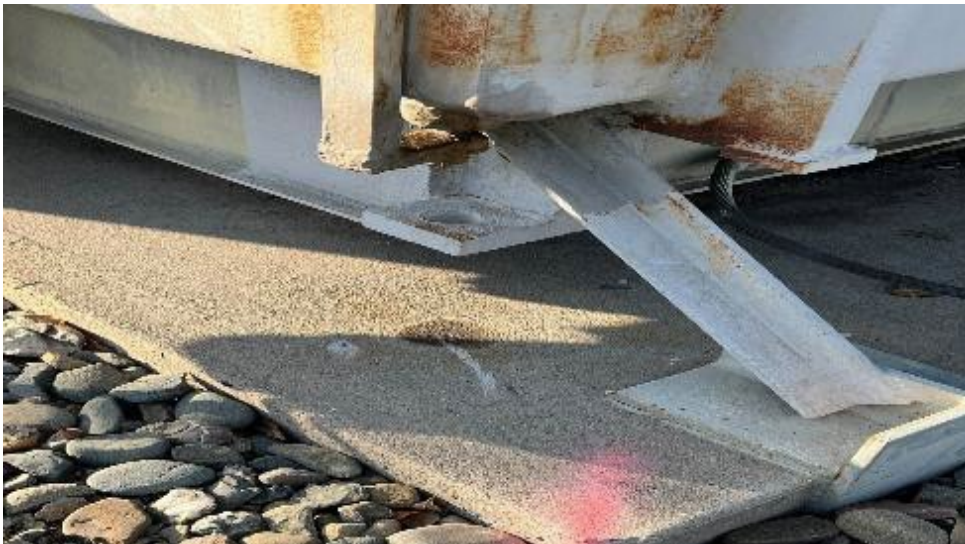
#### 14.3 Transformer Bank 2 Oil Left Corner of Transformer.

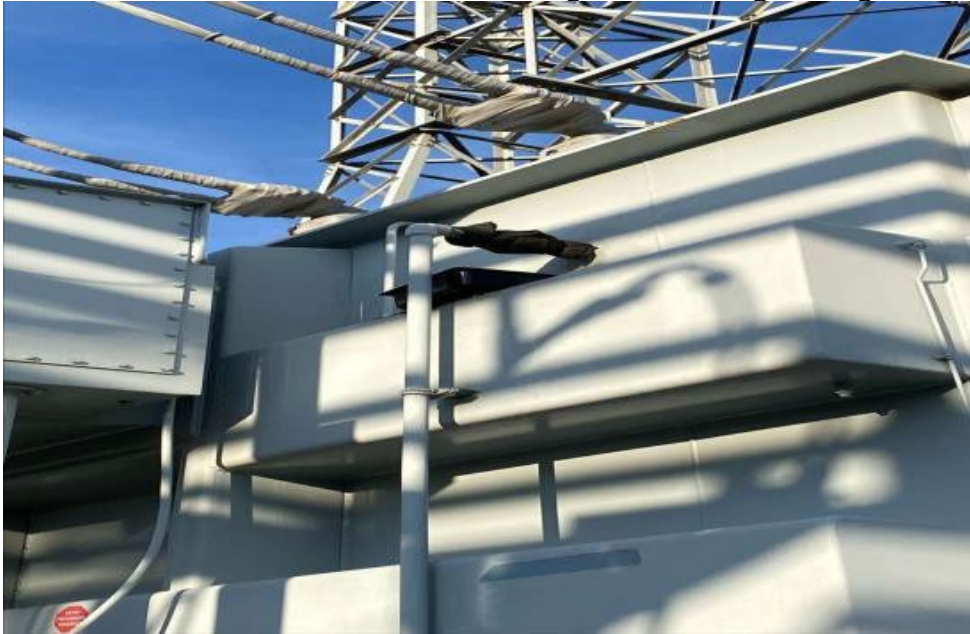
14.4 Transformer Bank 3 Oil Leak Mitigation. Existing LC Tag#130116554.

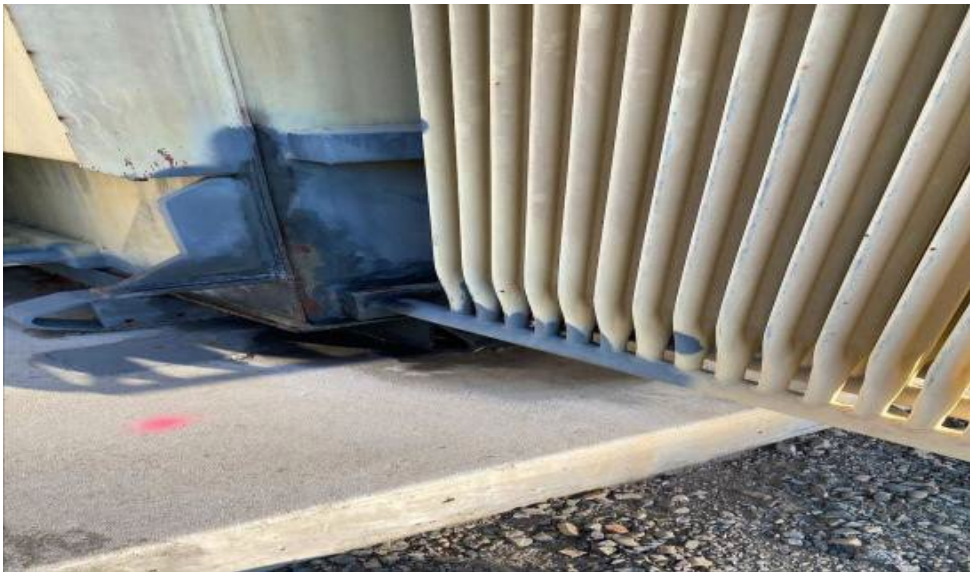
14.5 Transformer Bank 4 Oil Left Corner of Transformer.

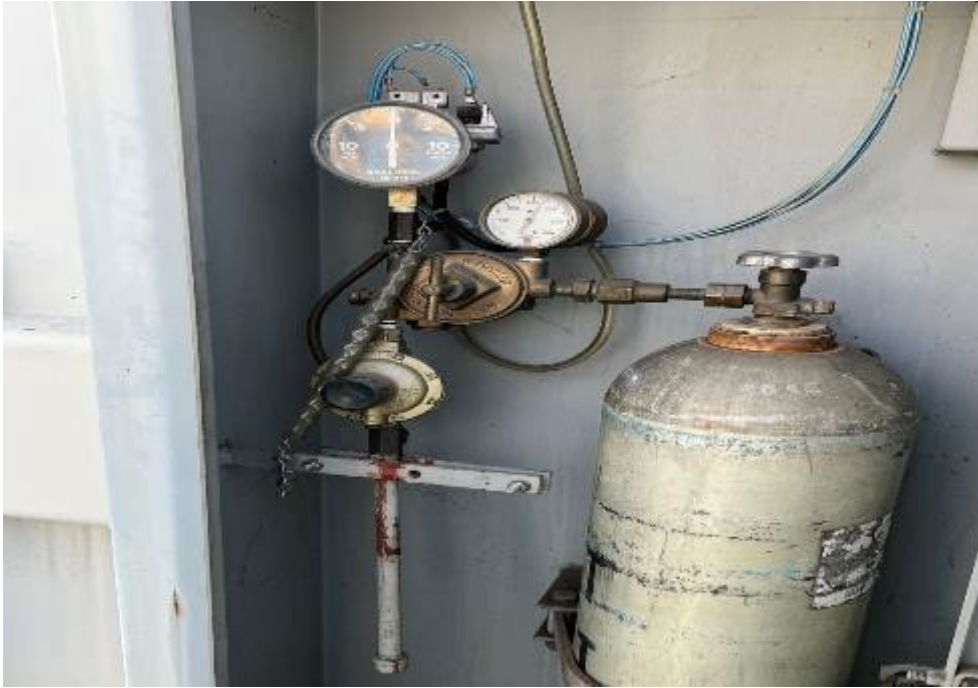
14.6 Transformer Bank 5 Low Nitrogen Pressure 0 psig. Existing LC Tag#128045443 dated 1/9/24 for possible Nitrogen Leak Repair. PG&E added Nitrogen to 0.5 psig in the field. Two most recent inspections on 10/10/24 and 12/5/24 had Nitrogen pressure inside transformer of 1.0 and 0.5 psig, respectively. Coupled with the 0 psig measurement on 1/30/25 supports a Nitrogen Leak in the transformer.

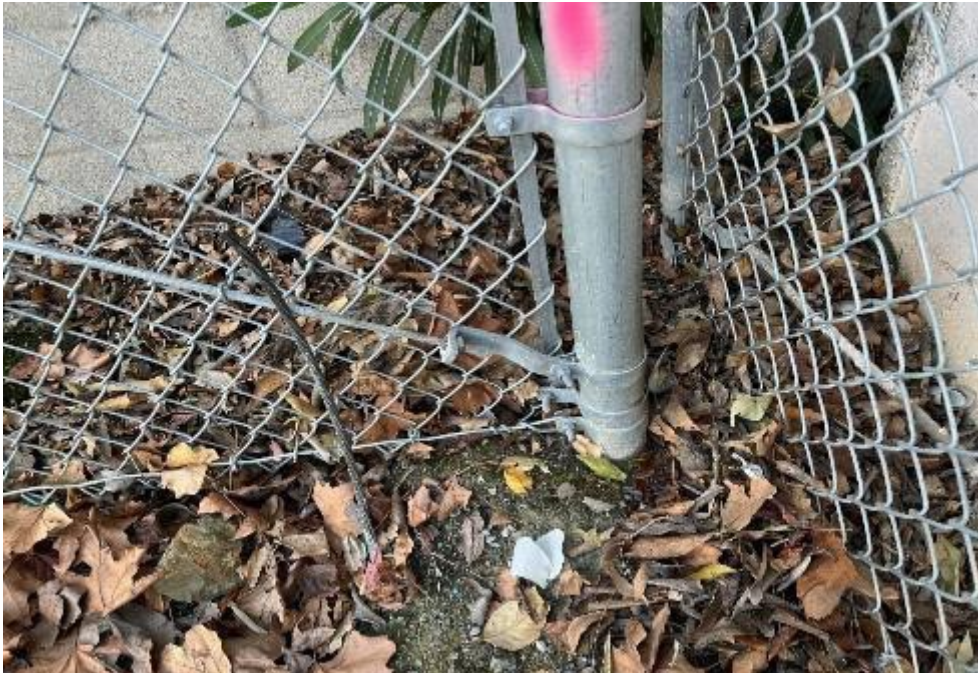
14.7 The Security Perimeter Fence Southwest Corner Ground Wire Not Connected to New Fence Post.

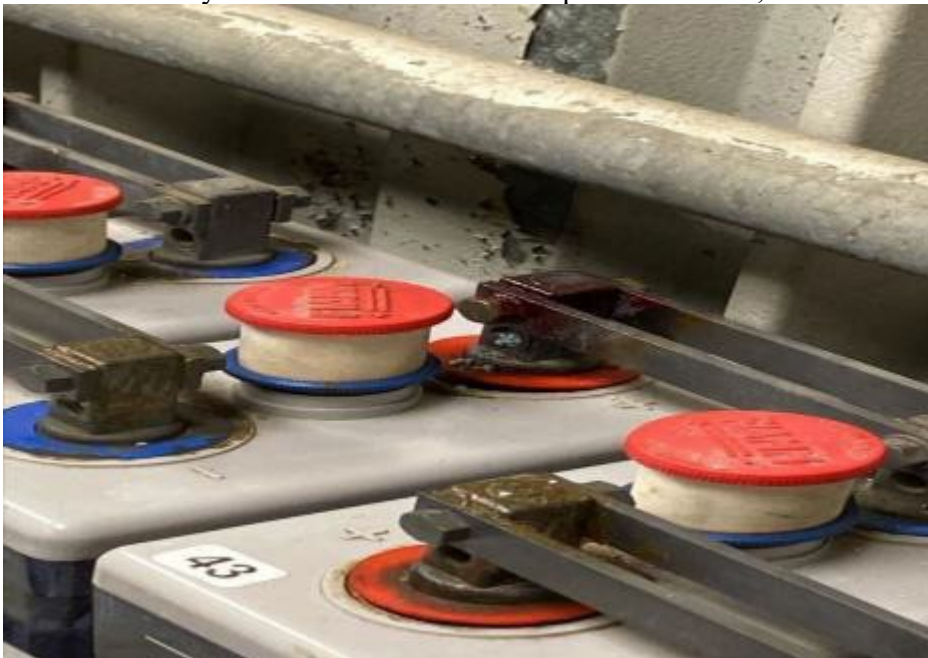
15.1 Battery had corrosion on terminal post of cells 60, 44 and 40. PG&E Fixed in Field.

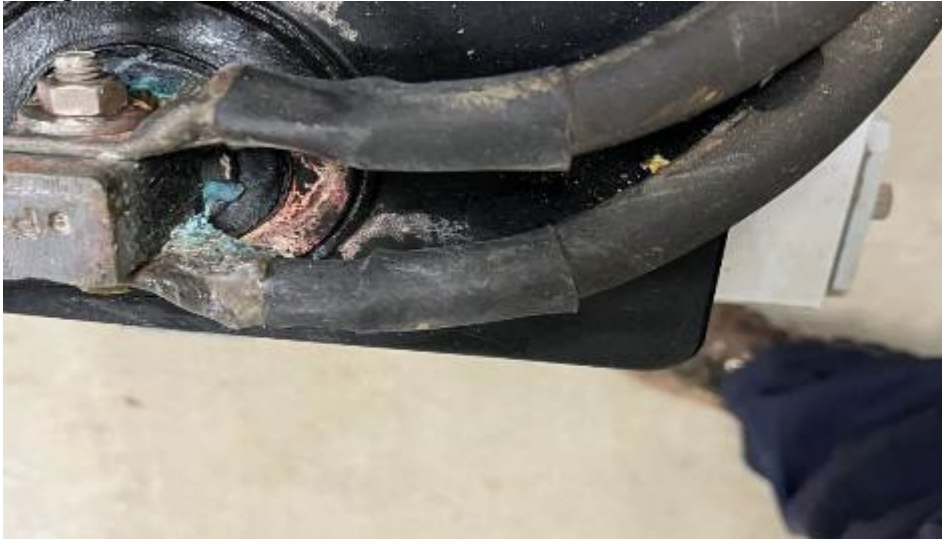
16.1 Upper Section of Substation 230 kV to 115 kV. Battery Corrosion Existing LC Tag#129789020.

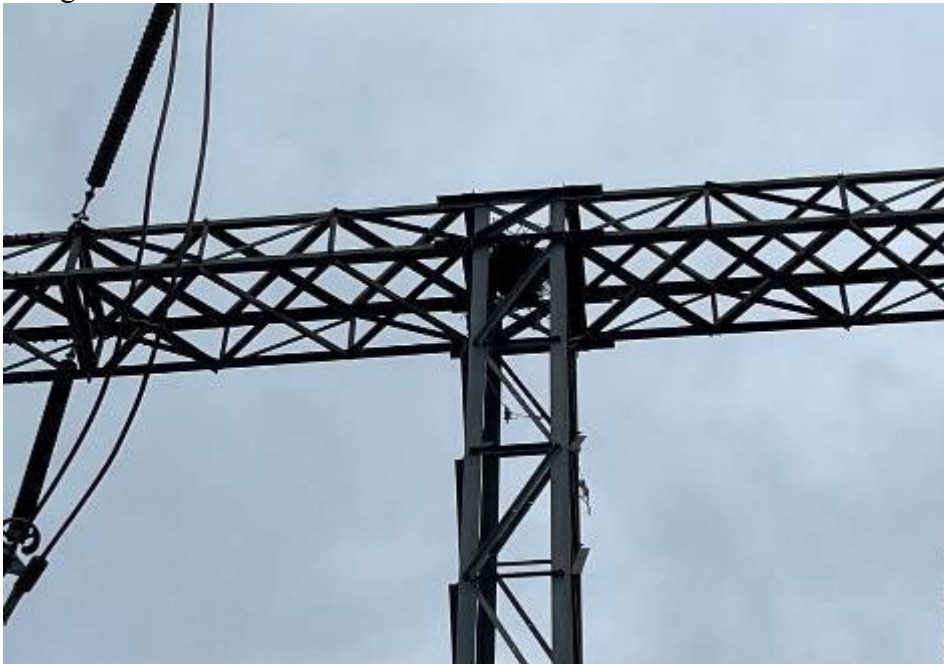
16.2 230 kV Bus Support Structure Near Circuit Breaker 252 had Bird of Prey Nest. New LC Tag#130810650.

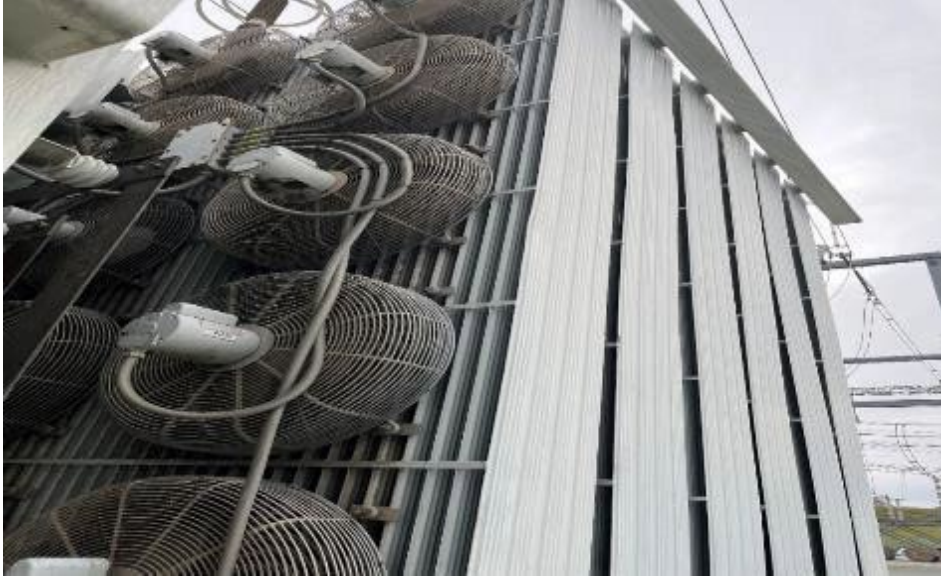
16.3 Transformer Bank 2 Had 6 Fans Not Working. Existing LC Tag#130116554.

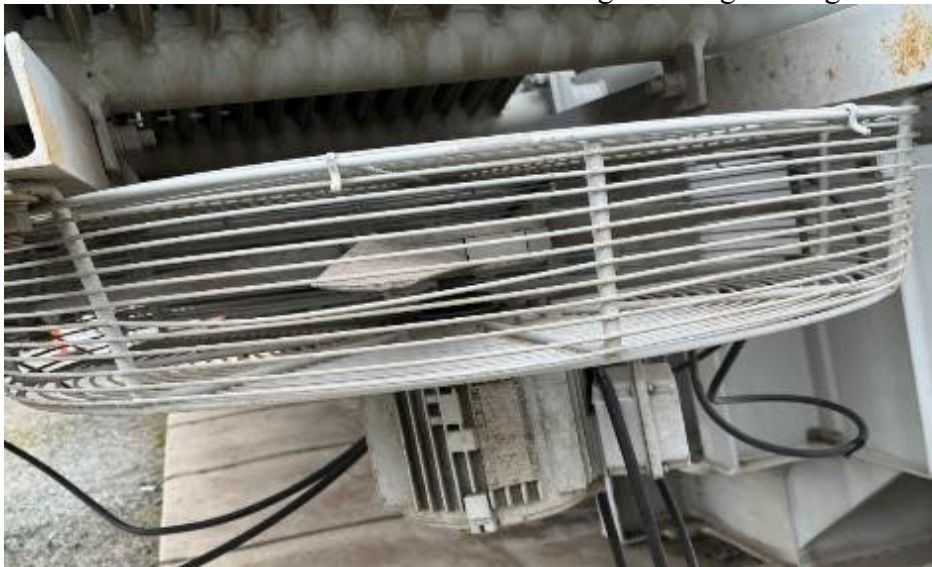
16.6 Transformer Bank 3 Fan Not Working. Existing LC Tag#130535715.

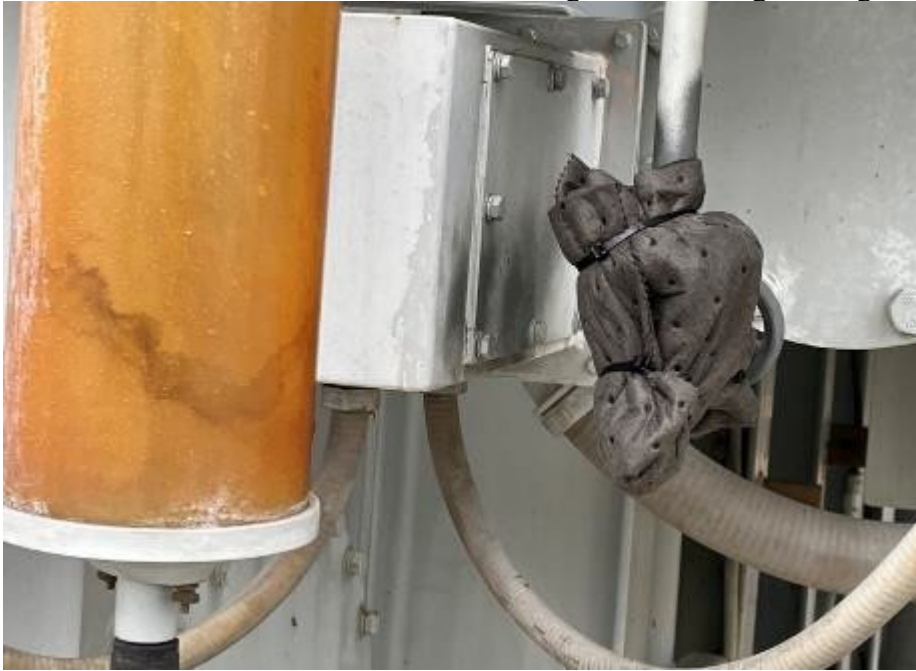
16.7 Transformer Bank 3 Oil Leak Mitigation. Existing LC Tag#130777299.

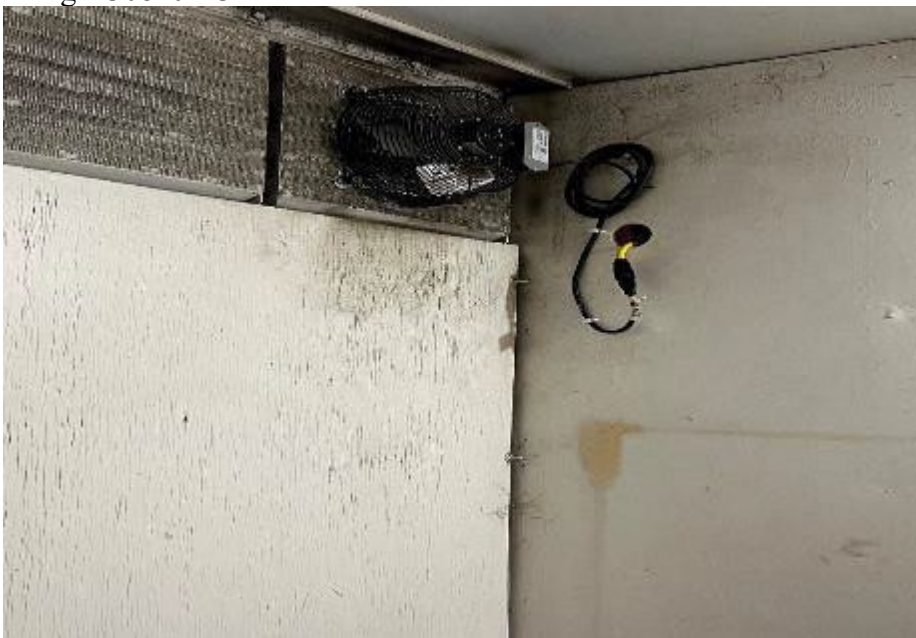
16.8 Low Section of Substation 115 kV to 60 kV. Battery Room Fan Not Working. New LC Tag#130810113.

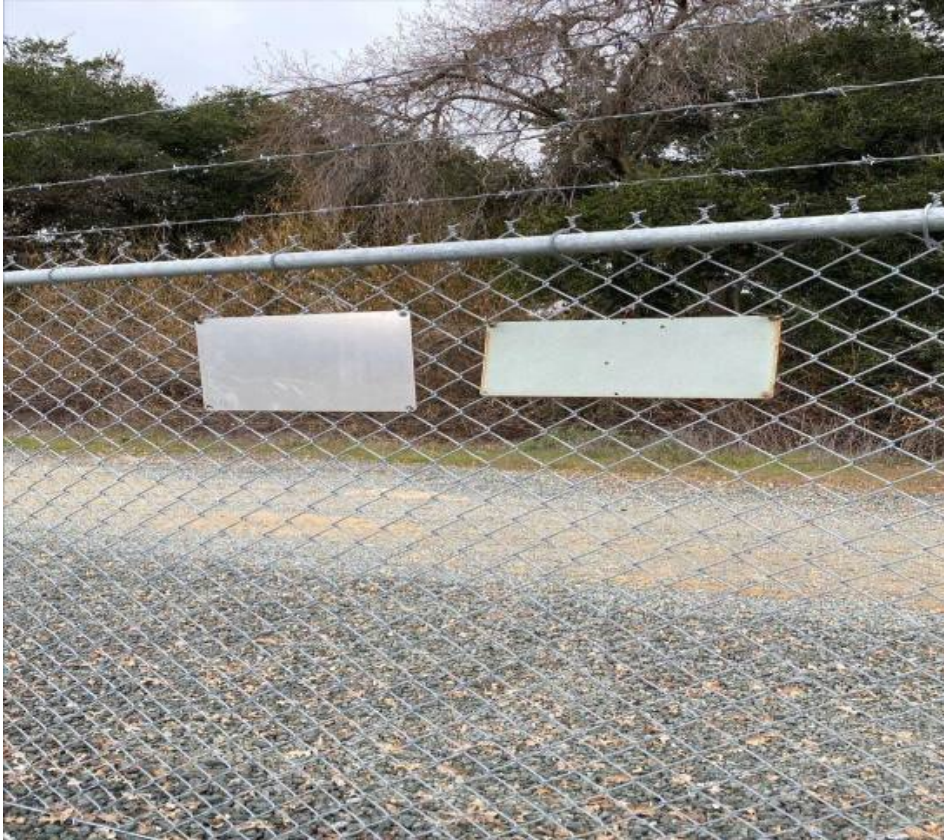
**16.9 Perimeter Security Fence Signs Installed Inside Fence. Existing LC Tag#129531740.**
