PUBLIC UTILITIES COMMISSION

505 VAN NESS AVENUE
SAN FRANCISCO, CA 94102-3298

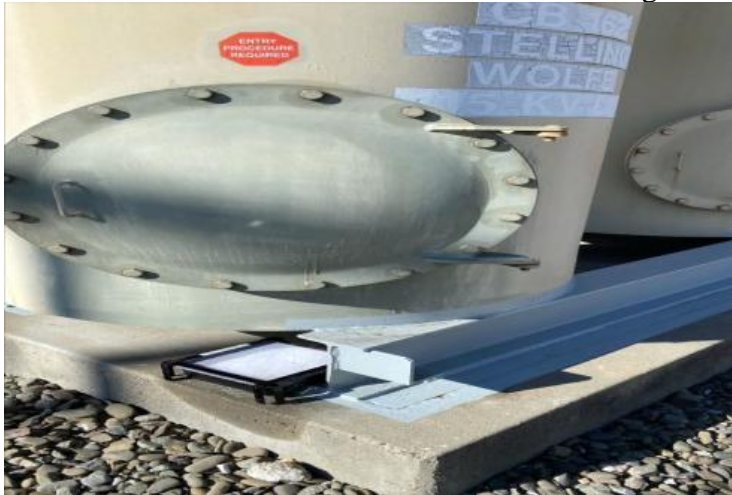
1.2 Transformer Bank 2 had an Oil Leak at Radiator Flange. Existing LC Tag#130788501.

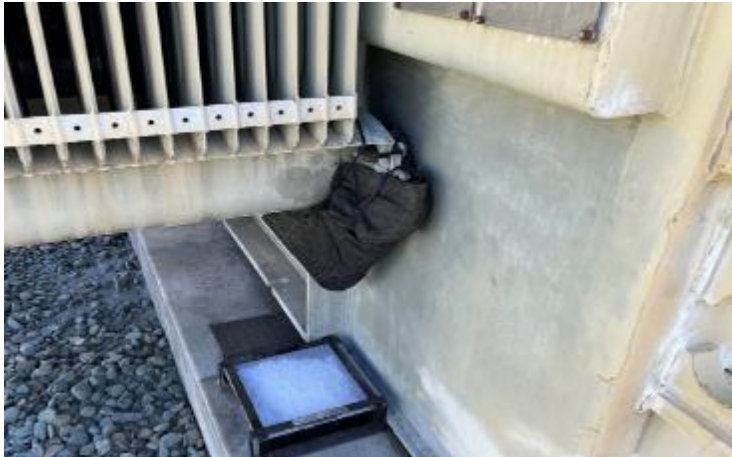
1.3 Transformer Bank 2 had Paper Trapped Inside Fan. Fixed in Field.

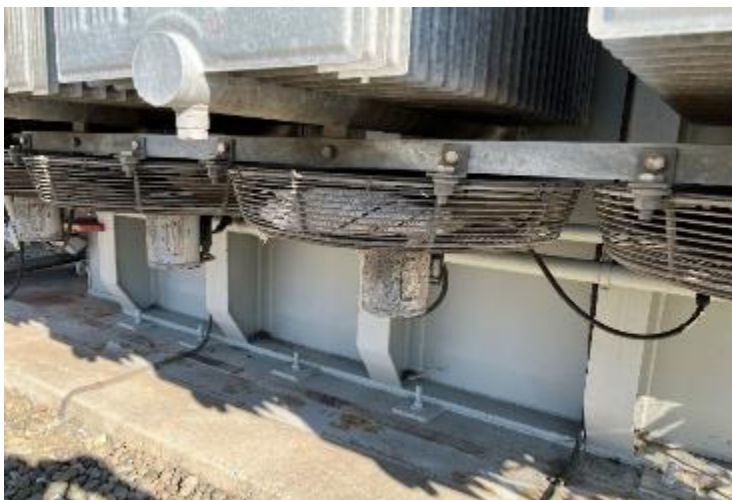
1.4 Transformer Bank 2 had Additional Oil Leaks at Load Tap Changer Conservator Tank Drain Valve and Fault Pressure Device Drain Valve.

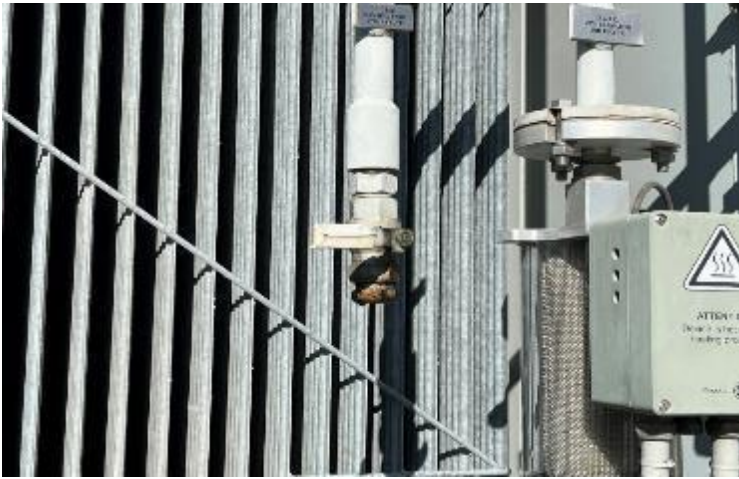
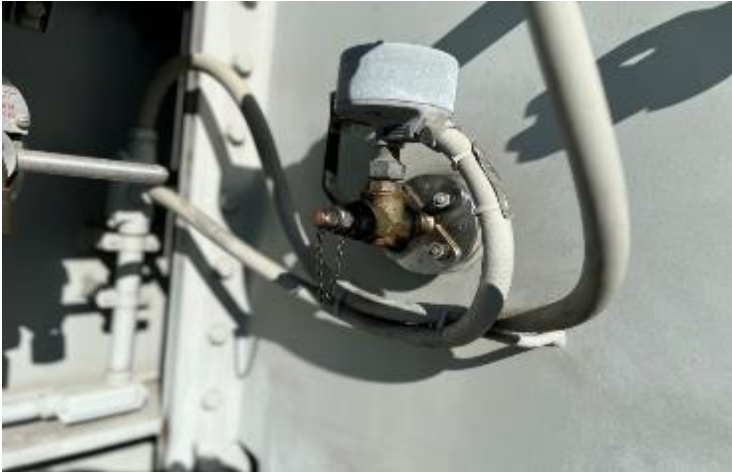
1.5 The Perimeter Fence had Gap Greater than 6 Inches Depth. PG&E Fixed in Field.

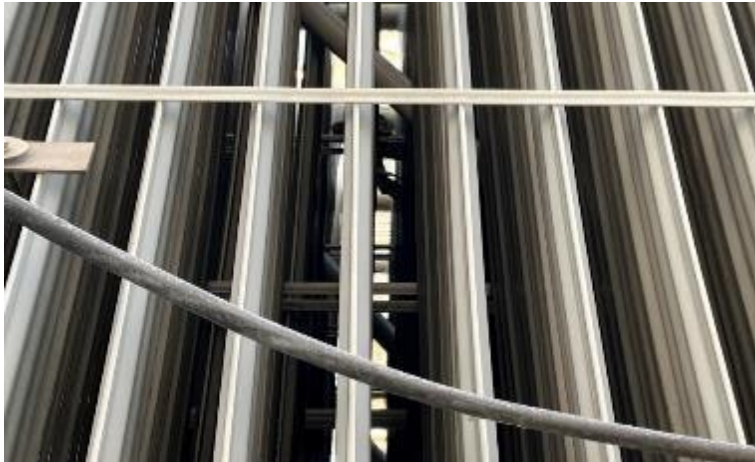
3. Llagas Substation

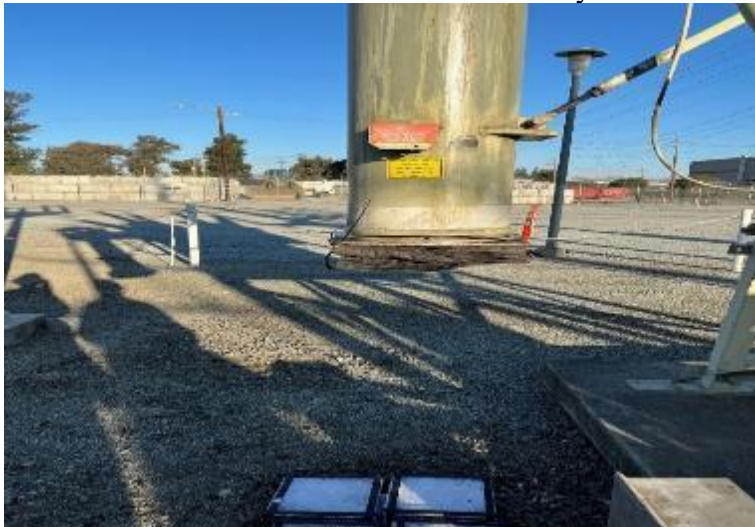
3.2 The Perimeter Fence had Warning Signs Posted Inside Fence. Existing LC Tag#130108978.

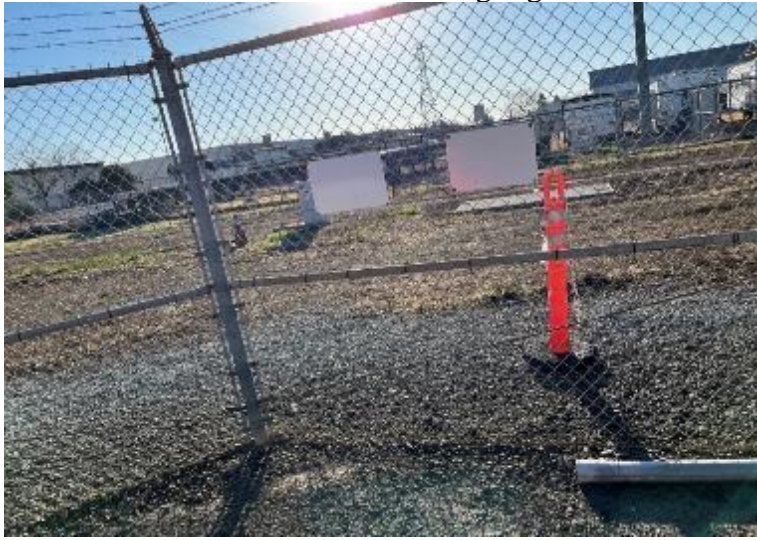
4. Morgan Hill Substation

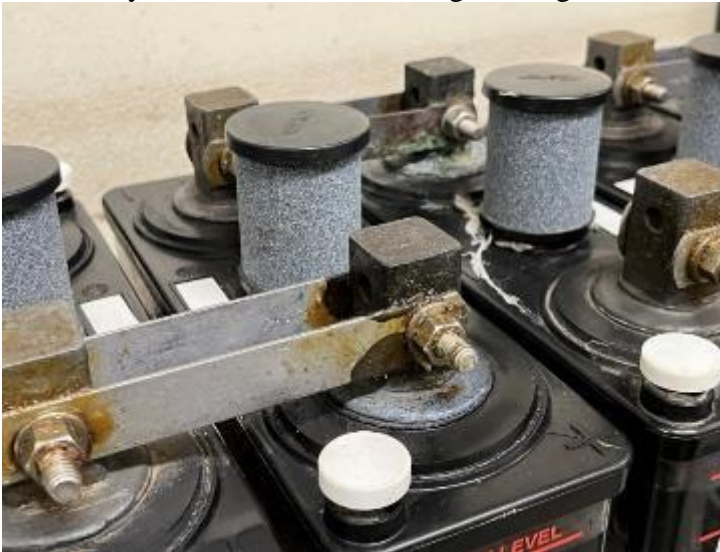
4.2 Transformer Bank 2 Nitrogen Bottle Missing Second Strap. PG&E Fixed in Field.

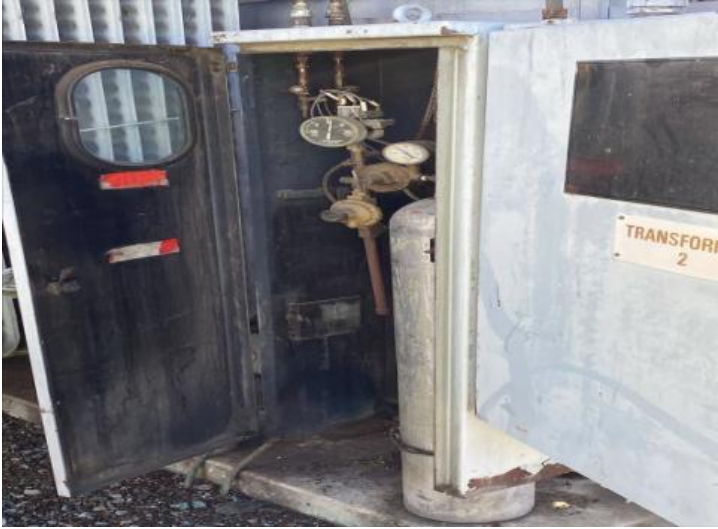
4.3 Transformer Bank 2 Had Wasp Nest. PG&E Fixed in Field.

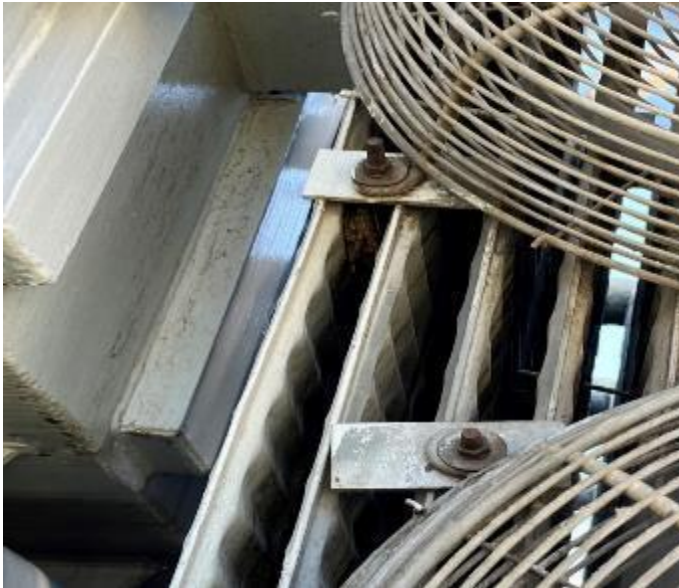
4.4 Transformer Bank 2 Had Oil Leak Mitigation. Existing LC Tag#130774181.

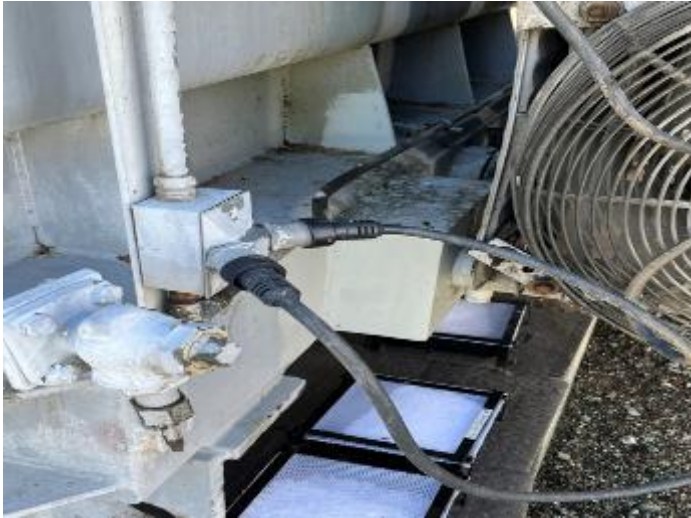
4.5 Circuit Breaker 172 had Oil Protection Berm Breach. Existing LC Tag#124924236.

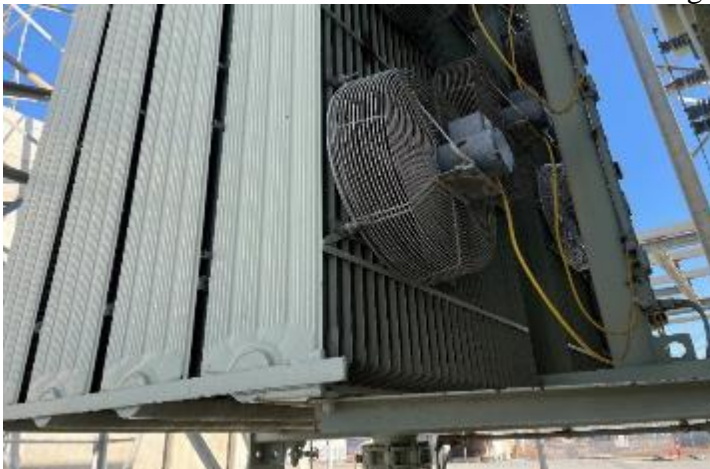
5.2 Transformer Bank 11 Phase C Oil Leak Mitigation Upper Manway Existing LC Tag#129715835.

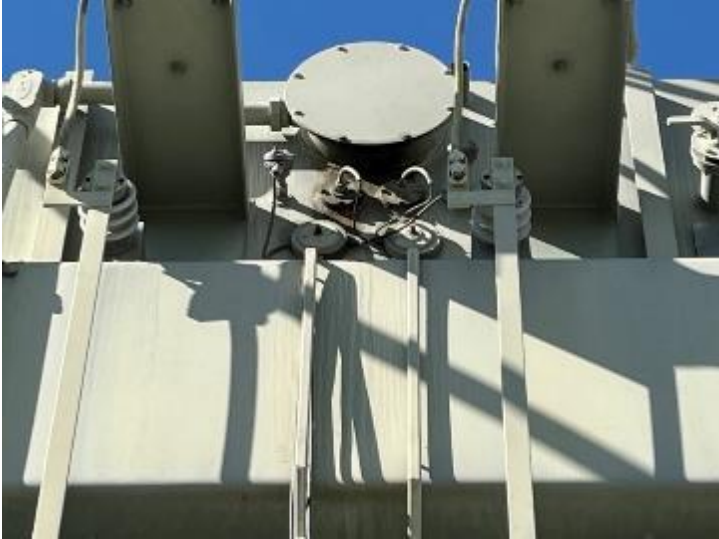
5.3 Transformer Bank 12 Phase A Oil Leak Mitigation Existing LC Tag#130780077.

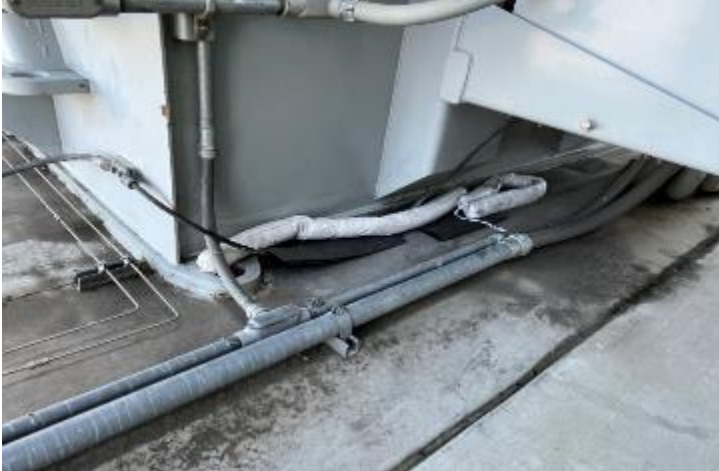
5.4 Transformer Bank 12 Phase B Oil Leak Mitigation Existing LC Tag#130783098.

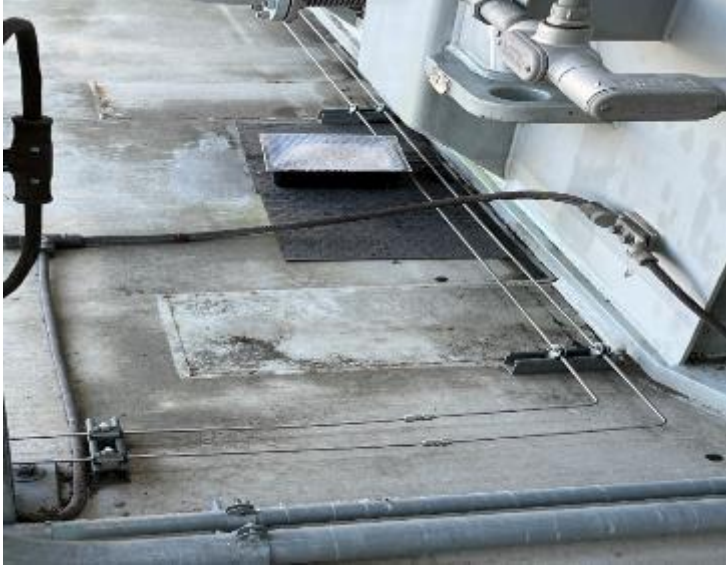
5.5 Transformer Bank 12 Phase B Conservator Tank Pressure Gauge Malfunction. Existing LC Tag#129692396 PG&E Fixed in Field.

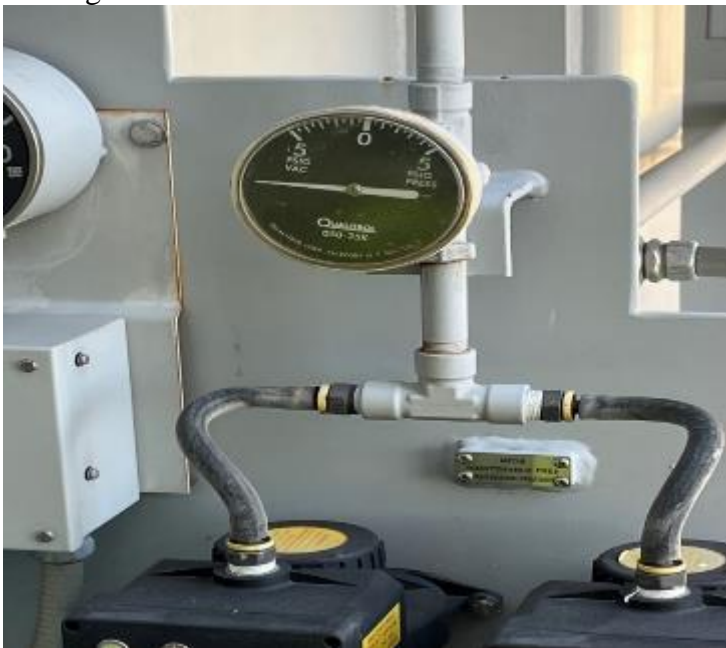
5.6 Transformer Bank 13 Phase B Oil Leak Mitigation Kelman Gas Analyzer Existing LC Tag#130713051.

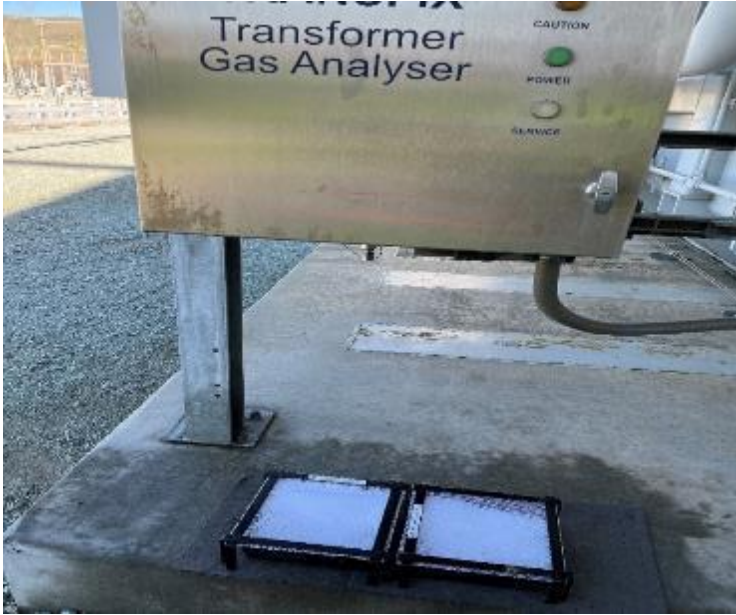
5.7 Transformer Bank 13 Phase B Oil Leak Mitigation Pump Flange Existing LC Tag#130783076.

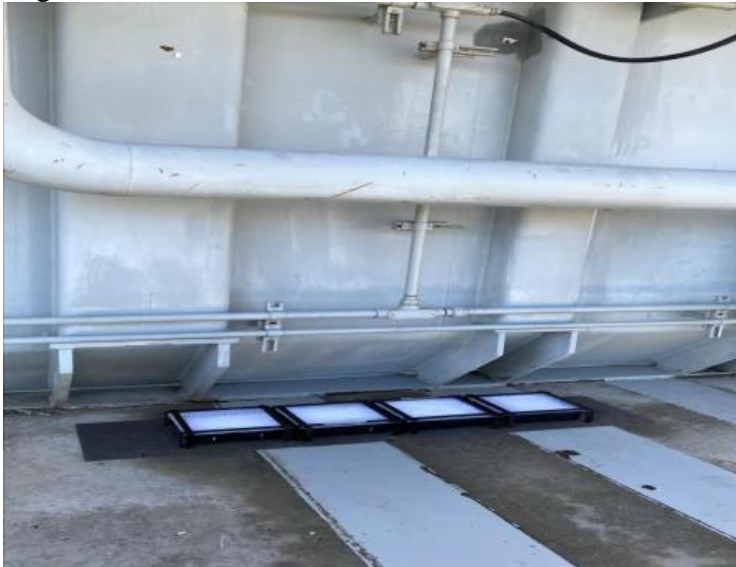
5.8 Transformer Bank 13 Phase B Birds Nest Radiator Fan Power Cord.

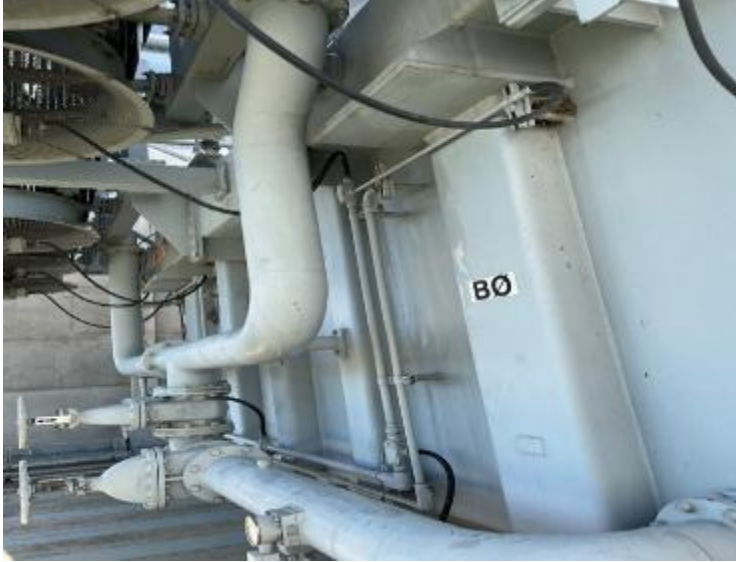
5.9 Transformer Bank 13 Phase C Oil Leak Mitigation Upper Flange Existing LC Tag#130783071.

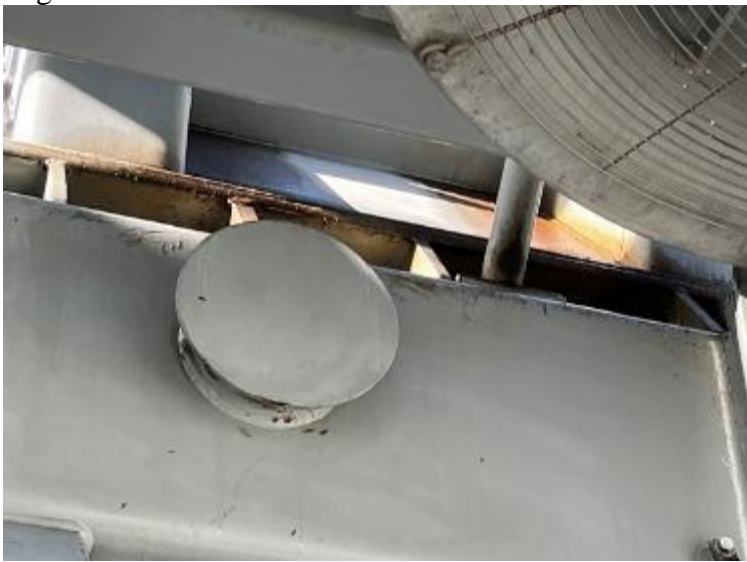
5.10 Transformer Bank 4 Oil Leak Mitigation Existing LC Tag#130116644.

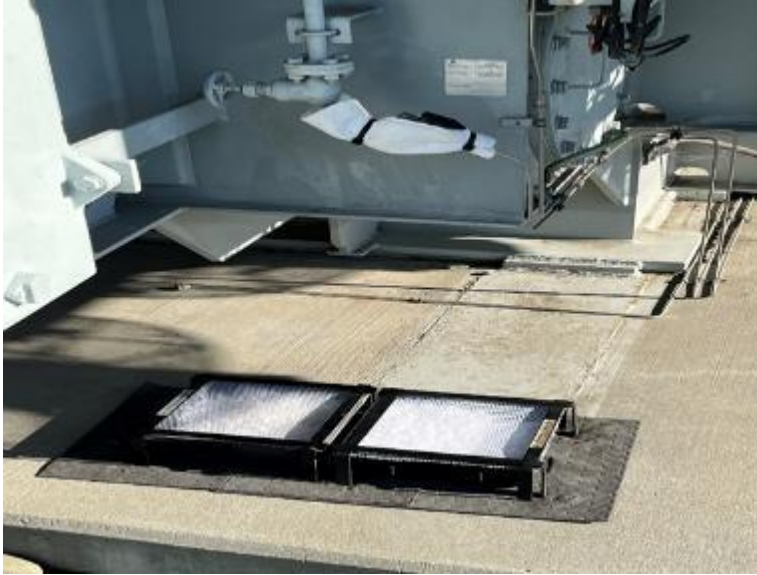
5.11 Transfer Bank Spare Oil Leak at Oil Filter Conservator Connection. PG&E Fixed in Field.

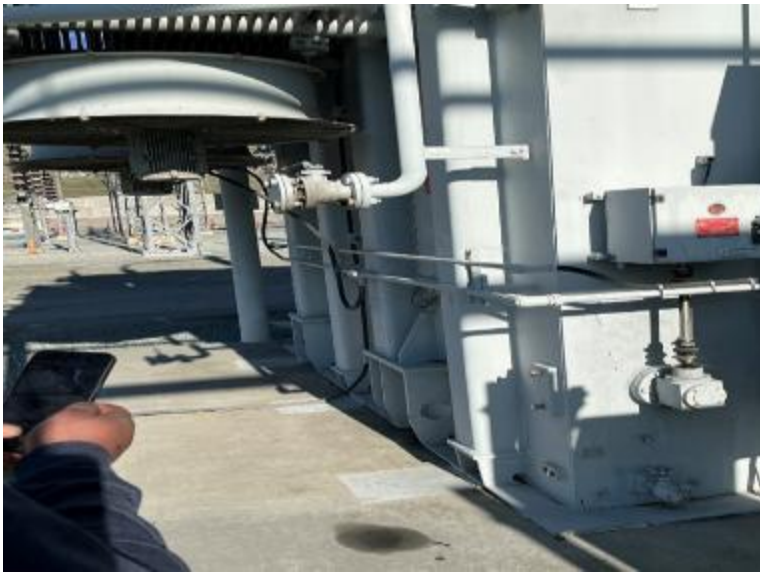
5.12 Transfer Bank 1A Oil Leak Mitigation at Conservator Drain Valve Existing LC Tag#130713052.

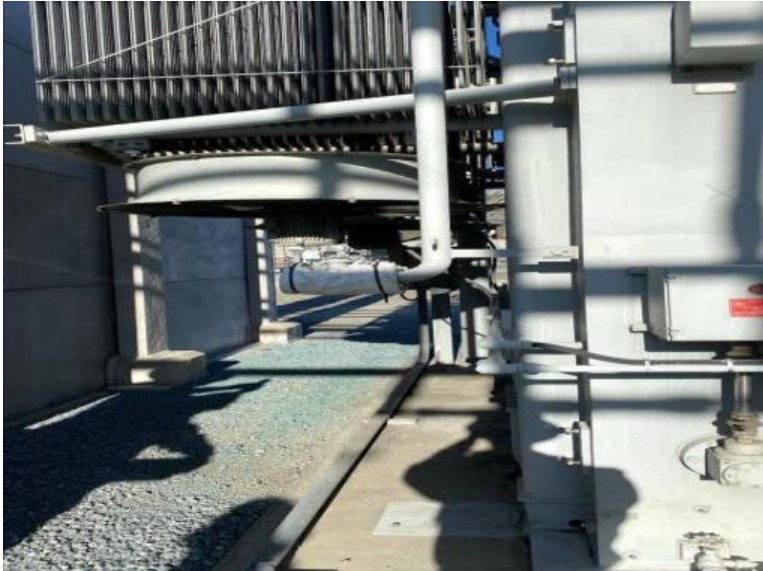
5.13 Transformer Bank 2 Phase C Desiccant Need Replacement.

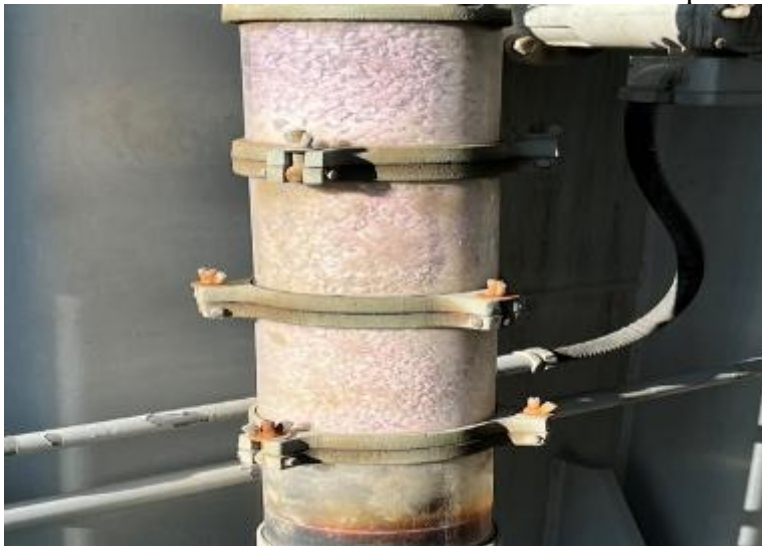
5.14 Transformer Bank 2 Phase C Oil Leak Mitigation at Top Flange Existing LC Tag#130116641.

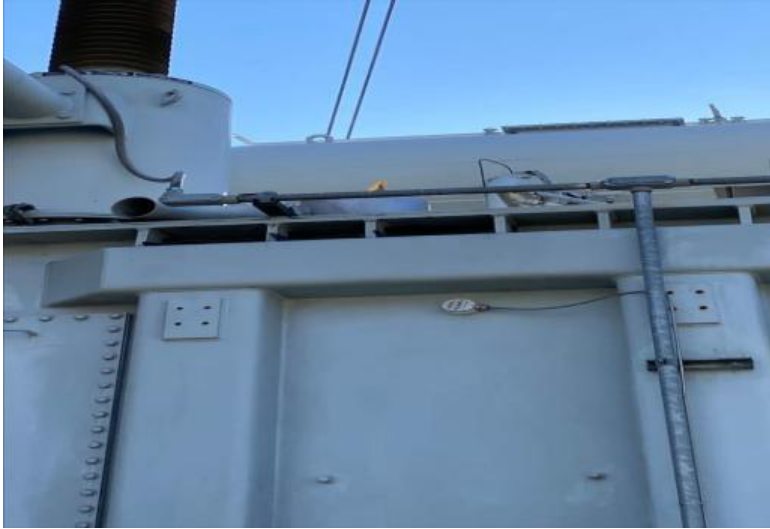
5.15 Transformer Bank 2 Phase B Desiccant Need Replacement.

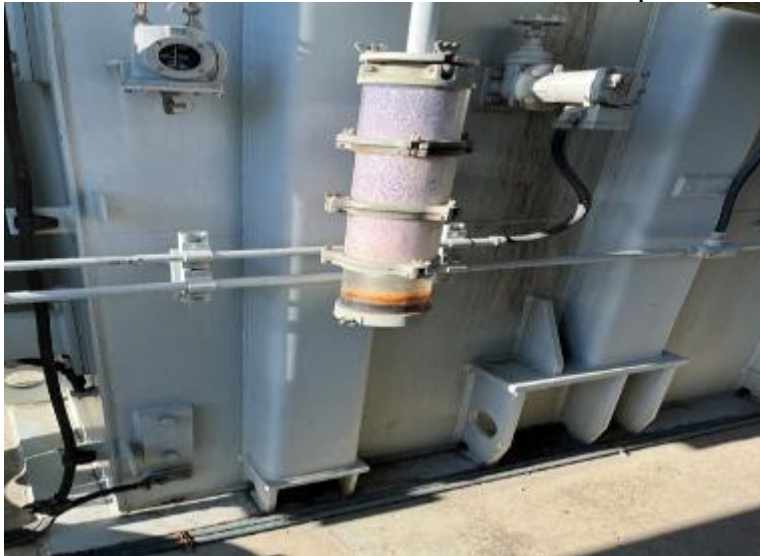
5.16 Transformer Bank 2 Phase B Oil Leak Mitigation at Top Flange Existing LC Tag#130116640.

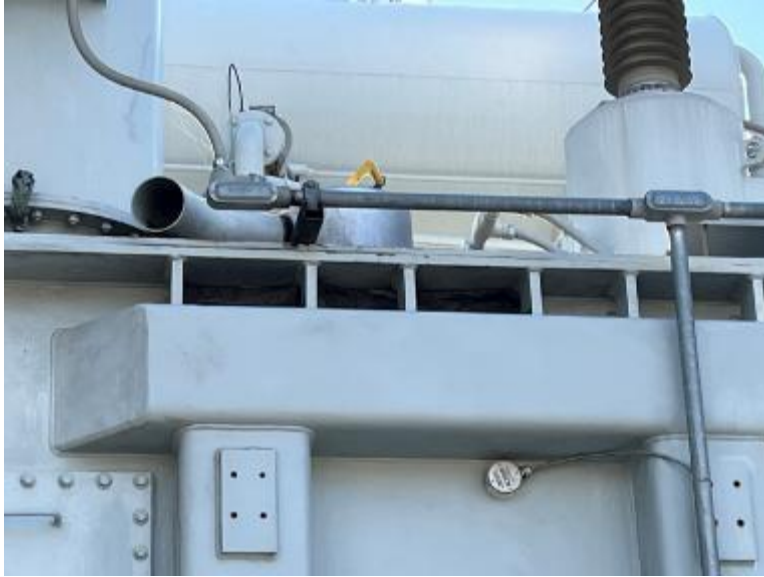
5.17 Transformer Bank 2 Phase A Desiccant Need Replacement. Existing Tag#130535711 Will be Changed to Also Cover Banks 2B and 2C.

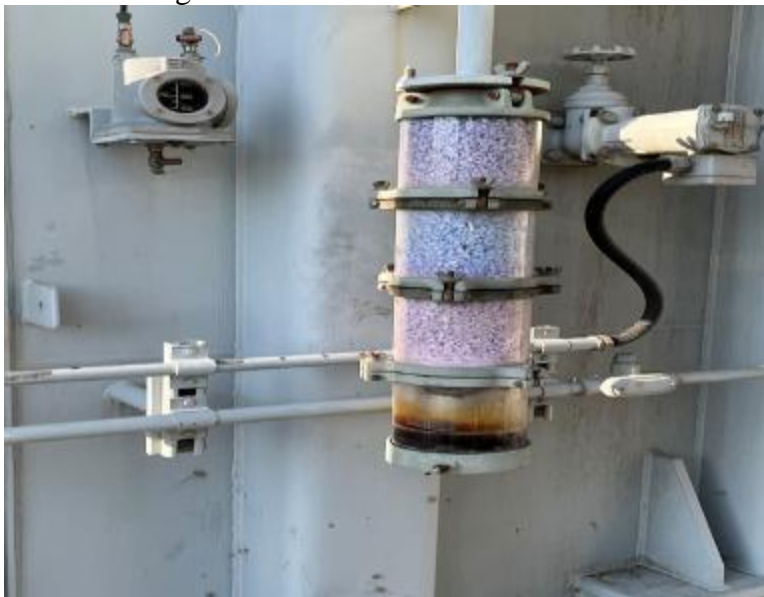
5.18 Transformer Bank 2 Phase A Oil Leak Top Flange Existing LC Tag#130783075.

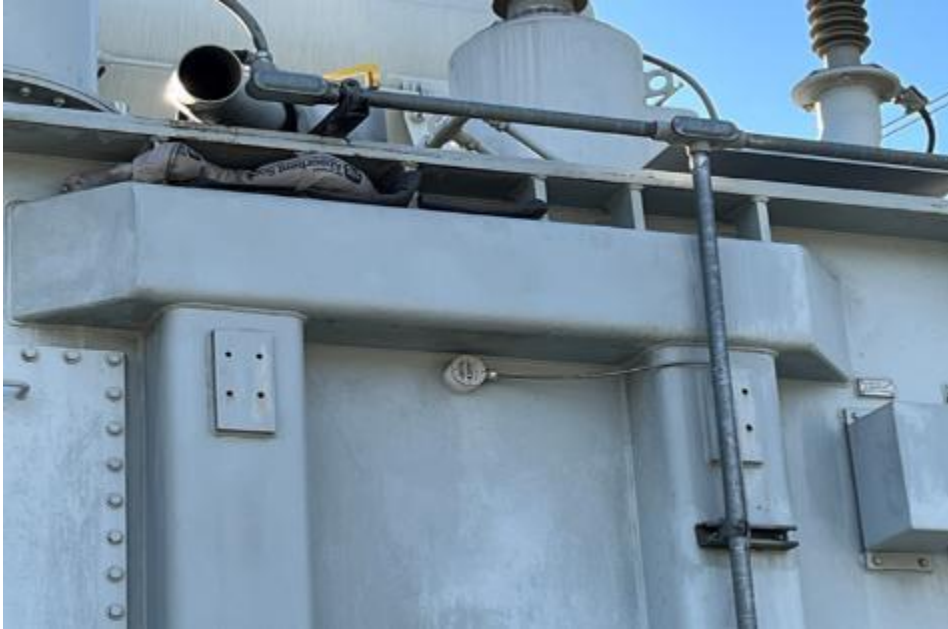
5.19 Battery Room Eyewash Missing Expiration Date Existing LC Tag#129670378.

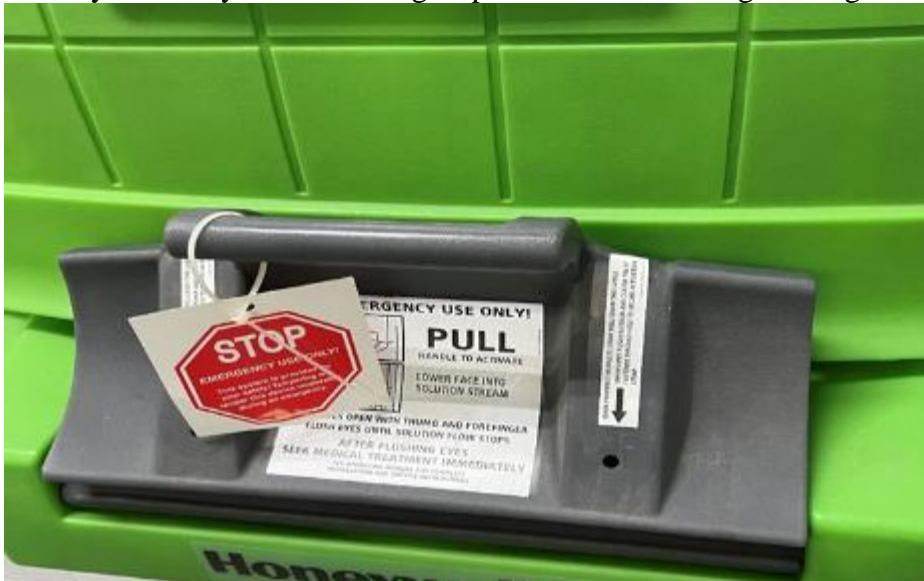
6. El Patio Substation

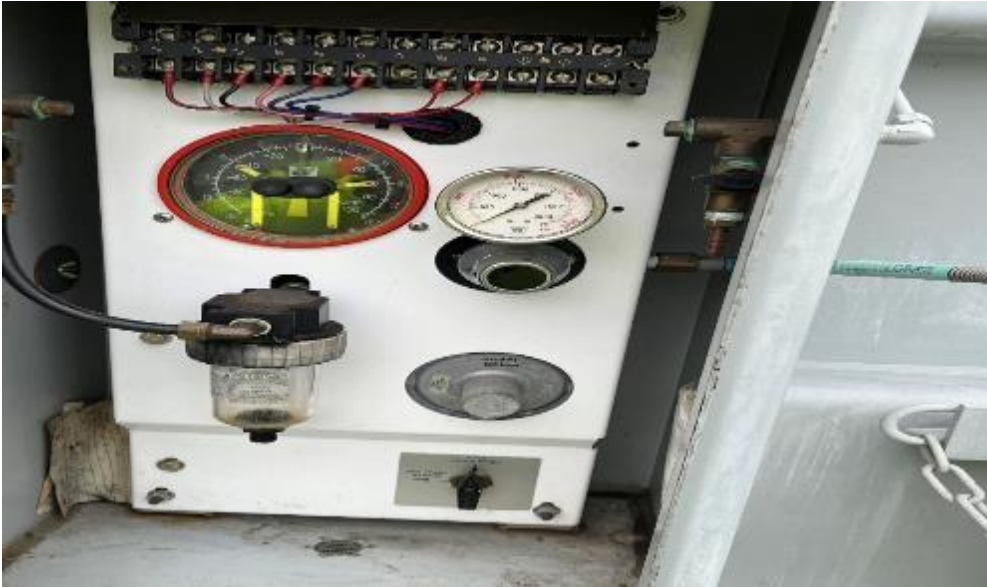
6.2 Transformer Bank 1 Sample Drain Valve Oil Leak Mitigation Existing LC Tag#129692374.

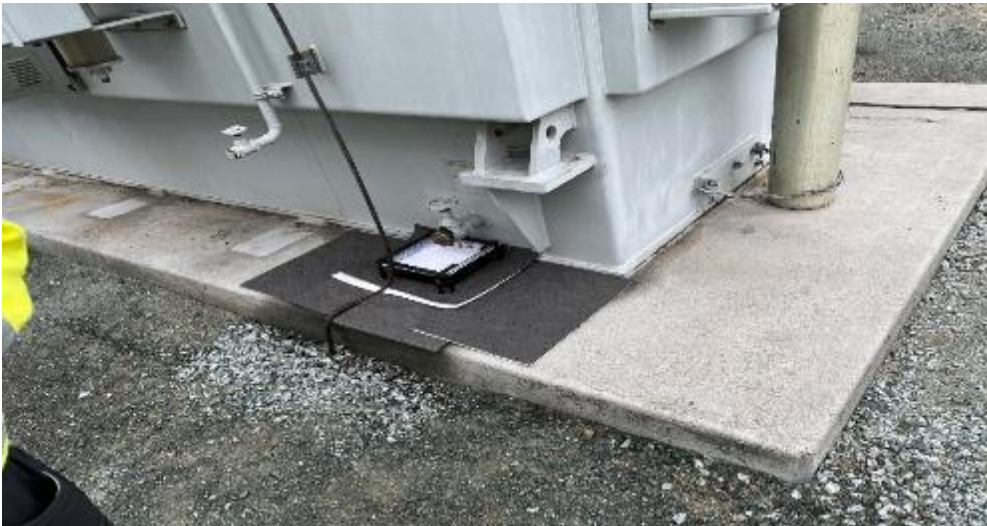
6.3 Transformer Bank 2 Two Fans Not Working

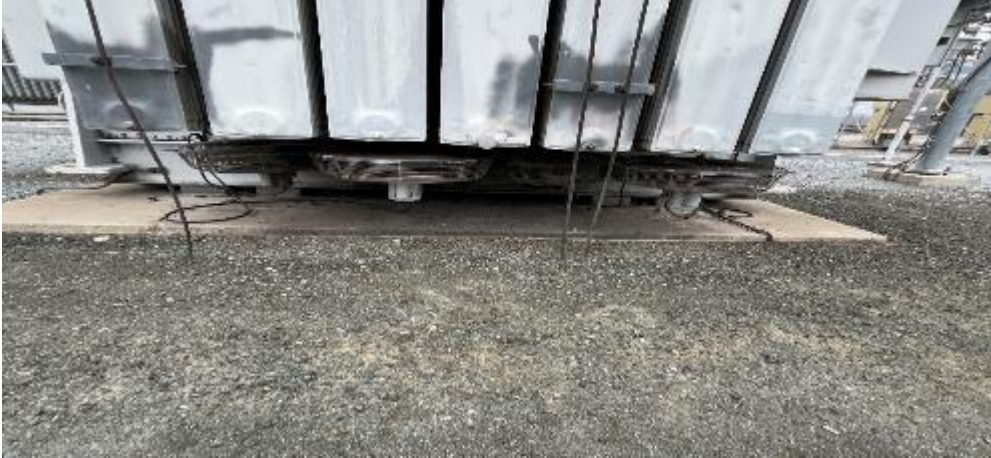
6.4 Transformer Bank 2 Oil Leak at Lower Flange

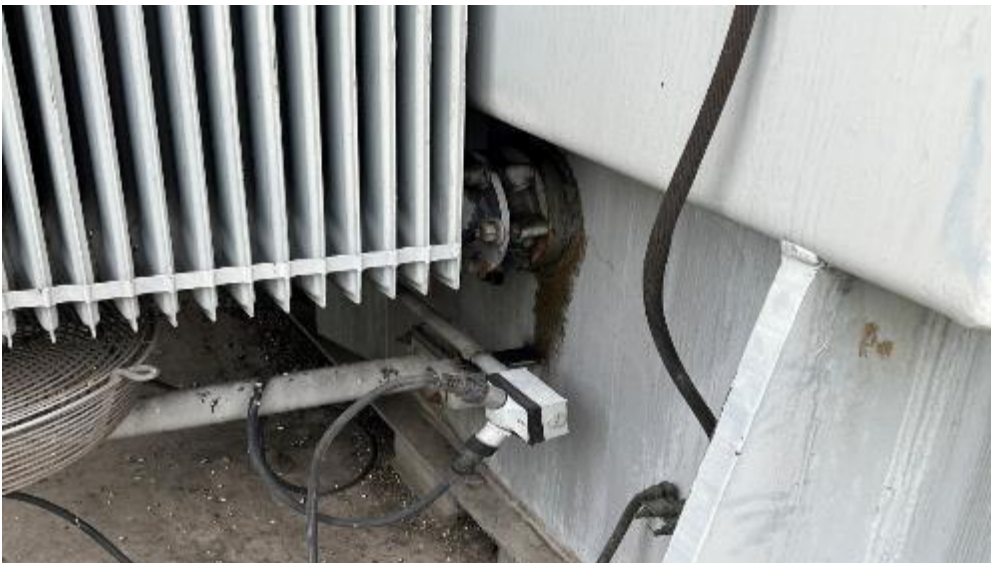
6.5 Perimeter Security Fence had Cut Ground Connection Due to Recent Vandalism

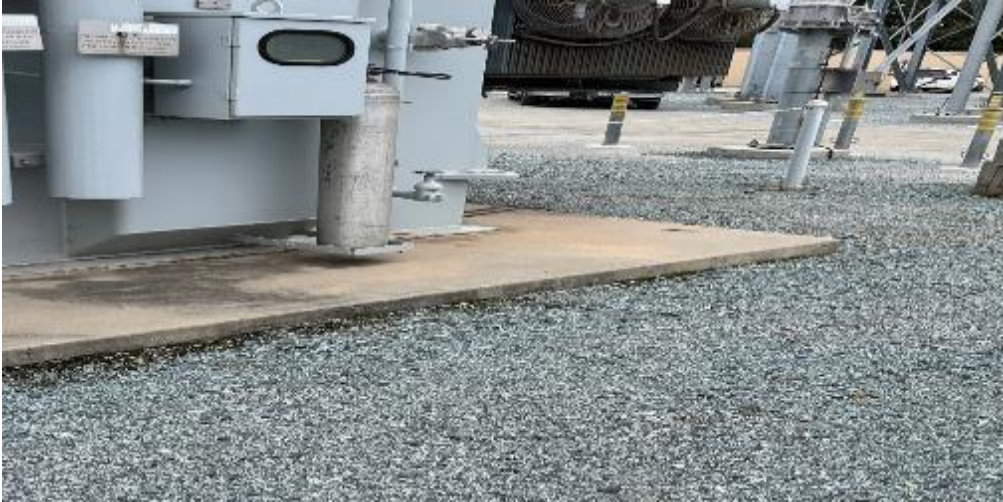
7.2 Transformer Bank 1 Oil Leak Mitigation Existing LC Tag#130535753.

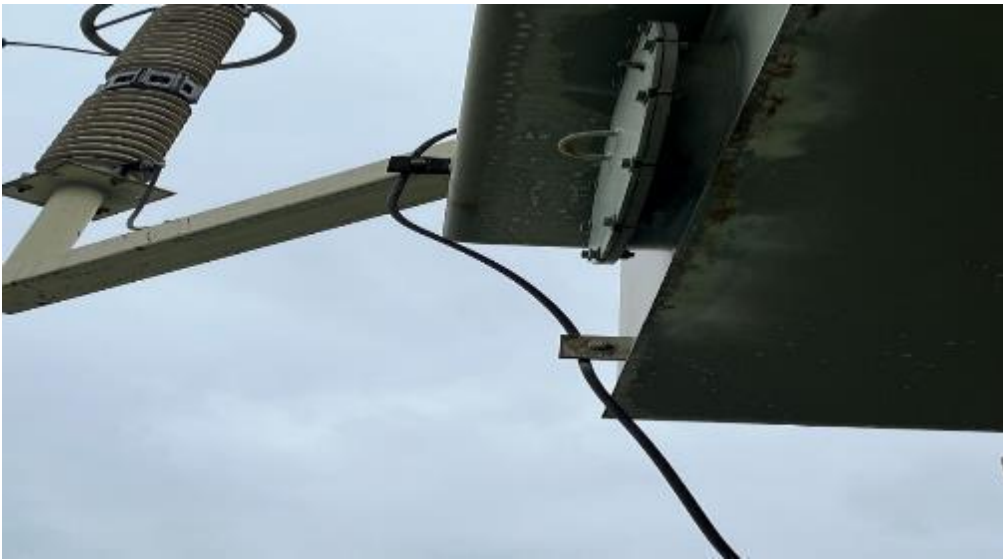
7.3 Transformer Bank 4 Oil Leak Mitigation Existing LC Tag#130535750.

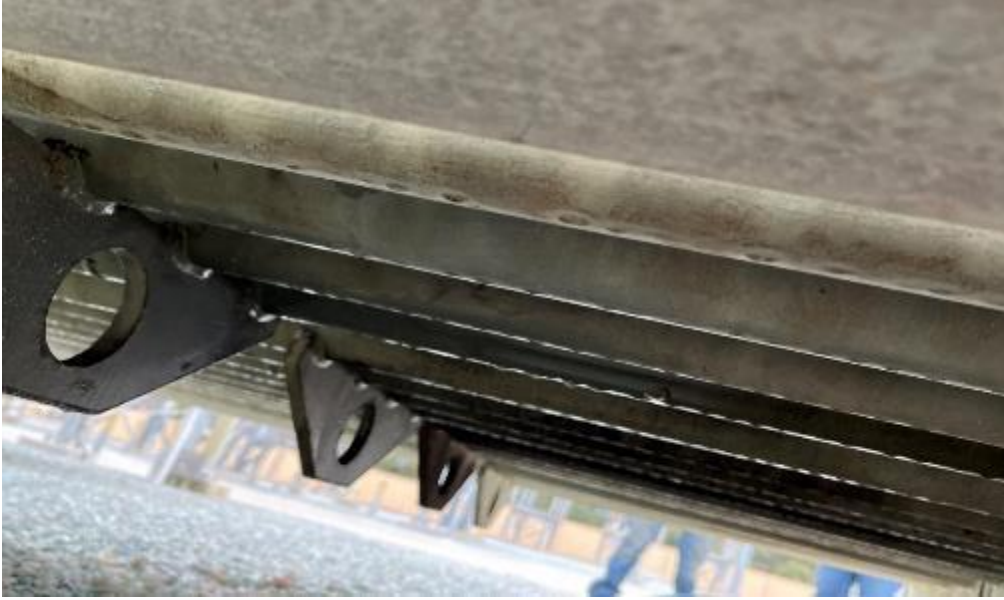
7.4 Transformer Bank 2 had an Oil Leak Mitigation Existing LC Tag#130535749.

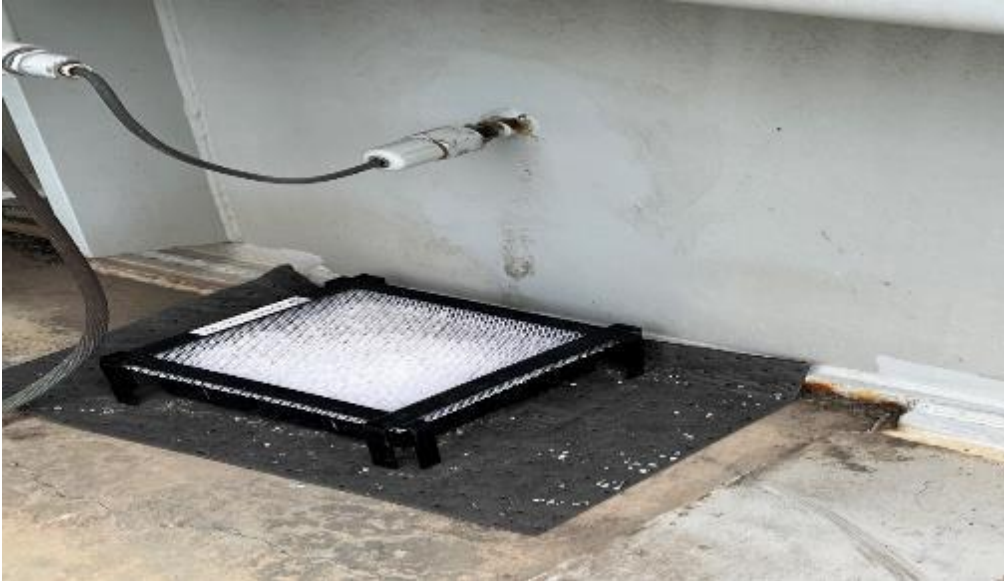
7.5 Transformer Bank 3 One Fan Not Working. PG&E Fixed in Field.

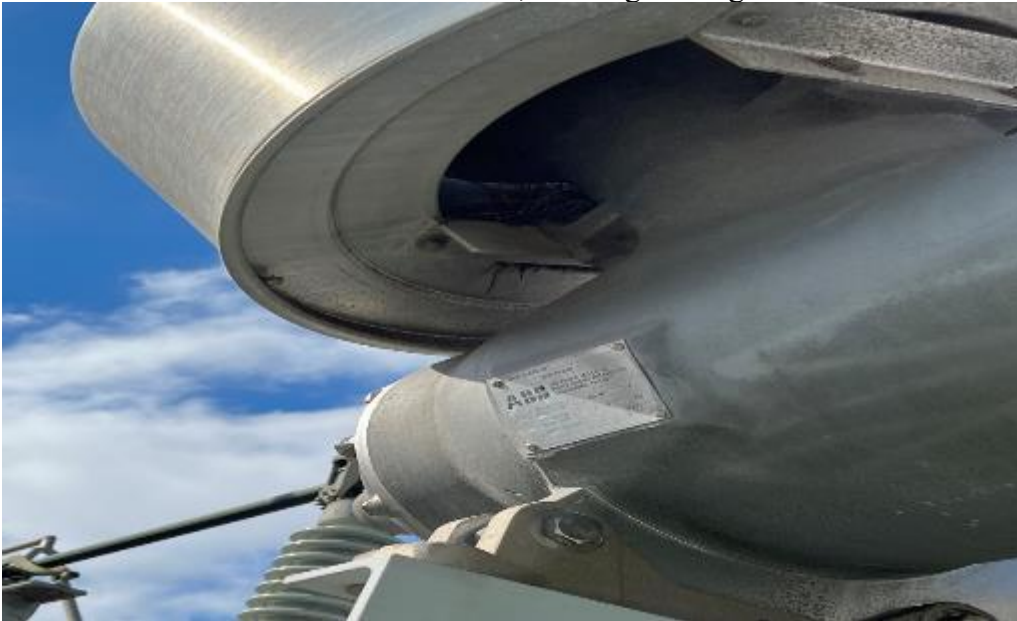
8.2 Transformer Bank 4 Desiccant Needs to be Replaced.

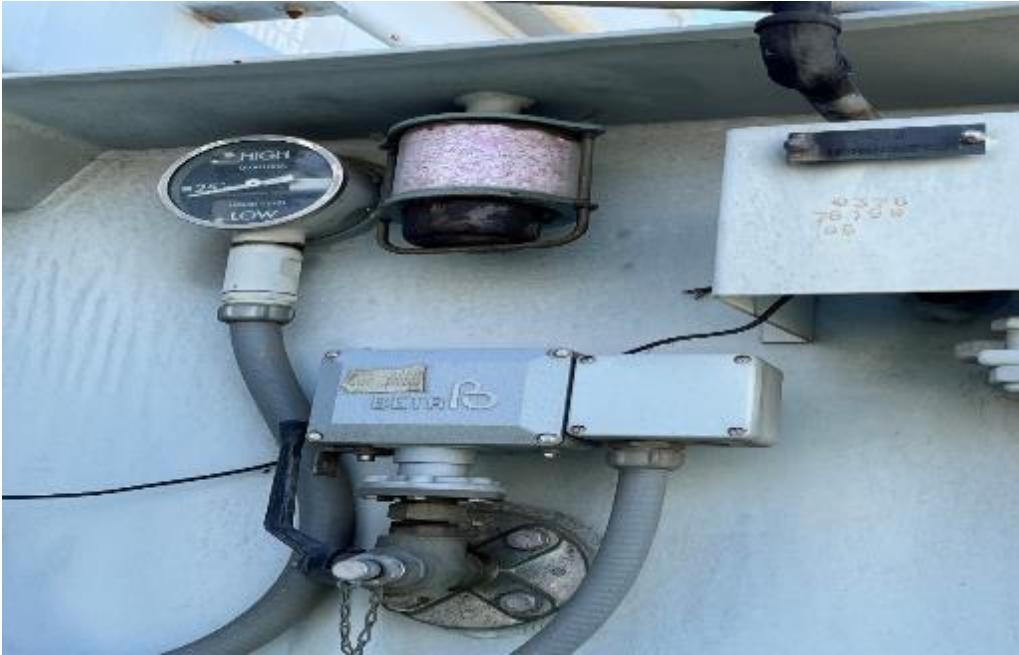
8.3 Transformer Bank 3 has Oil Leak at Lower Sampling Valve, Existing LC Tag#129384420.

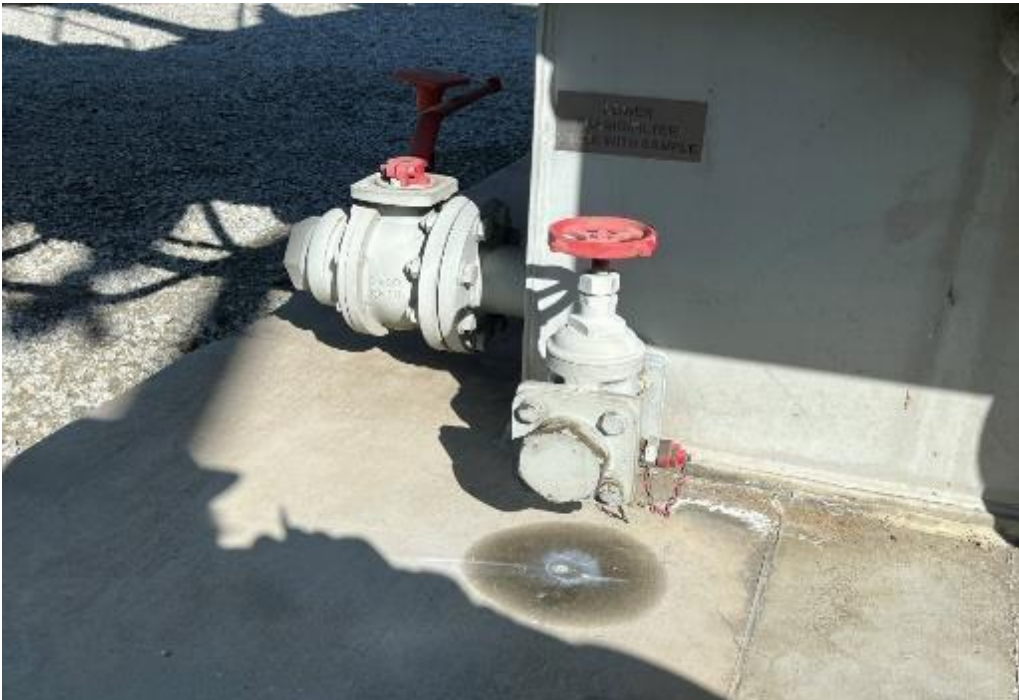
8.4 Transformer Bank 2 Nitrogen Bottle Needs 2nd Strap. PG&E Fixed in Field.

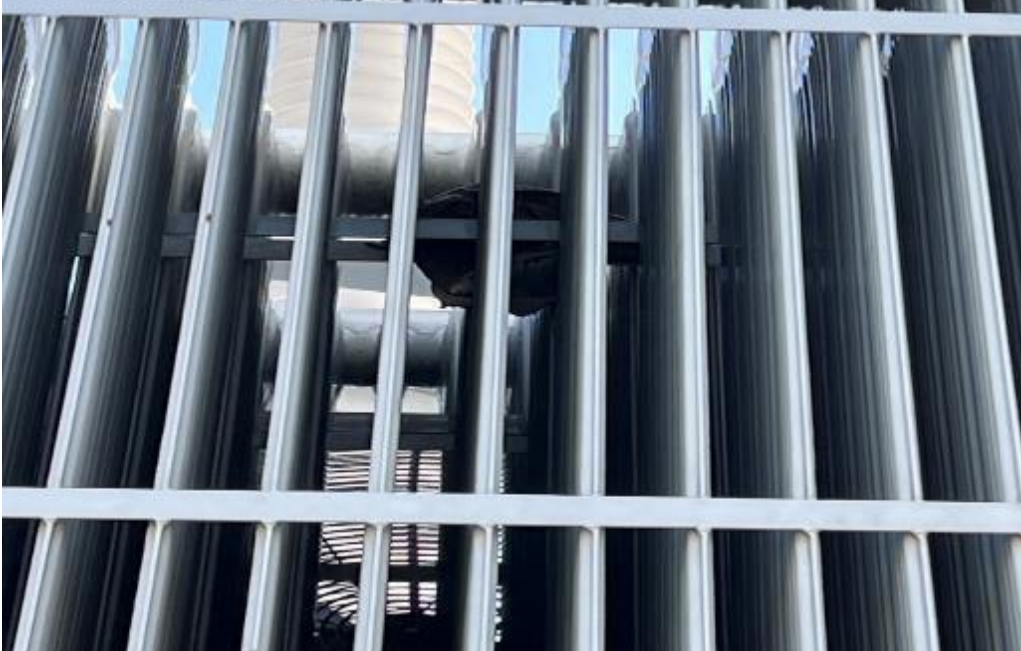
8.6 Transformer Bank 2 has Oil Leak Mitigation at Sample Valve. Existing LC Tag#130791809.

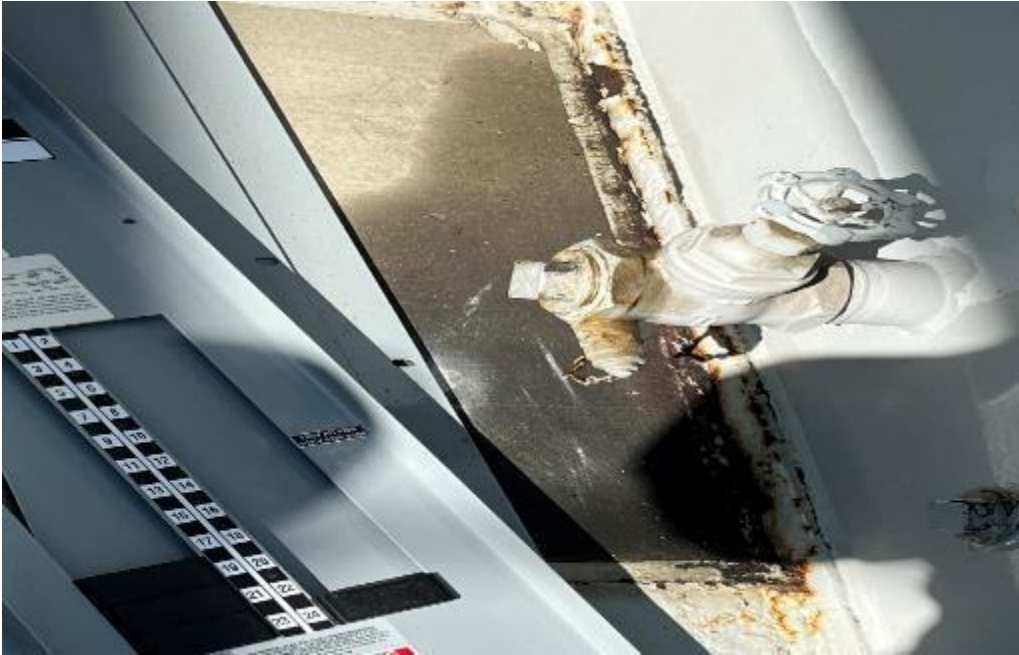
8.7 Transformer Bank 2 Need Animal Protection Tape at Bushing. Existing LC Tag#130791886.

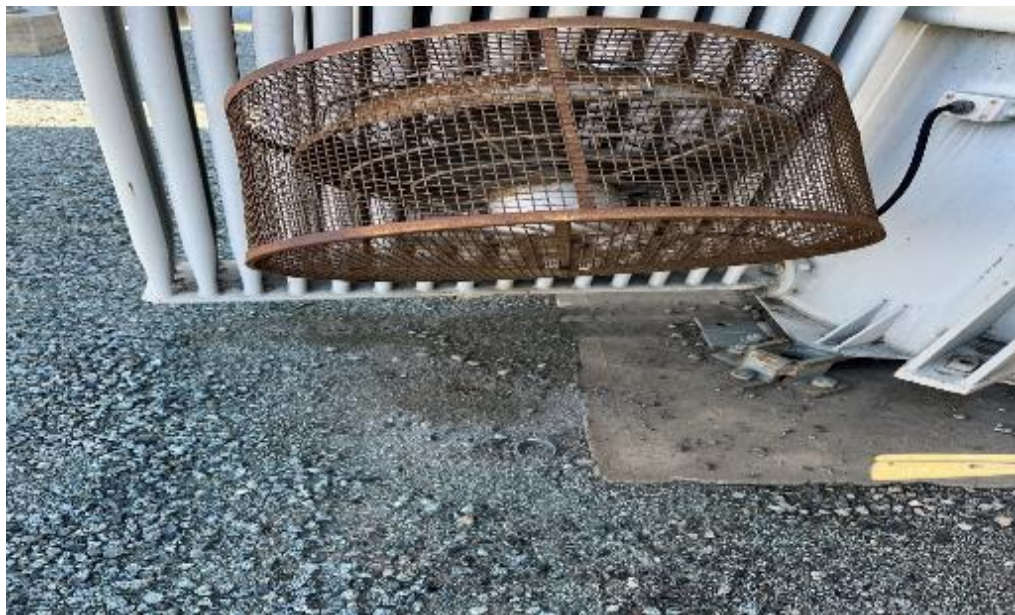
9.3 Transformer Bank 1 Phase B Oil Leak Mitigation. Existing LC Tag#129590535.

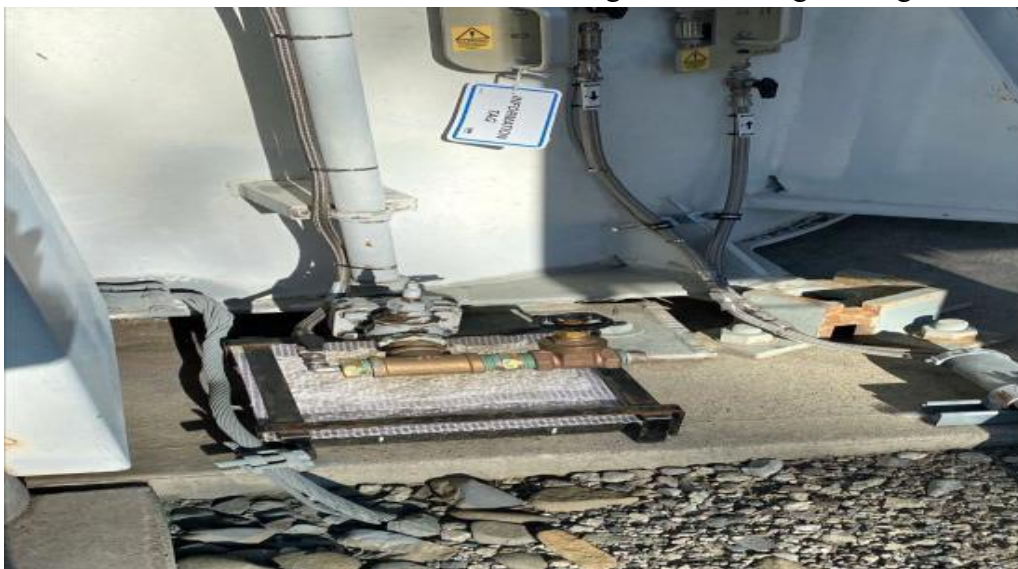
9.4 Transformer Bank 1 Phase A Oil Leak Mitigation. Existing LC Tag#129590535.

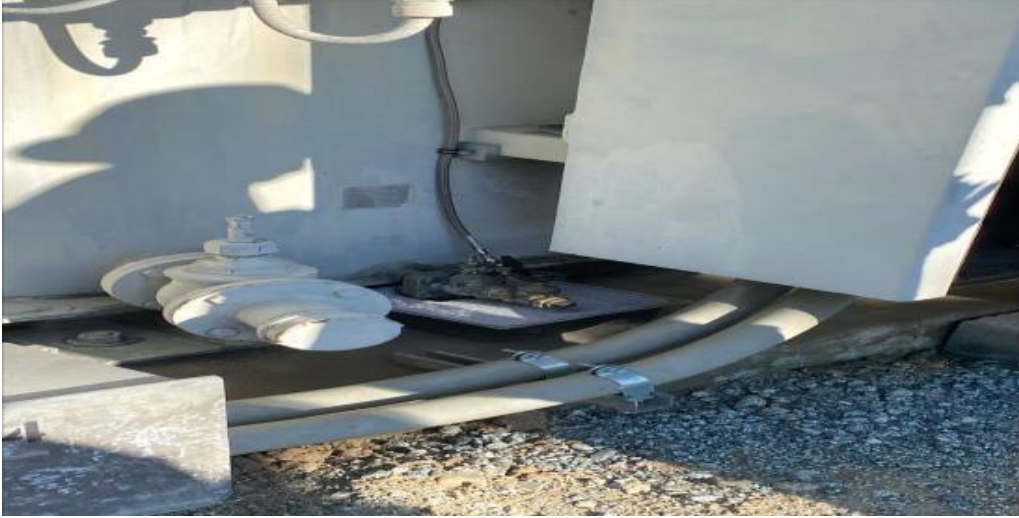
9.5 Transformer Bank 1 Spare Nitrogen Bottle Empty. Existing LC Tag#129590535.
