PUBLIC UTILITIES COMMISSION

505 VAN NESS AVENUE
SAN FRANCISCO, CA 94102-3298

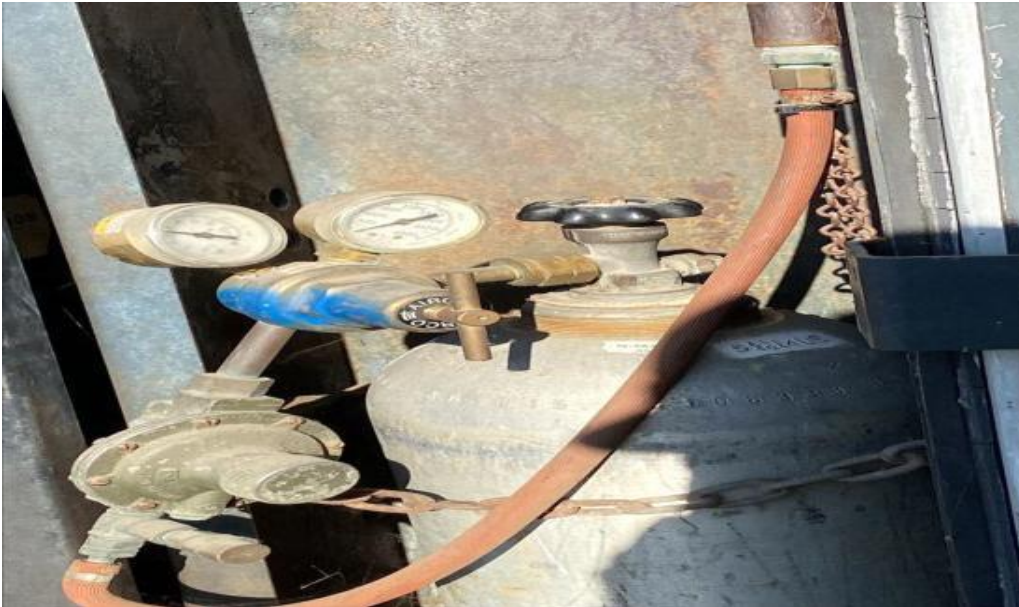
9.6 Transformer Bank 1 Spare Oil Leak Mitigation. Existing LC Tag#129590535.

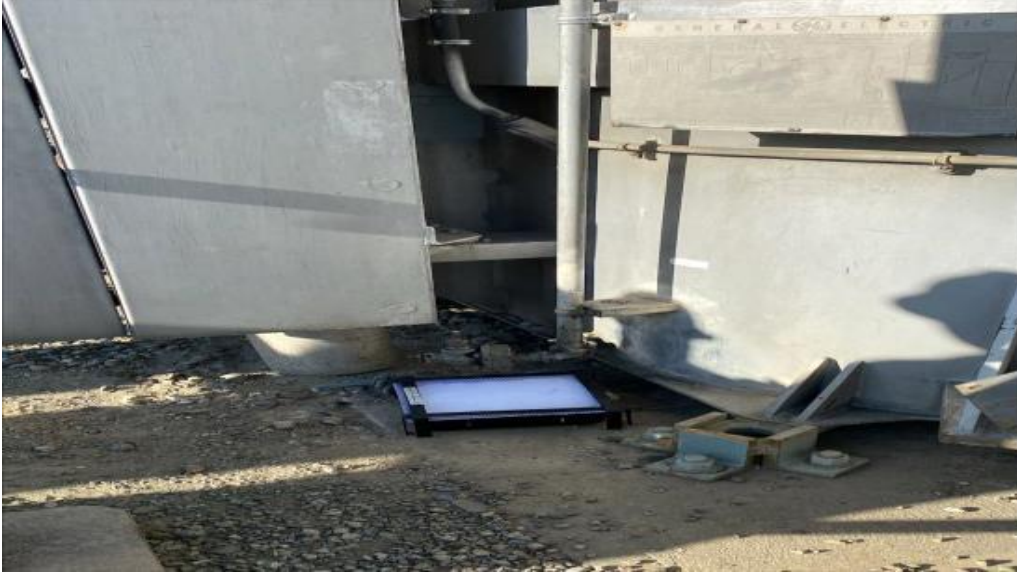
9.7 Circuit Breaker 172 Hydraulic Oil Leak Mitigation. Existing LC Tag#129590532.

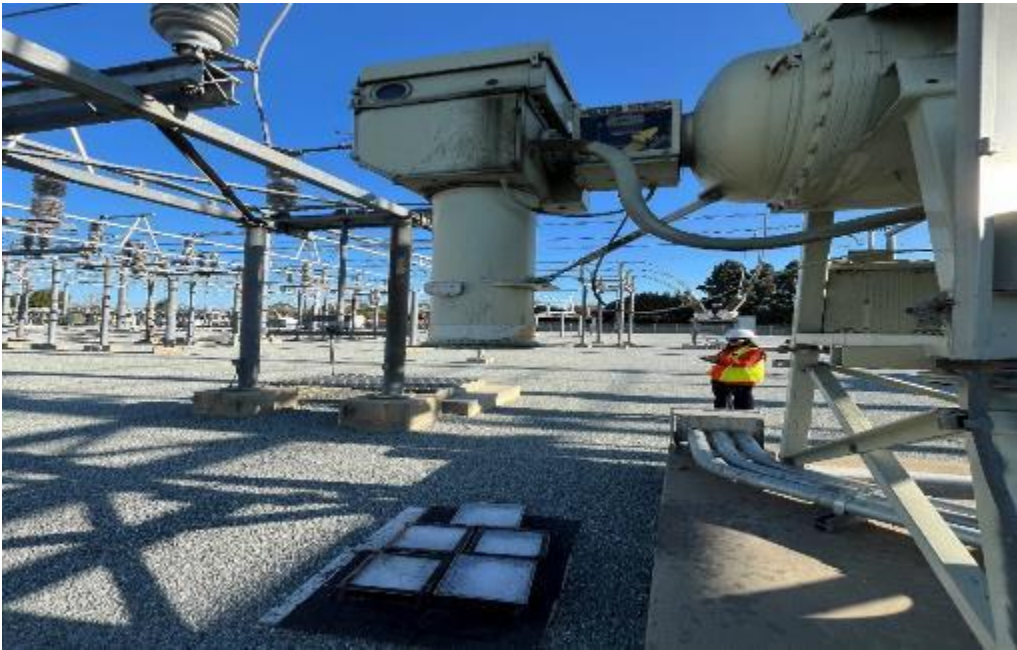
9.8 Transformer Bank 3 Oil Leak Mitigation. Existing LC Tag#129590690.

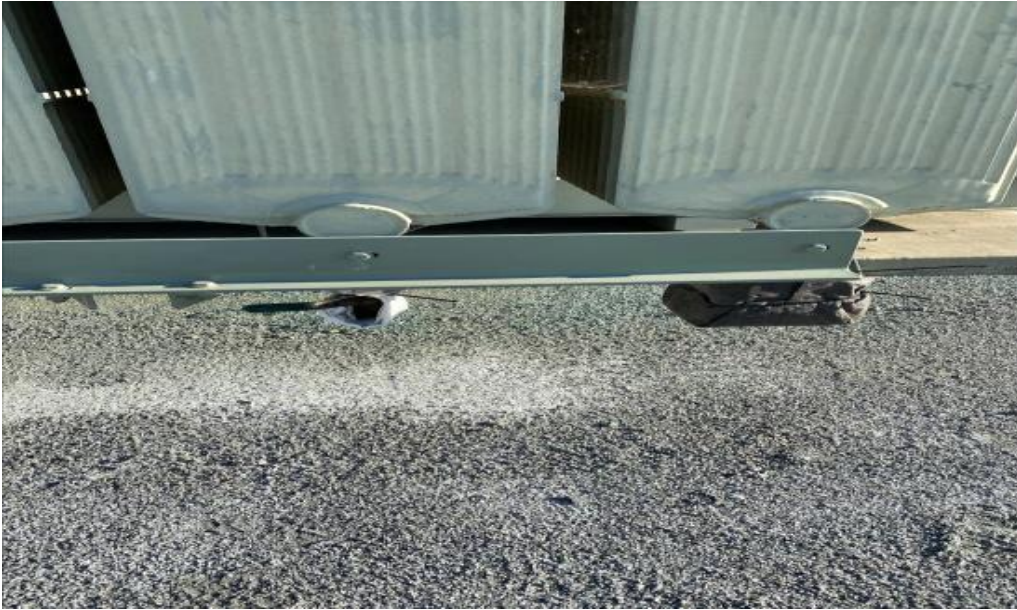
9.9 Transformer Bank 2 Load Tap Changer (LTC) Temperature Gauge Hard to Read.

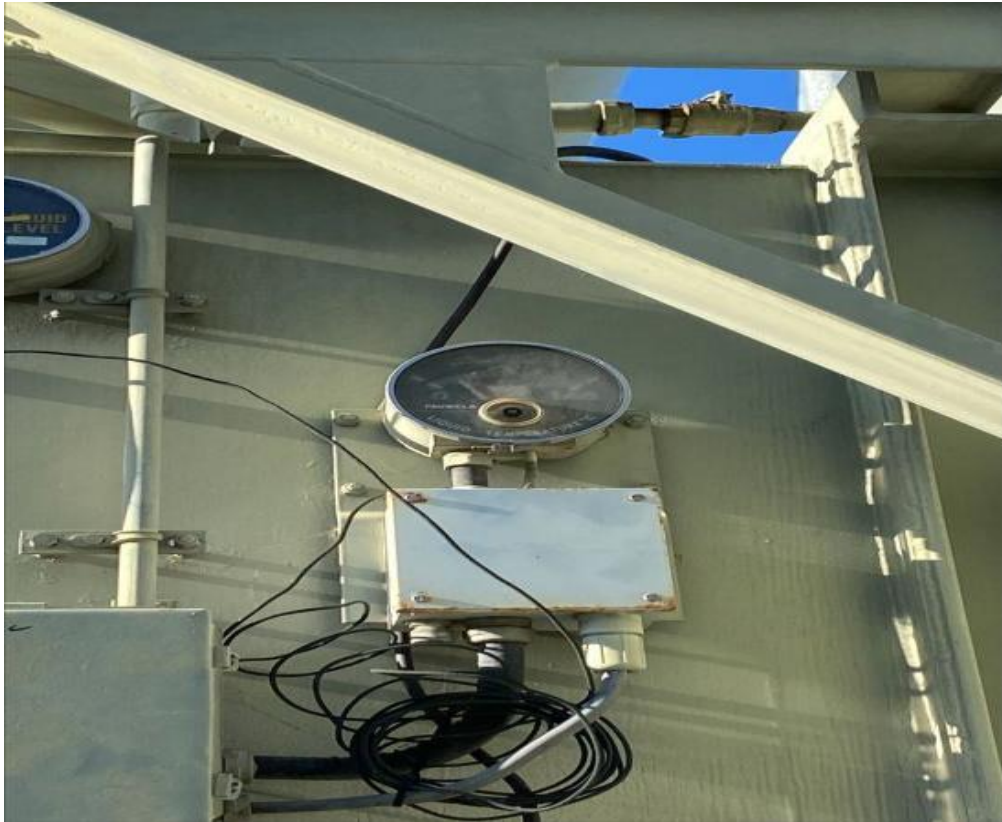
9.10 Transformer Banks 2 and 3 Neutral Reactor Missing Label. As a best practice, it should have labels to be consistent with Edendale Substation which has LC Tag #129619844.

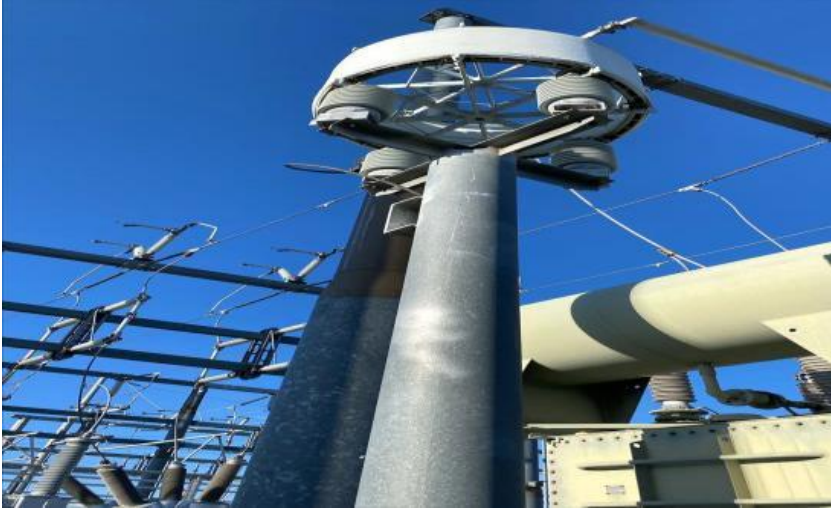
10. San Jose A Substation

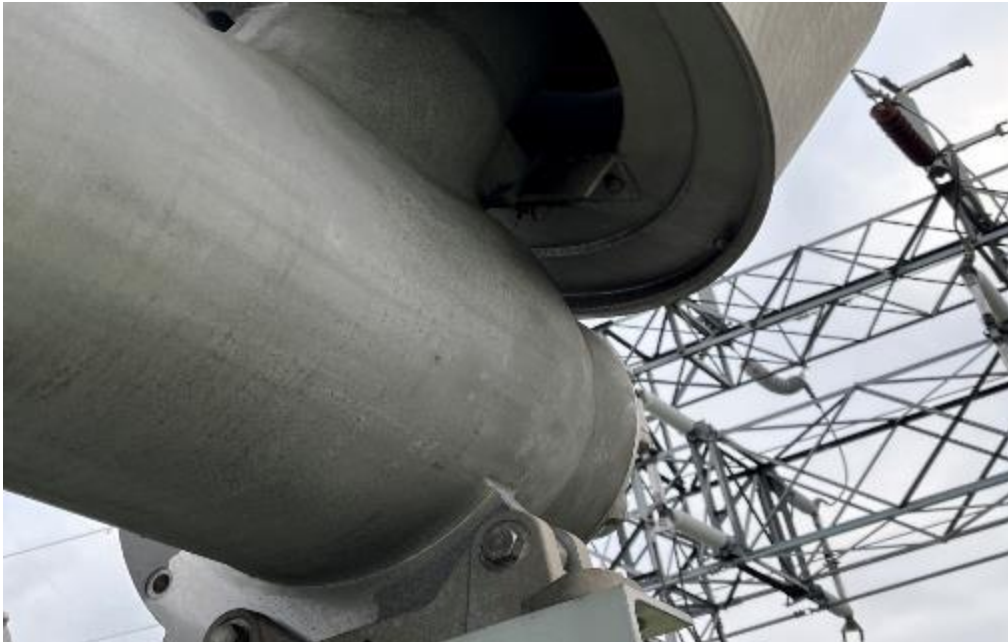
10.2 Transformer Bank 2 Oil Leak Mitigation at Main Oil Valve. Existing LC Tag#130718285.

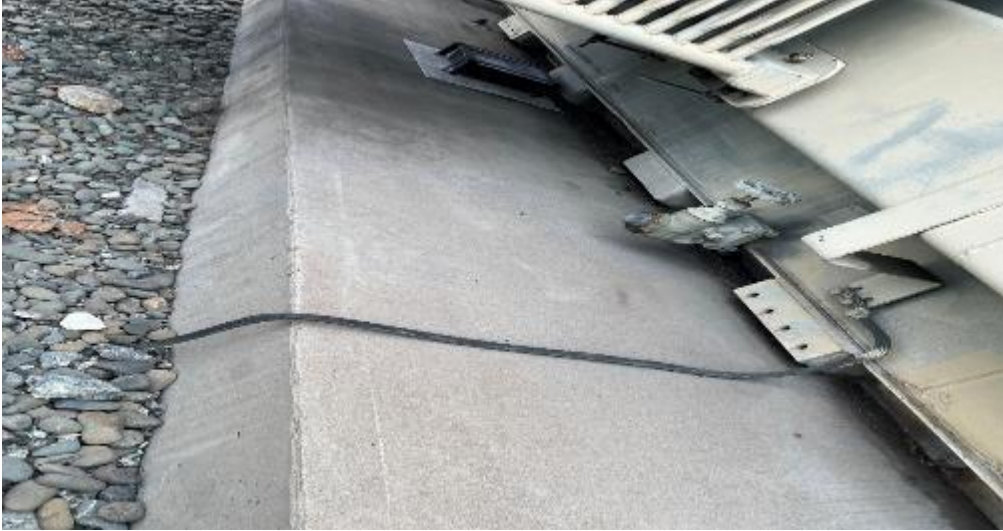
10.3 Transformer Bank 2 Oil Filter Line Leak. Existing LC Tag#130718286.

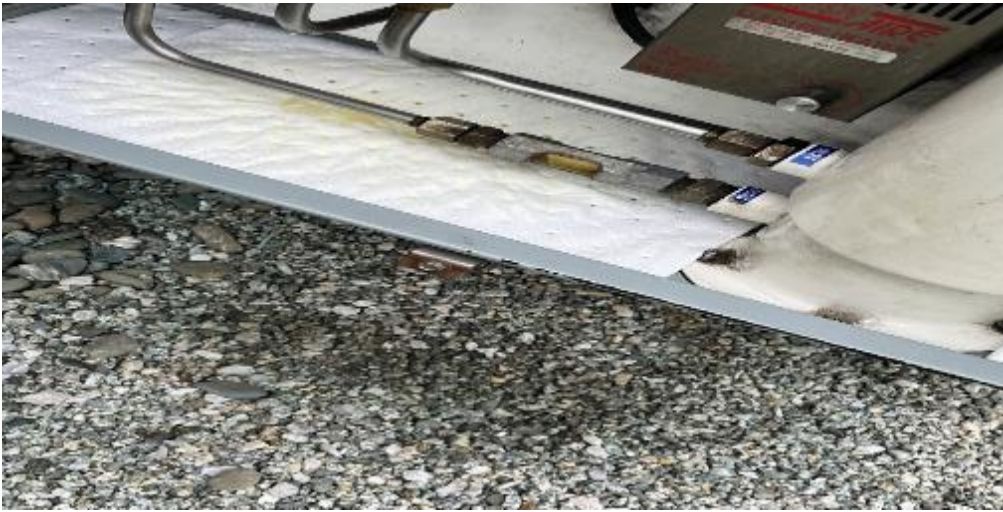
10.4 Transformer Bank 1 Oil Leak at Main Oil Pump Valve.

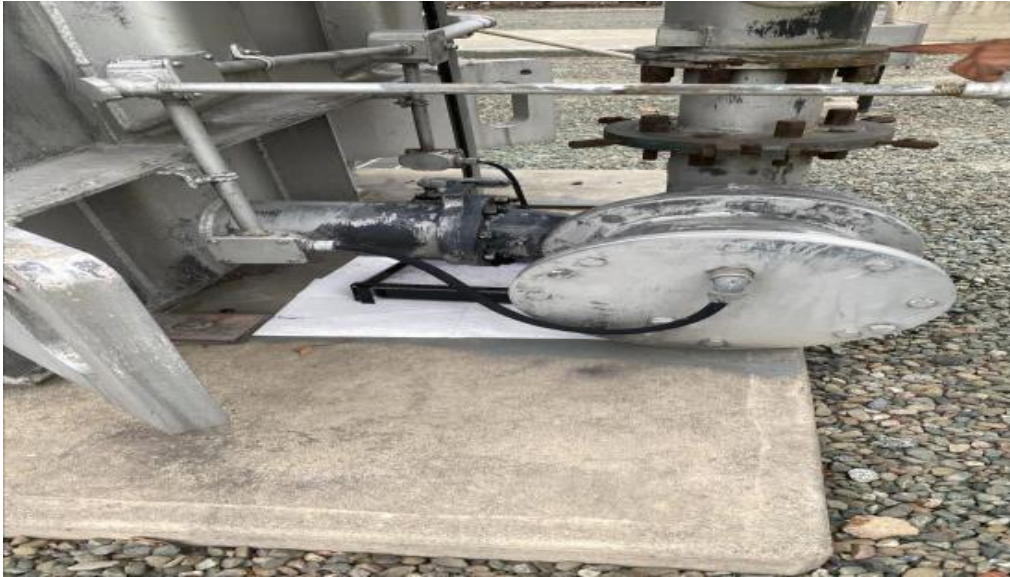
10.5 Transformer Bank 1 Cracked Glass Bushing Oil Level Gauge. Existing LC Tag#129389739.

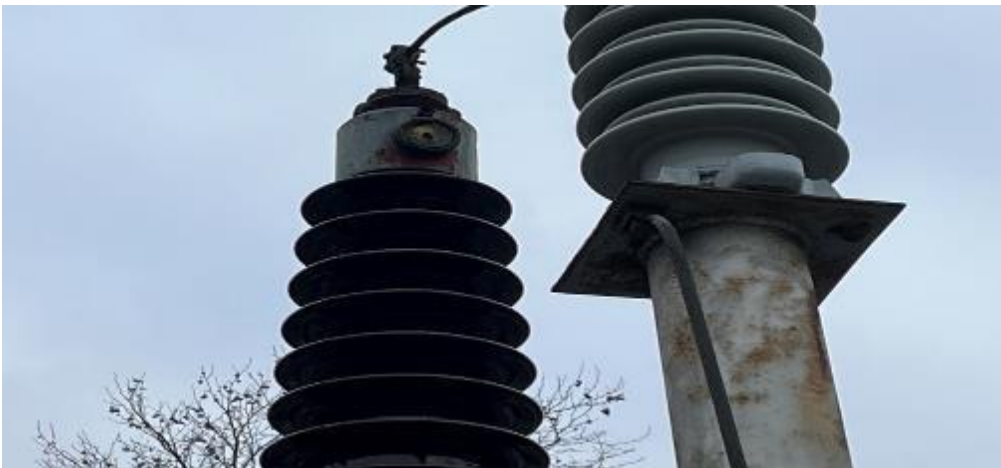
10.6 Transformer Bank 1 Rust. Existing LC Tag#129389229.

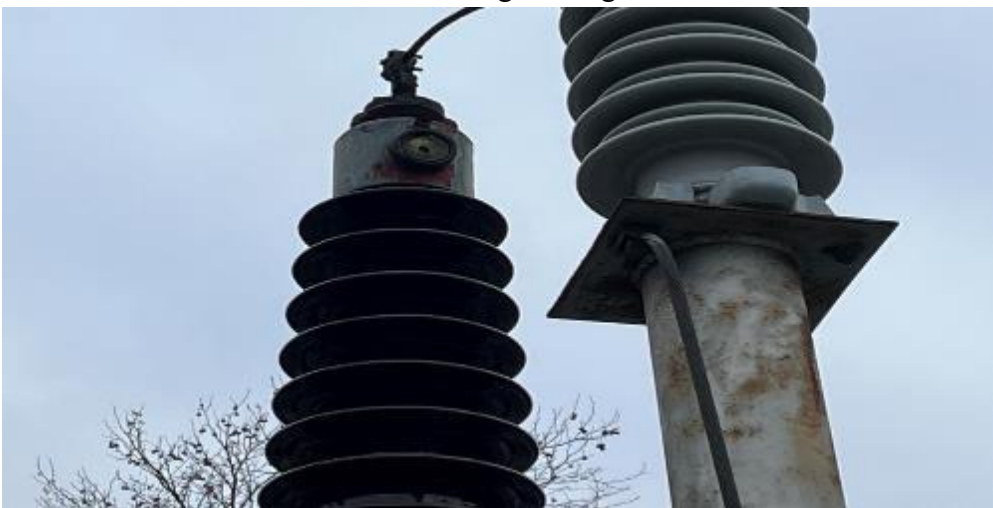
10.7 Transformer Bank 2 Oil Leak at Main Oil Pump Valve. Existing LC Tag#130718282.

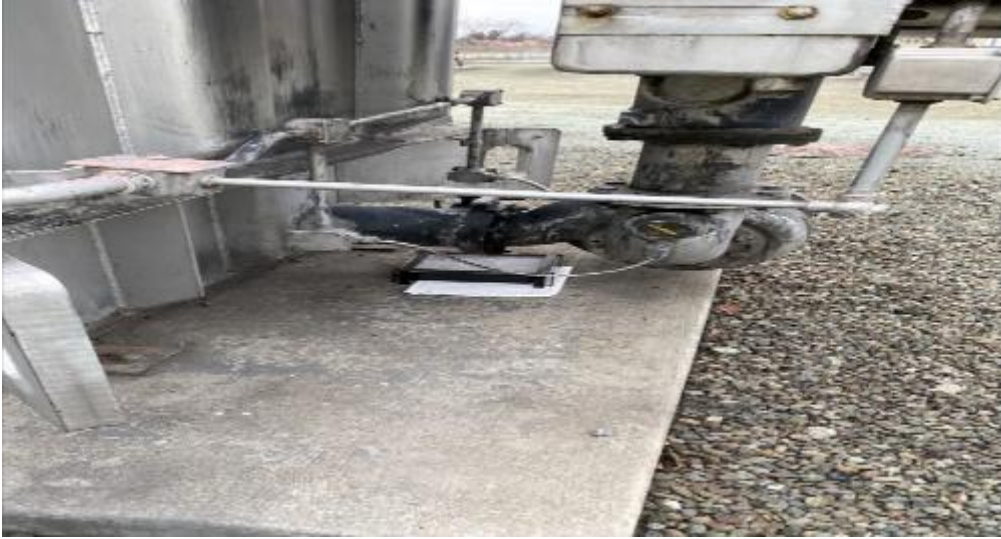
10.8 Transformer Bank 4 Desiccant Near End of Life Need Replacement.

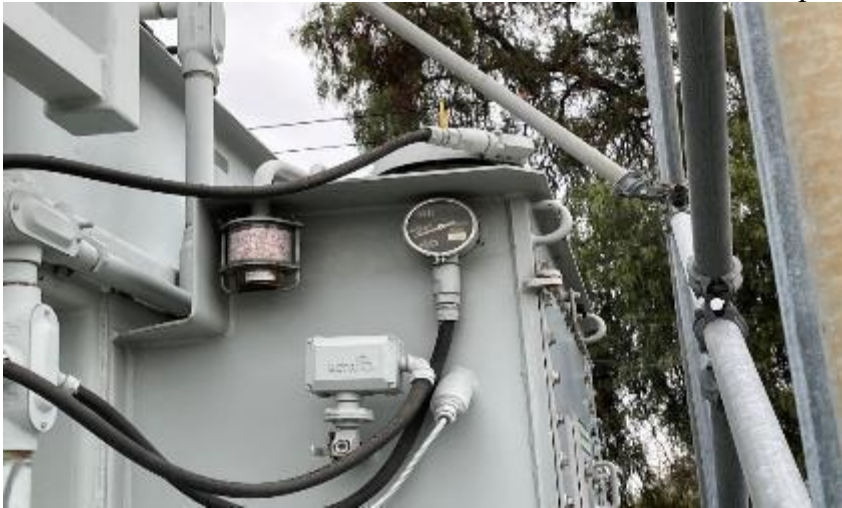
10.9 Perimeter Security Fence Signs Installed Inside Fence Existing LC Tag#130719763,
Ground Rod Missing Northeast Corner Existing LC Tag#129390970.

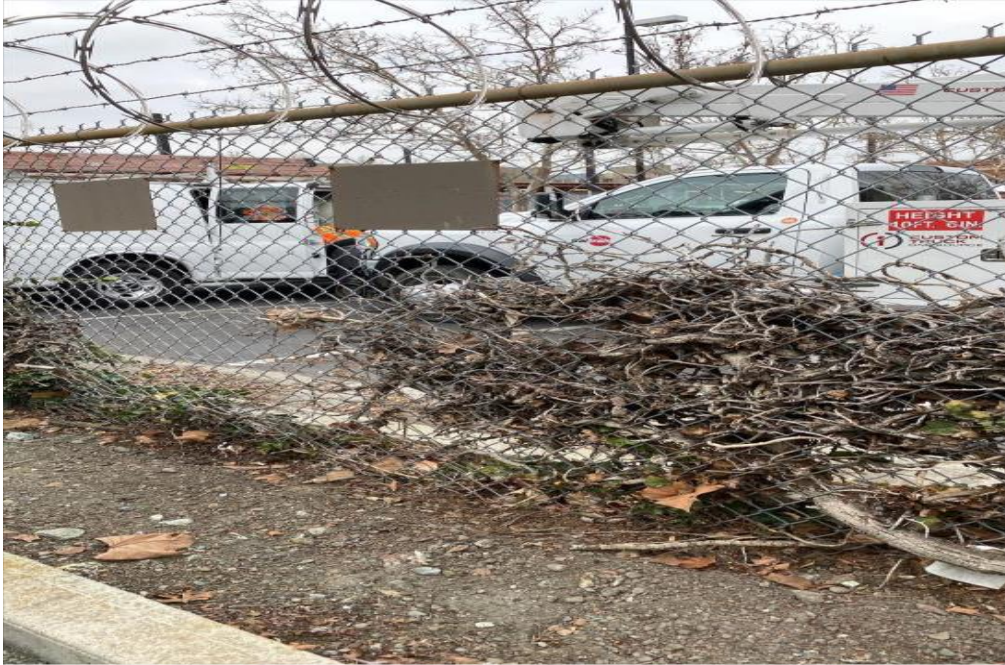
10.10 Ground Rod Missing Entrance Gate Left Side Post

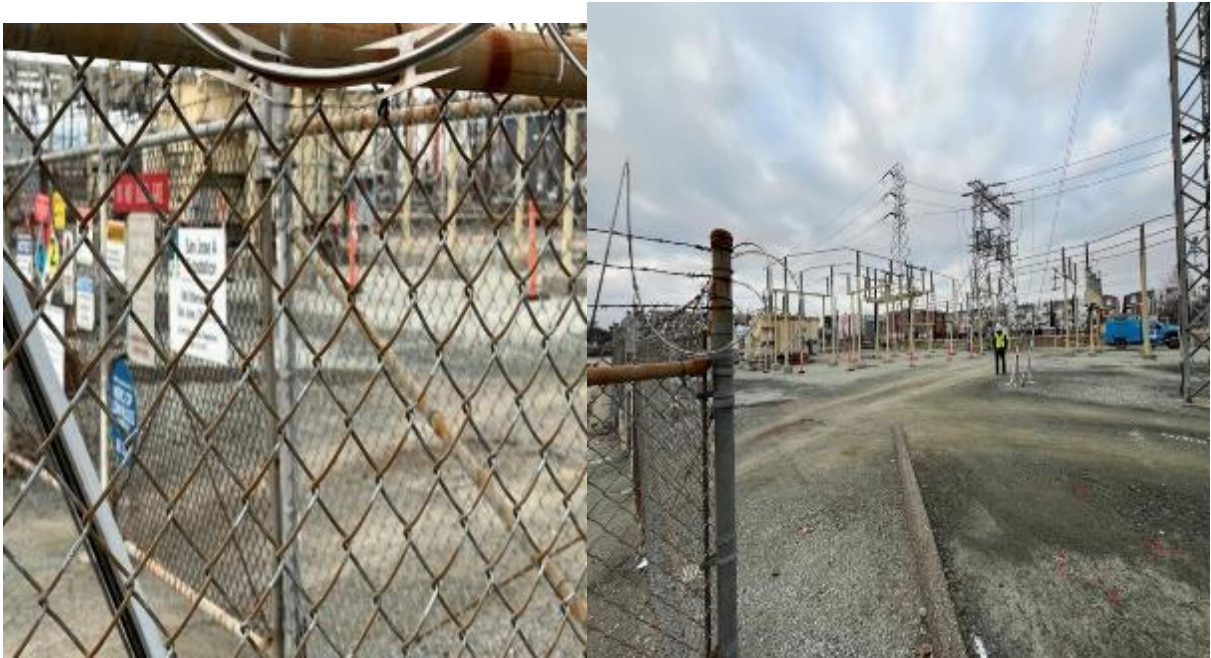
11. San Jose B Substation

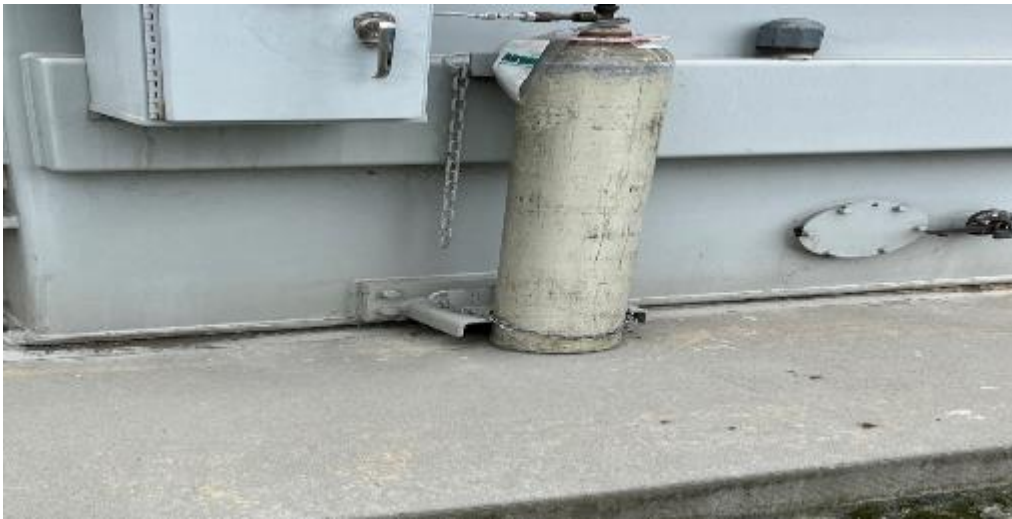
11.7 Transformer Bank 2 Oil Leak Mitigation Existing LC Tag#130791408, Oil Filter Not Running Existing LC Tag#129391900, Oil Residue on Conduit Existing LC Tag#129389768.

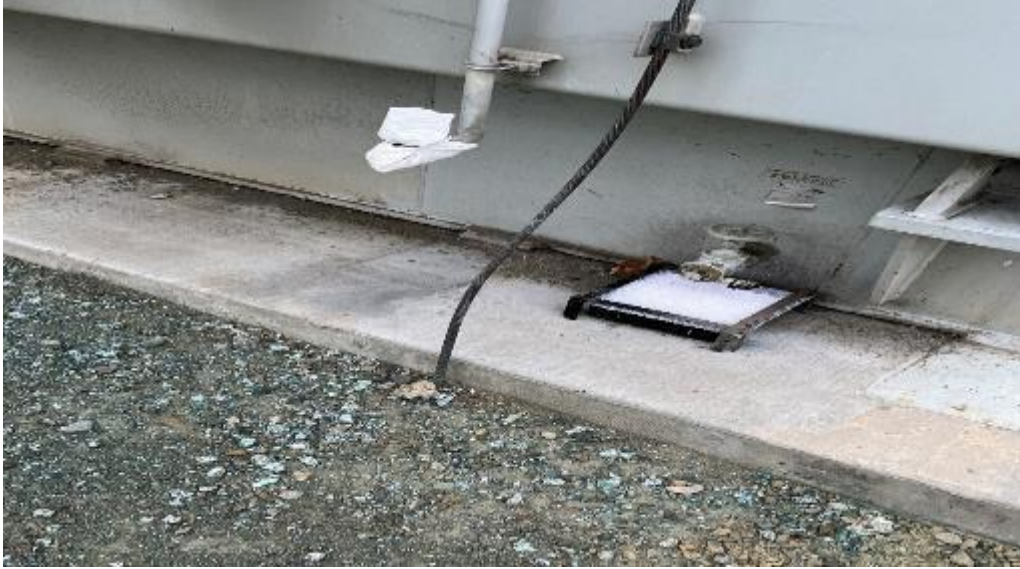
11.8 Transformer Bank 2 Animal Guard Damaged. Existing LC Tag#129390991.

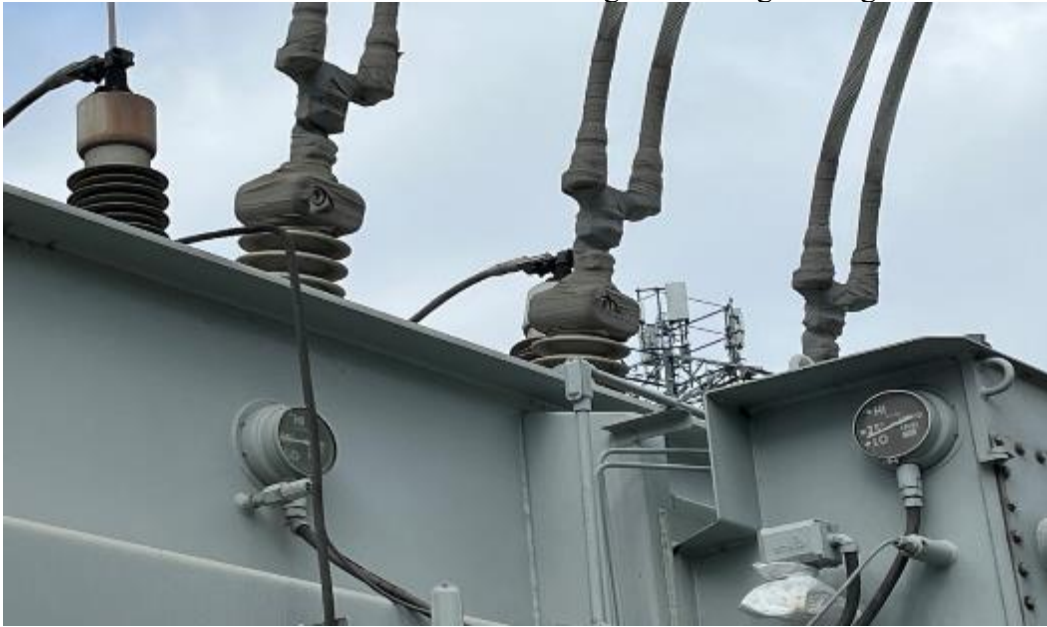
11.9 Transformer Bank 2 Fan Covers Rusted. Existing LC Tag#129389760.

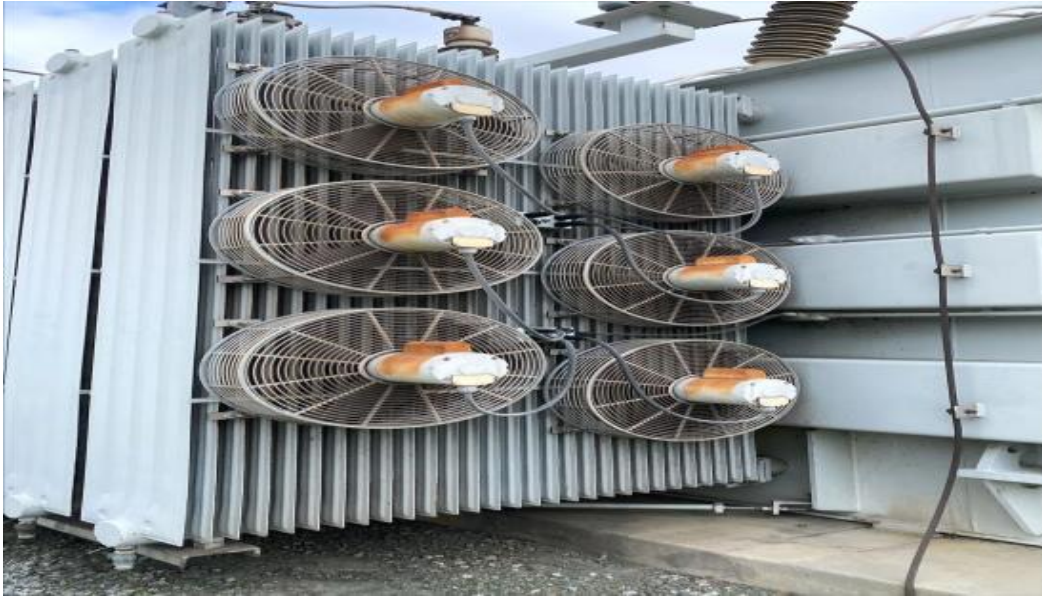
11.10 Transformer Bank 3 Fan Not Working. Existing LC Tag#130791434.

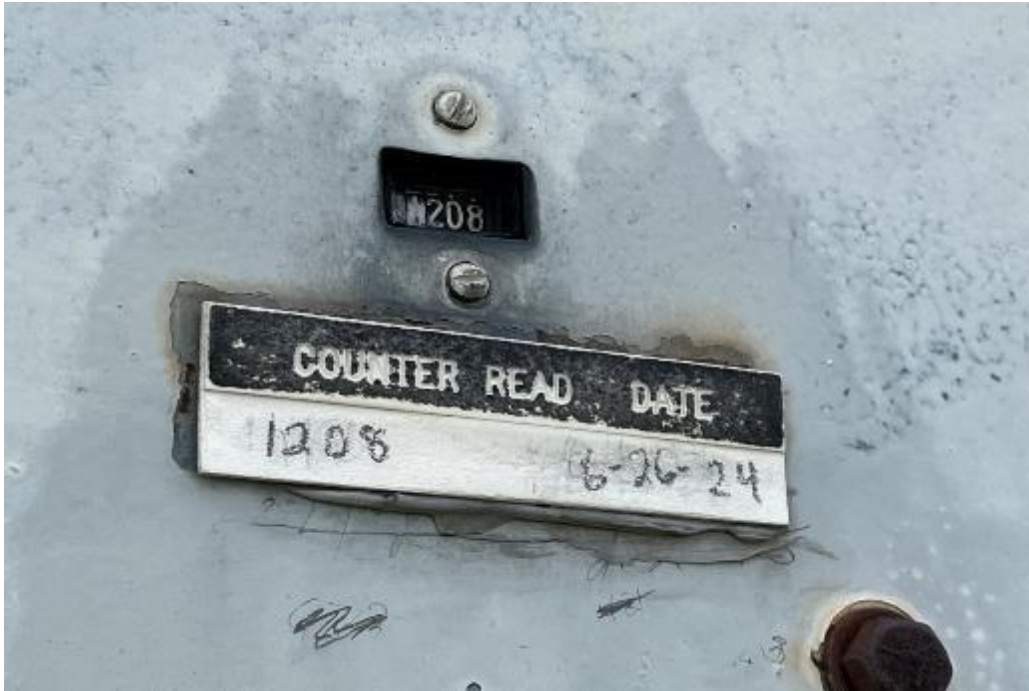
12. Mabury Substation

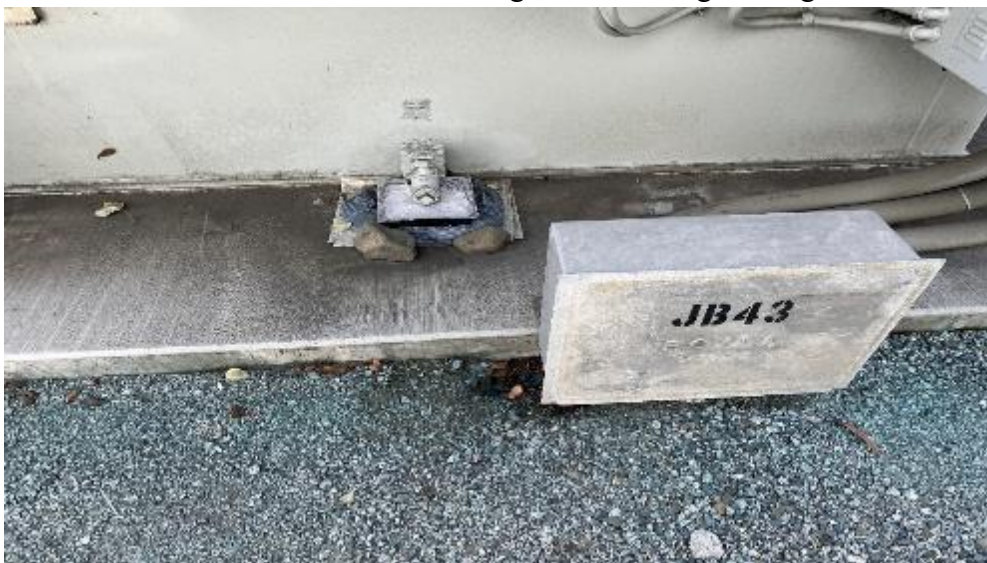
12.2 Circuit Breaker 72 Oil Leak Mitigation. Existing LC Tag#129395916.

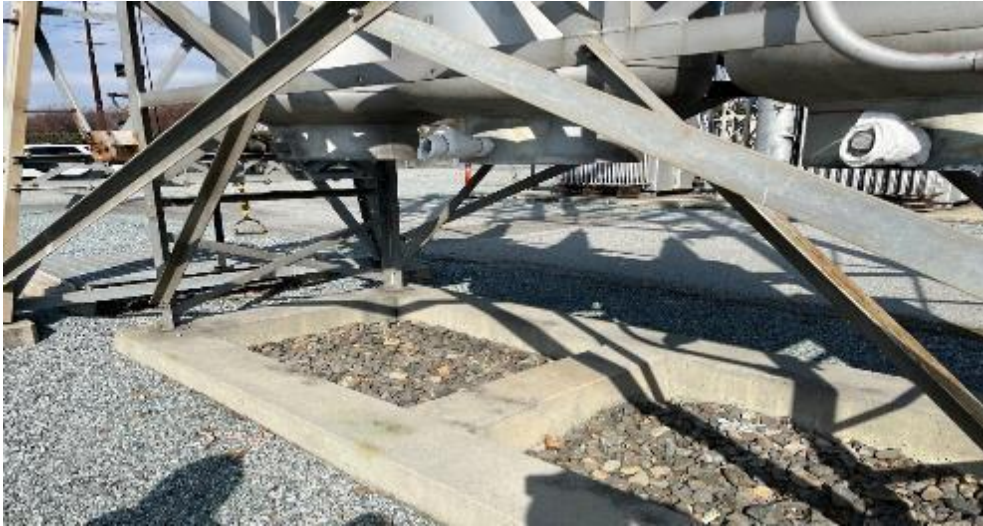
12.3 Transformer Bank 1 Phase C Oil Leak Mitigation. Existing LC Tag#130732652.

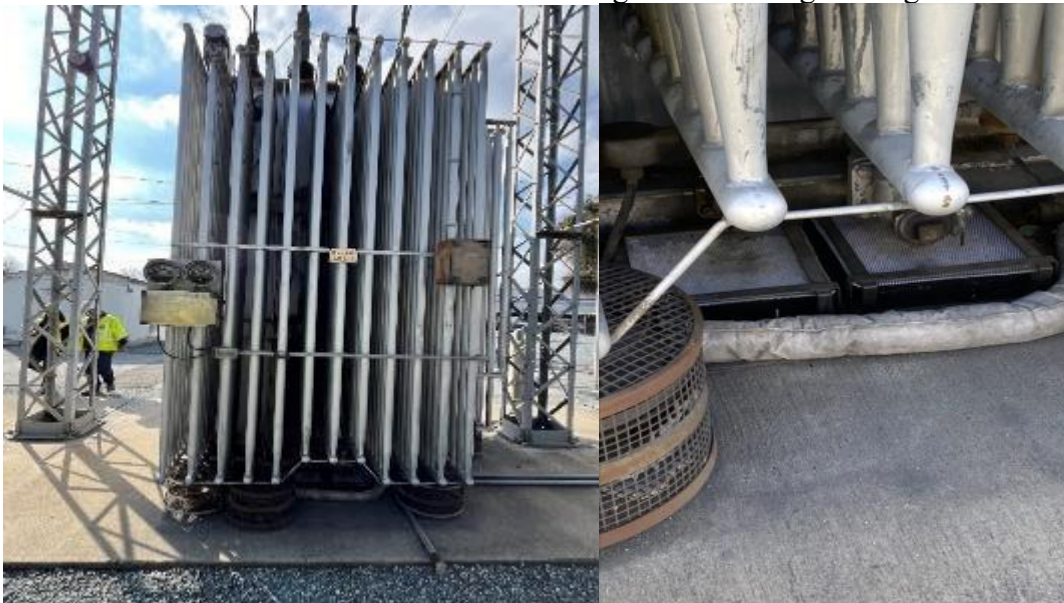
12.4 Transformer Bank 1 Phase B Oil Leak Mitigation. Existing LC Tag#130732701.

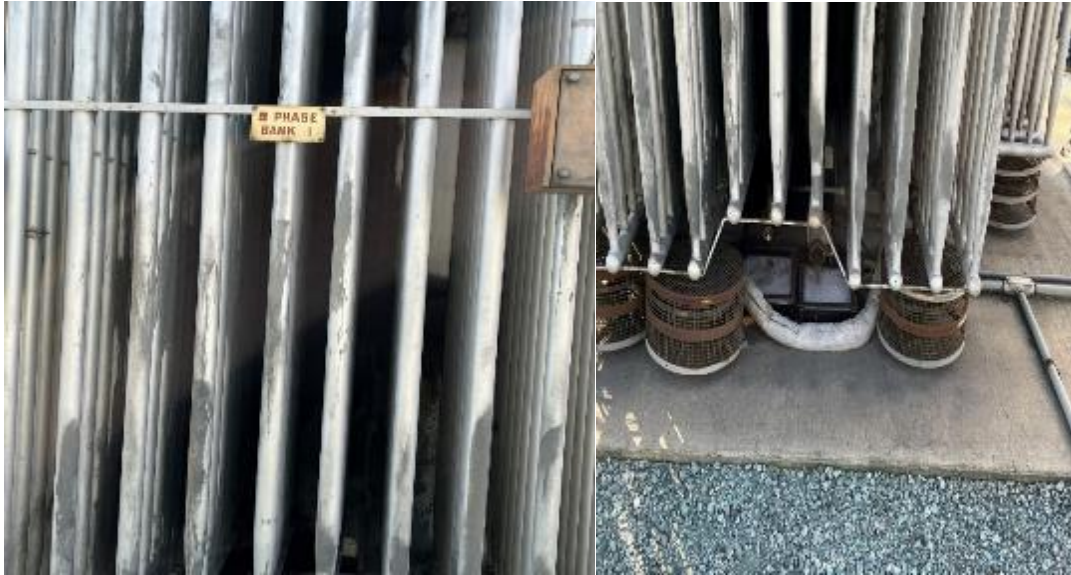
12.5 Transformer Bank 1 Phase A Oil Leak Mitigation. Existing LC Tag#130732657

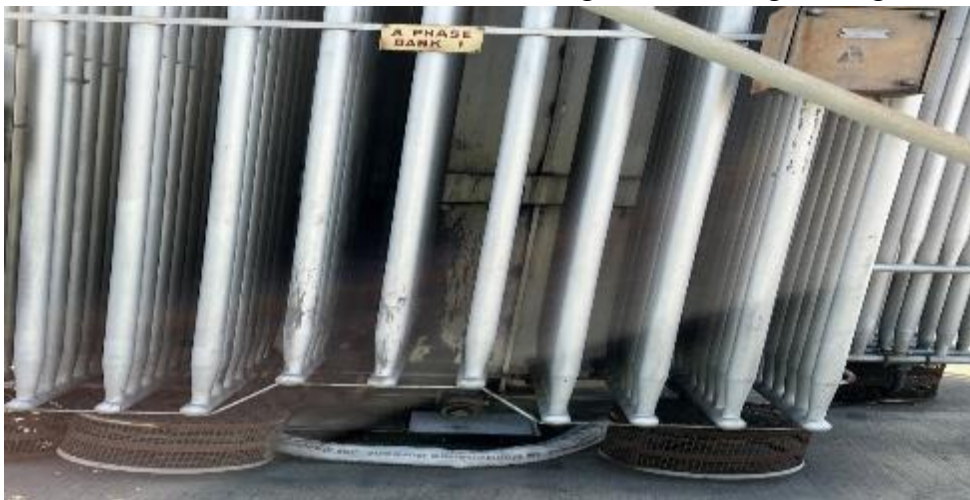
12.6 Voltage Regulator 1 Fan Not Working.

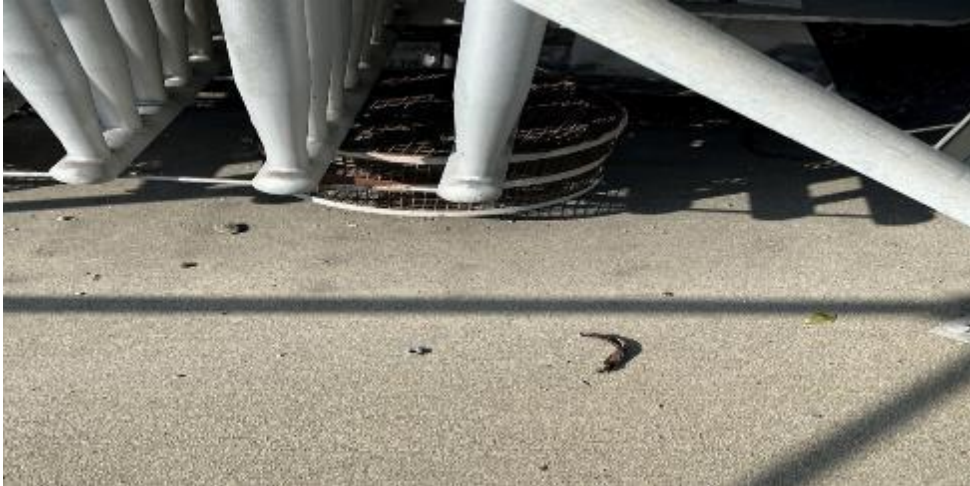
12.7 Battery Room Corrosion on Cells. Existing LC Tag#130713366.

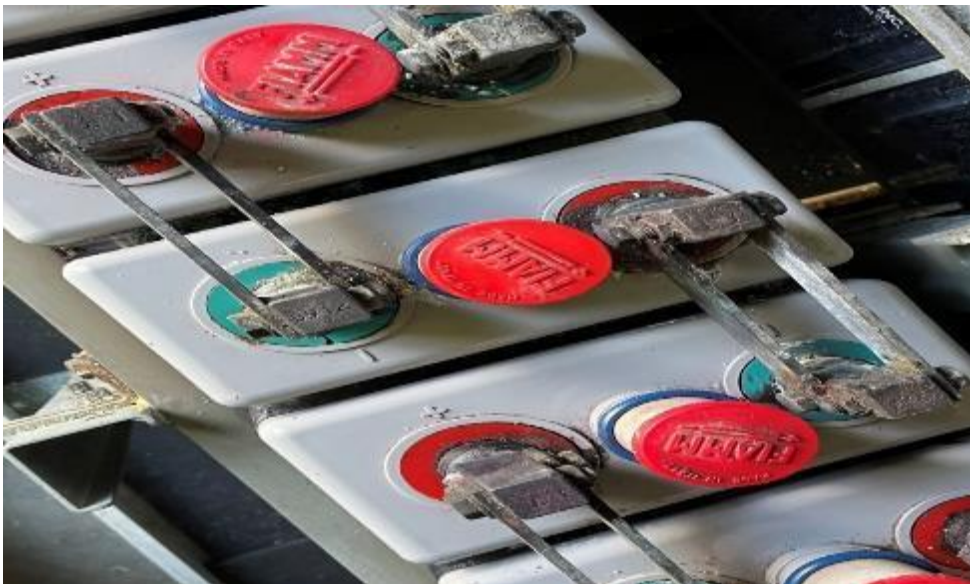
12.8 Perimeter Security Fence Signs Installed Inside Fence.

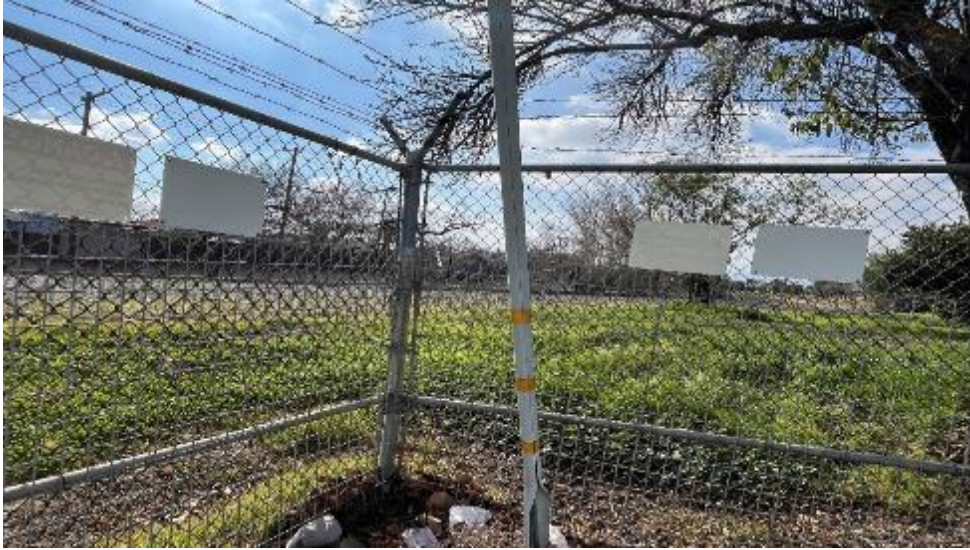
12.9 Perimeter Security Fence Ground Rod Missing Front Gate Right Side Post.

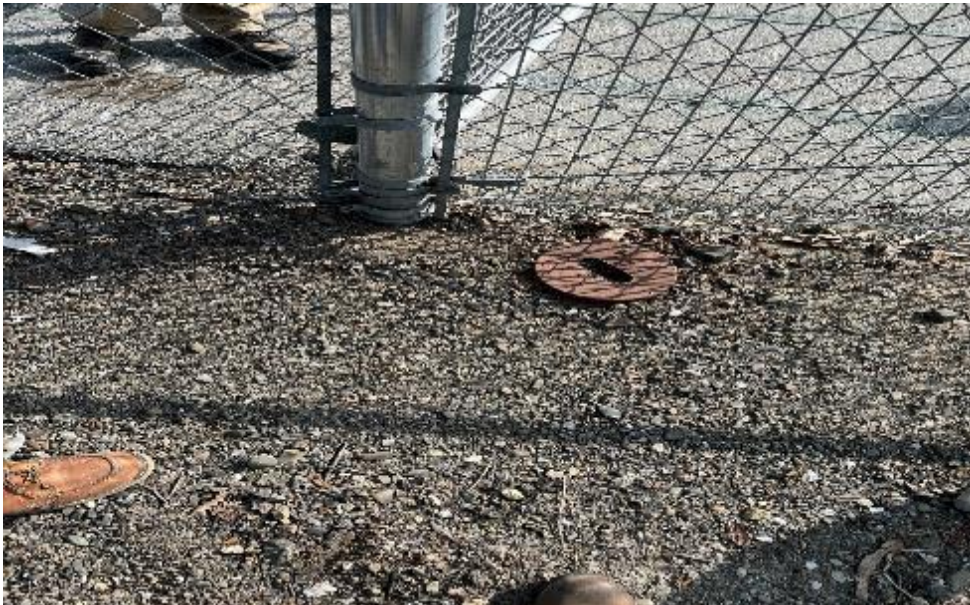
12.10 Perimeter Security Fence Ground Rods Missing at Substation Back Corner Posts.

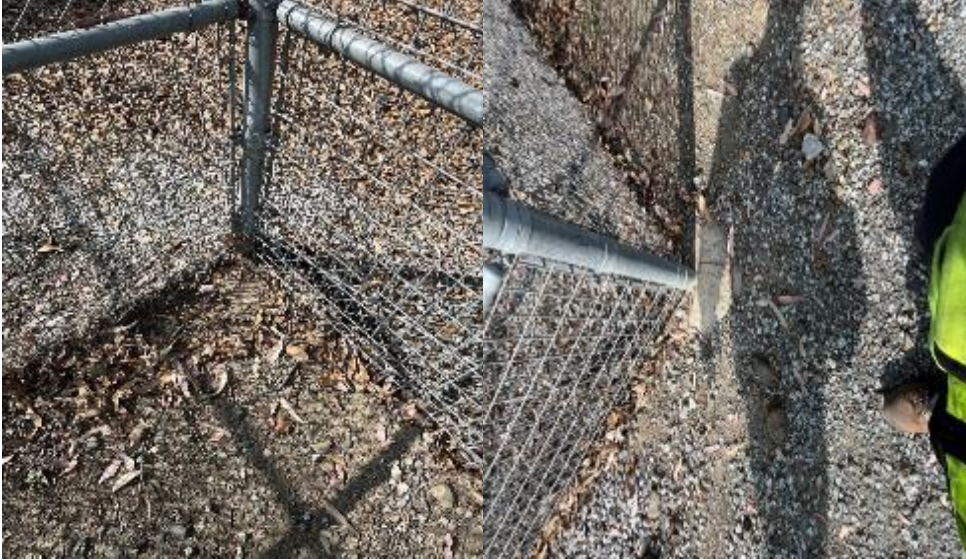
13. Trimble Substation

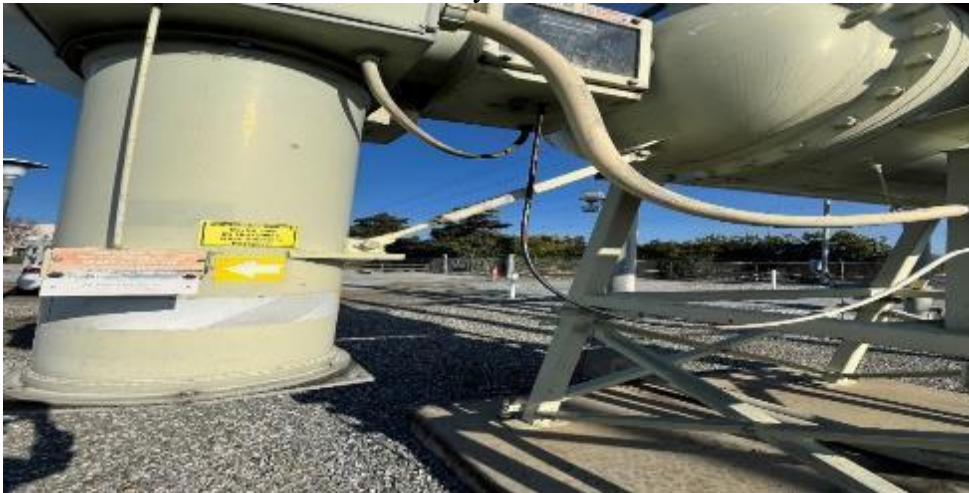
13.2 Circuit Breaker 312 Oil Leak Hydraulic Line. Existing LC Tag#130712304.

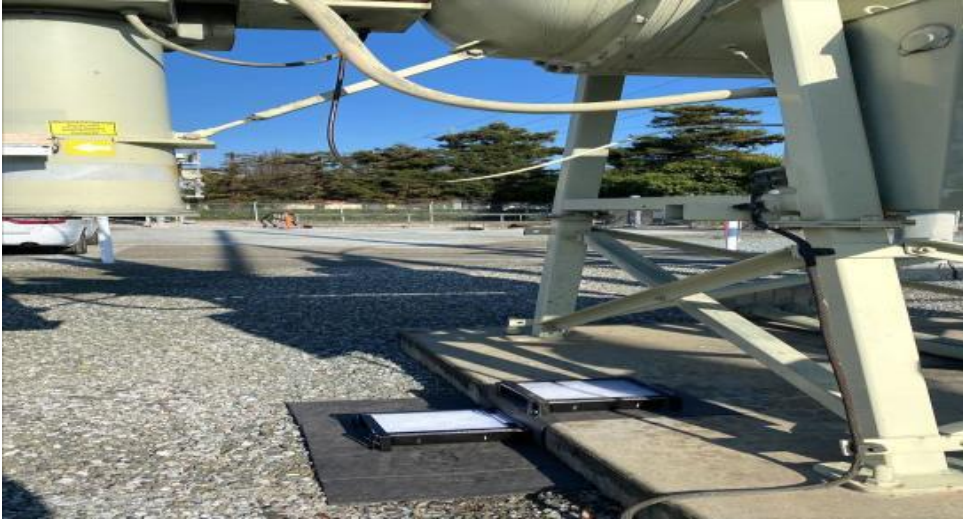
13.3 Transformer Bank 5 Birds Nest in Radiator. PG&E Fixed in Field.

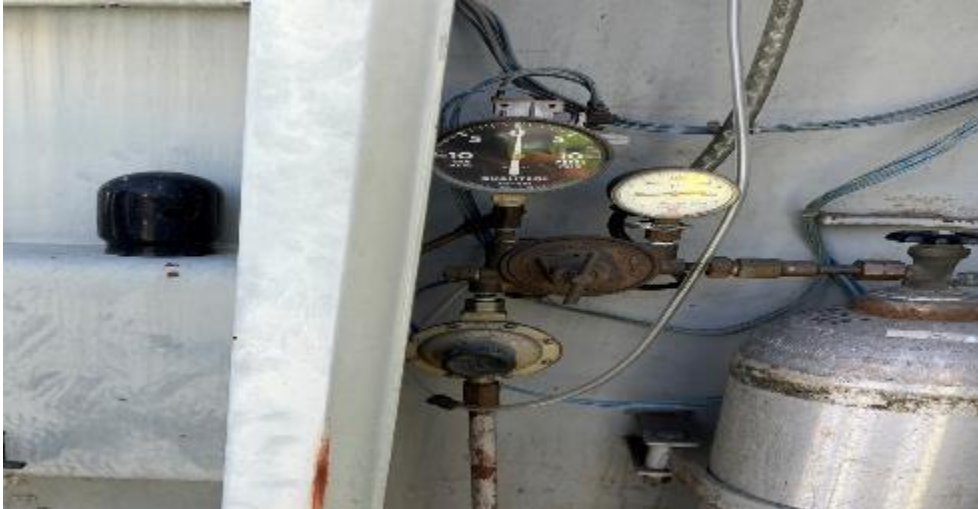
13.5 Rust on Fan Cover and Support Structure

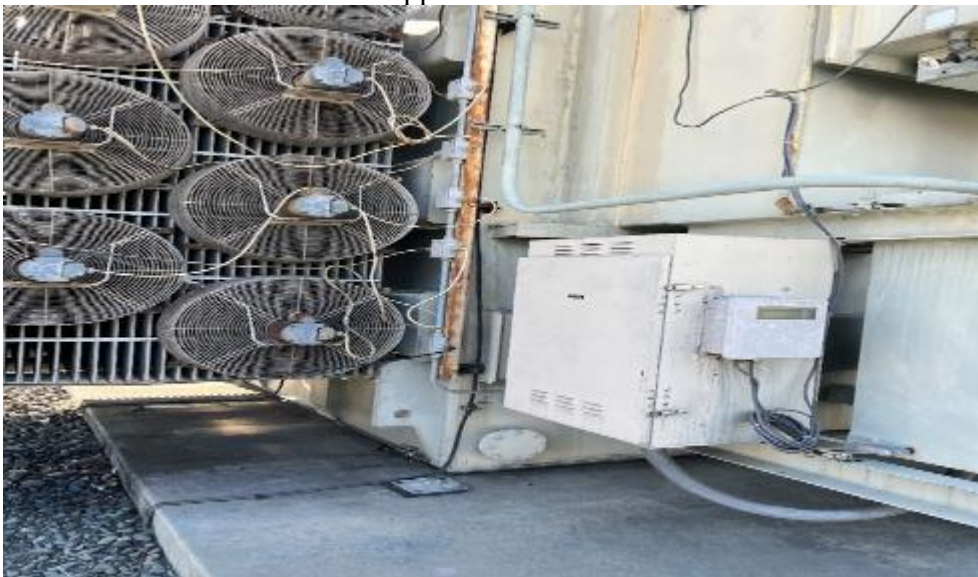
13.6 Transformer Bank 3 Oil Leak Mitigation. Existing LC Tag#130703901.

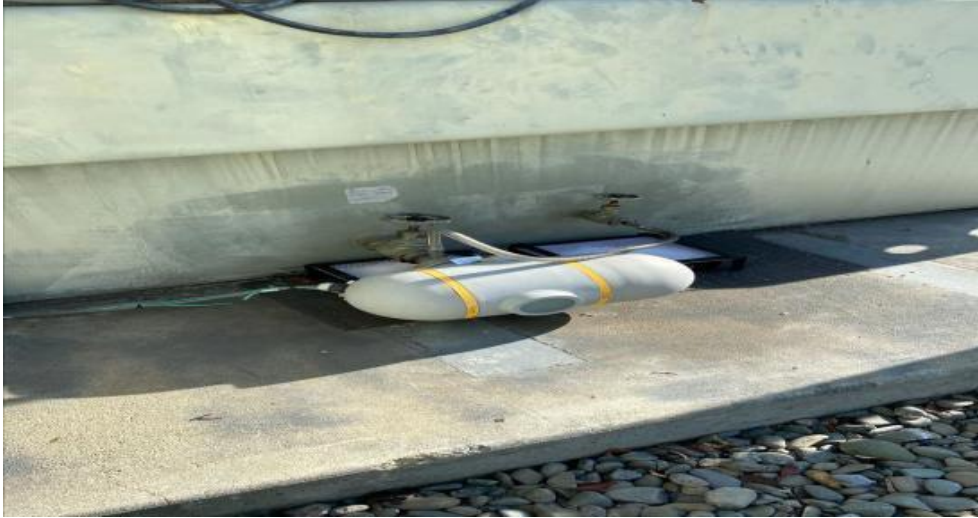
13.7 Transformer Bank 2 Oil Leak Mitigation at Filter. Existing LC Tag#130712699.

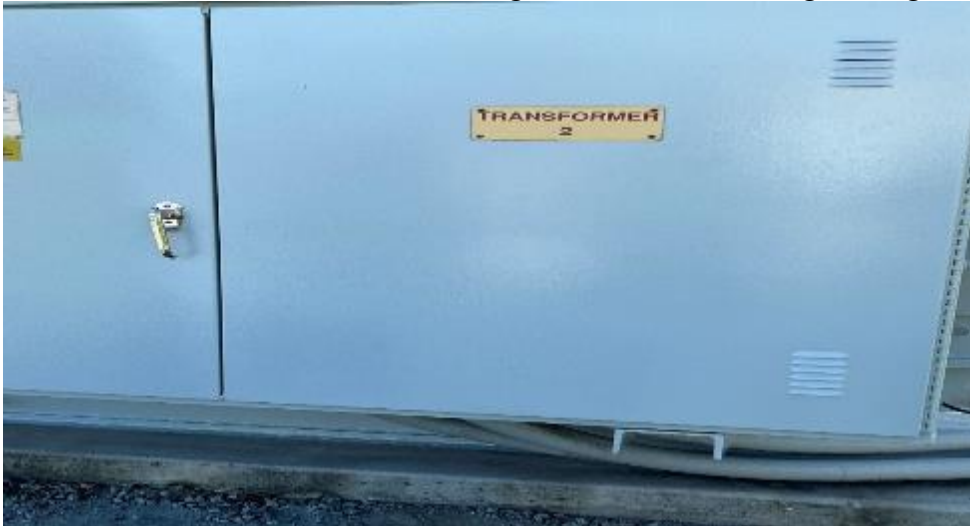
13.8 Transformer Bank 1 Oil Leak Mitigation at Main Drain Valve. Existing LC Tag#130712698.

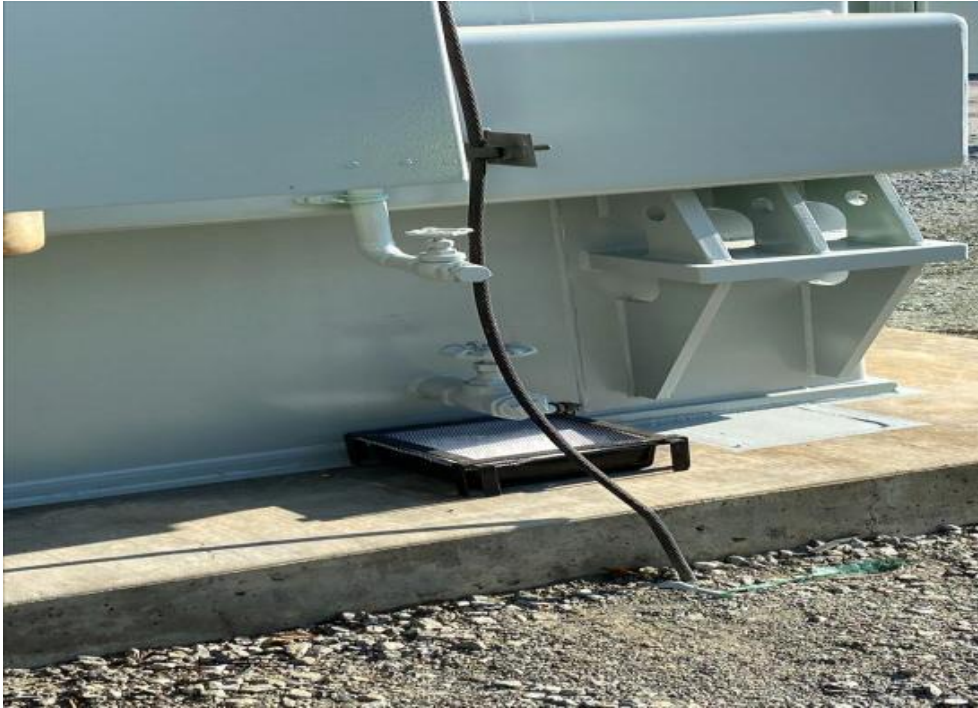
14. Milpitas Substation

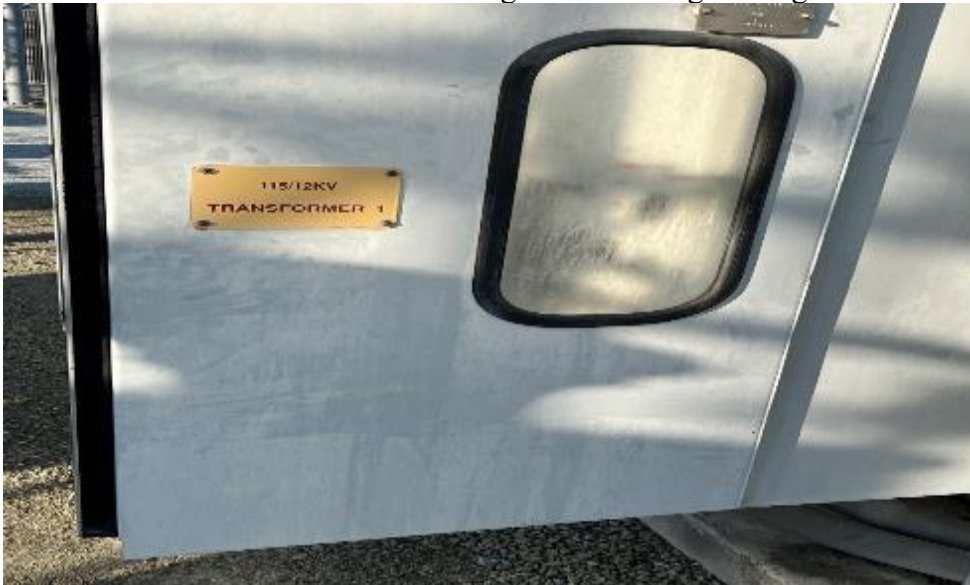
14.2 Transformer Bank 1 Desiccant Near End of Life Need Replacement
