PUBLIC UTILITIES COMMISSION

505 VAN NESS AVENUE
SAN FRANCISCO, CA 94102-3298

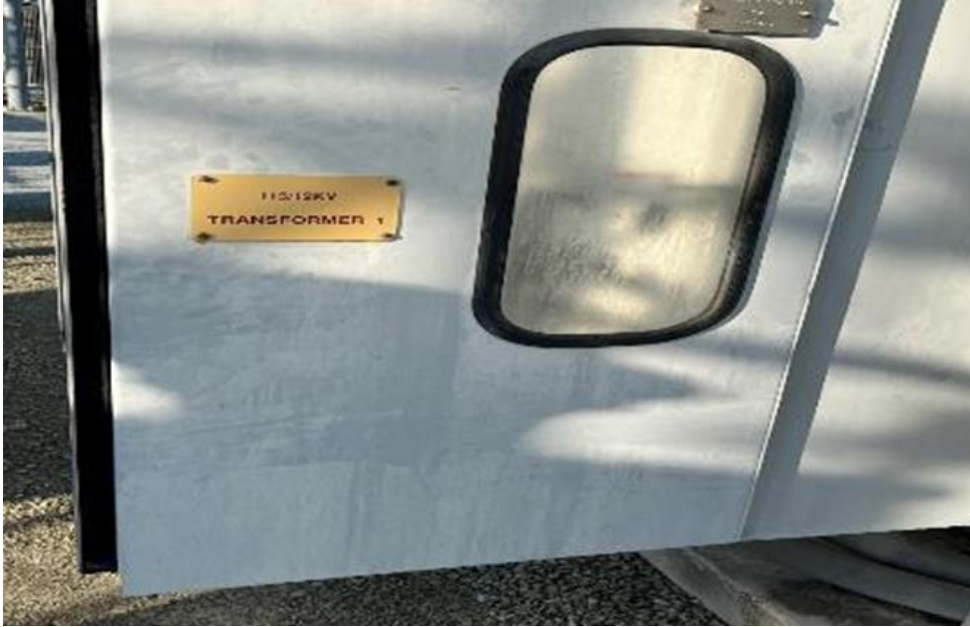
14.3 Transformer Bank 2 Oil Left Corner of Transformer.

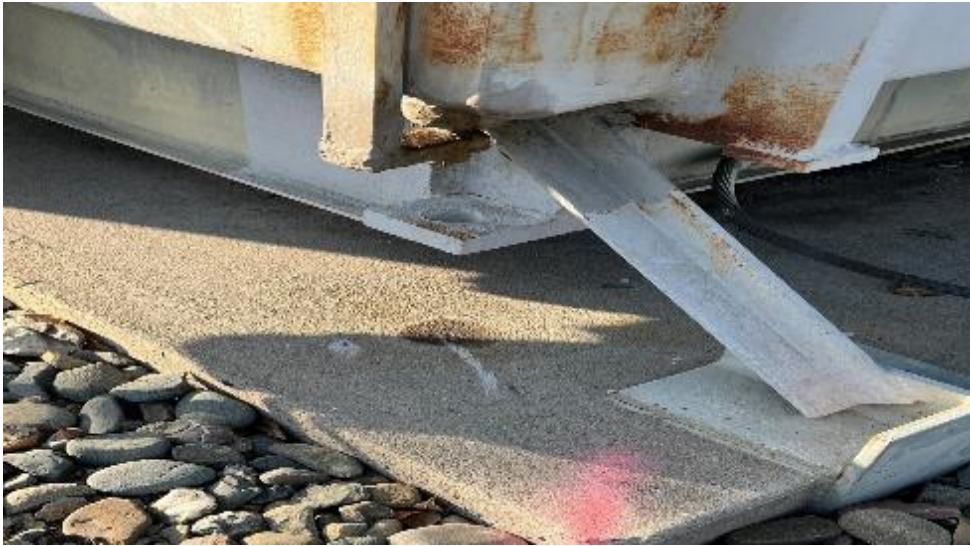
14.4 Transformer Bank 3 Oil Leak Mitigation. Existing LC Tag#130116554.

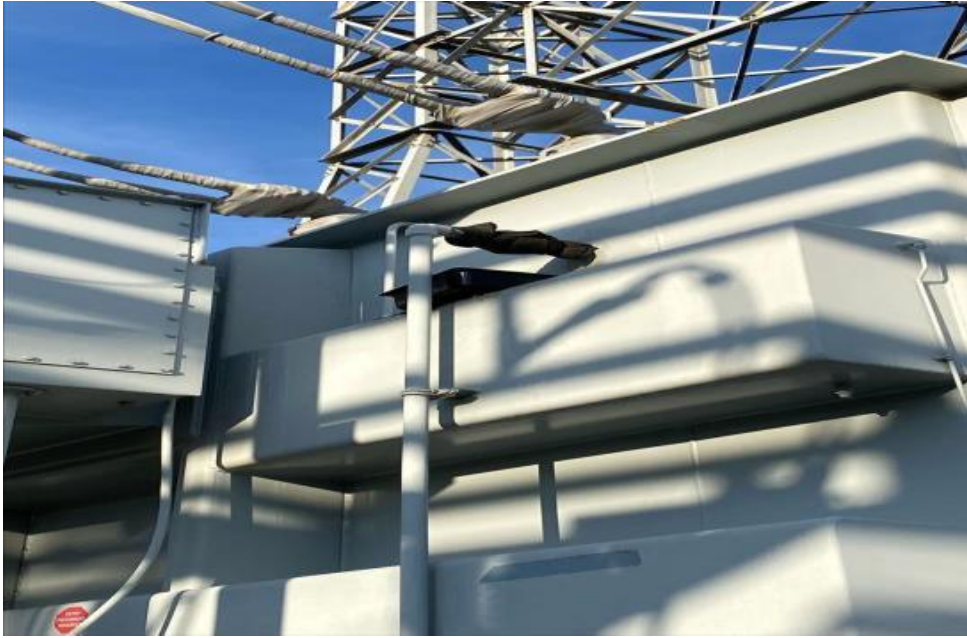
14.5 Transformer Bank 4 Oil Left Corner of Transformer.

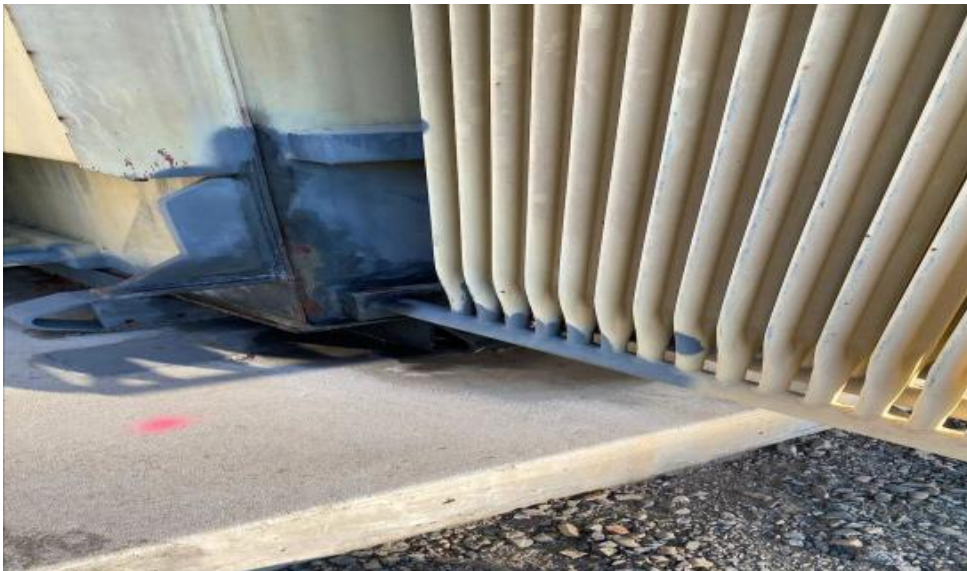
14.6 Transformer Bank 5 Low Nitrogen Pressure 0 psig. Existing LC Tag#128045443 dated 1/9/24 for possible Nitrogen Leak Repair. PG&E added Nitrogen to 0.5 psig in the field. Two most recent inspections on 10/10/24 and 12/5/24 had Nitrogen pressure inside transformer of 1.0 and 0.5 psig, respectively. Coupled with the 0 psig measurement on 1/30/25 supports a Nitrogen Leak in the transformer.

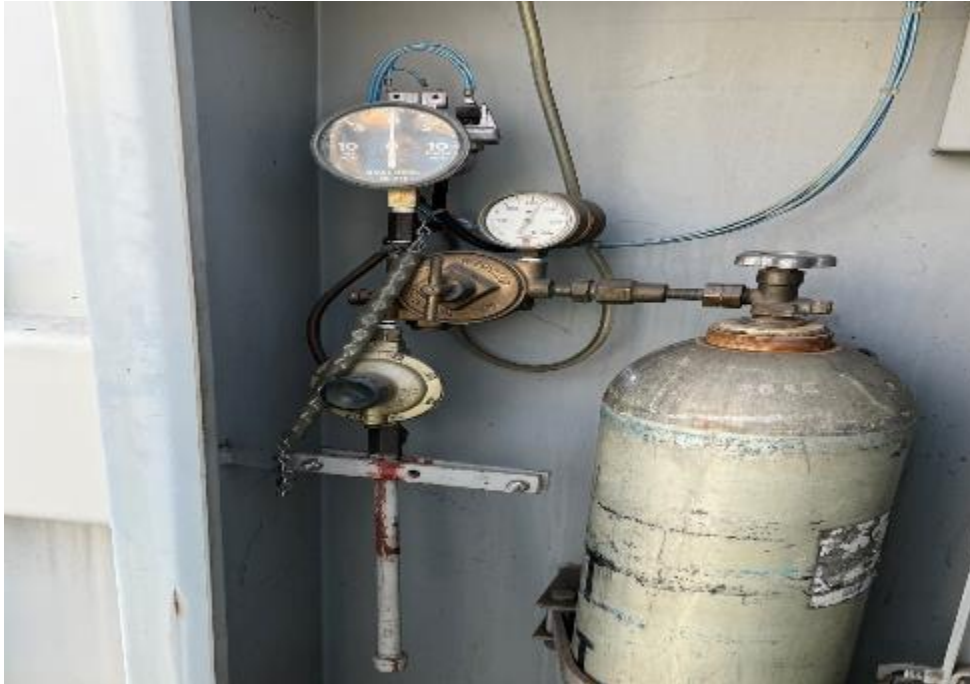
14.7 The Security Perimeter Fence Southwest Corner Ground Wire Not Connected to New Fence Post.

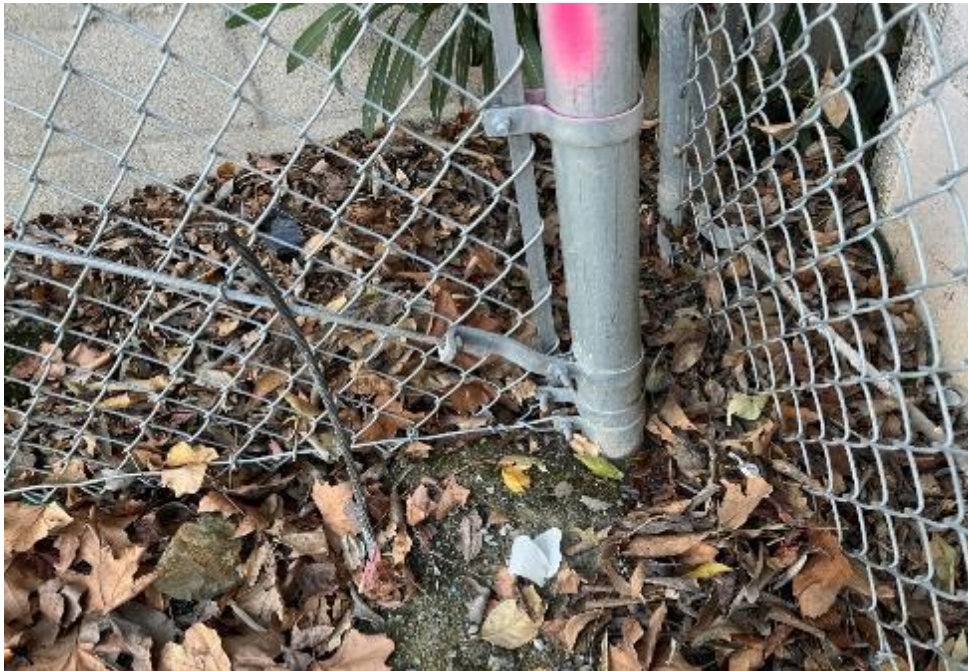
15. Britton Substation

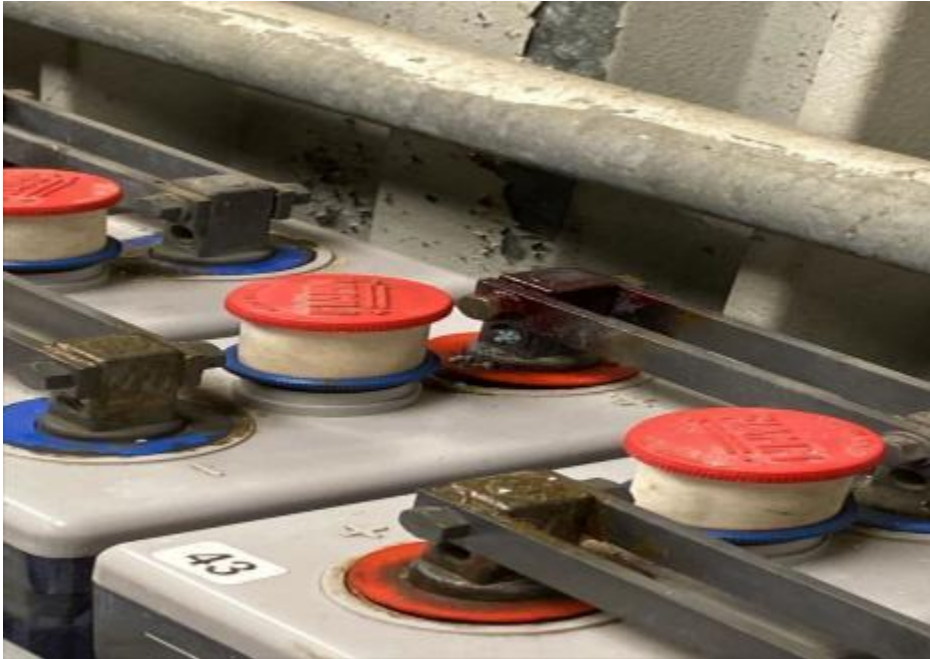
15.2 Transformer Bank 1 Oil Leak Mitigation. Existing LC Tag#124733582.

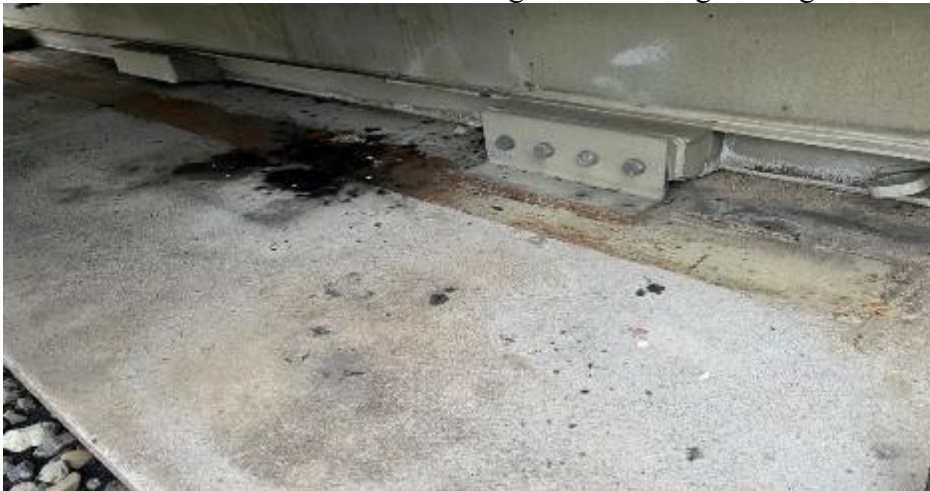
15.3 Transformer Bank 2 Oil Leak Mitigation. Existing LC Tag#130732362.

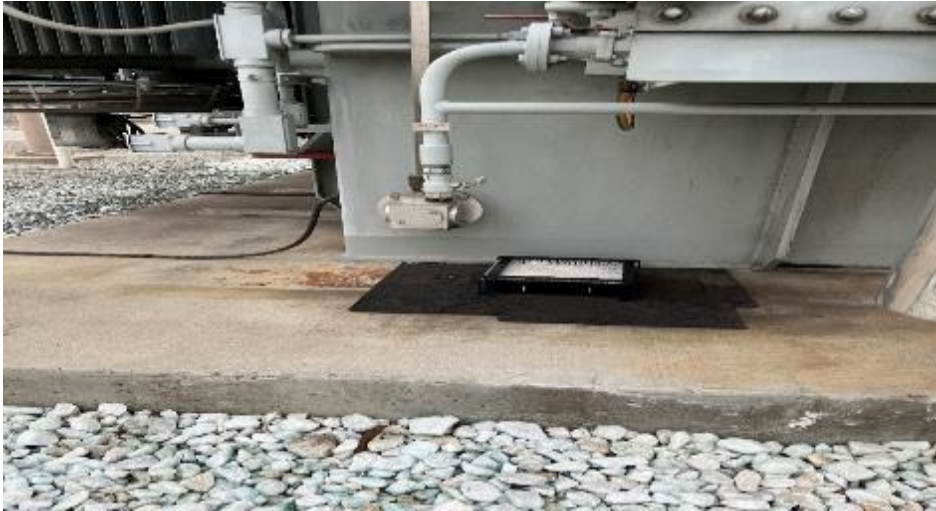
16. Monta Vista Substation

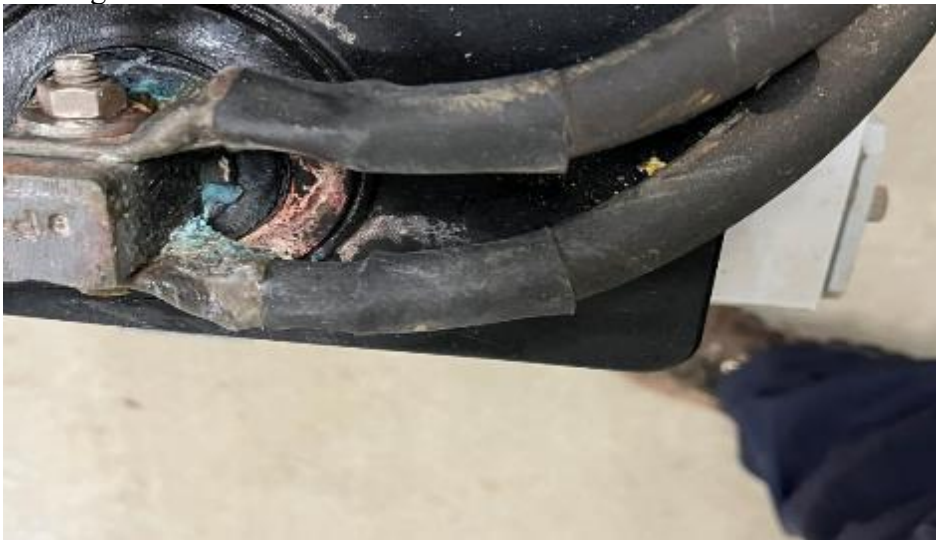
16.2 230 kV Bus Support Structure Near Circuit Breaker 252 had Bird of Prey Nest. New LC Tag#130810650.

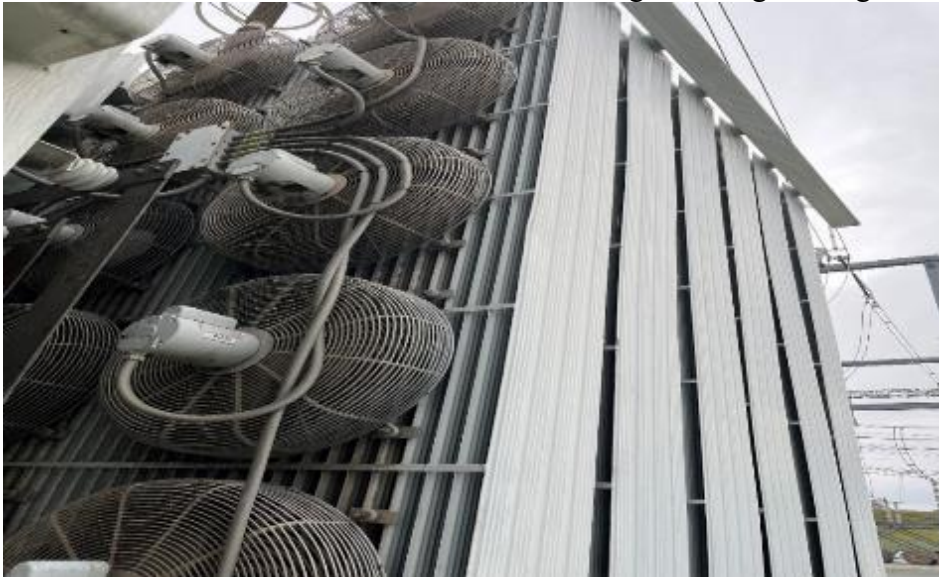
16.4 Transformer Bank 2 Oil Leak Mitigation. Existing LC Tag#130777293.

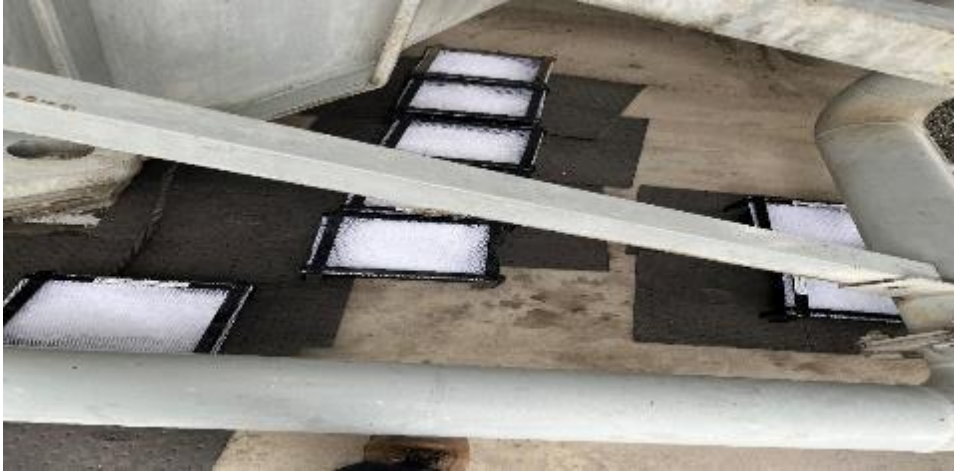
16.5 Transformer Bank 4 Oil Leak Mitigation. Existing LC Tag#130777294.

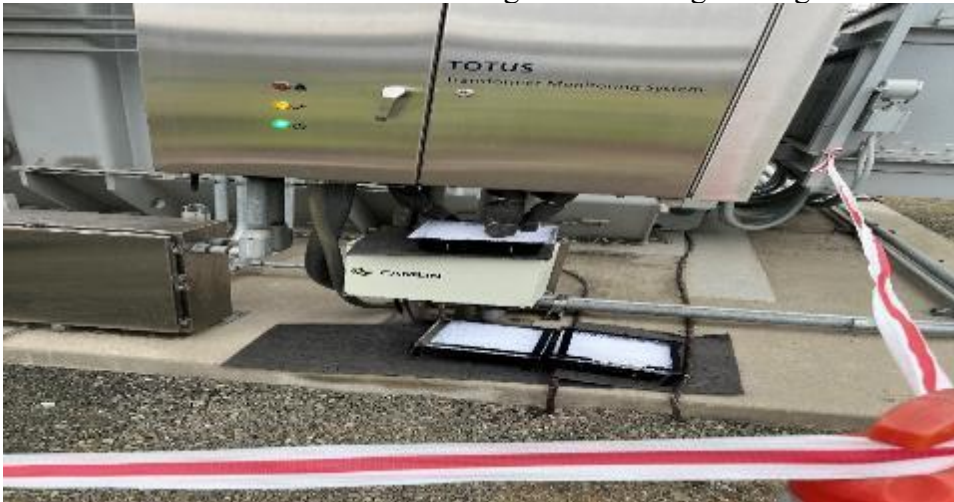
16.6 Transformer Bank 3 Fan Not Working. Existing LC Tag#130535715.

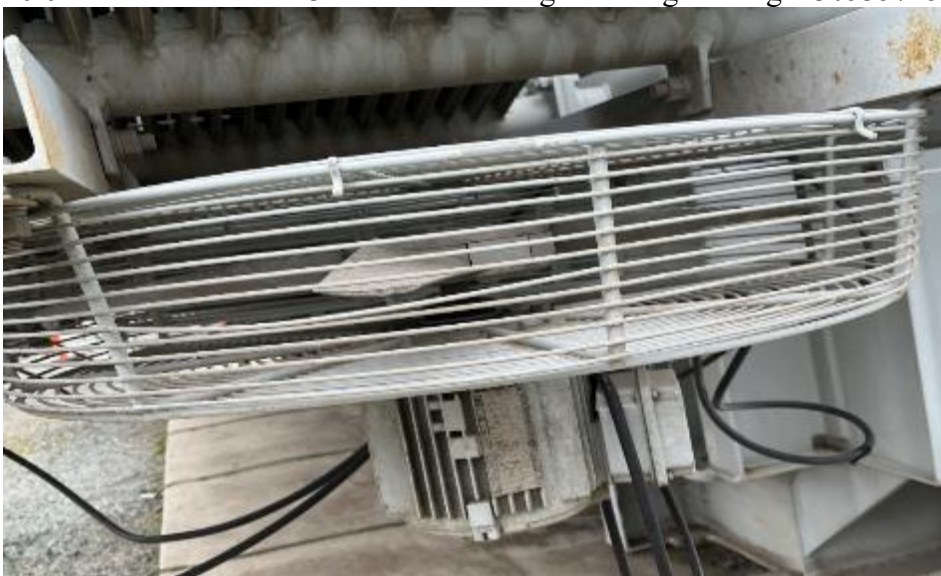
16.7 Transformer Bank 3 Oil Leak Mitigation. Existing LC Tag#130777299.

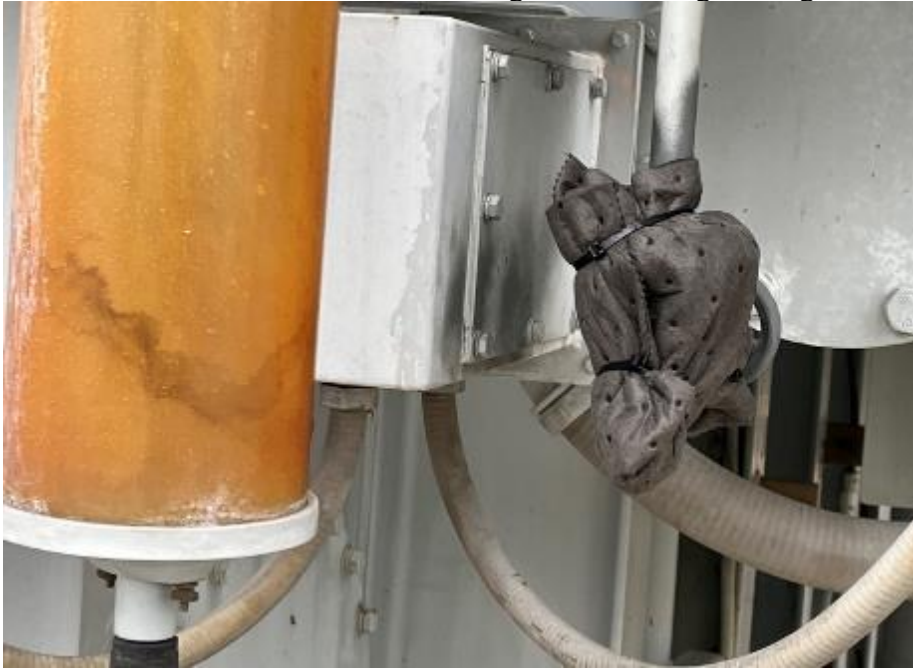
16.8 Low Section of Substation 115 kV to 60 kV. Battery Room Fan Not Working. New LC Tag#130810113.
