PUBLIC UTILITIES COMMISSION

December 29, 2025

SUBJECT: Electric Substation Audit of Sacramento Municipal Utility District (SMUD)

CPUC SUBSTATION AUDIT FINDINGS
SACRAMENTO MUNICIPAL UTILITY DISTRICT (SMUD)
OCTOBER 27-31, 2025

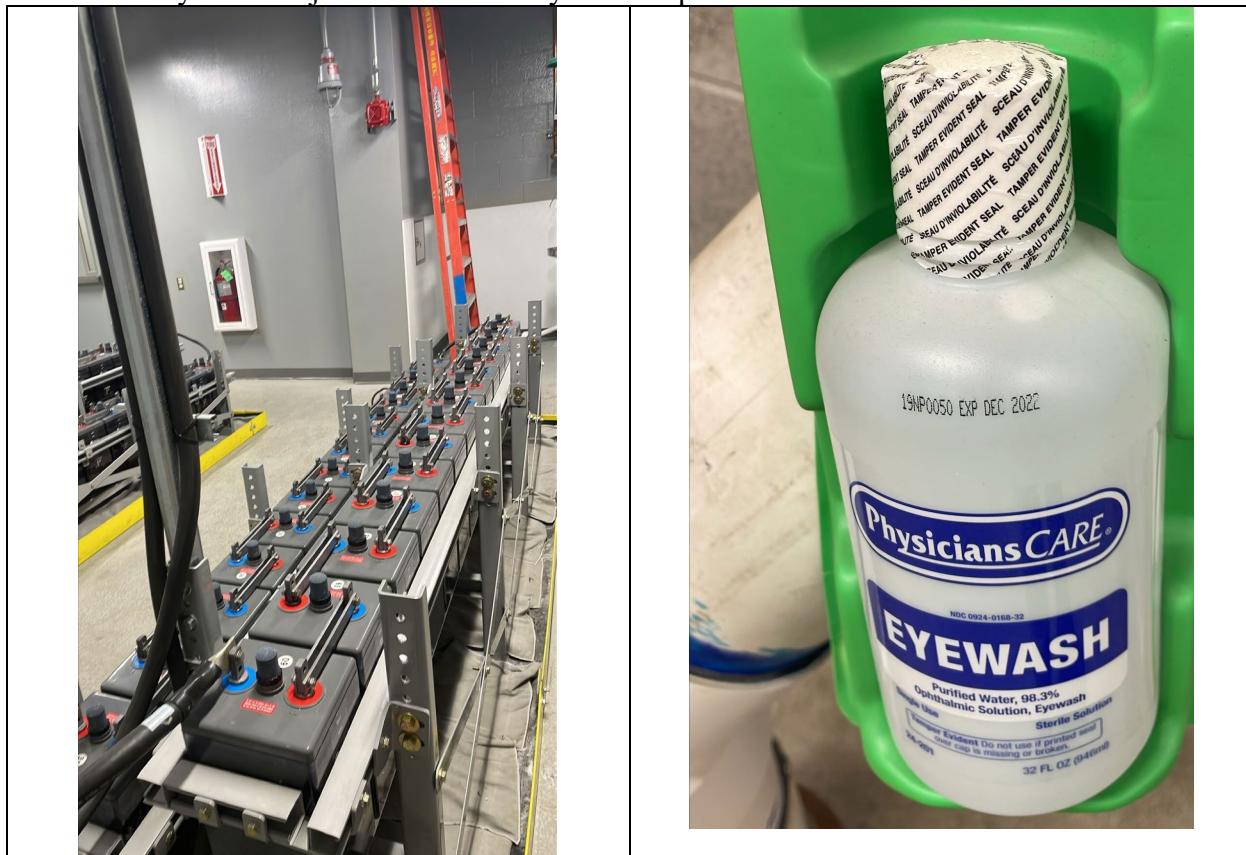
1. STG Substation

1.1. Eyewash adjacent to the battery room expired in December 2022.

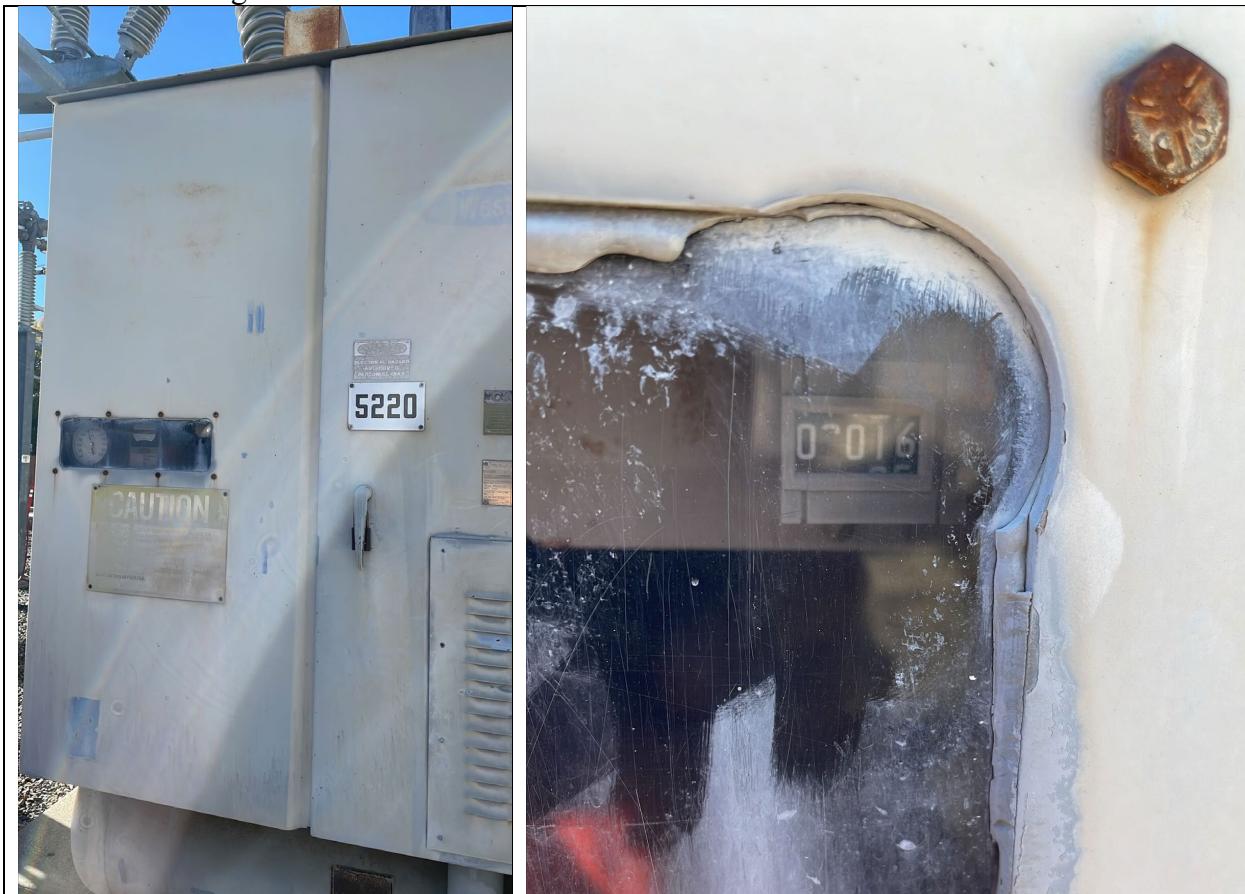
2. STB Substation

2.1. Damaged counter on CB 5220.²⁷

²⁷ Load and inspection reports for July and August 2025 show counter readings of 12 and 13, respectively.

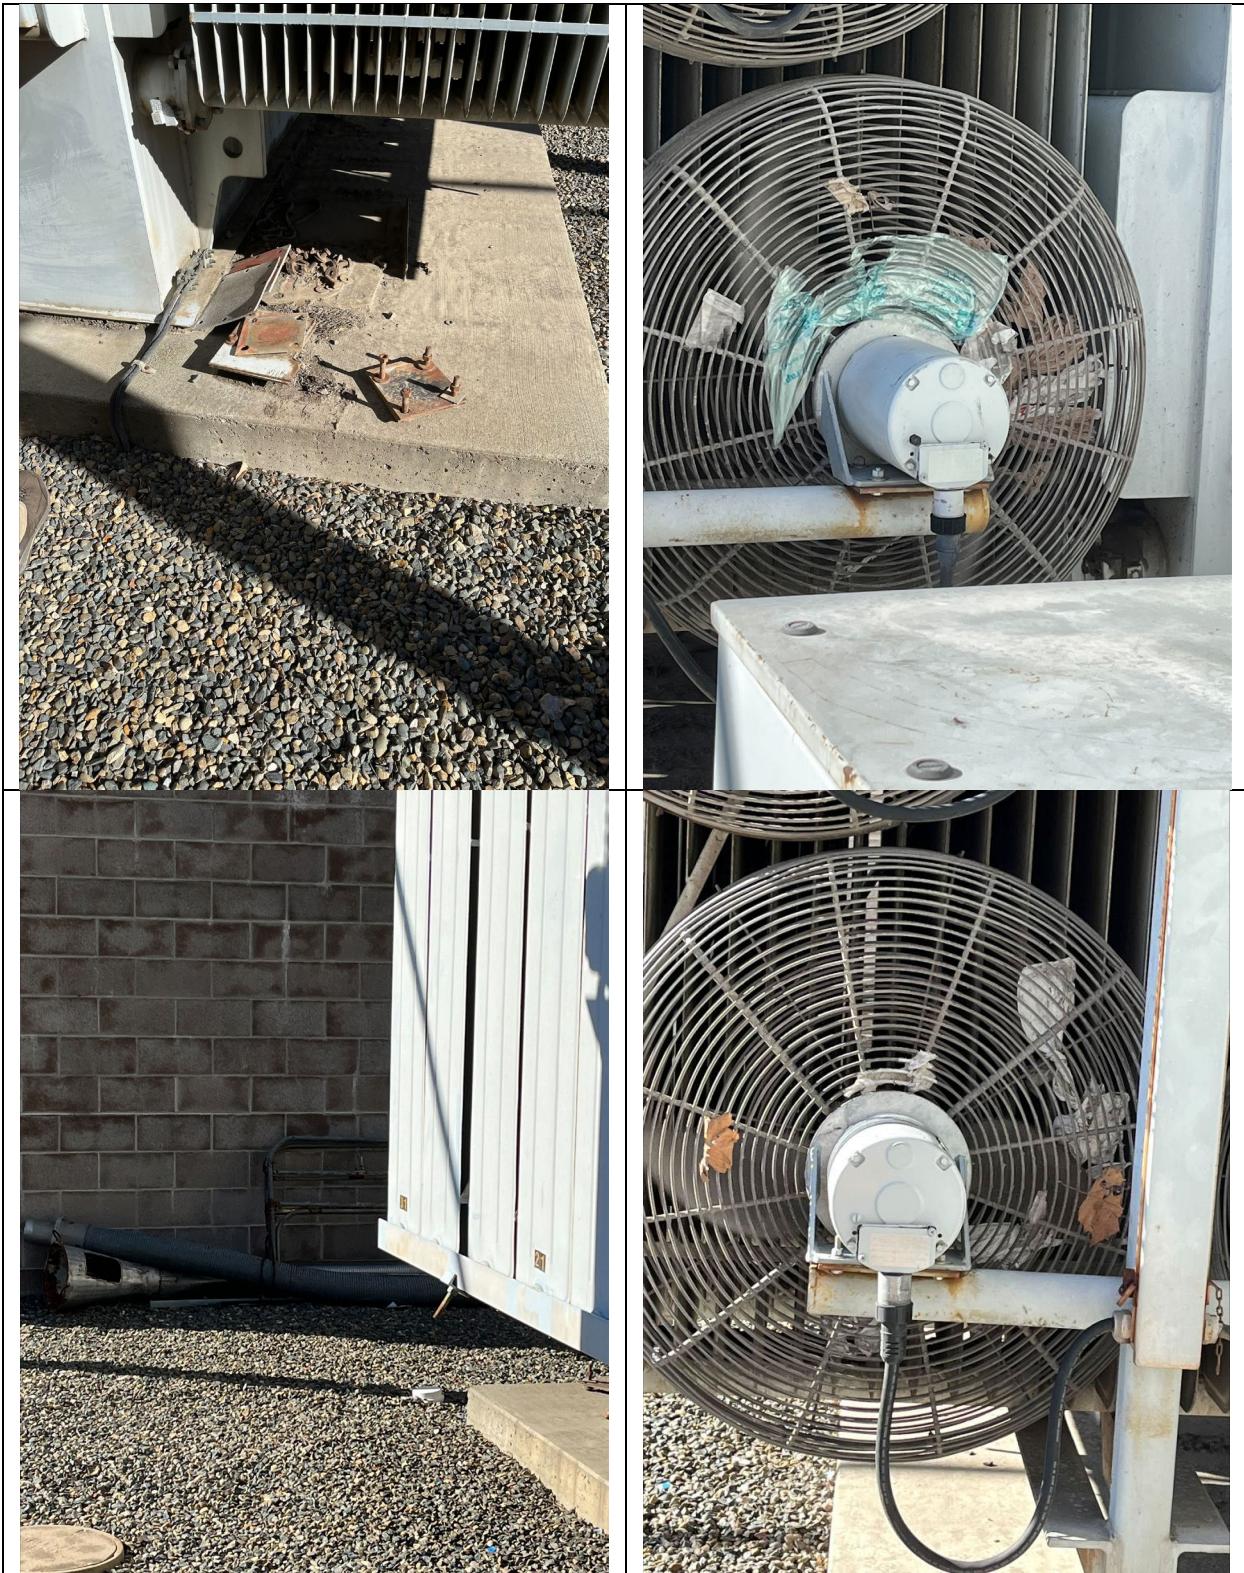
2.2. Debris around Bank 3 and in the cooling fans.

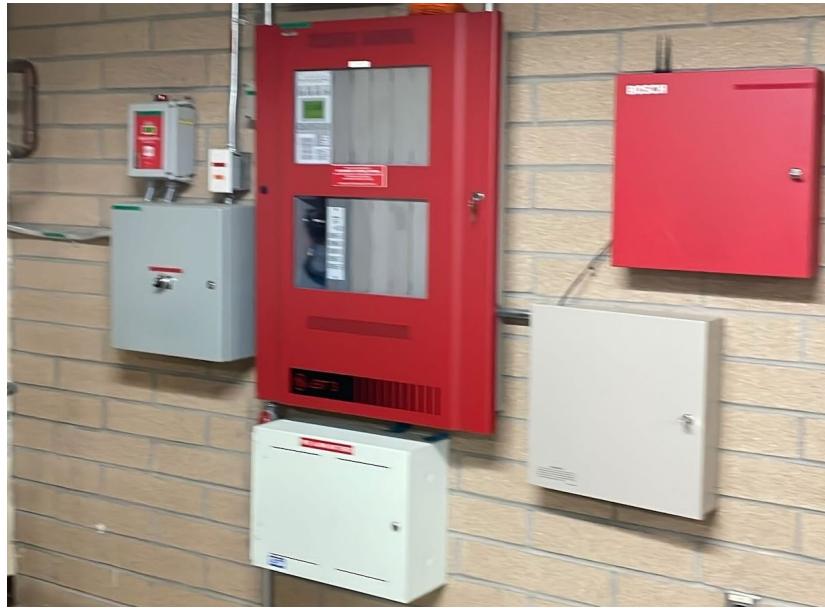
3. LAK Substation

3.1. The substation has a fire suppression system. Refer to Section II.2 above.

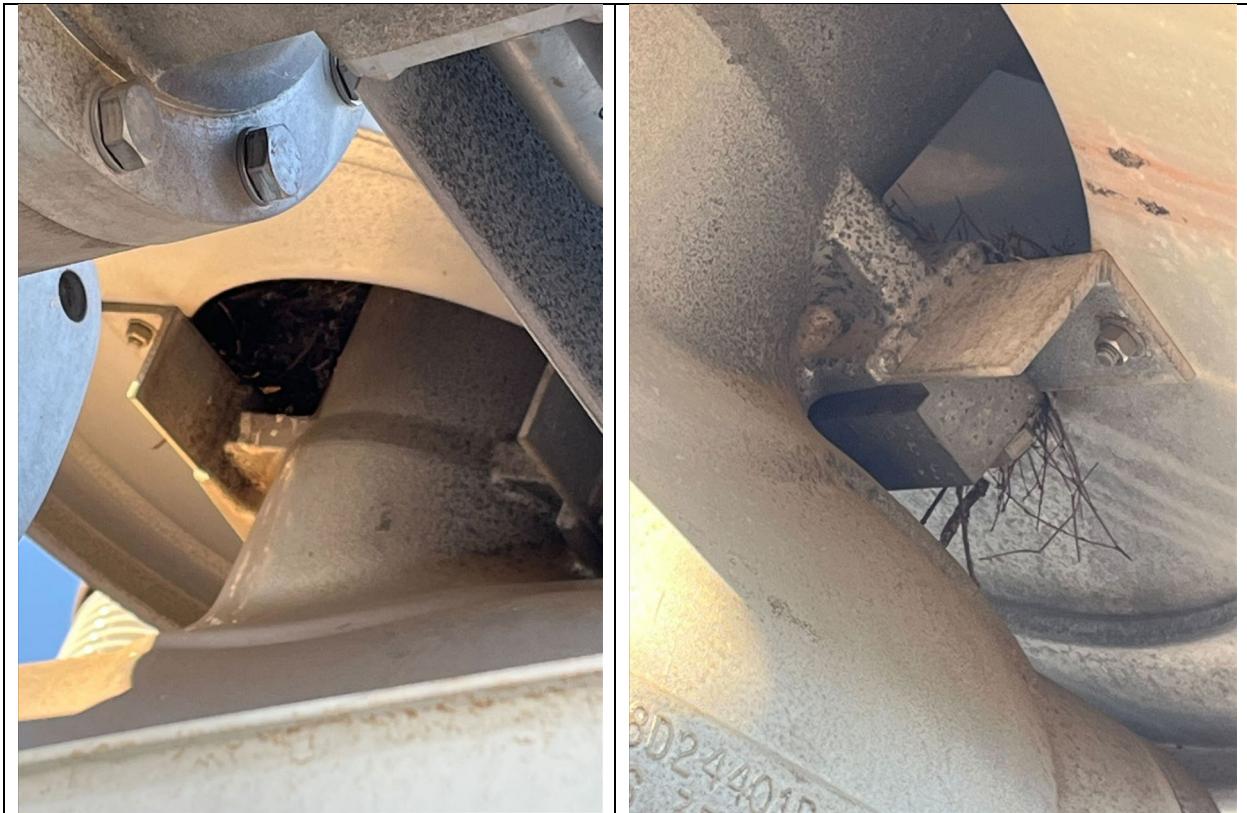
3.2. Bird nest in CB102 current transformer.

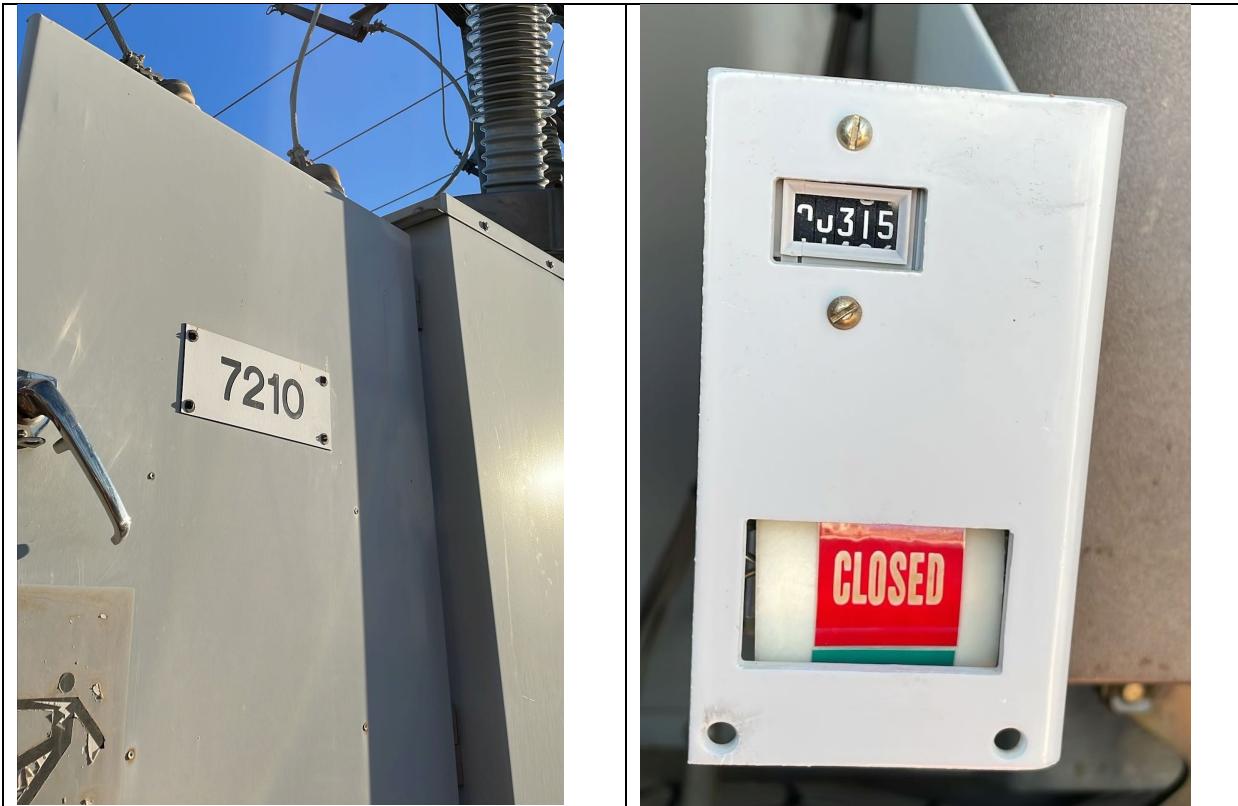
3.3. Damaged counter for CB 7210.²⁸

²⁸ Load and inspection reports for July and August 2025 each show counter readings of 314.

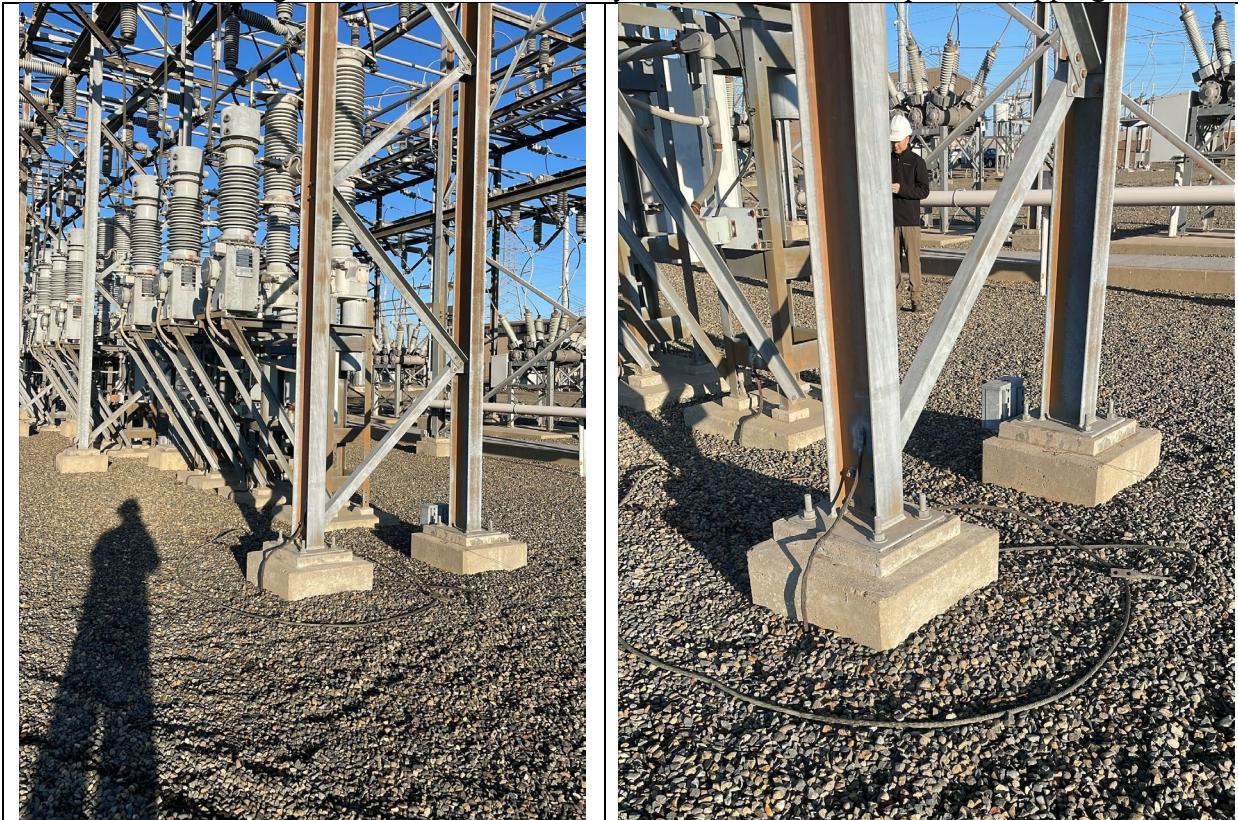
3.4. Exposed ground cable in the 69 kV yard near switch 7222 poses a tripping hazard.

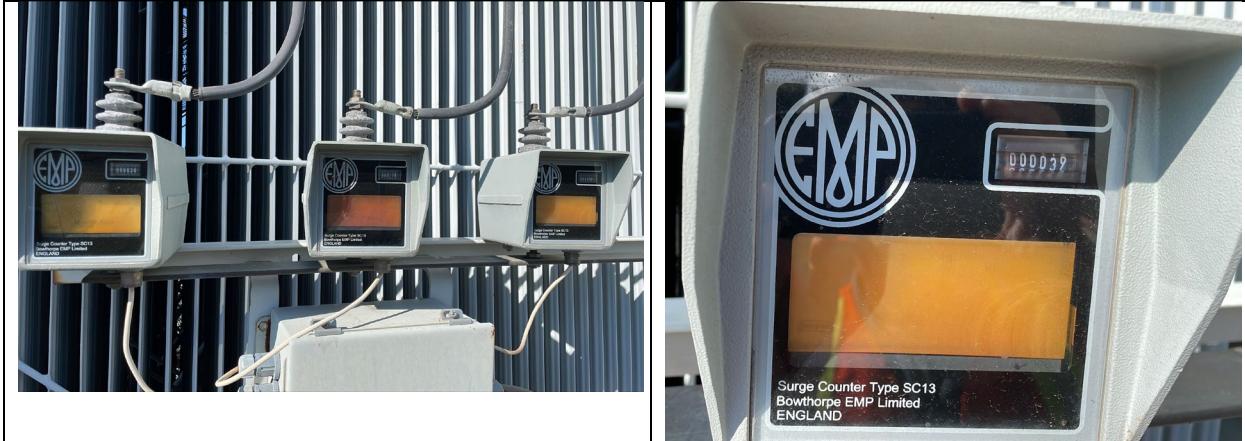
4. White Rock-Sunrise Substation

4.1.Two of the three surge arrester counters on Bank 1 have opaque and illegible screens.

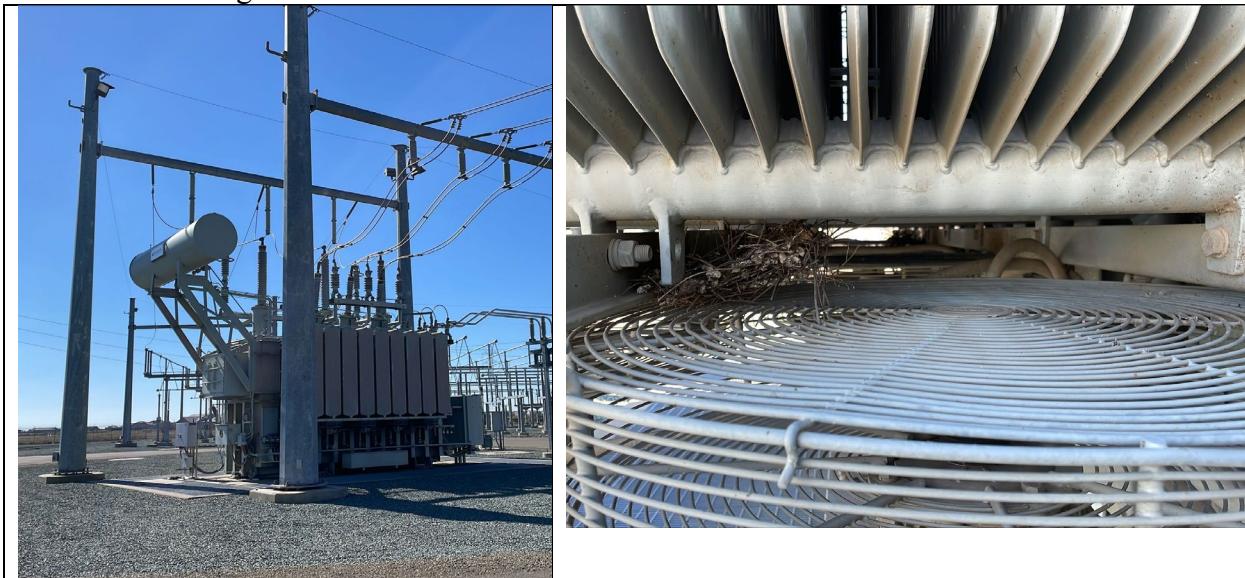
5. COR Substation

5.1.Bird nests have fallen out of the transformer bank radiators and are resting on the cooling fans.

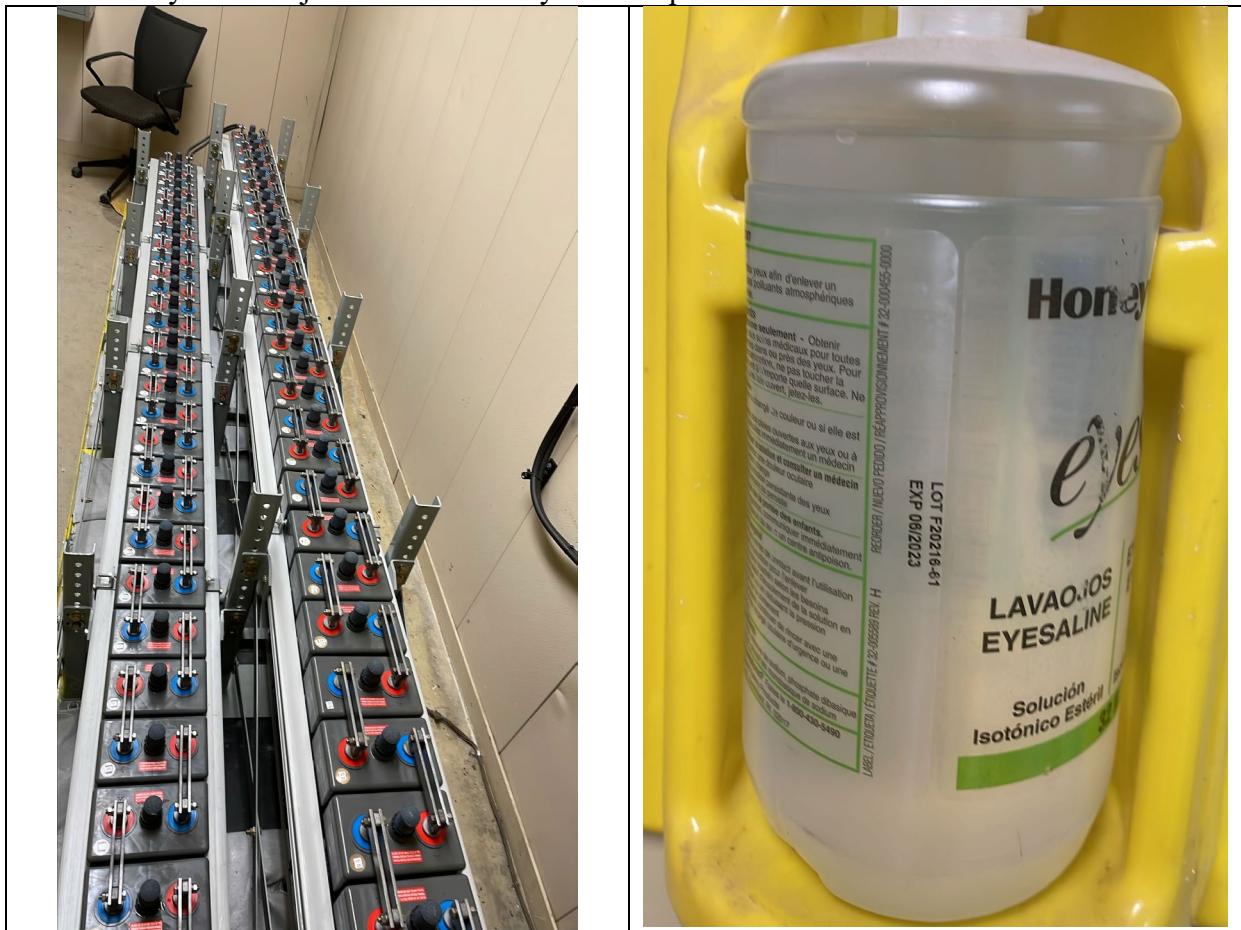
6. RSS Substation

6.1.Eyewash adjacent to the battery room expired in June 2023.

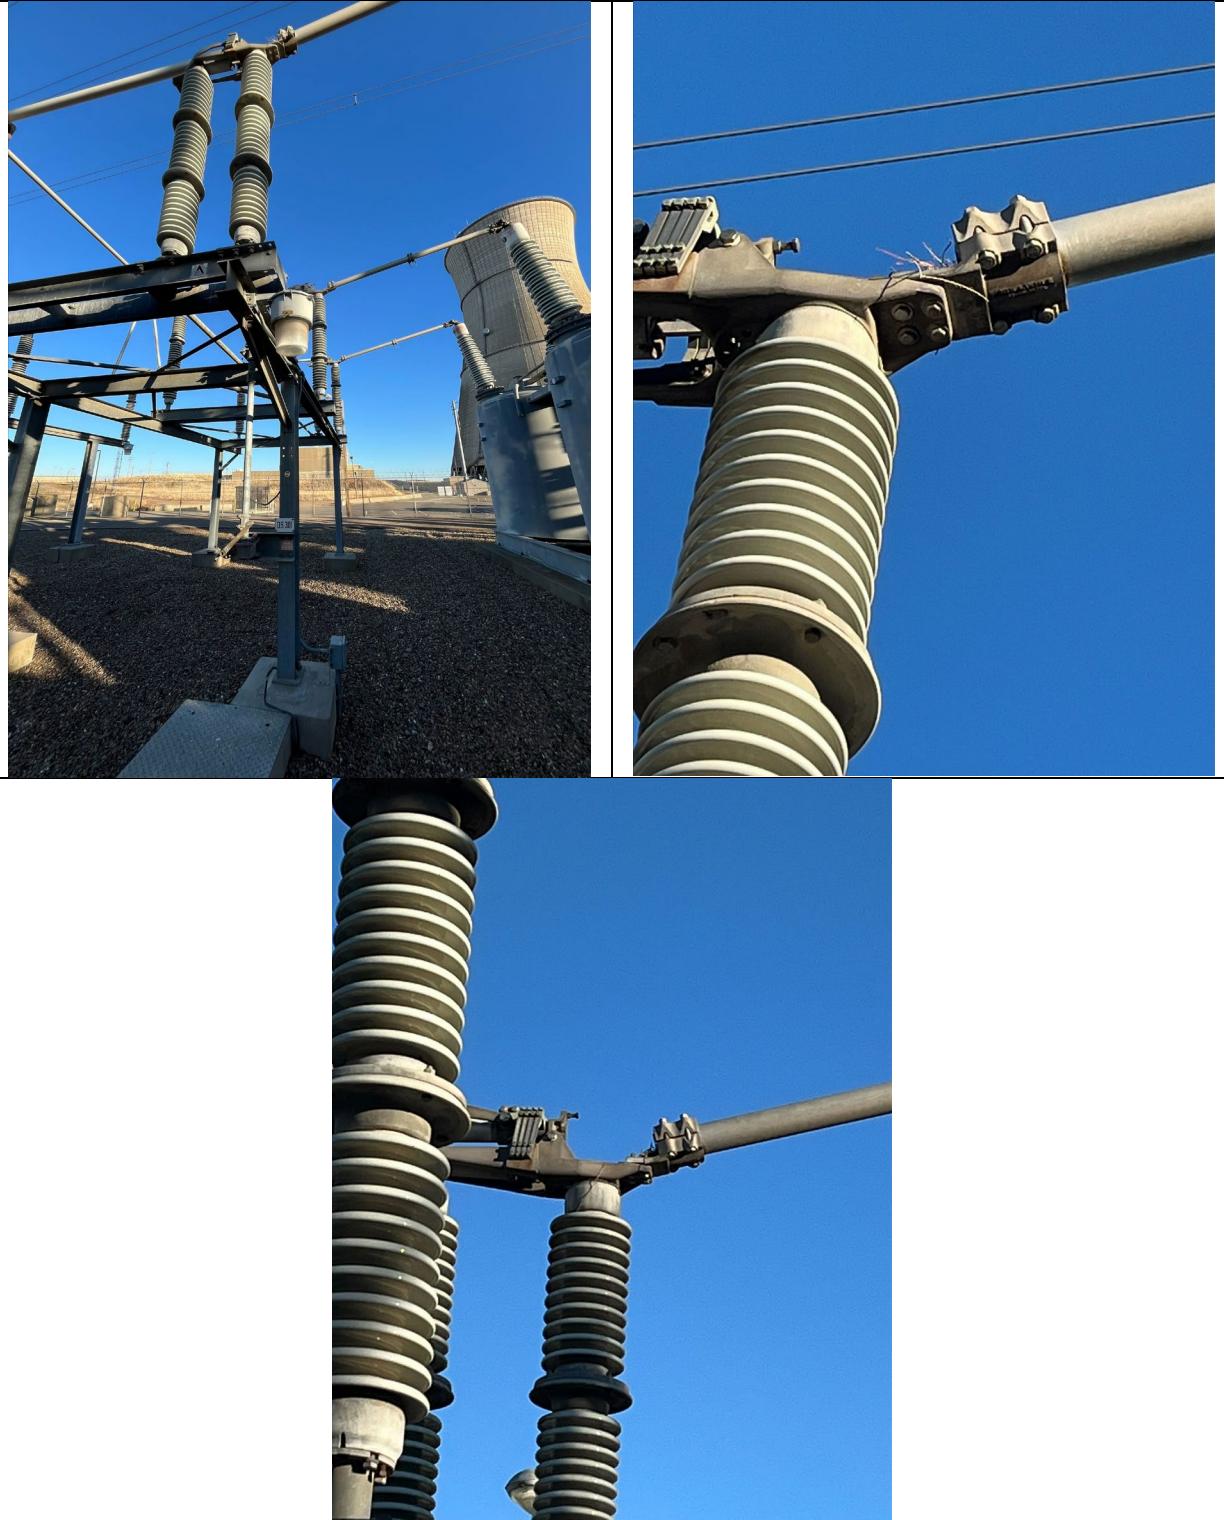
6.2.Bird nests on all phases of SW 301.

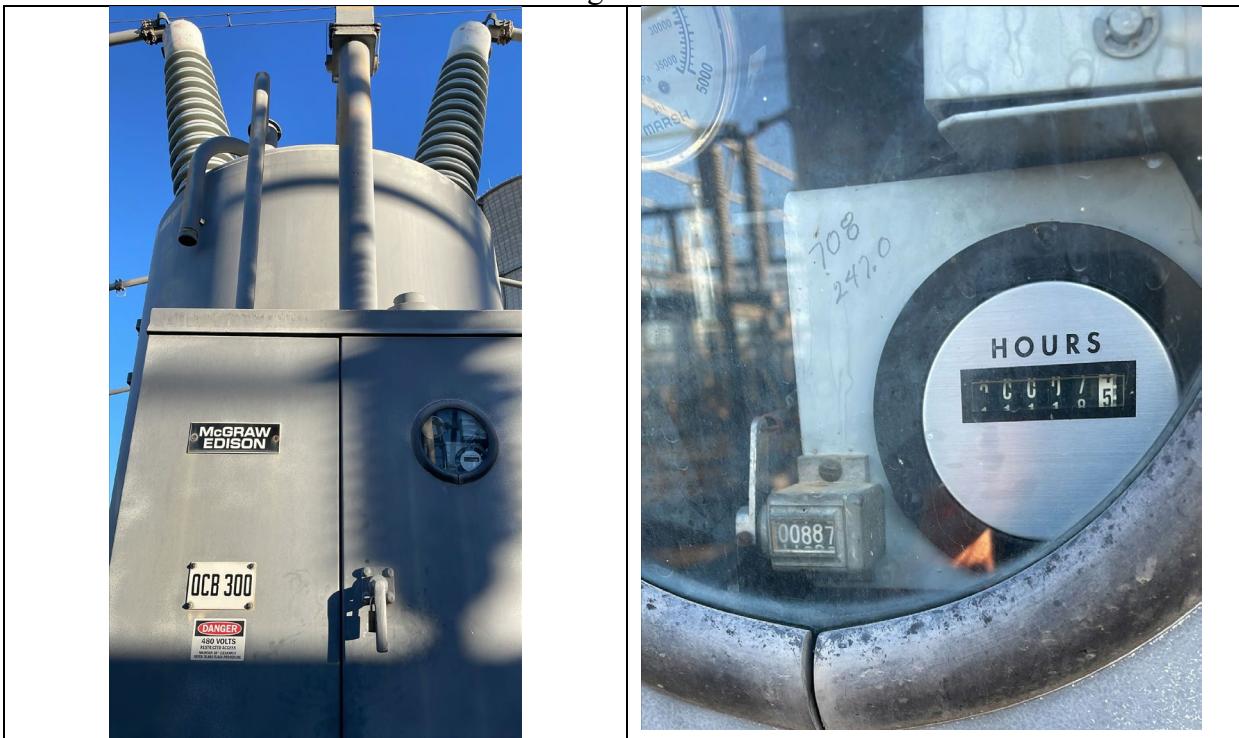
6.3. Hours counter for CB 300 is damaged.²⁹

²⁹ Counters in the image appear to read 7.5 hours and 887 cycles. Load and inspection reports for July and August 2025 each show counter readings of 6.2 hours and 887 cycles.

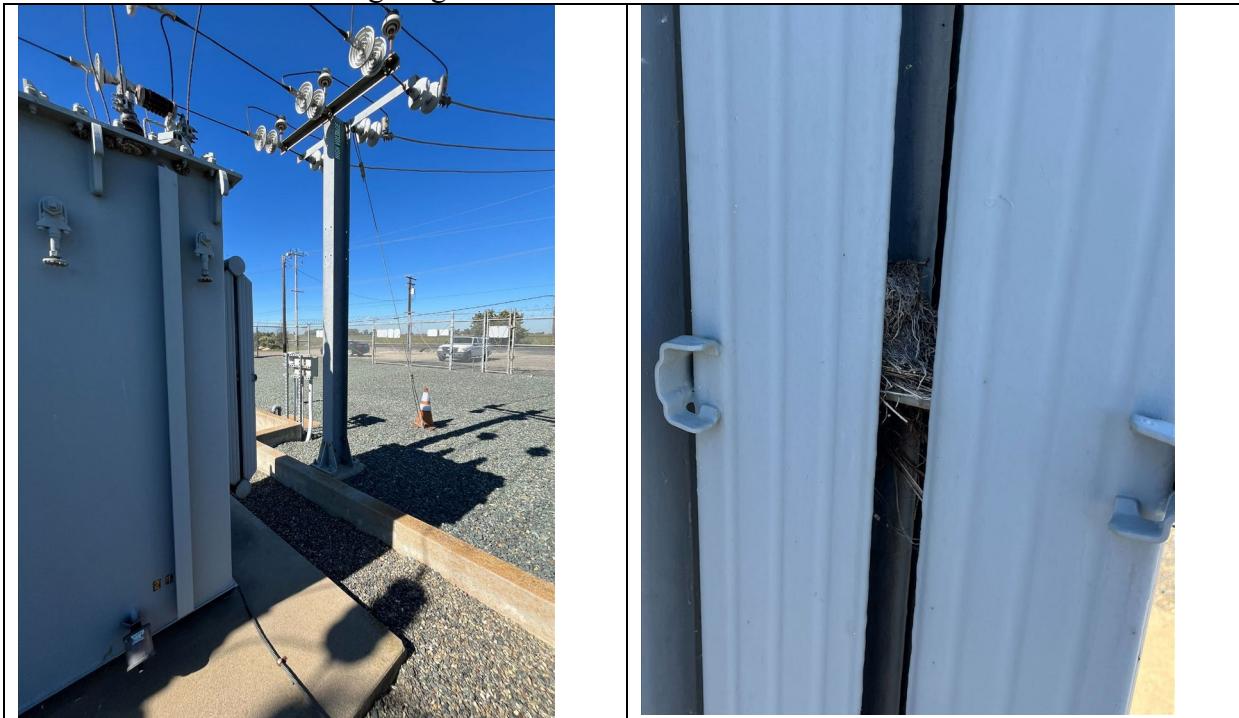
7. Eschinger – Bruceville Substation

7.1. Bird nest in voltage regulator radiator.

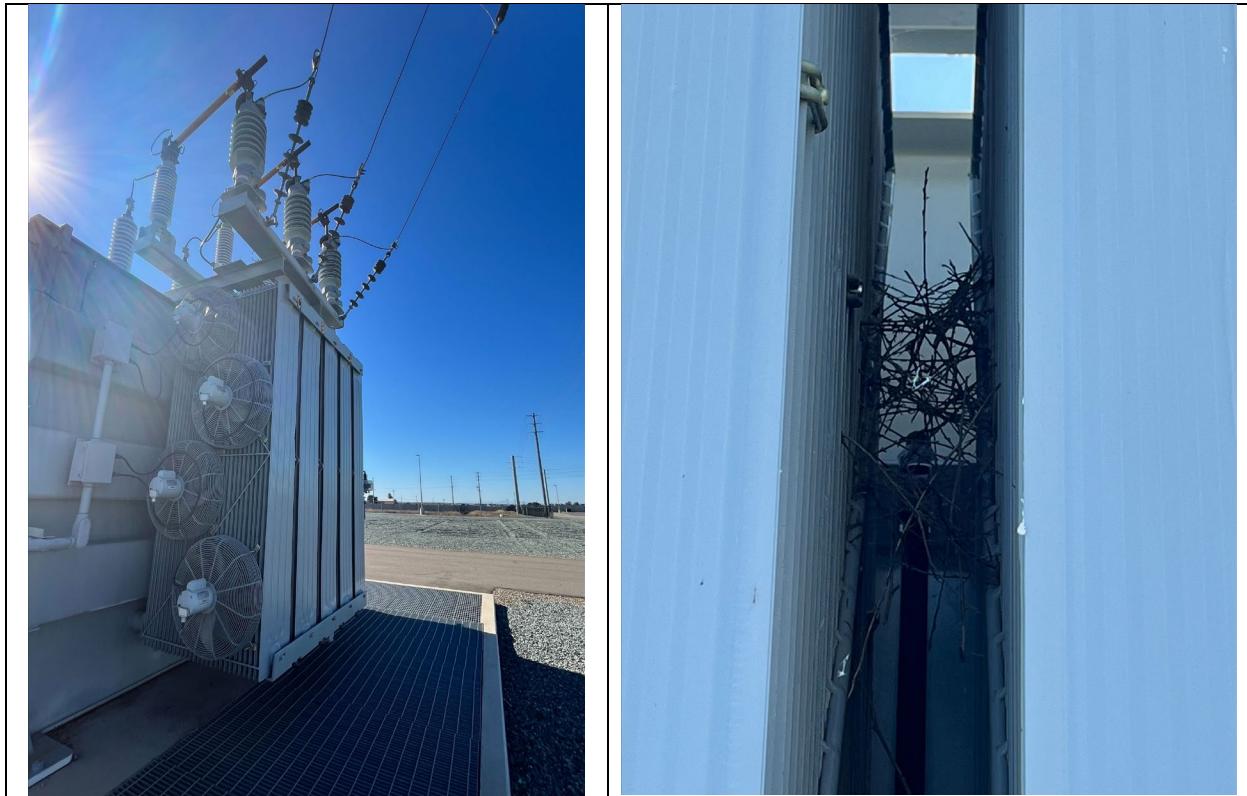
8. Franklin-Hood Substation

8.1. Bird nests in transformer radiator.

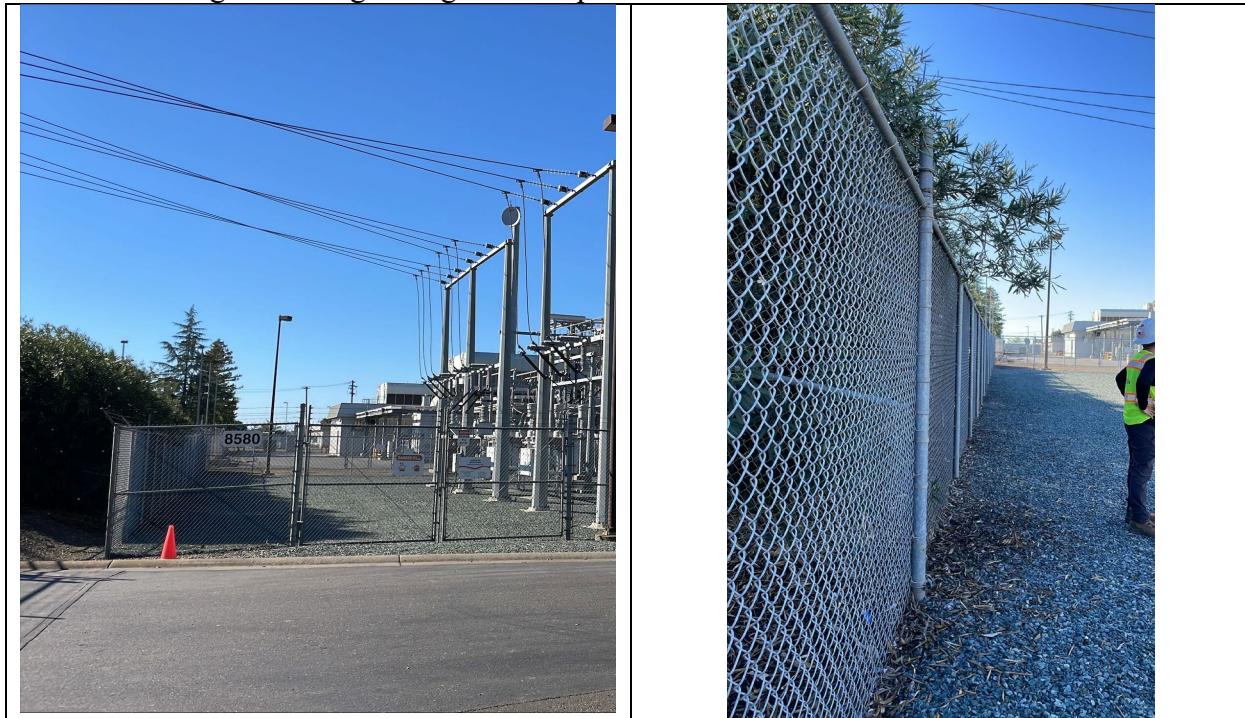
10. CNX Substation

10.1. Vegetation is growing over the perimeter fence.

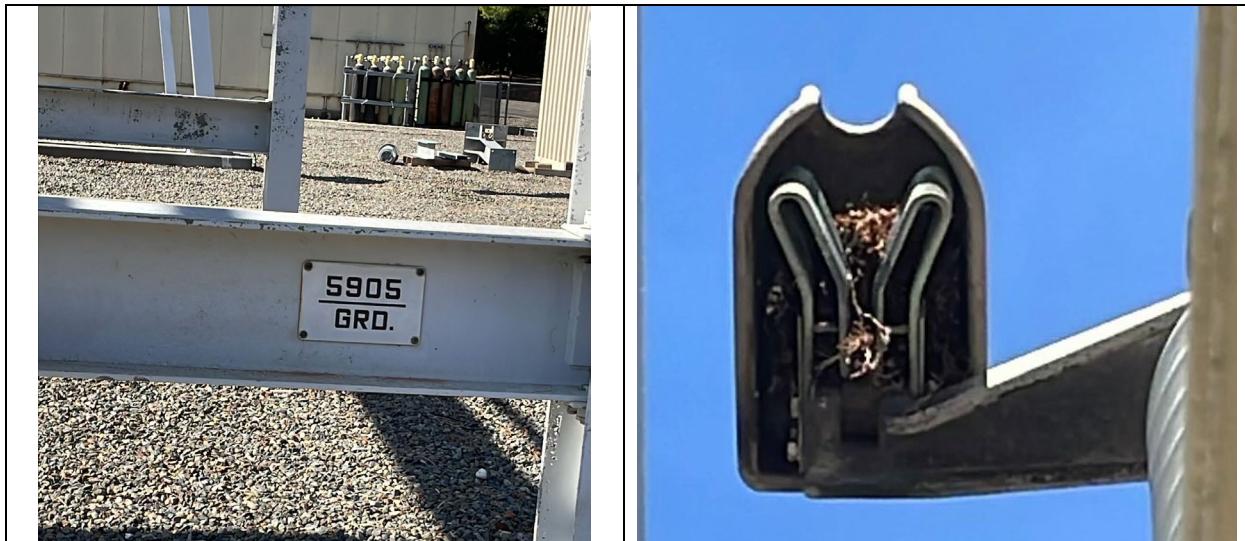
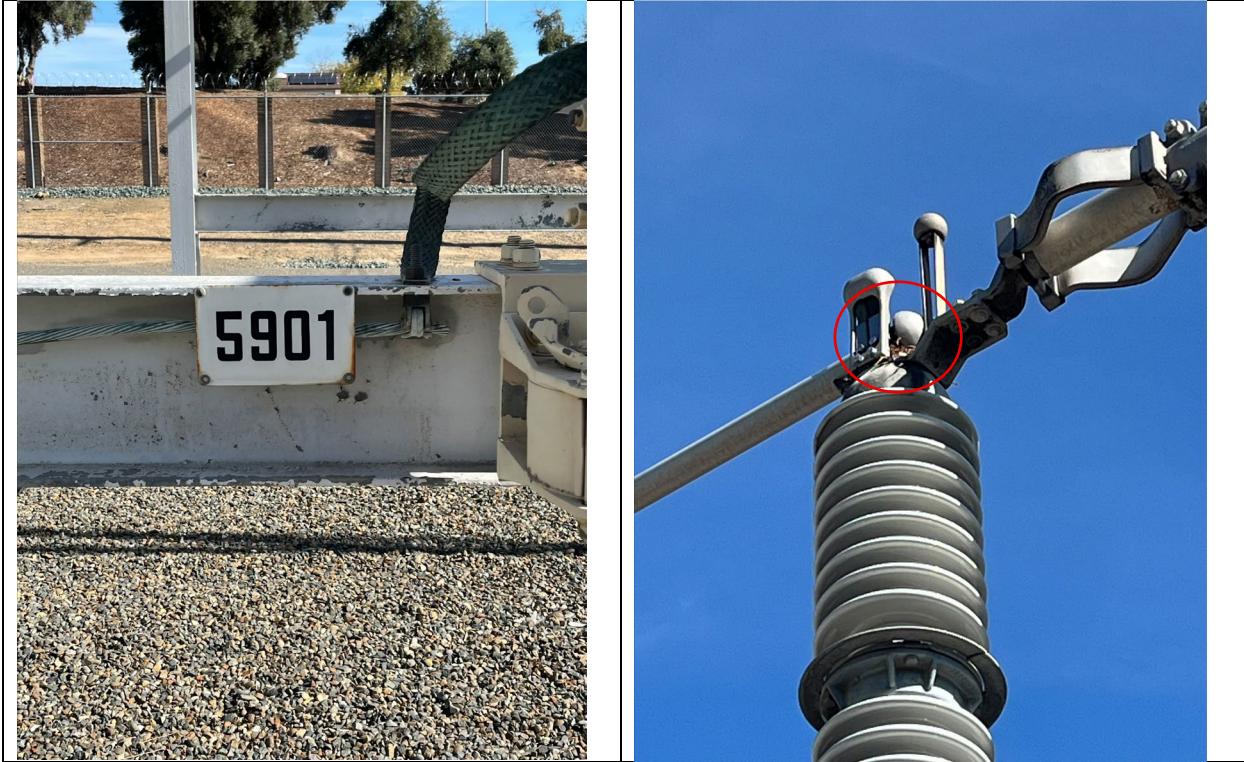
11. CAR Substation

11.1. Bird nests in switch 5905 and 5901 Phase C.

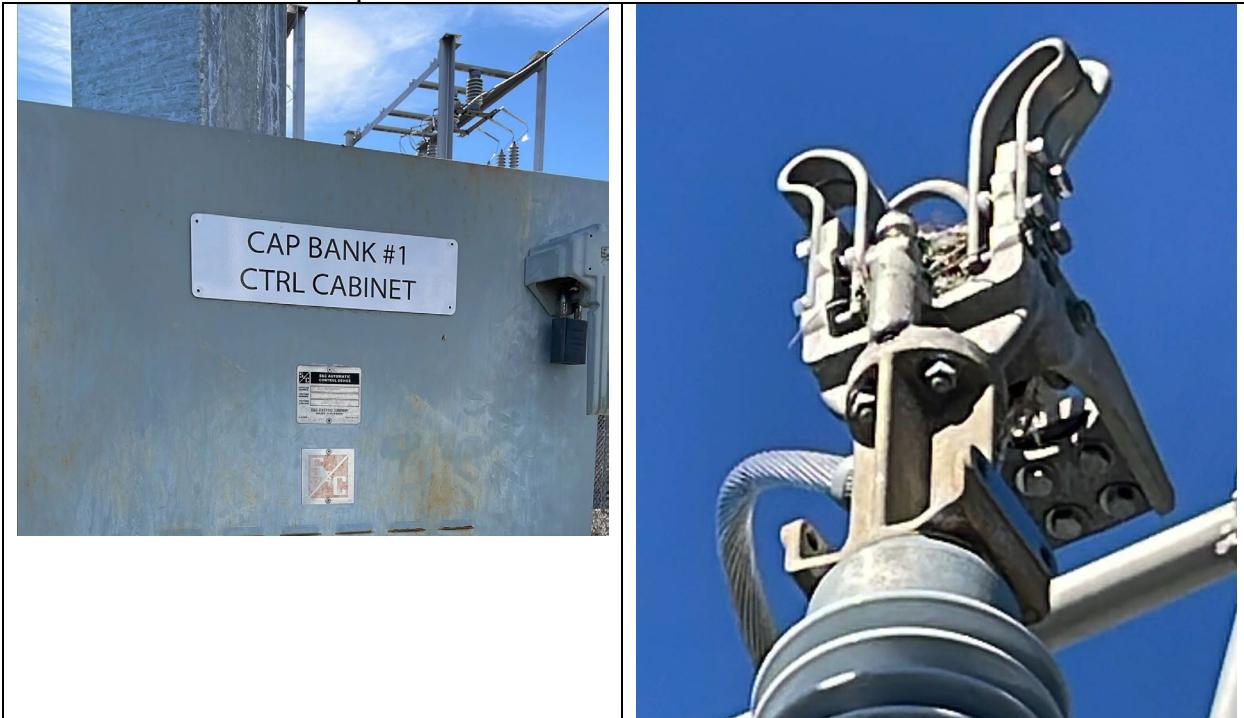
11.2. Bird nest in capacitor bank 1 switch.

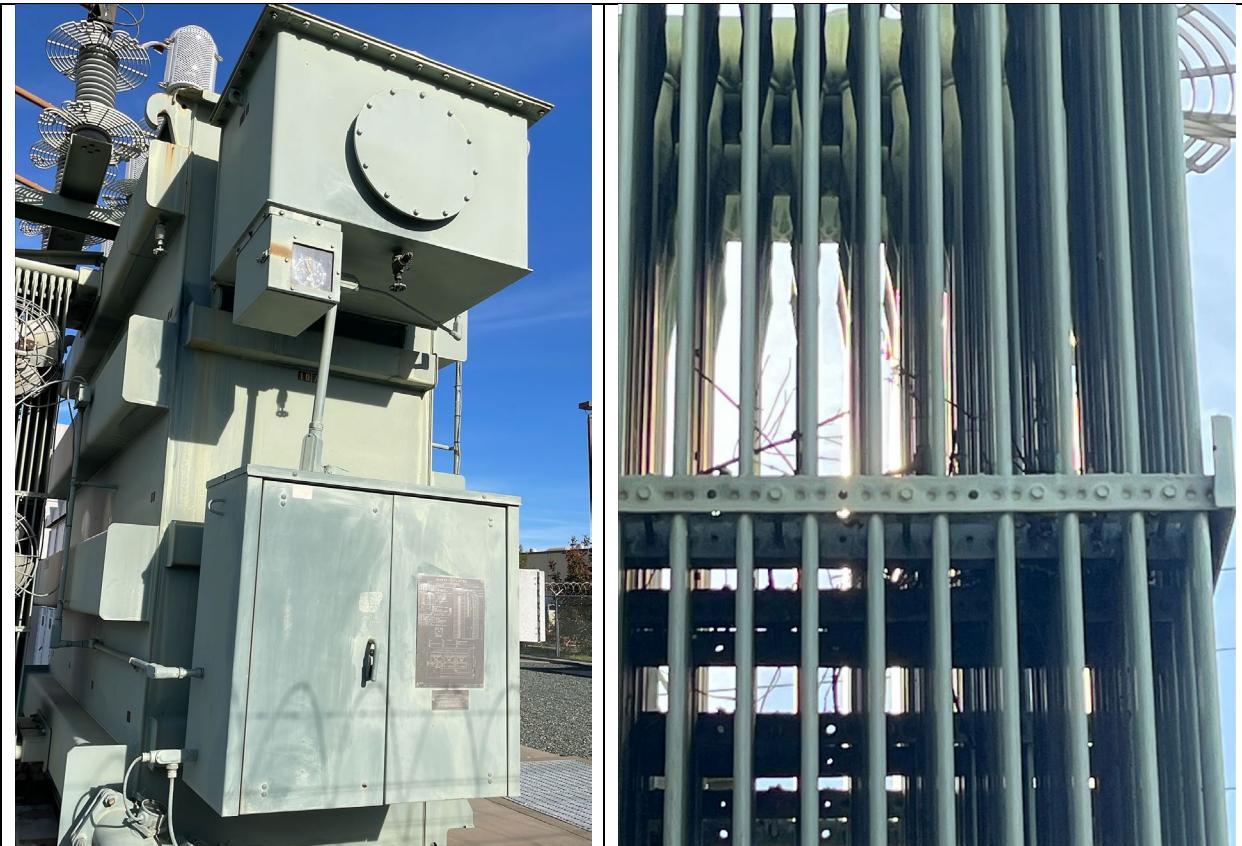
12. 88th - Fruitridge Substation

12.1. Bird nest in Bank 1 radiator.

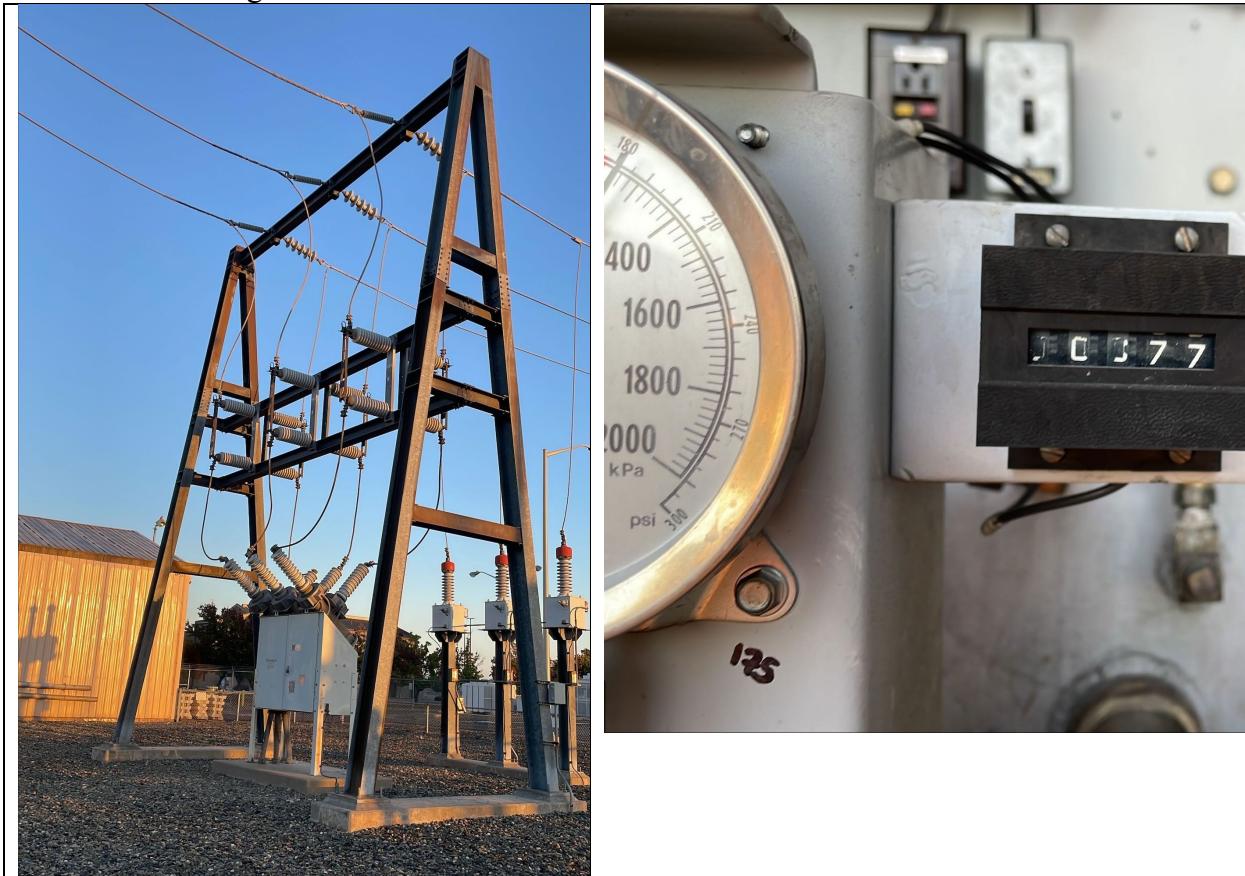
13. MC1 Substation

13.1. Damaged counter on CB 914.³⁰

³⁰ Substation Load and Inspection Reports for July and August 2025 each show 77 cycles.

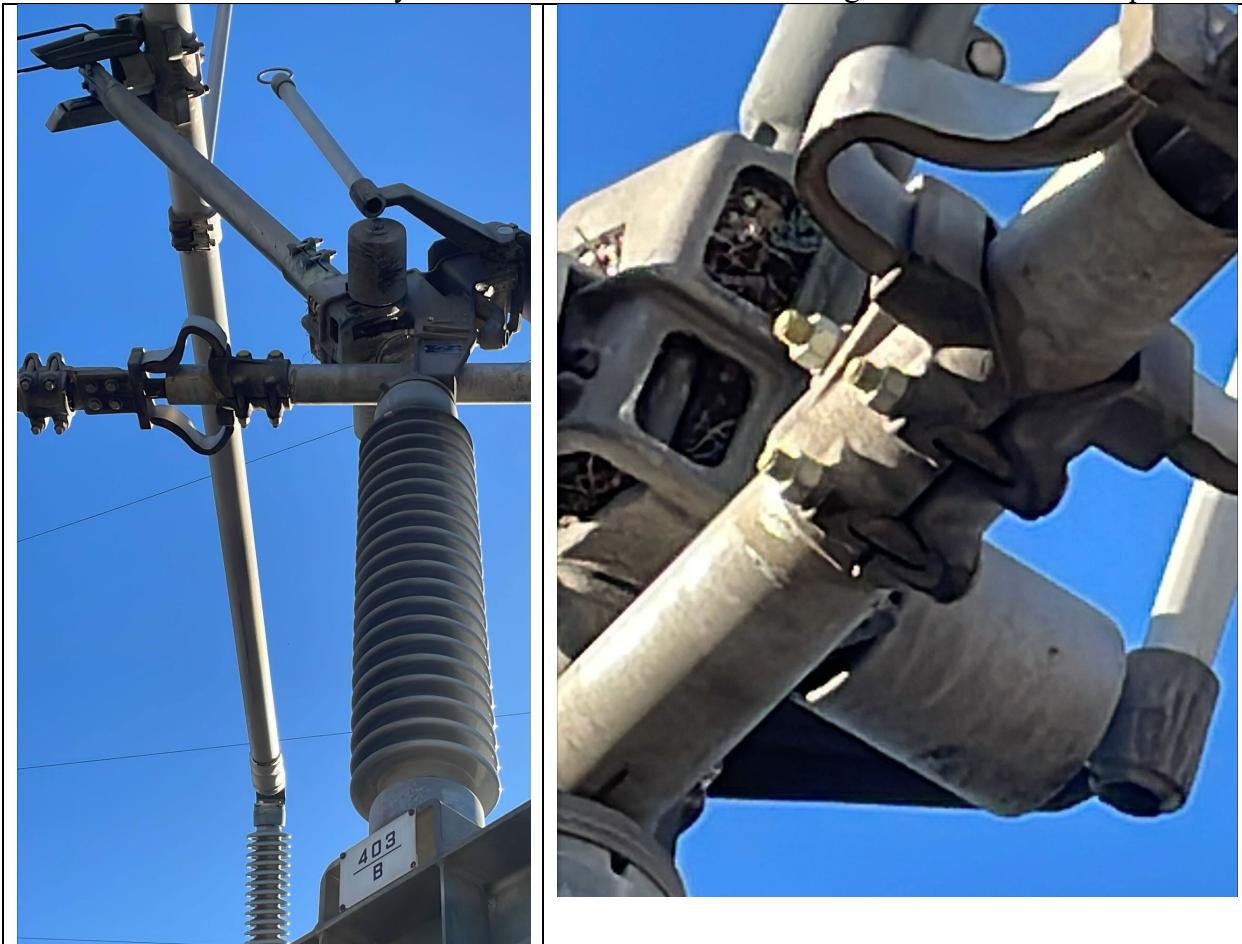
14. HUR Substation

14.1. Bird nests on many switches on the 115 kV bus. Image below is for 403 B phase.

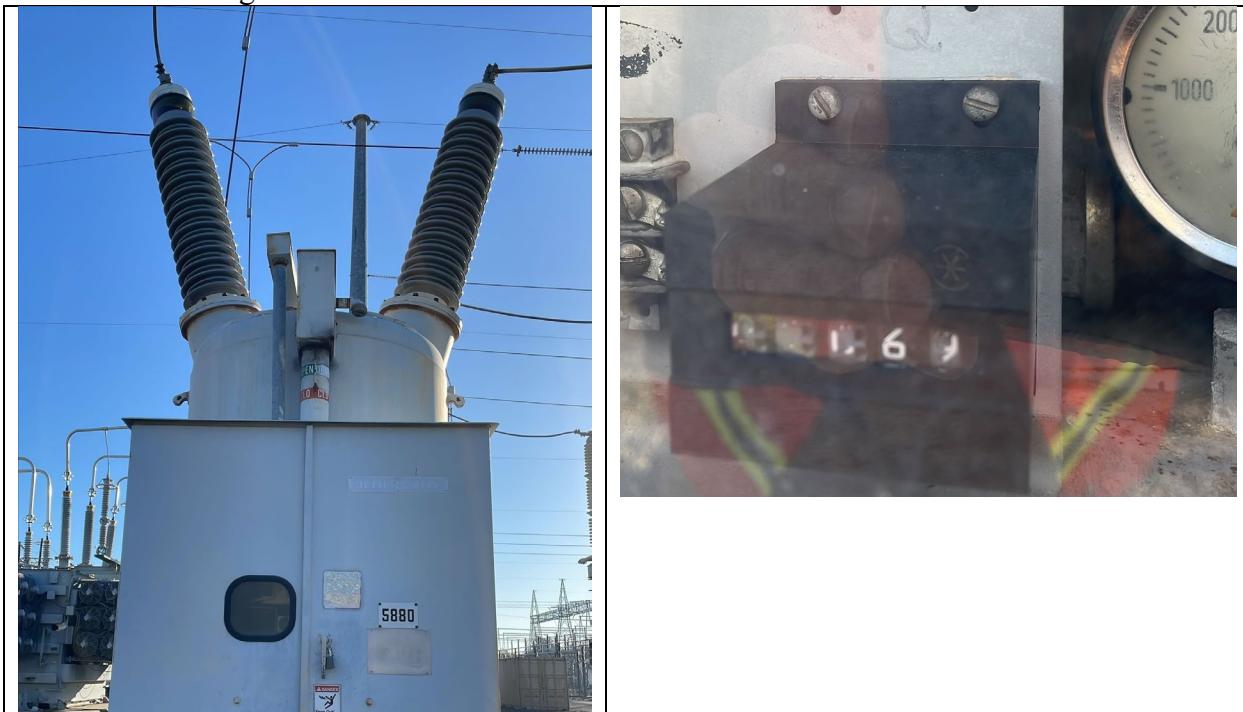
14.2.Damaged counter on CB 5880.³¹

³¹ Substation Load and Inspection Reports for July 2025 does not provide data for CB 5880. A report for August 2025 was not provided to ESRB.
