## PUBLIC UTILITIES COMMISSION

CA2026-1404

**SUBJECT:** Communication Infrastructure Provider (CIP) Audit of Charter's San Miguel-Guadalupe Service Area (San Luis Obispo and Santa Barbara Counties)

**CPUC AUDIT FINDINGS**  
**CHARTER SAN MIGUEL-GUADALUPE AUDIT**  
**MAY 18-22, 2026**

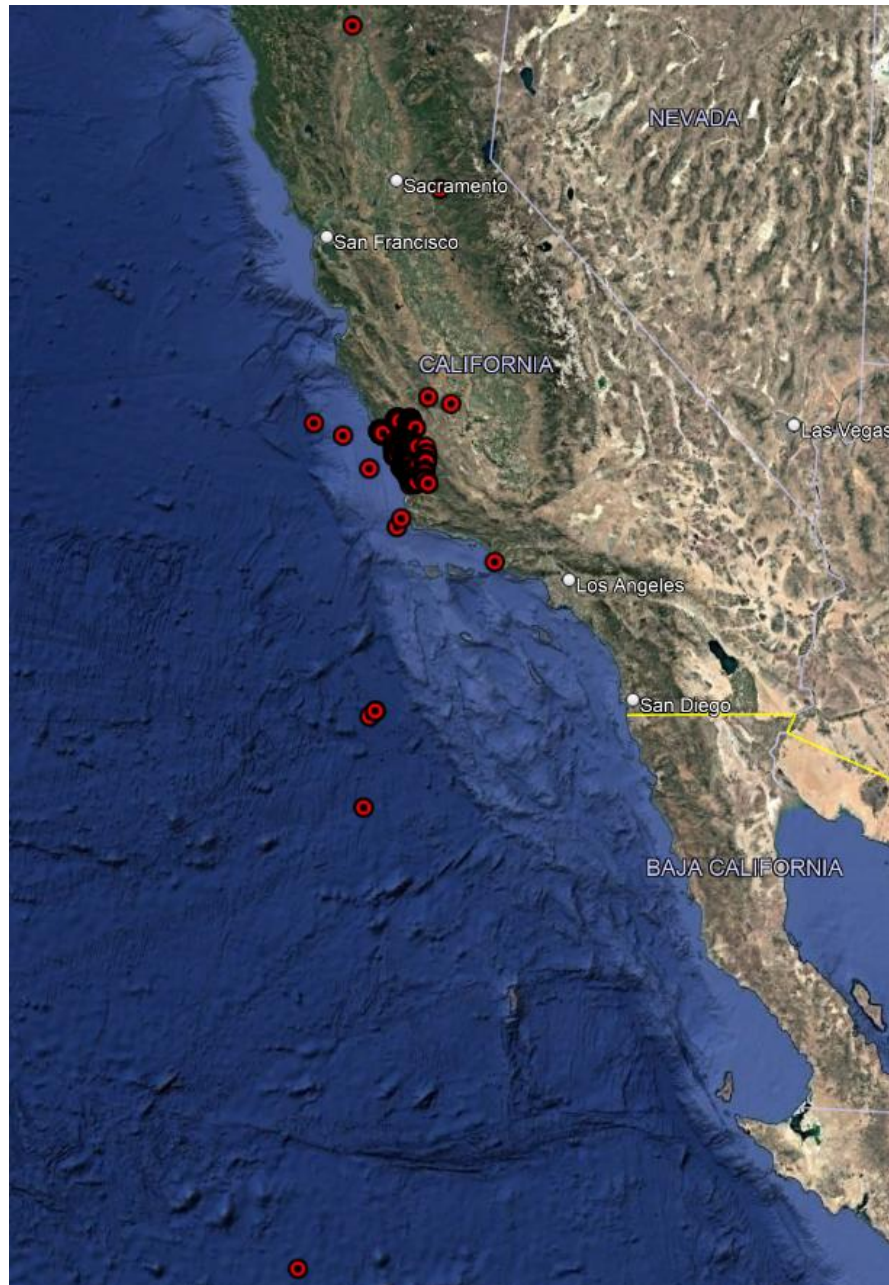
During the records review, ESRB found that various work order and inspection records had incorrect GPS coordinates. ESRB noted a total of 99 inaccurate GPS location records (21 work order records and 78 patrol and detailed-inspection records).<sup>5</sup> See Figures 1 and 2 below for examples of the inaccurate GPS locations plotted in Google Earth, with many located outside of the San Miguel-Guadalupe service areas and others in the ocean. ESRB asserts that it is essential for Charter to correctly record accurate GPS data since inaccurate location data makes it difficult for inspectors, service techs, and contractors to locate facilities; in addition, corrective action due dates for work orders are dictated by HFTD Tier levels and incorrect location data can lead to inaccurate HFTD Tier categorization.

**Figure 1:** Work Order Records with Incorrect GPS Coordinates

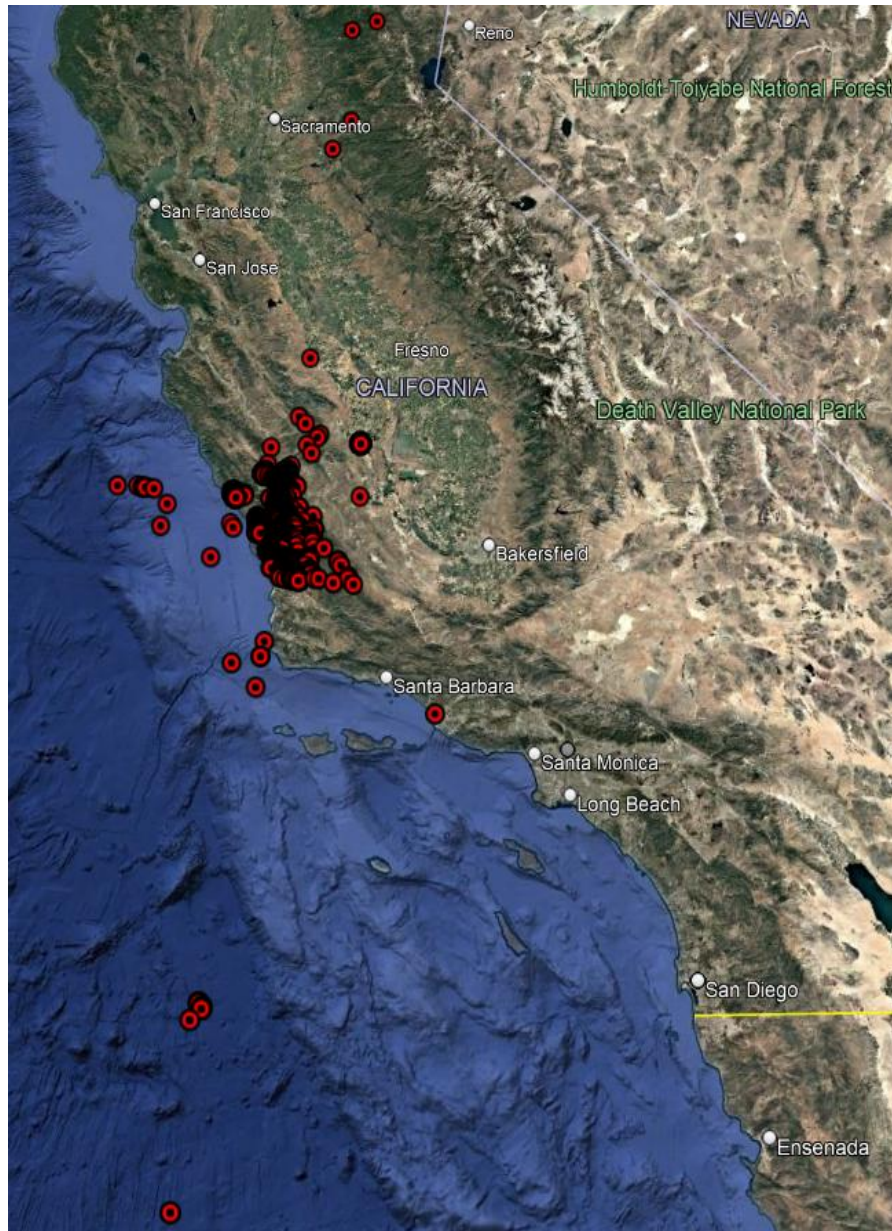
**Figure 2:** Inspection Records with Incorrect GPS Coordinates
