PUBLIC UTILITIES COMMISSION

EA2026-1426

SUBJECT: Electric Distribution Audit of PG&E's Fresno Division

**CPUC AUDIT FINDINGS
PG&E FRESNO DISTRIBUTION DIVISION
JANUARY 12-16, 2026**

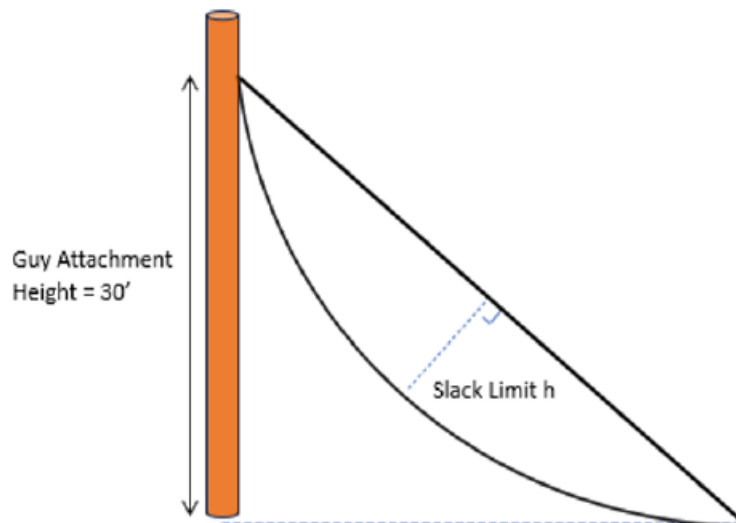
Figure 1: Guy slack limit, TD-2305M-JA02

PG&E’s Utility Bulletin: TD-2305M-JA02-B005, Effective Date: 2/14/2025, Rev. 0, Section 3, Guy Loose Adjust states in part:

“The original assessment to determine the acceptable slack on the guy was only looking at a leaning pole scenario, in this scenario the stresses (e.g., bending of pole due to overload) was not considered. ATS has updated the assessment to consider the overload scenario, the bending scenario gives us the limiting slack value, which is at 1.5-foot of slack (worst-case) in all the pole class/lengths evaluated.”

Per GO 95, Rule 56.2, guys are required to be maintained taut. PG&E’s Utility Bulletin: TD-2305M-JA02-B005 allows a deviation from taut by a maximum of one and a half (1.5) feet without regard to length or angle of attachment.
