## PUBLIC UTILITIES COMMISSION

SA2026-1453

**SUBJECT:** Electric Substation Audit of PG&E Moss Landing Headquarters

### **PG&E Moss Landing Headquarters**

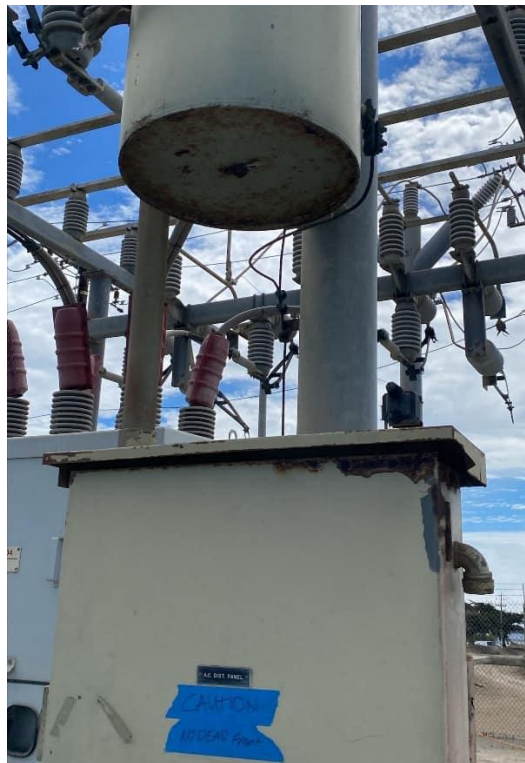
- 1.1. The station single line diagram (SLD) in the control room needs to be updated. The control room has Revision 9 of the SLD, however there is a more updated Revision 10 available.<sup>12</sup>
- 1.2. Station Service Transformer and AC Panel show signs of rust and corrosion and are in need of replacement. PG&E has existing Notification #118264647 for this issue.

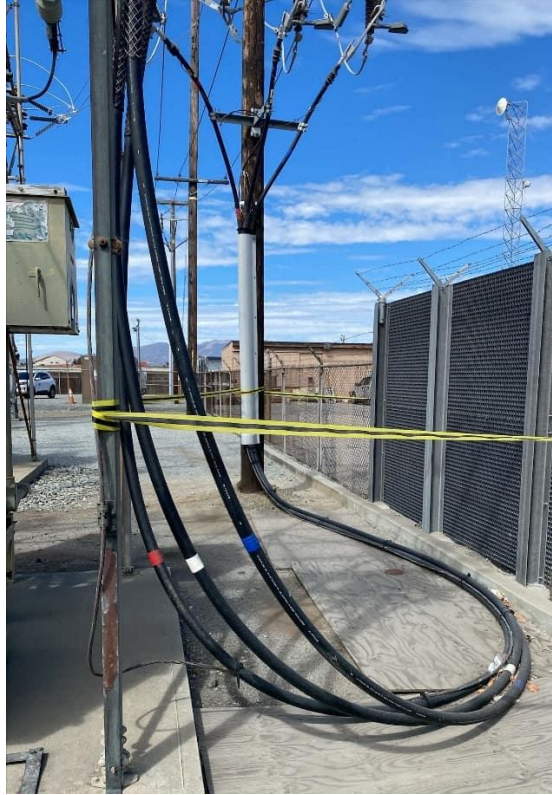
- 2.1. The station has exposed and unsecured conductors. PG&E has an existing Capital Job #74052882 for station upgrades.

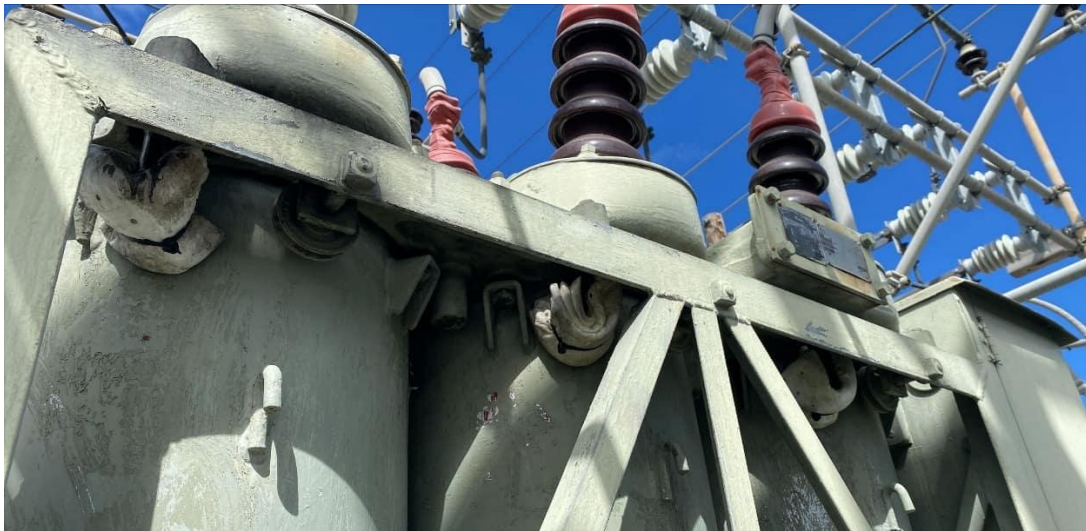
- 2.2. Circuit Breaker 412 shows signs of an oil weep and has oil residue. PG&E has existing Notification #133701808 for this issue.

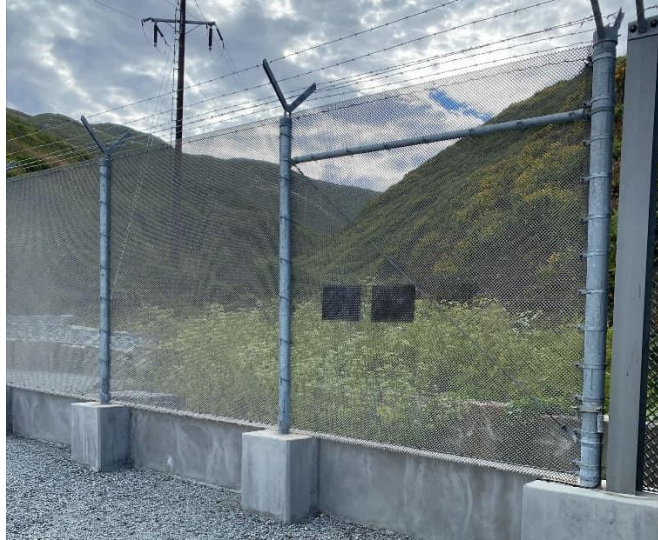
- 3.1. The station does not meet the wildfire defensible space Zone 1 clearance requirement of 30 feet.<sup>13</sup>

<sup>13</sup> PG&E Substation Maintenance and Construction Manual for Substation Inspections states “**ZONE 1** – The Clean Zone creates a firebreak by removing all vegetation and combustibles at a minimum circumference of 30 feet around the substation as measured from all outermost buildings or equipment.”

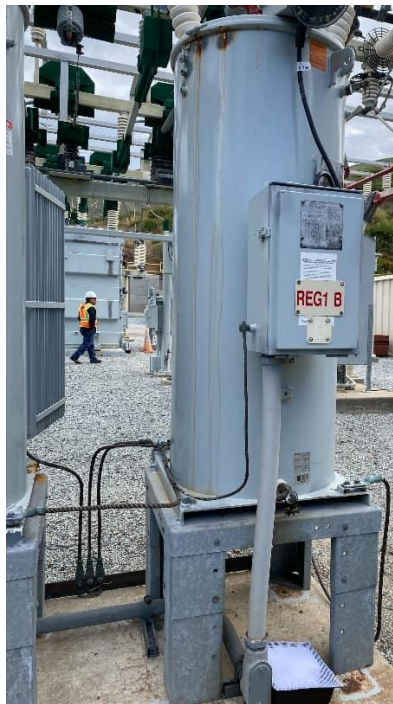
- 3.2. Regulator 1 B Phase shows signs of an oil leak and has oil residue. PG&E has existing Notification #133694441 for this issue.

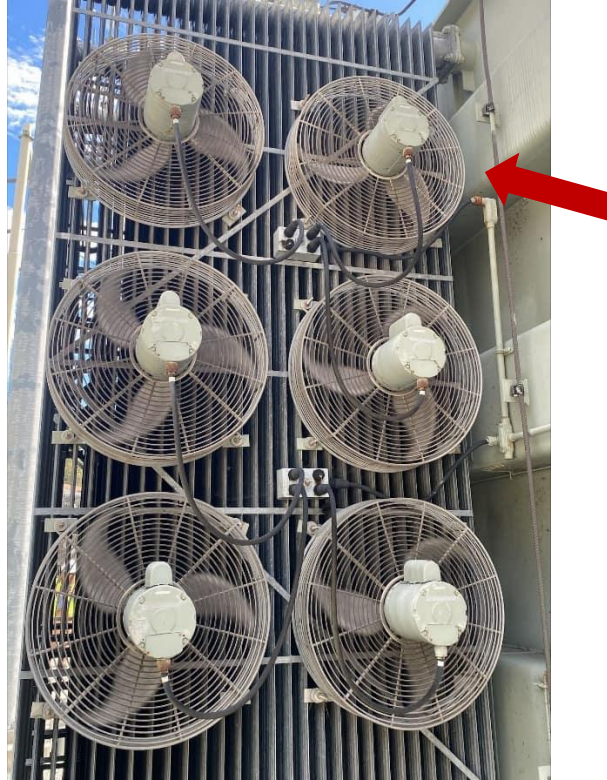
- 4.1. Transformer Bank 1 has a broken fan. PG&E has existing Notification #133577248 for this issue.

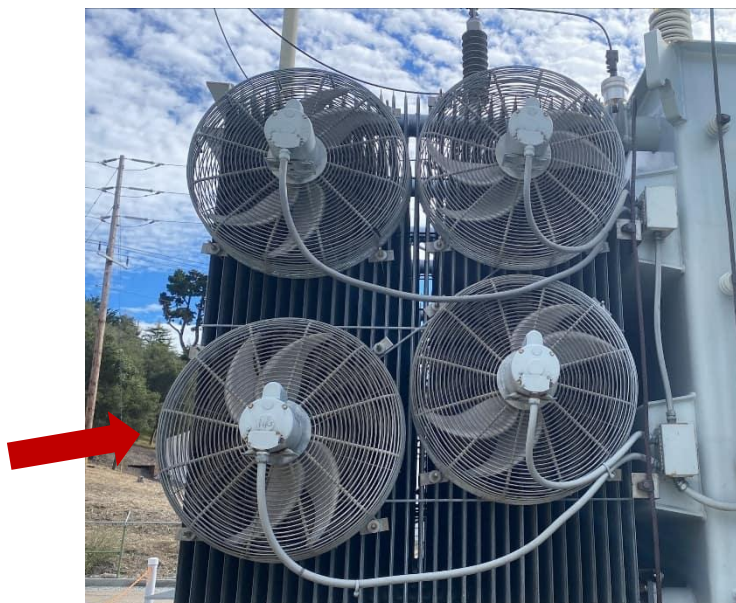
- 4.2. Transformer Bank 2 has a broken fan. PG&E has existing Notification #133577249 for this issue.

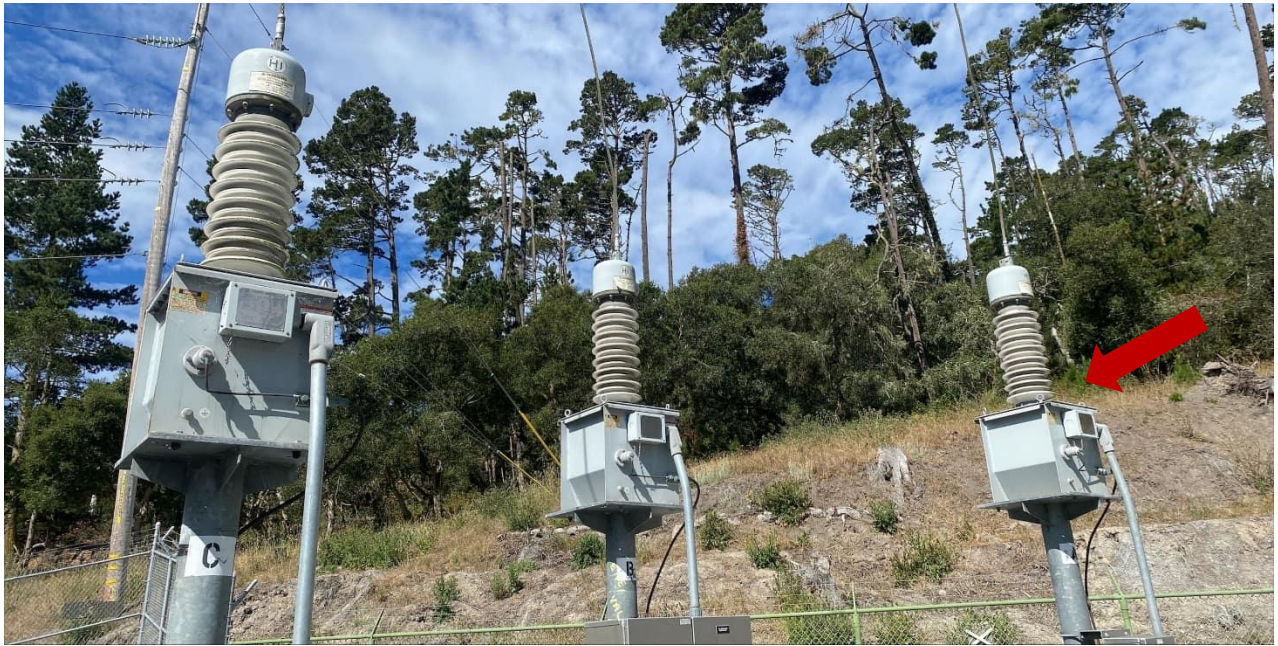
4.3. Del Monte Viejo 60kV Potential Transformer A Phase insulator is dirty. PG&E has existing Notification #133569296 for this issue.

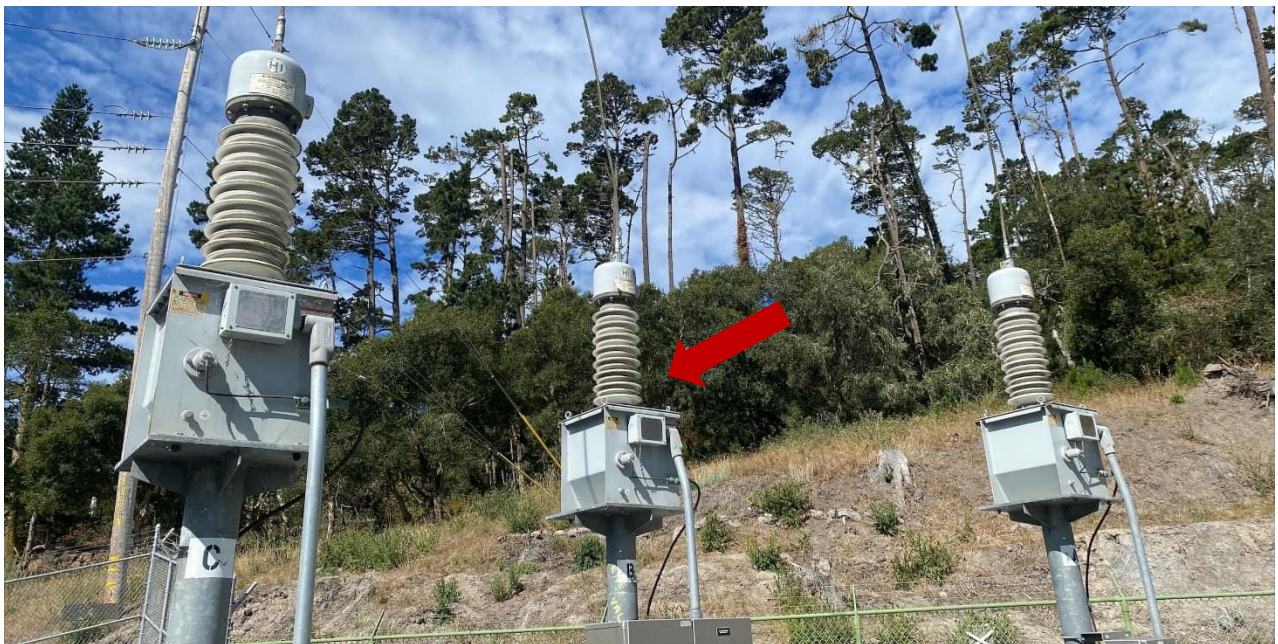
4.4. Del Monte Viejo 60kV Potential Transformer B Phase insulator is dirty. PG&E has existing Notification #133569254 for this issue.

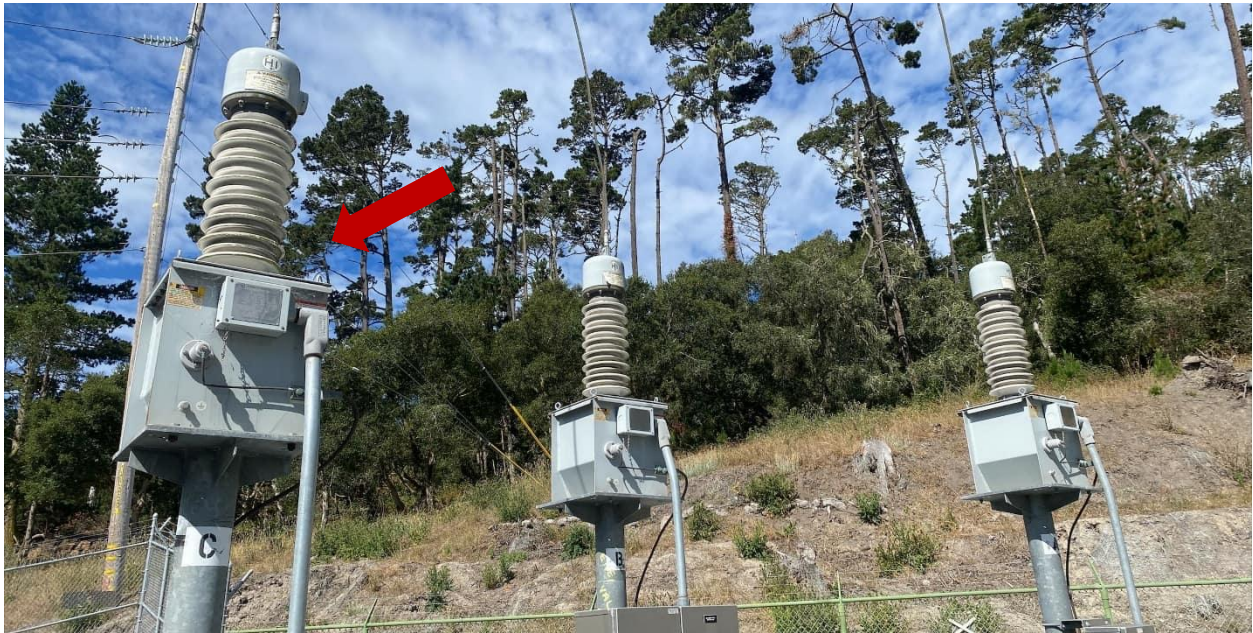
4.5. Del Monte Viejo 60kV Potential Transformer C Phase insulator is dirty. PG&E has existing Notification #133569257 for this issue.

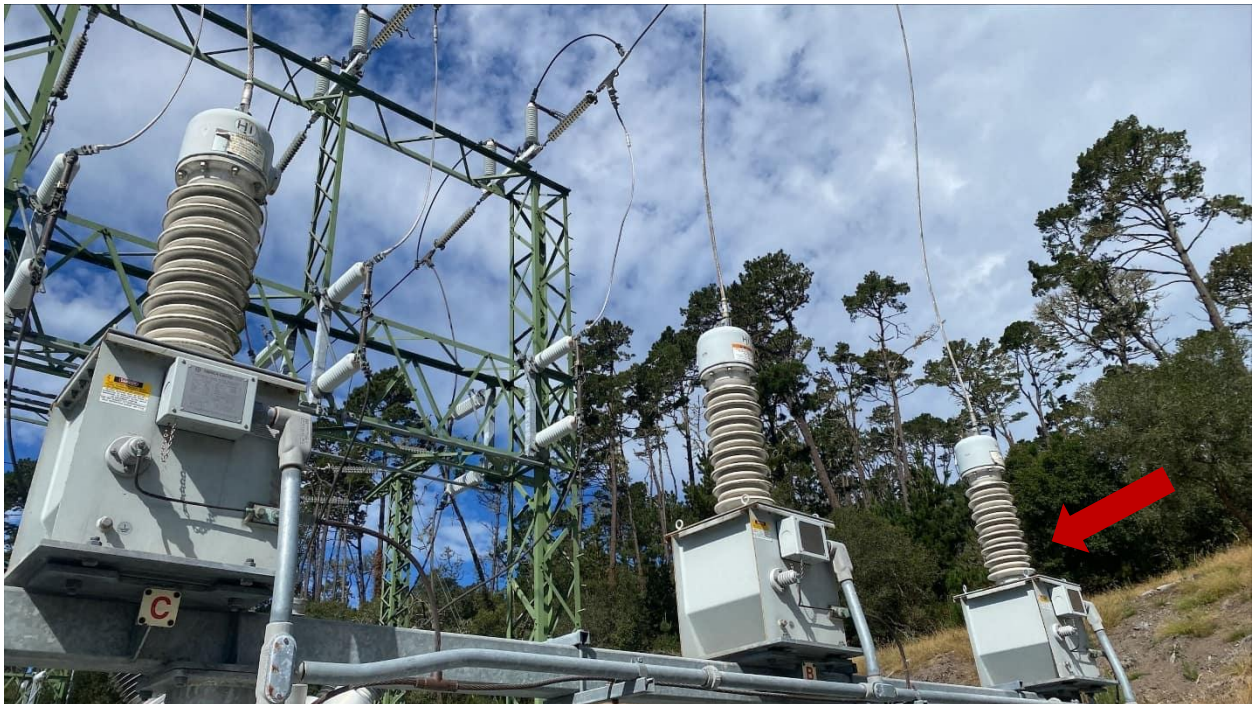
4.6. Monterey-Viejo 60kV Potential Transformer A Phase insulator is dirty. PG&E has existing Notification #133569281 for this issue.

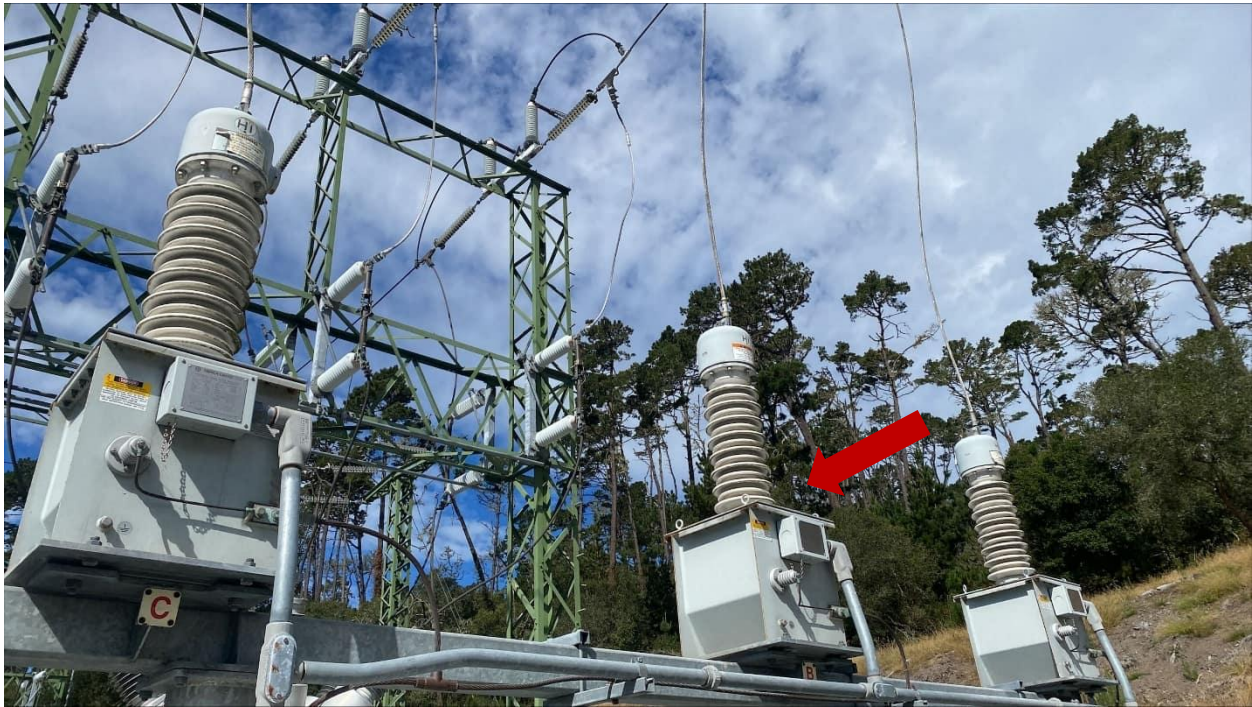
4.7. Monterey-Viejo 60kV Potential Transformer B Phase insulator is dirty. PG&E has existing Notification #133569282 for this issue.

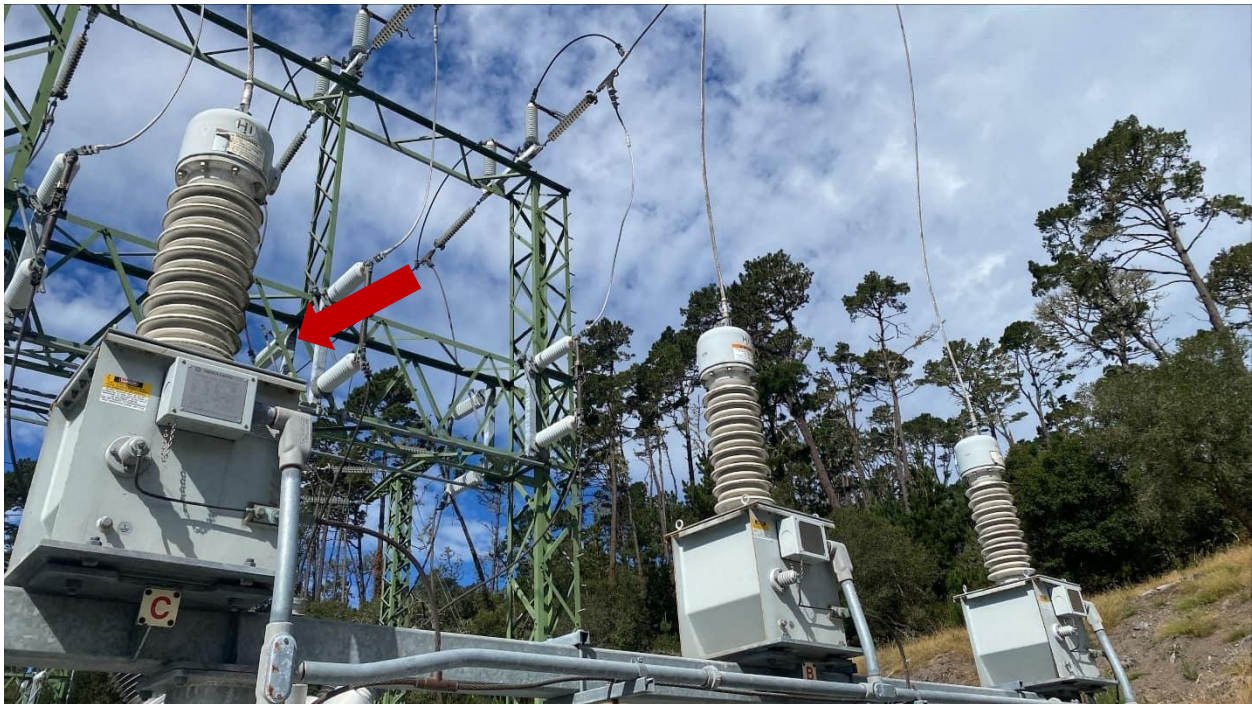
4.8. Monterey-Viejo 60kV Potential Transformer C Phase insulator is dirty. PG&E has existing Notification #133569250 for this issue.

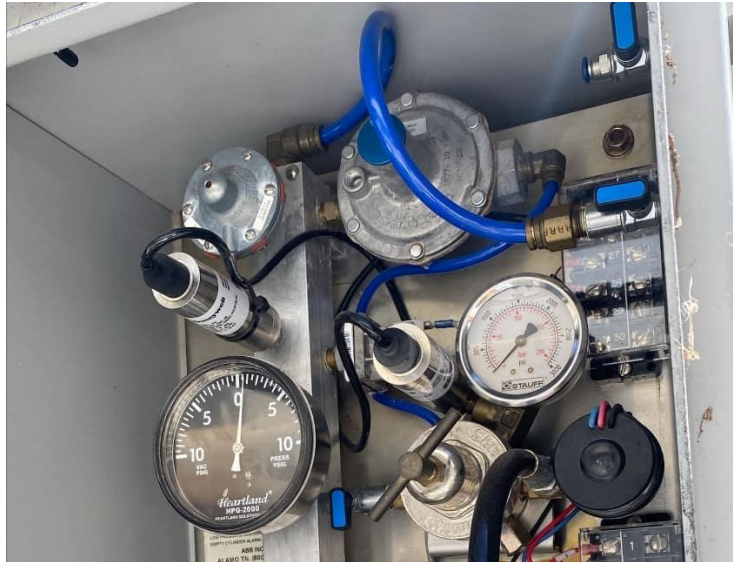
5.2. Transformer Bank 1 A Phase needs a new nitrogen bottle. PG&E added a new nitrogen bottle in the field.

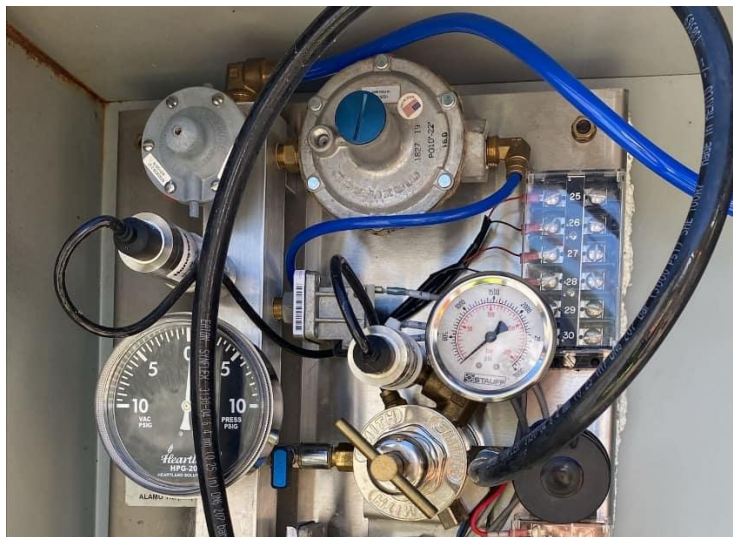
5.3. Transformer Bank 1 C Phase needs a new nitrogen bottle. PG&E added a new nitrogen bottle in the field.

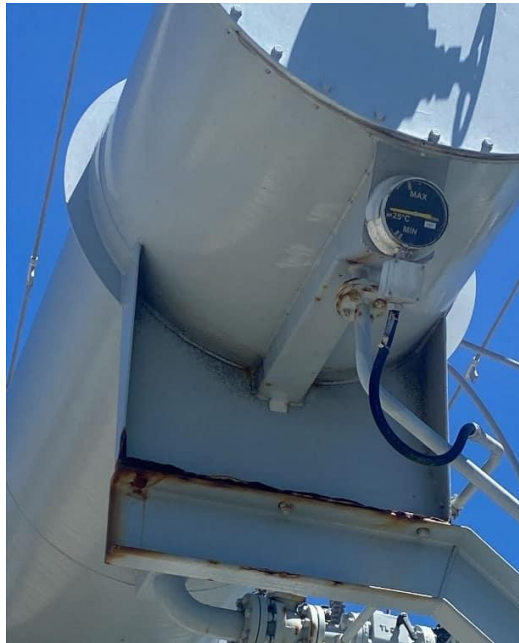
- 6.1. The station single line diagrams (SLD) in the control rooms are out of date however the latest Revision 9 is on site. The updated SLD must be posted in each control room.<sup>15</sup> PG&E has existing Notification #133701690 to update the SLD created on July 9, 2026.
- 6.2. Transformer Bank 2 conservator tank shows signs of rust and corrosion. PG&E has existing Notification #133521412 for this issue.

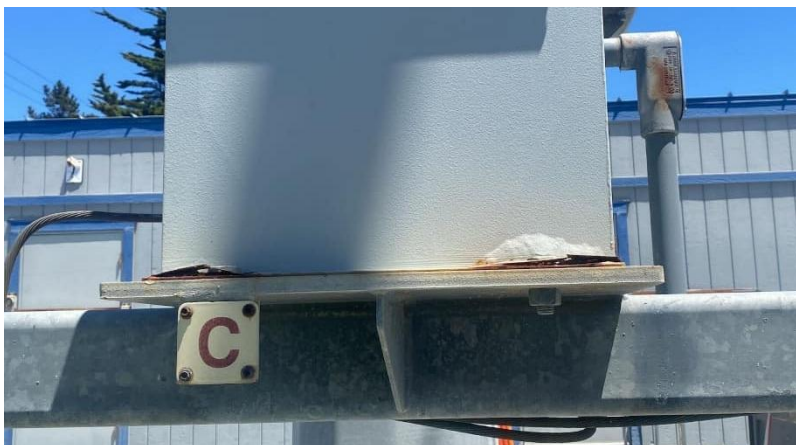
- 6.3. High Voltage Circuit Breaker 52 Potential Transformer C Phase shows signs of rust and corrosion. PG&E has existing Notification #133594427 for this issue.

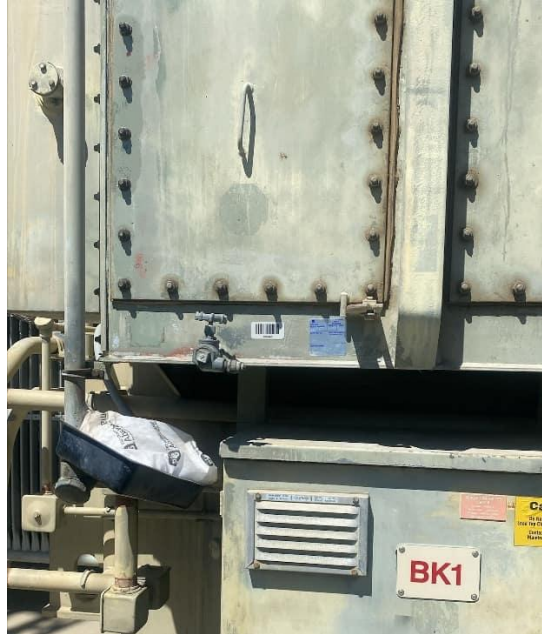
- 7.1. Transformer Bank 1 has an oil weep. PG&E has existing Notification #126488740 for this issue created on July 9, 2026.

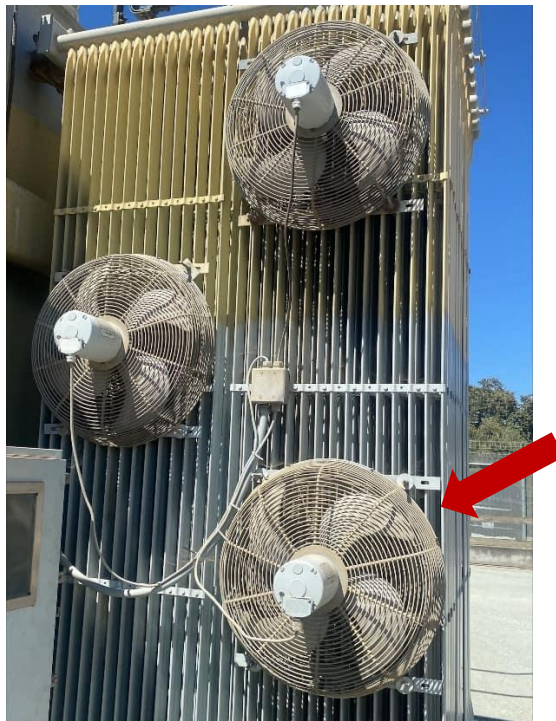
- 7.2. Transformer Bank 1 has a broken fan. PG&E has existing Notification #133701875 for this issue.

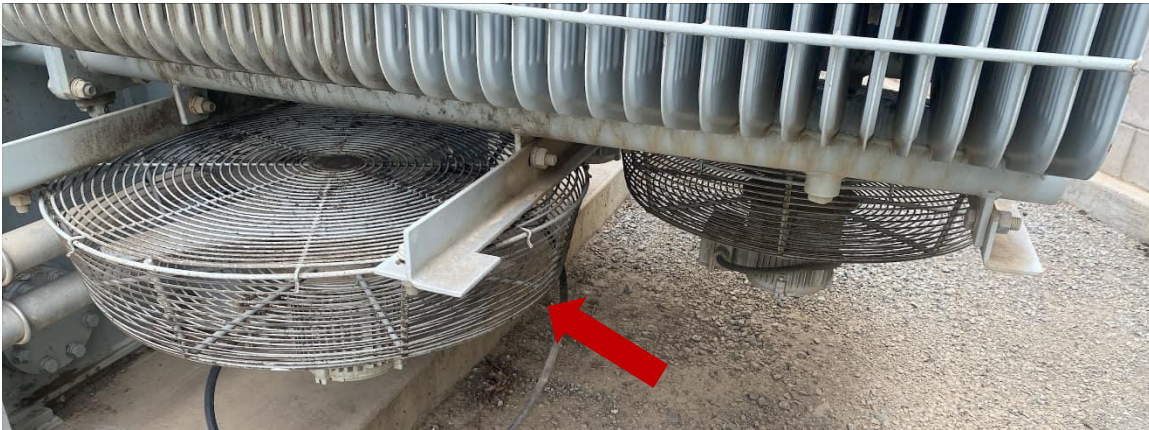
8.1. Transformer Bank 3 has a broken fan.

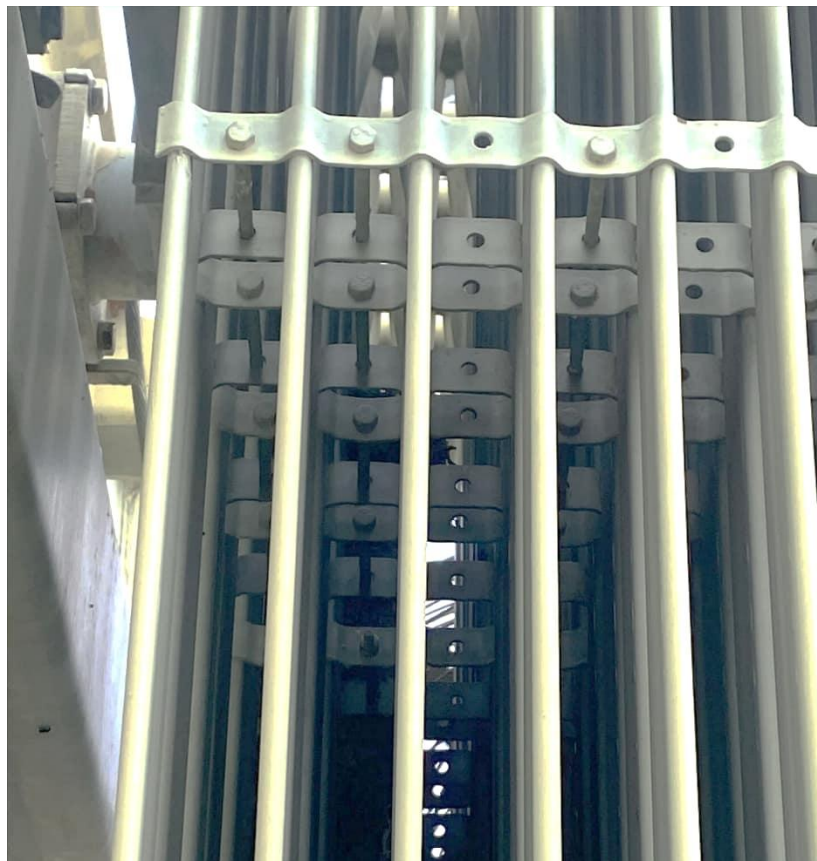
9.1. Transformer Bank 1 radiator has an active bird's nest. PG&E has existing Notification #133701320 for this issue.

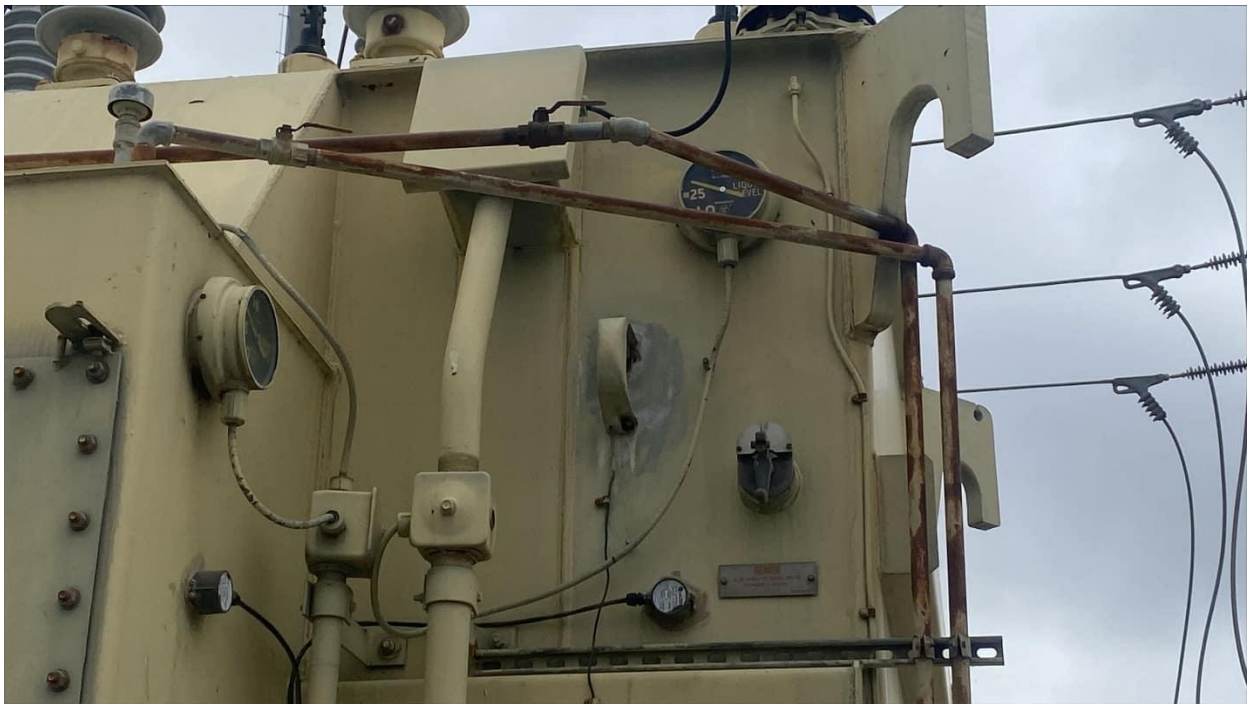
9.2. Transformer Bank 1 shows signs of rust and corrosion on the oil filtration system. PG&E has existing Notification #133638679 for this issue.

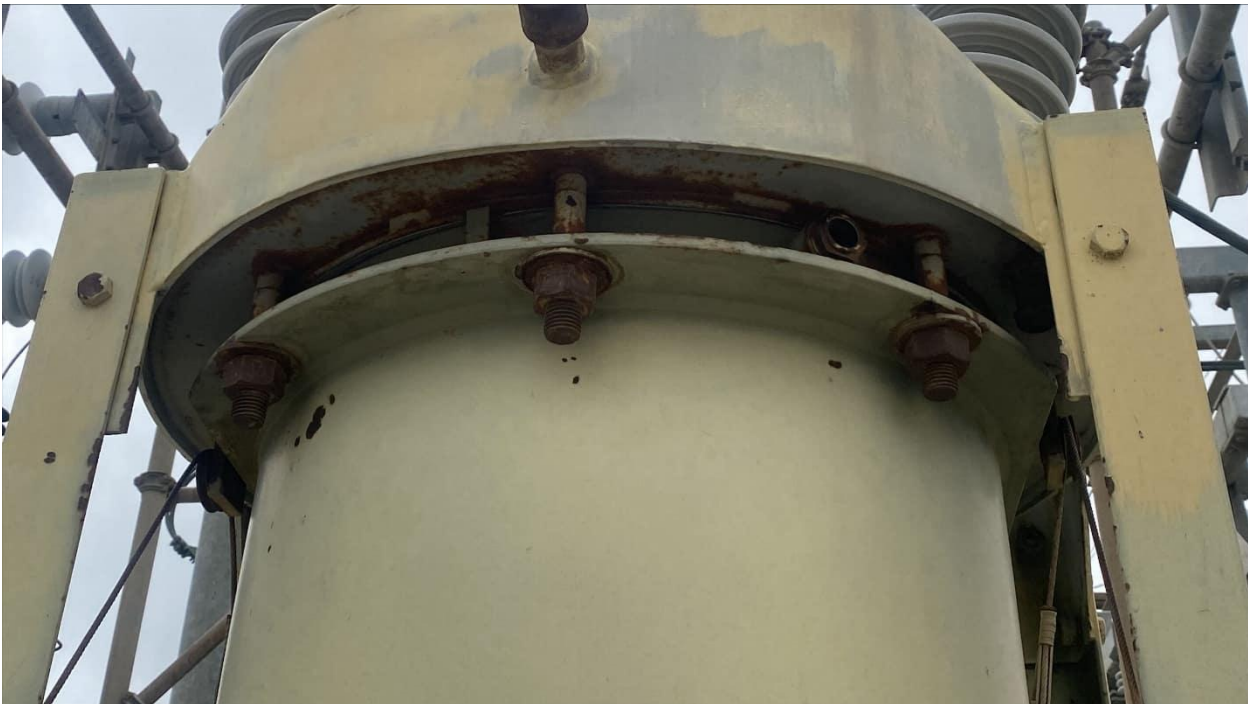
9.3 Circuit Breaker 2101 shows signs of rust and corrosion. PG&E has existing Notification #133623515 for this issue.

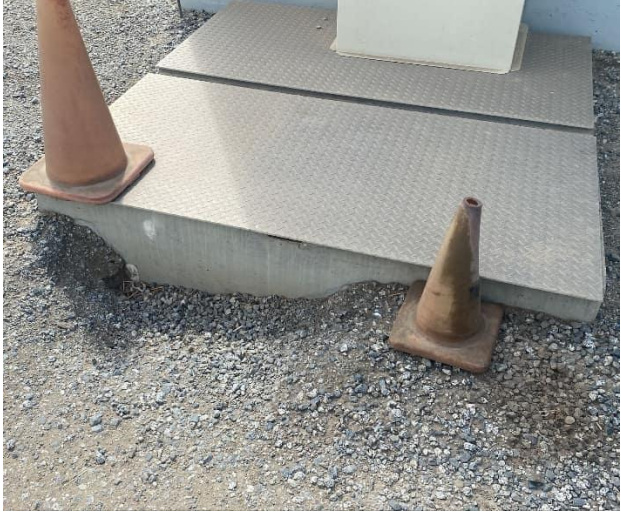
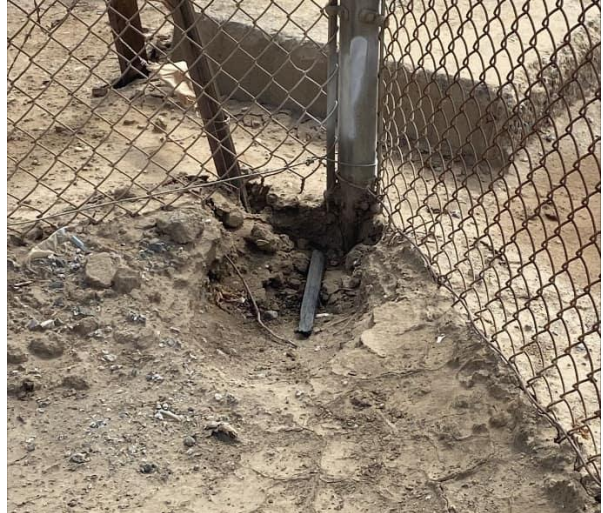
10.1. The station and station perimeter fence have soil erosion. PG&E has existing Notification #133538375 for this issue.

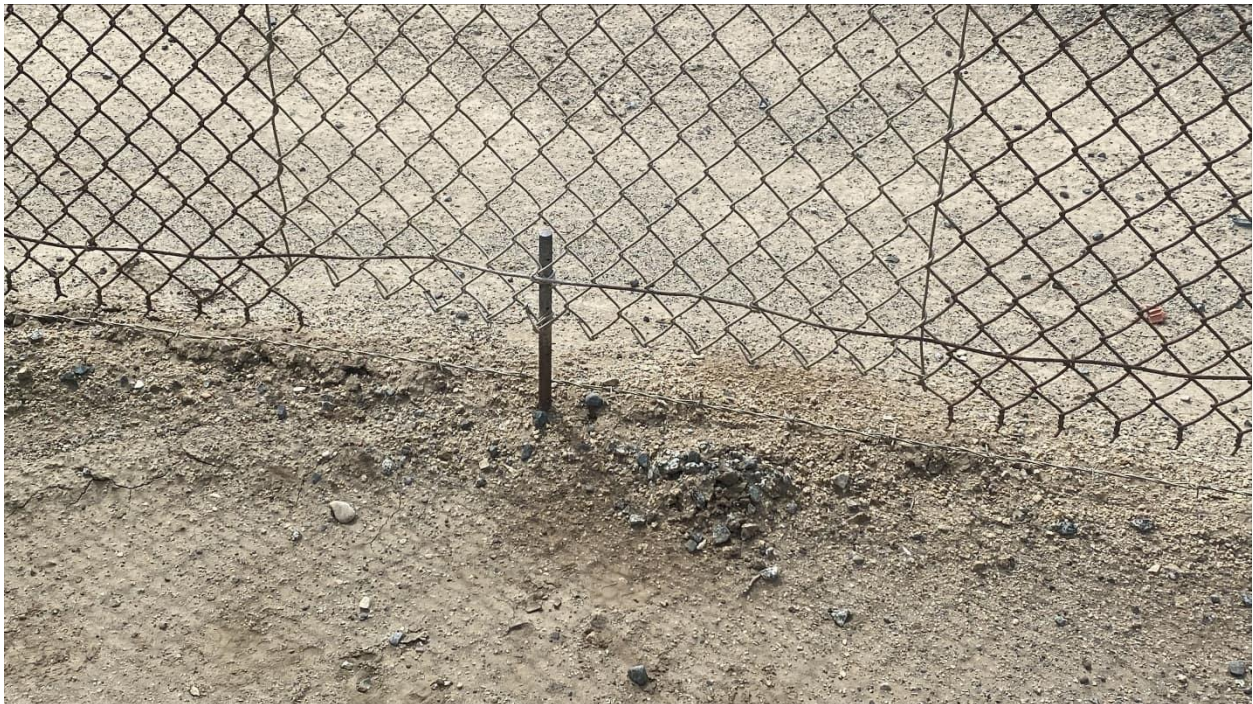
10.2. The station perimeter fence has gaps and accessibility concerns. PG&E has existing Notification #128519699 for this issue.

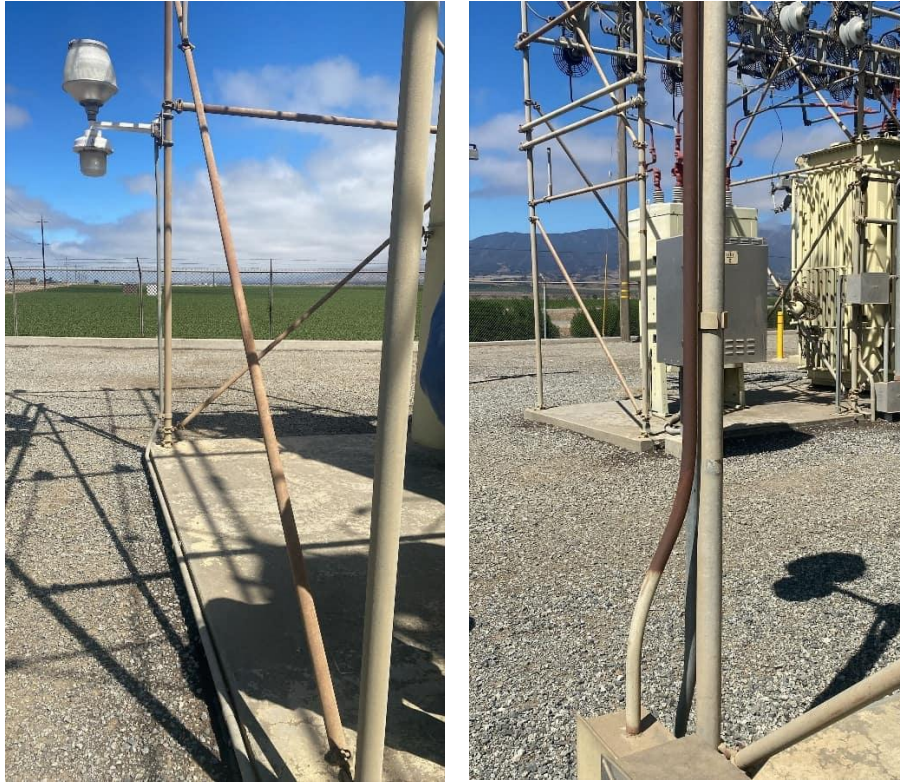
10.3. The station support structures show signs of rust and are in need of replacement. PG&E has existing Capital Job #74073780 for this issue.

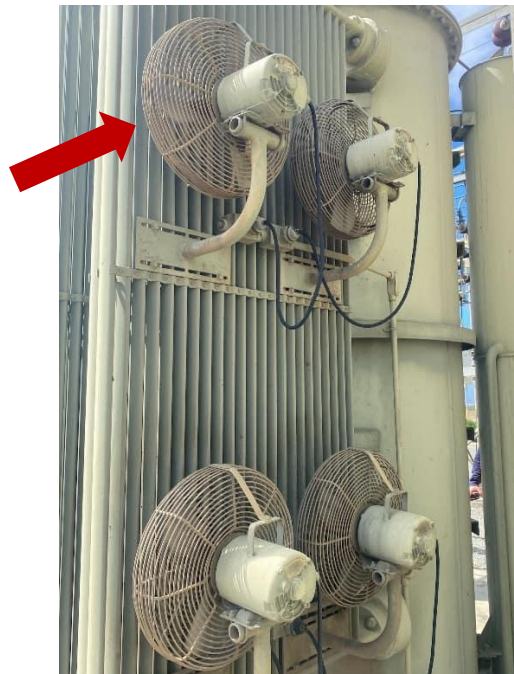
10.4. Transformer Bank 2 B Phase has a broken fan. PG&E has existing Notification #133657688 for this issue.

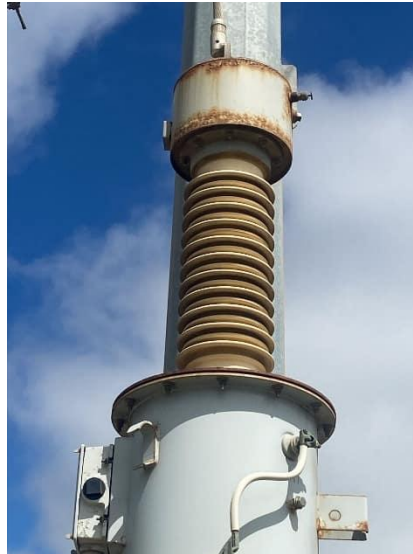
10.5. Potential Transformer 82 A Phase shows signs of rust and corrosion. PG&E has existing Notification #126905339 for this issue.

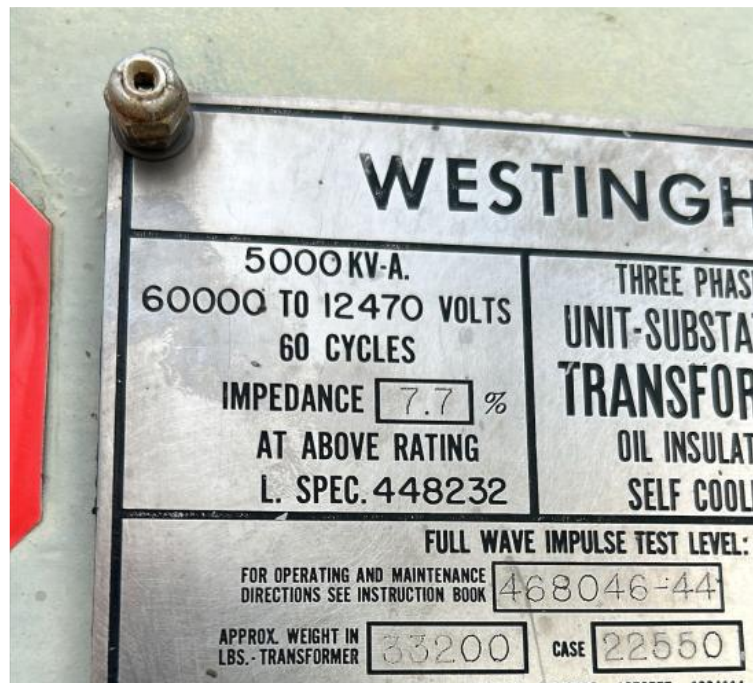
11.1. The station single line diagram (SLD) needs to be updated. Transformer Bank 3 nameplate does not have a fan rating and only lists 5,000kVA, however the SLD lists 5,600kVA and 7,000kVA. Transformer Bank 4 nameplate lists high voltage as 60,000V, however the SLD lists high voltage as 66,000V.

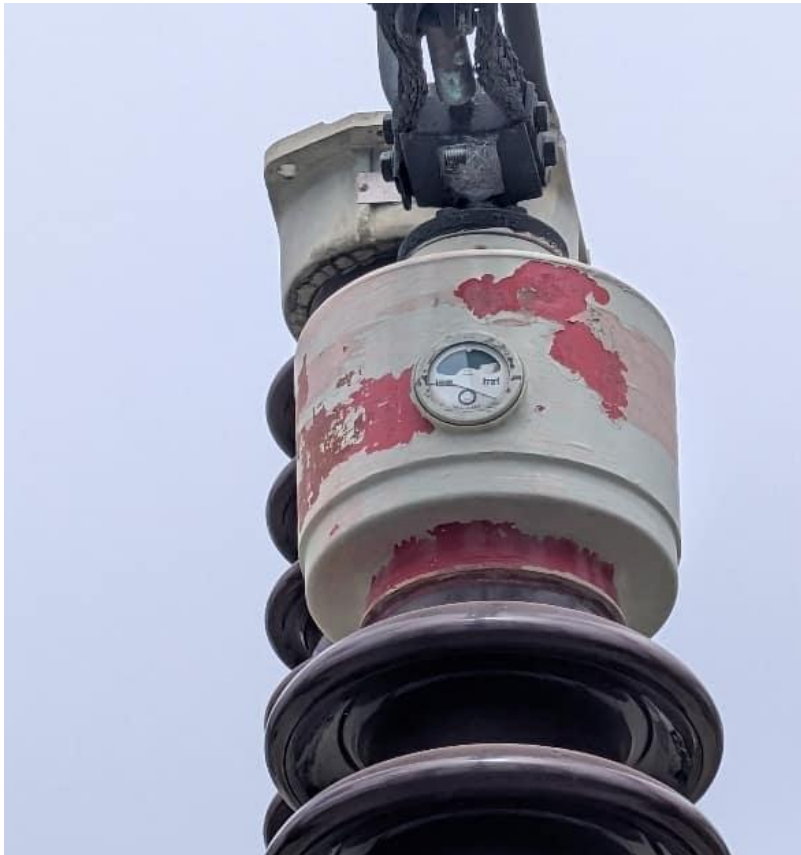
11.2. Transformer Bank 3 B Phase bushing has a cracked gauge.

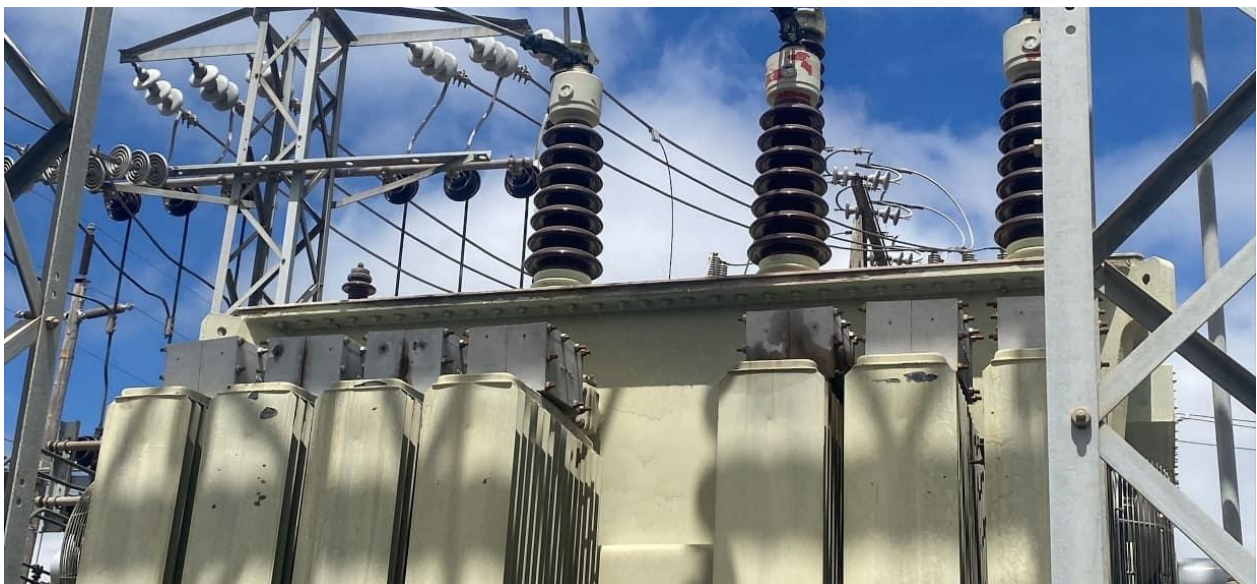
11.3. Transformer Bank 3 radiator has an oil weep. PG&E has existing Notification #133697406 for this issue.

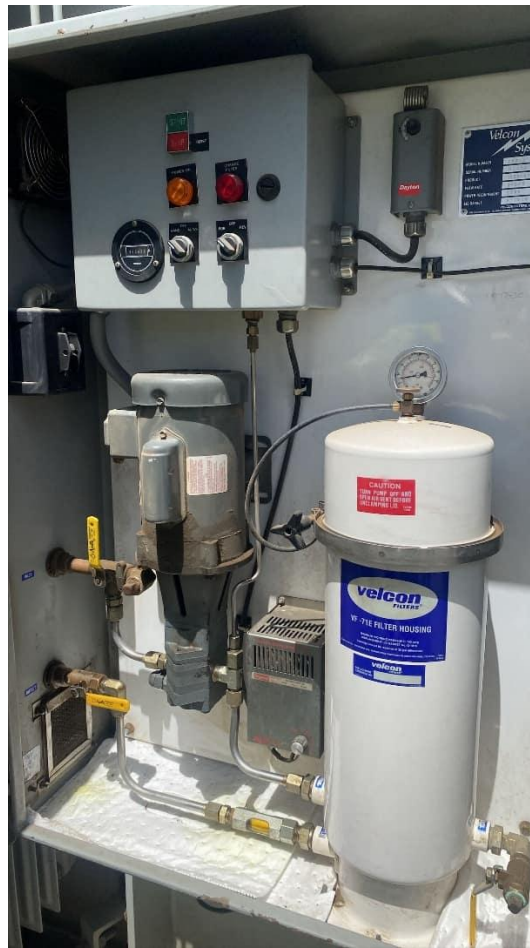
11.4. Transformer Bank 4 oil filtration system has an oil weep. PG&E has existing Notification #133538196 for this issue.

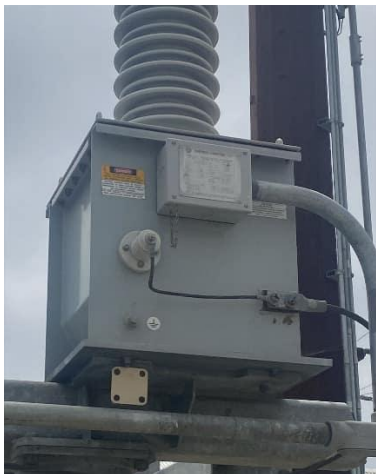
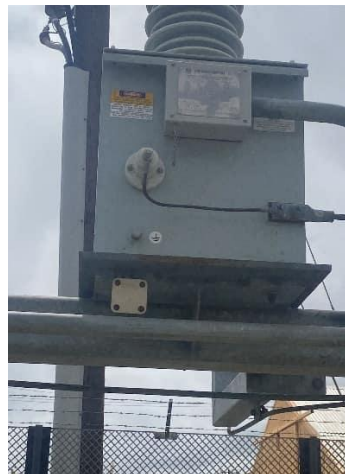
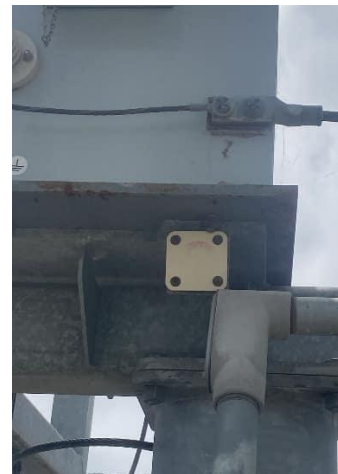
11.5. 60kV Potential Transformers A Phase, B Phase, and C Phase have faded labels. PG&E has existing Notification #133716580 for this issue.

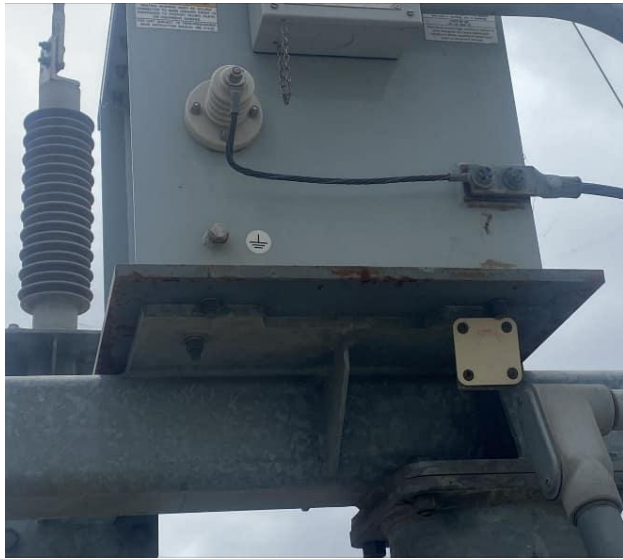
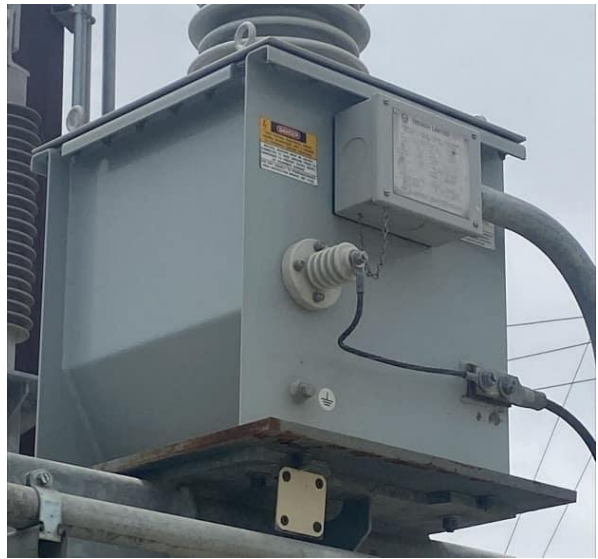
11.6. 60kV Potential Transformers A Phase, B Phase, and C Phase show signs of rust and corrosion. PG&E mitigated this issue in the field.

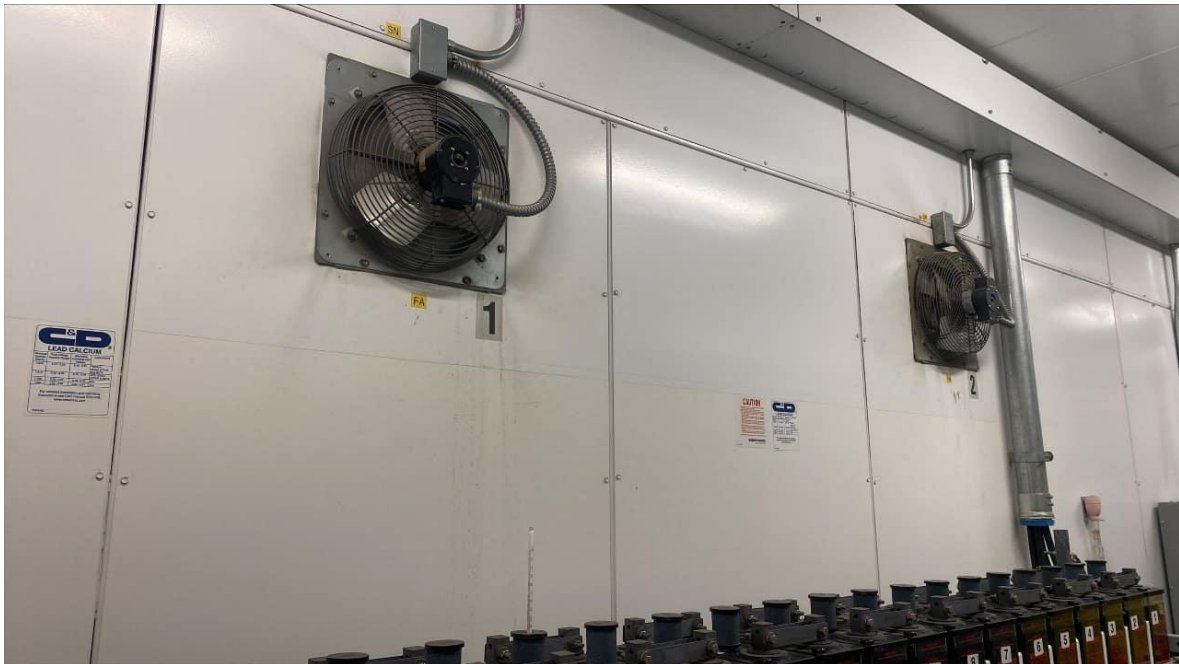
12.1. Station battery room has inoperable fans. PG&E has existing Notification #133702408 for this issue.

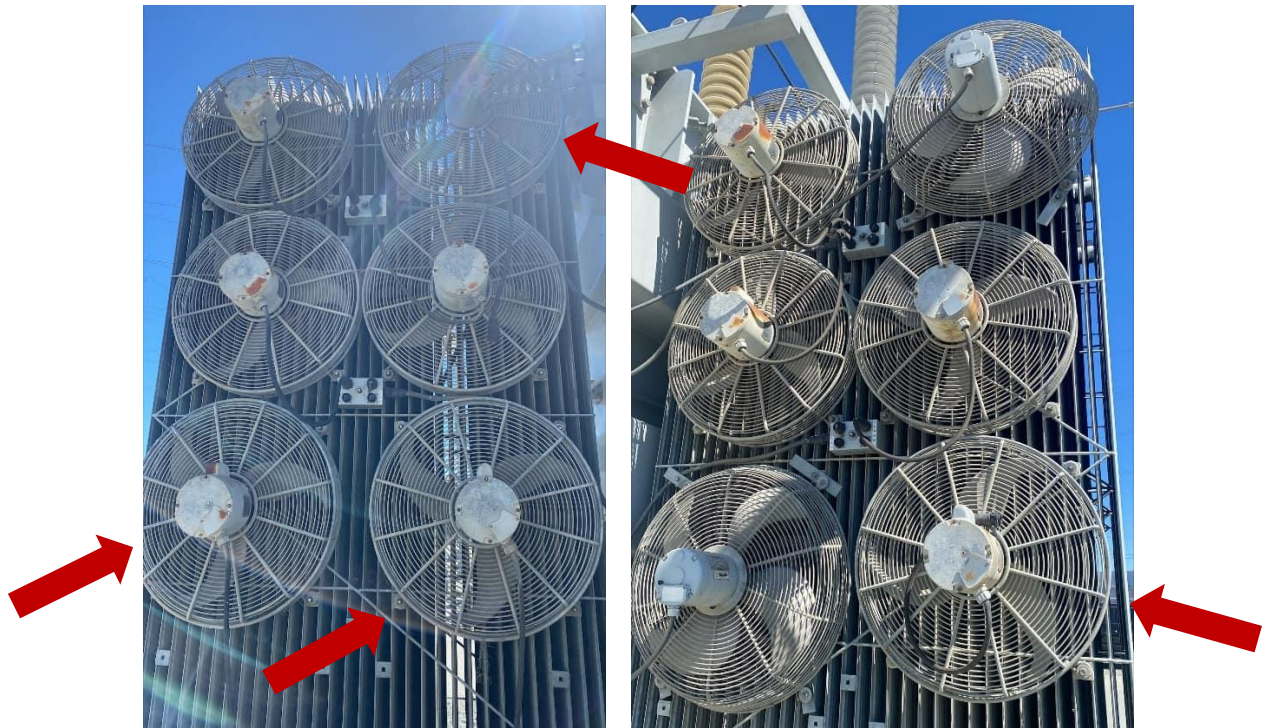
12.2. Transformer Bank 1 has four broken fans. PG&E has existing Notification #133493094 for this issue.
