## PUBLIC UTILITIES COMMISSION

SA2026-1453

**SUBJECT:** Electric Substation Audit of PG&E Moss Landing Headquarters

### **PG&E Moss Landing Headquarters**

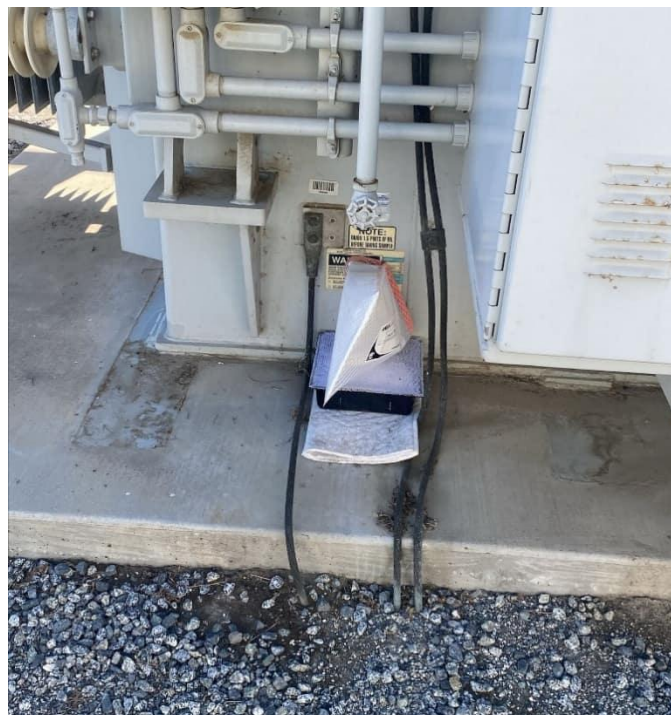
12.3. Transformer Bank 1 has an oil leak. PG&E has existing Notification #133288554 for this issue.

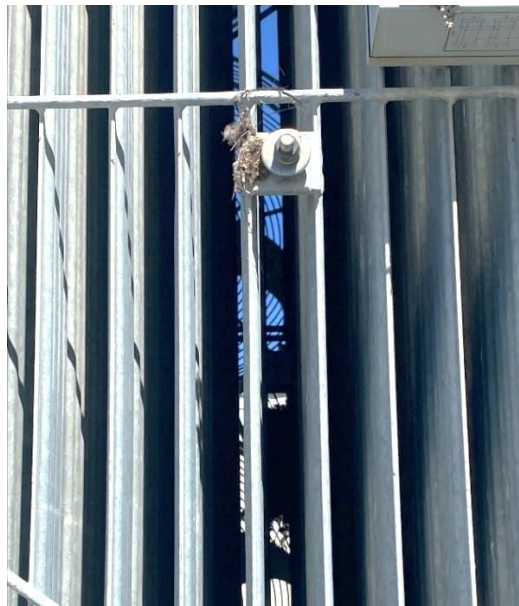
12.4. Transformer Bank 1 radiator has an active bird's nest. PG&E has existing Notification #133514283 for this issue.

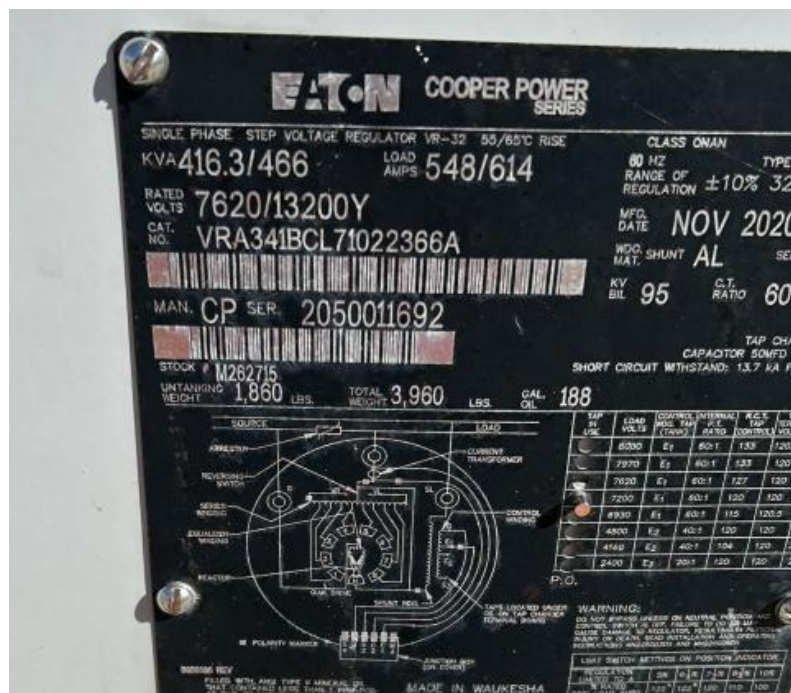
13.1. The station single line diagram (SLD) needs to be updated. Regulator 1 nameplate lists 416.3kVA for each of the three phases, however, the SLD lists 300kVA for each phase.

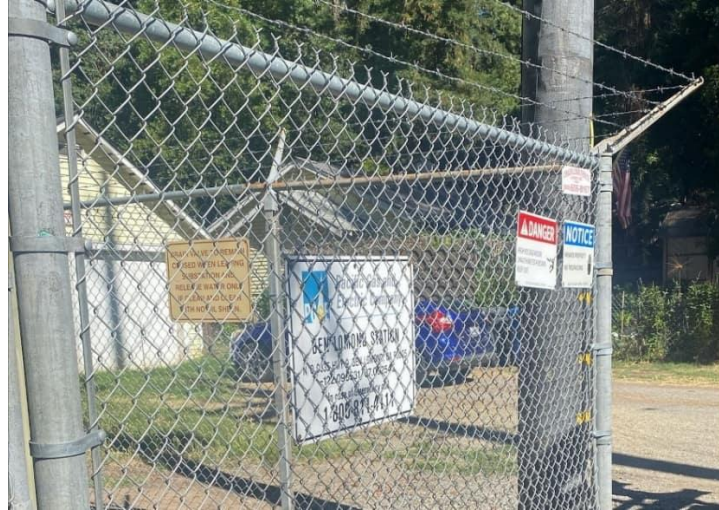
14.1. The station signs are inside of the fence. PG&E has existing Notification #133701595 for this issue.

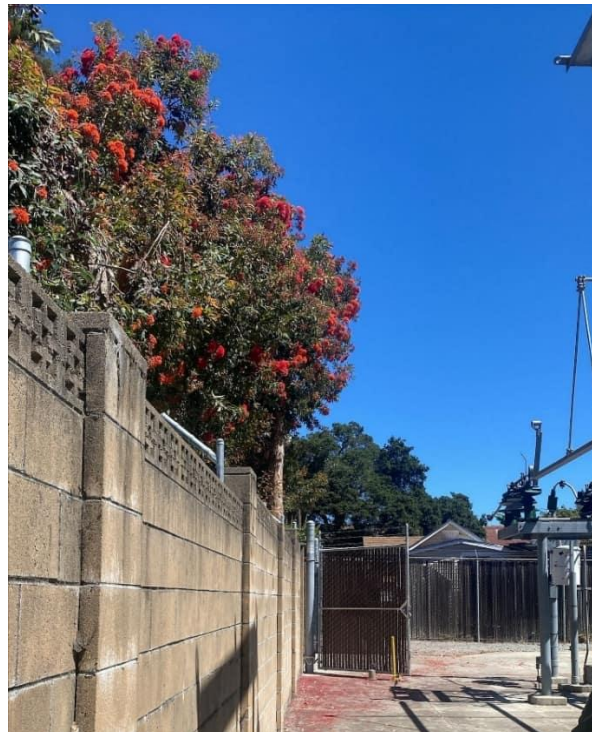
15.1. The station has trees encroaching on and hanging over the perimeter fence. PG&E has existing Notification #133721360 for this issue.

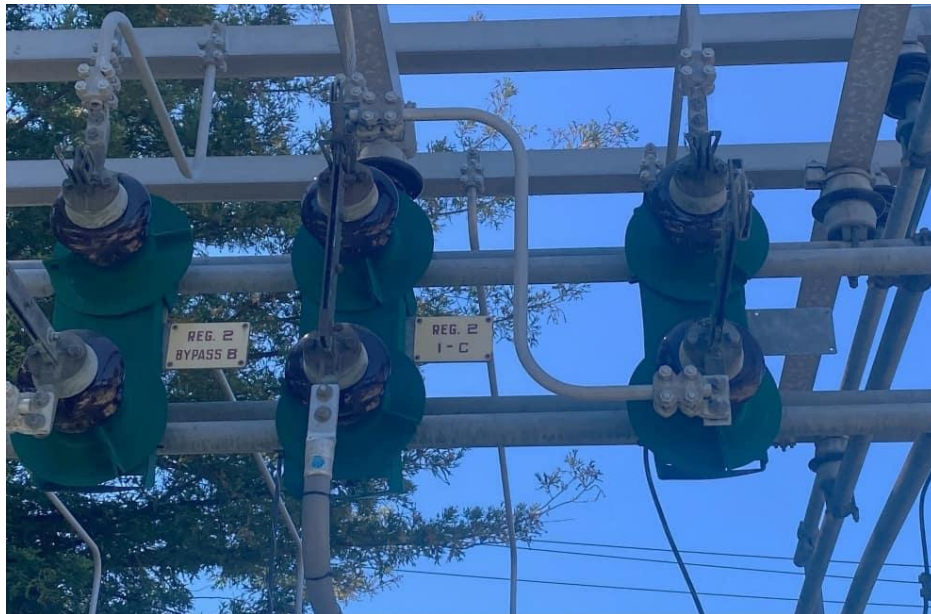
15.2. Regulator 2 Bypass C Switch is missing a target plate. PG&E has existing Notification #133721363 for this issue.

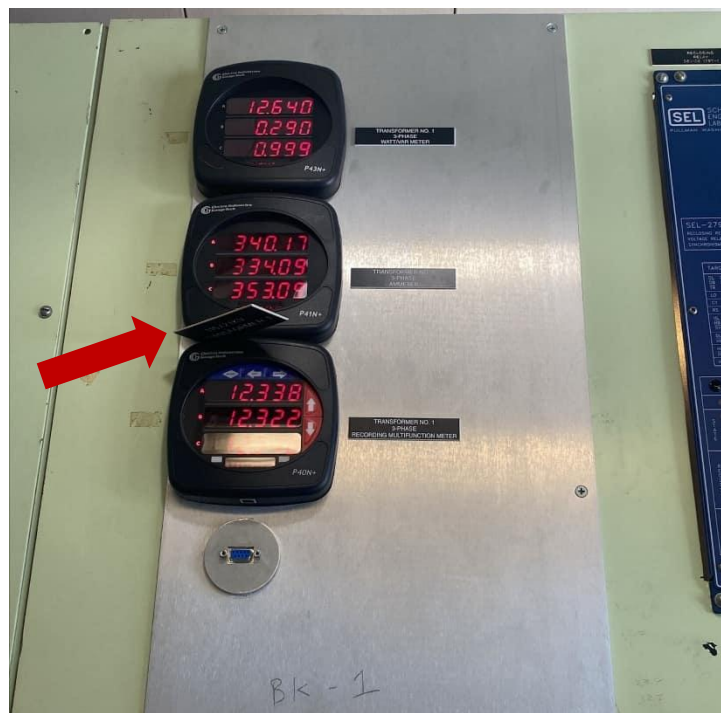
16.1. Transformer Bank 1 label in the control room needs to be attached. PG&E attached the nameplate in the field.

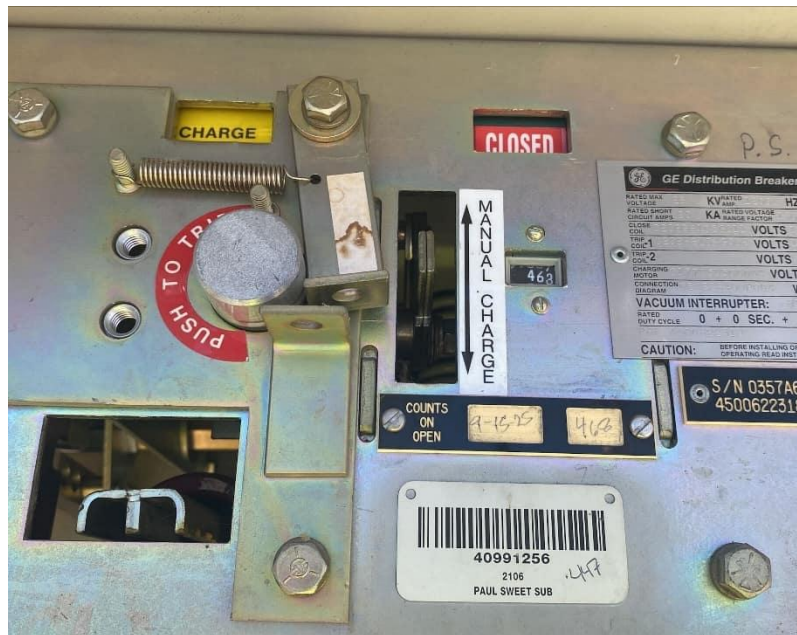
16.2. Circuit Breaker 2106 has a faded counter. PG&E has existing Notification #133564621 for this issue.

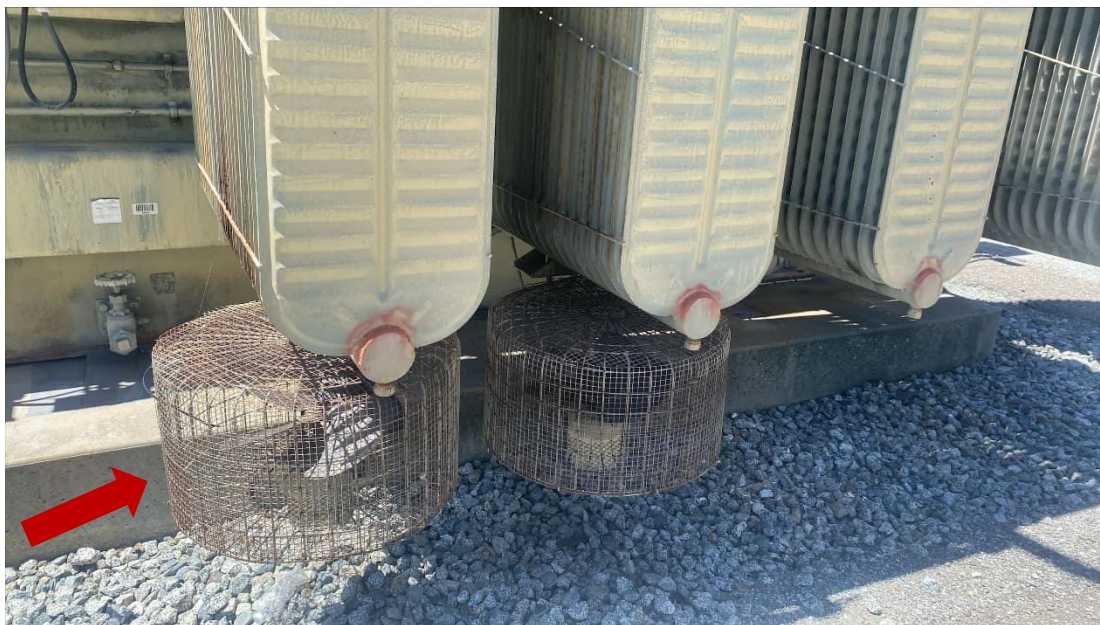
17.1. Transformer Bank 1 has a broken fan. PG&E has existing Notification #133760327 for this issue.

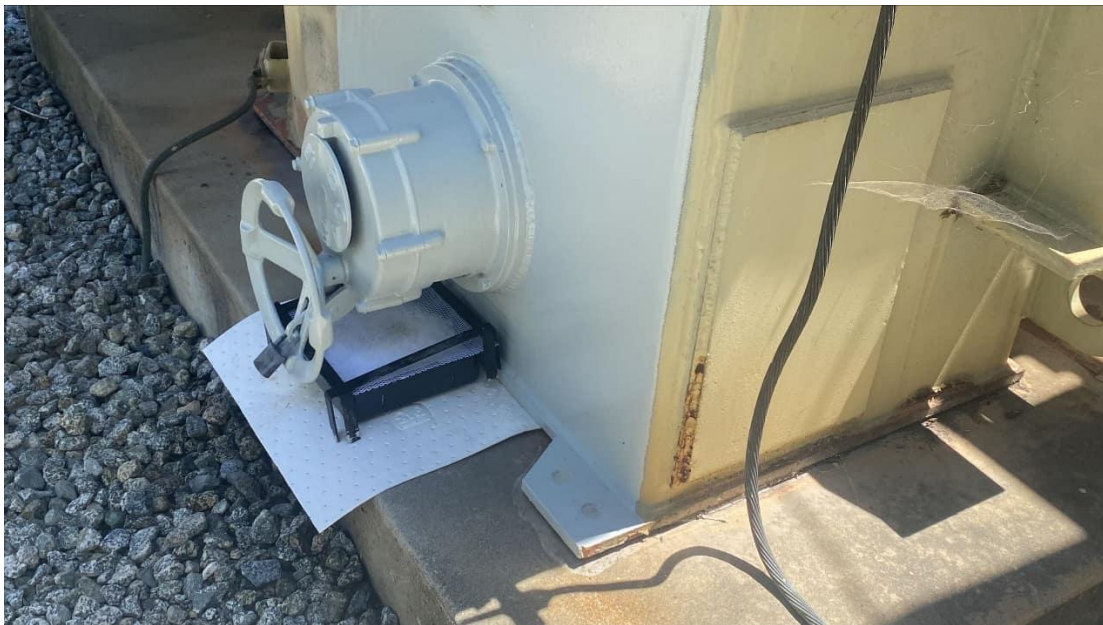
17.2. Transformer Bank 1 has an oil weep. PG&E has existing Notification #133736096 for this issue.

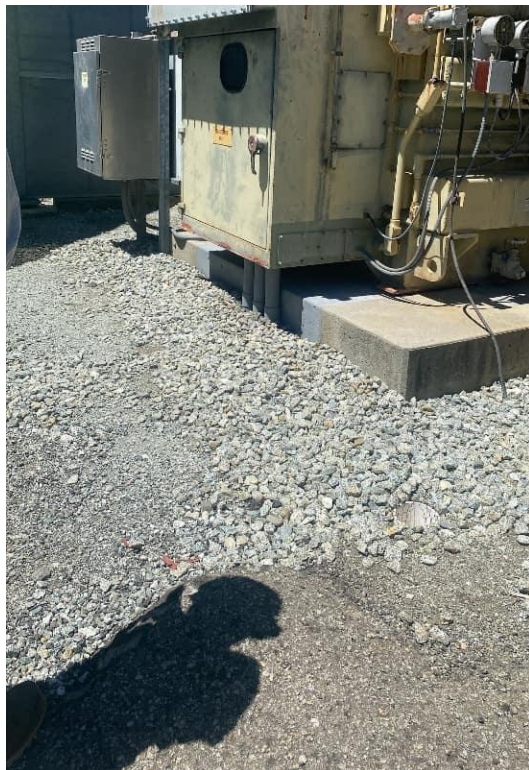
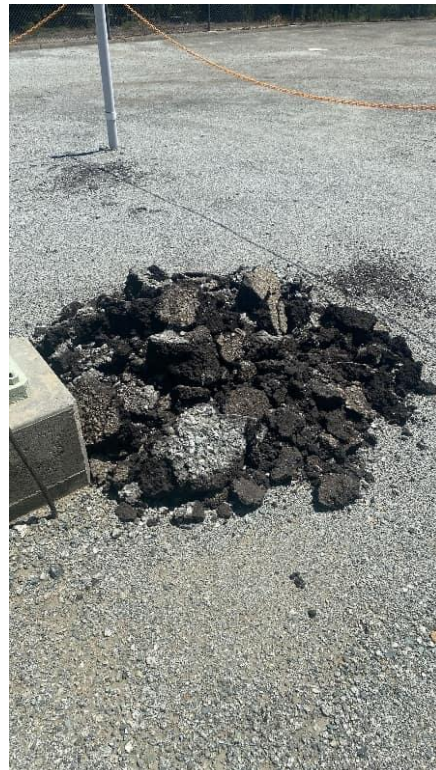
17.3. Transformer Bank 1 has a damaged berm and asphalt debris on site. PG&E has existing Notification #133764062 for this issue.

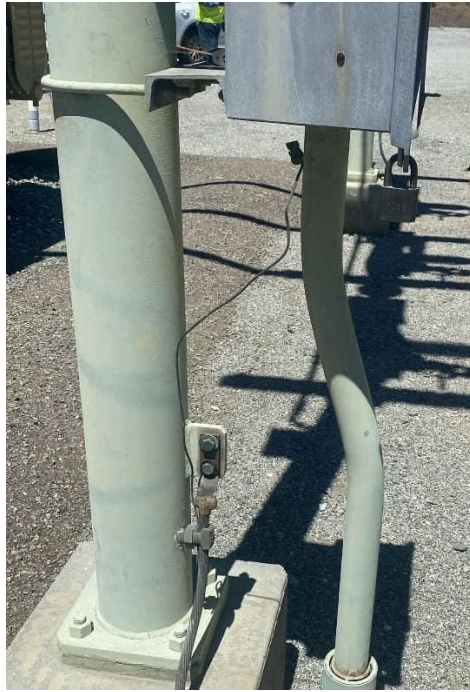
17.4. Bus Potential Transformer box has an unattached grounding wire. PG&E attached the grounding wire in the field.

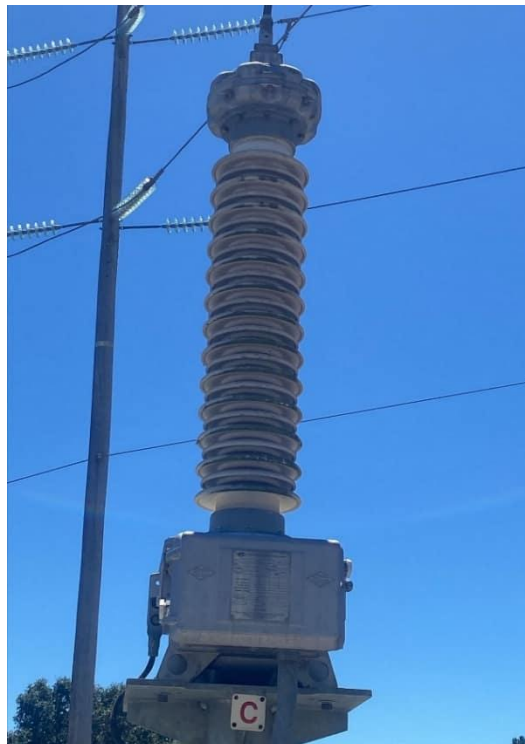
17.5. Green Valley-Paul Sweet 115kV Circuit Switcher 147 CCVT insulator is dirty. PG&E has existing Notification #133766623 for this issue.

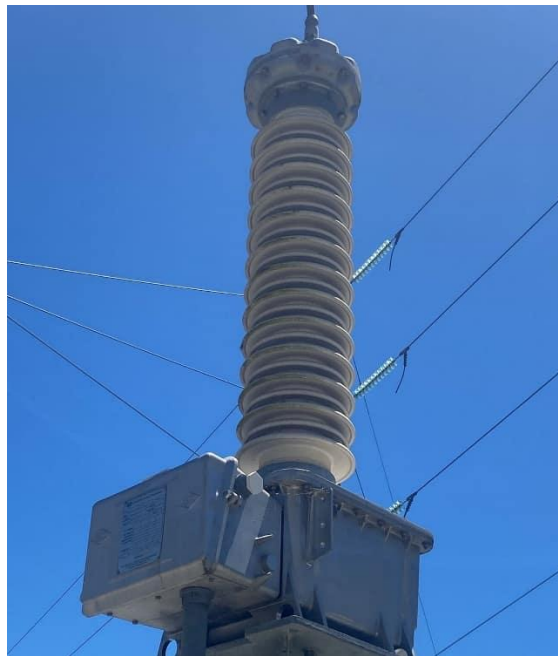
17.6. Green Valley-Paul Sweet 115kV Circuit Switcher 137 CCVT insulator is dirty.  
PG&E has existing Notification #133766569 for this issue.

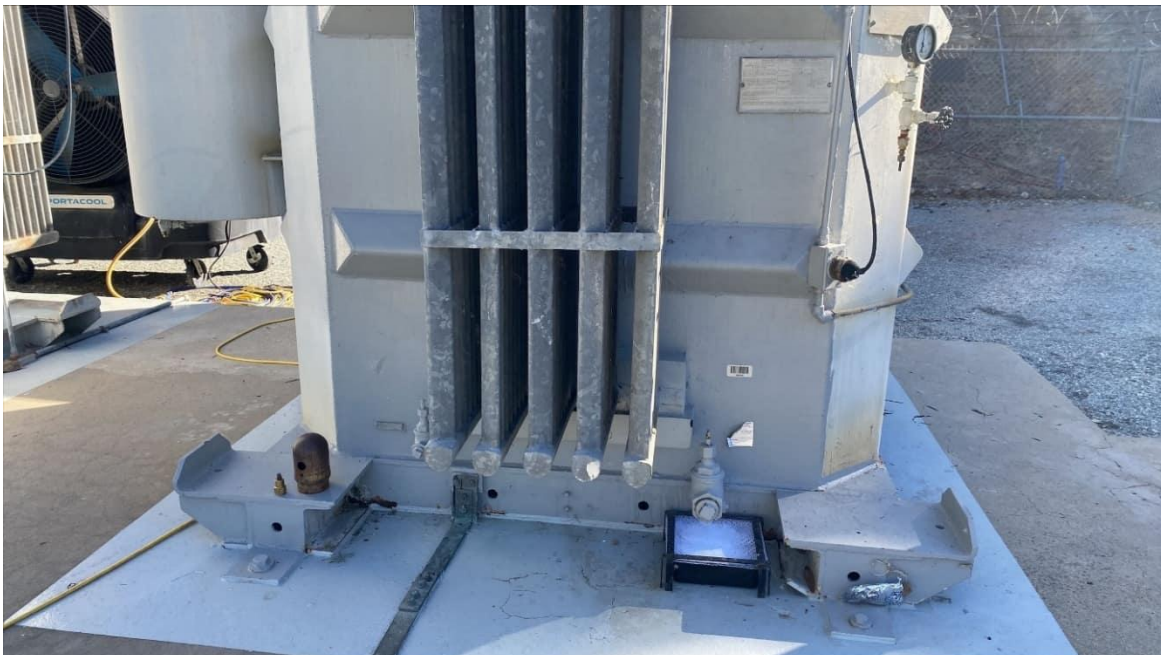
18.1. Transformer Bank 1 A Phase has an oil weep. PG&E has existing Notification #132825309 for this issue.

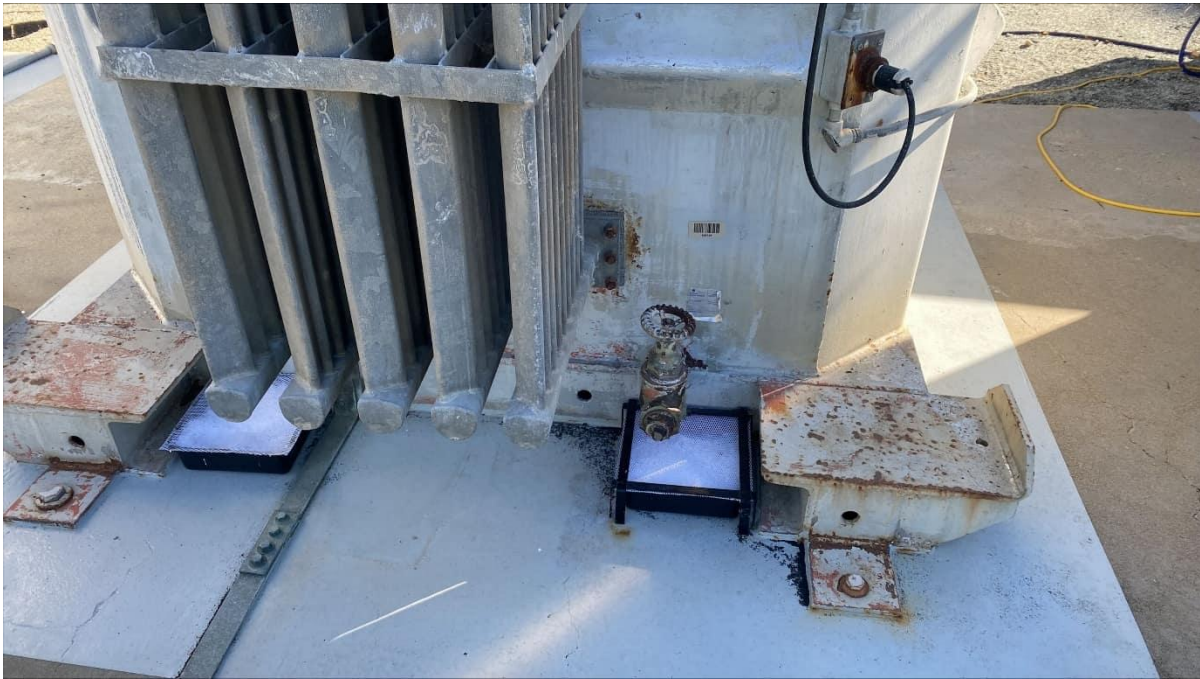
18.2. Transformer Bank 1 B Phase has an oil weep. PG&E has existing Notification #132825335 for this issue.

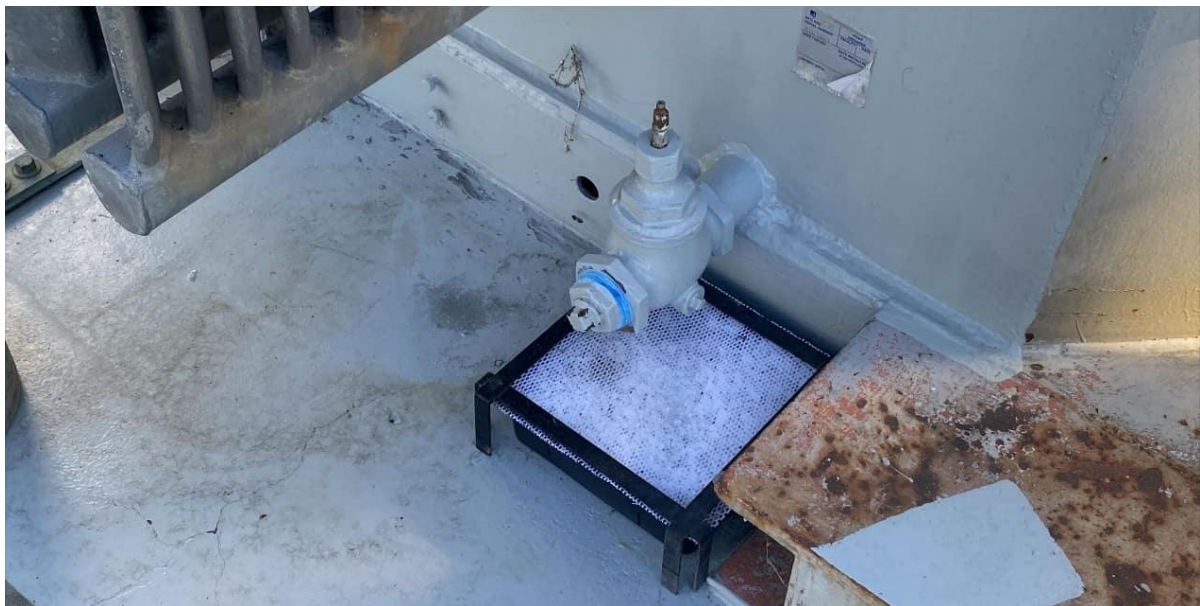
18.3. Transformer Bank 1 C Phase has an oil weep. PG&E has existing Notification #132825331 for this issue.

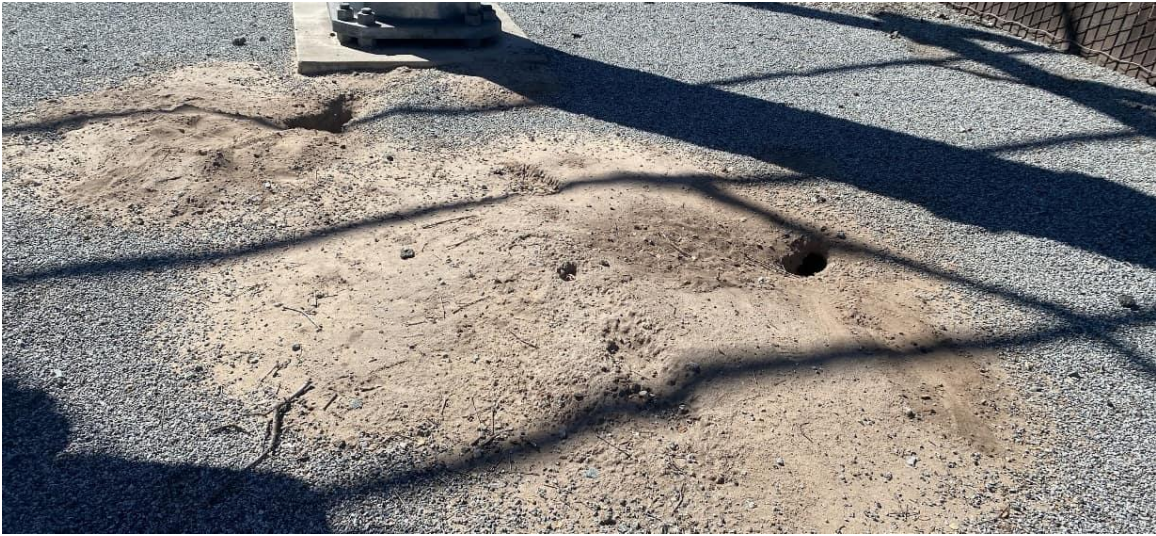
19.2. The transmission station has uneven ground and critter holes that present a tripping hazard. PG&E has existing Notification #133732465 for this issue.

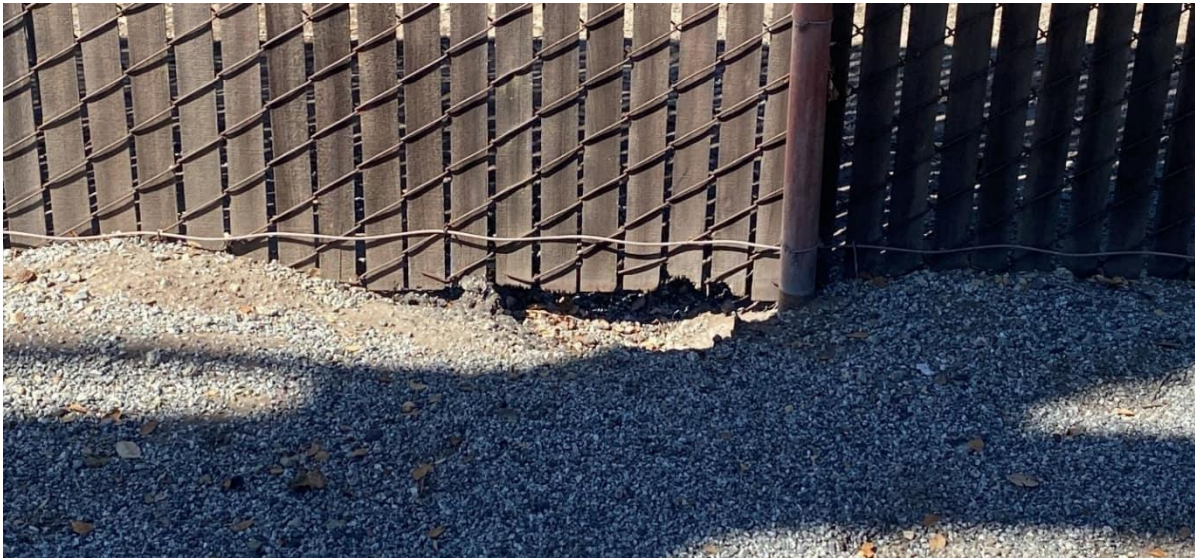
19.3. The transmission station perimeter fence has soil erosion and accessibility issues. PG&E has existing Notification #128745177 for this issue.

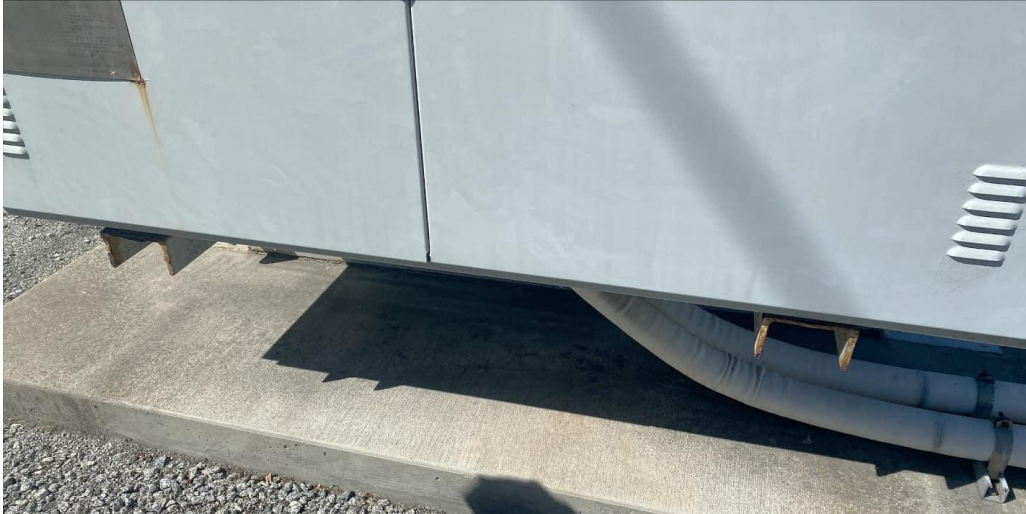
19.4. Transformer Bank 1 shows signs of corrosion and rust. PG&E has existing Notification #128744904 for this issue created on May 10, 2024 and updated for heavy rust on July 23, 2026.<sup>17</sup>

<sup>17</sup> ESRB identified the same issue under Notification #128882802 during the previous PG&E Moss Landing Substation Audit in June 2024 (SA2024-1172). Notification #128882802 was created on May 23, 2024 and closed on December 30, 2025 for the maintenance team to monitor and re-evaluate the issue.

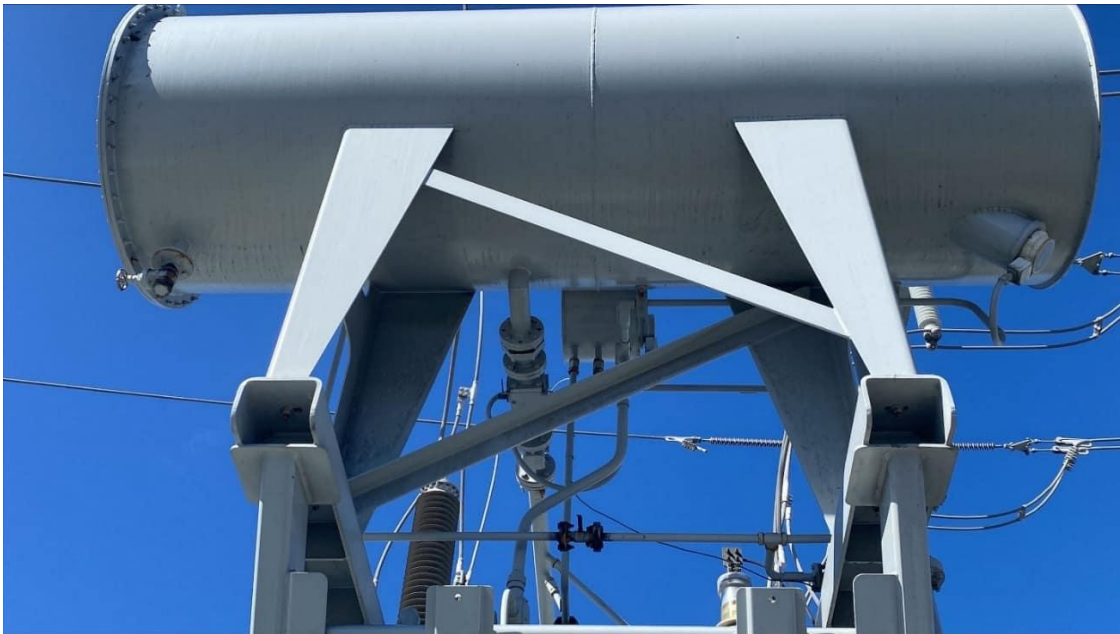
19.5. Transformer Bank 5 conservator tank has corrosion and shows signs of an oil weep. PG&E has existing Notification #133781904 for this issue created on July 23, 2026.<sup>18</sup>

<sup>18</sup> ESRB identified the same issue under Notification #128301423 during the previous PG&E Moss Landing Substation Audit in June 2024 (SA2024-1172). Notification #128301423 was created on March 18, 2024 and the oil leak was mitigated on January 28, 2025.

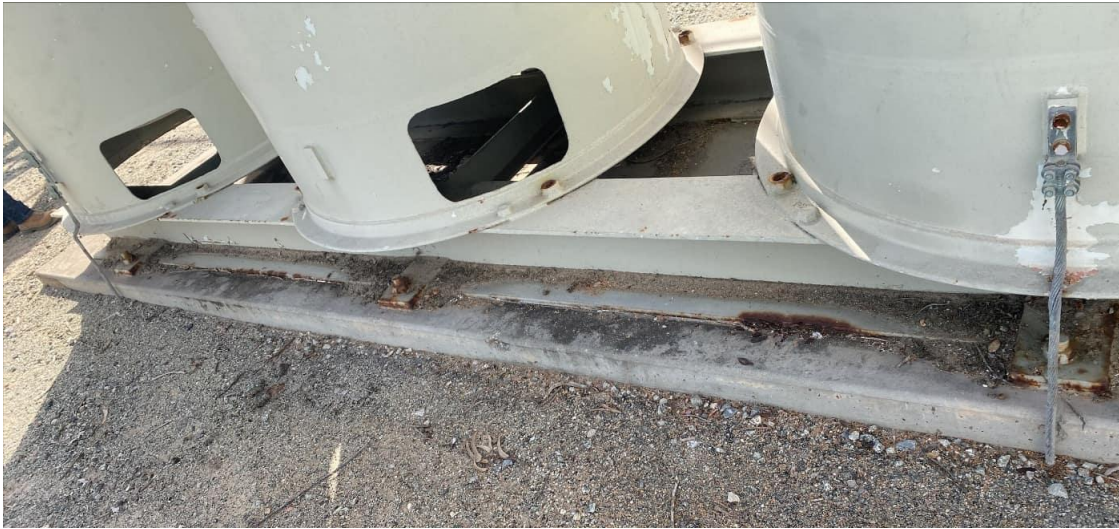
19.6. Circuit Breaker 312 shows signs of rust and corrosion. PG&E has existing Notification #128744756 for this issue created on May 10, 2024.<sup>19</sup>

<sup>19</sup> ESRB identified the same issue under Notification #128882800 during the previous PG&E Moss Landing Substation Audit in June 2024 (SA2024-1172). Notification #128882800 was created on May 23, 2024 and closed on December 30, 2025 because it was a duplicate tag.

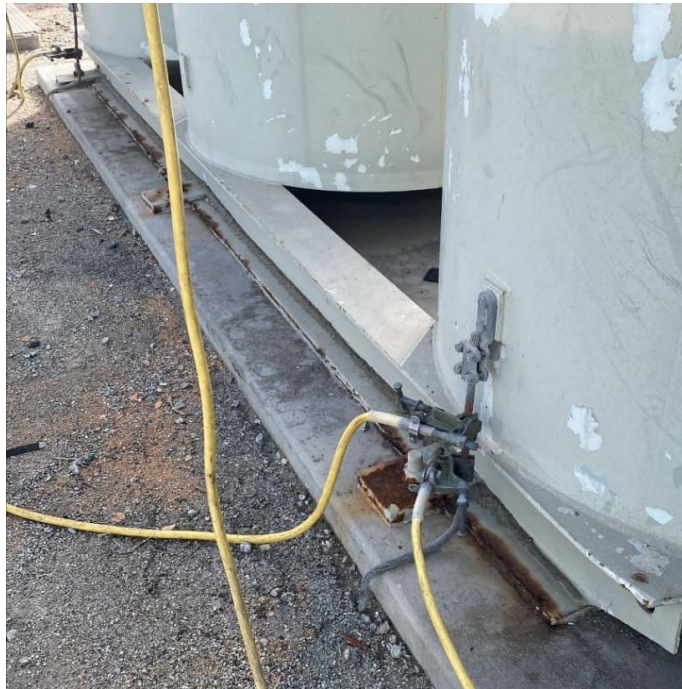
19.7. Circuit Breaker 322 shows signs of rust and corrosion. PG&E has existing Notification #128744759 for this issue created on May 10, 2024.<sup>20</sup>

<sup>20</sup> ESRB identified the same issue under Notification #128882765 during the previous PG&E Moss Landing Substation Audit in June 2024 (SA2024-1172). Notification #128882765 was created on May 23, 2024 and closed on December 30, 2025 because it was a duplicate tag.
