**CPUC AUDIT FINDINGS OF
EDWARDS SANBORN SOLAR AND
BATTERY ENERGY STORAGE
APRIL 21 – APRIL 24, 2025
RESPONSE**

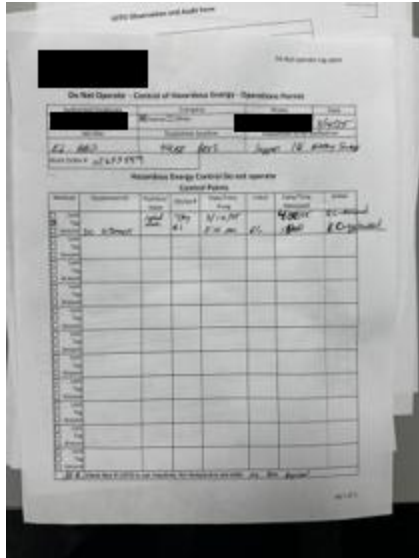
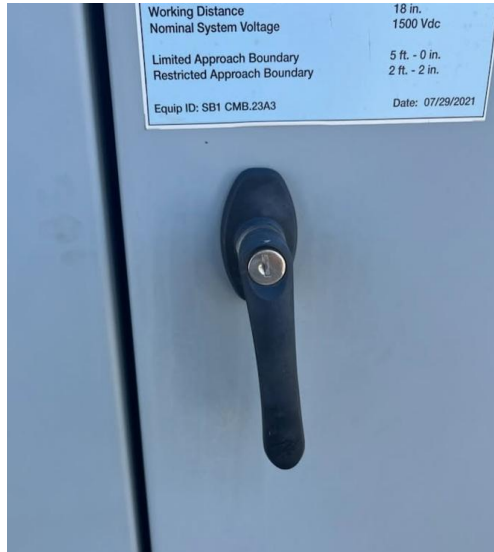
Finding 3: ESRB inspectors observed out-of-date tags on operational equipment.

Edwards Sanborn, along with the O&M provider, recognizes the operational and safety risk this presents and the seriousness of this item. As mentioned in the report, the documentation was reviewed by Plant and ESRB staff, and it was verified that day by all teams that the unit had been properly cleared for return to service per site procedures. The tag was removed.

The O&M provider has completed retraining of the site personnel to include the individuals involved. The O&M has also completed an audit of their LOTO procedure, including any open LOTO's. Finding closed on 4/28/25.

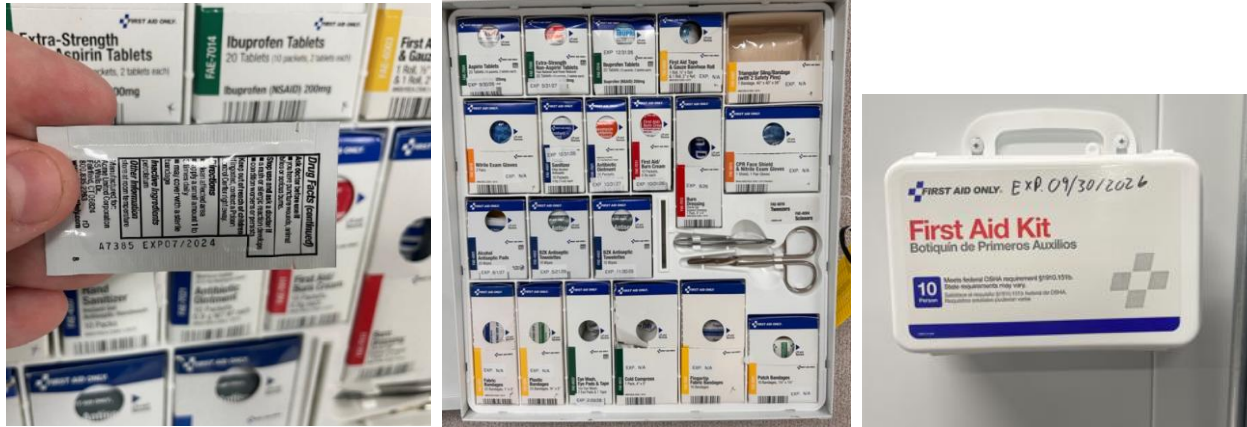
Finding 5: ESRB inspectors found expired inventory in the first-aid kit of the main operation building.

Edward Sanborn inspected all first aid kits including the first aid kit in the main operations building and ordered all expired inventory the day it was identified during the audit. All items were placed in the first aid kit upon arrival. All first aid kits at Edwards Sanborn have been and continue to be routinely inspected to ensure that the kits contain their proper inventory and that any medication, salve, etc. is swiftly ordered and replaced prior to its expiration. All items with an expiration date have been labeled on the front of that units box or on the kit for quick easy identification. The last item was completed and finding closed on 5/6/25.

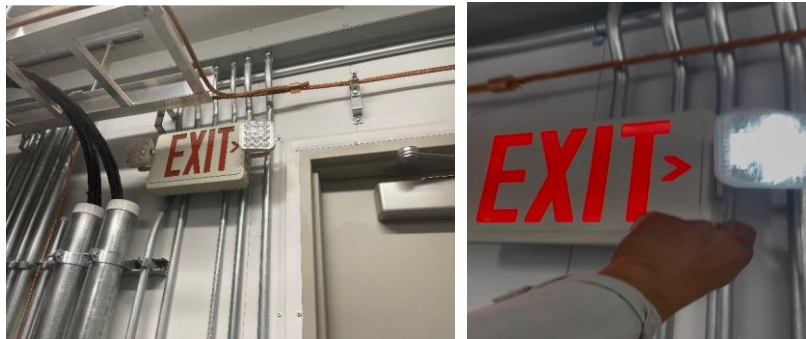
Finding 6: ESRB inspectors observed emergency exit lights at the substation that did not illuminate when tested.

As mentioned in the report, during the audit, Edwards Sanborn was able to rectify the issues with the substation emergency exit lights showing ESRB inspectors that they were operational and identifying the issue as a connection problem that occurred during construction. Edward Sanborn has revised the substation monthly inspection checklist to include emergency light testing to ensure they are in proper working condition. This includes monthly functional testing, annual comprehensive functional testing and establishes written records of all inspection and tests. While Edward's Sanborn establishes the CMMS system (ETA: Sept 2025), in the interim the interim CMMS platform is being used for scheduled notifications, logging and historizing. This finding is closed 4/24/25.

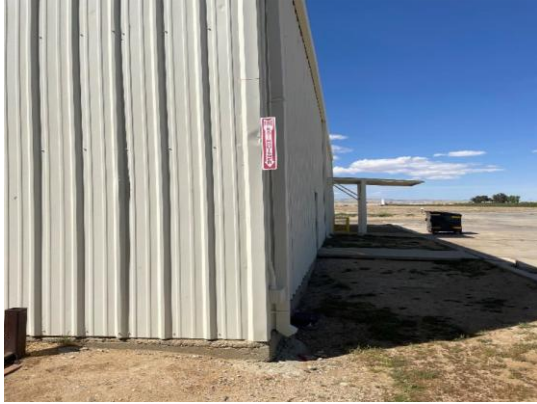
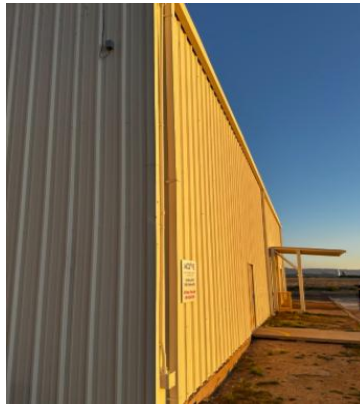
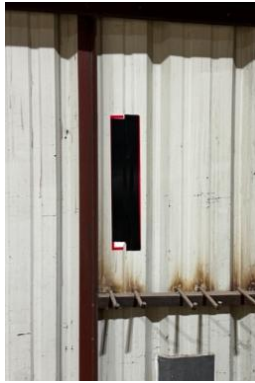
Finding 7: ESRB inspectors observed fire extinguisher signs in and around the storage warehouse missing their associated fire extinguishers.

As reported, this was due to a new leased building and the owner nor previous lessee had not removed this signage. It was not in a correct location for Edwards Sanborn daily use. During the audit, Edwards Sanborn staff rectified this finding by removing the inaccurate signage while maintaining the accurate signage of the fire extinguishers that were already in use. Finding closed 4/21/25.

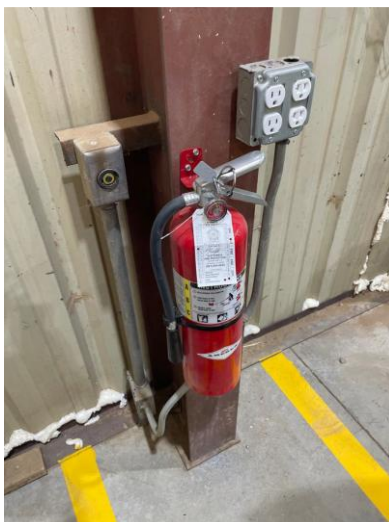
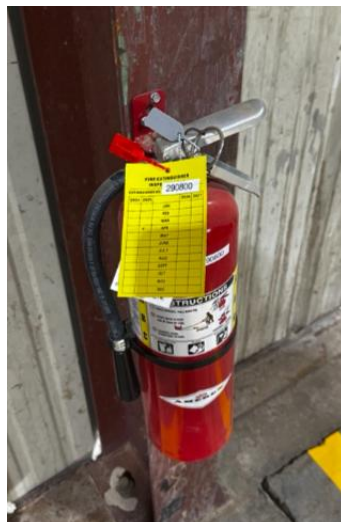
Finding 8: Various fire extinguishers are missing monthly inspection tags.

Edwards Sanborn has worked with the warehouse team to ensure that all fire extinguishers are equipped with current monthly inspection tags (as of 4/21/25) and that personnel are completing monthly inspections, as required. Edwards Sanborn has established a digital monthly checklist that will track completion and any discrepancies of all inspections. It will automatically notify the party responsible of the discrepancy, for corrective actions. Finding was corrected and closed 4/21/25.

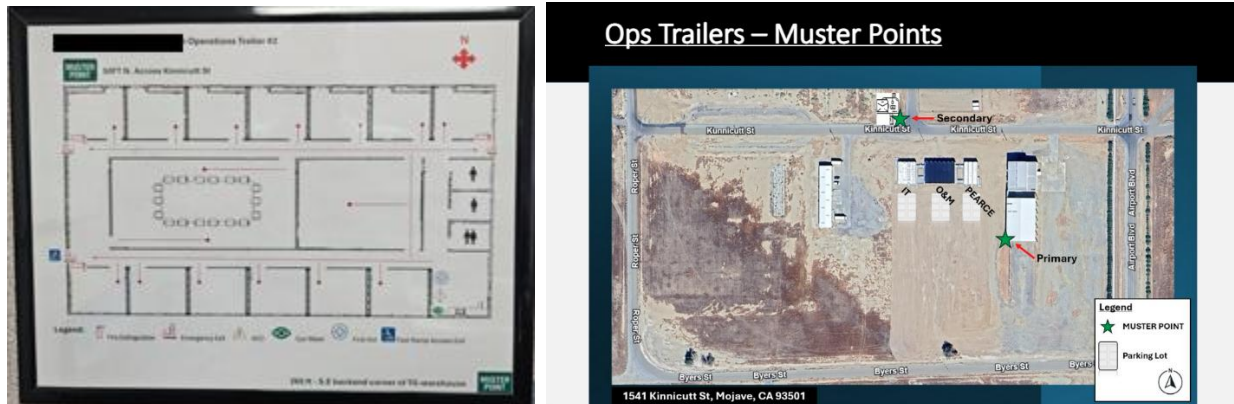
Finding 9: The site map does not identify muster points for the main operations building and surrounding structures.

Edwards Sanborn has revised and posted the evacuation maps for the main operations area that clearly identifies all muster points (primary / secondary) for the building and adjacent structures. They have also added an overhead view to the orientation that includes the primary and secondary muster points. Finding was corrected and closed 5/2/25.

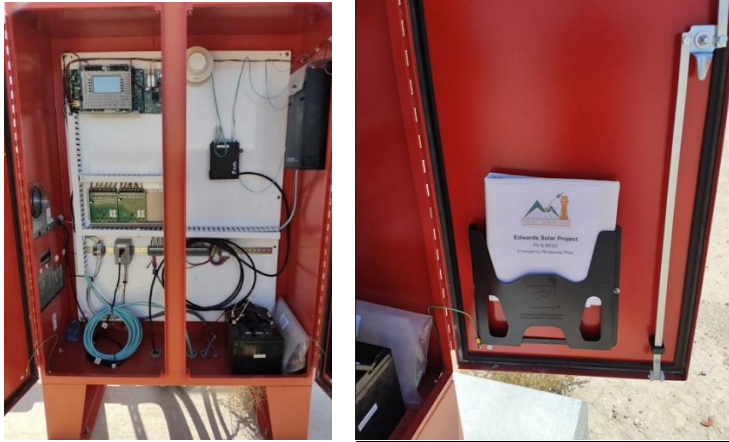
Finding 11: Edwards Sanborn did not maintain a copy of the ERP in the site's fire alarm control cabinet as required.

Edwards Sanborn has placed a current copy of the ERP in the fire alarm control cabinet. Please see submitted photographic documentation of completion. The absence of the ERP in this location would not delay access to critical response information during an emergency since Edwards Sanborn has previously provided this information to the fire depts and it is kept digitally in their system for remote use, as needed. Revised 4/29/25, installed in FACP 4/30/25. Finding was corrected and closed 4/30/25.

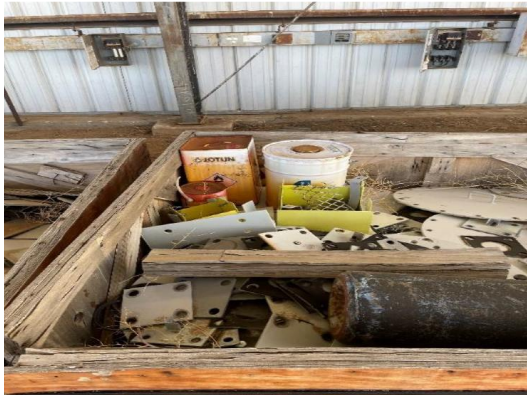
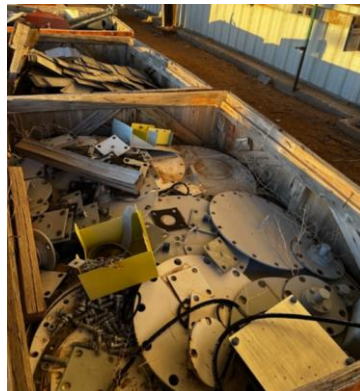
Finding 12: ESRB inspectors observed hazardous waste and gas cylinders improperly stored.

Terra-Gen staff further explained that the materials observed were not part of the typical hazardous materials inventory used by Terra-Gen operating sites. It was believed that these materials were residual items left behind by a contractor following the completion of construction activities associated with the Edwards solar projects. When they were discovered in the field, personnel likely noted that the materials had not been stored in a location designated on the Edwards Solar & BESS HMBP. Acting under the assumption that the materials had been abandoned, and intending to temporarily secure them while the responsible contractor was identified, field personnel relocated the items to the new warehouse area until final determination and appropriate disposition or location reassignment could be made by Site Management.

Since the April 21st observation, Terra-Gen has completed and formally submitted the HMBP for the new operations office and warehouse to the local CUPA via the CERS database. The submittal has since been accepted by the local CUPA.

The finalized HMBP has been incorporated into the site-specific environmental compliance training program, and targeted communications have been issued across relevant departments to reinforce the following:

- Only designated and approved storage areas may be used for hazardous materials and waste.
- All handling and storage must be conducted in full compliance with applicable regulatory requirements and Terra-Gen's Corporate Handling and Storage of Hazardous Materials & Waste Program.
- Contractors are required to remove all of their materials off site once the contracted scope of work has been completed.
- Abandoned or unidentified materials must be reported immediately to the EHS staff and to Site Management for proper evaluation and management.
