CPUC AUDIT GA2025-02MH FINDINGS RESPONSE  
MARSH LANDING GENERATING STATION  
April 21-24, 2025

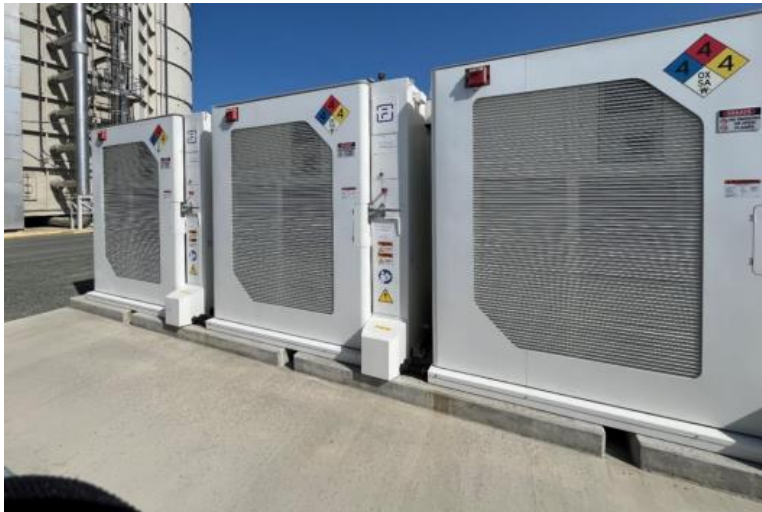
**Finding 2: The Plant must conduct the required maintenance activities on the Black Start system.**

Marsh Landing has not yet received the requested documentation from Fluence. We have renewed our request for record of services performed and will provide them to the CPUC as soon as they are available.

While documentation is pending, Marsh Landing emphasizes that the team has diligently monitored the status and availability of the BESS system since the project began commercial operation. Weekly coordination meetings with Fluence, along with frequent informal interactions, ensure timely attention whenever anomalies are observed.

Figure 1 Black Start BESS

To further ensure compliance, negotiation of a Long-Term Service Agreement with Fluence is complete, and execution will occur no later than August 29, 2025. The LTSA will establish a structured framework for preventive maintenance, including recordkeeping, to address the CPUC's concerns going forward.

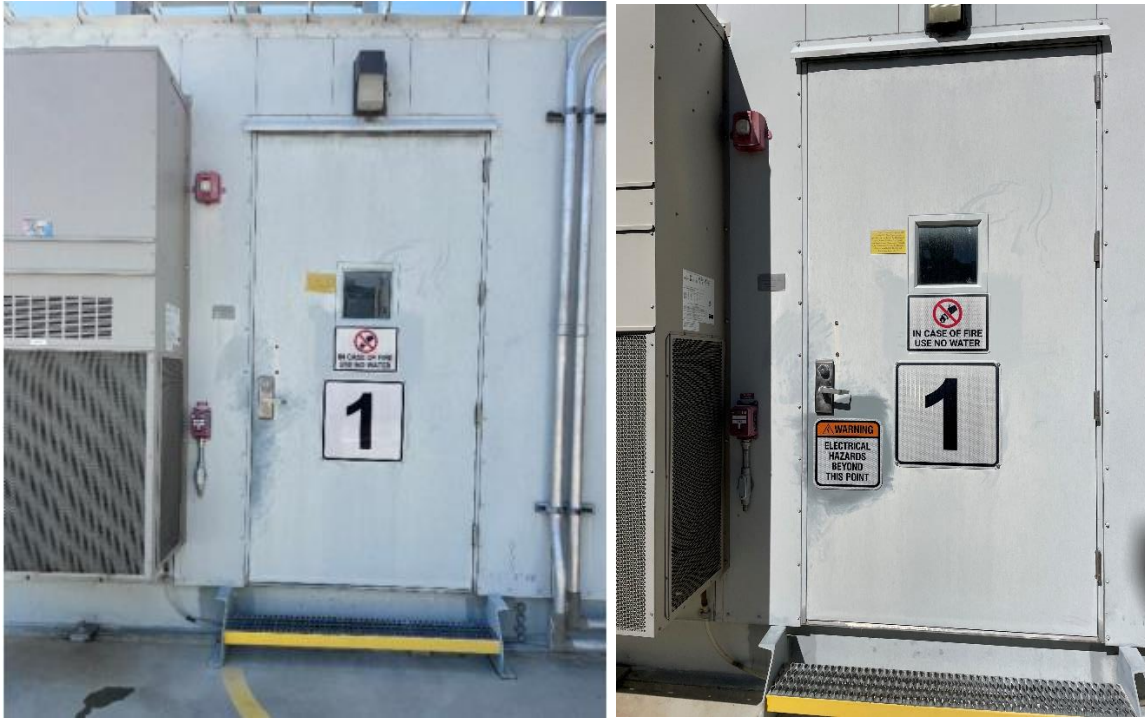
**Finding 3: Safety signage identifying electrical and high voltage hazards on buildings must be improved.**

Figure 2: Electrical Package door without, and with, electrical hazard identification signage

New exterior signage indicating electrical hazard warning beyond this point have been added to all appropriate locations.

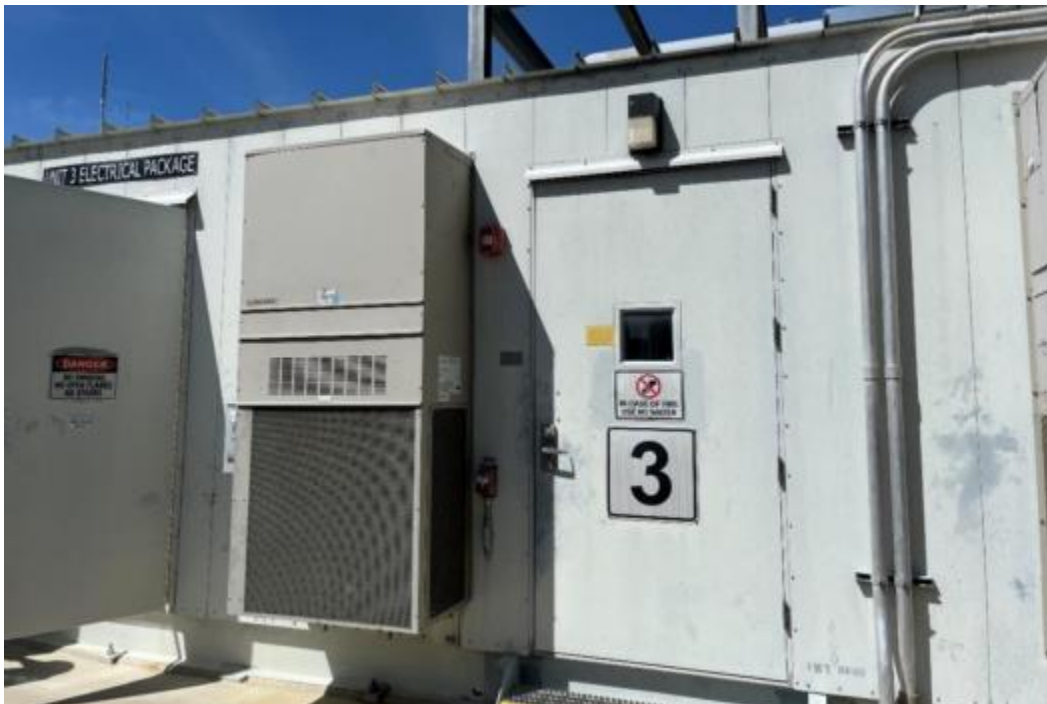
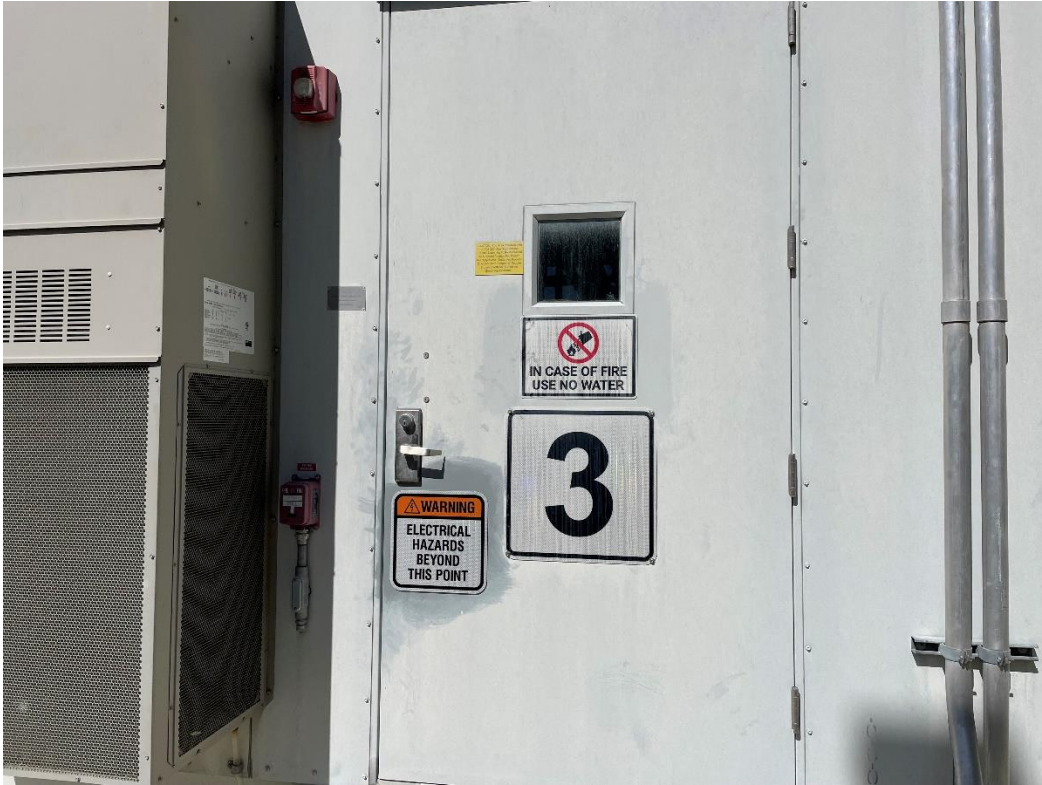
Figure 3: Electrical Package entrance without, and with, electrical hazard identification signage

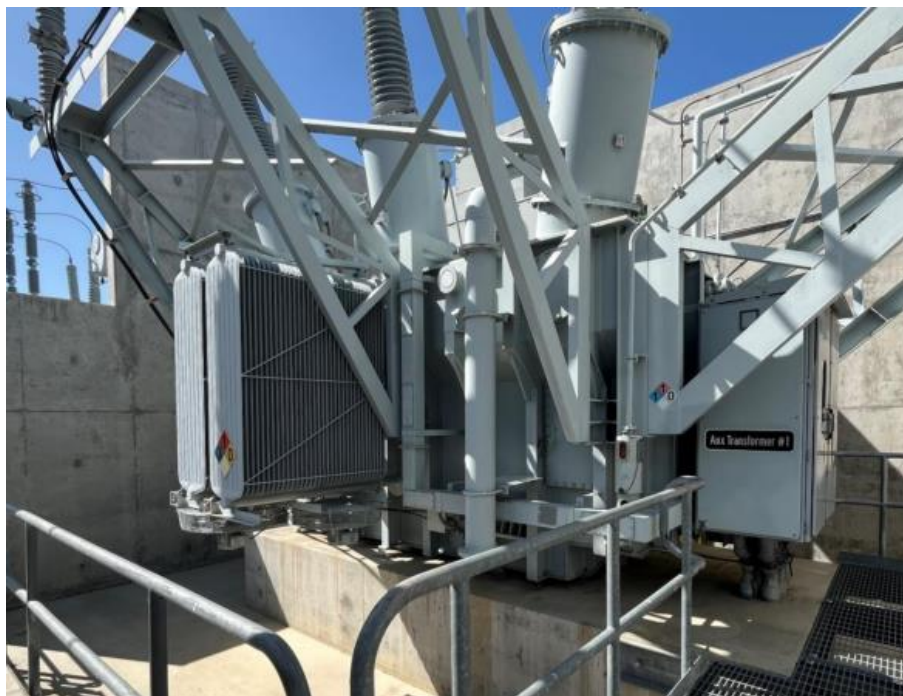
**Finding 4: National Fire Protection Association (NFPA) 704 placards are inaccurate and must be corrected.**

Figure 4: UAT NFPA Placard; Left: Health rating of 1, Right: Health rating of 0

NFPA signage was update immediately at time of ESRB visit.

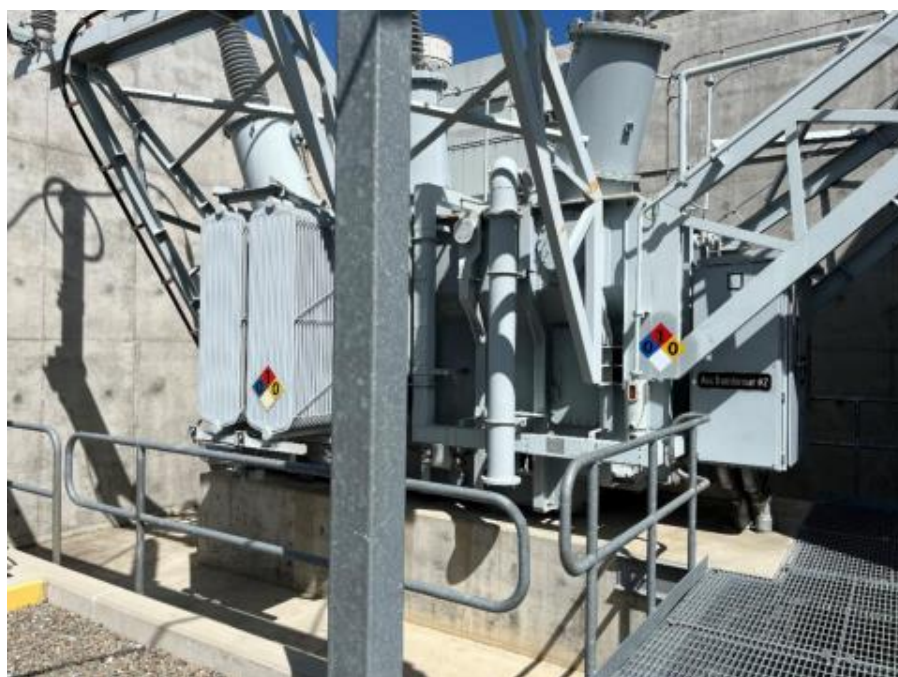
Figure 5: Corrected NFPA Placards

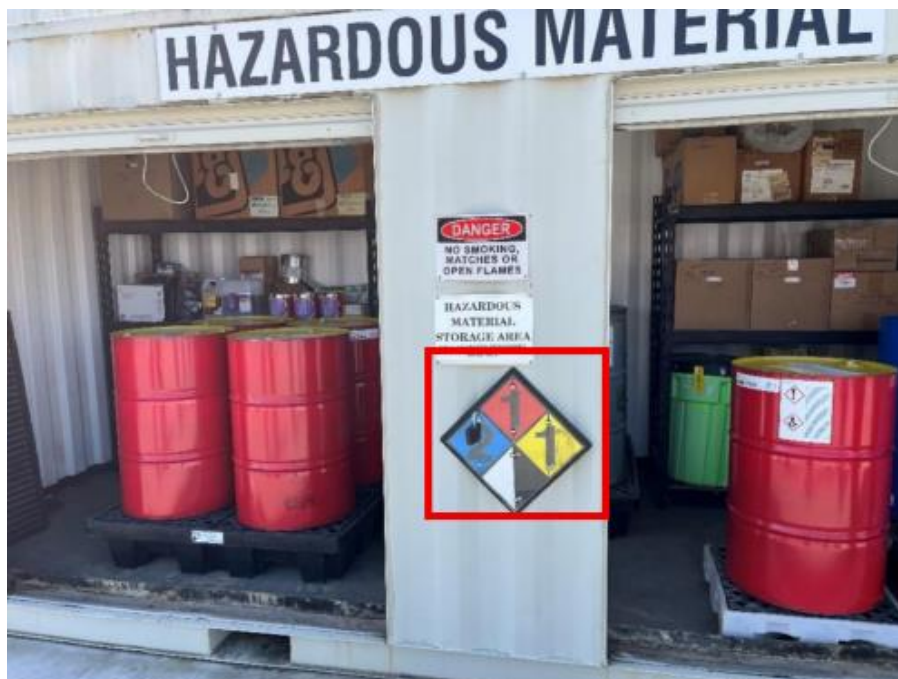
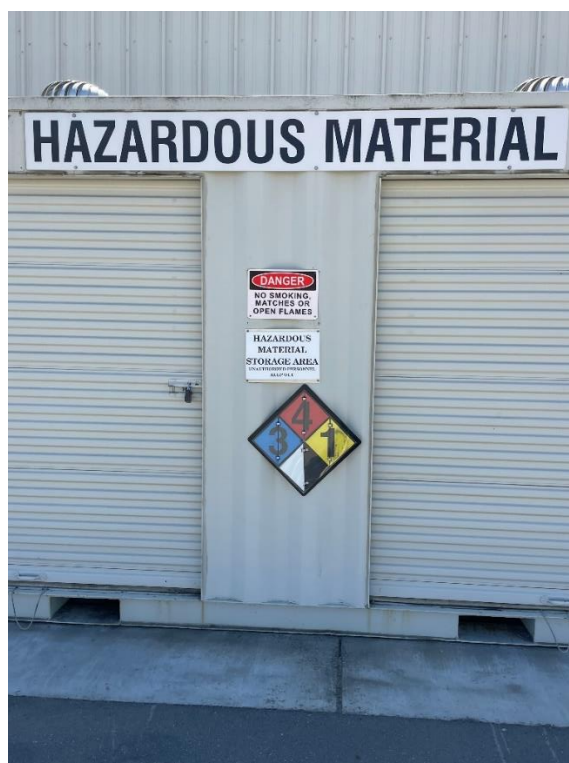
Figure 6: Hazardous Material Storage NFPA sign was updated to reflect the highest level stored inside the container at time of ESRB visit.

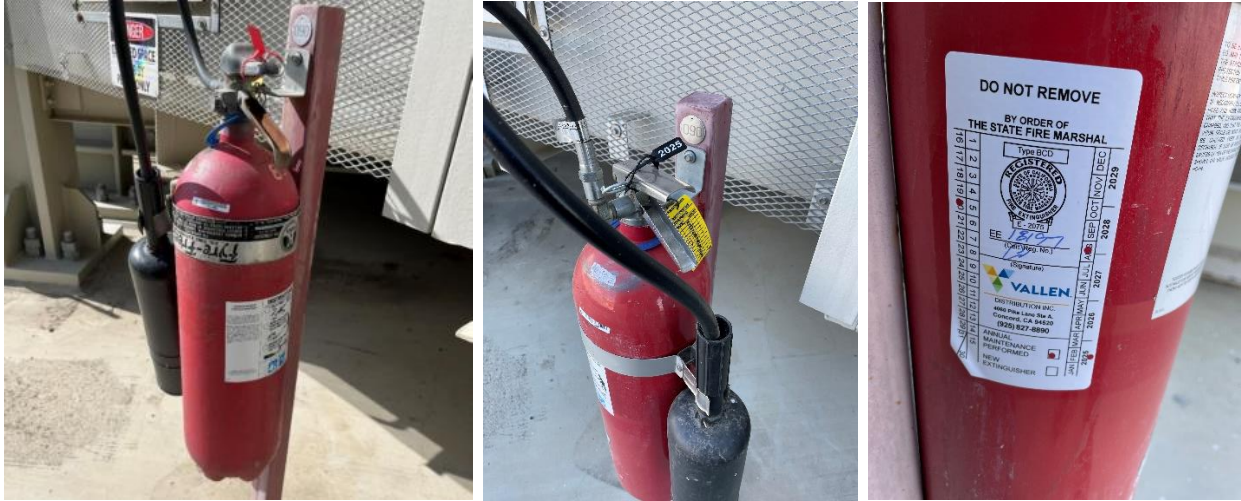
**Finding 5: Portable fire extinguisher inspection and maintenance practices must be improved.**

Figure 7: Fire Extinguisher 090 (Unit 4 Stack) before and after photos.

The Plant promptly removed the three units from service during the audit and replaced with appropriate spare extinguishers. The contracted vendor completed the annual PM services on all station extinguishers on 8/20-21/2025.

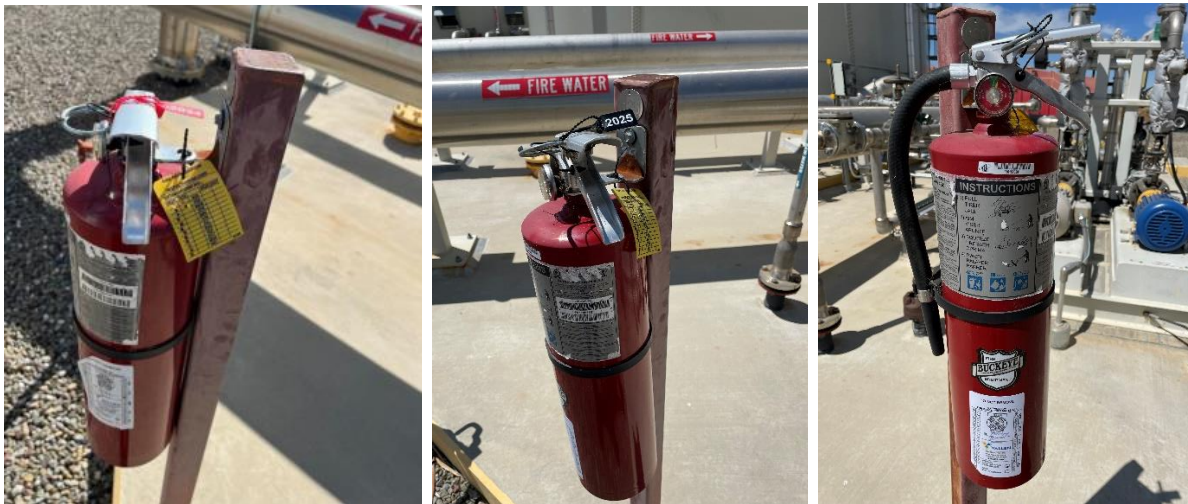
Figure 8: Fire Extinguisher 26 (Water Tank) before and after photos.

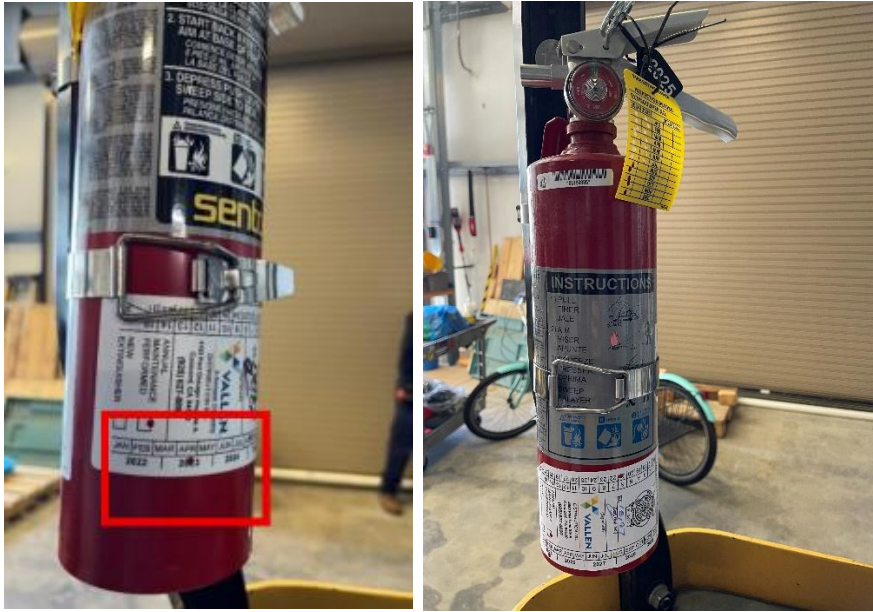
Figure 9: Fire Extinguisher on Forklift before and after photos.

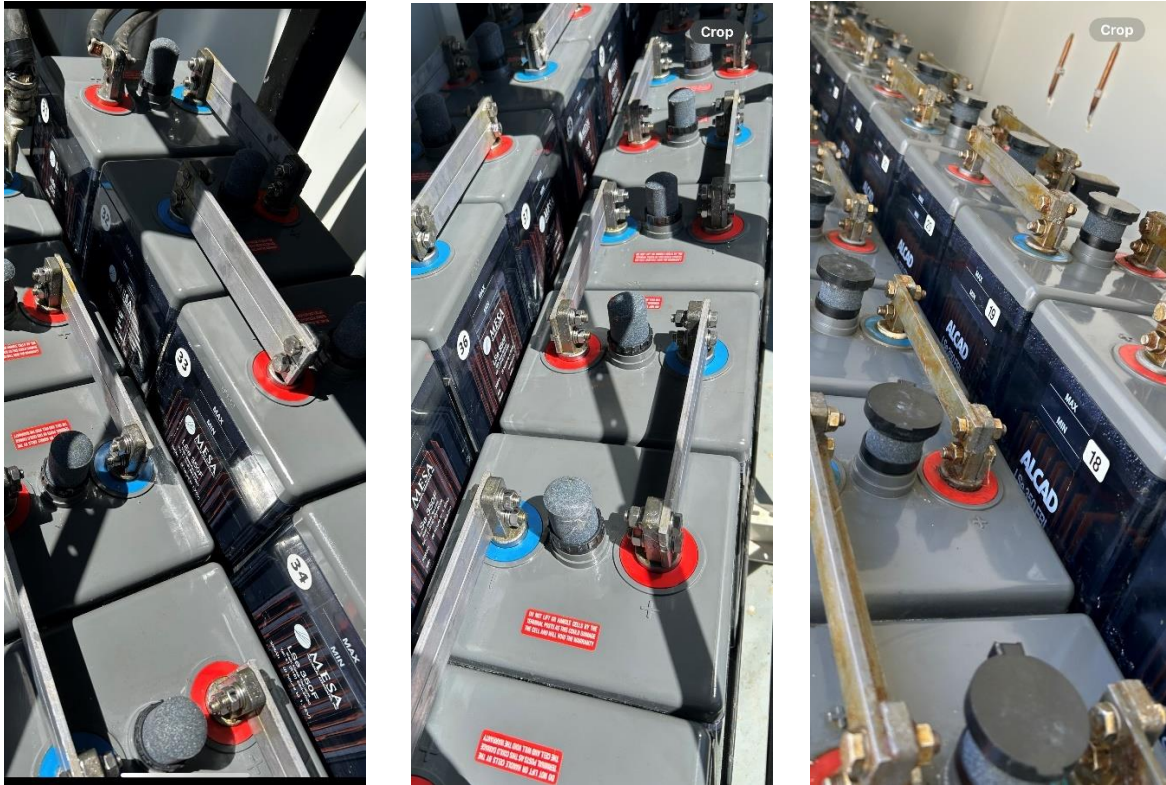
**Finding 6: Lead acid DC Battery terminal corrosion must be cleaned and routinely monitored.**

Figure 11: Clean Battery Banks.

Battery PM work plan updated to include clean & note corrosion.

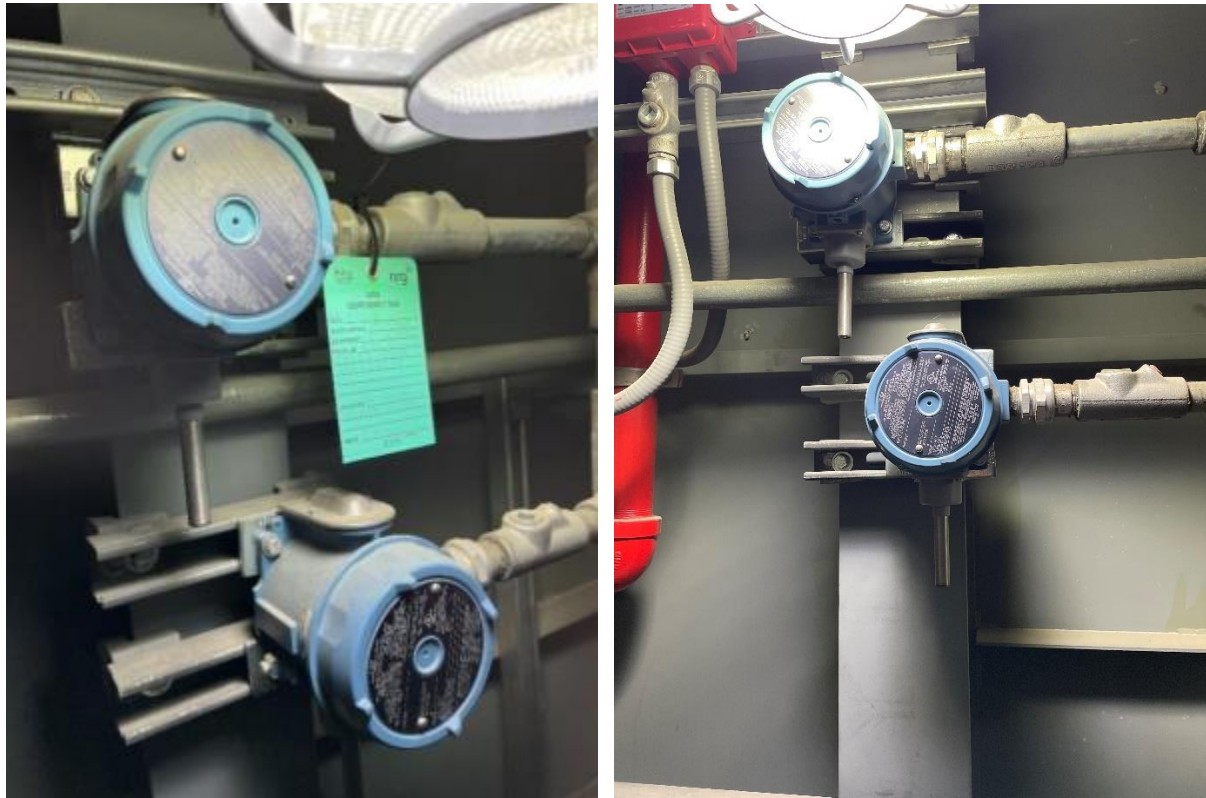
**Finding 7: A Deficiency Tag that is no longer applicable must be removed from Combustion Turbine 4 compartment.**

Figure 13: Artifact Deficiency Tag removed.

Deficiency tag for notification 1401874223 was an artifact of past practice. Work was completed by onsite technician who adjusted temperature settings. Deficiency tag has been removed from location.

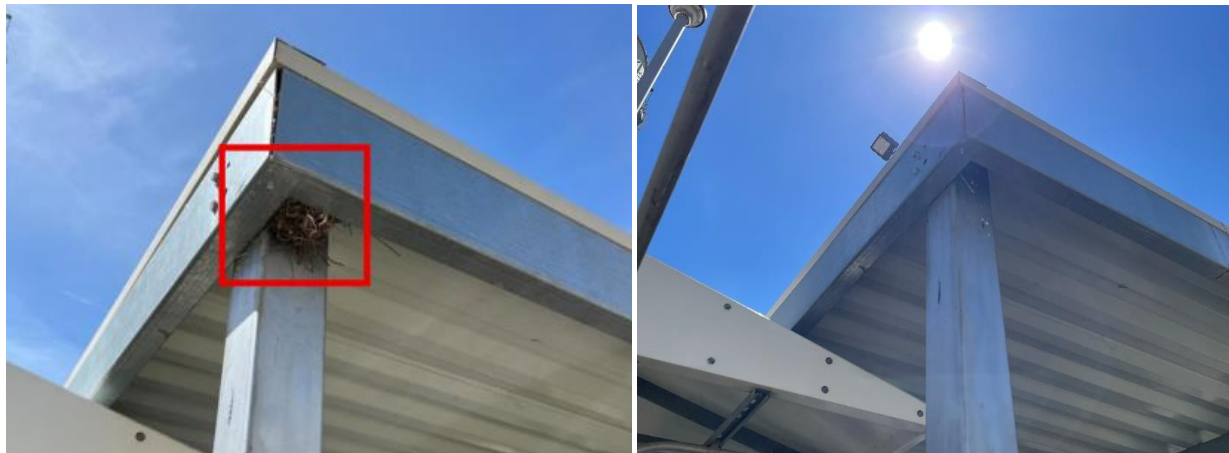
**Finding 10: Bird nests were present on equipment at the Plant.**

After quiet observation, I erected a step ladder next to the nest and climbed the ladder for a closer inspection. I used a handheld mirror to look over the rim of the nest into its cup, which was empty. Using text descriptions and images in the field guides *Nests, Eggs, and Nestlings of North American Birds* (Baicich and Harrison, 2005) and *Western Birds' Nests* (Harrison 1979), I identified the nest as an inactive house finch (*Haemorhous mexicanus*) nest. This identification was supported by comparing the condition of the nest to various images found online, consistent with the habit of the house finch to allow fecal sacs and waste from the nest to accumulate around its rim. The nest at MLGS contained no eggs or chicks, but was completely covered in fecal sacs and waste, suggesting it was used successfully to fledge one or two broods in 2025.

ongoing background noise and disturbance, and the apparent success of this year's nest, it seems unlikely that operations at MLGS would cause harm to future nests at this or similar locations.

Figure 14: Bird nest in Gas Chromatograph before and after photos.

Because the nest was inactive and was a source of concern to regulators, and therefore to MLGS, I removed the empty nest on August 6, 2025, immediately after confirming species identification and inactive status. Active house finch nests are protected under the Migratory Bird Treaty Act and California Fish and Game Code, but inactive house finch nests are not a protected resource. The house finch has an extensive range and is noted by the IUCN Red List as having an increasing population, categorized as "Least Concern."
