Incident Investigation Report
Reference Documents
SED Incident E20211223-01
(Brewer Fire)

ELECTRIC INCIDENT REPORT FORM

PG&E Reference Number: EI210707A

Grass Valley – Property Damage

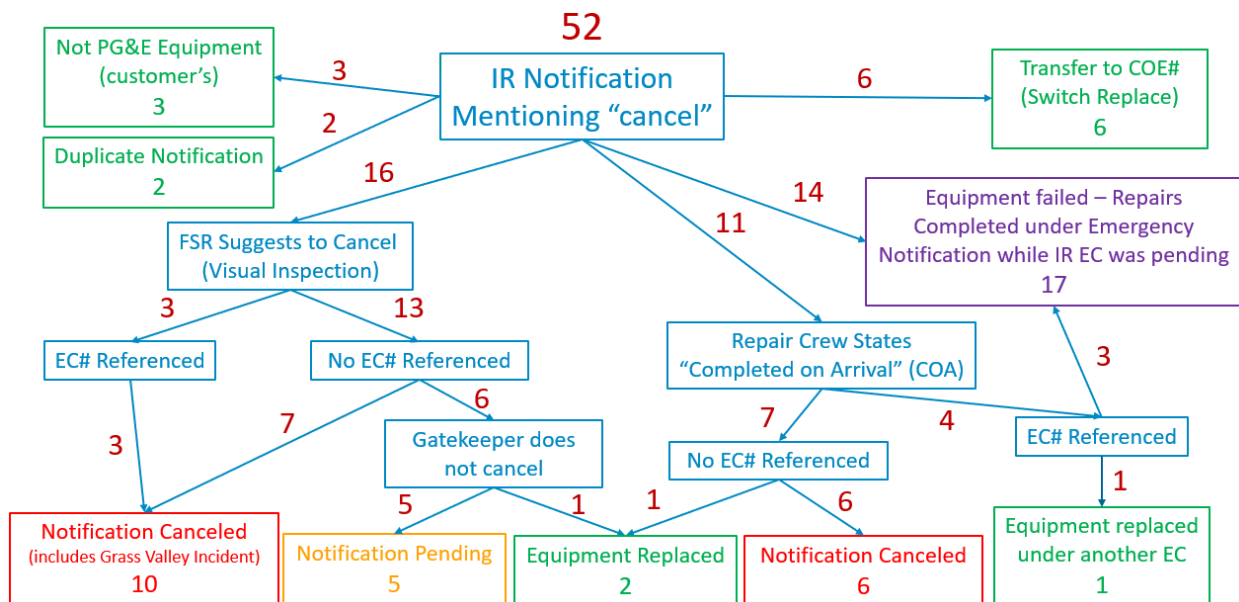
In total, sixteen notifications, ten from FSR suggestion and six from repair crews, were canceled without any evidence of work being completed at any point after the IR inspection identified an overheating equipment.

The investigation also found that in seventeen instances, including this incident, the infrared notification was canceled because the underlying equipment failed in the field before being addressed and was repaired under an emergency notification.

Figure 1: Flow chart of canceled IR notifications. Red boxes are incorrectly canceled, Green boxes were correctly canceled or fixed, Orange box is currently pending, Purple box was canceled due to the equipment failing before being addressed.

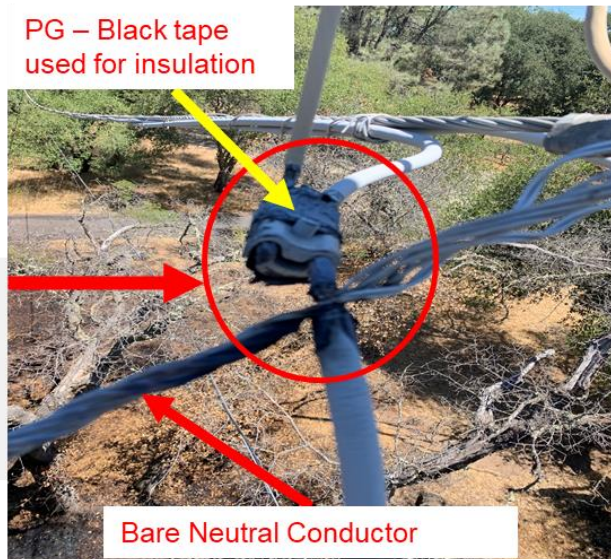
Neutral conductor overlay on the service drop caused direct short. Low voltage insulation failed and caused arcing.

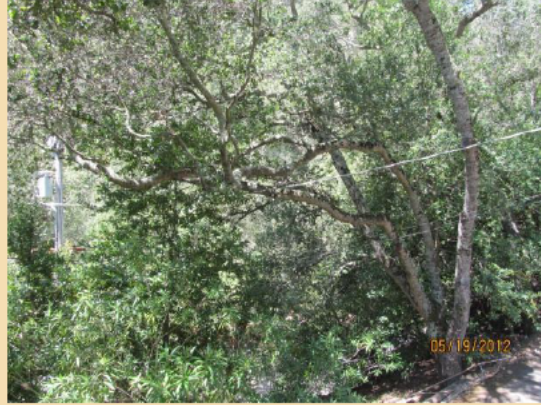
OVERHEAD SERVICE STRAIN ABRASION

At this Location: Service strain abrasion, no slack remaining

Perform Minor Work: Yes, if safe to do so. If you replace the service conductor this is capital Minor Work.

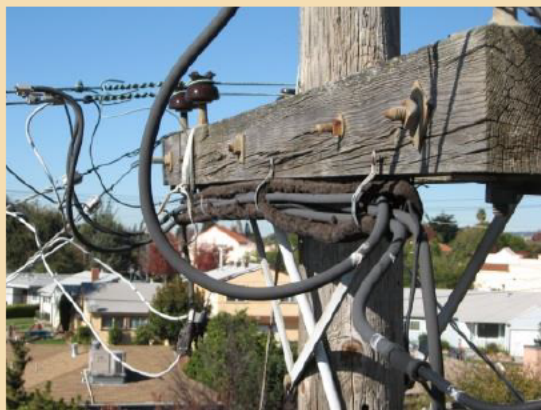
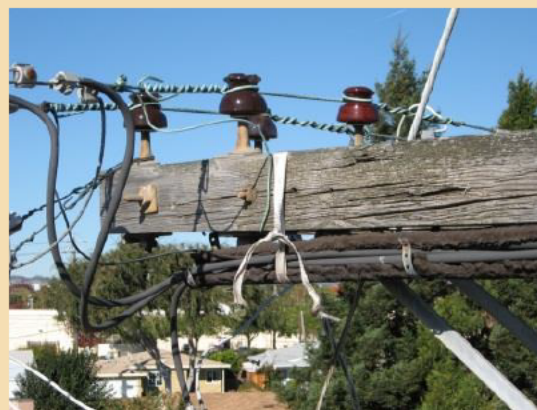
UNDER-ARM BUS LOOSE AND DETERIORATED

At this Location: UAB deteriorated, partial repair with rope, secured with one strap.

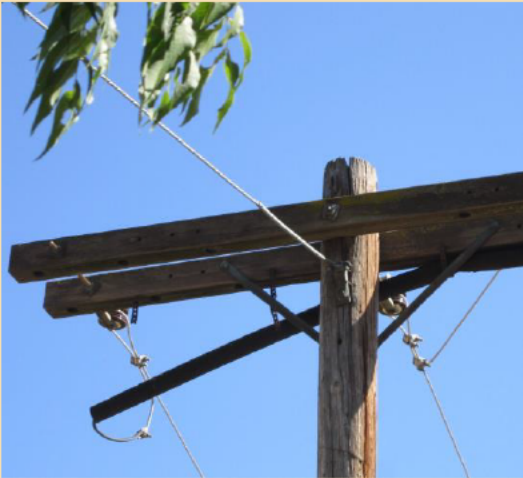
UNDER-ARM BUS LOOSE

At this Location: UAB Loose

Perform Minor Work: Yes

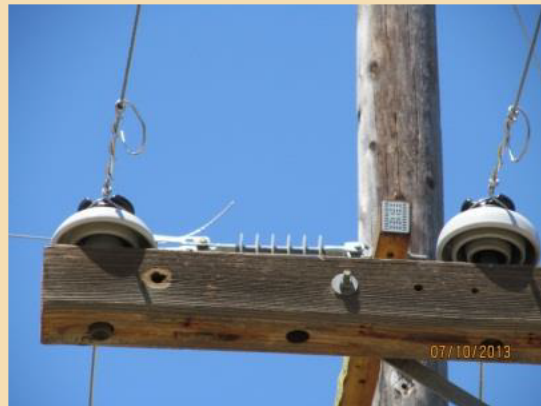
PRIMARY WOOD PIN SQUATTER

At this Location: Primary wood pin squatter. Replace Crossarm. No armor rod with hand-tie.

Perform Minor Work: No

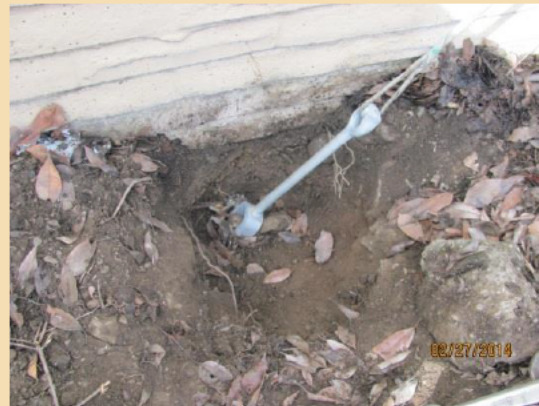
Anchor extension

At this Location: Inspector performed minor work, exposed anchor, evaluated anchor to be in good condition so that extension could be installed, then installed extension. (Back fill not shown)

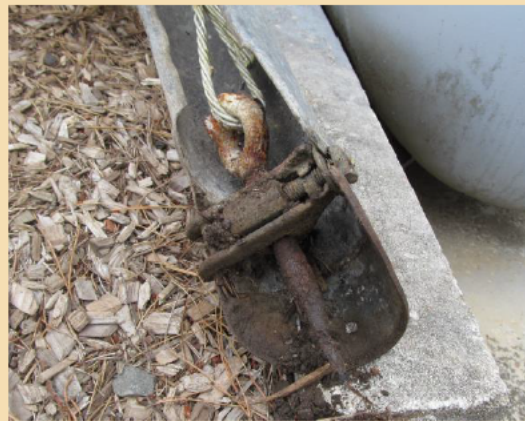
At this Location: Corroded Anchor

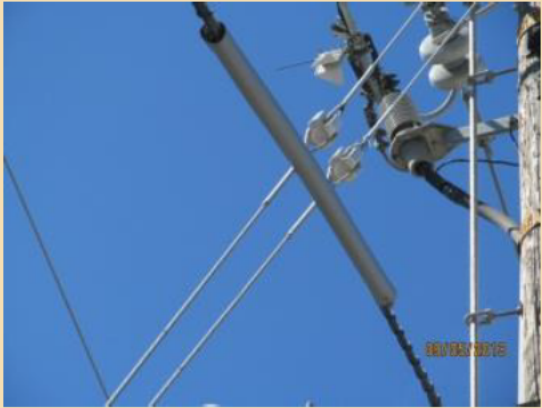
GUY CLEARANCE	GUY DAMAGED REPAIR

<p>At this Location: Acceptable solution through plastic barrier.</p> <p>GO 95 requires 3" of radial clearance. Plastic barriers can be installed if less than 3" of clearance.</p>

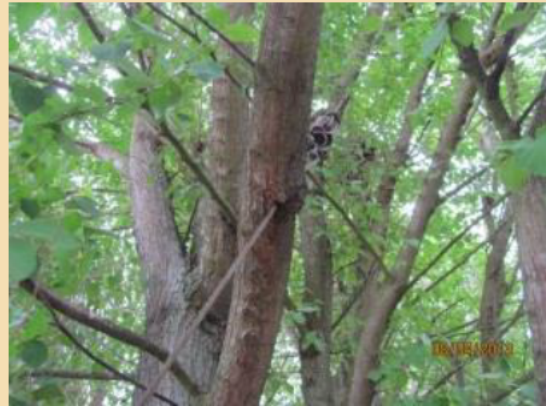
TREE GROWING AROUND GUY

At this Location: Tree growing around guy

Perform Minor Work: No

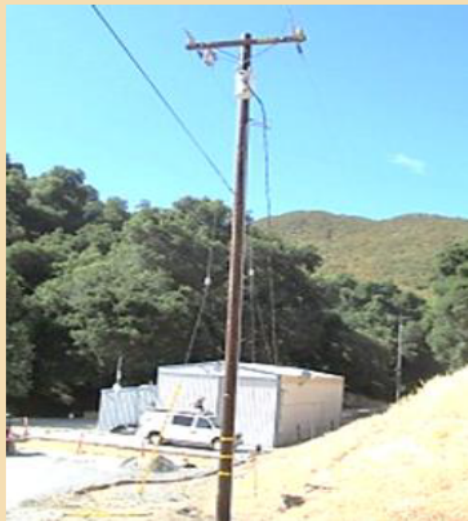
SLACK GUY

At this Location: Loose guy on left side

Perform Minor Work: Yes

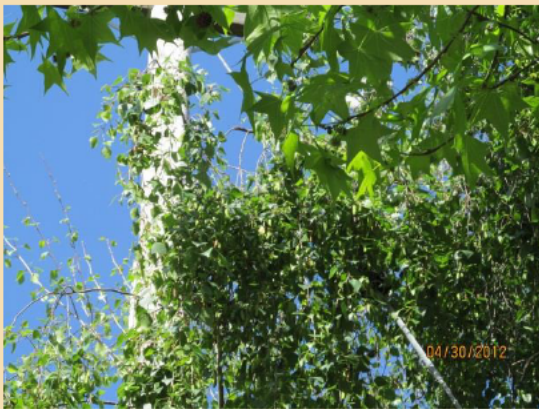
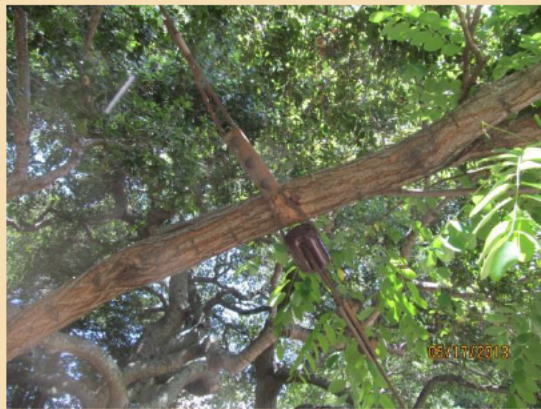
DOWN GUY GROUNDED ABOVE GUY INSULATOR	DOWN GUY GROUNDED ABOVE GUY INSULATOR CAUSING STRAIN AND ABRASION

<p>At this Location: Vine growing up and across the guy insulator grounding the guy.</p>	<p>At this Location: Tree grounding the guy above the guy insulator causing strain and abrasion.</p>
<p>Perform Minor Work: Yes</p>	<p>Perform Minor Work: Yes, if minor work not possible</p>
<p>Write Third-Party Notification: No</p>	<p>Write Third-Party Notification: No</p>
<p>Write EC Form: Yes, only if minor work cannot be performed</p> <ul style="list-style-type: none"> • FDA=Guy / Overgrown / Trim • Priority "E", 3-12 months depending upon exposure 	<p>Write EC Form: Yes, only if minor work cannot be performed</p> <ul style="list-style-type: none"> • FDA=Guy / Strain/Abrasion / Remove • FDA=Guy / Overgrown / Trim • Priority "E", 3-12 months depending upon exposure

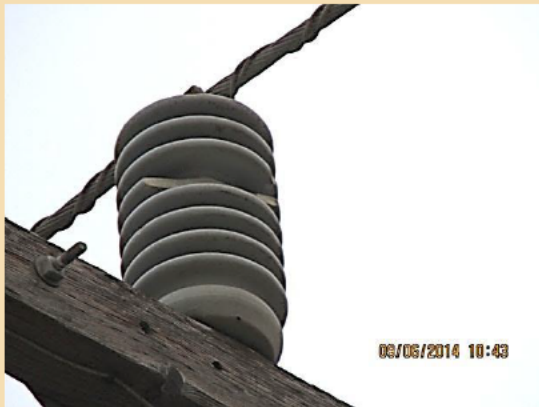
DAMAGED INSULATOR

At this Location: Damaged insulator with an insulator that I no longer approved. Replace all insulators and the arm

Perform Minor Work: No

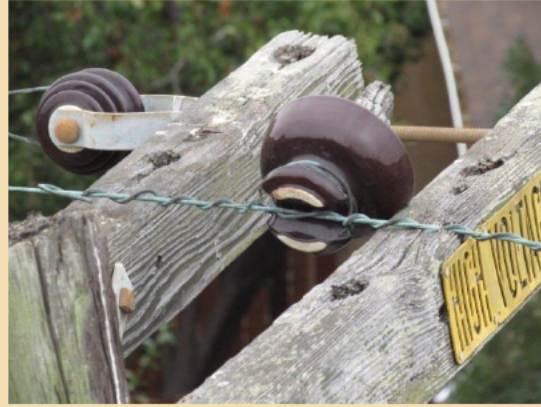
INSULATOR LAYING ON ITS SIDE / PRIMARY ON THE ARM

At this Location: Insulator lying on its side. Primary on the arm.

Perform Minor Work: No

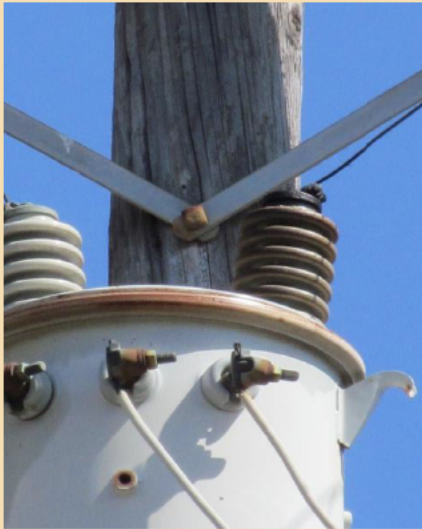
FLASHED INSULATOR ON TRANSFORMER

At this Location: Flashed insulator on transformer

Perform Minor Work: No

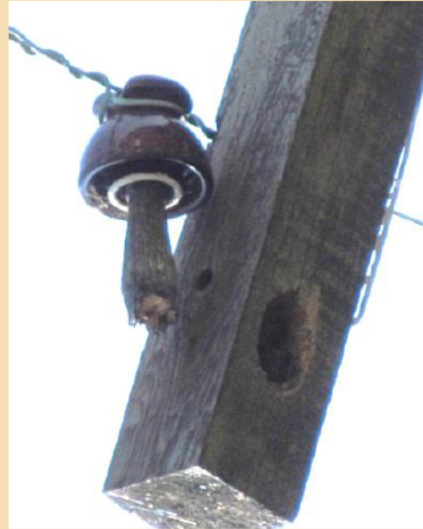
BROKEN WOOD PIN ON PRIMARY

At this Location: Broken wood pin. Primary (High Voltage Sign). Conductor on arm. Replace all insulators and the crossarm with a composite arm.

Perform Minor Work: No

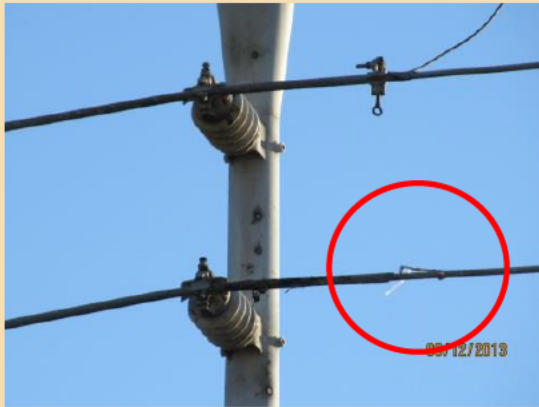
FLASHED INSULATOR MYLAR BALLOON

At this Location: Flashed insulator by Mylar balloon

Perform Minor Work: No

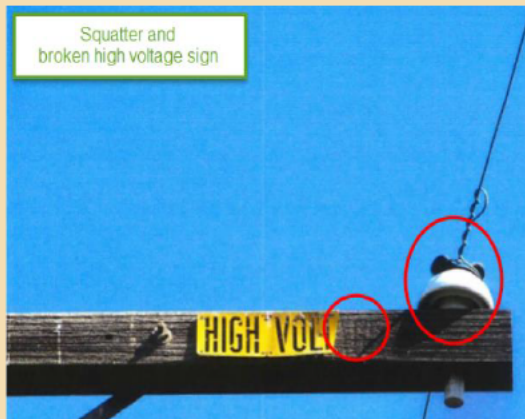
PRIMARY SQUATTER AND BROKEN HIGH VOLTAGE SIGN

At this Location: Primary squatter and broken high voltage sign

Perform Minor Work: No

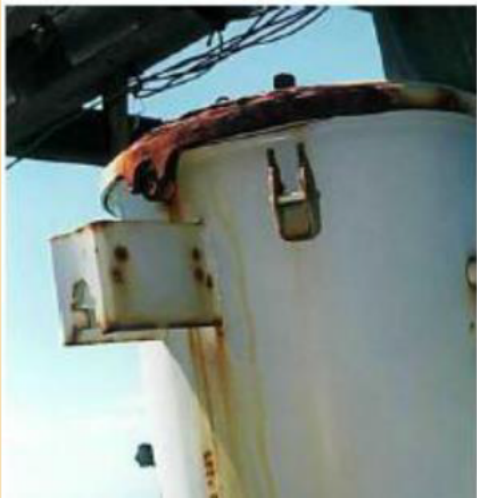
OH CORROSION EXAMPLES

At this Location: Corrosion Weakening Integrity of Tank

Metal is separating into layers

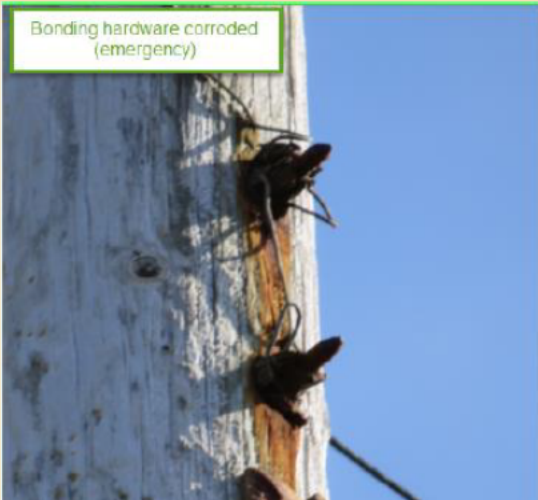
At this Location: Bonding hardware corroded

Perform Minor Work: No

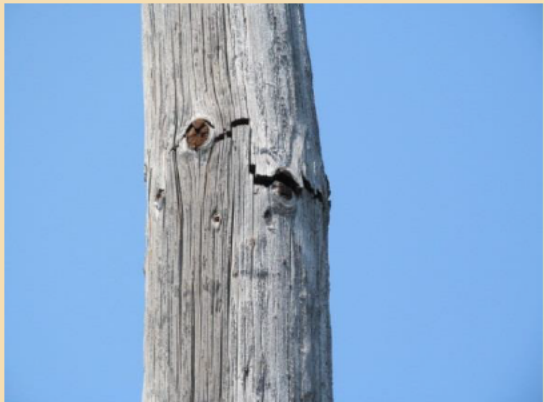
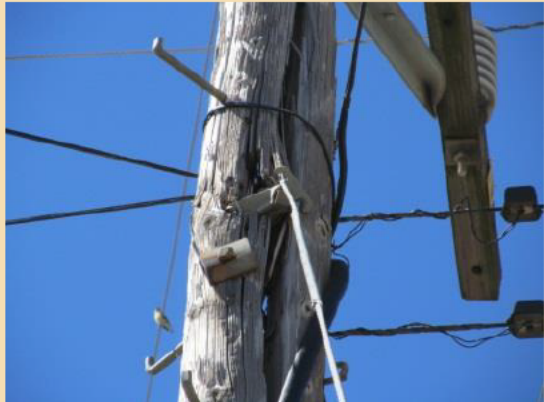
BROKEN POLE	POLE SPLIT AT COMMUNICATION LEVEL

<p>At this Location: Broken pole. Complete the Pole Inspection Test Report. Pole supported in four directions.</p>	<p>At this Location: Pole split at communication level. Complete the Pole Inspection Test Report.</p>
<p>Perform Minor Work: No</p>	<p>Perform Minor Work: No</p>
<p>Write Third-Party Notification: No</p>	<p>Write Third-Party Notification: No</p>
<p>Write EC Form: Yes</p> <ul style="list-style-type: none">• FDA=Pole / Broken/Damaged / Replace• Priority "B", 0-3 months depending upon exposure	<p>Write EC Form: Yes</p> <ul style="list-style-type: none">• FDA=Pole / Broken/Damaged/ Replace• Priority "B", 0-3 months depending upon exposure

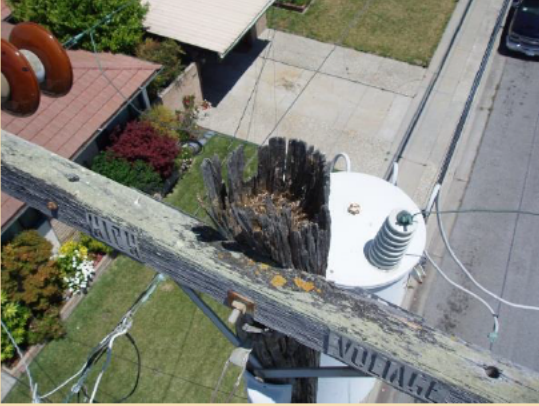
DAMAGE TO POLE FROM SPECIFIC EVENT	DECAY OF POLE OVER TIME

<p>At this Location: Pole burnt</p> <p>If pole has reduced circumference. Write EC notification for estimating to confirm pole loading.</p>	<p>At this Location: Pole top decayed. Entire pole failed pole test. Complete the Pole Inspection Test Report.</p>
<p>Perform Minor Work: No</p>	<p>Perform Minor Work: No</p>
<p>Write Third-Party Notification: No</p>	<p>Write Third-Party Notification: No</p>
<p>Write EC Form: Yes, Write EC notification for estimating to confirm pole loading.</p> <ul style="list-style-type: none"> • FDA=Pole/Overloaded/Test • Priority "E", 3-12 months depending on exposure. 	<p>Write EC Form: Yes</p> <ul style="list-style-type: none"> • FDA=Pole Decayed/Rotten/Replace • Priority "E", 3-12 months depending upon exposure

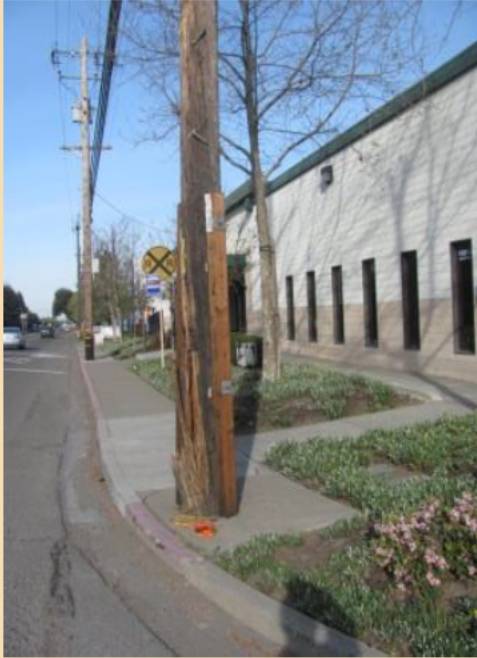
POLE DAMAGED ON THE BOTTOM BUT OK

At this Location: Pole damaged by vehicle. Splint installed as temporary repair. Inspection shows adequate circumference/strength. Sharp ragged splinters. Curb is adequate protection – visibility strips not required.
If pole has reduced circumference write EC notification for estimating to confirm pole loading. If damage requires replacement, create an EC notification to replace the pole.

Perform Minor Work: Yes, Remove sharp edges, remove splint.

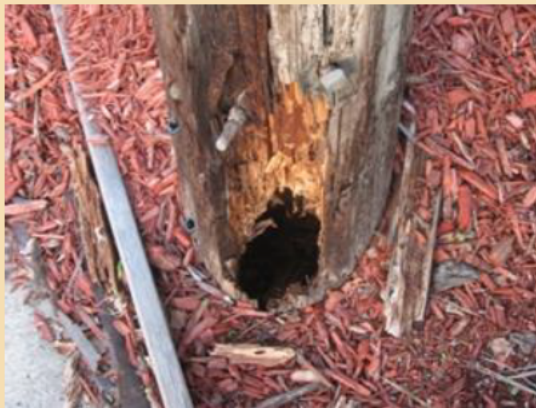
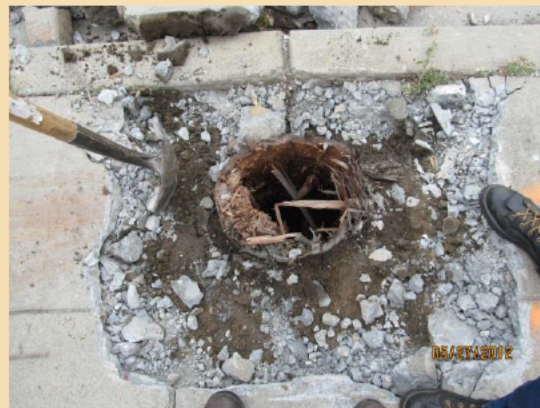
DETERIORATION AROUND GROUND LINE

At this Location: Deteriorated condition found during normal inspection. Complete Pole Inspection Test Report. If pole has reduced circumference. Write EC notification for estimating to confirm pole loading.

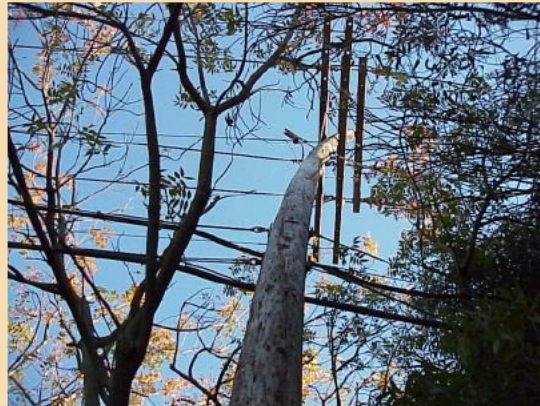
UNBALANCED LOAD AT TOP

At this Location: Deformed pole with bowed top in line with conductor.

Perform Minor Work: No

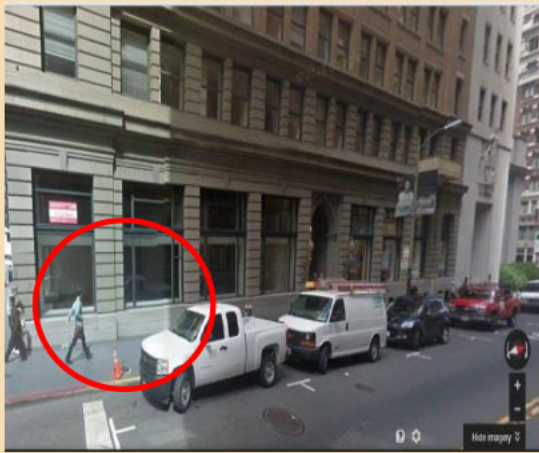
MISSING STREET LIGHT

At this Location: Cone indicates location of missing decorative street light and pole. Exposed wire is de-energized. Include picture of similar street light for replacement.

Perform Minor Work: Yes, make safe.

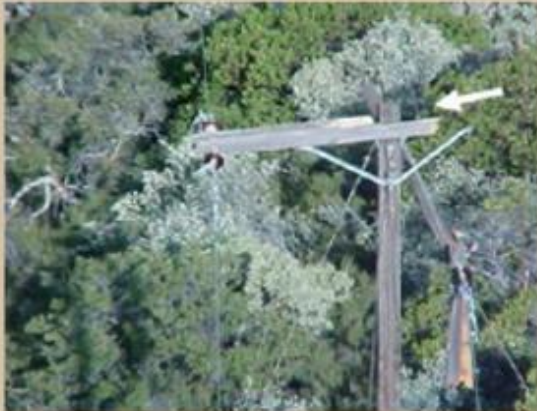
Crossarm is completely broken/fractured

Emergency - make safe immediately

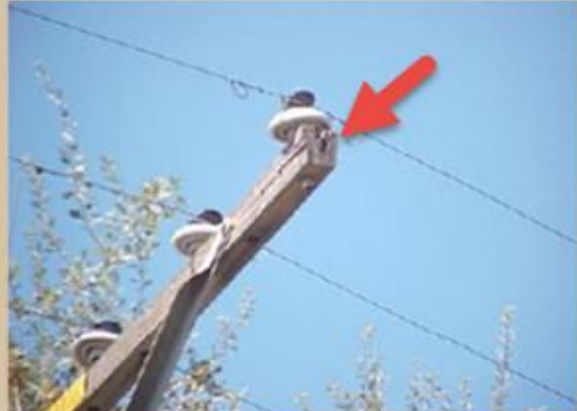
SPLIT CROSSARM

Primary Squatter (wood pin). Crossarm split within 2" of pinhole.

Replace in the next 3 months.
