CALIFORNIA PUBLIC UTILITIES COMMISSION
Safety and Enforcement Division
Wildfire Safety Enforcement Branch

Incident Investigation Report

Incident Number: E2021111-01 (Middle Fire)

Utility: Southern California Edison Company (SCE)

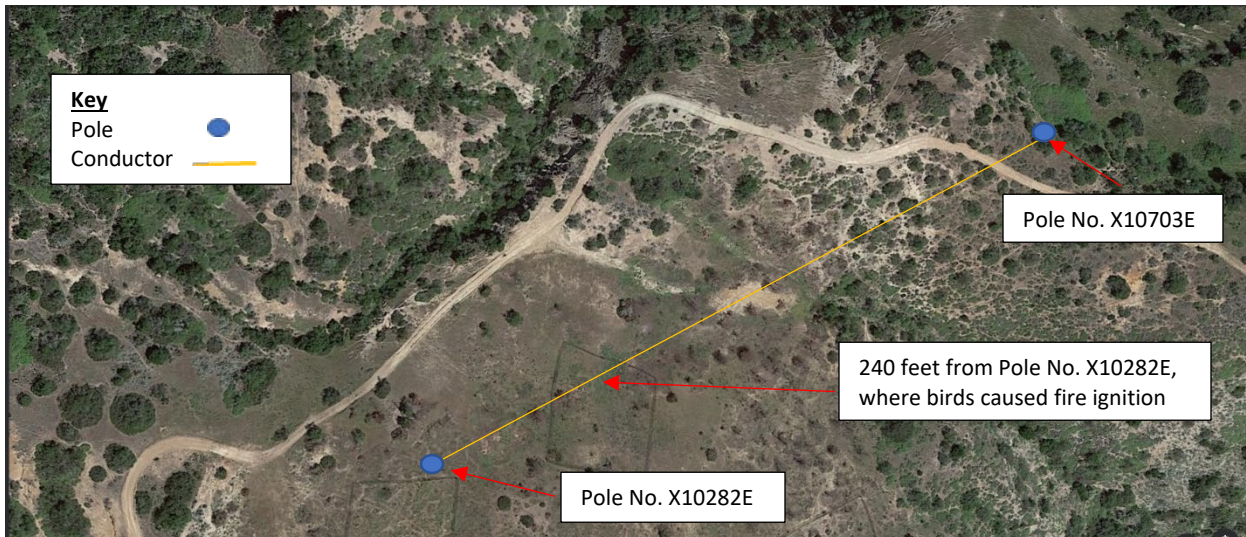
Figure 4: Incident Location between pole supports via Google Earth.

The conductor span between Pole No. X10282E and Pole No. X10703E is approximately 782 feet. The conductors on Pole No. X10282E are in a vertical configuration. The conductors on Pole No. X10403E are in a horizontal configuration. LiDAR data from May 14, 2020 show the closest dimension of radial clearance between any two conductors to be approximately 3.5 feet.⁶ The ignition location was

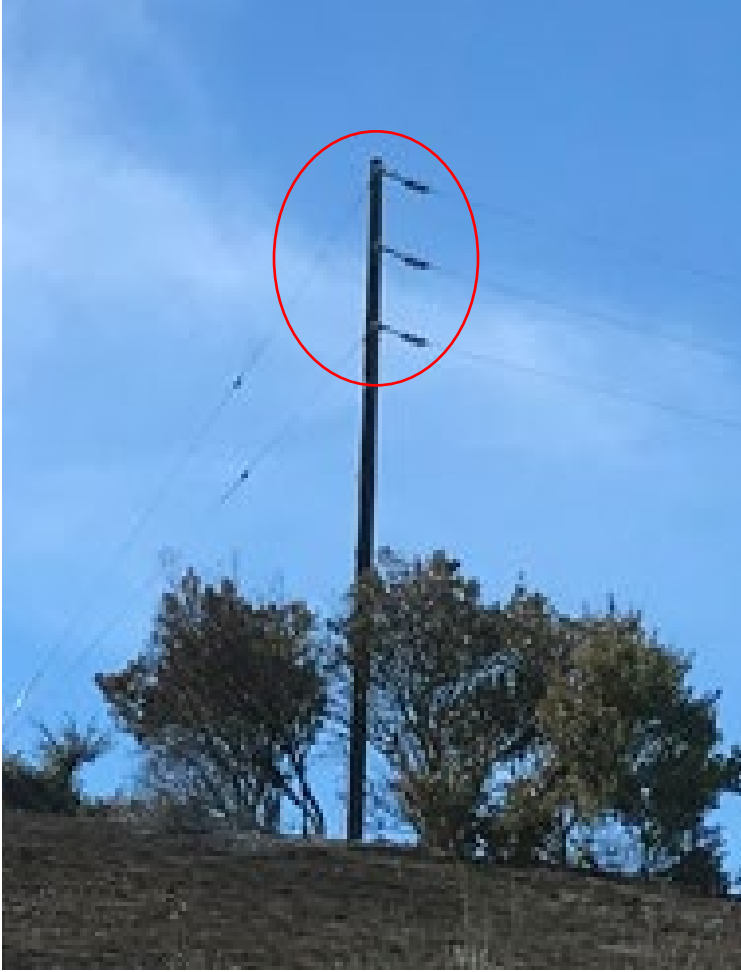
Figure 5: Pole No. X10282E with conductors in a vertical configuration, circled in red (Source: SCE).

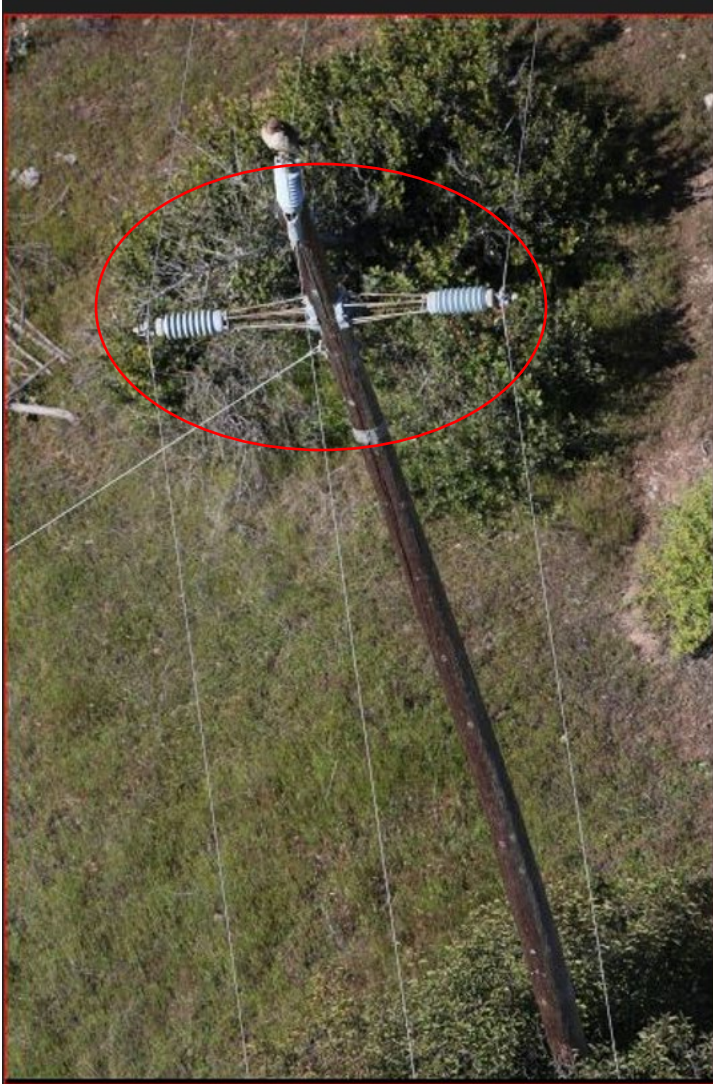
Figure 6: Pole No. X10703E with conductors in a horizontal configuration, circled in red (Source: SCE).

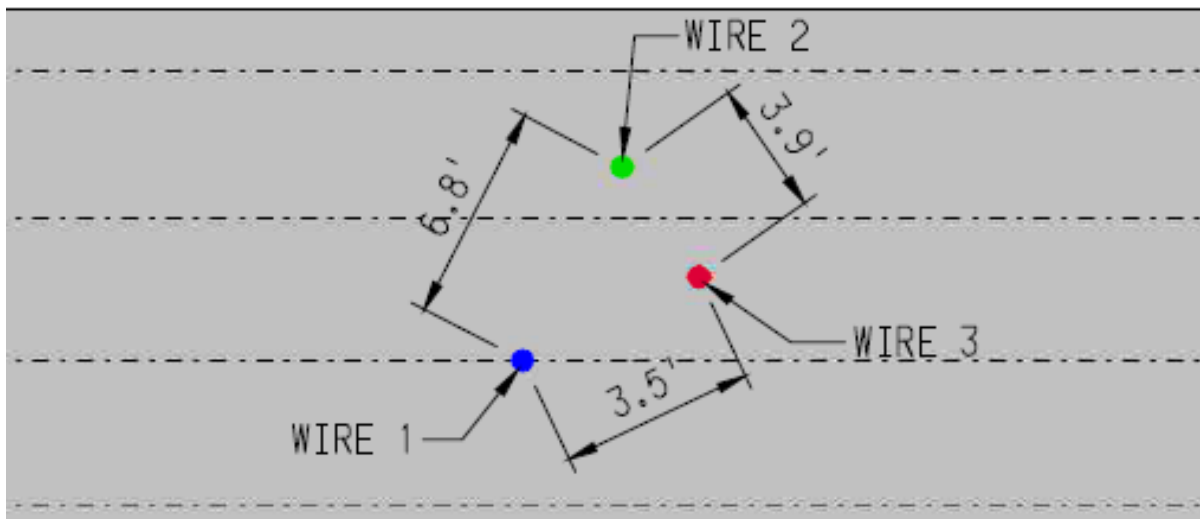
approximately 240 feet from Pole No. X10282E measured in the direction towards Pole No. X10703E. Figure 7 shows a cross section of the clearance between conductors approximately 240 feet from Pole No. X10282E based on the LiDAR data from May 14, 2020.

Figure 7: Conductors cross section approximately 240 feet from Pole No. X10282E (Source: SCE).

LACFD and LASD suspected two ravens were perched on two different conductors, and while simultaneously spreading their wings, potentially making contact, they were electrocuted by arcing between the two phases. The arcing caused the birds to catch fire, one fell to the ground and ignited vegetation, thus causing the fire. With the conductor cross section configuration, the birds could make wing contact by perching on any two adjacent conductors and spreading their wings.⁷

Based on the statements made by first responders, and the distances between conductors relative to the wingspan of a common raven, SED notes the LACFD's findings that the birds on the conductors were the cause of the ignition of the Middle Fire. SED finds that SCE maintained adequate clearances between the conductors at the Incident Location and the arcing between the two birds on the conductors does not constitute a violation of the Commission's General Orders.
