PUBLIC UTILITIES COMMISSION

SUBJECT: Closure letter for Notice of Probable Violations for SDG&E Non-DOT (NOPV Non-DOT) Reportable incidents issued during the period of 2019-Q2.

SUMMARY OF INVESTIGATION FINDINGS

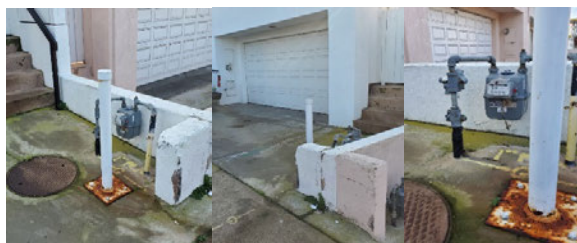
On 4/28/2018, a vehicle struck a meter set assembly (MSA) in an alley resulting in a gas release and interruption of service to 33 customers.

SDG&E disagrees with the SED assessment that the meter in question was unprotected or identifiable as an Abnormal Operating Condition (AOC). The meter in question is positioned with concrete block walls in close proximity on two sides and located at the base of a stairway leading to a residence (as shown in the photos provided below). Based on this positioning, the meter was considered protected.

Post Incident Installation of Meter Warning Device

SED has reviewed SDG&E’s response and accepts the proposed corrective actions. However, SED disagrees with SDG&E’s narrative that the meter located at [REDACTED], City of La Jolla, San Diego was positioned with concrete block walls and protected. SED’s staff visited the site and talked to the property owner who stated that a meter protection was installed after the meter was hit by a vehicle. SED acknowledges that the proposed corrective actions will sufficiently address the probable violation. SED recommends that no fine or penalty be imposed since the violation did not create any hazardous conditions for the public or utility employees. However, SED may review the implementation of these stated corrective actions during future inspections.

SDG&E management will continue to emphasize the importance of the gas standard G8145, Leakage Surveys, Section 4.12.1, “Issue Follow up orders to investigate and correct any AOC’s encountered,” focusing particularly on Section 4.12.1.10 - “When MSA protection (barricades or barriers) are required per gas standard D7115, Barricades for Gas Meter Sets.” In addition, the gas standard D7115 will be updated to provide clarification on when to identify an exposure to vehicular traffic. An information bulletin will be circulated to communicate and reinforce the importance of reporting AOCs while performing leakage surveys/atmospheric corrosion inspections, focusing on instances related to ensuring MSAs are protected as required, per gas standard D7115.
