Kettleman Compressor Station (Avenal) Incident Investigation Report

SAFETY AND ENFORCEMENT DIVISION
GAS SAFETY AND RELIABILITY BRANCH

Final Report

Report Date:	April 7, 2025
Investigators:	Wai Yin (Franky) Chan
Date incident reported to CPUC	July 10, 2024
Utility:	Pacific Gas and Electric Company (PG&E)
Date and Time of the Incident:	July 10, 2024 @ 21: 00 Hours
Location of the Incident:	Avenal, CA, Kings County

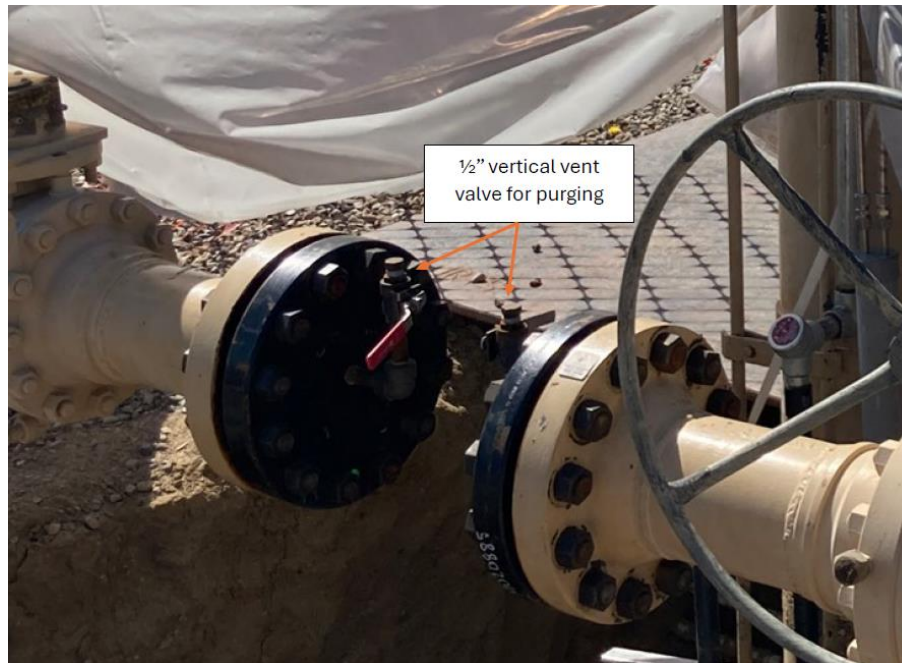
Figure 1: Half-Inch Diameter Vertical Vent Valve Intended for Purging At V-78

The RCE report indicated that this hand valve had been included as a technical object in the clearance, defined as “VENT D/S V-78,” and incorporated into the system configuration for clearance operations. The RCE found that the removal of this blind flange ultimately resulted in an un-intended system configuration of a 6-inch horizontal opening pointing directly into an opposing 6-inch blind flange 18 inches away. Figure 2 shows a picture from the RCE report with V-78 and its blind flange hanging.

On July 9, 2024, at 0545, after initial efforts failed to achieve an acceptable LEL, a blind flange, downstream of Valve-78 (V-78), was removed for additional fresh air. The blind flange that was removed had an installed, half-inch diameter, vertical hand valve assembly intended for blowdown and purging. This hand valve had been included as a technical object in the clearance, defined as “VENT D/S V-78,” and incorporated into the system configuration for clearance operations. The removal of this blind flange ultimately resulted in an un-intended system configuration of a 6-inch horizontal opening pointing directly into an opposing 6-inch blind flange 18 inches away.

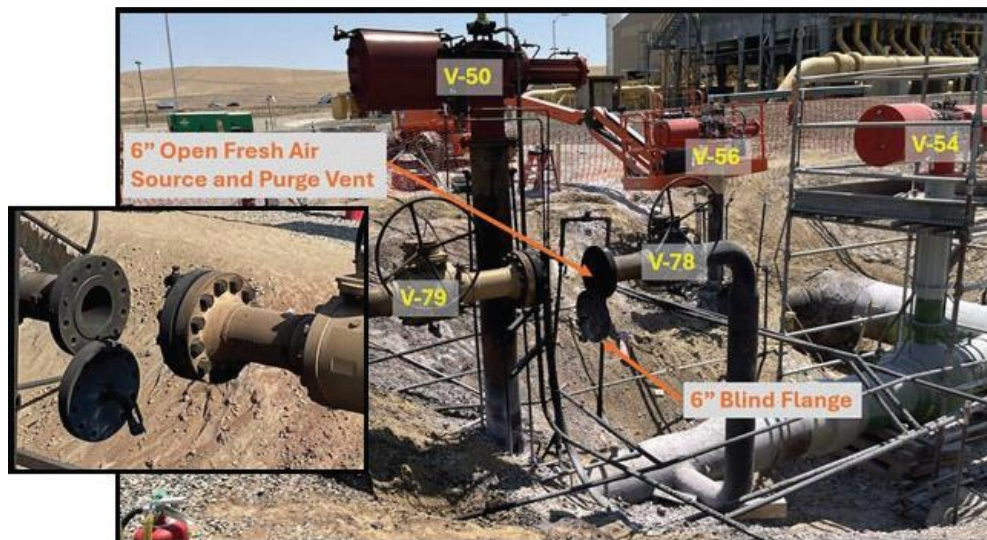
Figure 2: Valve-78 Blind Flange Removed (shown hanging)

According to the RCE report, acceptable LEL readings were achieved after removing the blind flange. At 0822, the isolated piping was confirmed clear, and the system was released to the contractor for construction. At 0923, the contractor began the cut out and removal of the existing 24-inch Valve-54 (V-54) and the 34-inch by 24-inch tee assembly. At 1209, the contractor began installing the new 34-inch by 24-inch tee. The RCE report indicated that by 1422, installation of the tee was completed, but the installation of the final tie-in piece, including V-54, was left for the following day. As a result of the 24-inch end of the tee being open to atmosphere, air moving operations continued overnight to maintain acceptable air-gas levels. The gland and stem seal replacement work on V-56 continued through the end of the shift.

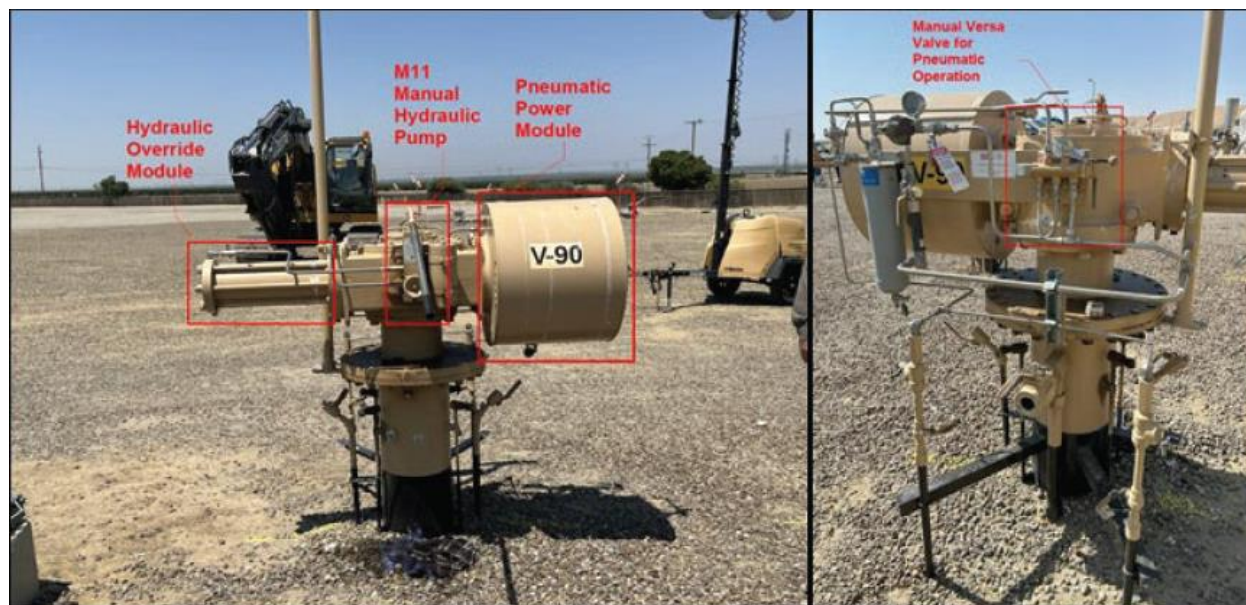
Figure 3: V-90 Detail View

V-90 is a 34-inch buried full port ball valve with a high-head extension. It is equipped with a pneumatic double acting actuator with a hydraulic backup override. The RCE report indicated that the intent was

to slowly open the valve with the hydraulic override system. At 1808, the differential across V-90 was approximately 618 psid. Upon attempting to open the valve with the hydraulic override system, oil was discharged from the relief port and the valve failed to turn. According to the RCE report, the last maintenance of V-90 was performed in May of 2024 without any deficiencies found, and the exact failure mechanism of the hydraulic override system prior to the incident is unknown. The RCE report indicated that a decision was then made to utilize the actuator's pneumatic system to open the valve. The RCE found that this method is not effective for fine throttling. At 1825, V-90 was opened and gas was re-introduced into the system. A PG&E employee, Transmission Project Clearance Operations (TPCO) Lead Gas Control Technician 1 (TLT-1) positioned at the monitoring location near V-20, provided direction, by text message, to the PG&E employee operating V-90 Gas Pipeline Operation and Maintenance (GPOM) Gas Control Tech 2 (GCT-2). An increase in gas flow was made three times. At 1843, it had been indicated that too much gas had been sent. V-90 was immediately closed when excess flow was recognized through audible and haptic indication.

On July 10, 2024, at 1808, upon attempting to open Valve-90 (V-90) with the hydraulic override system, oil was discharged from the relief port and V-90 failed to turn. The RCE report indicated that a decision was then made to utilize the actuator’s pneumatic system to open the valve. The RCE Team found that this method is not effective for fine throttling.
