# GO Kettleman Compressor Station Ignition RCE Evaluation Report

**Cause Evaluation Report Type:** RCE

CAP Title: Gas Operations Kettleman Compressor Station Ignition RCE

CAP # 129207510

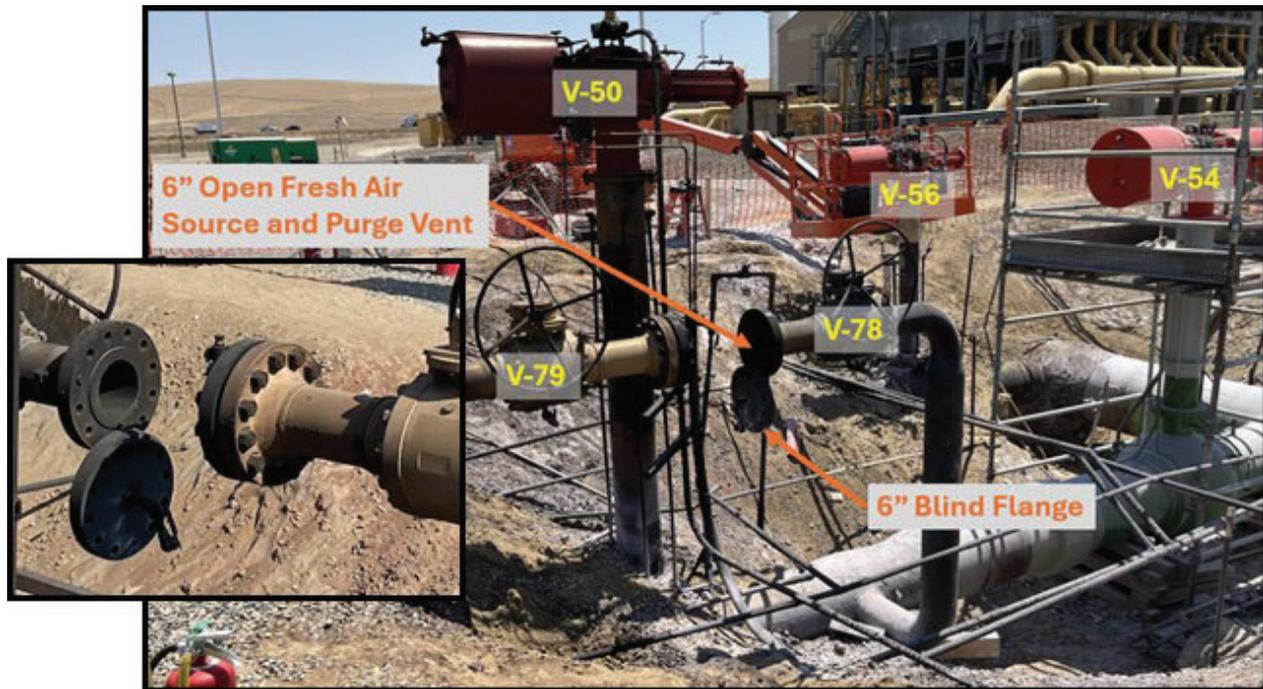
Figure 2: V-78 Blind Flange Removed (shown hanging)

The blind flange that was removed had an installed, half-inch diameter, **vertical** hand valve assembly intended for blowdown and purging. This hand valve had been included as a technical object in the clearance, defined as “VENT D/S V-78,” and incorporated into the system configuration for clearance operations. The removal of this blind flange ultimately resulted in an un-intended system configuration of a 6-inch **horizontal** opening pointing directly into an opposing 6-inch blind flange 18 inches away (Figure 2).

During this purging operation, gas exited the 6-inch diameter opening downstream of V-78 directly into an opposing blind flange 18-inches away. Gas was deflected in all directions, including into the excavation below, creating a large dust and debris cloud. Ignition occurred shortly after the formation of this cloud and lasted for approximately 1 minute, self-extinguishing as gas flow was shut off at V-90 prior to ignition.

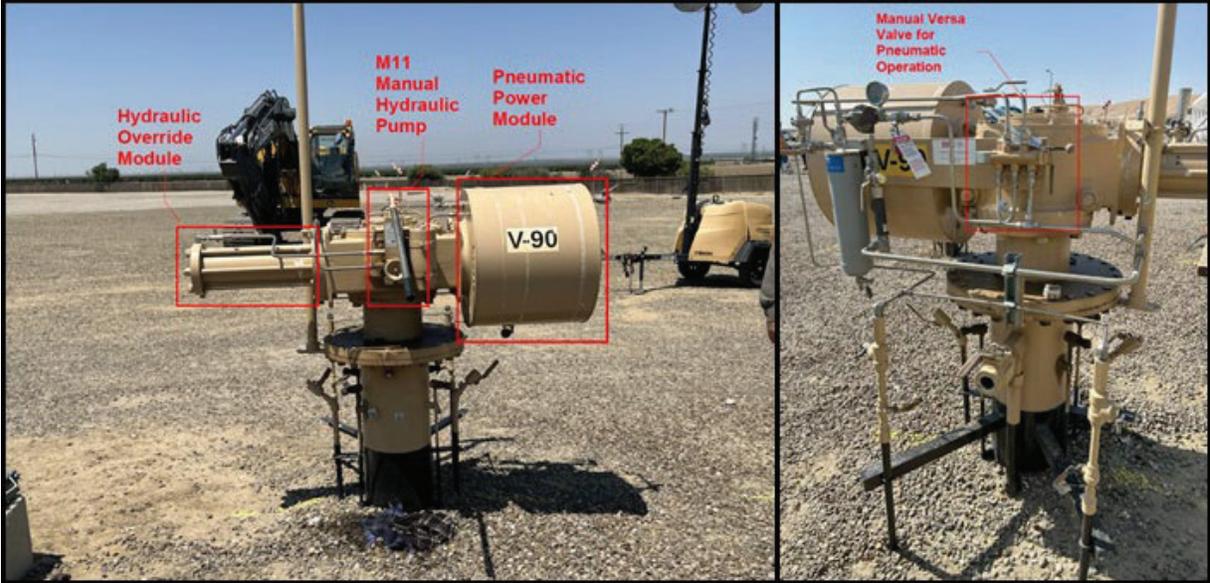
**Figure 4:** V-90 Detail View (Purge Drive Valve for Purge into Service Sequence and Ignition)

V-90 is a 34-inch buried full port ball valve with a high-head extension. It is equipped with a pneumatic Bettis G5024 double acting actuator with a M11 hydraulic backup override. The intent was to slowly open the valve with the M11 hydraulic override system. At this time, the differential across V-90 was approximately 618psid. Upon attempting to open the valve with the hydraulic override system, oil was discharged from the relief port and the valve failed to turn. A decision was then made to utilize the actuator's pneumatic system to open the valve. The exact failure mechanism of the hydraulic override system is unknown at the time of this writing. However, after consulting with the manufacturer and review of the vendor manual it is presumed the hydraulic fluid relieved due to incorrect position switch configuration leading to operating the valve into the "closed"

At 1825, V-90 was opened and gas was re-introduced into the system. A coworker, TPCO Lead Gas Control Technician 1 ([TLT-1](#)) positioned at the monitoring location near V-20, provided direction, by text message, to the coworker operating V-90 GPOM Gas Control Tech 2 ([GCT-2](#)). An increase in gas flow was made three times. At 1843, it had been indicated that too much gas had been sent. V-90 was immediately closed when excess flow was recognized through audible and haptic indication.

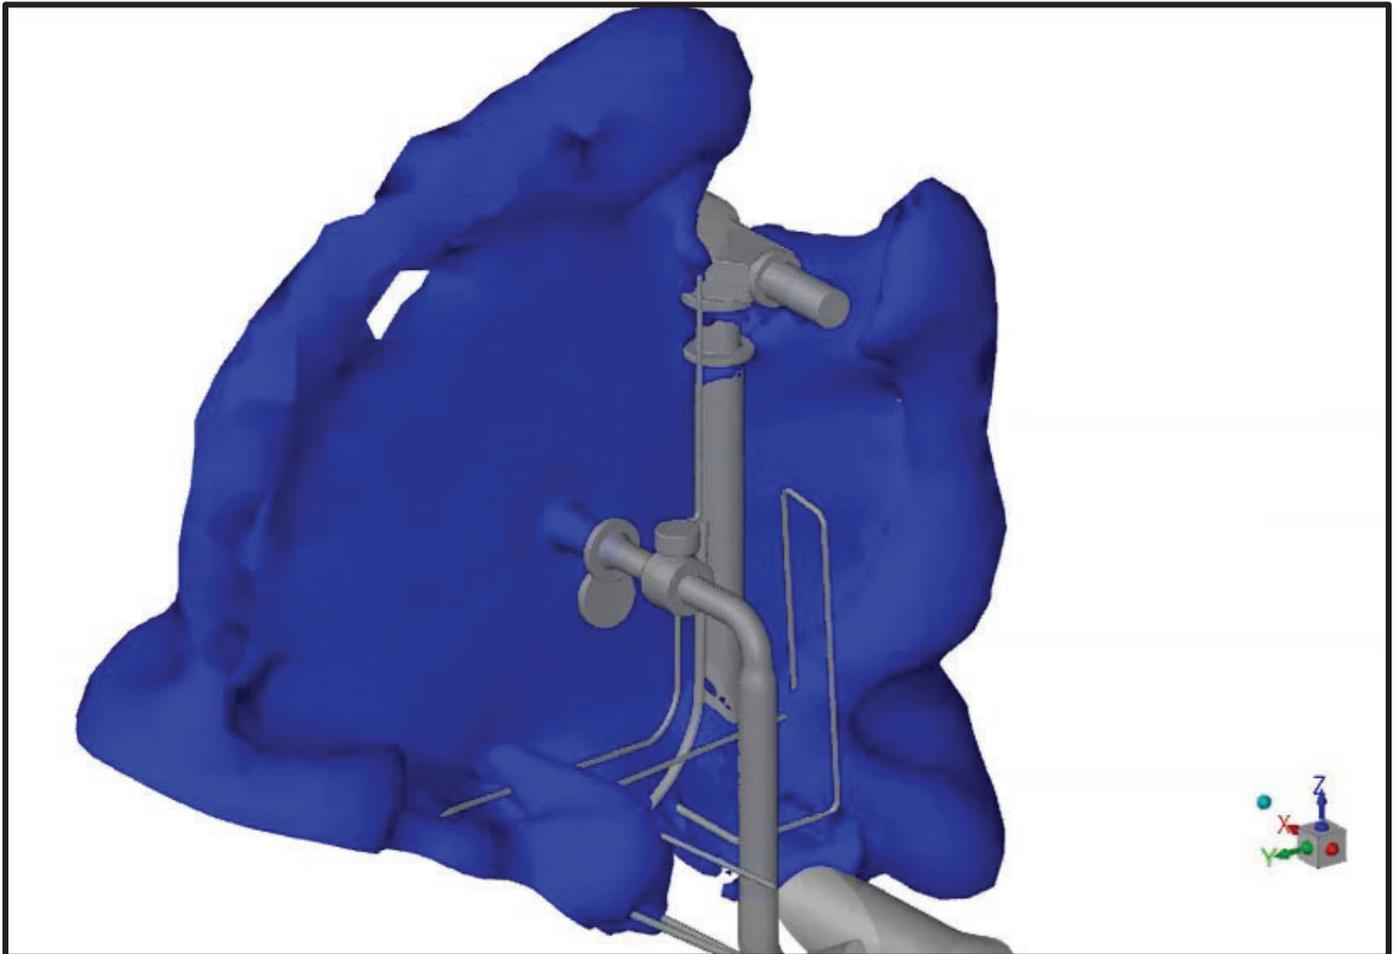
**Figure 7:** ATS ANSYS model of gas plume (blue) at V-78 vent location

The preliminary results of the simulations indicate that the gas flow rate at the V-78 vent outlet ranged widely depending on how much the inlet purge valve V-90 was open and whether V-56 was open but were significant even when V-90 was barely open with V-56 open as well. Based on preliminary results, even with V-90 7.5° open, which is 2.5° after flow would have been initiated which occurs at 5°, the velocity of gas leaving at V-78 vent location would have been over 100 feet per second (ft/sec).

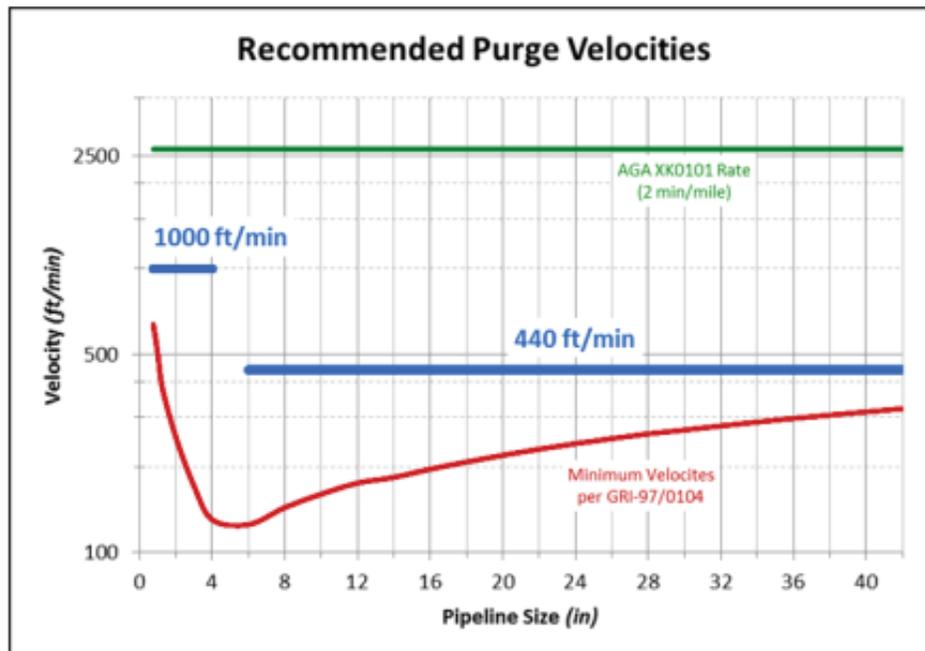
Figure 10: GDS A-38 Recommended Purge Velocities

HYSYS model results show the flow velocity leaving V-78 to be excessive under all modeled conditions. GRI recommends that for large bore pipe we do not drop below 7.3 ft/sec purge velocity (Figure:9) while the modeled conditions may indicate the velocity was as high as almost 1,500 ft/sec (sonic velocity), at V-78. (Figure 9)

Based on research by the Gas Research Institute (GRI) that developed a method of calculating the minimum purge velocity needed to minimize mixing, a 440 feet per minute (ft/min) (7.3 feet per second [ft/sec] or 5 miles per hour [mph]) velocity is recommended for large-bore pipe and a 1000 ft/min (16.7 ft/sec or 11.4 mph) velocity for small-bore pipe. [Figure 1](#) illustrates how the recommended purge velocities compare and exceed the minimum GRI-calculated velocities.

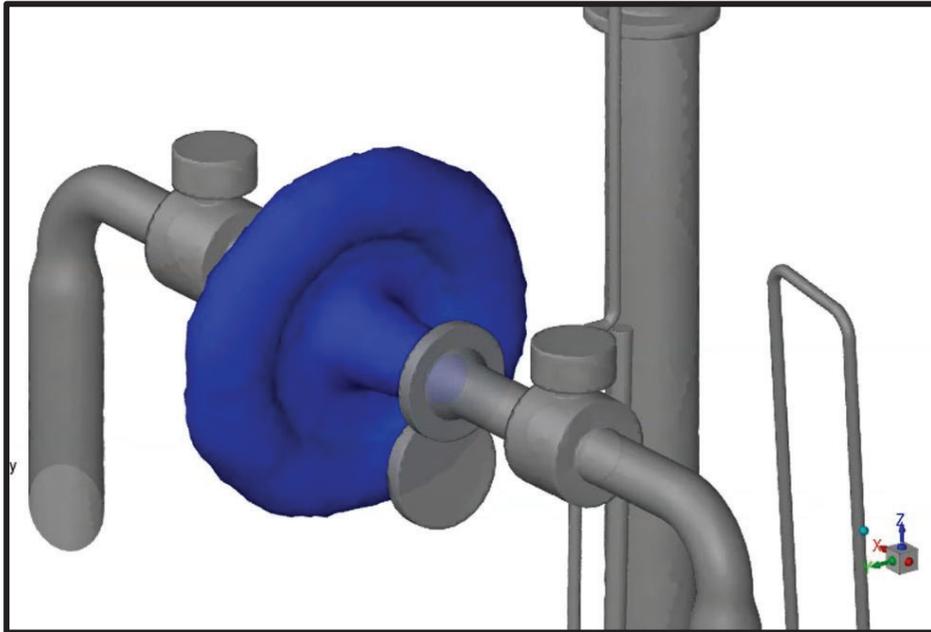
Figure 11: ATS ANSYS simulation using 3D scanned V-78 vent location (Dark Blue surface indicates LEL)

ATS modeling software produced 3D simulations of the plume of gas leaving V-78 (figures 10, 11). To accomplish this, the ATS team recorded the incident location using 3D laser scanning technology to create an immersive virtual environment for further investigations. The 3D captures were then imported into ANSYS, which is a computational tool to simulate the fluid dynamics of the plume emerging from V-78. Results of the HYSYS model developed by Exponent were applied to the ATS ANSYS model. ATS performed the simulation on the in-house workstation spending approximately 3600 CPU-hour of computation to resolve 4 seconds of the purging process.

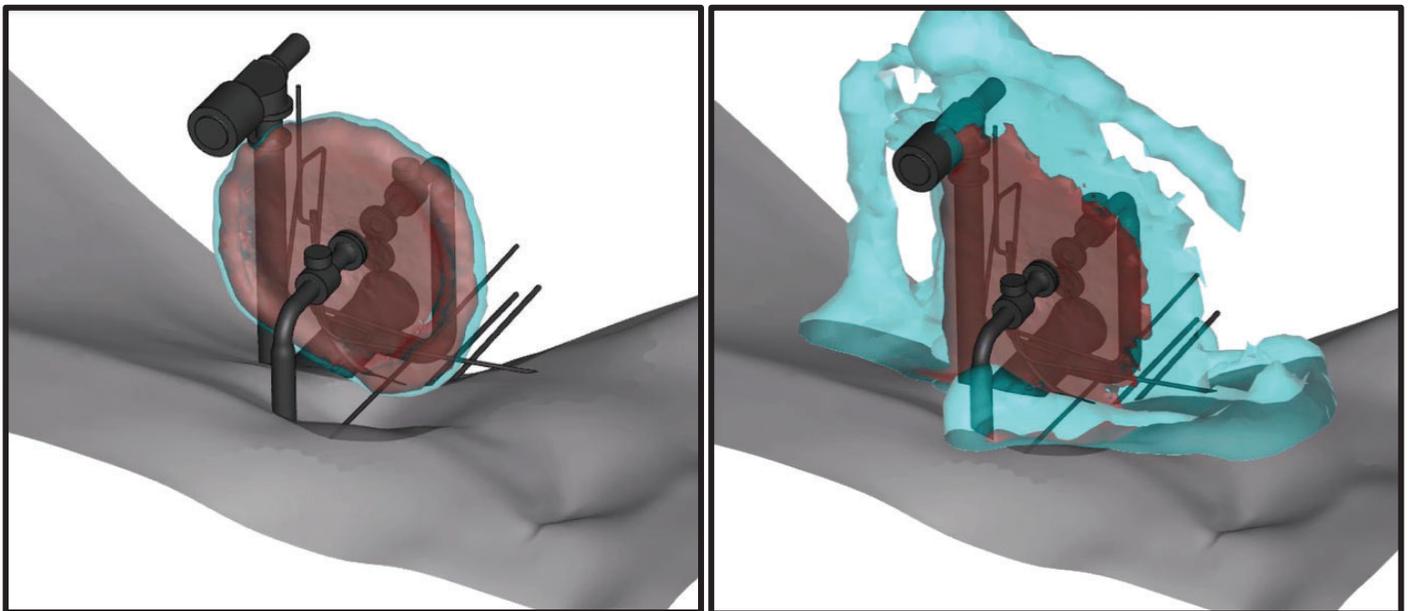
**Figure 13:** ANSYS Results Purging into Obstruction at V-78. LEL boundary in blue and UEL boundary in red.

Electrostatic discharge from the generated dust cloud cannot be ruled out as the ignition source and is more likely than other ignition sources considered in the purge ignition assessment. The act of purging horizontally, directly into an obstruction, redirected the flow of gas from horizontal to all directions away from the opposing flange from V-78. This redirection of flow, some toward the ground, generated a dust cloud potentially containing electrostatic discharge that created conditions that could lead to ignition. Vertical purging without an obstruction would have generated a plume shape that is more uniform, likely mitigating conditions that develop electrostatic discharge and a source for ignition. The images in the figure below demonstrate that the LEL boundary reached the soil where electrostatic discharge could have ignited the mixture. The blind flange opposing V-78 was removed and retained for evaluation at ATS.

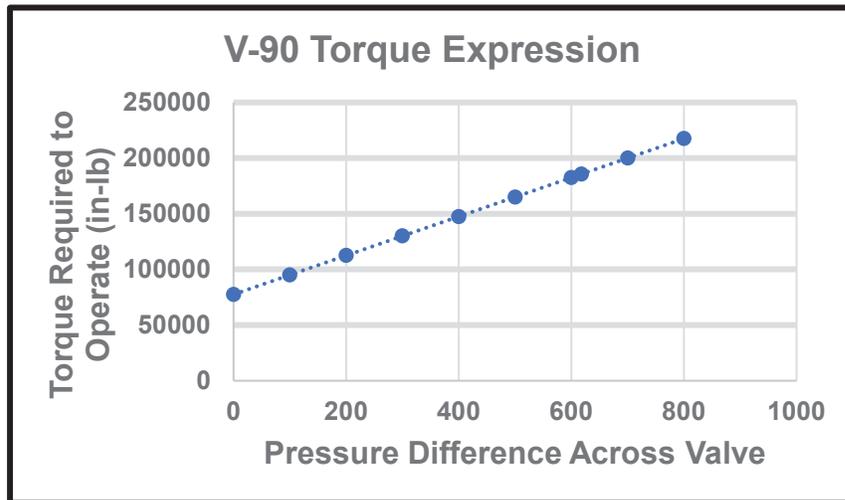
Figure 14. Torque Required v. Pressure Differential across valve

V-90 was selected as the purge driver during the clearance development process. At the time of the purge, the differential pressure (psid) across the valve was 618 psid. As differential increases, additional torque is needed to operate the valve. The torque required to operate the valve at 0 differential is 77,500 in-lbs vs. 185,650 in-lbs at a pressure of 618 psid. (see figure 13) The initial plan was to use the M-11 hydraulic operator to provide fine control of the valve opening.

When this strategy was implemented, the hydraulic operator failed to move the valve off the closed stops and relieved oil out of the relief valve that serves to limit the amount of torque the operator can apply to the valve stem. While the hydraulic pump is rated to produce enough torque with this amount of differential, it is never tested under these conditions. Additionally, it was noted during a site visit that the reservoir on the hydraulic operator had a plug installed where a breather should exist. Per the manufacturer this can cause damage to shaft seal due to pressure build up in the reservoir while operating the valve but is not likely to prevent movement. At this time we cannot confirm if the plug was installed during the event or if this was a contributing cause.

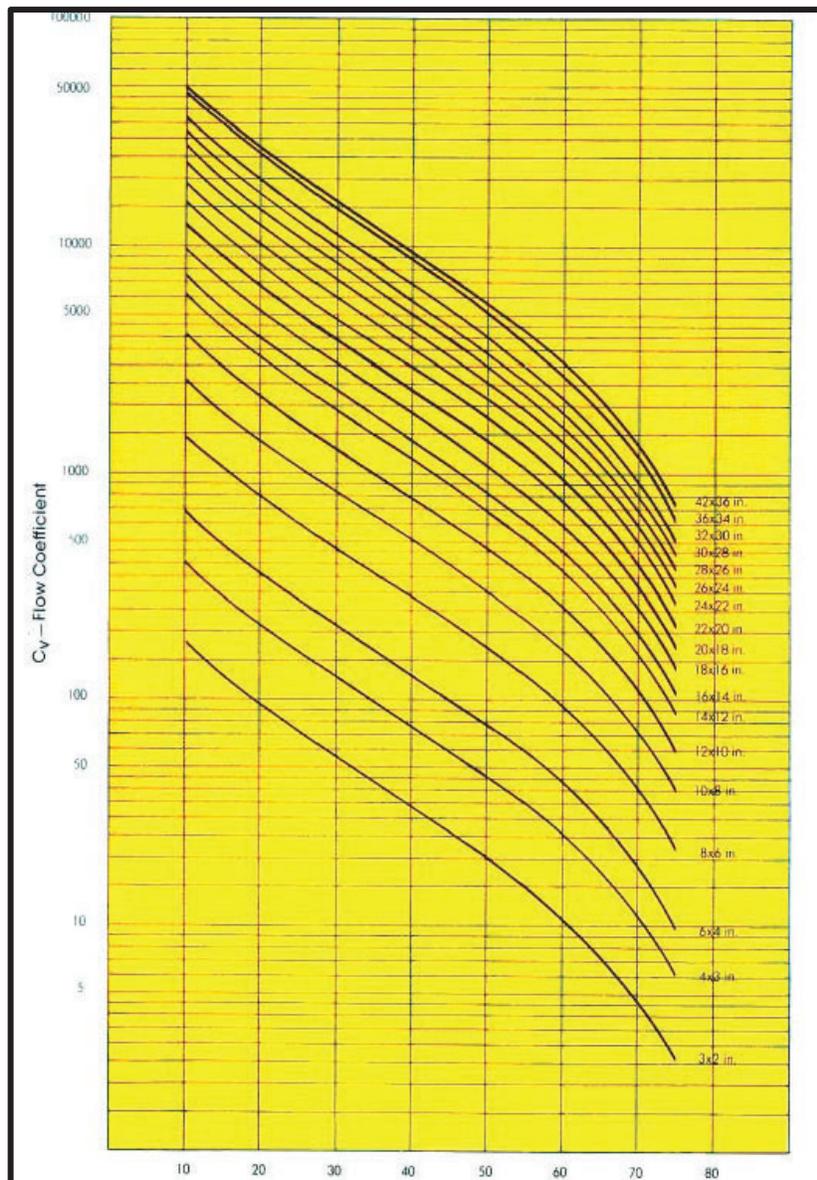
Figure 15: Flow Coefficient Cv vs Closure Angle for reduced opening Cameron ball valves

Due to the geometry of full port ball valves, the flow rate through the valve is not linear with position. As the valve begins to open, flow increases rapidly with relatively small increases in position. This is shown in the documentation provided by Cameron below in figure 15 that correlates the valve position to the flow coefficient of the valve.

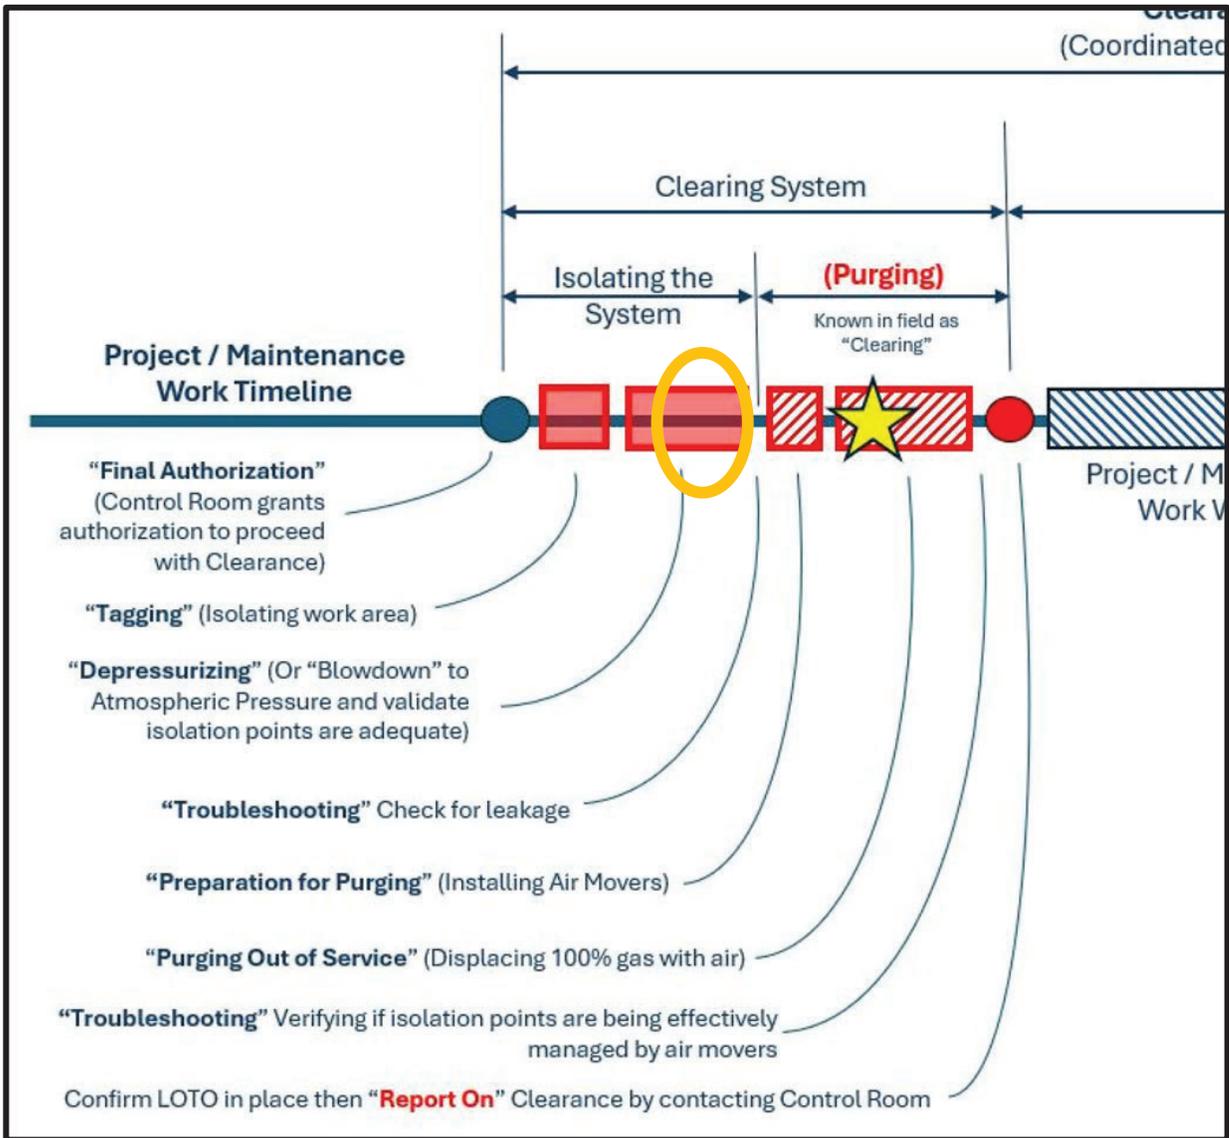
Figure 23: No HU controls when transitioning between Depressurization & Purging out of Service

*Event Note: Currently, during the depressurization or “blowdown” phase of clearance work in Gas, Clearance Supervisors have the task of troubleshooting leak-by at clearance isolation point locations as*

they are hanging tags and configuring the system in preparation for purging out of service. There is currently no guidance for how the clearance supervisors are to troubleshoot in this phase and what expectations there are for managing leak-by or other system configuration challenges arise. There are also no steps provided in the clearance work documents denoting how to handle this phase of work from a sequence of steps or Placekeeping standpoint. The transition from depressurization to purging out of service is understood by the RCE team to be a seamless transition with no controls in place to queue the Clearance Supervisor that Placekeeping and following a strict sequence of steps is now required. Through this investigation the organizational factors involved in the HU error of removing the blond flange was caused by a combination of issues. Caution Tags note not to modify configuration without contacting Clearance Supervisors and lack of controls to indicate transitioning from troubleshooting to performing steps in sequence. Clearance Supervisors are given opportunity to operate equipment outside of clearance guidance although TD-4441S guidance says to contact Gas Control for redlining.

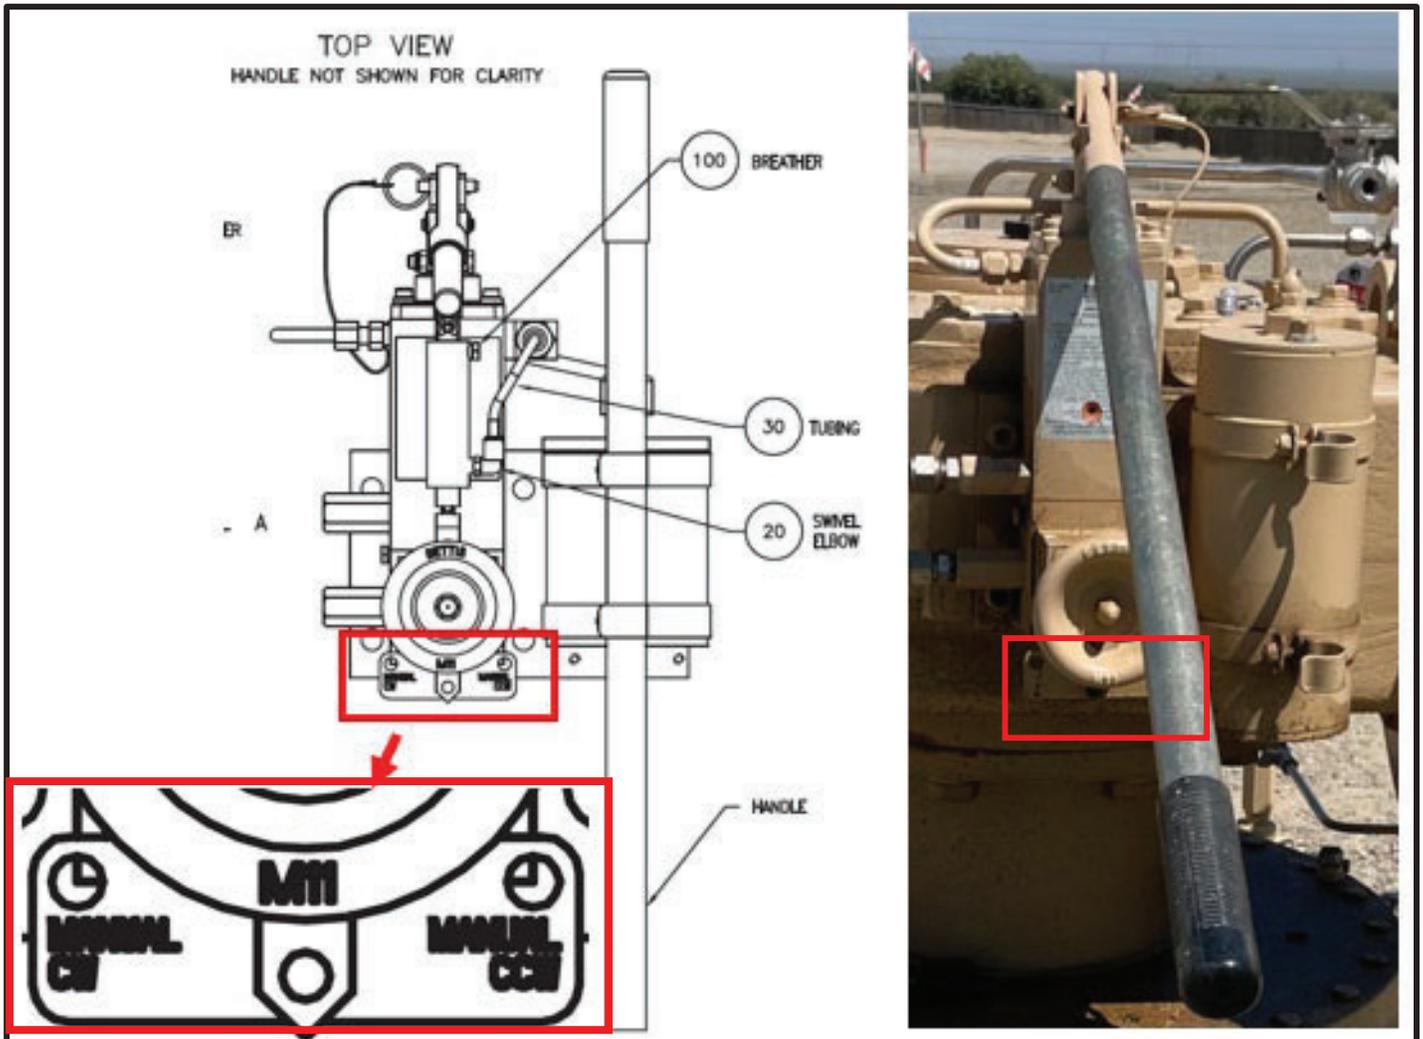
Figure 27: Position switch location and valve position indicator

- Figure:22 shows V-90's position switch that must be positioned prior to opening or closing the valve. A review of the vendor manual is required prior to operating to confirm which position to select to open or close the valve. The actual image of V-90 currently in the field, shows no text on the plate below to help the operator know which position to select. It is suspected, based on consultation with the valve manufacturer, that V-90 was operated in the closed position instead of the open position, per the clearance instructions. The field condition issue, HU error, and skills and knowledge gaps identified above are not limited to V-90 but is likely applicable to a variety of installed equipment across the gas system where a lack of device specific training is provided. Based on SME consultation, it is not uncommon to have new equipment installed without providing maintenance and operations personnel additional training.

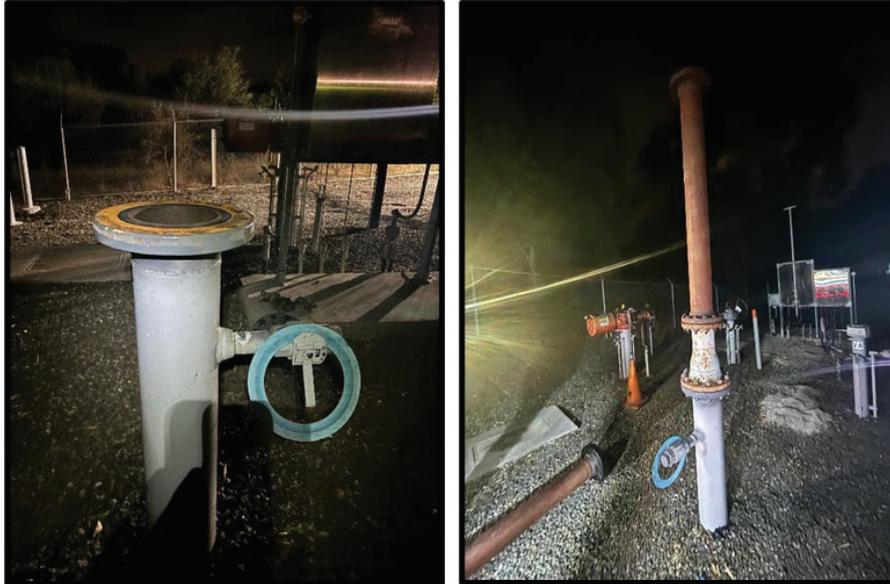
**Figure 37: Blowdown Riser locations before stack added (after, on right)**

On 8/03/2024, while responding to a cross-bore incident near the San Francisco Bay area, crews were performing emergency blowdown activities on an 8-inch pipeline. One crew member onsite, who was part of this RCE who was also responding to the incident, noticed a riser / stack extension was not in place at the time blowdown was to begin. The work was stopped and did not proceed until a proper stack extension was installed. This was considered a good catch as no injury or consequence occurred.

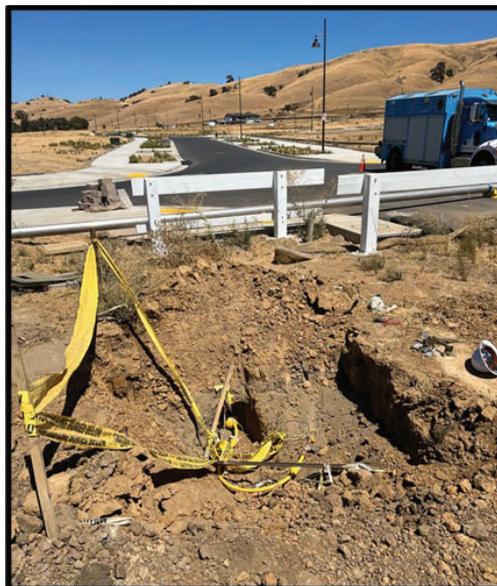
**Figure 38: Distribution purge incident locations 8/21/2024**

*(Only preliminary details are available)* On 8/21/2024, while performing distribution purging a coworker passed out and received minor injuries. Evidence supports the absence of some essential controls mandated by purging procedure A-38 that were missing from this job. In this incident, a coworker purging new construction distribution line was potentially exposed to a hazardous atmosphere (lack of oxygen due to gas accumulation) and collapsed. A-38 contains requirements on how to safely dissipate escaping gas away from the coworker to atmosphere and prevent worker asphyxiation, to include the use of purge stands and not purging into an excavation. As an interim corrective measure of the Kettleman RCE, a stand-down in A-38 guidance was distributed to all crews that perform purging activities. It is not yet known why the A-38 required essential controls covered in this stand down were not implemented in this recent 8/21/2024 purge incident. There is a concern by the RCE Team that gaps in safety behaviors shared between the Kettleman and recent 8/21/24 incident will continue unless effectively abated by Leadership.

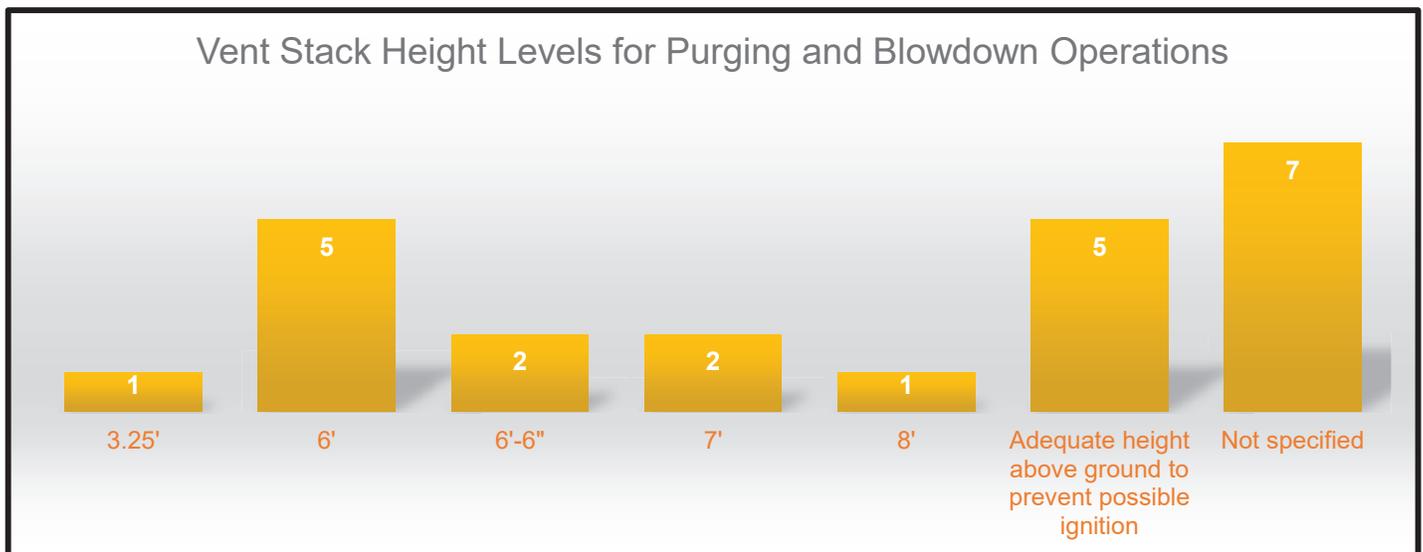
**Figure 41:** Vent Stack Height Levels for Purging and Blowdown Operations

As shown above, 6-feet or greater vent stack heights are required by 10 of the 23 respondents from the 2023 NiSource survey. PG&E falls in the "Not Specified" category along with 7 of the 23 operators, as the most explicit guidance in the Code of Safe Practices Section 1304 simply states, "*Vent stacks shall be of sufficient size and height to minimize the hazard of releasing gas.*"

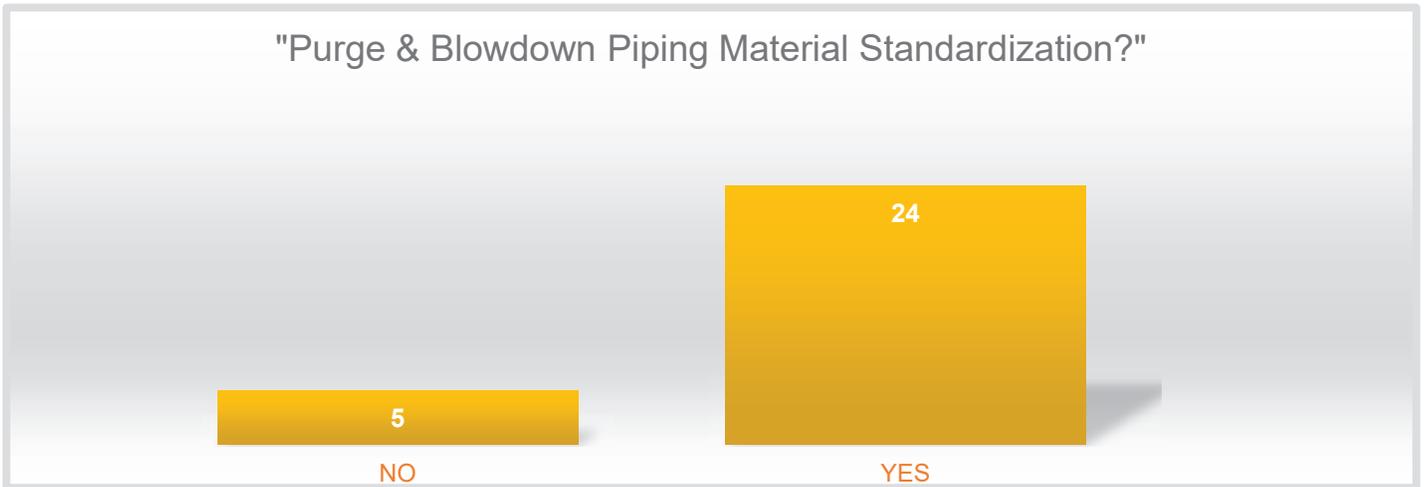
**Figure 42:** Purge & Blowdown Piping Material Standardization

The above chart shows data from the 2019 Exelon AGA survey, with 24 of the 29 respondent operators stating that they have standardized their materials for purging and blowdown piping. While PG&E provides guidance on aluminum and steel piping for temporary vent stacks, and recently introduced a new purge stand for distribution purge operations after a SIF-A incident in Marina in 2022, additional material and bracing/support design standardization for purging into service on the transmission side would place PG&E more in line with peer operators.
