Subject: Audit of Sacramento Municipal Utility District (SMUD)

SMUD'S RESPONSE TO 2024 CPUC ELECTRIC DISTRIBUTION AUDIT SUMMARY

Field Inspection Photographs

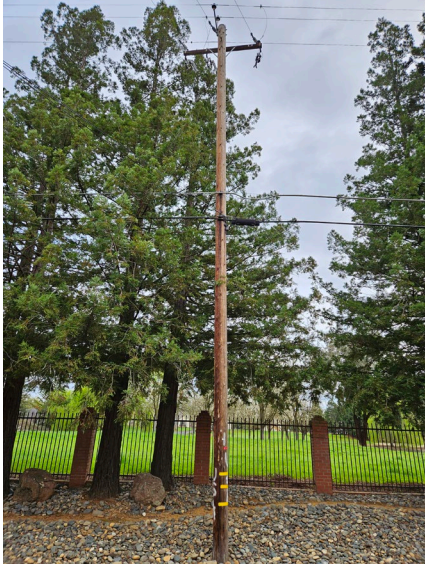
Before SMUD Correction:

1.2 ESRB Finding: Wood Pole #077083 at 8911 Mooney Rd in Wilton (Location 12) needs to be replaced due to a failed intrusive test. SMUD has a preexisting notification (#31971177) to replace the pole.

1.2 Pole Failed Intrusive Test, UD077083 (Replaced with UD199989)

SMUD Response: Wood pole UD077083 was replaced March 19, 2024.

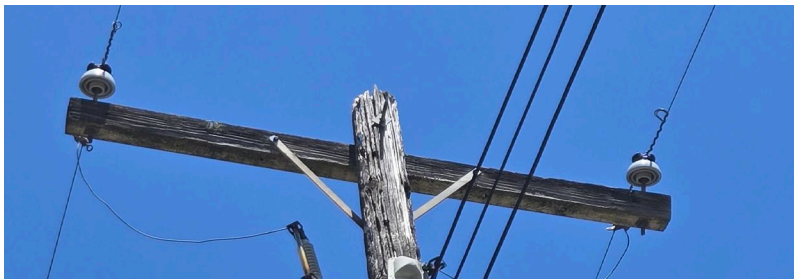
Before SMUD Correction:

1.6 ESRB Finding: Wood Pole #062246 located at GPS coordinates 38.6935908, -121.215892 in Orangevale (Location 39) has a significantly degraded and shrunk/reduced pole top.

1.6 Degraded Pole Top, UD062246

SMUD Response: SMUD installed a split bolt at the top of the pole and conducted a drill test at pole top May 7, 2024. The drill test was satisfactory and no further corrective action is required.

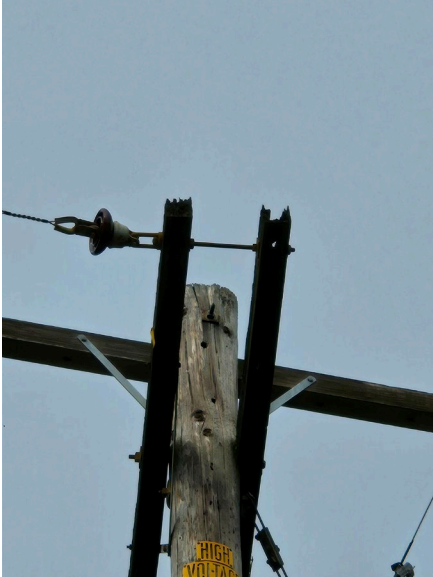
Before SMUD Correction:

1.7 ESRB Finding: Wood Pole #087567 at 9475 Golden Gate Ave in Orangevale (Location 40) has a degraded primary crossarm that is missing a section of wood near the insulator hardware.

1.7 Degraded Primary Crossarm, UD087567

SMUD Response: SMUD replaced the primary crossarm March 26, 2024.

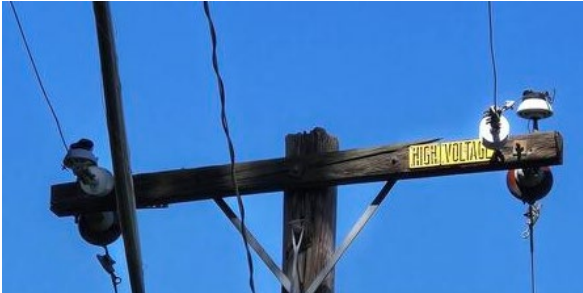
Before SMUD Correction:

1.8 ESRB Finding: Wood Pole at 4701 Chicago Ave in Fair Oaks (Location 49) has a primary crossarm with a crack approximately 2.5 feet long at the through bolt.

1.8. Crack on Primary Crossarm, UD049351

SMUD Response: This wood pole is identified as UD049351. SMUD replaced the crossarm May 23, 2024.

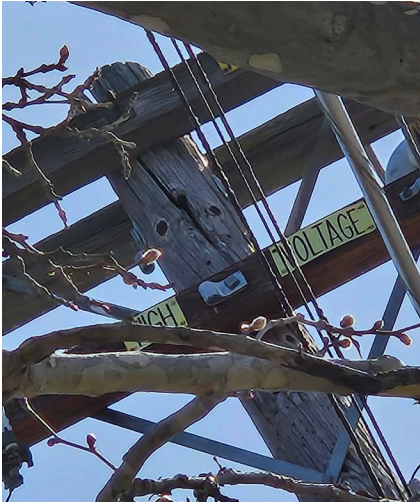
Before SMUD Correction:

1.10 ESRB Finding: Wood Pole #124652 located at GPS coordinates 38.6027186,-121.3922284 in Sacramento (Location 59) has a degraded pole top with a 2 foot long crack

1.10. Degraded Pole Top with Crack, UD124652

SMUD Response: SMUD repaired the degraded pole top May 7, 2024.

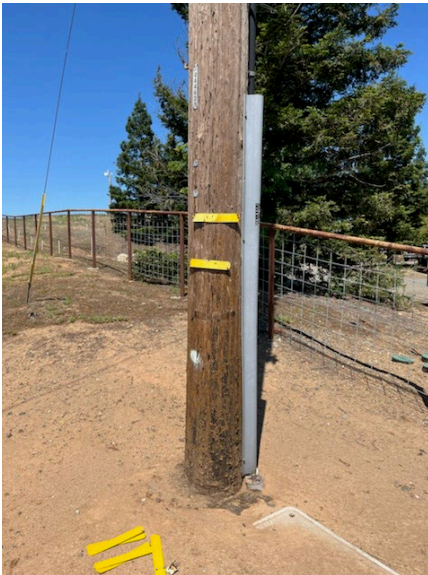
Before SMUD Correction:

2.1 ESRB Finding: Wood Pole #044629 at 13639 Jackson Rd in Sloughouse (Location 9) has a broken high-visibility strip.

2.1 Broken Visibility Strips, UD044629

SMUD Response: SMUD replaced the visibility strips May 7, 2024.

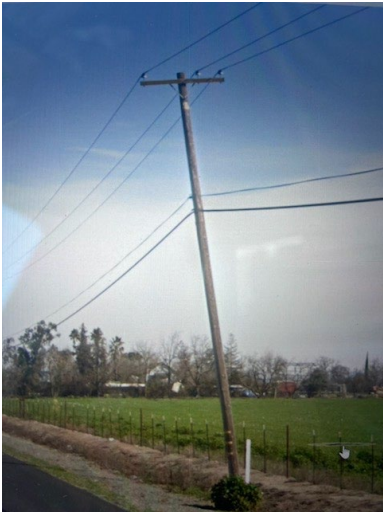
Before SMUD Correction:

2.2 ESRB Finding: Wood Pole #024085 located at GPS coordinates 38.3256352,-121.3198484 in Galt (Location 10) is leaning more than 10% and has soil erosion at its base.

2.2 Leaning Pole, UD024085

SMUD Response: SMUD replaced the wood pole May 10, 2024.

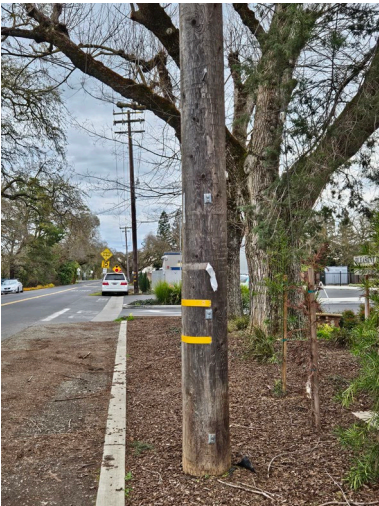
Before SMUD Correction:

2.3 ESRB Finding: Wood Pole #135085 at Pleasant Grove Elementary in Elk Grove (Location 16) has a damaged/loose high-visibility strip.

2.3 Damaged / loose visibility strip, UD135085

SMUD Response: SMUD replaced visibility strip May 17, 2024.

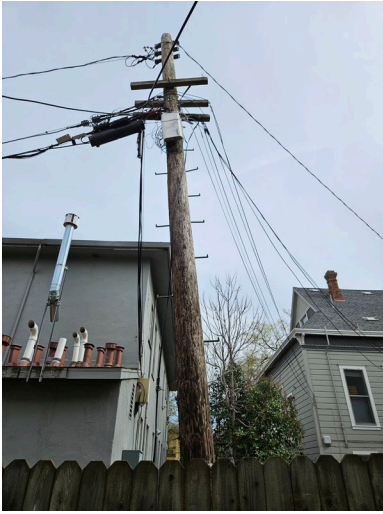
Before SMUD Correction:

2.4 ESRB Finding: Secondary Wood Pole at 1520 23rd St in Sacramento (Location 26) is leaning more than 10%. SMUD has a preexisting notification (#32073607) to adjust the pole.

2.4 Leaning Pole, UD020814

SMUD Response: SMUD straightened the leaning wood pole May 8, 2024. The pole was tested good.

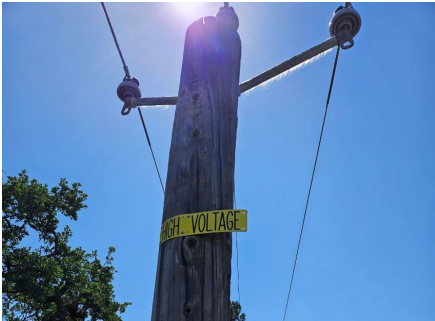
Before SMUD Correction:

3.2 ESRB Finding: Wood Pole #077082 at 8911 Mooney Rd in Wilton (Location 13) has a loose high voltage sign.

3.2 Loose High Voltage Sign, UD077082

SMUD Response: SMUD re-attached the loose high voltage sign May 16, 2024.

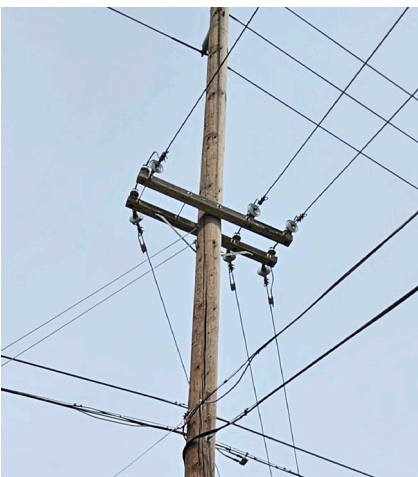
Before SMUD Correction:

3.3 *ESRB Finding: Wood Pole #072797 at 1516 Florin Rd in Sacramento (Location 25) is missing high voltage signs on both sides.*

3.3 Missing High Voltage Signs, UD072797

SMUD Response: SMUD installed new high voltage signs May 7, 2024.

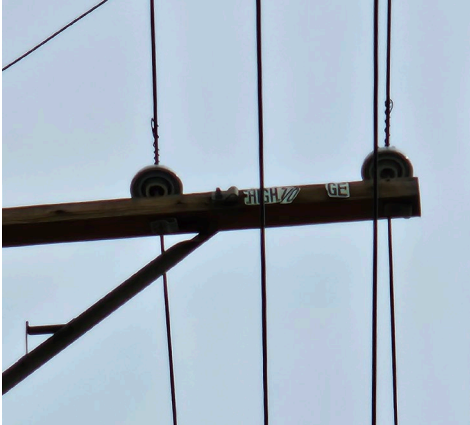
Before SMUD Correction:

3.4 *ESRB Finding: Wood Pole #020812 at 2212 Opera Aly in Sacramento (Location 30) has a damaged/partially missing high voltage sign.*

3.4 Damaged High Voltage Signs, UD020812

SMUD Response: SMUD installed new high voltage sign May 8, 2024.

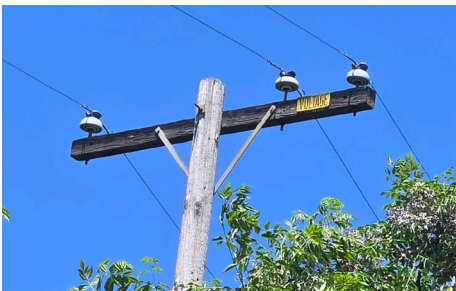
Before SMUD Correction:

3.5 *ESRB Finding: Wood Pole #060080 at 7300 Bonita Way in Citrus Heights (Location 46) has deteriorated/partially missing high voltage signs on both sides.*

3.5 Deteriorated/Partially Missing High Voltage Signs, UD060080

SMUD Response: SMUD installed new high voltage signs May 8, 2024.

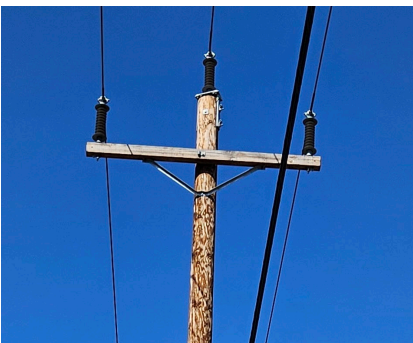
Before SMUD Correction:

3.6 *ESRB Finding: Wood Pole #192024 located at GPS coordinates 38.602351,-121.3922023 in Sacramento (Location 55) is missing a high voltage sign.*

3.6 Missing High Voltage Sign, UD192024

SMUD Response: SMUD installed new high voltage signs May 7, 2024.

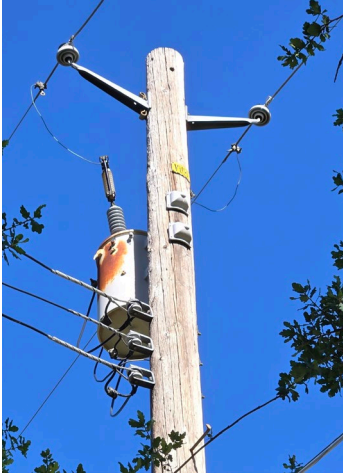
Before SMUD Correction:

3.7 *ESRB Finding: Wood Pole #068862 at 5601 Rich Ln in Antelope (Location 75) is missing a high voltage sign.*

3.7 Missing high voltage sign, UD068862

SMUD Response: SMUD installed new high voltage signs May 7, 2024.

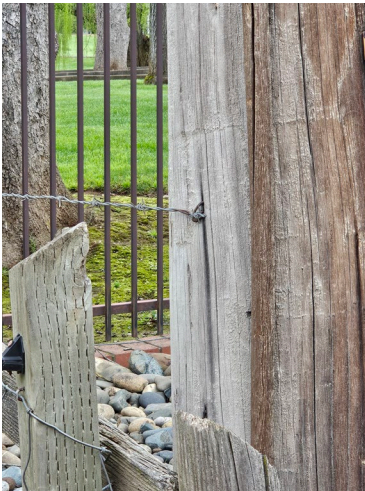
Field Audit Condition:

4. *ESRB Finding: Wood Pole #077082 at 8911 Mooney Rd in Wilton (Location 13) has a barbed wire fence attached to it.*

4. Barbed Wire Attached to Pole, UD077082

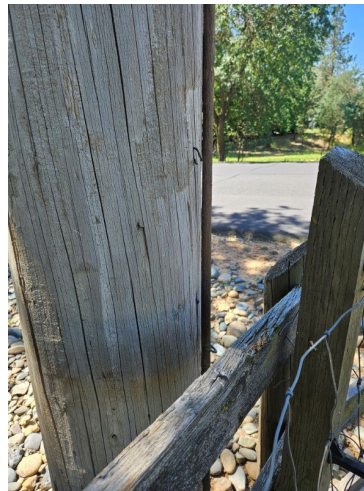
SMUD Inspected May 16, 2024

SMUD Response: SMUD inspected the site May 16, 2024 but did not find barbed wire on the pole. Crews removed some staples from where the wire may have been attached to the pole.

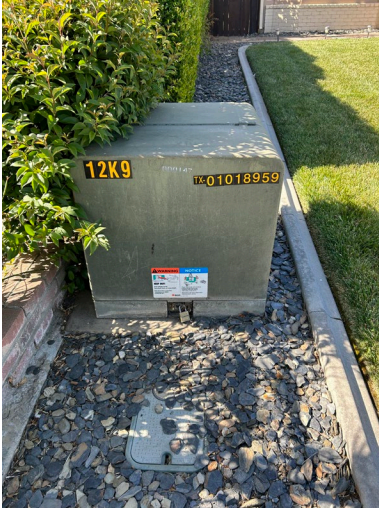
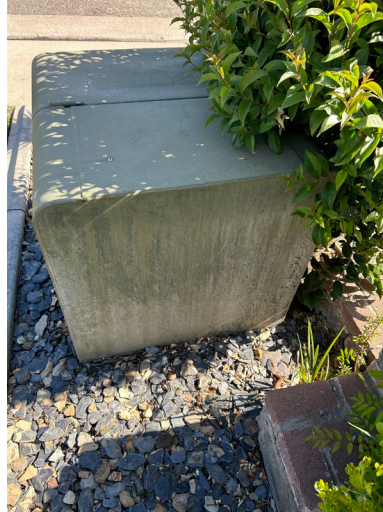
After SMUD Correction:

5.1 *ESRB Finding: Padmount Transformer TX-01018959 at 8458 Casablanca Way in Sacramento (Location 19) has an oil leak. SMUD has a preexisting notification (#32140777) to repair the leak.*

5.1 Transformer Oil Leak, TX-0108959

SMUD Response: SMUD completed addressing the oil leak March 18, 2024.

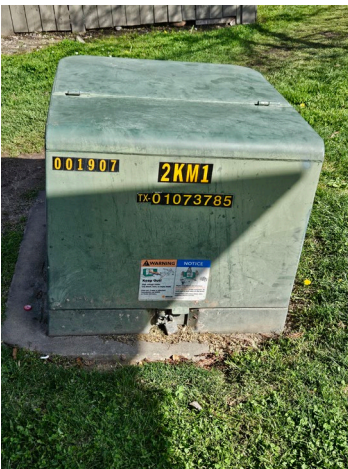
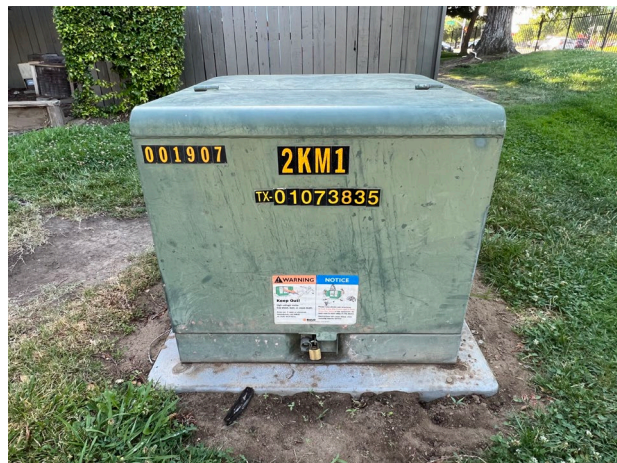
5.2 ESRB Finding: Padmount Transformer TX-01073785 at 2201 Howe Ave in Sacramento (Location 62) has sunk several inches into the ground causing it to slant sideways. SMUD has a preexisting notification (#32068191) to reset the padmount.

5.2 Slant Transformer Pad, TX-01073835 (TX-01073785)

SMUD Response: SMUD completed the work associated with notification #32068191 April 29, 2024. The corrective action on the padmount transformer at 2201 Howe Ave (TX-01073835) was completed May 28, 2024.

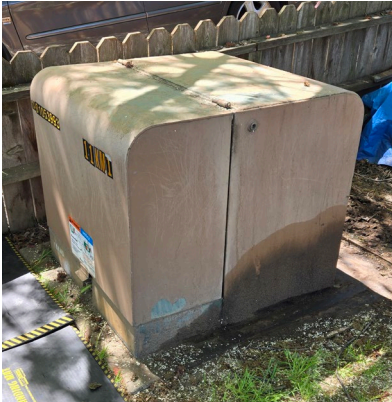
Before SMUD Correction:

5.3 ESRB Finding: Padmount Transformer TX-01053993 at 8427 Lichen Dr in Citrus Heights (Location 70) has dried oil residue on the exterior enclosure that needs to be cleaned.

5.3 Dried oil residue on the exterior of PM transformer, TX-01053993

SMUD Response: SMUD replaced the old padmount transformer with a new unit March 5, 2024.

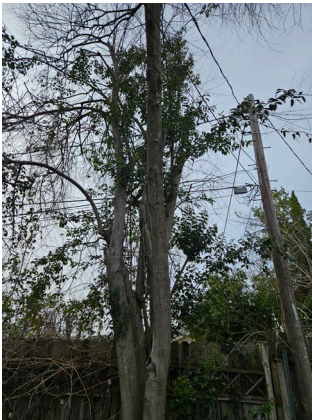
Before SMUD Correction:

6. ESRB Finding: Vegetation is causing strain/abrasion to a secondary line at Secondary Wood Pole #117552 at 3531 Becerra Way in Sacramento (Location 32). SMUD has a preexisting notification (#35705412) to trim the vegetation.

6. Vegetation causes strain / abrasion on secondary line, UD117552

SMUD Response: SMUD completed all vegetation work May 22, 2024.

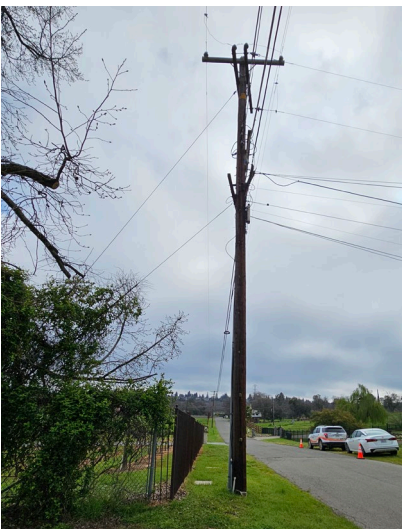
Before SMUD Correction:

7. ESRB Finding: Wood Pole #087567 at 9475 Golden Gate Ave in Orangevale (Location 40) has vegetation contact at/above the anchor guy bob which is providing a path to ground.

7. Vegetation contact at/above the anchor guy bob, UD087567

SMUD Response: SMUD completed all vegetation work May 8, 2024.

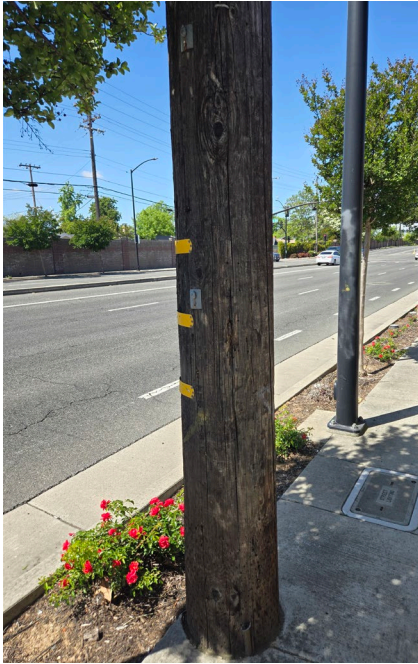
Before SMUD Correction:

8. ESRB Finding: Wood Pole #184802 located at GPS coordinates 38.707344,-121.3201984 in Citrus Heights (Location 68) is missing a 7 foot section of ground wire and ground molding at the base of the pole.

8. Missing a 7-foot section of ground wire and ground molding at the base of UD184802.

SMUD Response: SMUD repaired / installed ground wire and ground molding at the base of wood pole UD184802 May 7, 2024.
