EA2024-1174

**SUBJECT:** Electric Transmission and Distribution Facilities Audit of Redding Electric Utility (REU)

**REDDING ELECTRIC UTILITY**  
**ELECTRIC DISTRIBUTION, TRANSMISSION AND SUBSTATION AUDIT FINDINGS**  
**APRIL 29 – MAY 3, 2024**

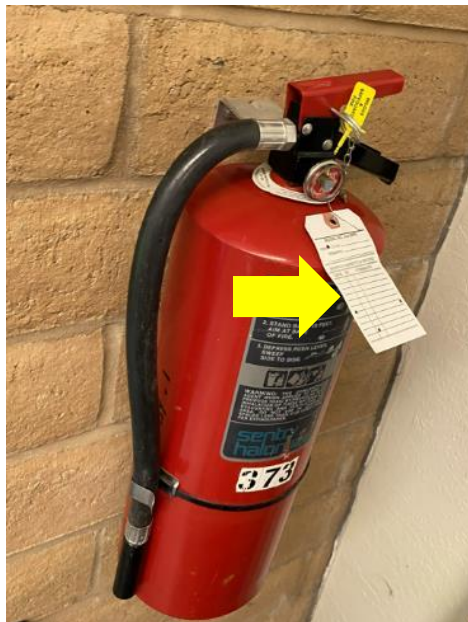
1.1. Fire extinguisher inspection is out of date.

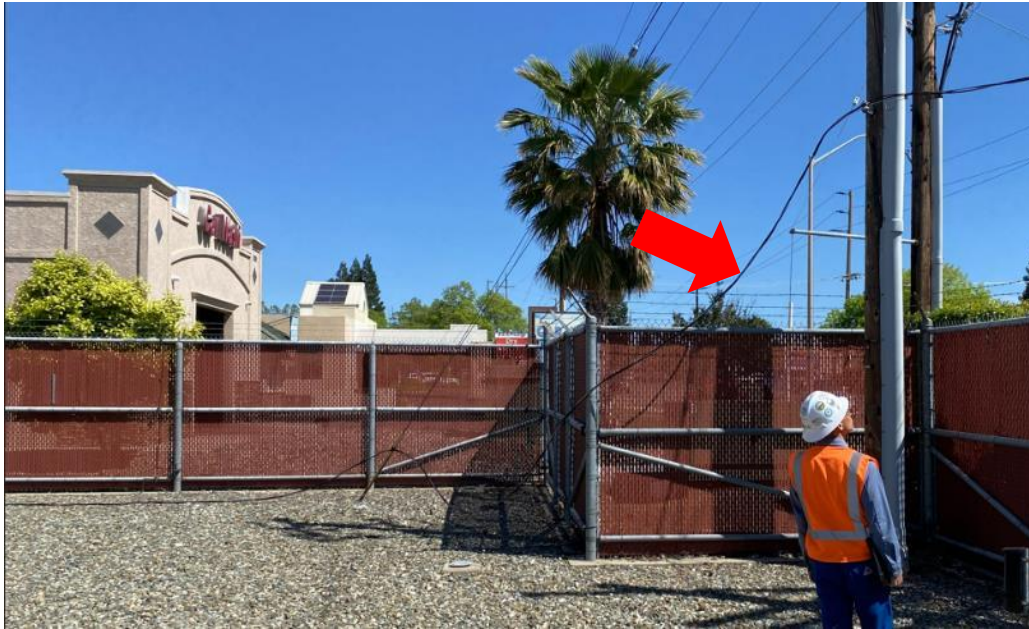
1.2. 120 V temporary line on ground, attached to fence.

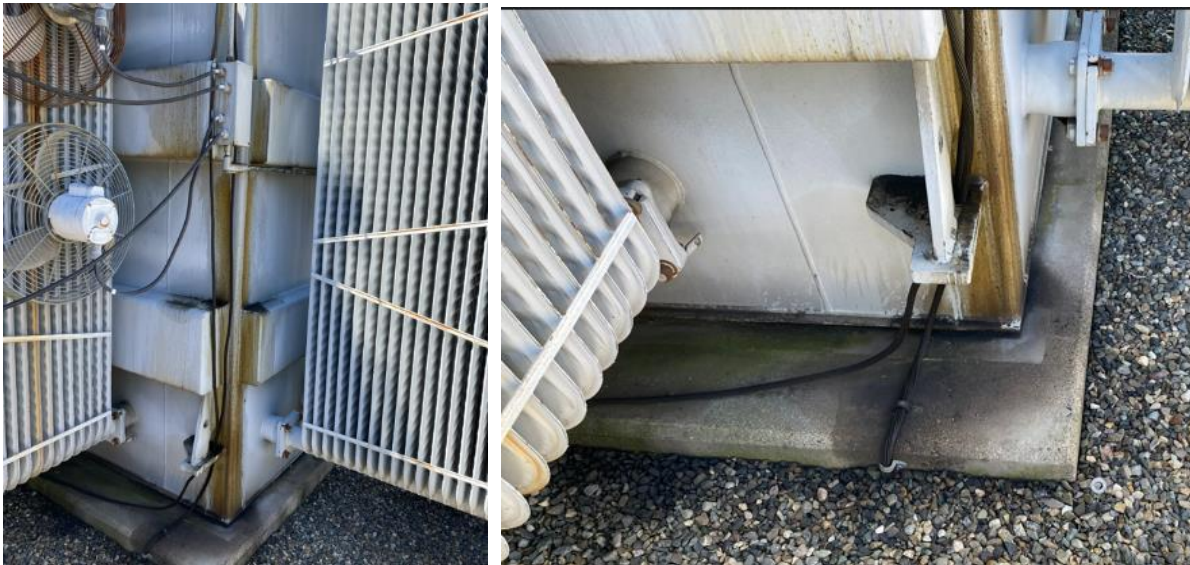
1.3. Transformer Bank 2 has an oil leak.

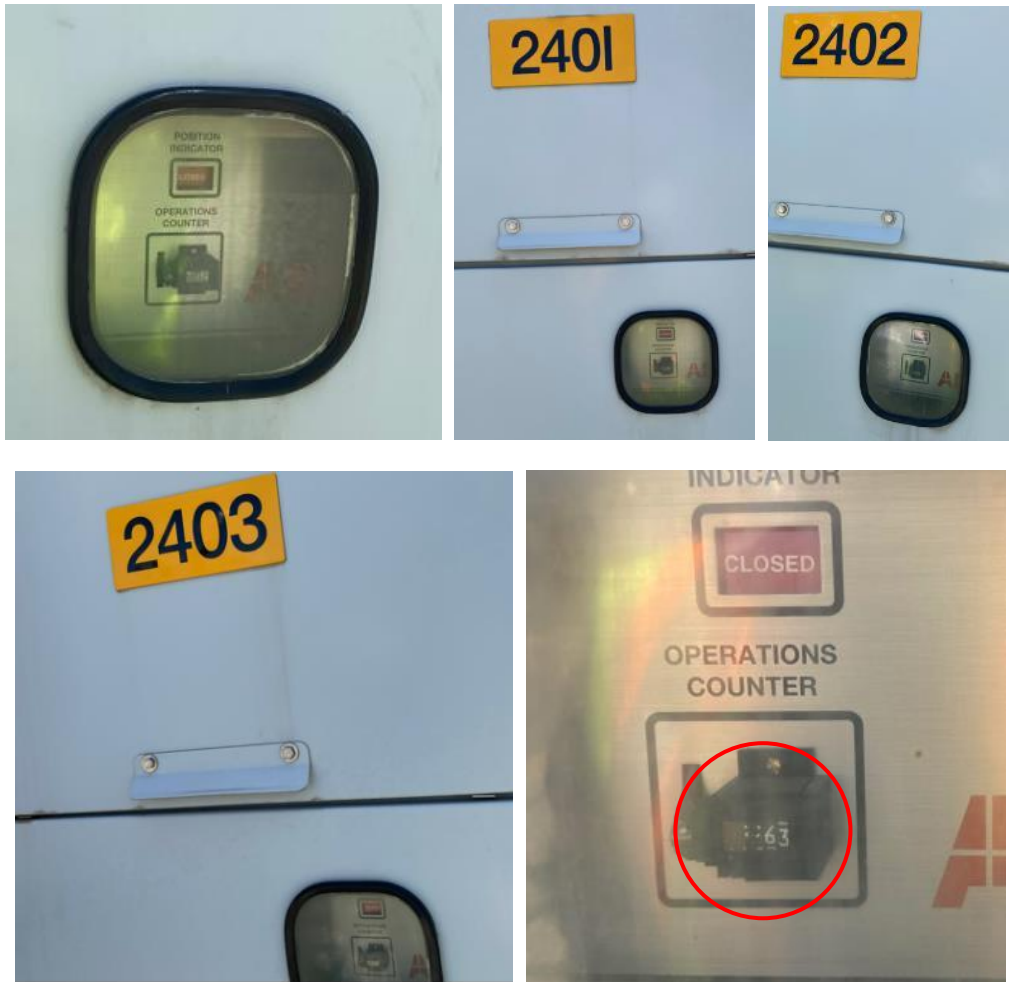
1.4. Faded/illegible counters on feeder breakers: 1203, 2401, 2402, 2403, 2404.

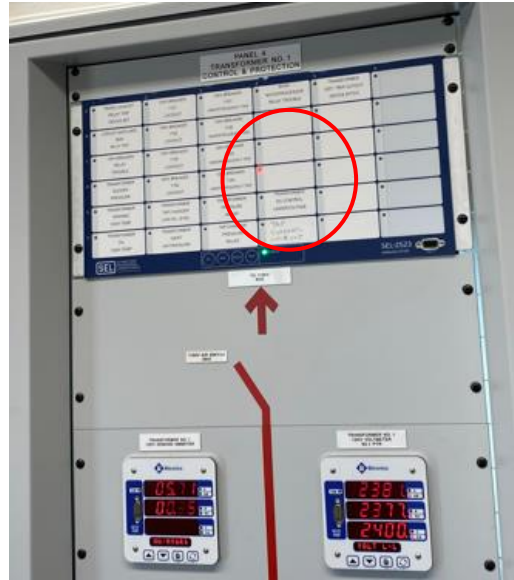
2.1. Annunciator light on: Panel 4, XFMR 1. No label on alarm, no action being taken.

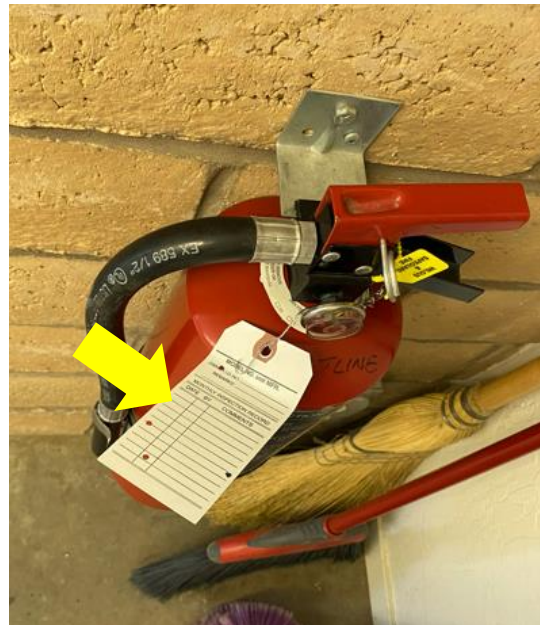
2.2. Fire extinguisher inspection is out of date.

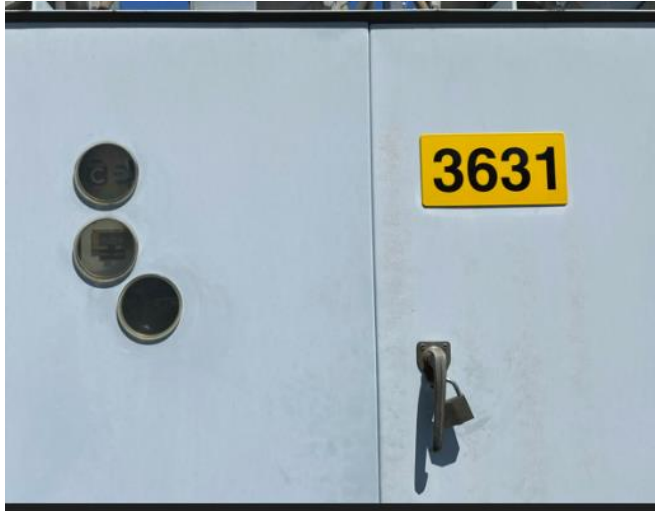
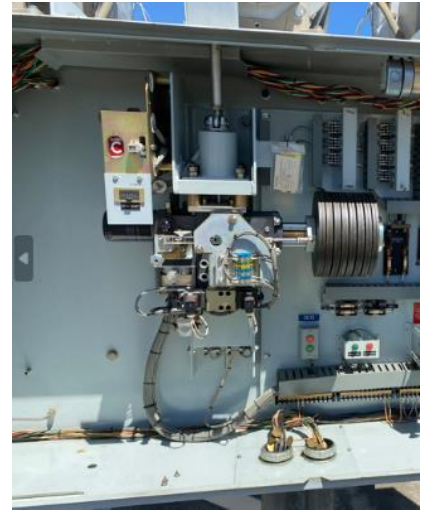
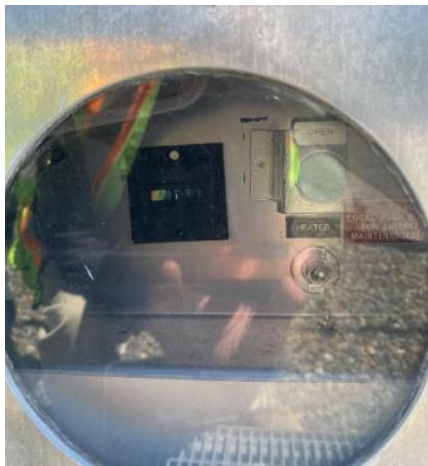
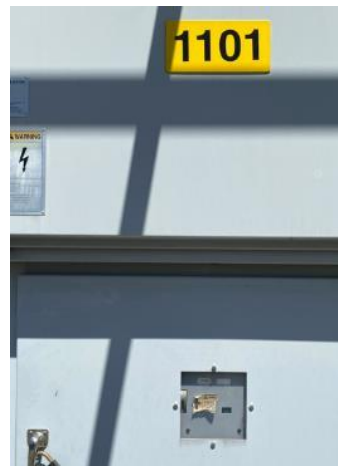
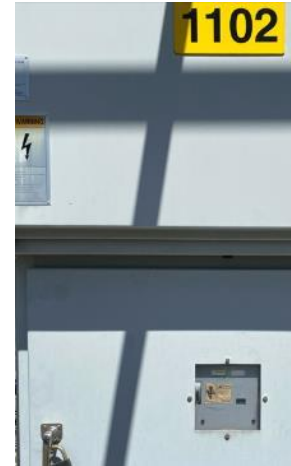
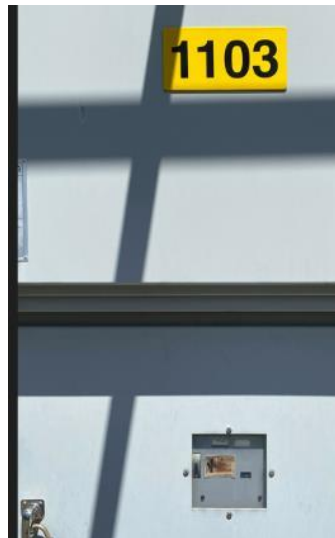
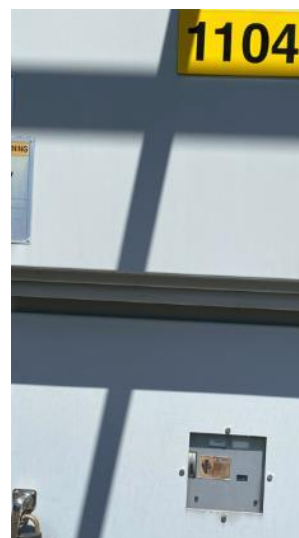
2.3. Faded/illegible counters on feeder breakers:  
3631, 3635, 3544, 1101, 1102, 1103, and 1104.

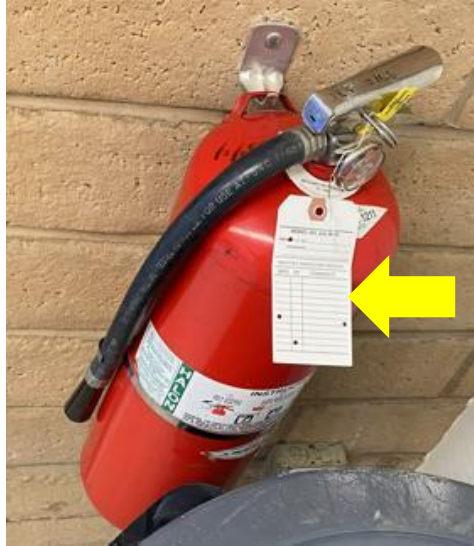
3.1. Fire extinguisher inspection is out of date.

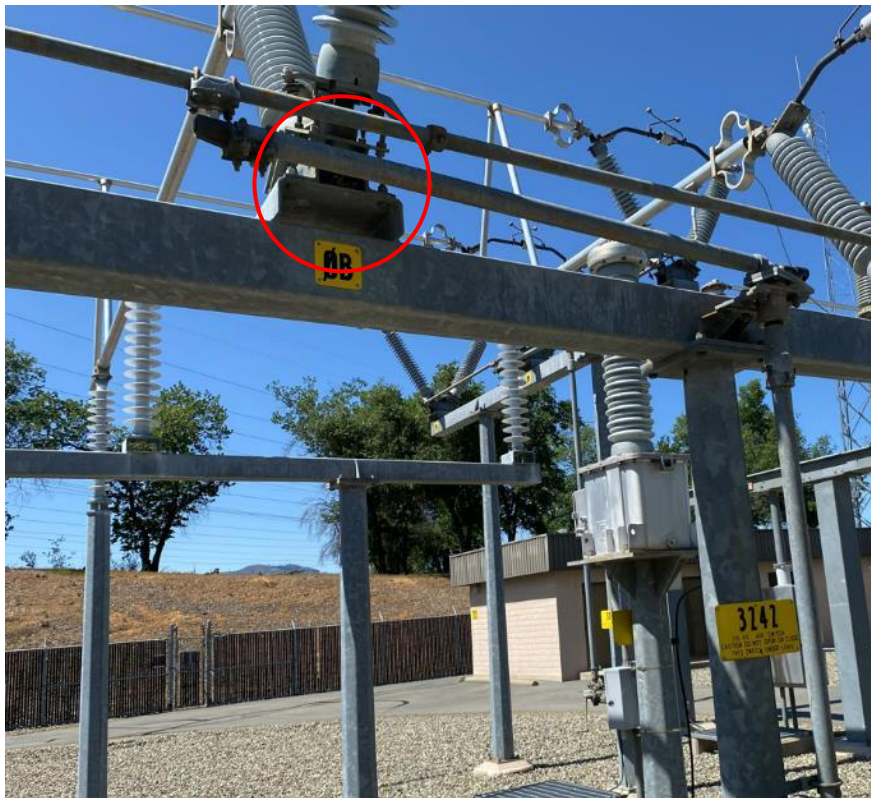
3.2. Bird nest in SW 3242 B phase bushing base.

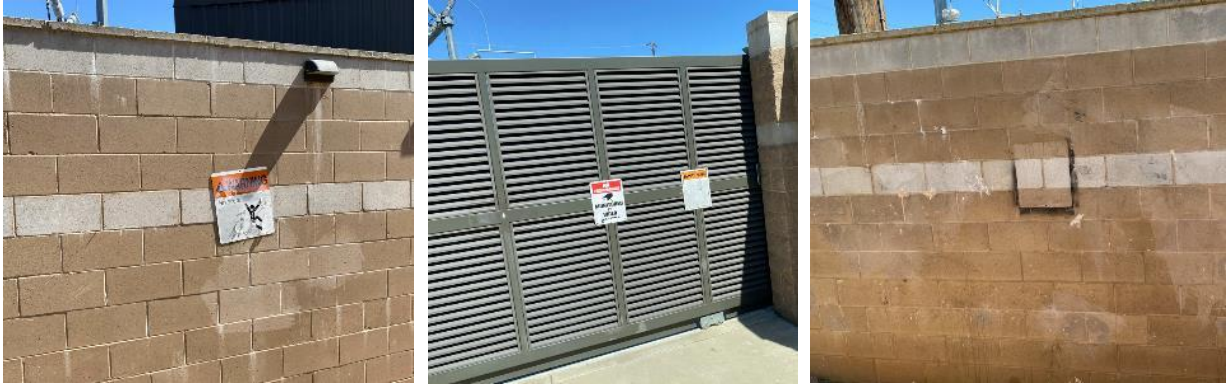
4.1. External warning signs are unreadable on the north side of substation.

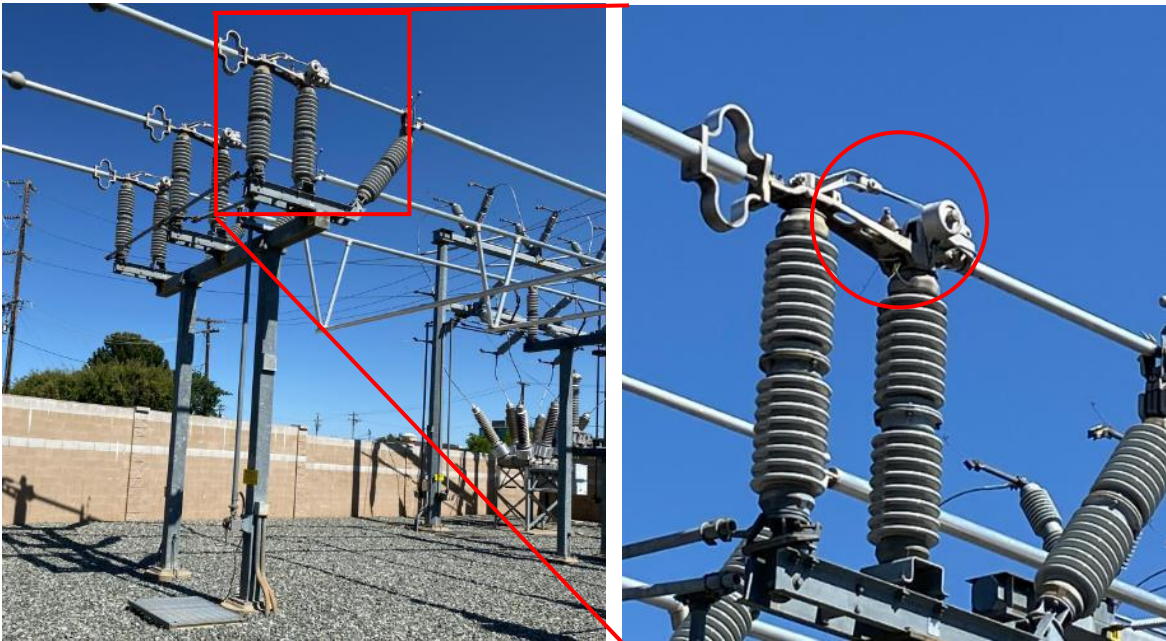
4.2. Bird nest, SW 3205 A phase, switch pivot.

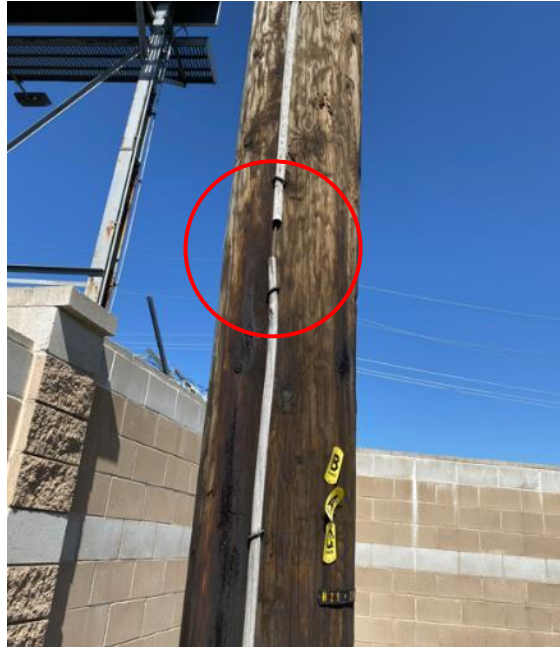
4.3. Exposed ground, broken moulding, transmission pole H29-205 located within the substation.
