PUBLIC UTILITIES COMMISSION

EA2024-1184

SUBJECT: Electric Facilities and Substation Audit of Kirkwood Meadows Public Utility District

**CPUC AUDIT FINDINGS OF
KIRKWOOD MEADOWS PUBLIC UTILITY DISTRICT
MAY 20 – MAY 23, 2024**

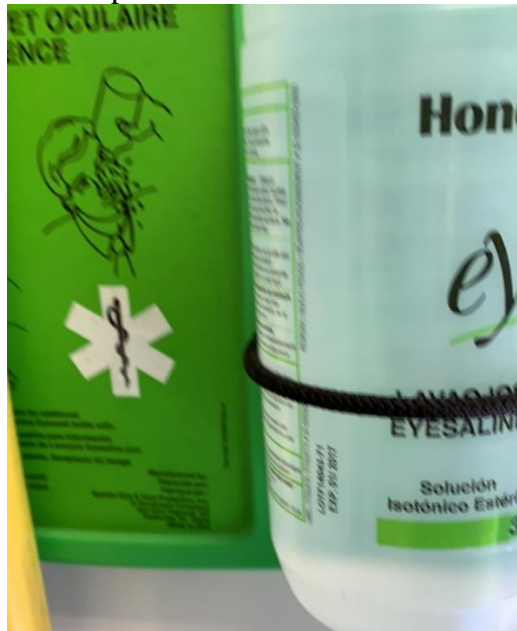
6.1 The on-site eye wash expired in 2017.

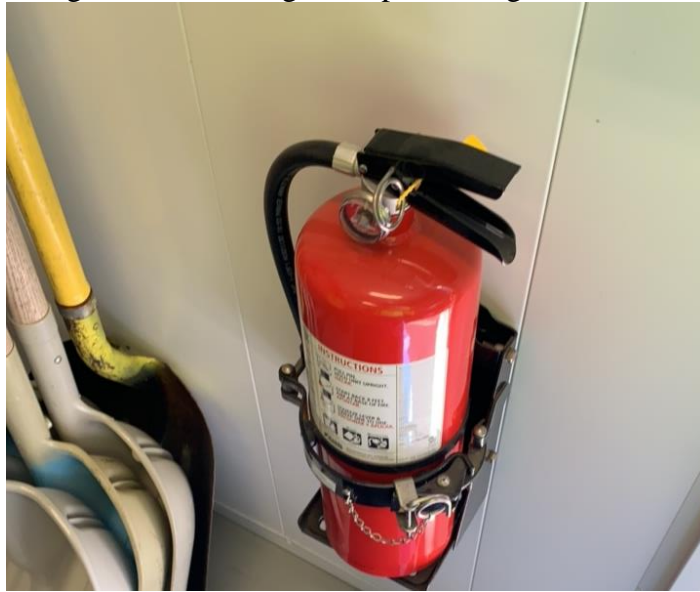
6.2 The fire extinguisher is missing an inspection tag.

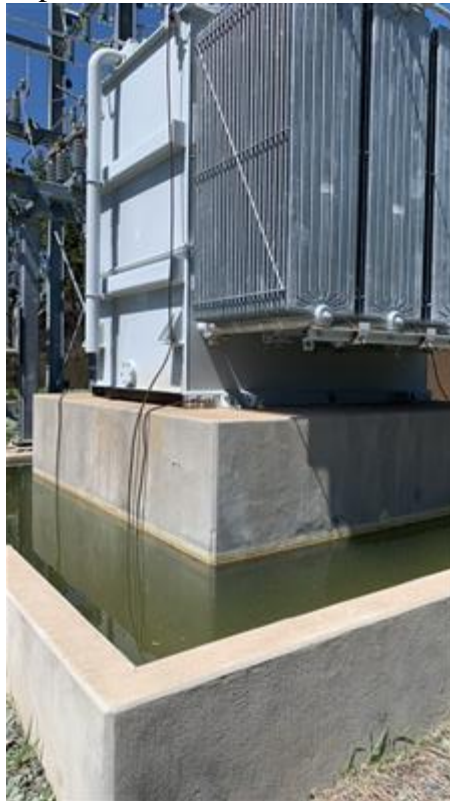
6.3 The containment pond is full of water.
