## PUBLIC UTILITIES COMMISSION

EA2024-1189

**SUBJECT:** Electric Transmission, Distribution, and Substation Audit of LMUD

**LASSEN MUNICIPAL UTILITY DISTRICT (LMUD)**  
**ELECTRIC TRANSMISSION, DISTRIBUTION, & SUBSTATION AUDIT FINDINGS**  
**May 13-17, 2024**

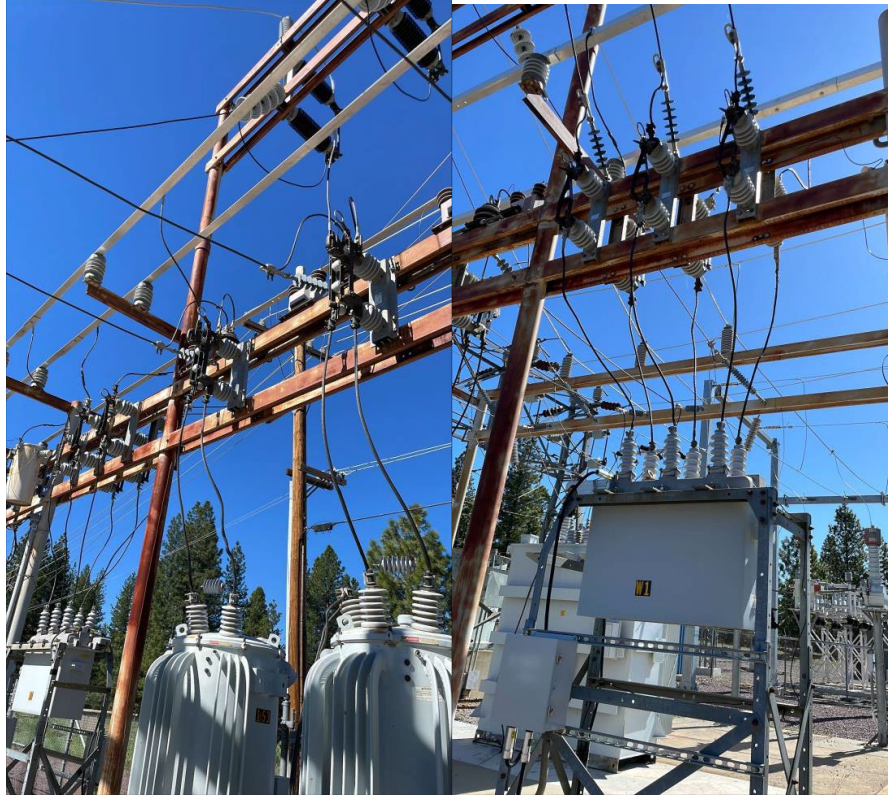
1.1. There is rust on the distribution bus structure.

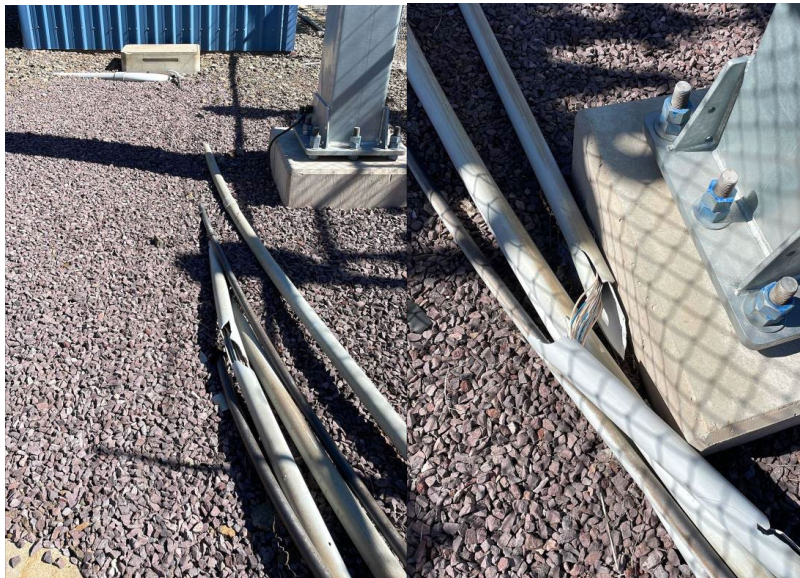
1.2. There are idle conduits on the ground that are damaged and have exposed wiring.

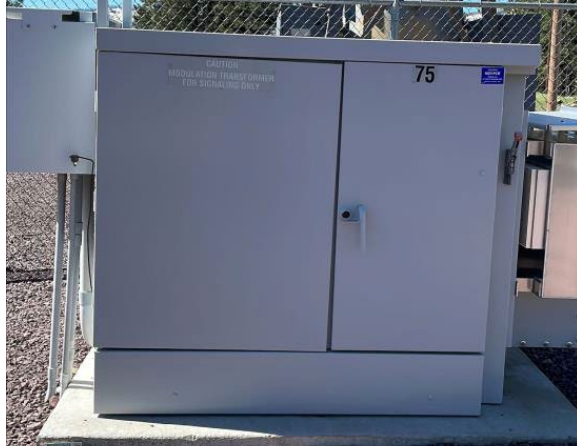
1.3. Modulation transformer is missing a high voltage sign.

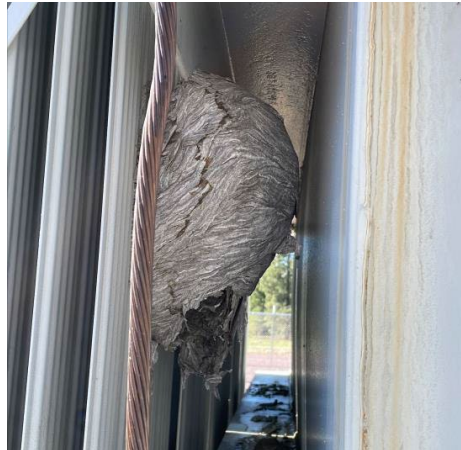
1.4. There is a hornet's nest on the transformer cooling fins.

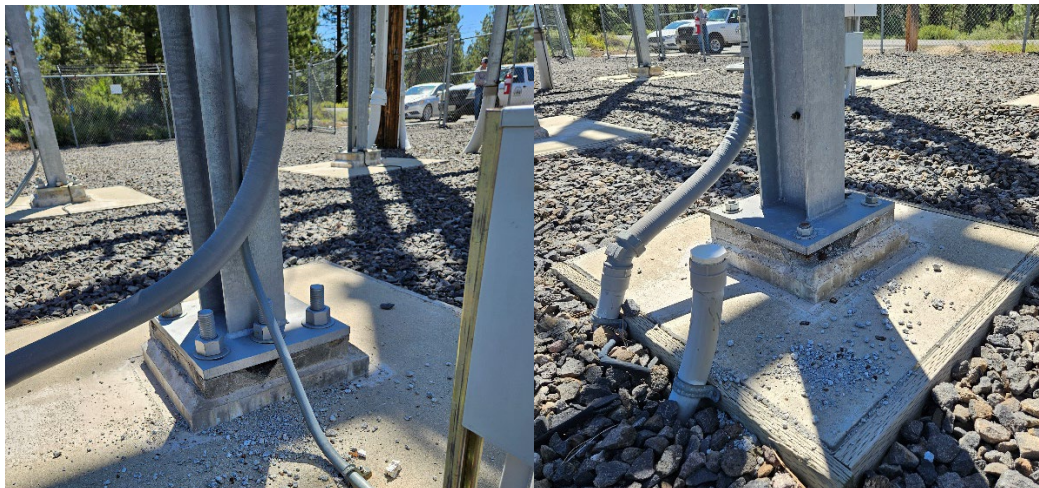
2.1. There is spauling/crumbling concrete at the structure footings for the 480/240 V Transformer Bank and Distribution UG service to meter.

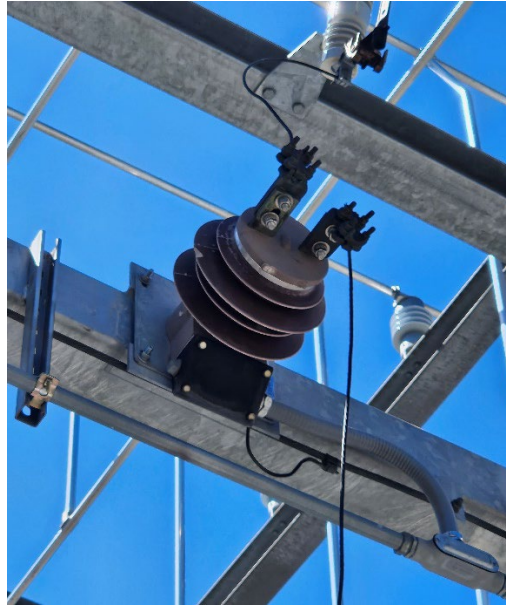
2.2. The middle insulator for Transformer 9948 is chipped.

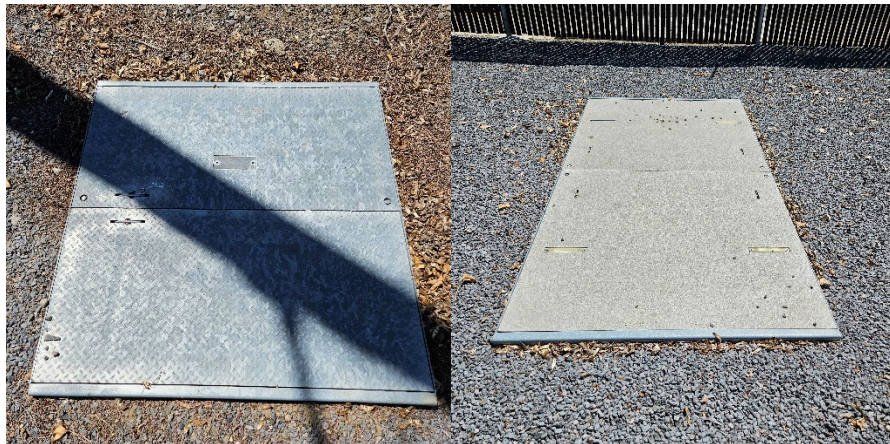
Two UG vaults are missing high voltage signage.

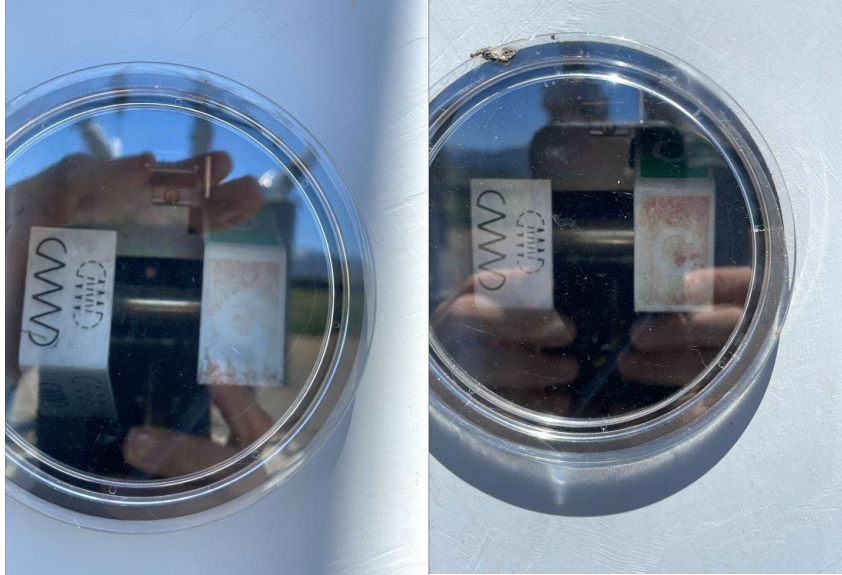
4.1. Circuit Breakers P101 and P202 have faded annunciators.

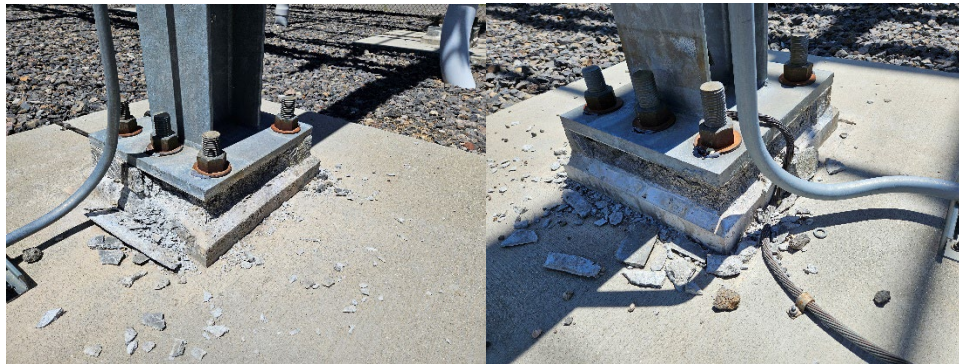
4.2. There is spauling/crumbling concrete at the structure footing for the distribution Circuit Breakers.

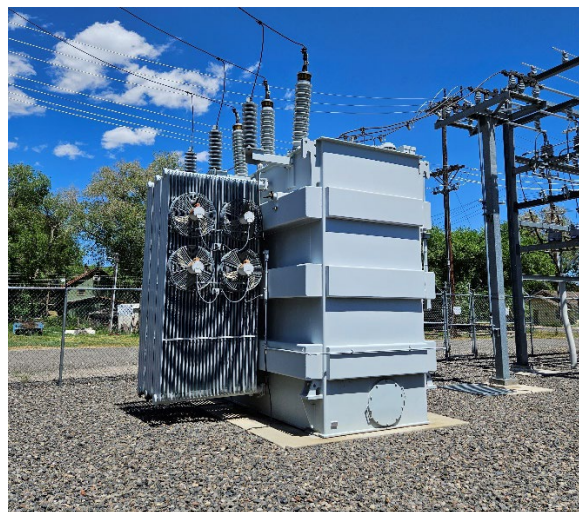
4.3. Main Transformer is missing confined space entry signage.

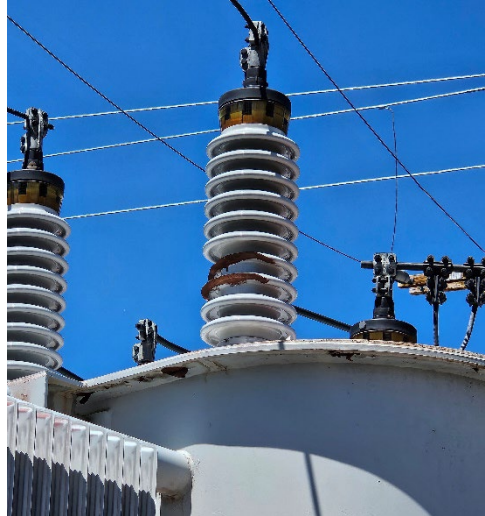
5.1. Main Transformer has a significantly chipped bushing.

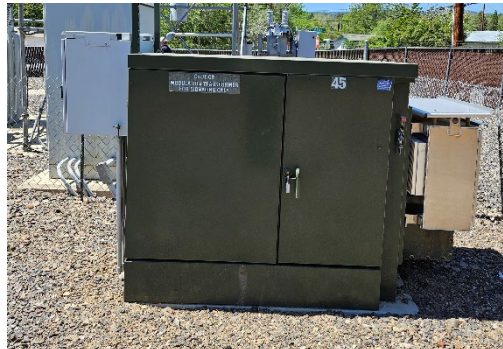
5.2. The Modulation Transformer is missing a high voltage sign.

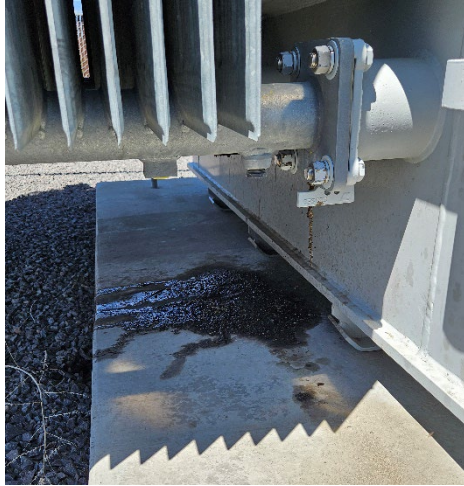
6.1. Main Transformer has an oil leak.

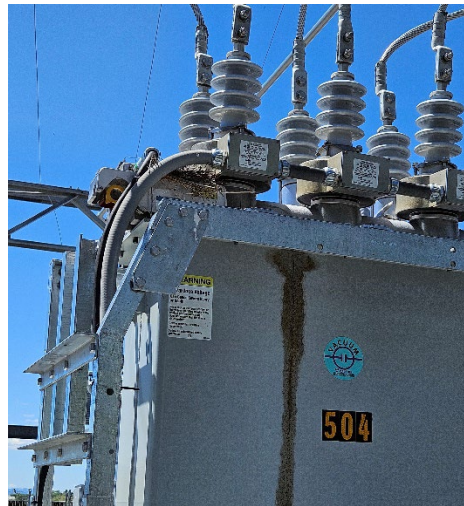
6.2. Circuit Breaker 504 has a bird's nest.

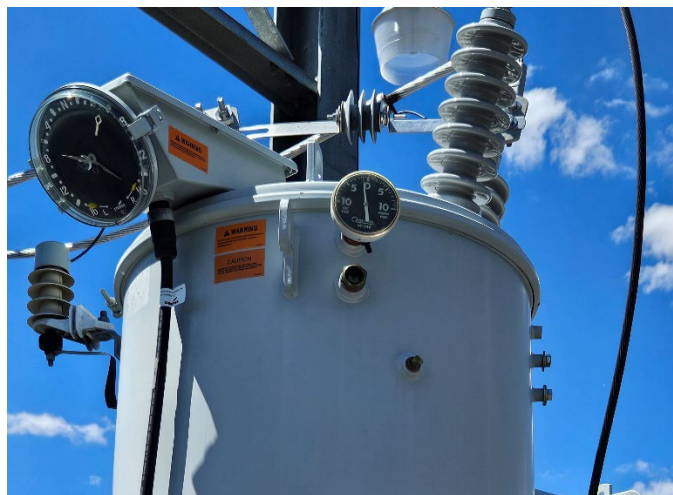
6.3. Voltage Regulator 3 has negative nitrogen pressure.

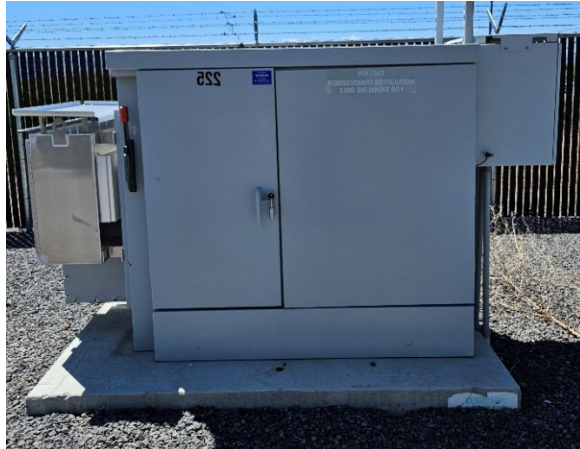
6.4. The Modulation Transformer is missing a high voltage sign.

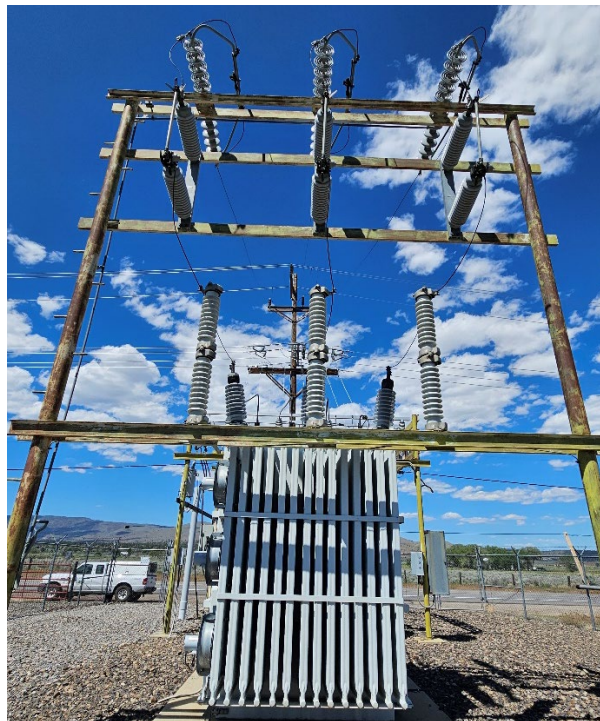
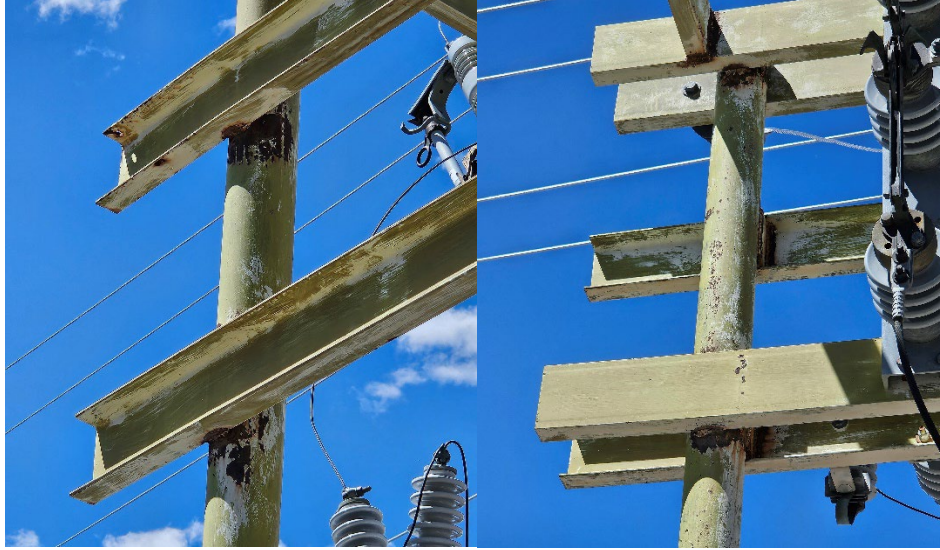
7.1. Steel structure has rust.

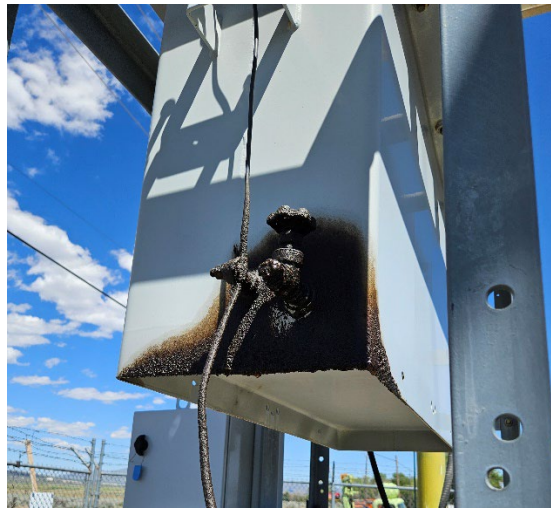
7.2. Recloser H303 has an oil leak.

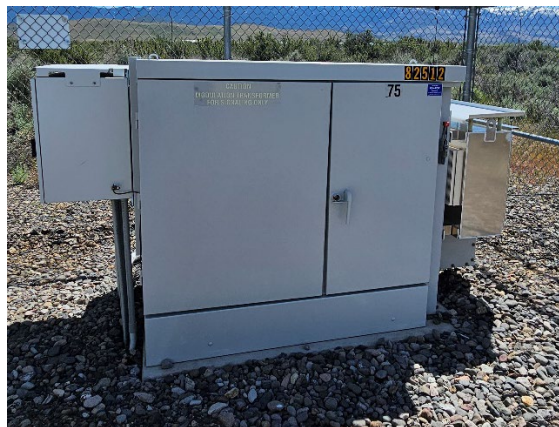
7.3. The Modulation Transformer is missing a high voltage sign.
