## PUBLIC UTILITIES COMMISSION

EA2024-1237

**SUBJECT:** Electric Distribution Audit of PG&E's East Bay Division

**PG&E EAST BAY DIVISION  
ELECTRIC DISTRIBUTION AUDIT FINDINGS  
OCTOBER 21 – 25, 2024**

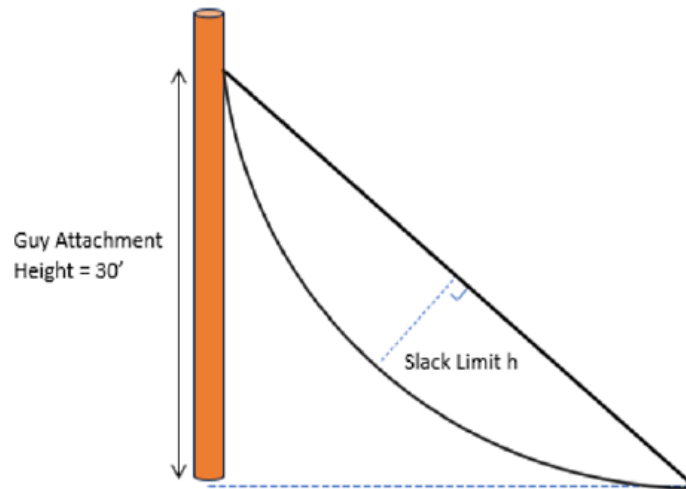
Figure 1: Guy slack limit, TD-2305M-JA02 Rev13

Per GO 95, Rule 56.2, guys are to be maintained taut<sup>1</sup>. PG&E's TD-2305M-JA02 allows a deviation from taut by as much as 3 feet without regard to length or angle of attachment.<sup>2</sup>

PG&E’s TD-2305M-JA02, Job Aid, Miscellaneous Other Compelling Abnormal Conditions, Guy Broken/Slack/Corroded does not comply with GO 95, Rule 56.2, which requires guys to be maintained taut in all circumstances.
