PUBLIC UTILITIES COMMISSION

EA2024-1244

SUBJECT: Electric Distribution Audit of PG&E's Kern Division

**PG&E KERN DIVISION
ELECTRIC DISTRIBUTION AUDIT FINDINGS
NOVEMBER 18-22, 2024**

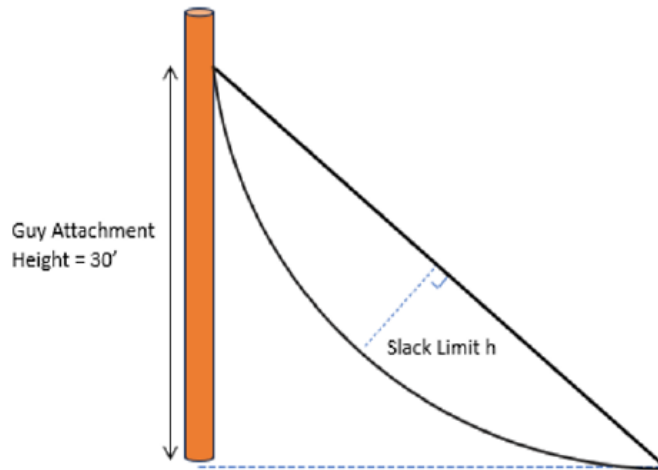
Figure 2: Guy slack limit, TD-2305M-JA02

PG&E’s TD-2305M-JA02, Job Aid: Overhead Assessment, March 25, 2024 Rev. 13, Miscellaneous Other Compelling Abnormal Conditions, Guy Broken/Slack/Corroded states, *“Pole must be straight with Guy no more than an arm’s length (3ft) from taut, that does not have significant impact on the structural integrity of the pole.”* See Figure 2.

Per GO 95, Rule 56.2, guys are to be maintained taut.²⁶ PG&E’s TD-2305M-JA02 allows a deviation from taut by as much as 3 feet without regard to length or angle of attachment.²⁷

PG&E’s TD-2305M-JA02, Job Aid, Miscellaneous Other Compelling Abnormal Conditions, Guy Broken/Slack/Corroded does not comply with GO 95, Rule 56.2 requiring guys to be maintained taut in all circumstances.

²⁷ ESRB revised PG&E’s FDA Tag Evaluation, Guy Loose/Adjust ATS Report 006.4.3-23.9 Sept 2023, an analysis of guy slack limits to achieve a taut guy at a lean of 10 %. The analysis assumed 30-foot attachment points and various angles of down guys. The analysis did not evaluate stresses on poles without guying per Rule 56.2 nor the effects of slack guys on Safety Factors per Rule 44. The analysis included the statement: “Pole overload and pole lean are two different phenomena, and pole may be overloaded without guy support before overall lean reaches [PG&E’s] allowable limit.”
