**SUBJECT: Generation Audit of Henrietta Solar Facility (Henrietta) - Audit Number GA2024-02HS**

**CPUC AUDIT FINDINGS OF  
HENRIETTA SOLAR FACILITY (HENRIETTA)  
February 5-7, 2024**

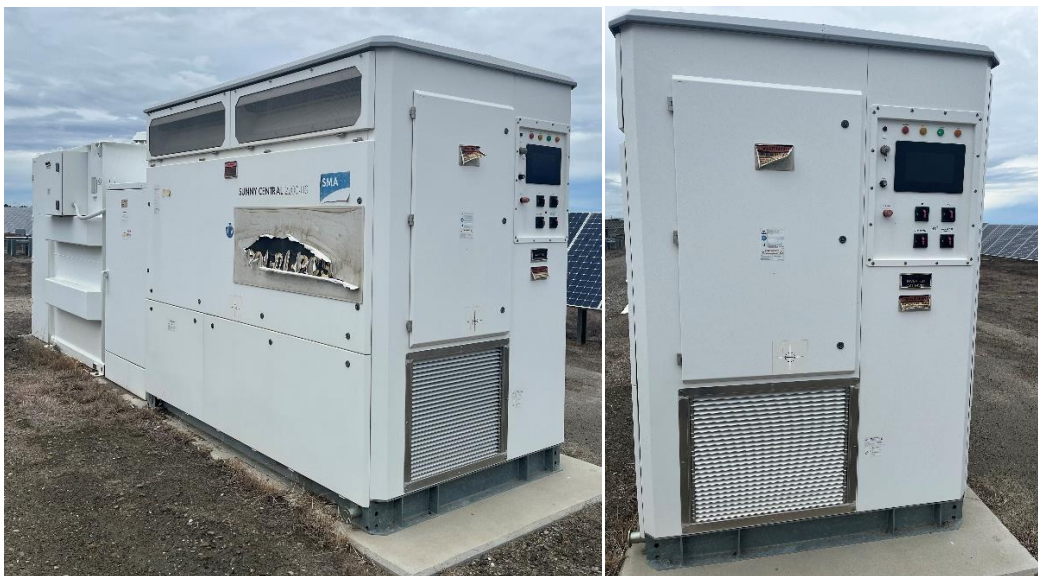
ESRB noted that high voltage signage on the inverters at each solar array were deteriorated and/or faded, depicted below in Figures 1 through 3. Signage is required to identify threats and safety hazards for staff, contractors, and emergency personnel. The Plant must continuously monitor the condition of all signage and replace as needed.

Figure 1: Inverter with deteriorated/faded high voltage signage at Array 1.

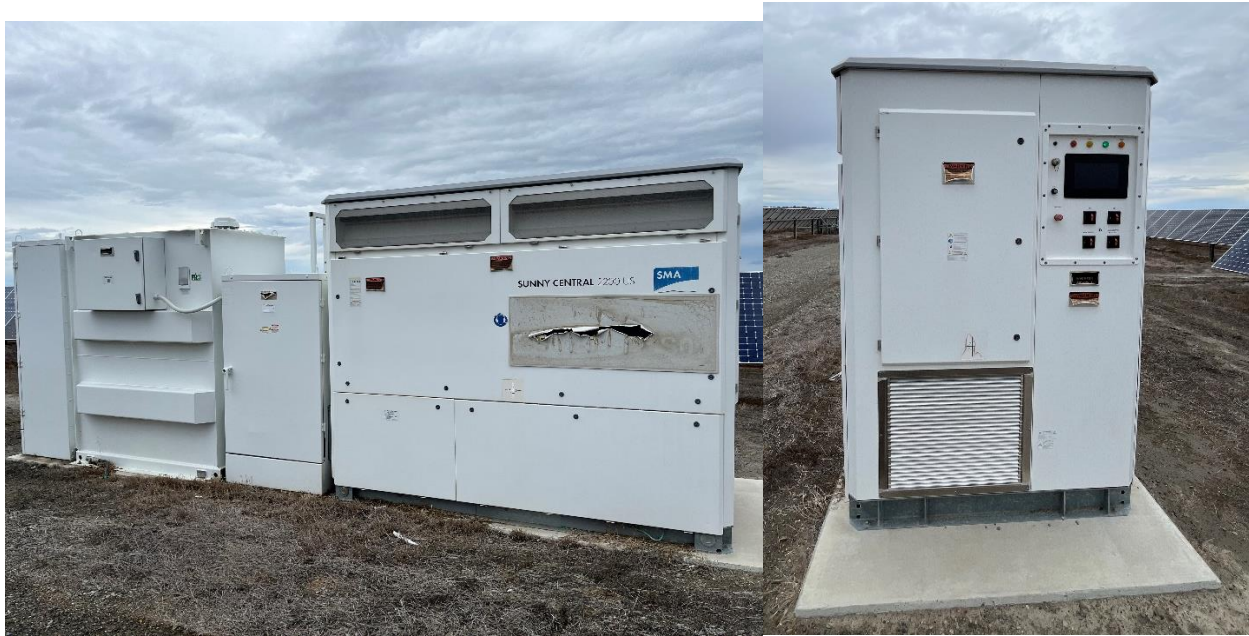
Figure 2: Inverter with deteriorated/faded high voltage signage at Array 2.

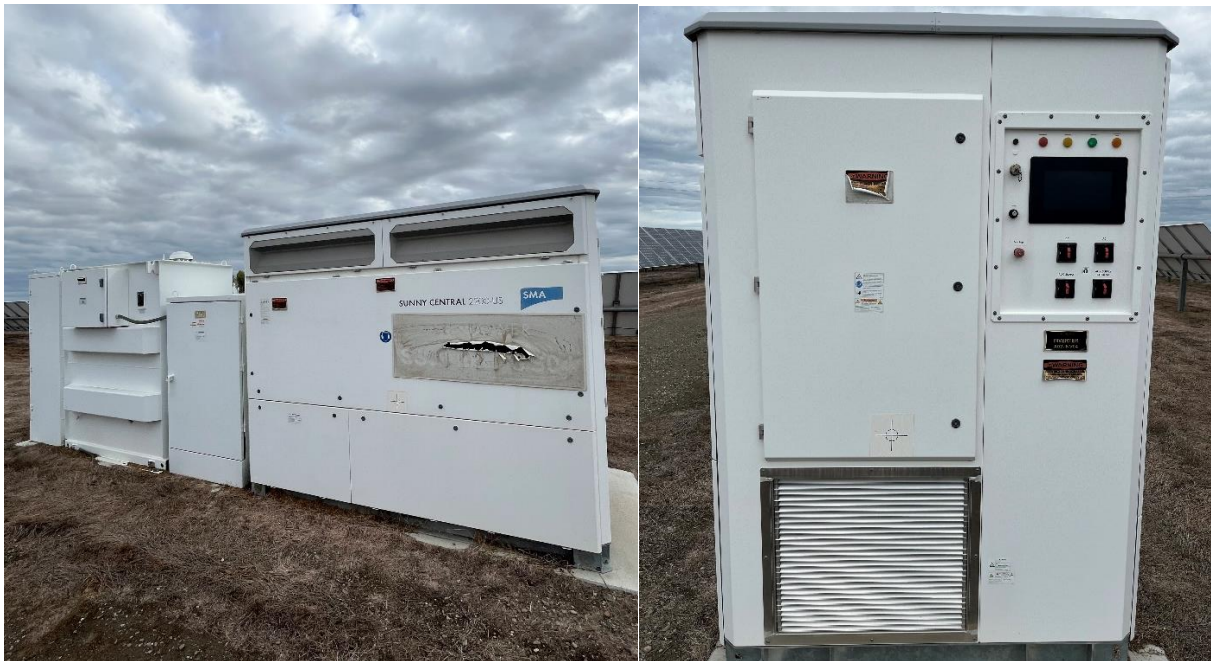
Figure 3: Inverter with deteriorated/faded high voltage signage at Array 3.

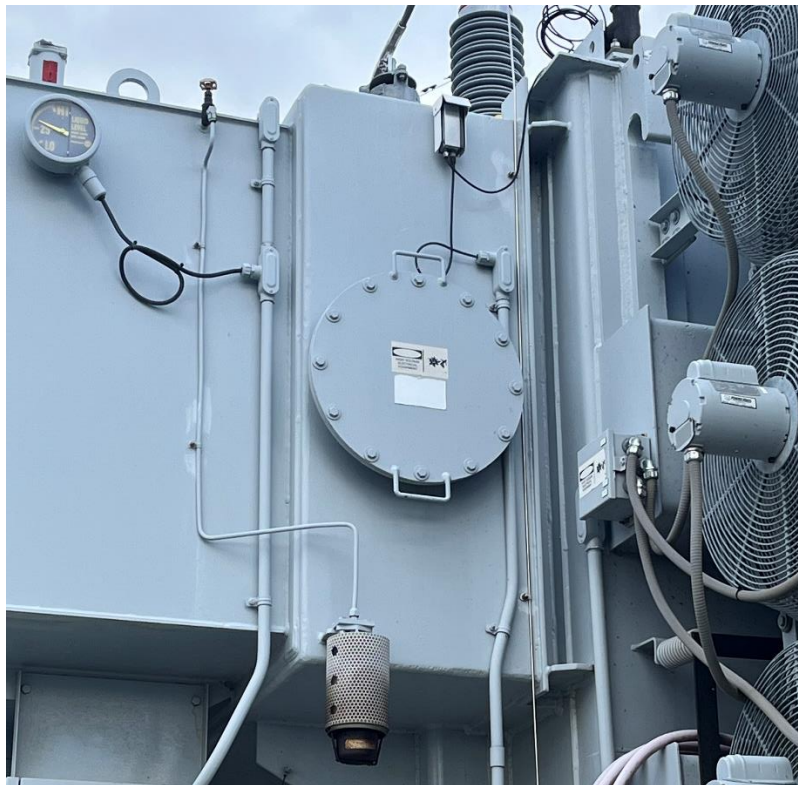
ESRB staff identified a deteriorated/faded confined space sign on the manhole of the main transformer in the substation, see Figure 4. Confined space signage is required for the operational safety of the plant, so staff and contractors are aware of the potential safety hazards and the need to obtain a permit before entering a confined space. The Plant must continuously monitor the condition of all signage and replace them as needed.

Figure 4: Confined space sign on manhole in substation is deteriorated/faded.

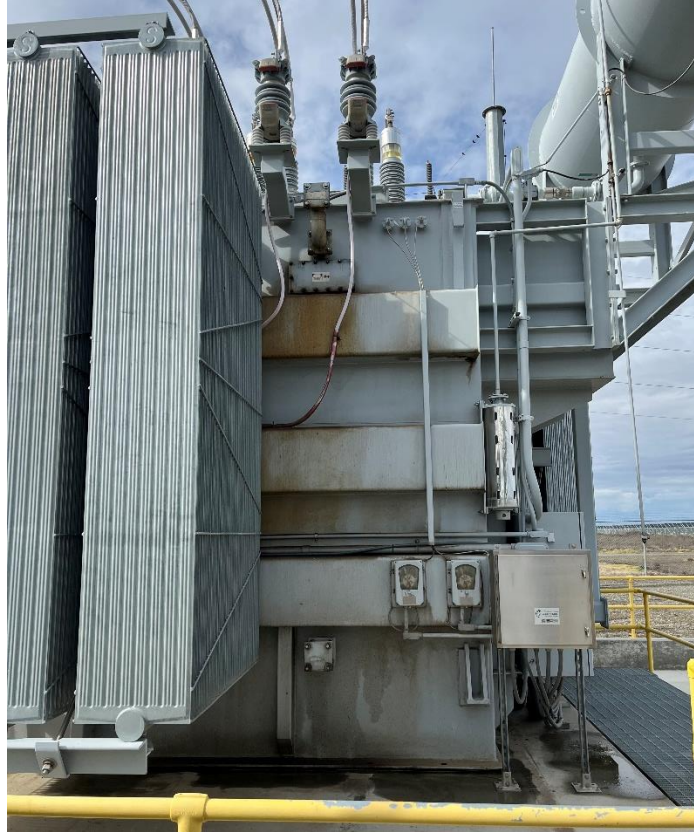
ESRB staff observed that the main transformer in the substation had a minor oil leak. The oil leak was observed on the low side of the main transformer, coming from the flange shown in Figure 5. Per ESRB’s review of the Plant’s substation inspection records, the oil leak was noted periodically by the Plant staff in the 8/7/2023 through 12/4/2023 substation inspection records. Leakage of oil poses risks to worker safety, environmental hazards, and operational reliability and efficiency. The leak had been noted since August of 2023, and was still present by the time ESRB conducted the audit in February of 2024 and had not been resolved. The Plant must promptly generate and execute corrective maintenance work orders and repair leaks to maintain safety, reliability, and efficiency of the Plant.

Figure 5: Oil leak at the low side flange of the main transformer.

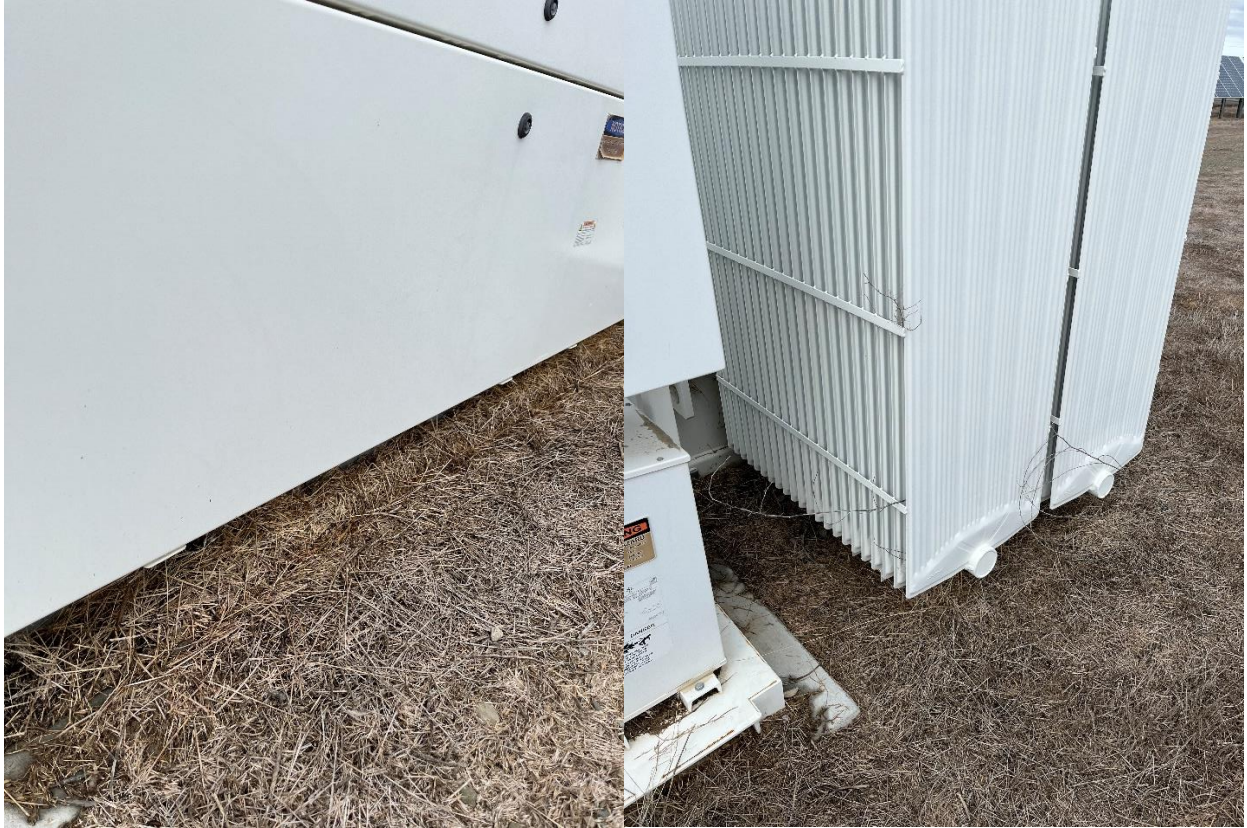
During the audit of the facility, ESRB inspected inverters in each array. There is a total of 51 SMA type inverters which convert DC solar array power to AC power. There are also transformers at the inverters which step up the low-voltage, high current output from the inverters. ESRB observed overgrown vegetation extending under the inverter, as seen in Figure 6 and 7. Some of the vegetation under the inverter is cut or dead vegetation which also poses a significant threat because it can act as loose, flammable debris. Figure 7 also shows a wider view of an inverter with vegetation surrounding the entirety of the inverter all the way up to the concrete pad. The close proximity of vegetation to an inverter and transformer poses a potential fire hazard and safety risk. Section 3.3.1 of *Henrietta Owner's Manual* provided to Henrietta Solar by SunPower outlines the recommended vegetation management practices for the Plant. The Plant should follow the recommendations in the owner's manual and remove vegetation around all site equipment to mitigate the fire risk. The overgrown vegetation was seen at multiple inverter locations and should be corrected throughout Henrietta Solar.

Figure 6: Overgrown vegetation at Inverter

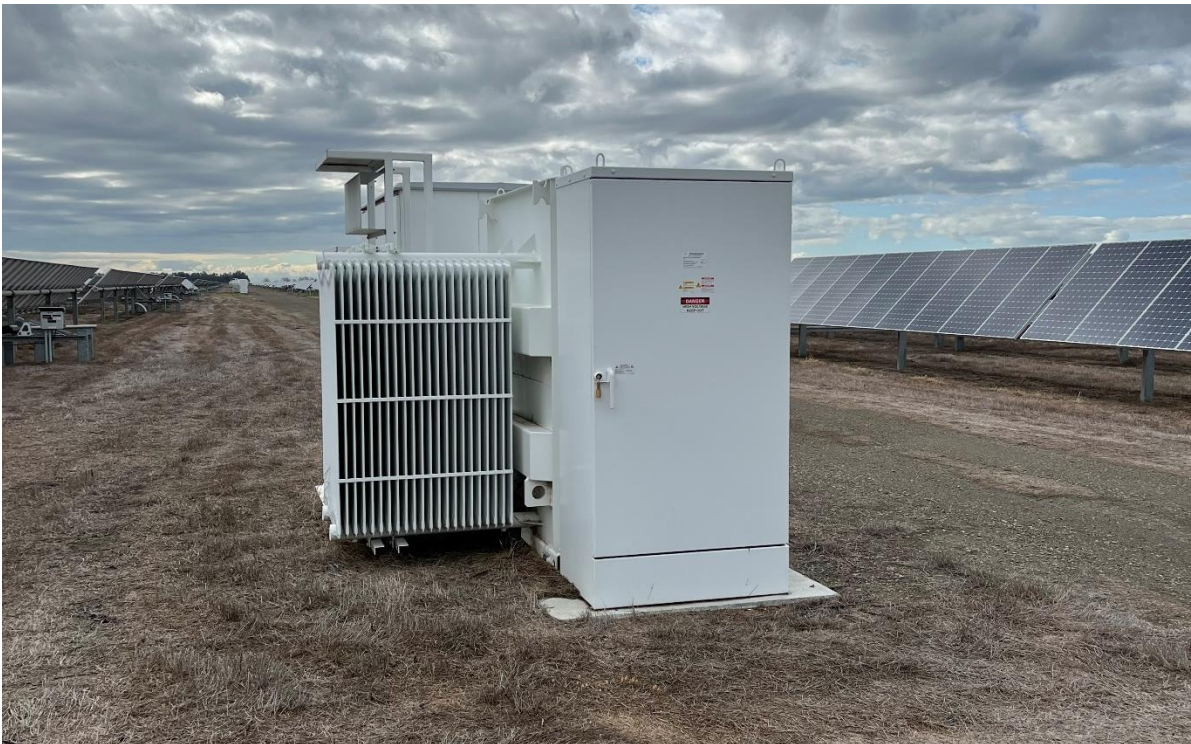
Figure 7: Invasive Loose Vegetation
