**CALIFORNIA PUBLIC UTILITIES COMMISSION  
Safety and Enforcement Division  
Electric Safety and Reliability Branch**

**Incident Investigation Report**

**Incident Number:** E20200614-01

**Utility:** Pacific Gas and Electric Company (PG&E)

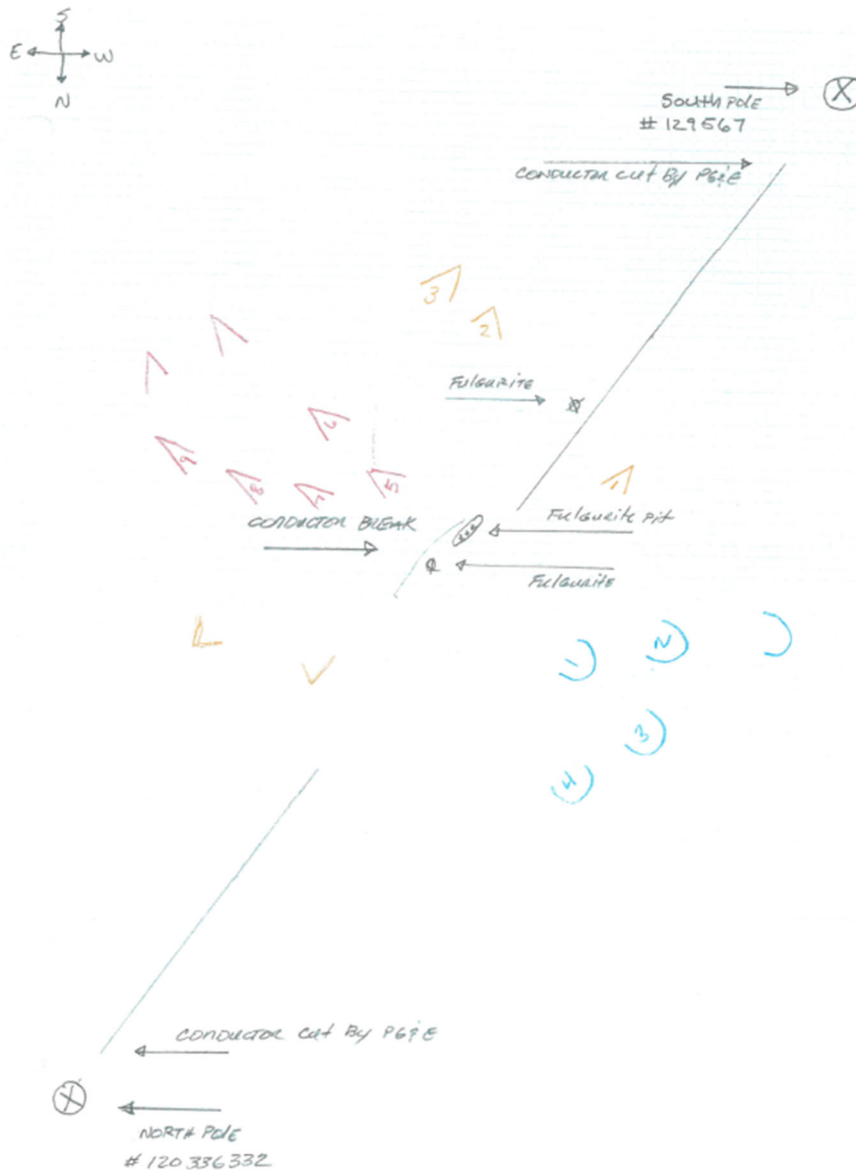
The incident location near Highway 246 and Drum Canyon Road did not involve any vegetation or other foreign object contact. SBCFD provided a drawing of PG&E's facilities and evidence of electrical ignition in Figure 3.

**Figure 3:** Drawing of incident location provided by SBCFD (not to scale)<sup>4</sup>.

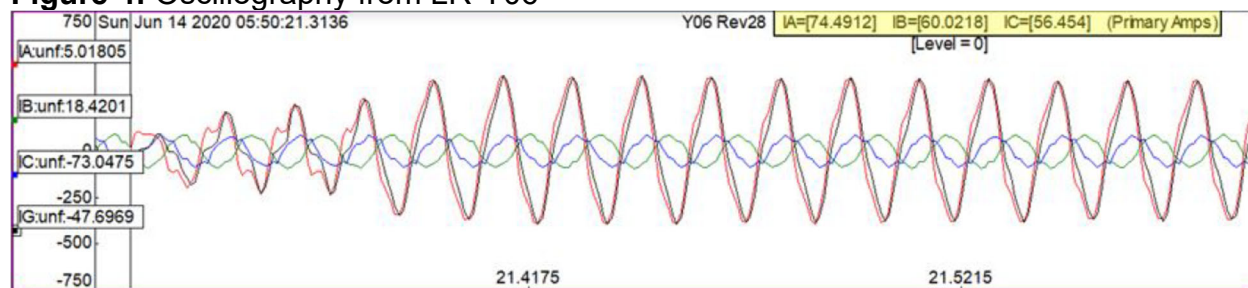
PG&E was able to provide oscillography from the nearest upstream line recloser, LR-Y06, when the South PG&E Distribution and Control Center (DCC) tried to remotely close the recloser at 1250 hours on June 14, 2020. The recloser detected a fault and automatically reopened. The A, B, and C phase conductors recorded loads of 74, 60, 56 amps, respectively. The oscillography in Figure 4, below, shows the spike in current on the A phase and ground, indicating a line-to-ground fault on the A phase. Measurements of the current are shown at the black vertical line on the left of the image, between Sun and Jun in the date heading.

**Figure 4: Oscillography from LR-Y06<sup>13</sup>**

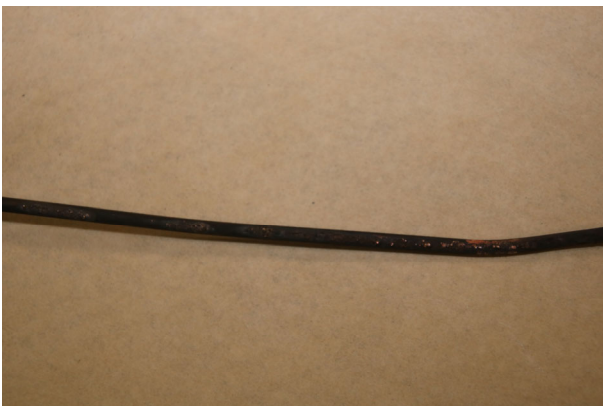
The east and center conductors both had damage indicating electrical arcing. The damage can be seen in Figures 6 and 7.

**Figure 6:** Damaged east conductor.

SBCFD's investigation report concluded that the origin and cause of the Drum Fire was a conductor owned and operated by PG&E. It was determined that the fire was ignited when an electrical conductor failed and arced to ground. The SBCFD eliminated all other potential causes of the fire.<sup>18</sup> The faulted east conductor, and the center conductor that later failed while SBCFD was on scene, were determined to have sustained damage consistent with electrical arcing during a conductor-to-conductor contact.<sup>19</sup>

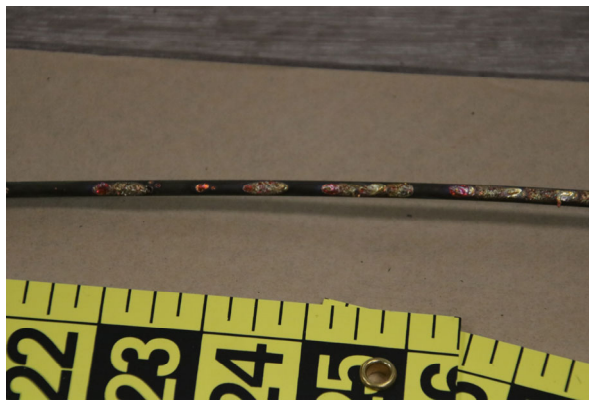
**Figure 7:** Damaged center conductor.
