CALIFORNIA PUBLIC UTILITIES COMMISSION

Incident Investigation Report

Incident Number: E20191028-01

Utility: Pacific Gas and Electric Company (PG&E)

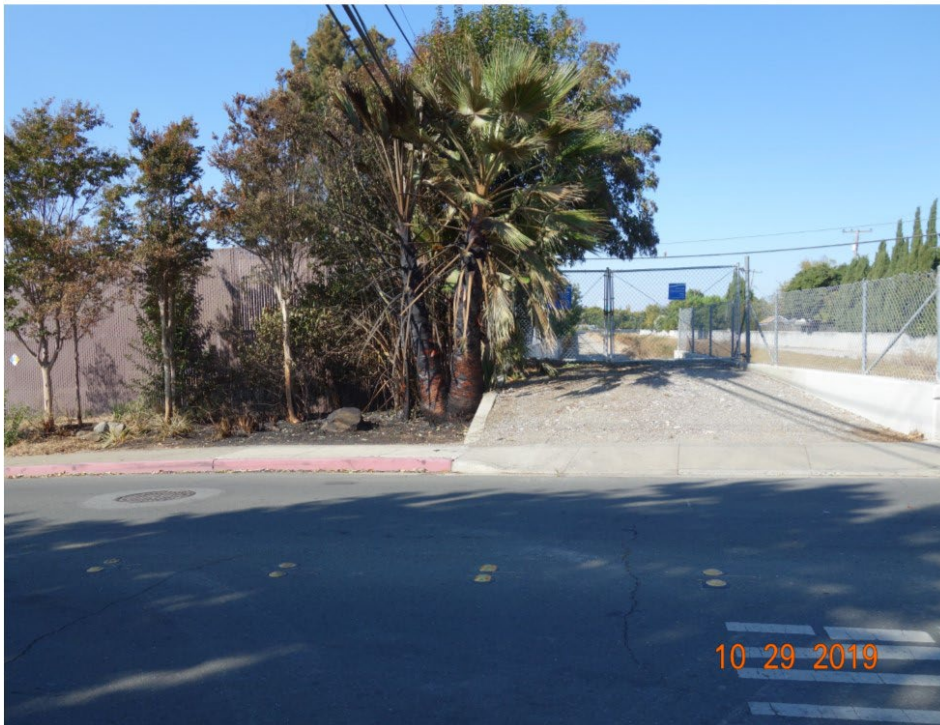
On October 27, 2019, the City of Milpitas experienced high winds of 15 mph, gusting up to 40 mph, and National Weather Service issued “Red Flag Warning”. At approximately 1440 hours, a resident heard two sharp sounds like glass bottles dropping on the ground and saw a fire, Fire 1, ignited from several palm trees on the north side of Marylinn Drive. Please see Figure 1 for the damages caused by Fire 1.

Figure 1: Fire 1 on North Side of Marylinn Drive, Milpitas, CA

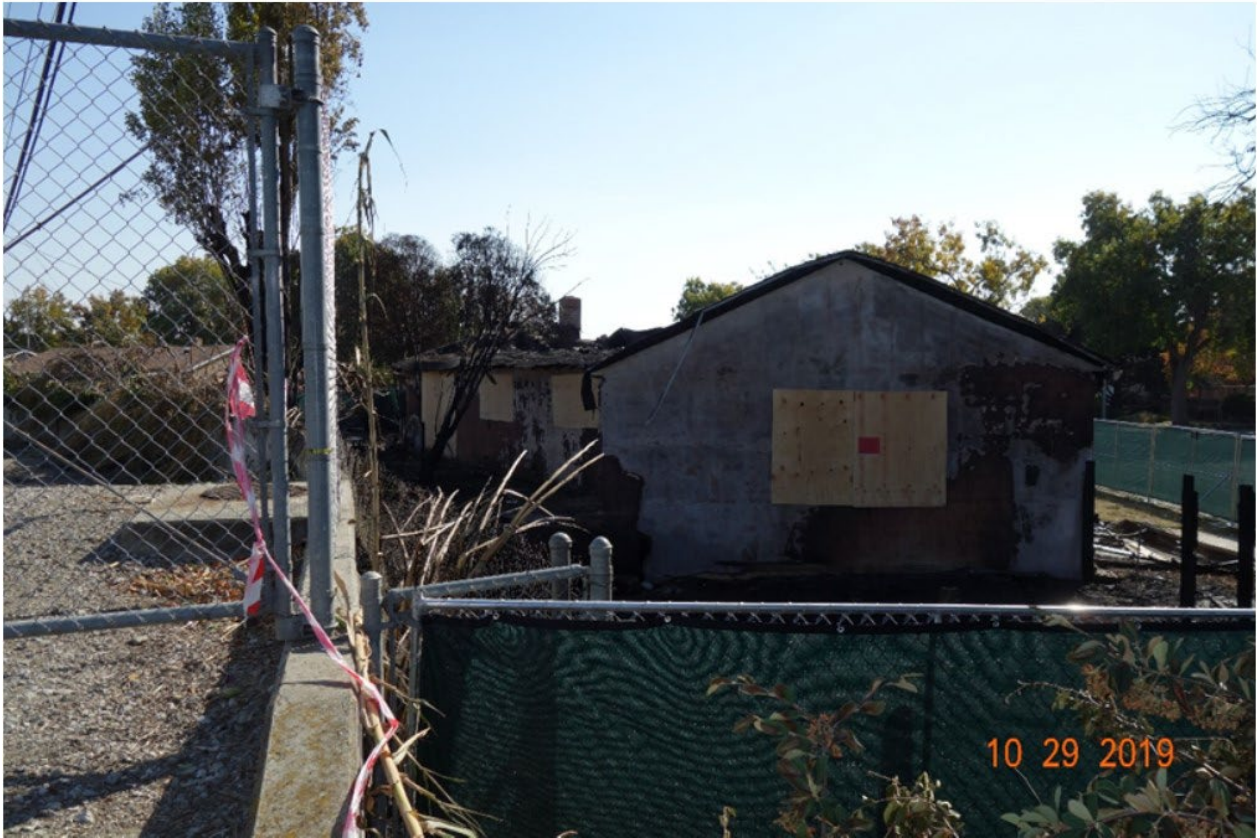
Almost at the same time, another fire, Fire 2, started on the south side of Marylinn Drive near 294 Barker Street. Two to three houses were seriously damaged by Fire 2. Please see Figure 2 for the damages caused by Fire 2.

Figure 2: Fire 2 on South Side of Marylinn Drive, Milpitas, CA

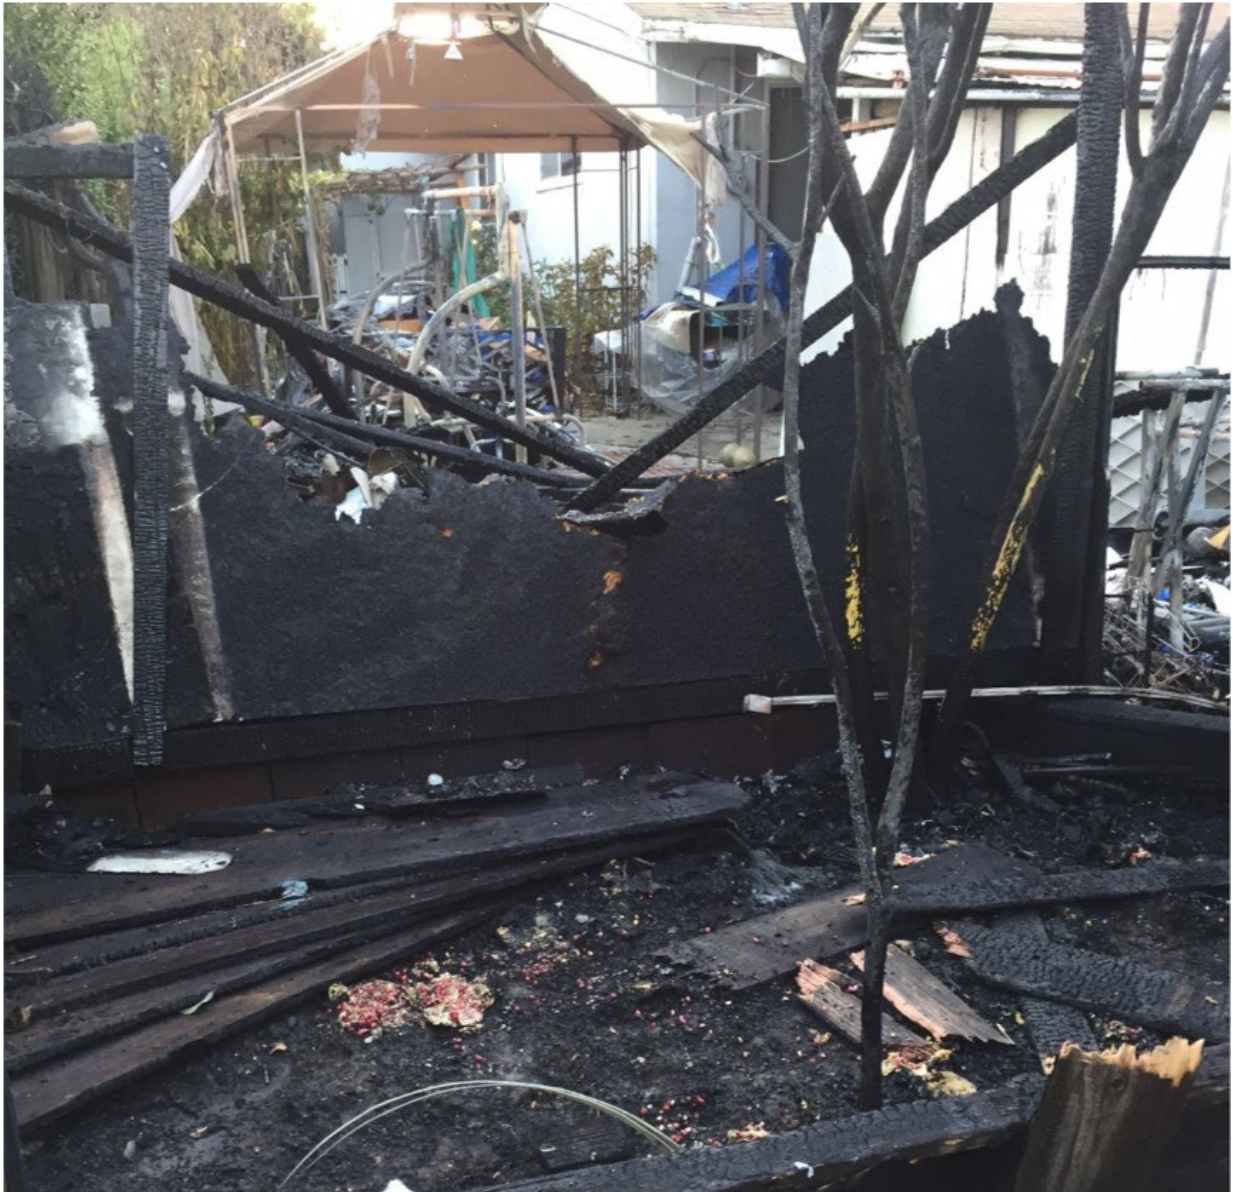
The Fire 2 grew exponentially in the heavy bamboo landscaping, spreading to the residence and the detached garage of 294 Barker Street. Embers traveled further south and caused Fire 3 at 235 Casper Street, damaging at least one house. Please see Figure 3 for the damages caused by Fire 3.

Figure 3: Fire 3 at 235 Casper Street

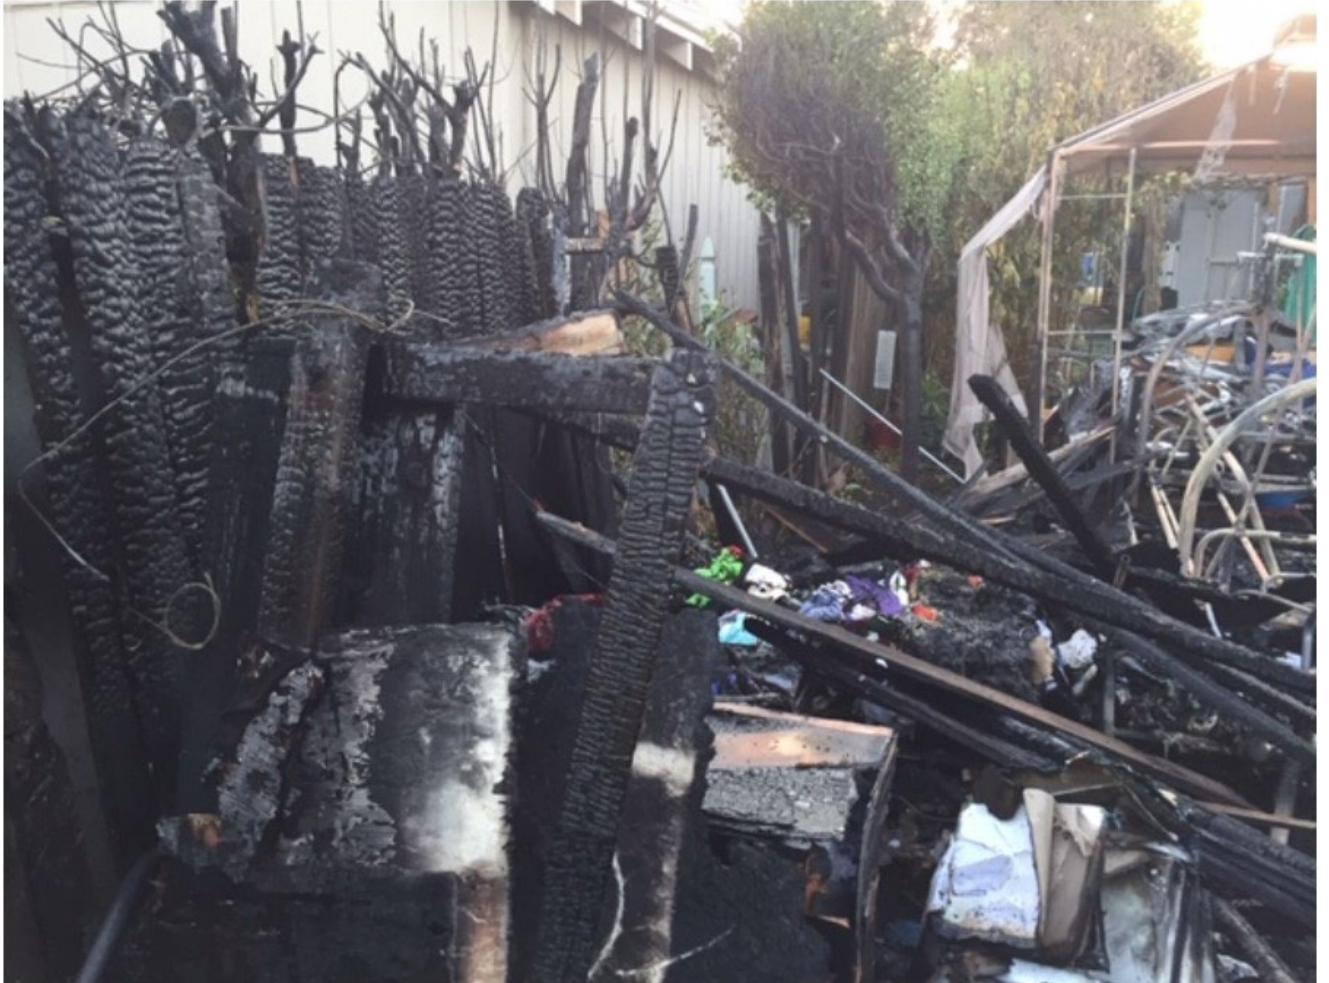
Later on, another fire, Fire 4, started near 258 Barker Street, damaged two to three houses. Please see Figure 4 for the damages caused by Fire 4.

Figure 4: Fire 4 at 258 Barker Street

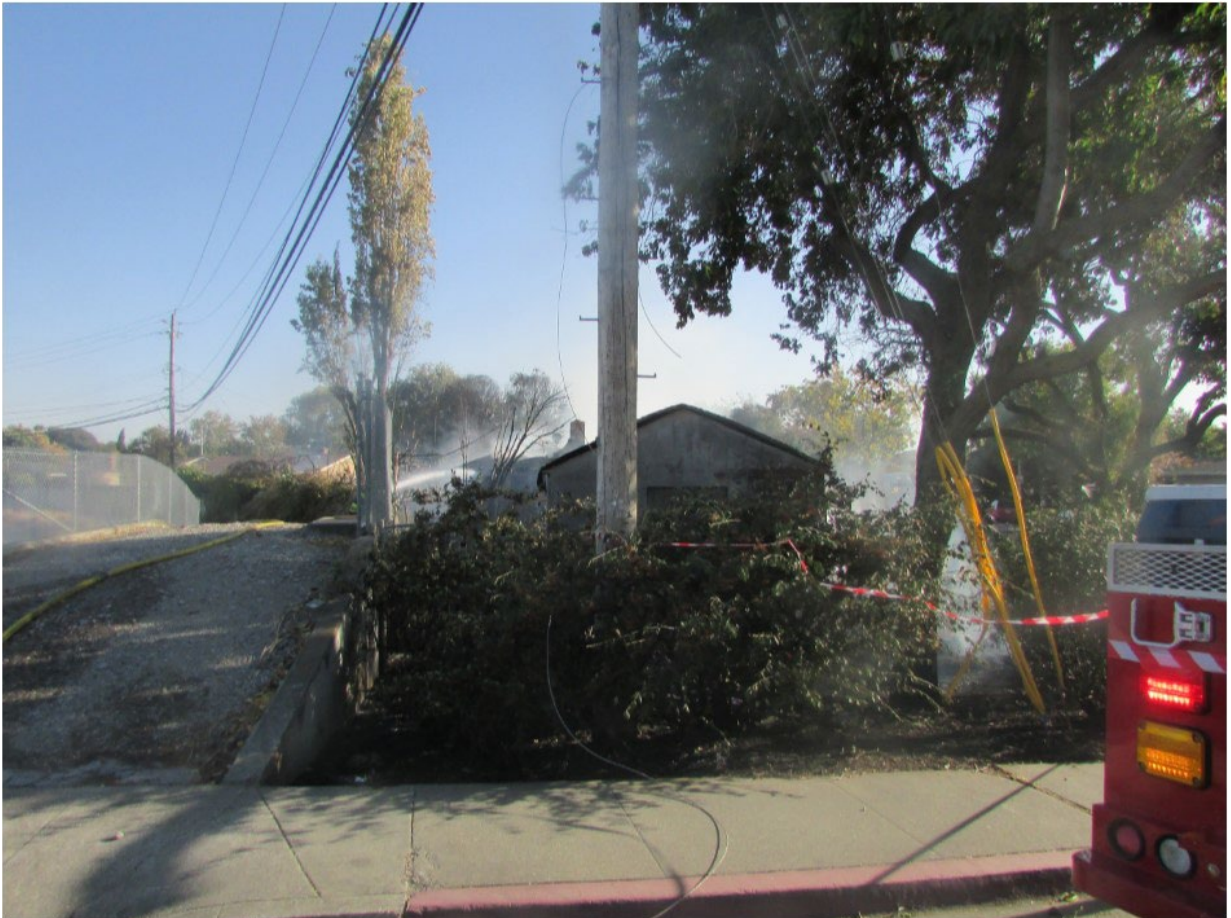
Per the MFD report, the MFD responded the fire call on October 27 at 1445 hours and contained the fires to this scope and extinguished the fires on October 27 at 1600 hours with no injuries. The MFD also noted broken down wire segments located between Fire 1 and Fire 2 sites. Please see Figure 6 for the broken wire.

Figure 6: Broken Wire Between Fire 1 and Fire 2 Sites

Since PG&E does not know the strength of the 4 ACSR wires in the Dixon Landing Feeder 2102, PG&E cannot maintain the required strength with minimum safety factor of 1.33 for the 4 ACSR wires, PG&E failed to replace the wires before the wires deteriorated to a safety factor of less than 1.33. Ultimately, the wires were broken, interrupting power supply and causing fires and damages.

On October 28, 2019 at 1535 hours, the MFD released the scene to PG&E. At this point, PG&E repair crews replaced one 100 foot span of 4 ACSR, and the remaining 1,210 customers were restored on October 28 at 1650 hours.

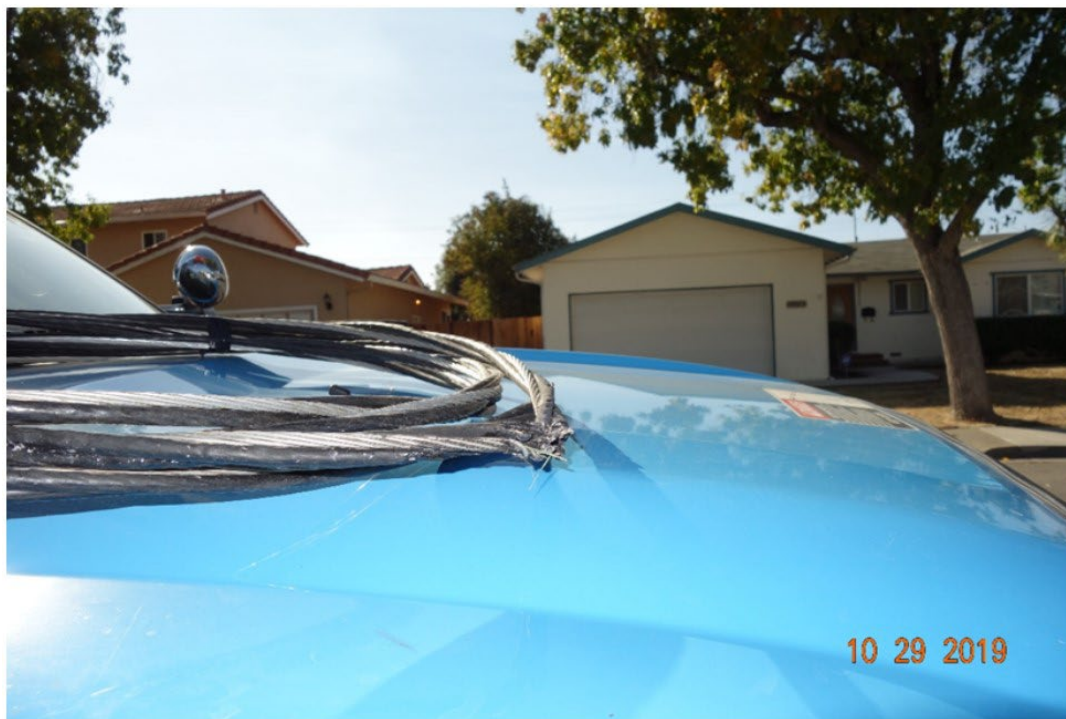
The MFD also reported that during the power restoration, a service drop lost insulation and caused sparks. Fortunately, these sparks did not cause another fire. Through communication, someone cut and isolated the damaged service drop from the distribution system. After that, the power restoration was conducted smoothly. Please see the Figure 7 for the damaged service drop.

Figure 7: Damaged Service Drop
