CALIFORNIA PUBLIC UTILITIES COMMISSION
Safety and Enforcement Division
Electric Safety and Reliability Branch

Incident Investigation Report

Incident Number: E20210601-01 (Slope Fire)

Utility: Pacific Gas and Electric Company (PG&E)

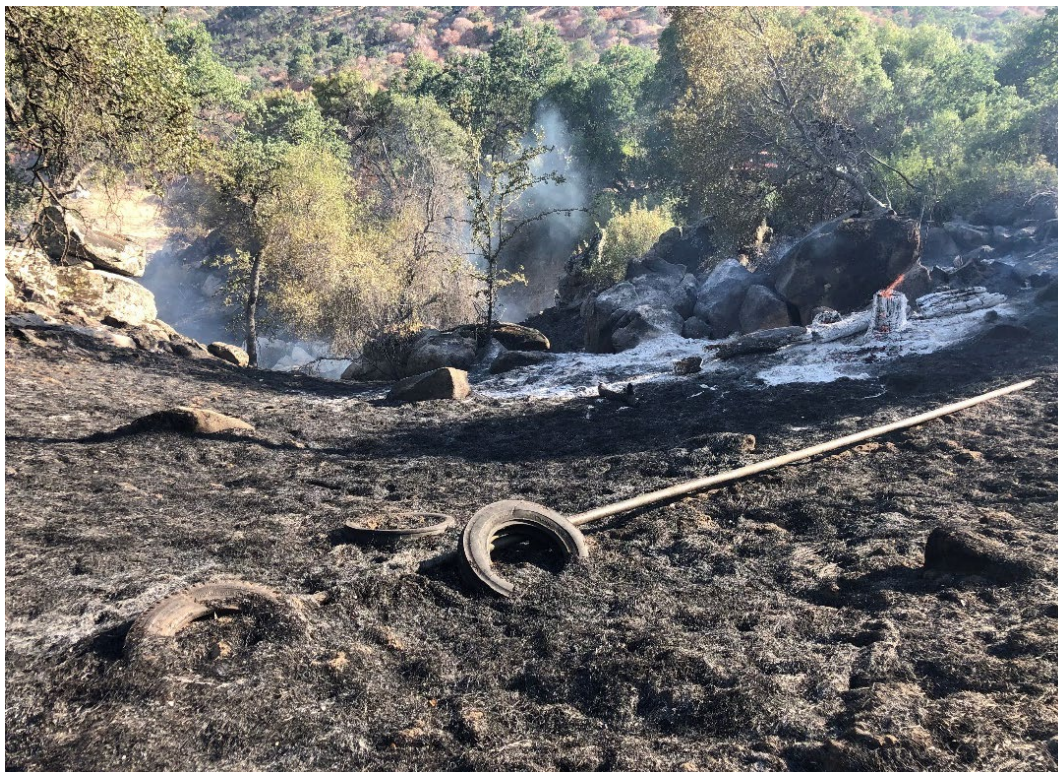
Figure 1. Photo showing burned area (Source: PG&E).

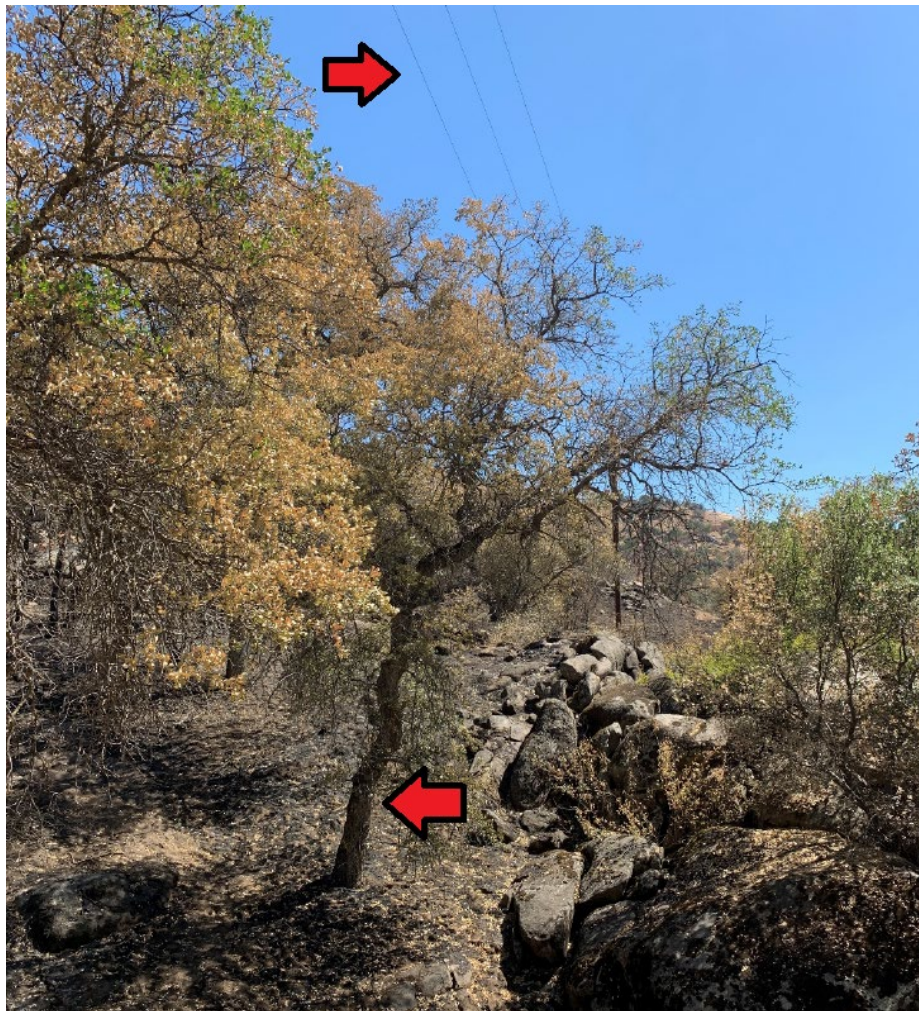
Figure 2. Photo showing PG&E secondary conductors passing through an oak tree at the mid-span (Source: PG&E).

At 2200 hours, A PG&E repair crew arrived on-scene. The troubleman and repair crew reported that a 35-foot Blue Oak tree (Subject Tree) likely made contact with the 240 Volts open wire secondary conductors and contributed to wire-to-wire contact.

SED's investigation determined that a 35-foot Blue Oak tree (previously identified for removal) grew into PG&E's 240-volt secondary conductors at mid-span, causing a phase-to-phase contact that resulted in arc sparks that likely ignited the Slope Fire. Although the conductor did not fail and fall, it did exhibit damage consistent with wire-to-wire contact (middle phase was splattered and pitted with one or two broken strands). PG&E identified the tree for removal on June 11, 2020, due to potential impacts from future growth.

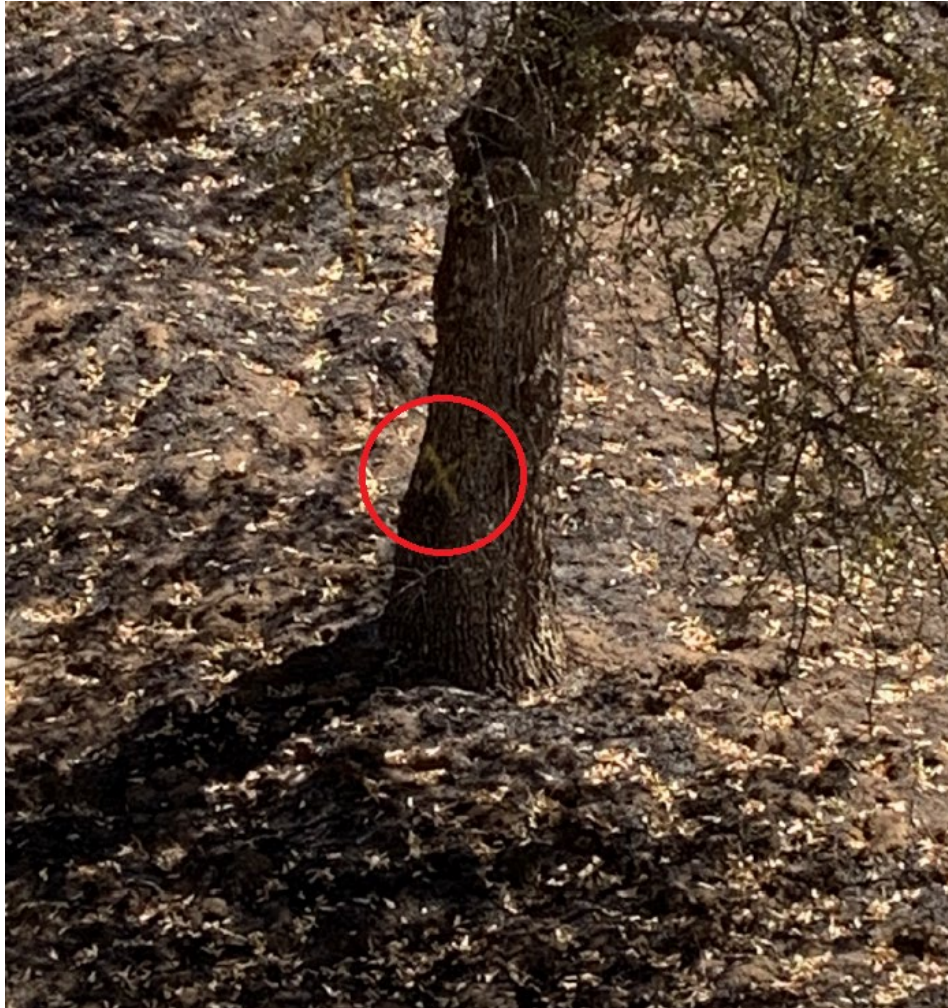
Under its Enhanced Vegetation Management Program, PG&E had previously identified the Subject Tree for removal on June 11, 2020, due to potential impacts from future growth. PG&E contacted the customer on June 11, 2020 to request permission to remove the tree, but the customer verbally refused. PG&E documented the refusal in its database, but did not obtain the refusal in writing, nor did PG&E obtain a signed liability release from the customer due to the tree being in compliance with General Order (GO) 95 and Public Resources Code (PRC)² at the time. When PG&E reinspected the tree on January 13, 2021, PG&E determined that the tree was still in compliance with regulatory requirements.

Figure 3. Photo showing Blue Oak tree marked with a yellow "X" for removal (Source: PG&E).

between the phases. PG&E also removed the Blue Oak Tree on July 19, 2021 and verified the work on July 20, 2021.

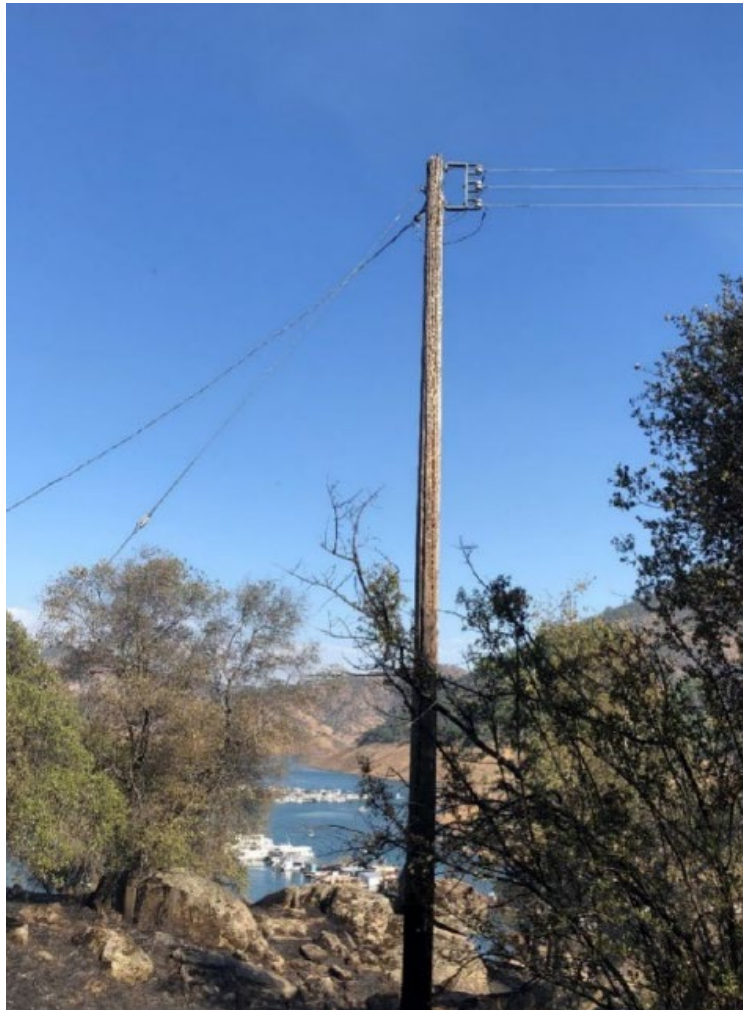
*Figure 4. Photo showing the 35-foot secondary pole with **vertical** rack configuration. PG&E replaced this pole with a new 40-foot pole and triplex with a horizontal configuration (Source: PG&E).*

PG&E's March 2019 detailed inspection identified that both the transformer and secondary poles (Figures 4 and 6 above) needed replacement.³ As a result, PG&E created two Priority E tags to replace the poles (EC Notification #116807973 and #116807908). The tags had a required completion date of twelve months or by March 21, 2020. This schedule was set based on PG&E's Electric Distribution Preventative Maintenance Manual (published April 1, 2016), which defined the priority codes and associated time frames for completion as follows:

To prevent future recurrence of tree contact, PG&E replaced the existing 35-foot secondary pole that had a vertical rack configuration with a new 40-foot pole with a horizontal configuration. The new pole will provide greater ground clearance and the horizontal configuration will minimize the risk of future phase-to-phase contacts due to greater separation

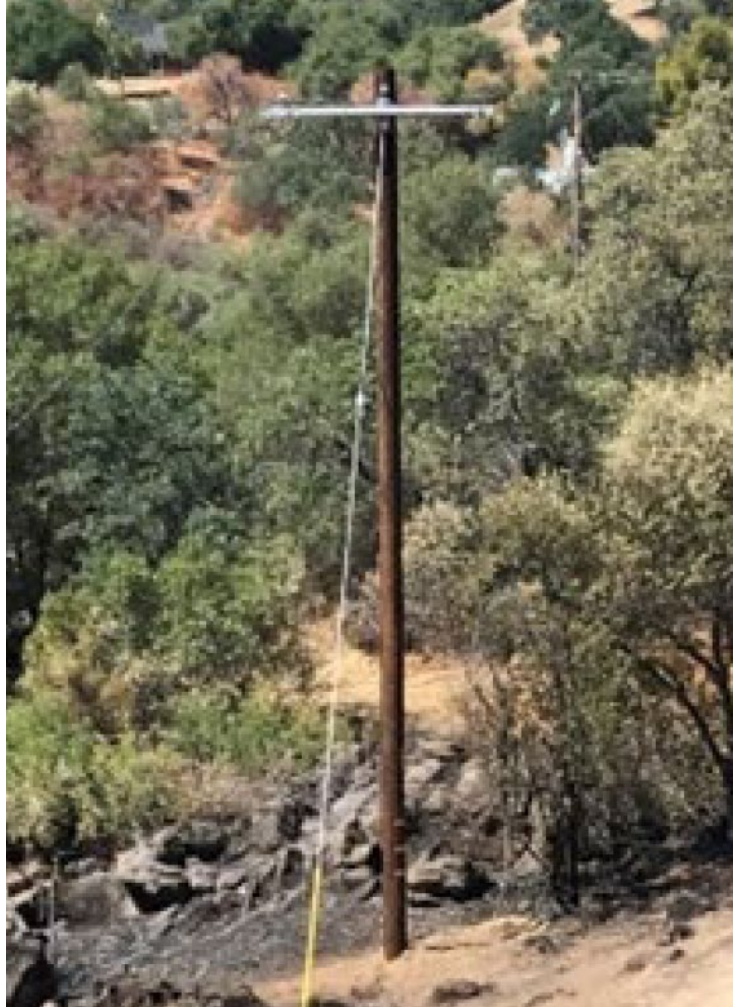
Figure 5. Photo showing the new 40-foot **replacement** pole and triplex with a **horizontal** configuration (Source: PG&E).

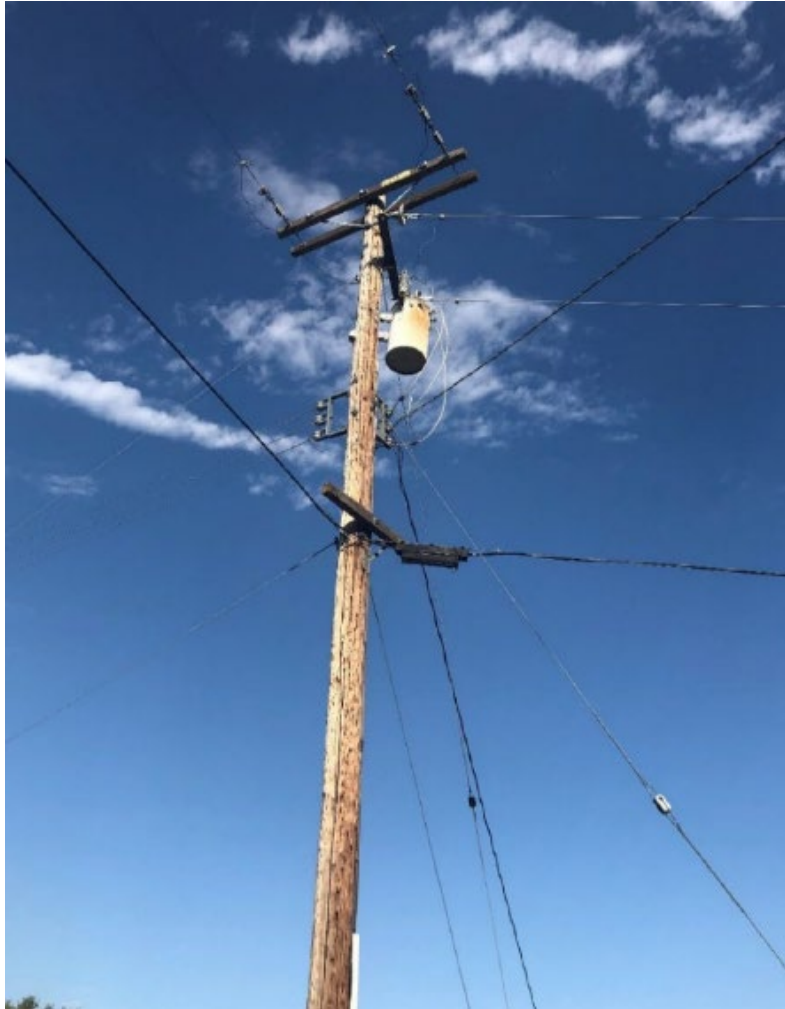
Figure 6. Photo showing the transformer pole. No work was performed on this pole (Source: PG&E).
