PUBLIC UTILITIES COMMISSION

505 VAN NESS AVENUE
SAN FRANCISCO, CA 94102-3298

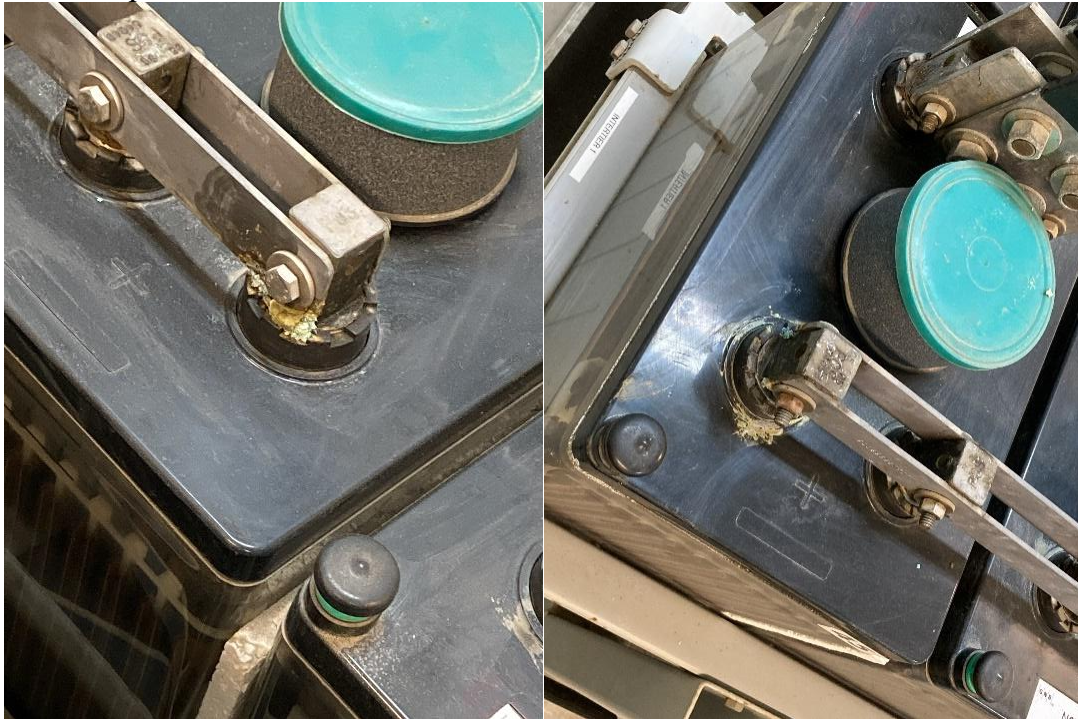
1.2. Switch 2341 closed semaphore is faded.

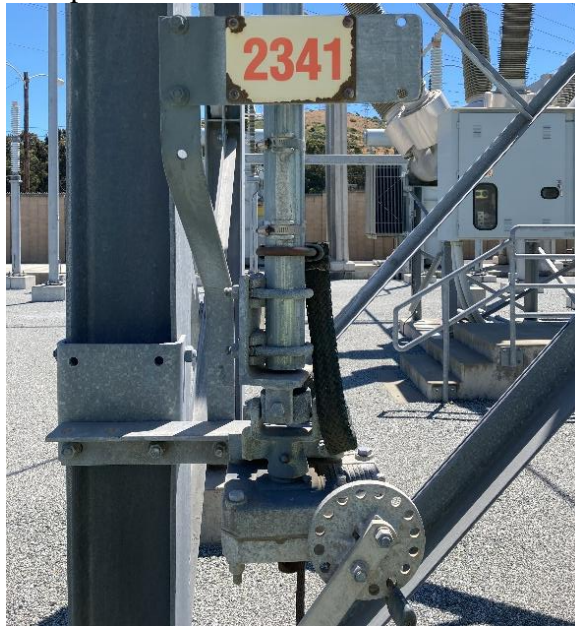
1.3. The bus structure hardware is corroded at the HZ-2 230 kV Cable.

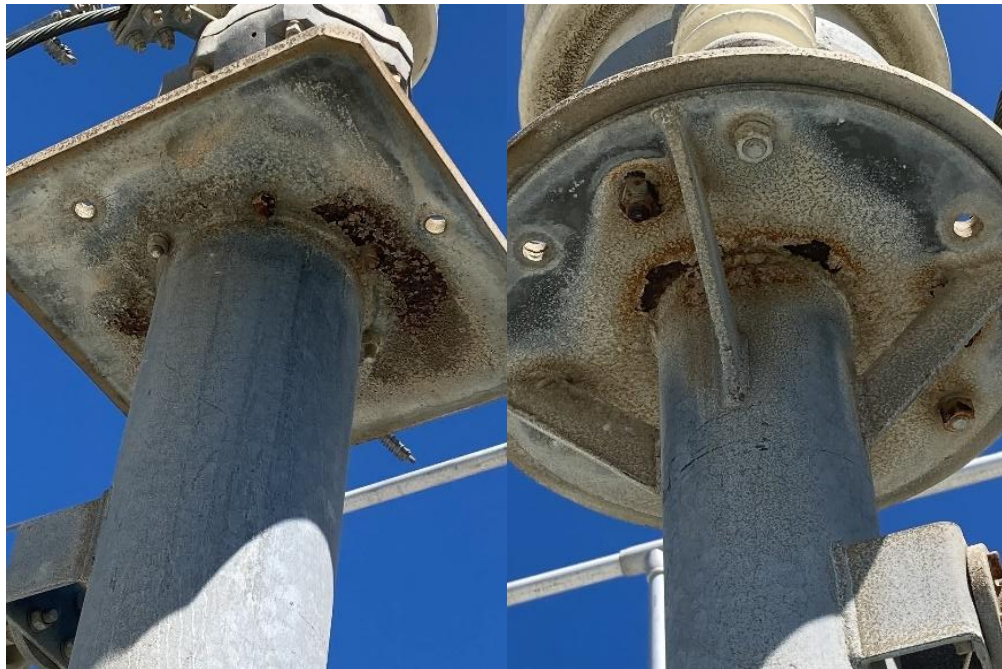
1.4. San Mateo-Martin bus structure hardware is corroded.

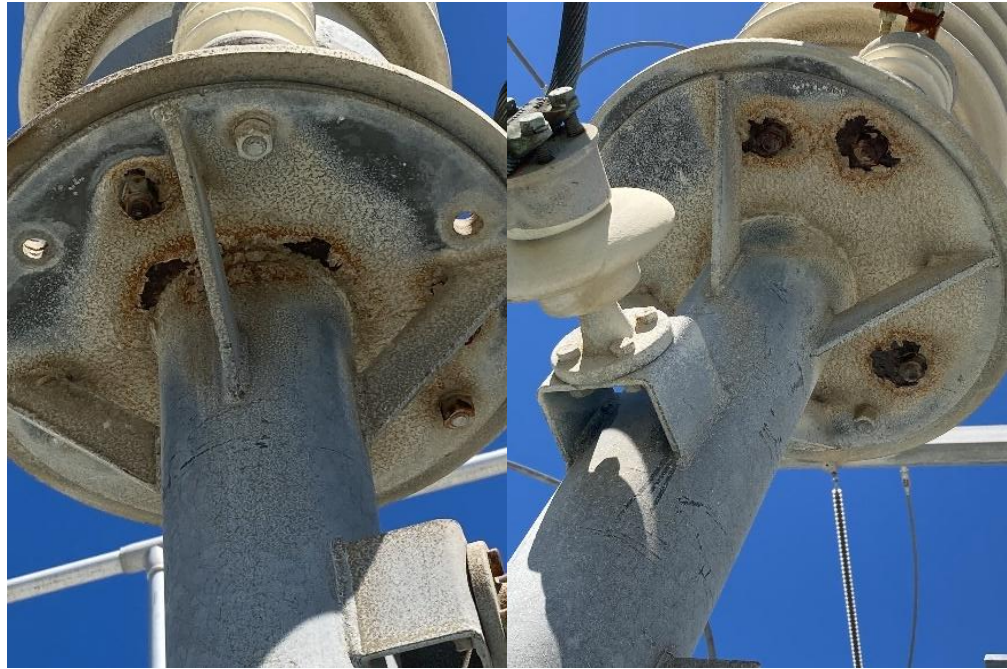
1.5. Faded closed semaphore and faded caution sign at Switch 4335.

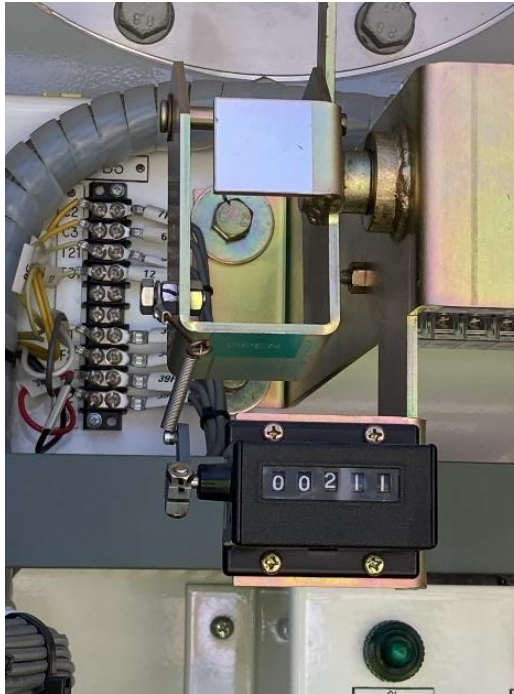
1.7. HP-3 Pothead structure is corroded.

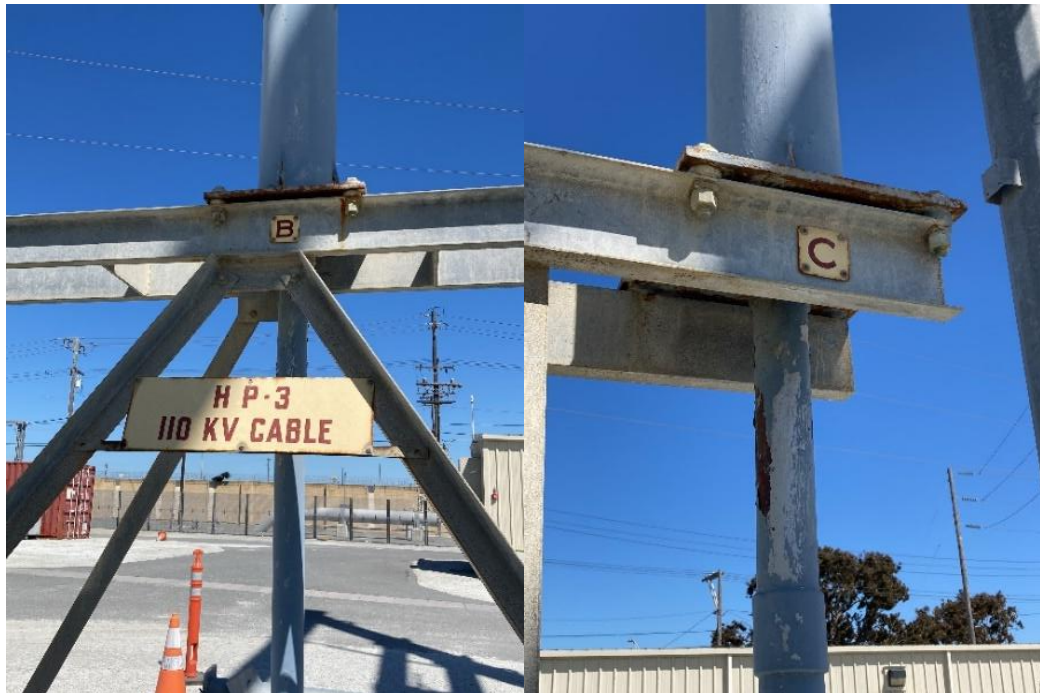
1.8. HP-3 115 kV Pipe Ground Switch cabinet has significant corrosion.

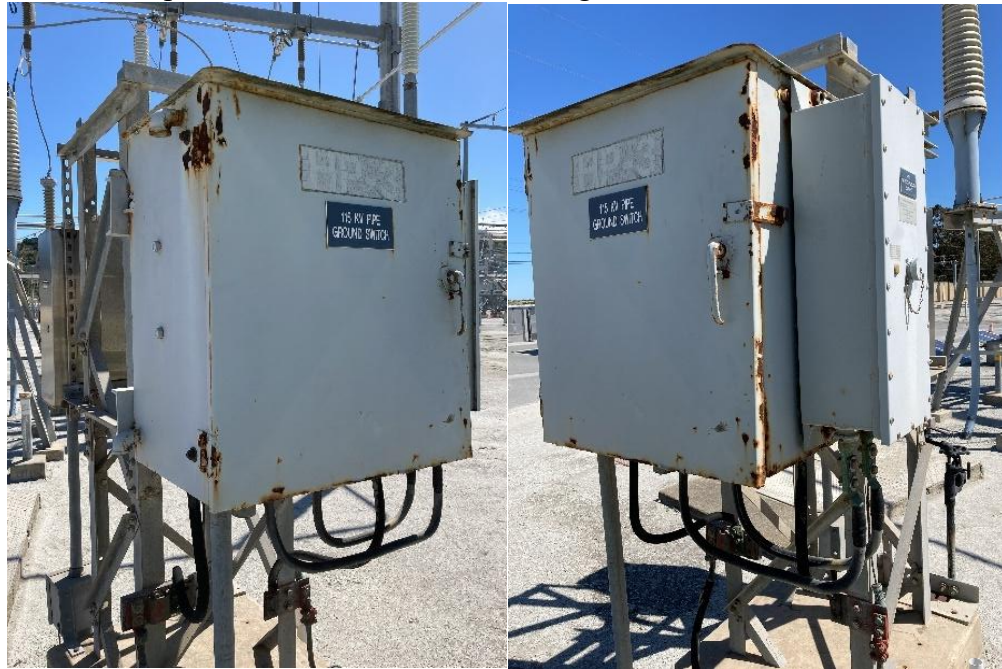
1.9. Fire extinguisher is missing the 7/2024, 8/2024, 10/2024, and 3/2025 monthly inspections and another fire extinguisher is missing the 3/2025 monthly inspection in the 12 kV Section E Control Room.

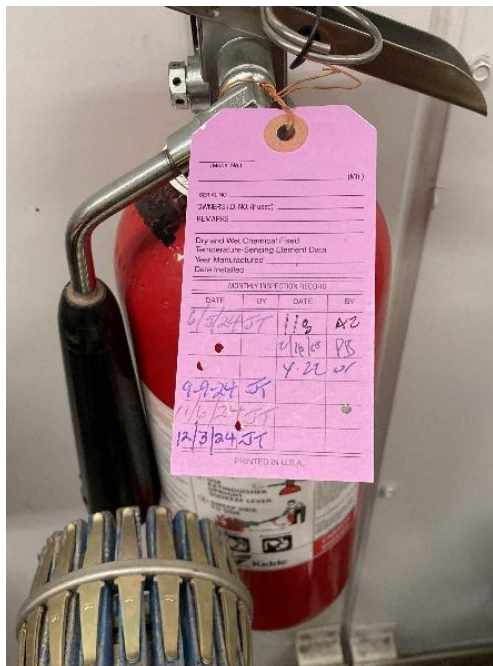
- 1.10. Deteriorated signage at the 12 kV Section E Building. PG&E has an open LC 131234687 to replace the signage.

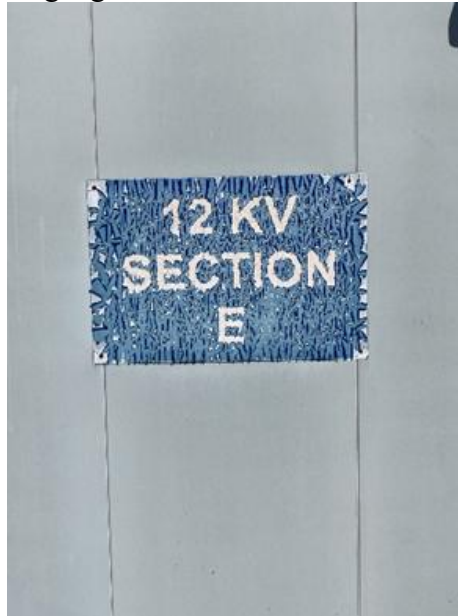
- 1.11. CB 1132 closed semaphore is faded.

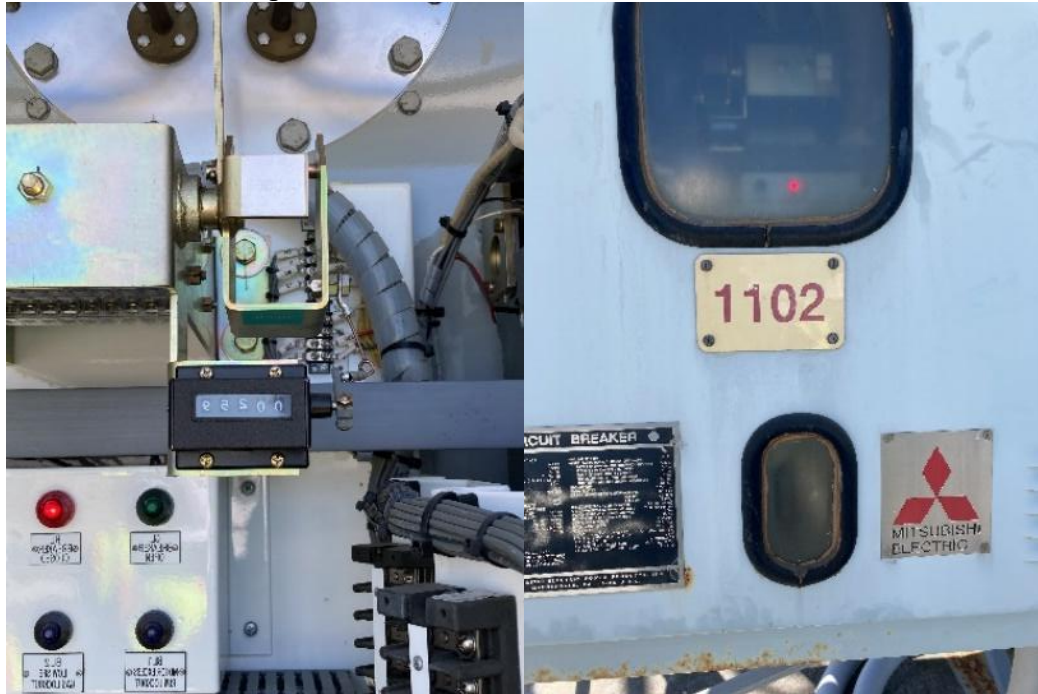
1.13. Both fire extinguishers missing 4/2025 monthly inspection in the 115 kV MPAC #2 control room.

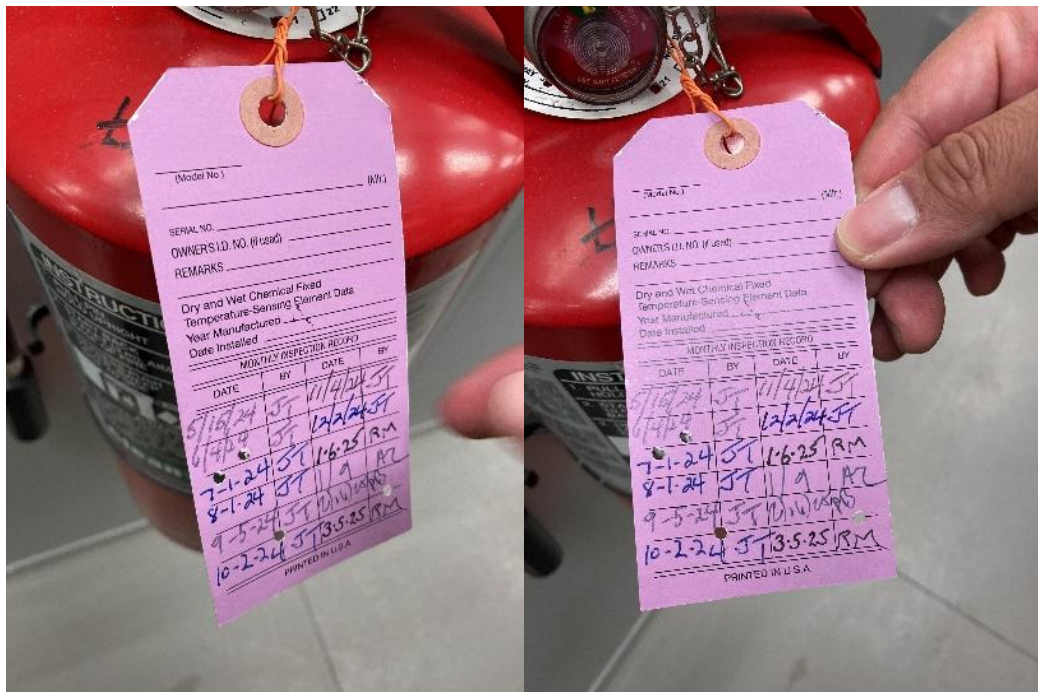
- 1.14. CB 1302 has a faded counter. PG&E has an open LC 126035884 to replace the counter.

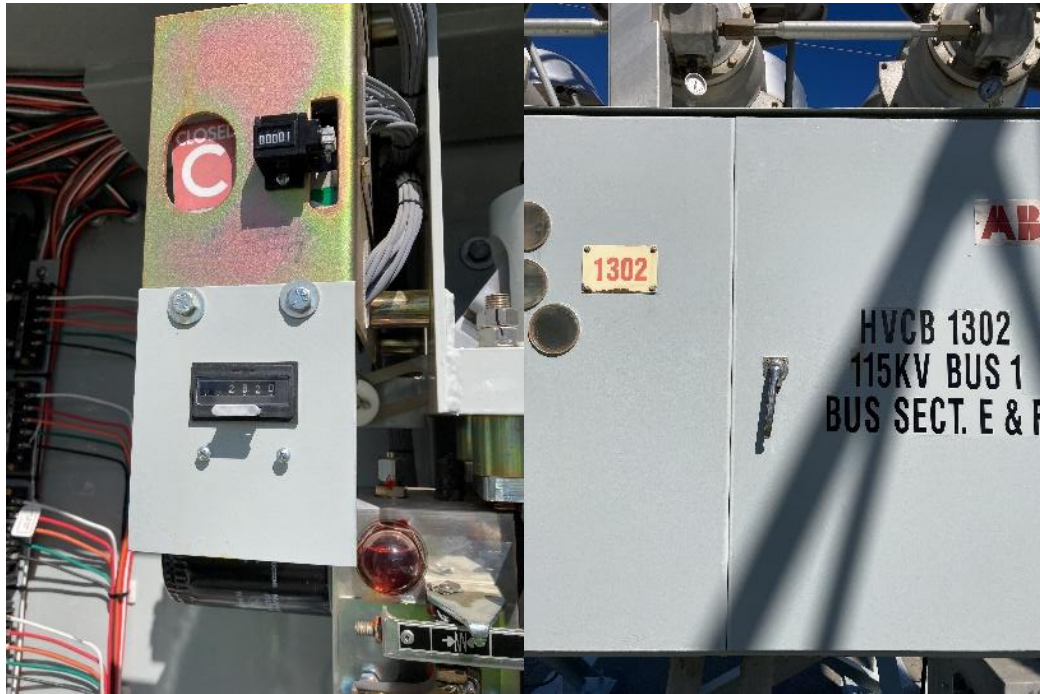
- 1.15. CB 1402 has a faded closed semaphore.

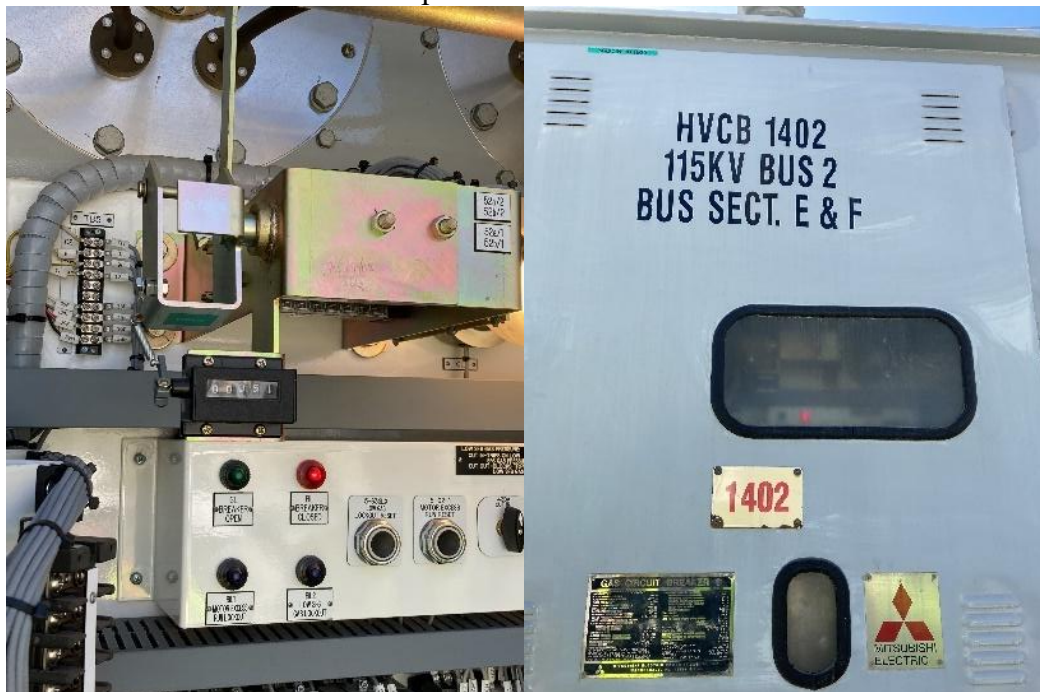
1.16. Housekeeping needs improvement. Buckets, rags, trash, hardware, etc. observed around substation.

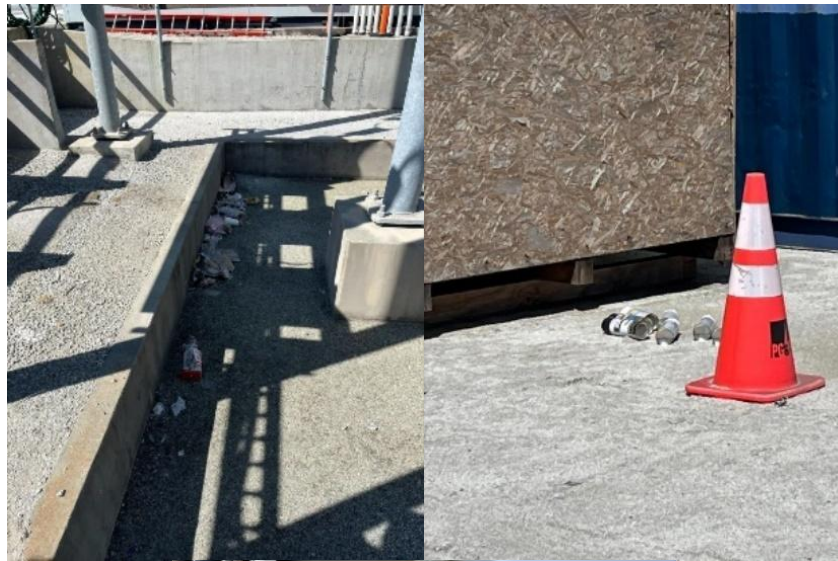
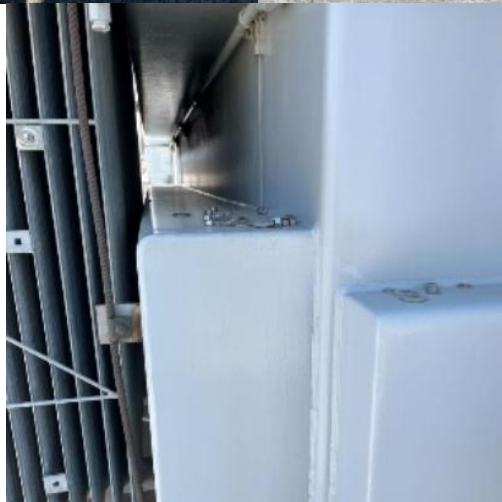
1.17. Bird nest at TX Bank 7.

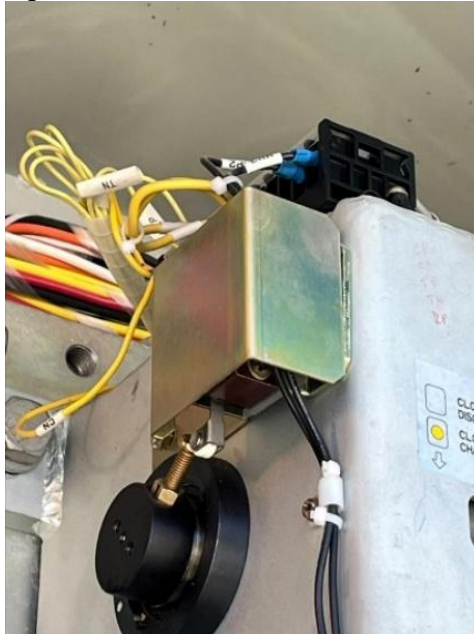
1.21. Bank 6 Digital Voltmeter screen is not working. PG&E has an open LC 131235142 to repair the Voltmeter.

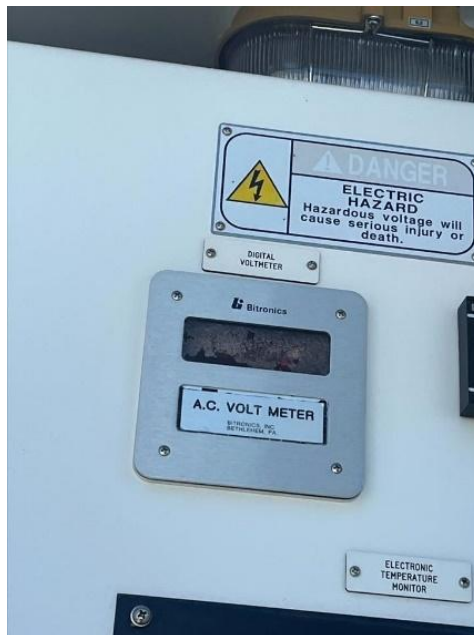
1.22. Control cabinets left unlatched in multiple control rooms.

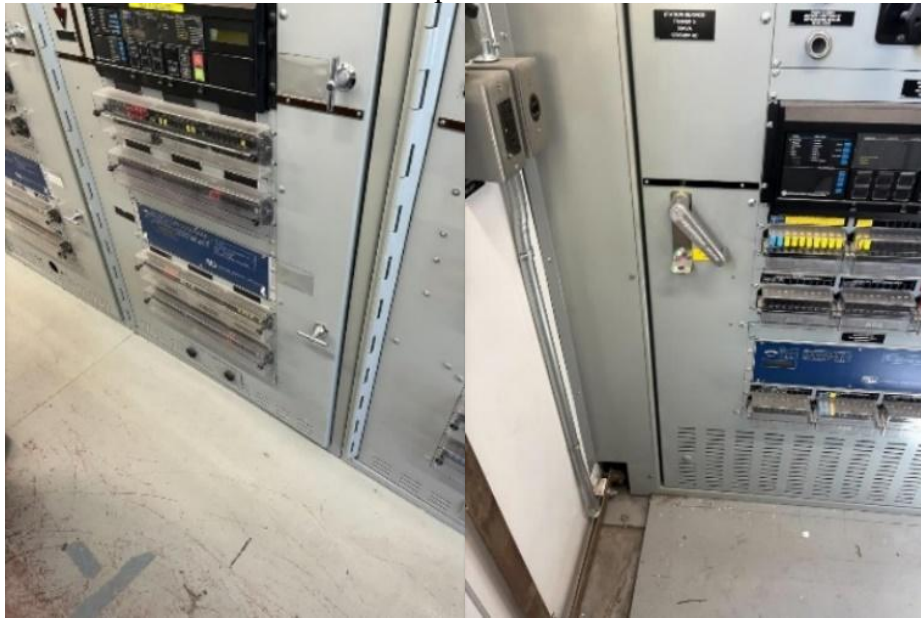
2. East Grand Substation

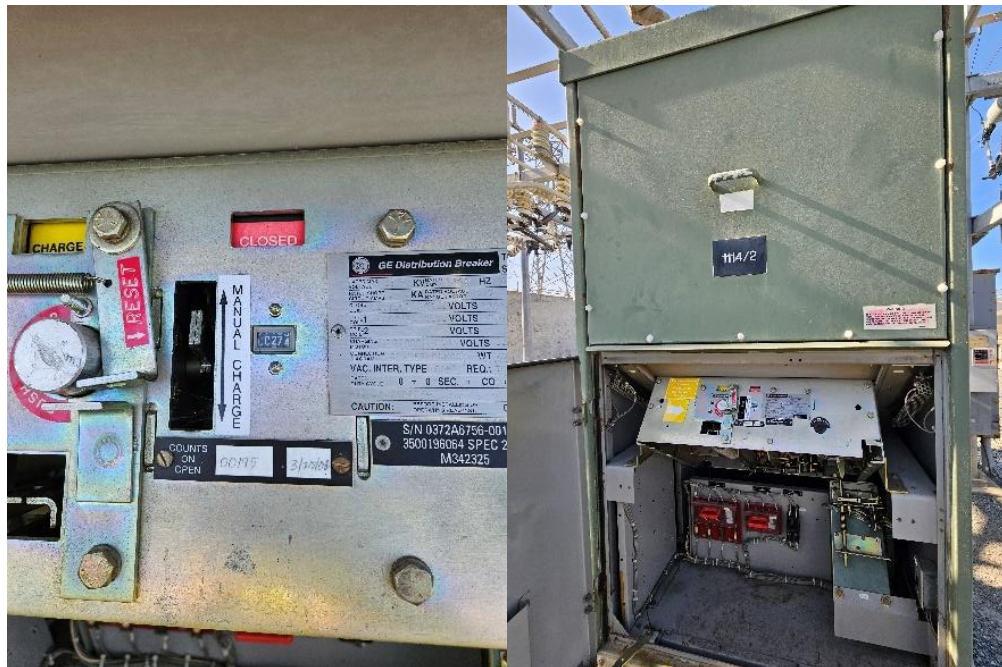
2.1. CB 1114/2 has a faded counter. PG&E has an open LC 130774717 to replace the counter.

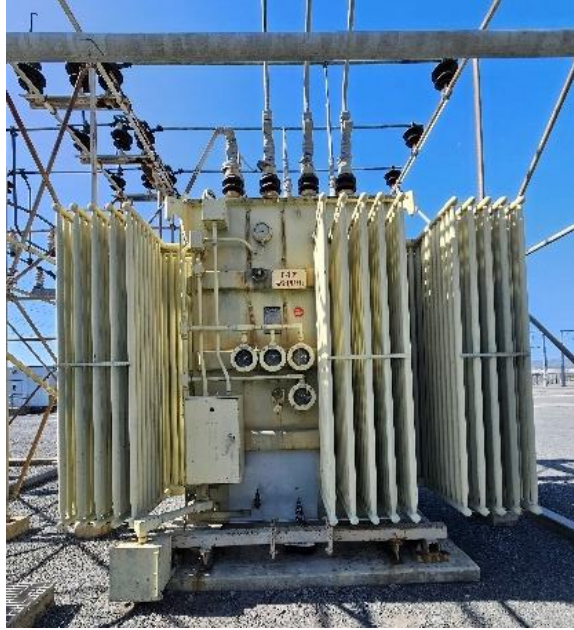
3. San Francisco Airport Substation
3.1. AC Panel 120/208 V left open.

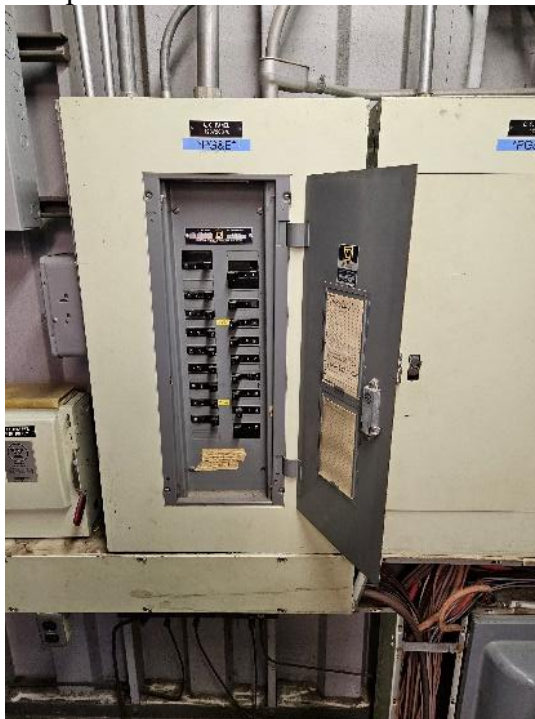
3.2. CB 112 counter is faded. PG&E has an open LC 129282051 to replace the counter.

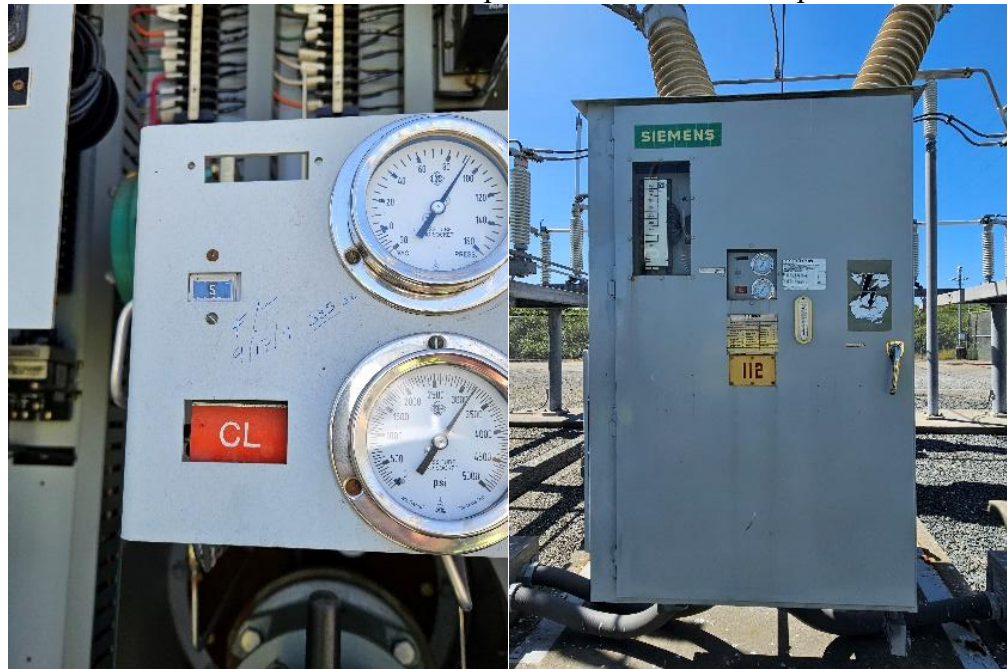
4. Millbrae Substation

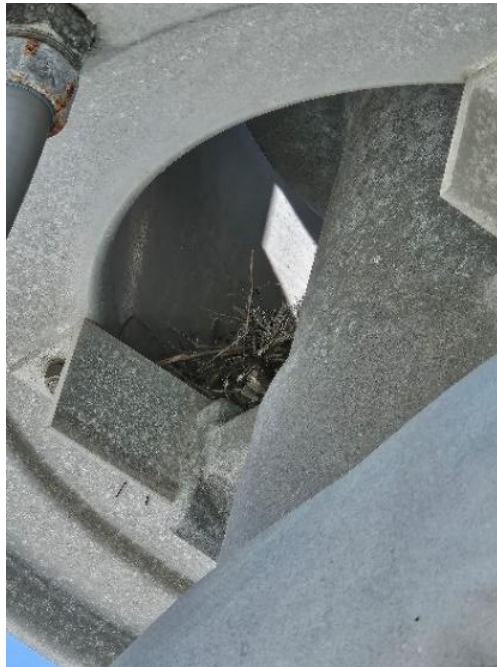
- 4.2. CB 1106/2 has a faded counter. PG&E has an open LC 131244546 to replace the counter.

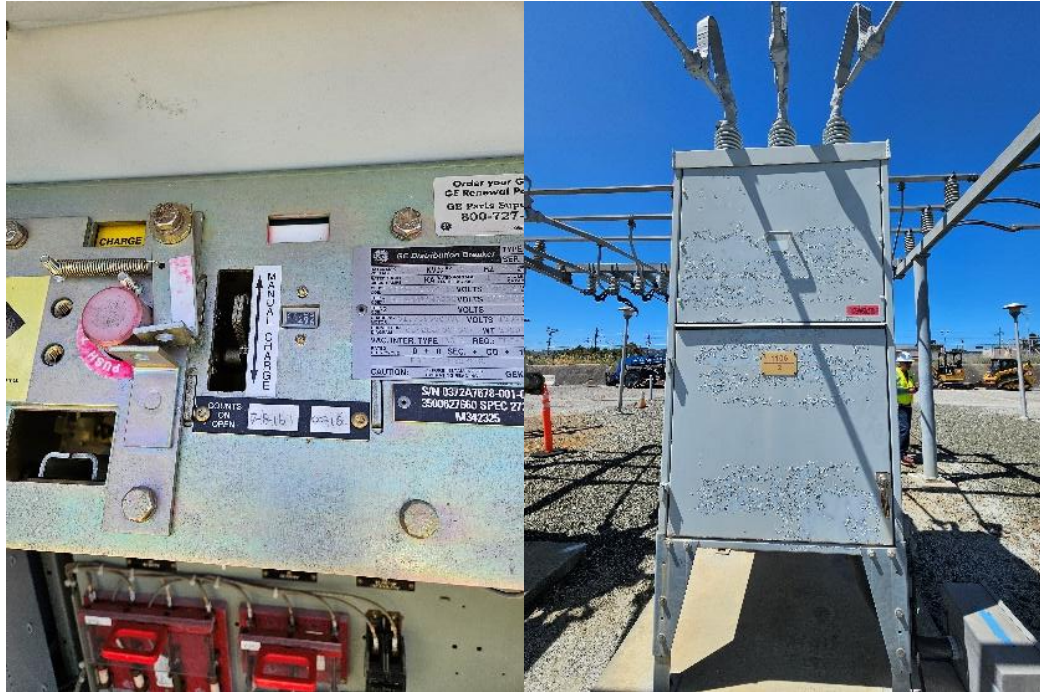
- 4.3. Station BK 3 1A bushing is missing half of bird guard.

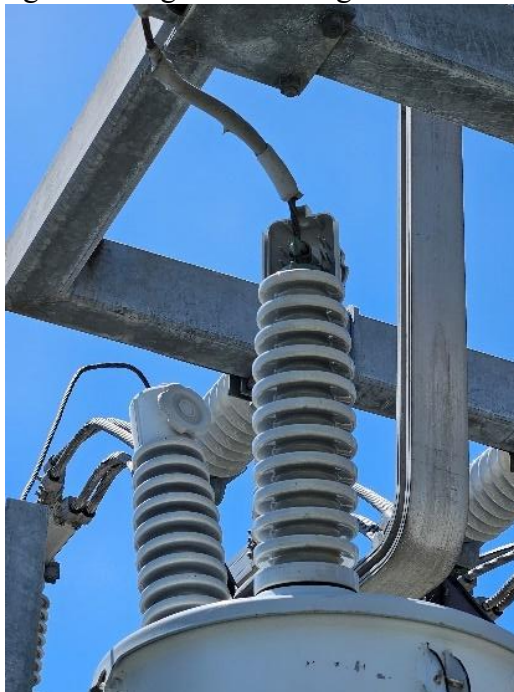
4.4. Closed semaphore faded for Auxiliary Tie 2.

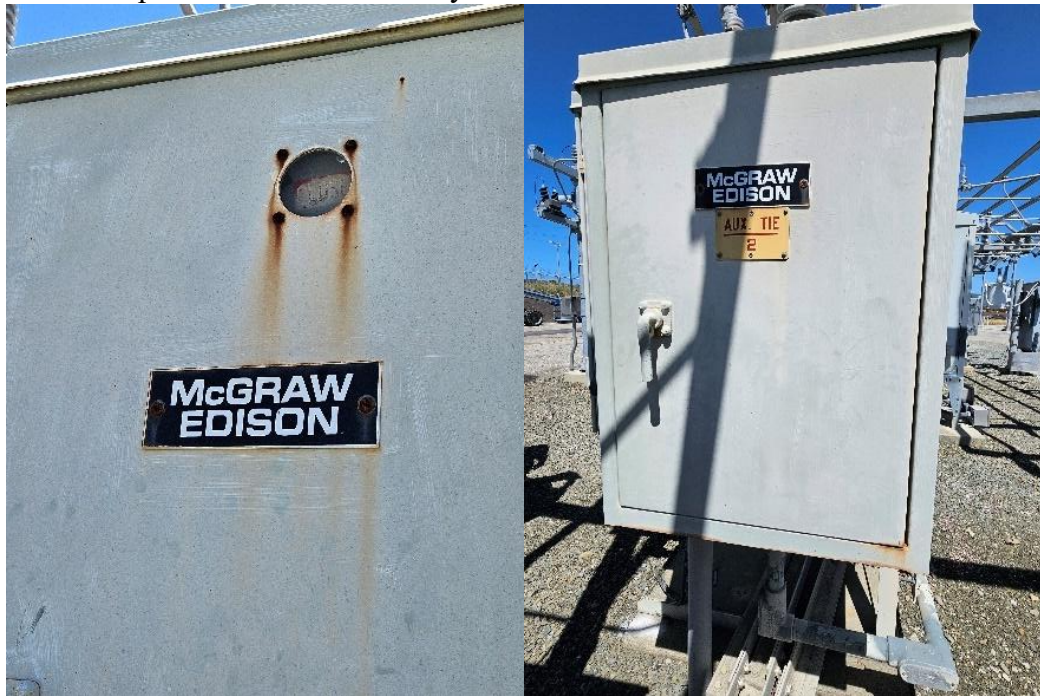
4.5. Station Service BK 4 1A missing half of bird guard on both bushings.

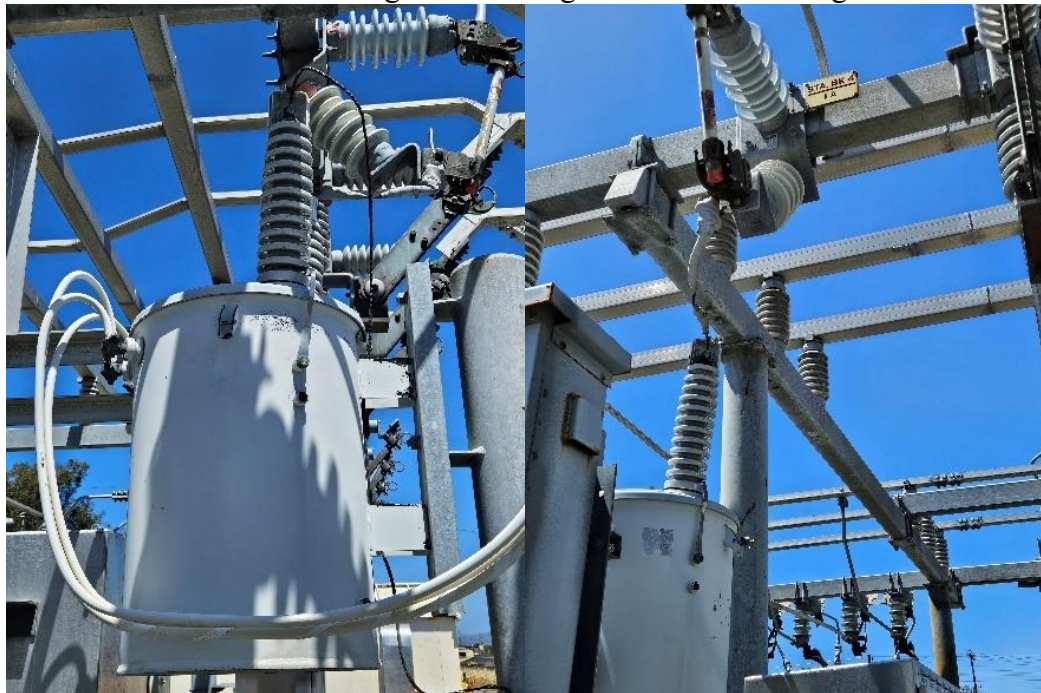
4.6. Bird nest at CB 122.

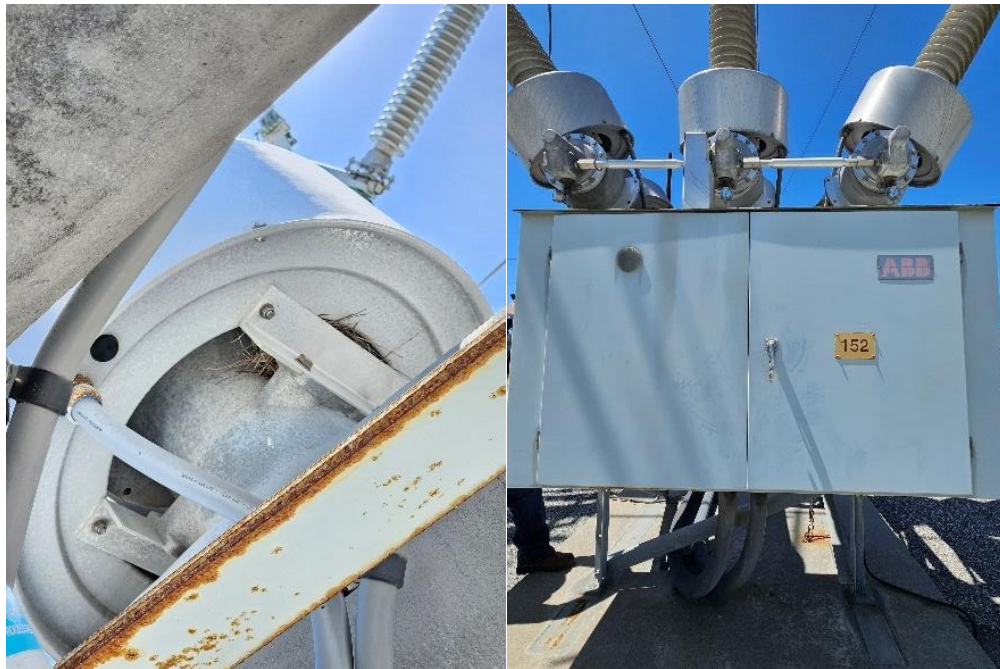
4.8. Corrosion at Spare TX Bank 1.

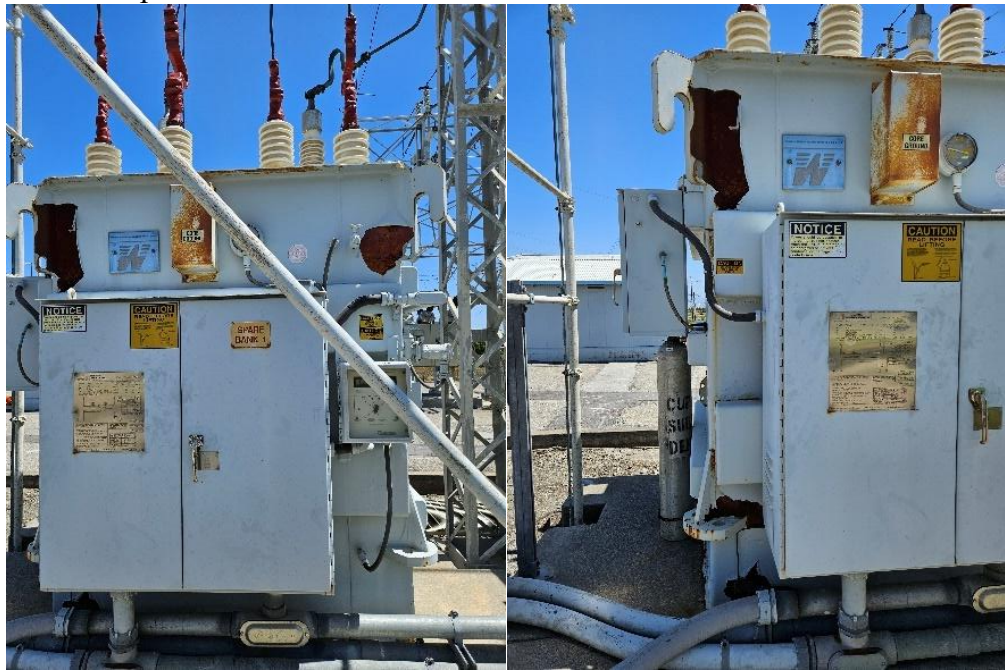
4.9. Faded Entry Procedure sign at TX Bank 1.

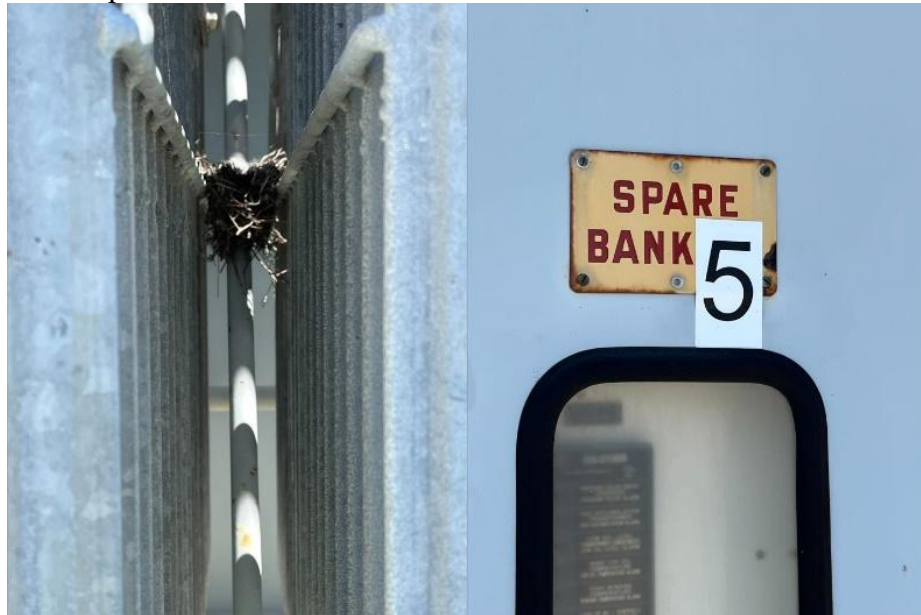
5. San Andreas Substation

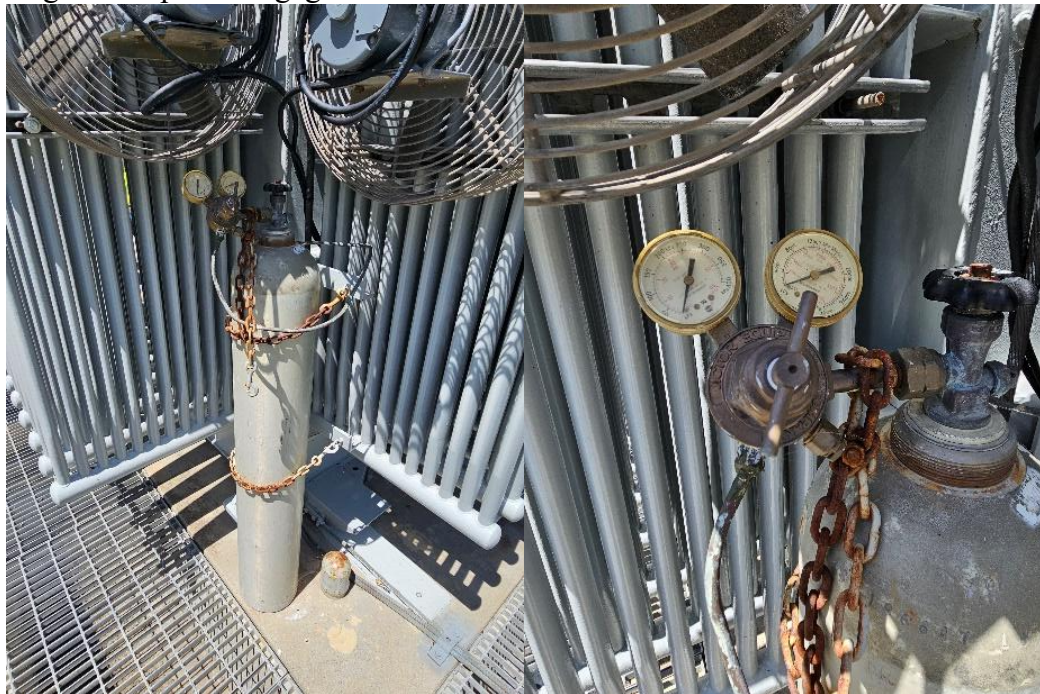
5.2. Bank 1 has a deteriorated Entry Procedure sign.

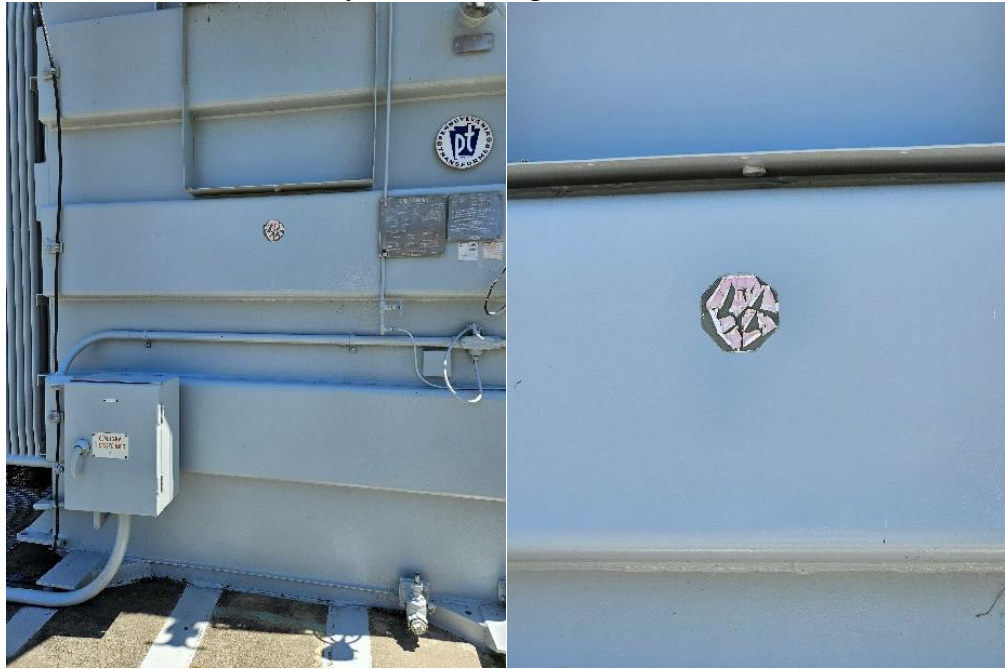
5.3. Bird nest at low side insulator bushing of Bank 1.

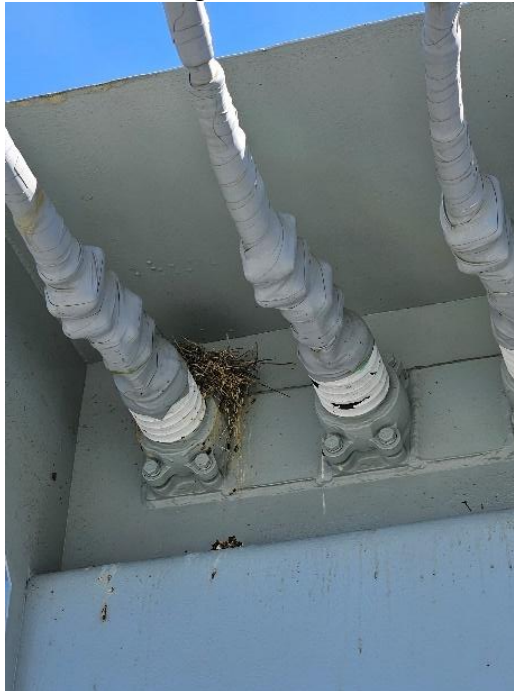
6. Serramonte Substation

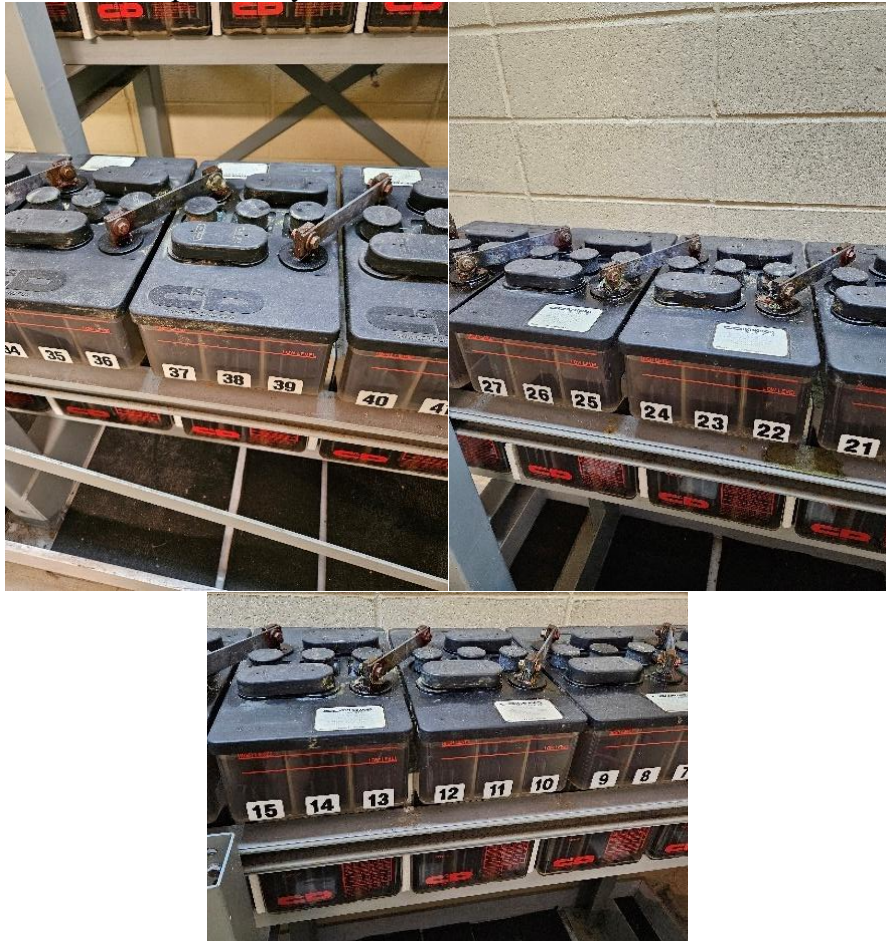
6.2. Bank 1 has a leaking gage and low oil level. PG&E has an open LC 129517779 to repair Bank 1.

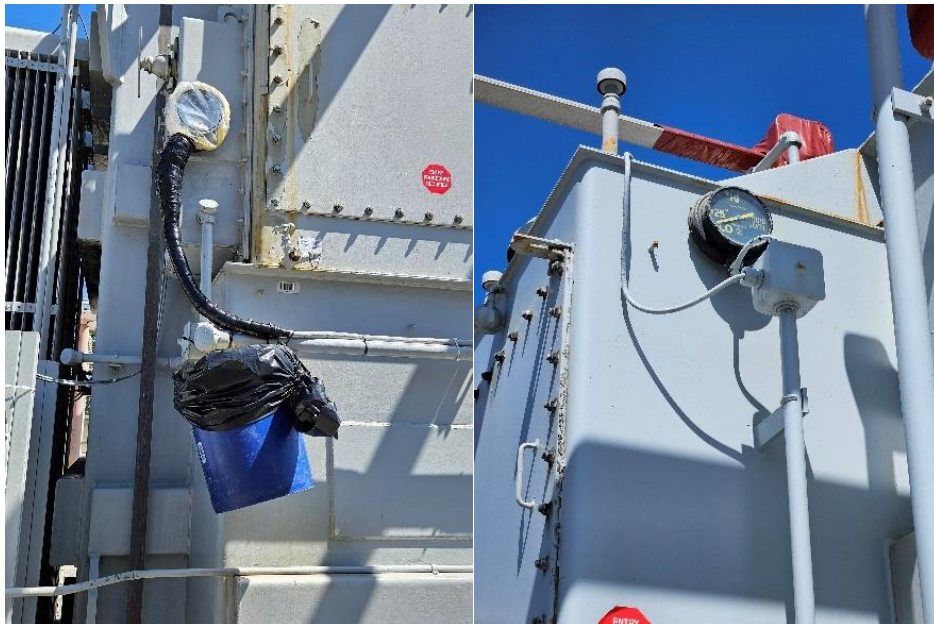
7. Daly City Substation

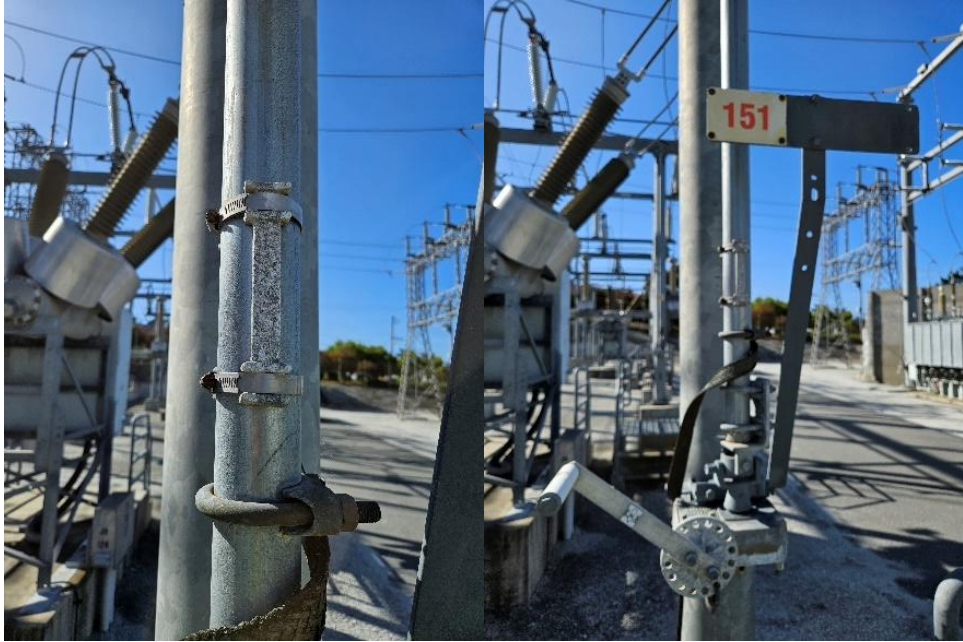
7.2. Station Service Bank 2 has two bushings missing half of the bird guard.

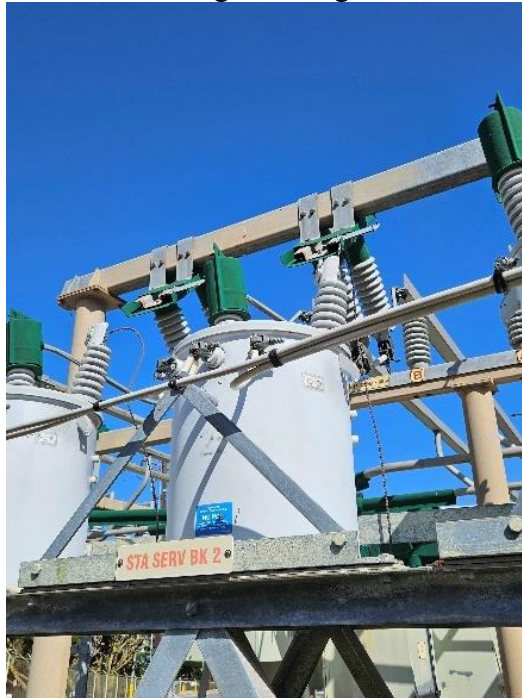
8. Westlake Substation

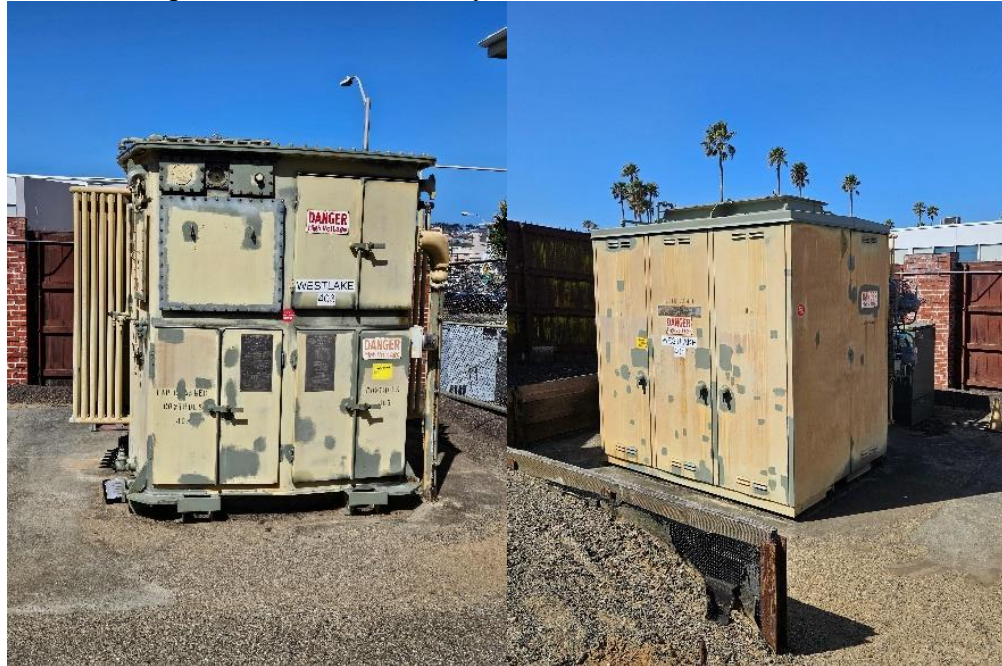
9. Plymouth Substation

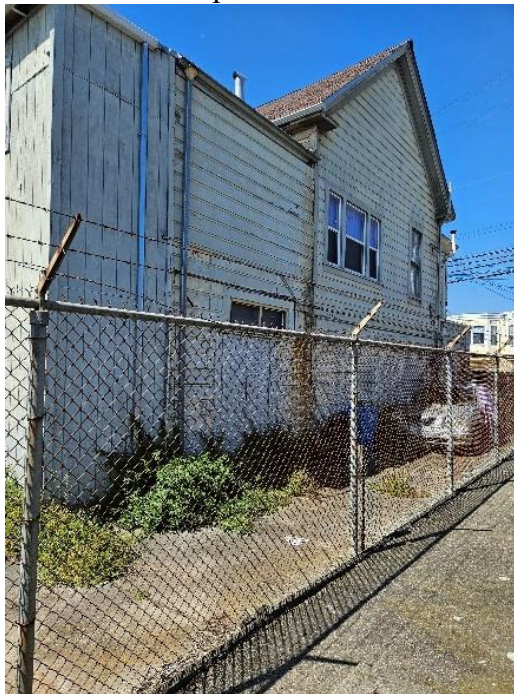
10. Ocean Ave Substation

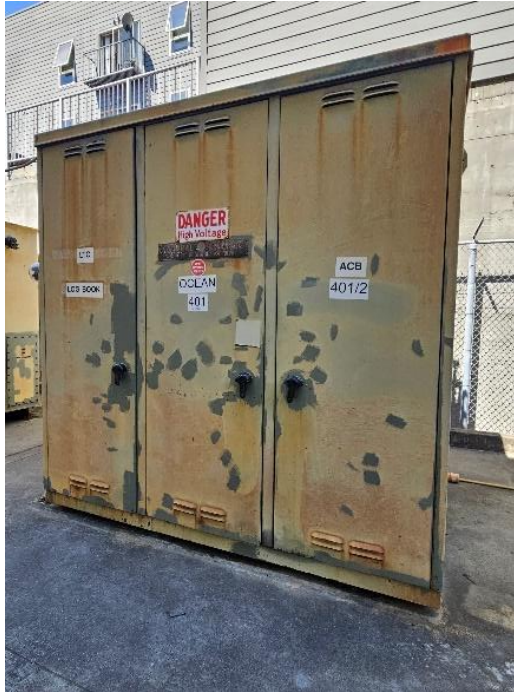
10.2. Bank 2 (402) has moderate rust. PG&E has an open LC 130544674 to repaint it.

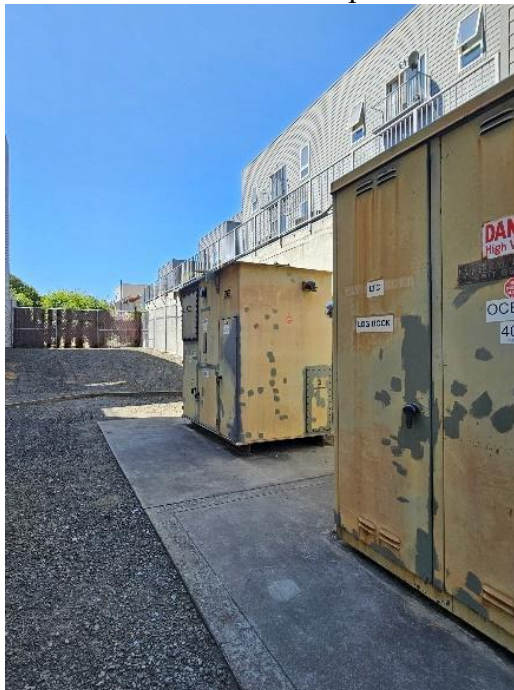
10.3. Distribution riser cover damaged and wrapped with tape.
