PUBLIC UTILITIES COMMISSION

505 VAN NESS AVENUE
SAN FRANCISCO, CA 94102-3298

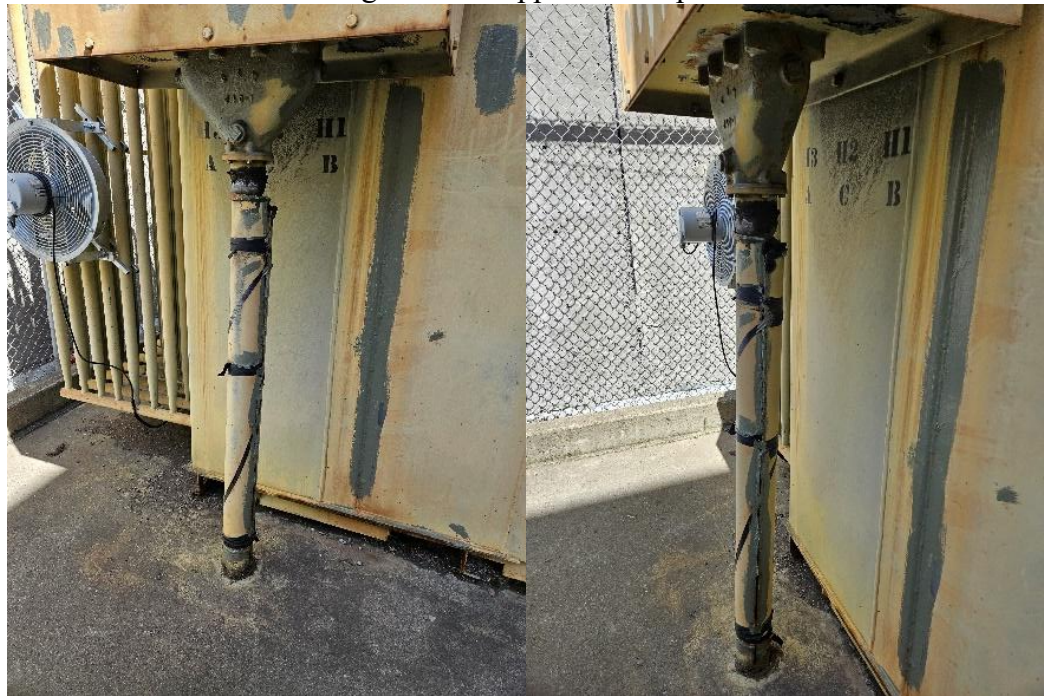
11. San Fran L Substation

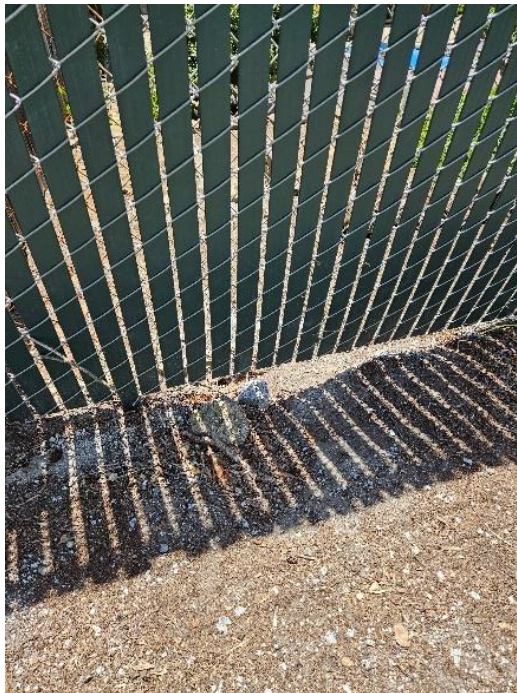
12. Noriega Substation

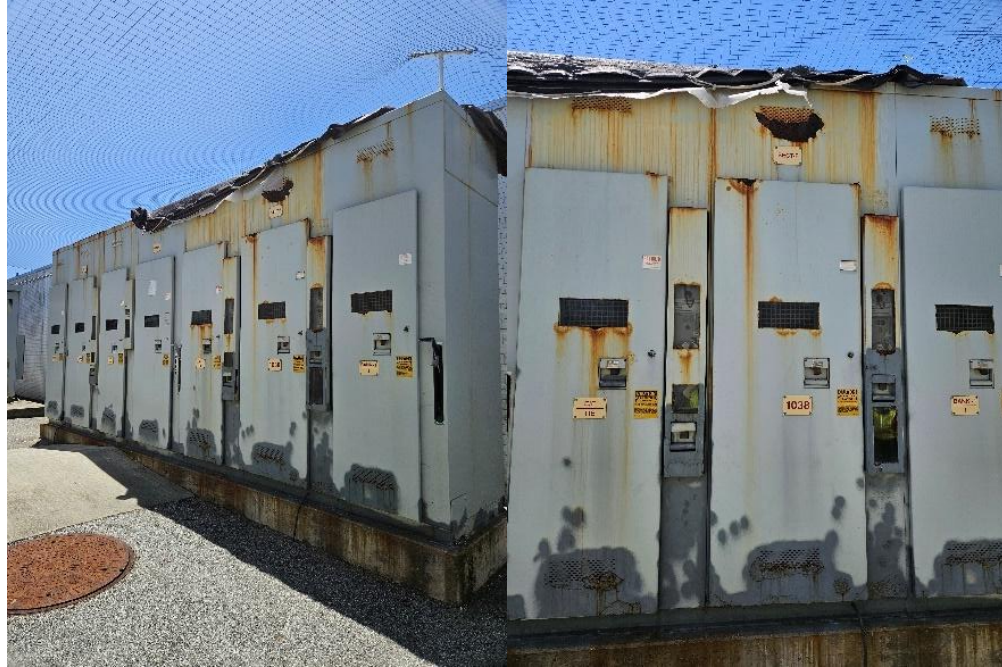
12.2. Water damage due to condensation buildup in Battery Shed. PG&E has an open LC 129349480 to repair the water damage.

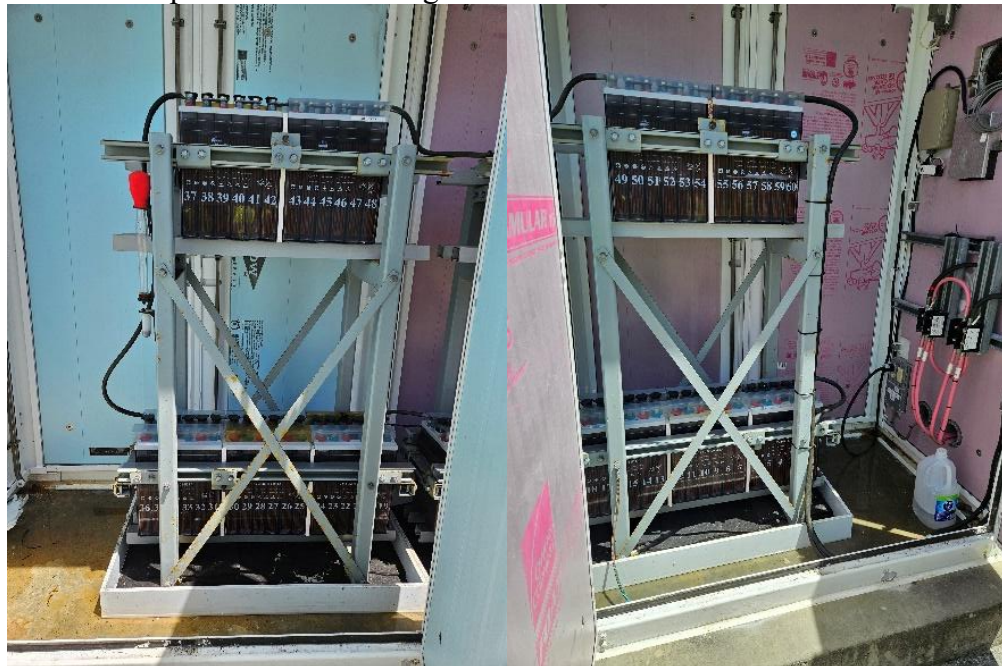
12.3. Faded identification signage and Danger signage at Bank 2 Unit 402.

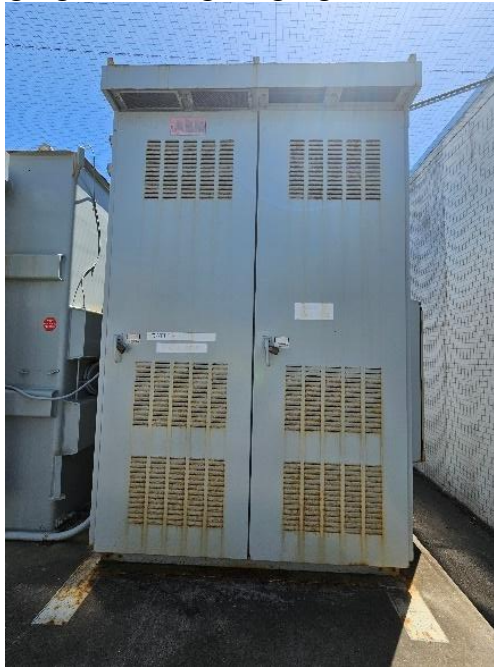
12.4. Rust at CB 401/2. PG&E has an open LC 129350326 to repaint it.

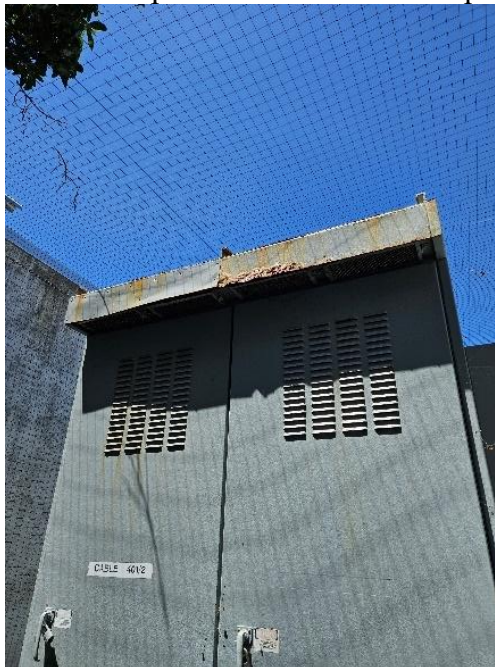
12.5. Clamps for ground wire rusted through.

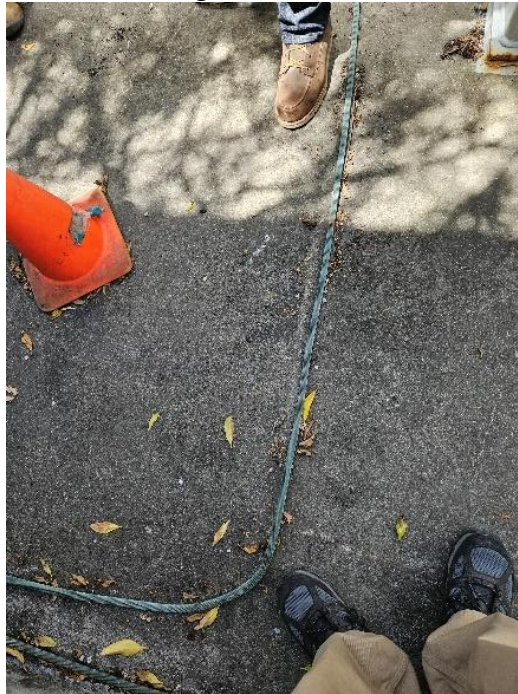
13. Judah Substation

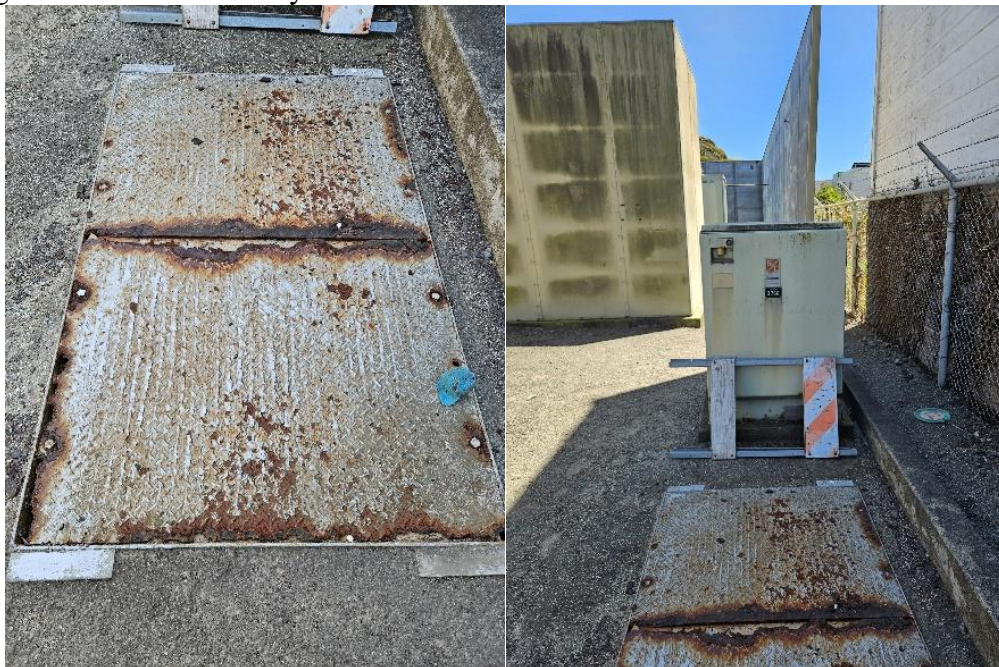
13.2. Pothead riser needs duct seal at Bank 402.

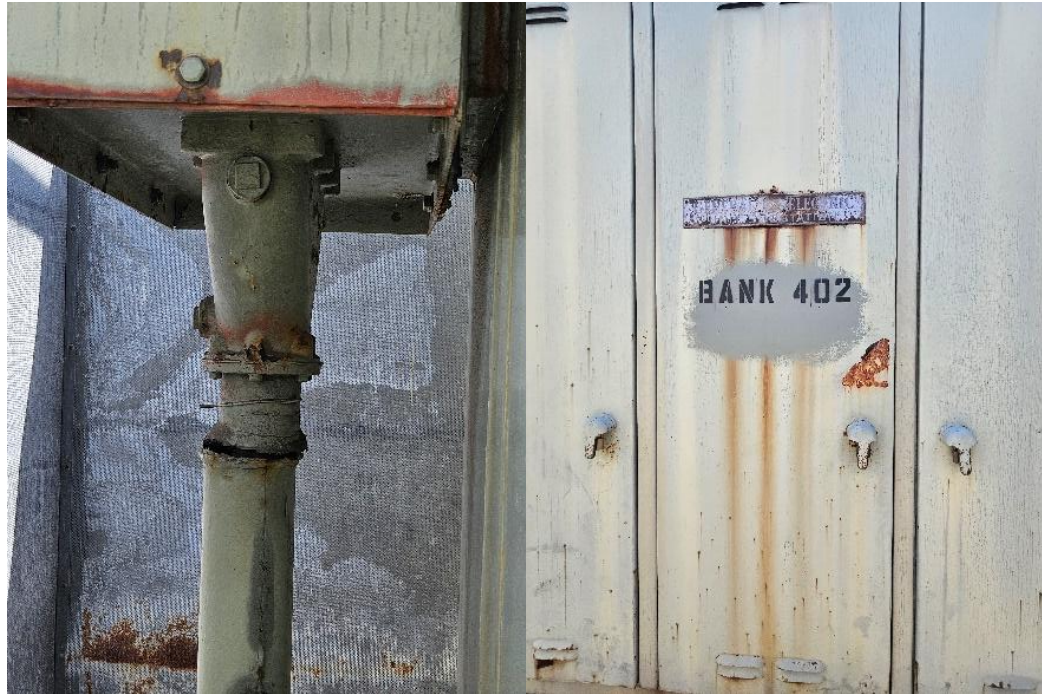
14. San Fran K Substation

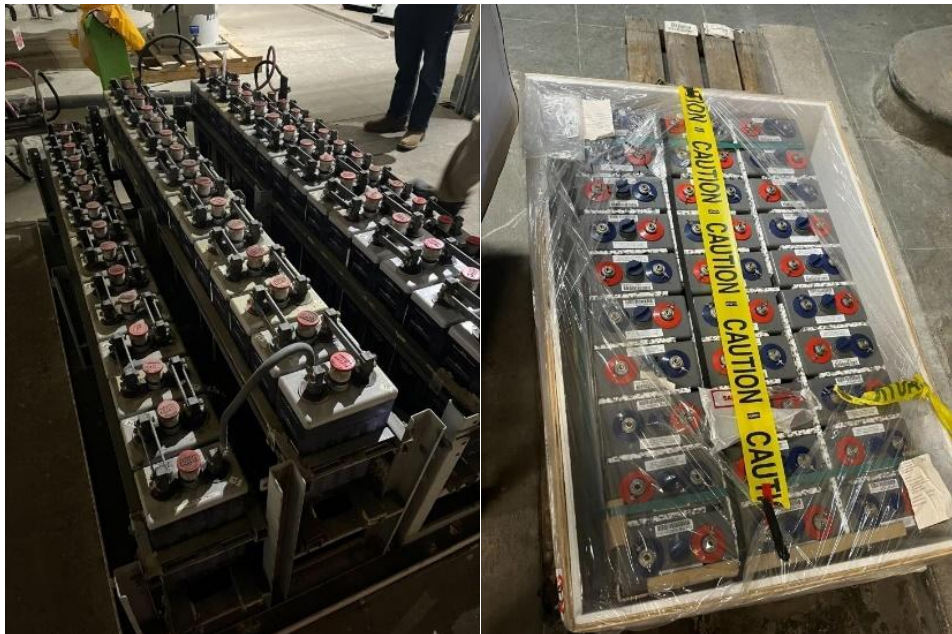
14.2. The 205 Regulators require chain/barrier and Danger signage.

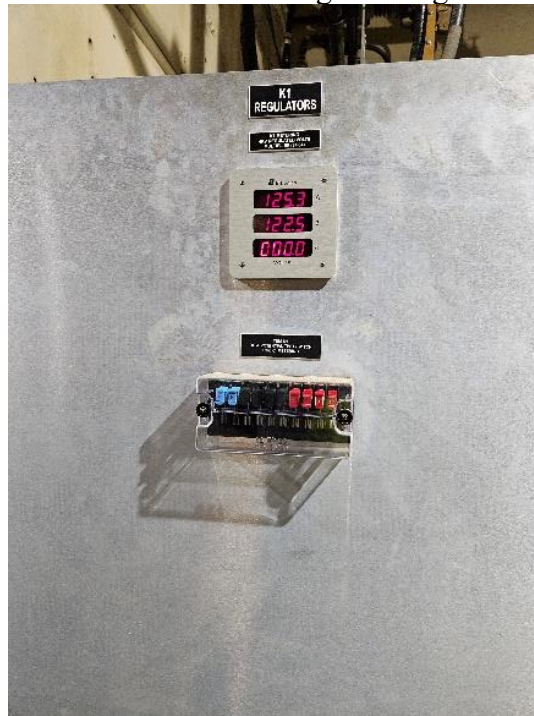
15. Beach St Substation

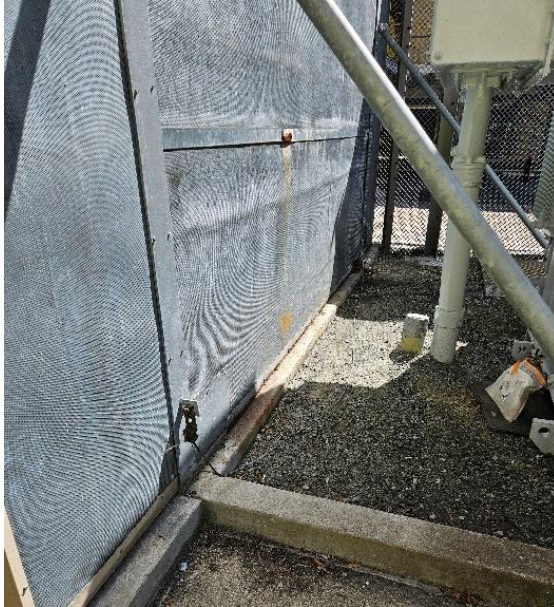
16. San Fran J Substation

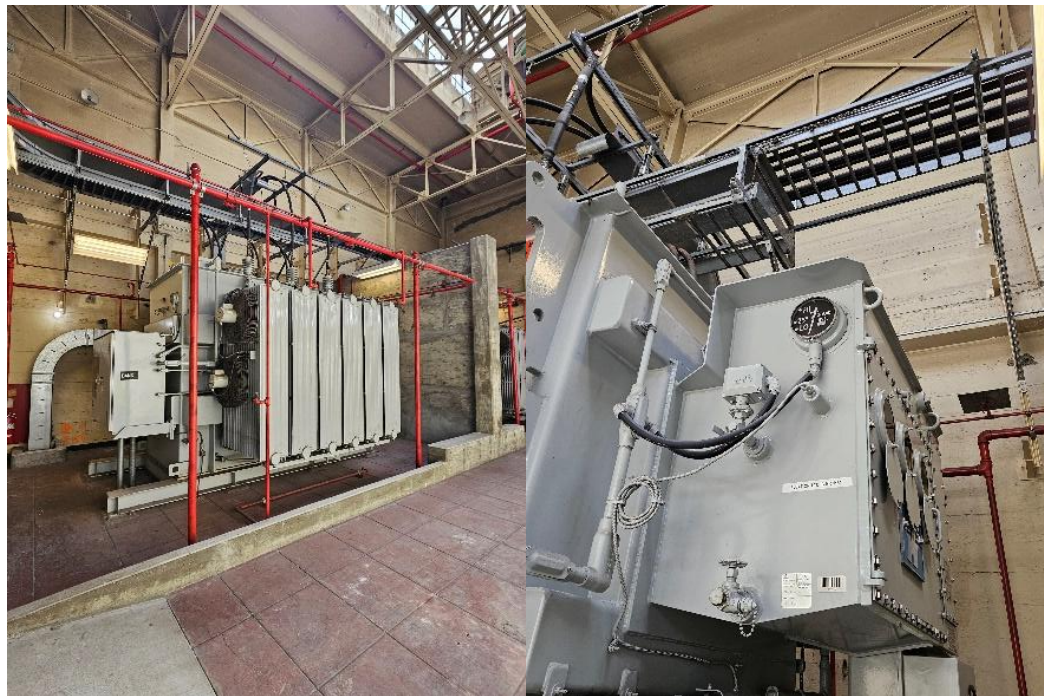
16.2. Bank 2 has an oil leak at the radiator flange. PG&E has an open LC 122446898 to repair the leak.

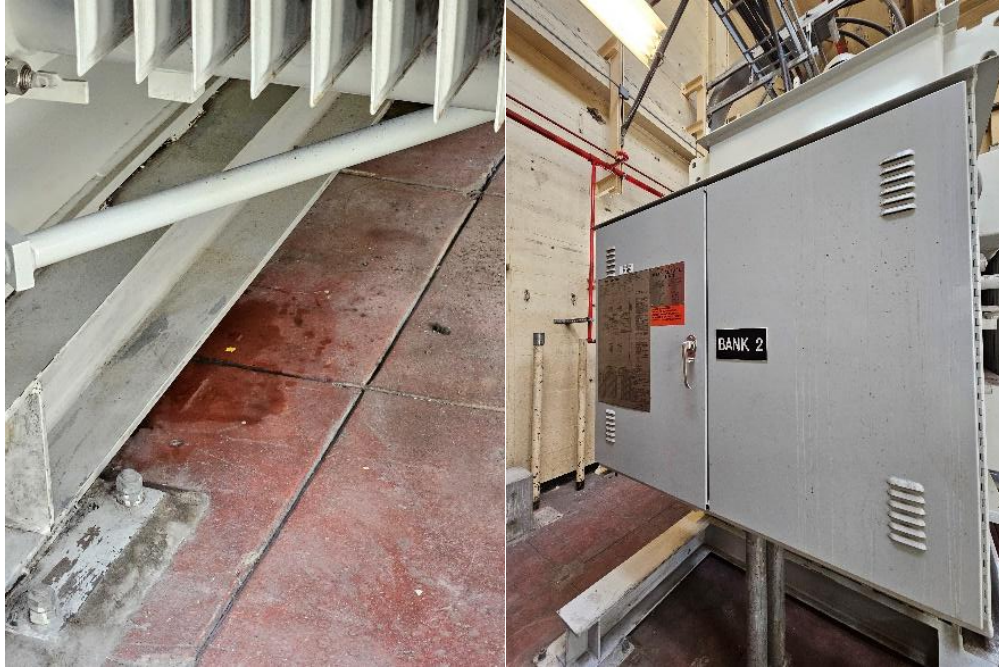
17. Larkin Substation

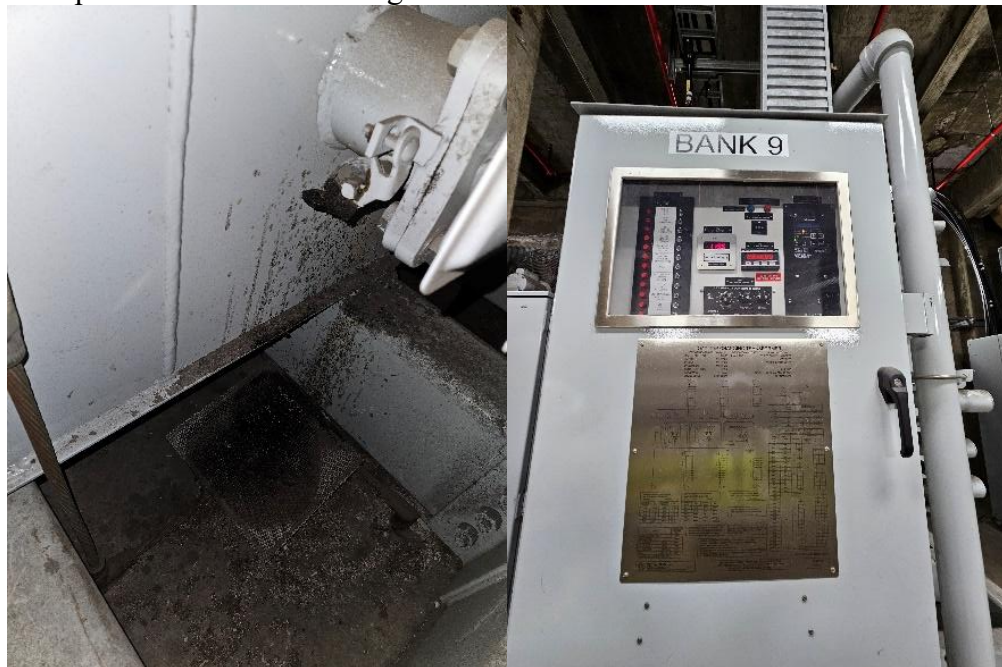
18.2. Alarm Relay C30-ANN-4 has an alarm for FSR 1125 Relay fail at Cell 45 BK4-22.

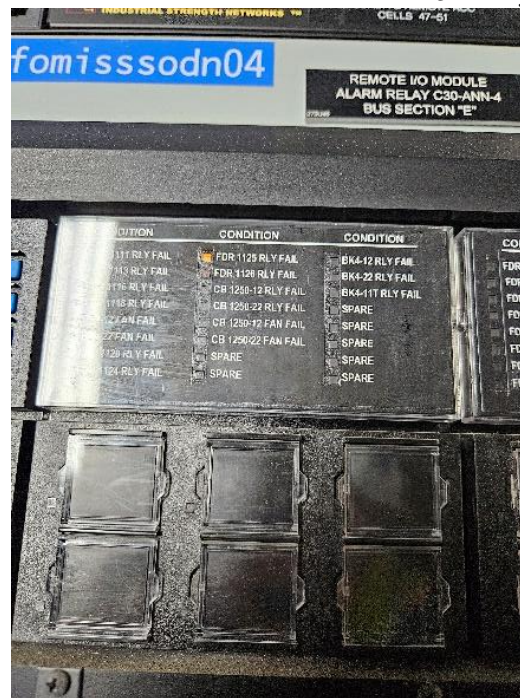
18.3. Broken Nitrogen gauge at Bank 1 and “Low Nitrogen Pressure” alarm shown at the Annunciator panel.

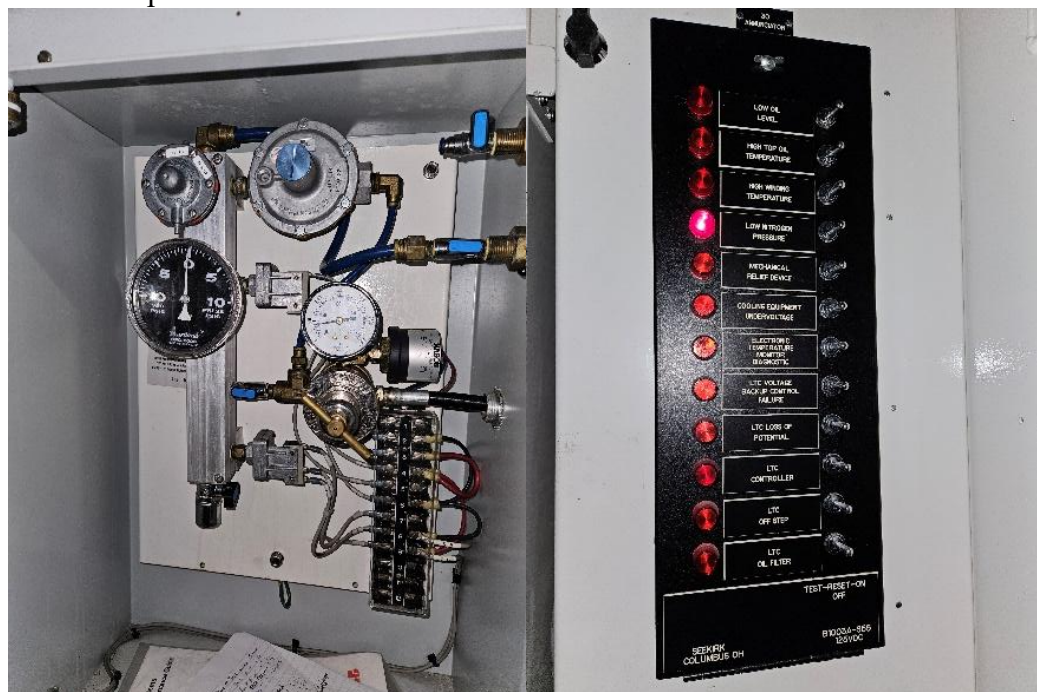
19. San Fran A (Potrero PP) Substation

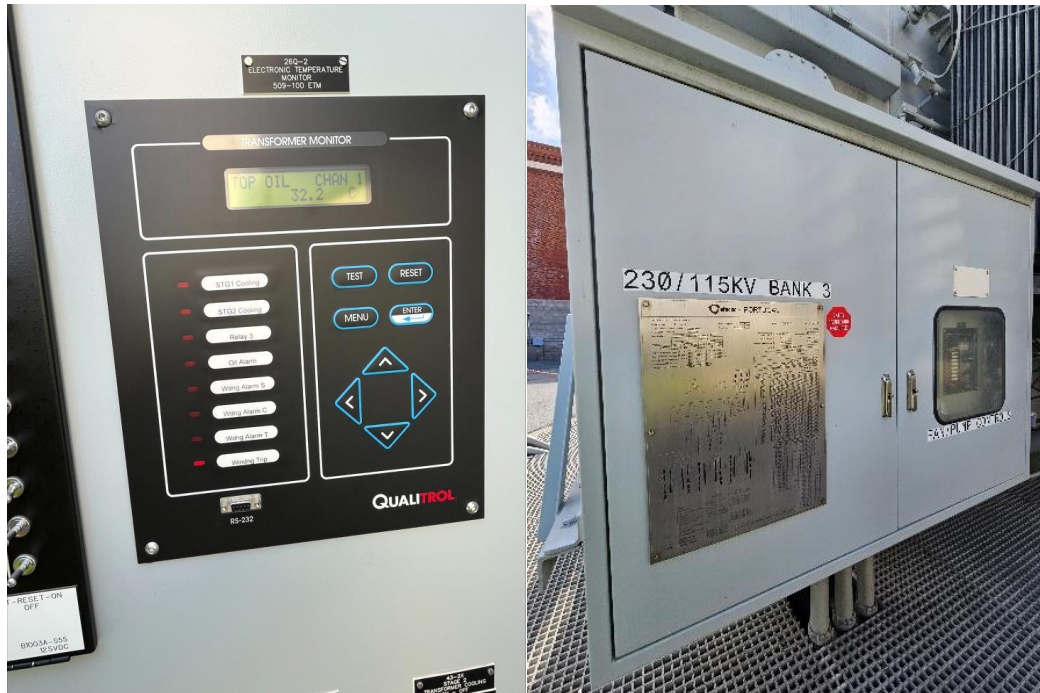
19.3. Pump motor counter faded at CB 362. PG&E has an open LC 129477721 to replace the counter.

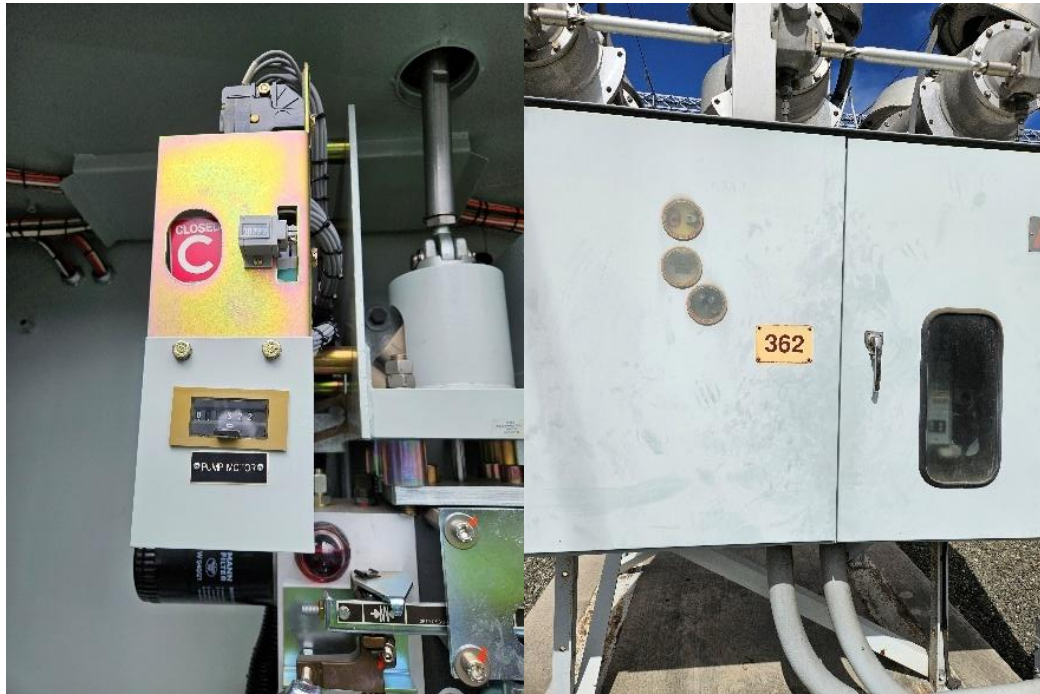
19.4. Pump motor counter faded at CB 132.

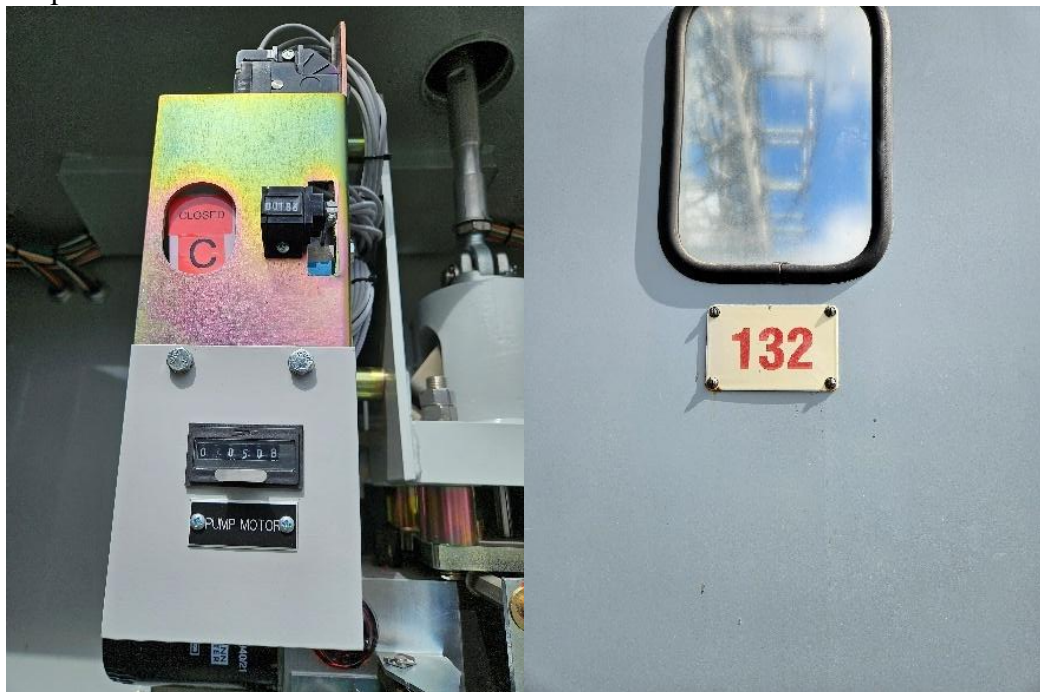
19.5. Pump motor counter faded at CB 182. PG&E has an open LC 129477720 to replace the counter.

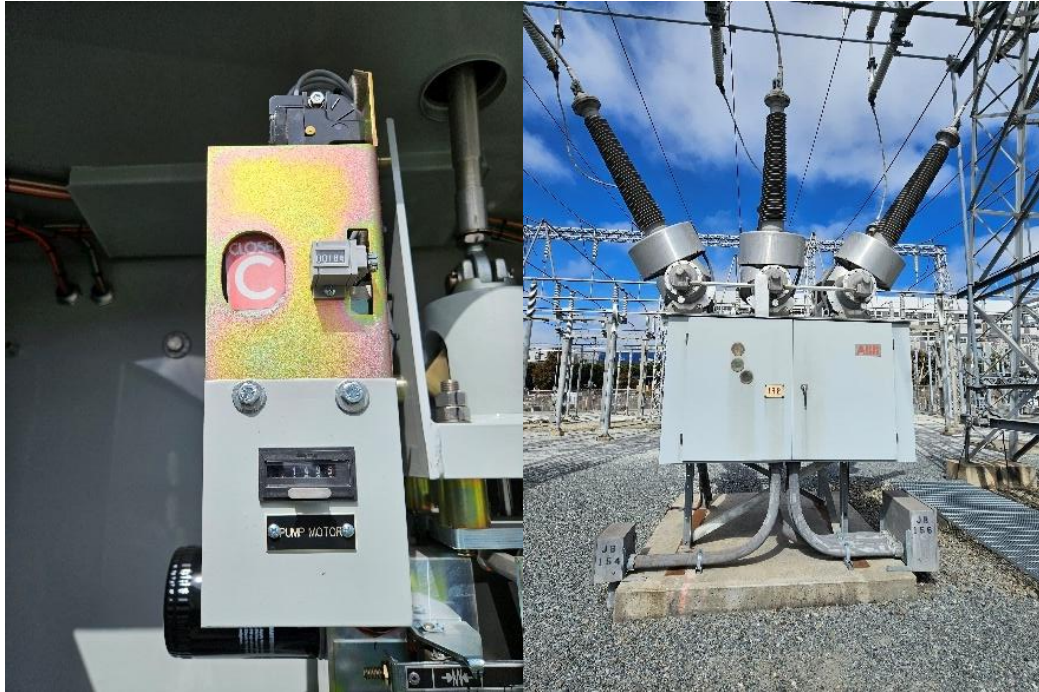
19.6. Bird nest under the middle bushing at CB 192. PG&E has an open LC 129477848 for the bird nest.

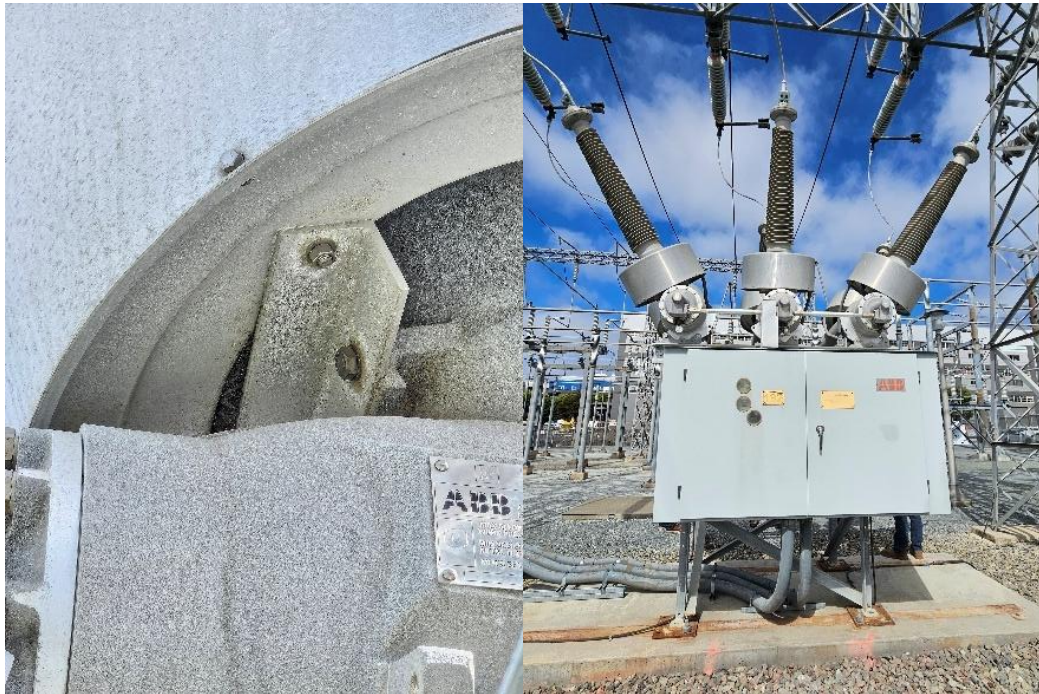
19.7. Faded counter at CB A1115/2. PG&E has an open LC 125983508 to replace the counter.

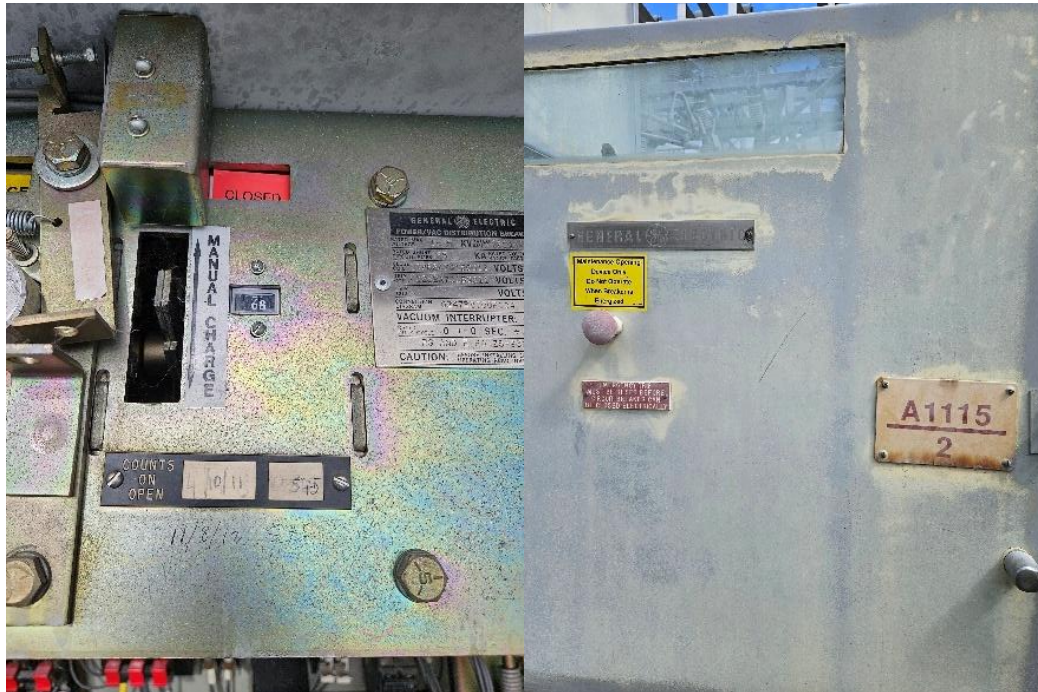
19.8. Pump motor counter faded at CB 412.

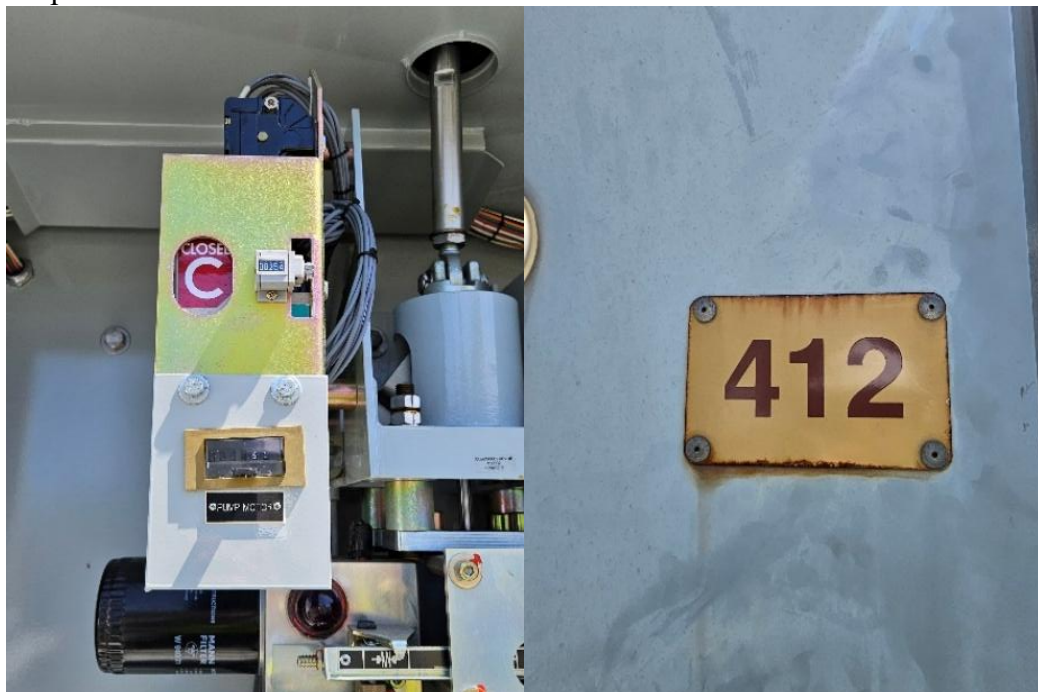
19.9. Faded counters at CB A-1114/2 and CB A1117/2. PG&E has an open LC 128457081 to replace the counters.

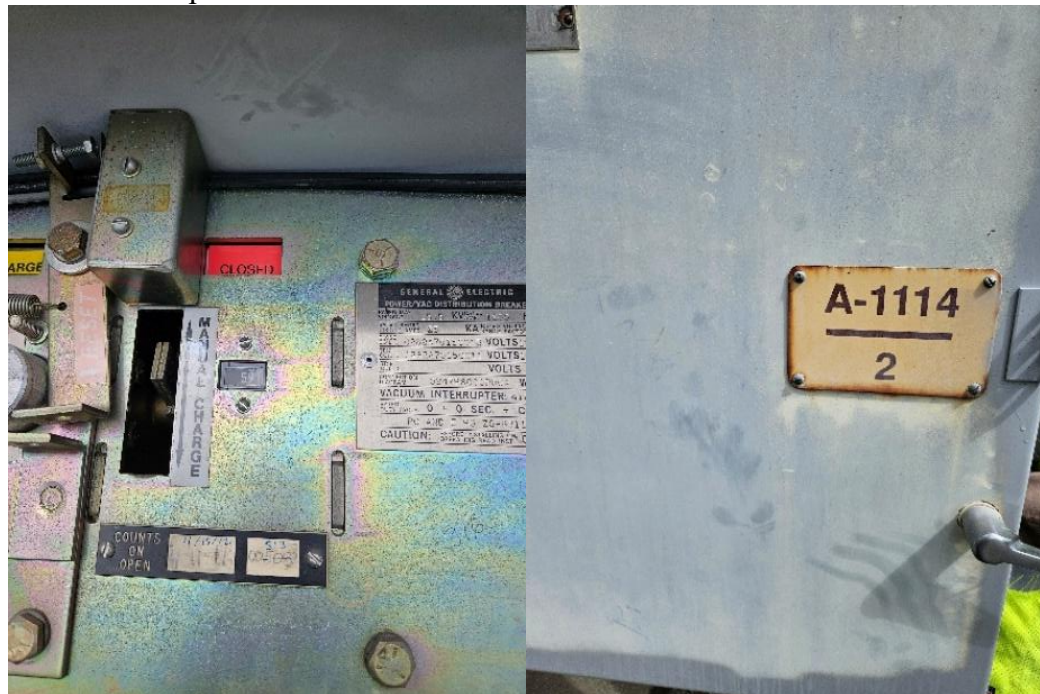
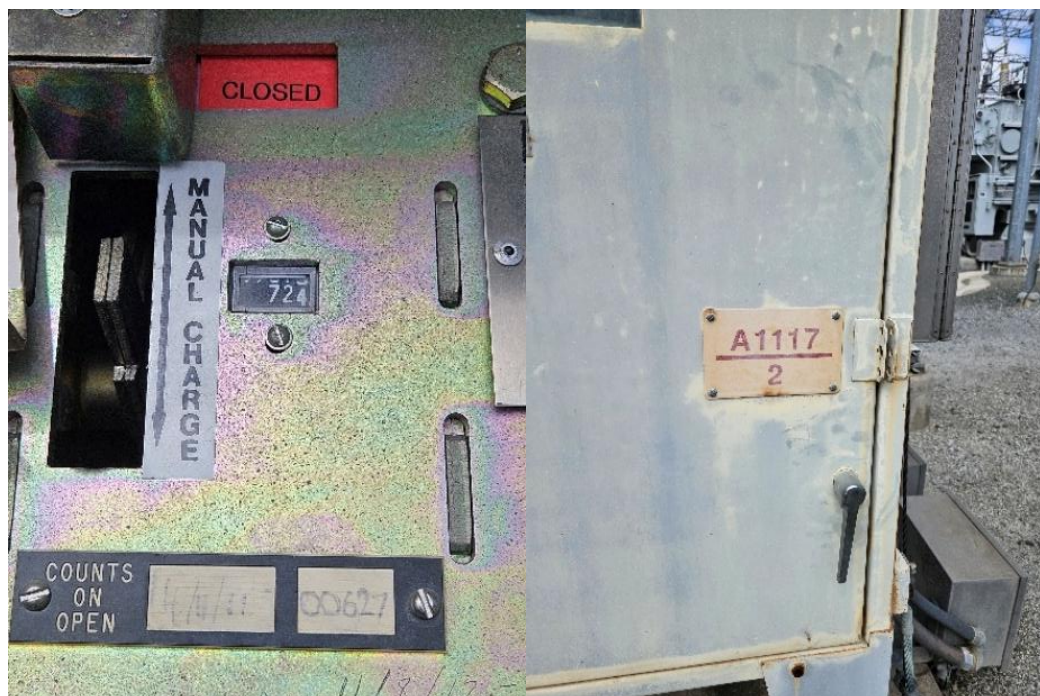
19.10. Faded semaphore at CB 432.

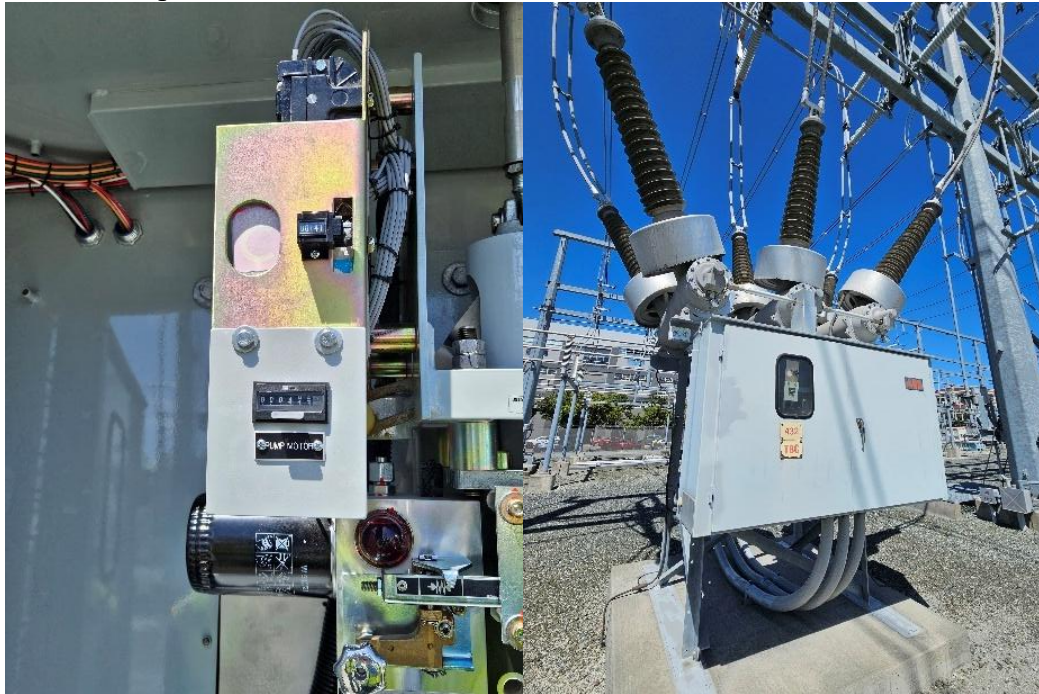
19.11. Corrosion on battery cells 54 and 55 in the Station Battery Room. PG&E has an open LC 130533738 to clean the corrosion.

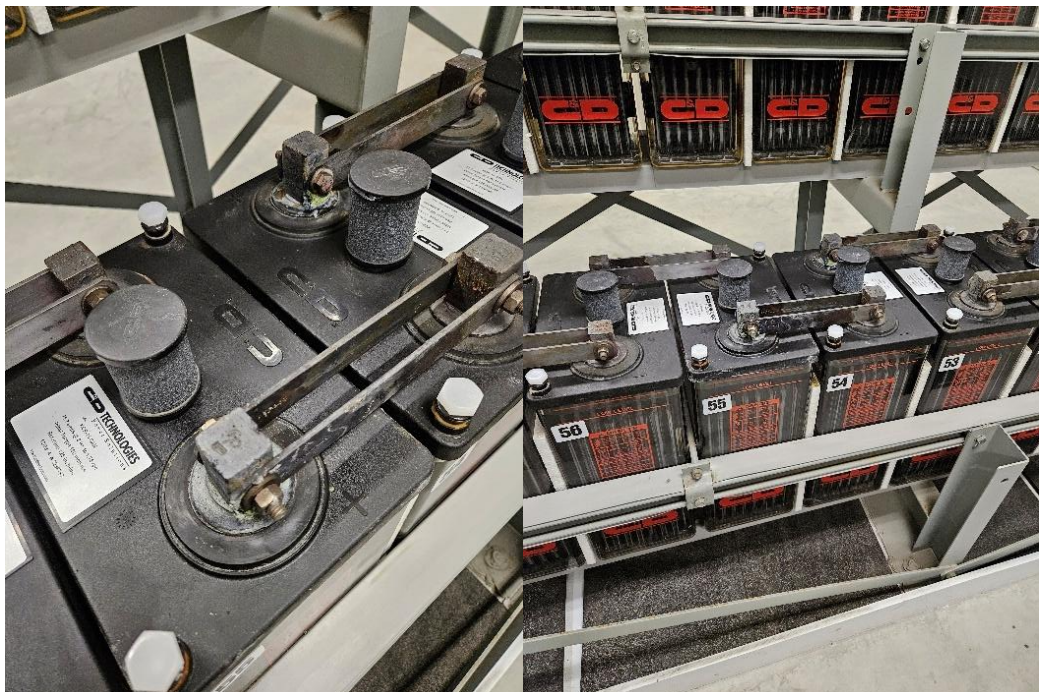
19.12. Faded counter at CB 386. PG&E has an open LC 129477723 to replace the counter.
