**CALIFORNIA PUBLIC UTILITIES COMMISSION**  
**Safety and Enforcement Division**  
**Wildfire Safety Enforcement Branch**

**Incident Investigation Report**

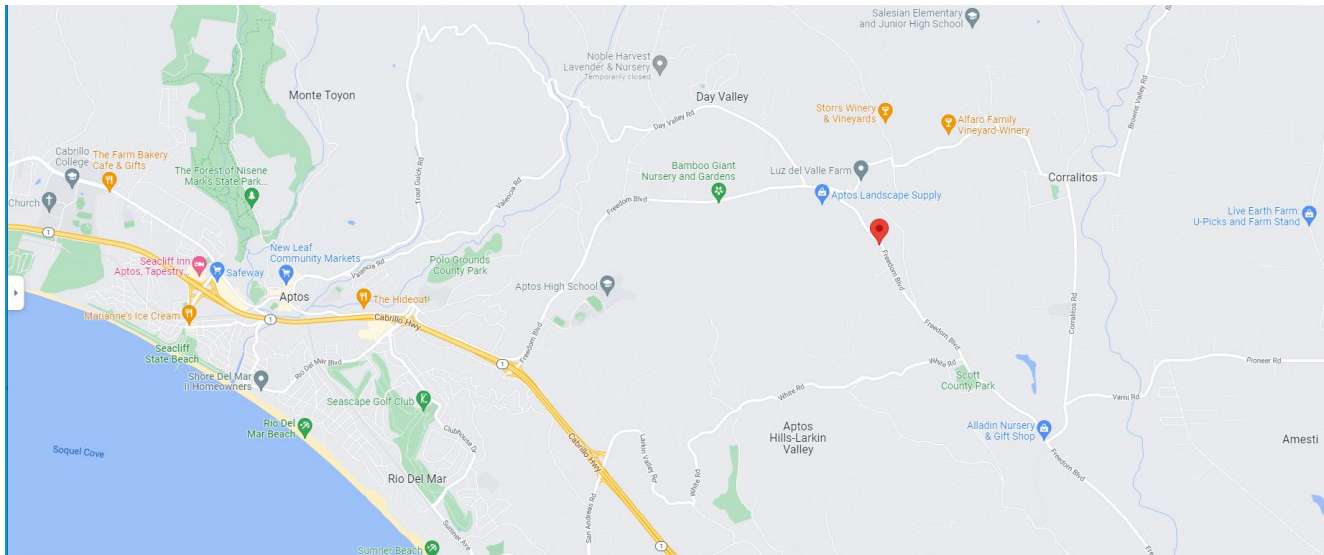
**Figure 1:** The origin of the fire via Google Maps.

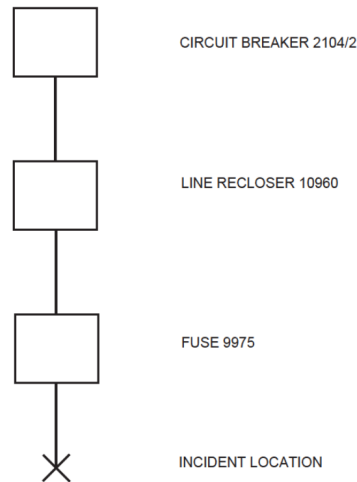
**Figure 2:** Circuit Map and Protective Devices near Incident Location (Source: PG&E).

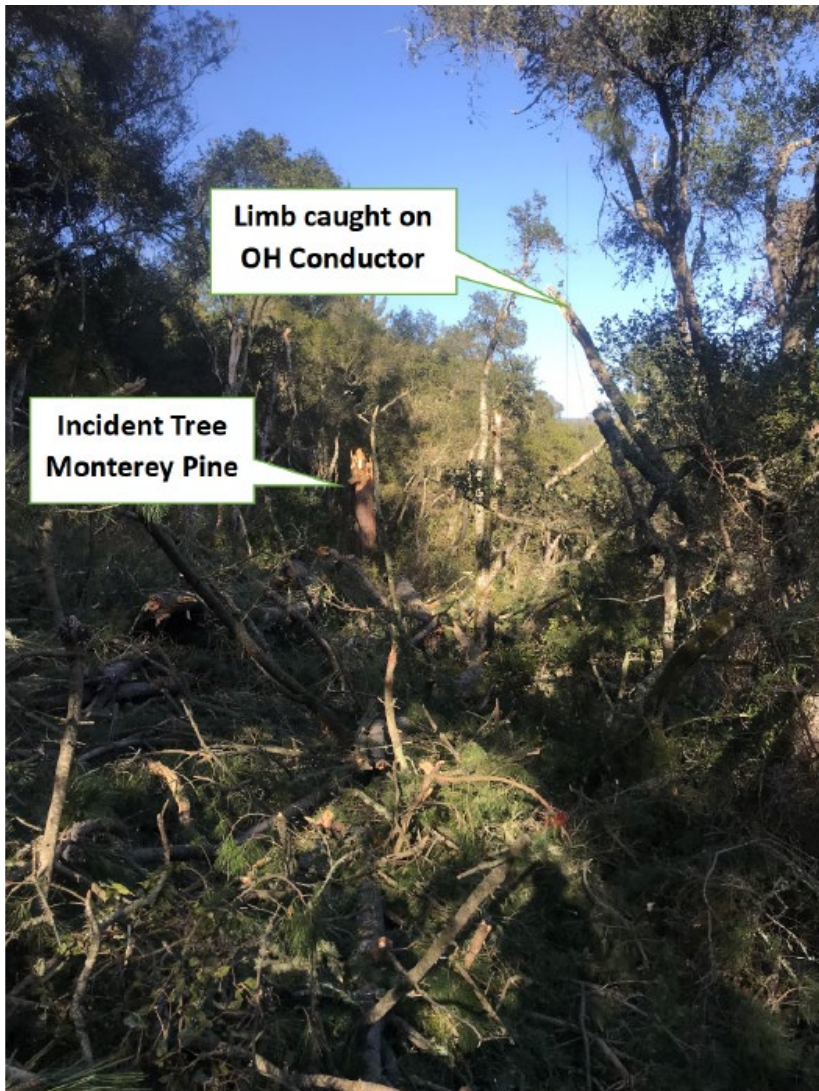
**Figure 3:** Incident Tree fallen into Rob Roy 2104 Circuit (Source: PG&E).

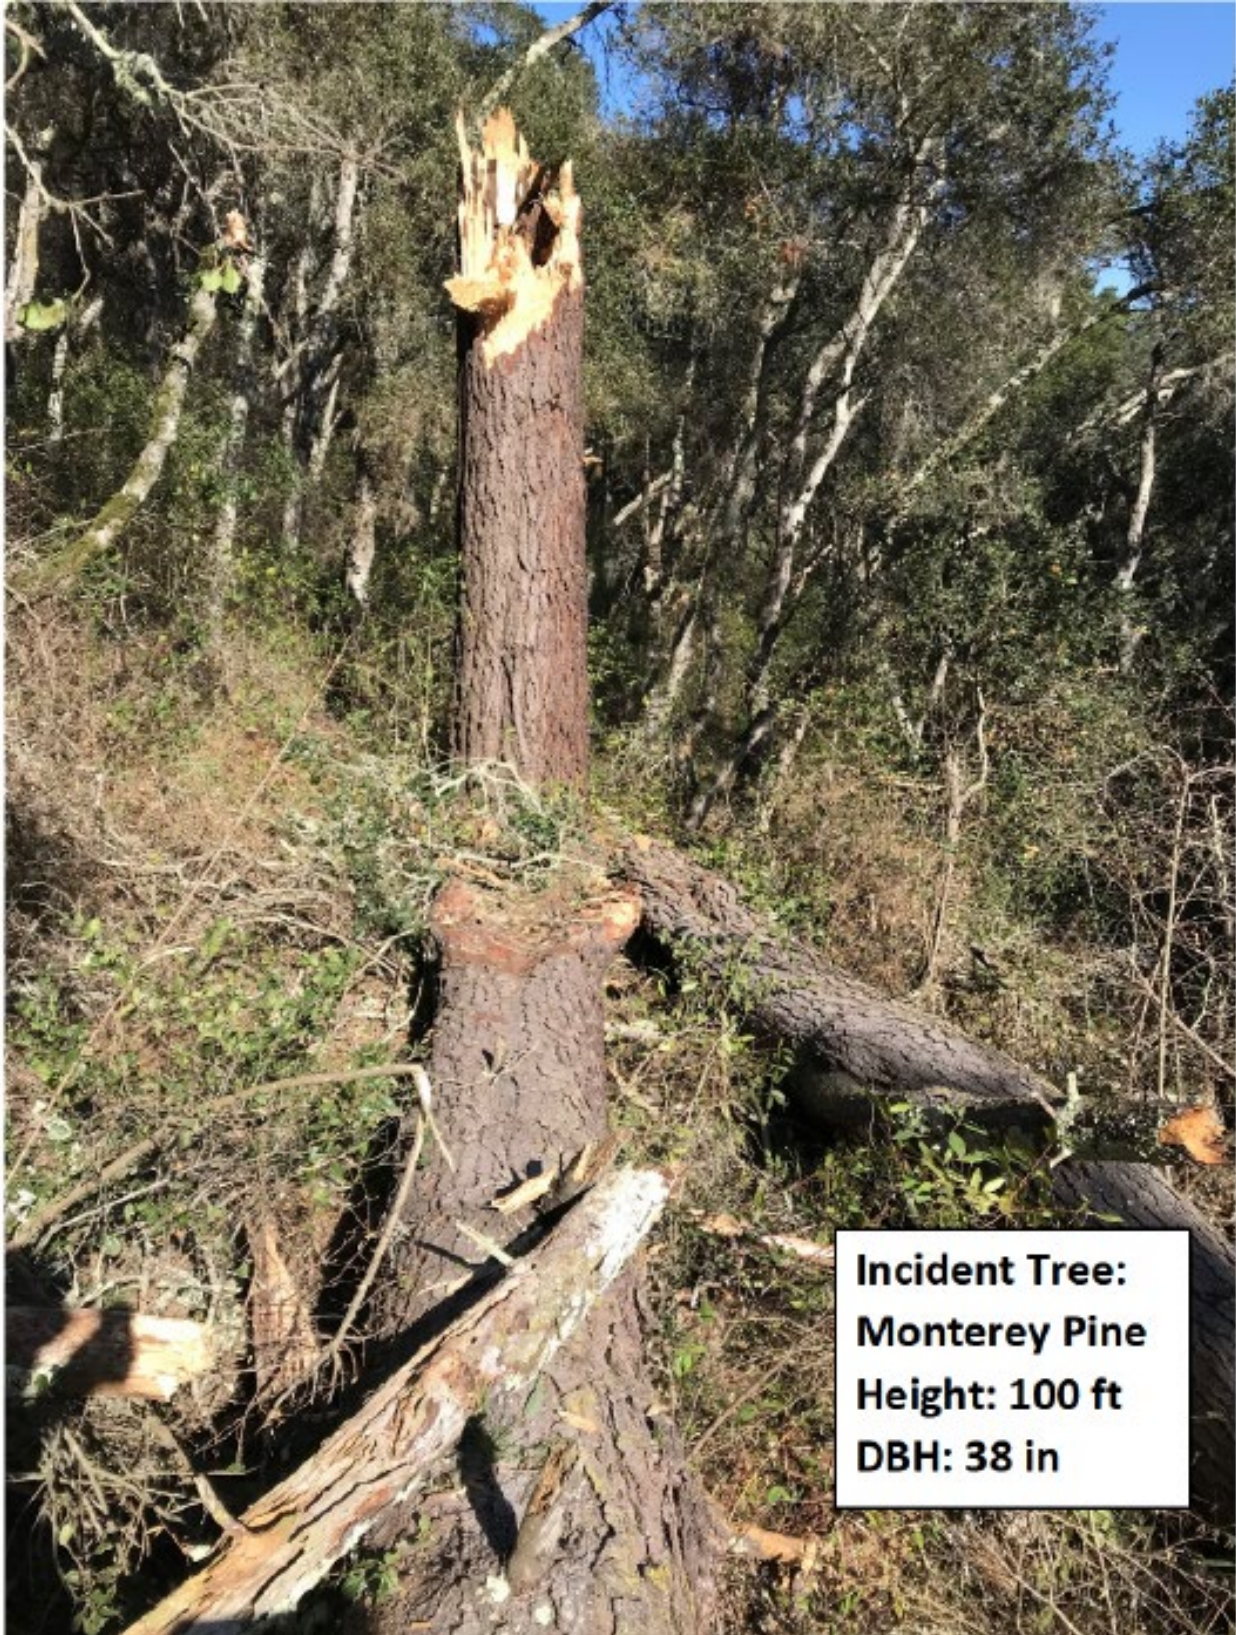
**Figure 4:** Incident Tree failure at fork top 20 feet above ground (Source: PG&E).

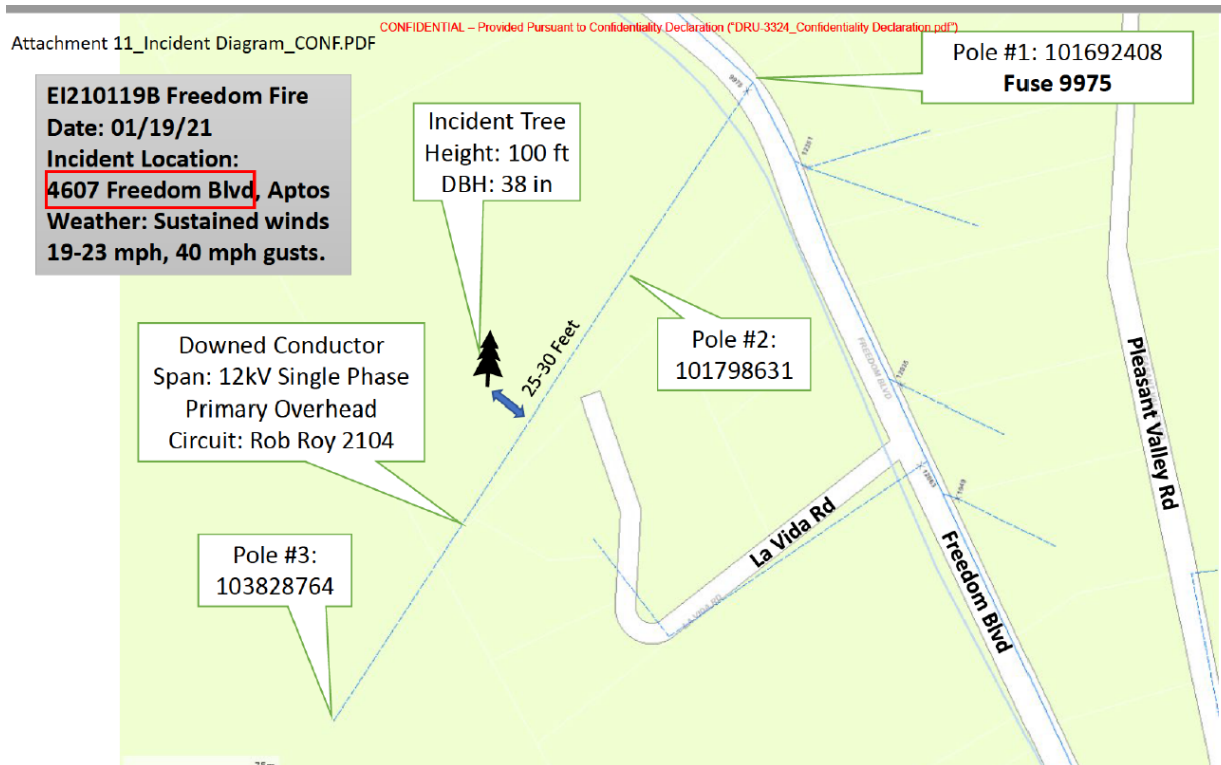
**Figure 5:** Incident Diagram showing the Incident Tree relative to Poles (Source: PG&E).
