CPUC SUBSTATION AUDIT
FINDINGS PG&E Eureka
Headquarters October 16 –
October 20, 2023

I. Records Review

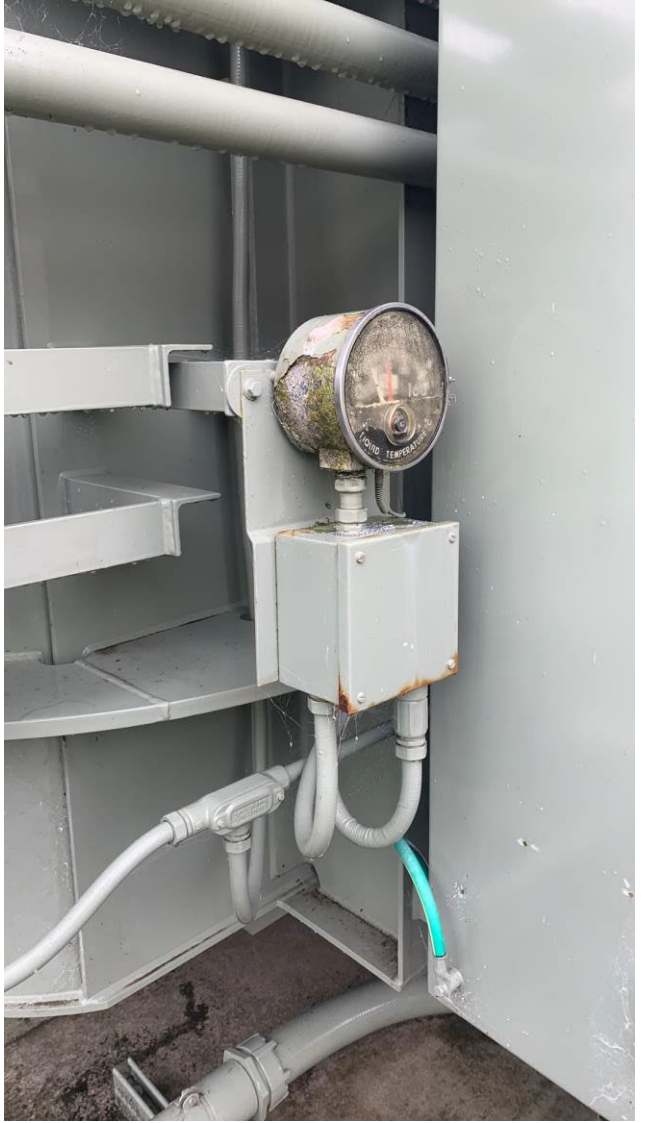
Violation #	Violation Description	Image
1	<p>The temperature gauge at one of the transformer banks has deteriorated paint, moss growth, and low readability. PG&E stated that there is already a corrective tag for this issue.</p> <p>PG&E Response: We agree with the finding of deteriorated paint, moss growth and low readability on Transformer 2 at Humboldt Substation. We created priority B notification 127285519 and we completed the work on 11/17/2023.</p>

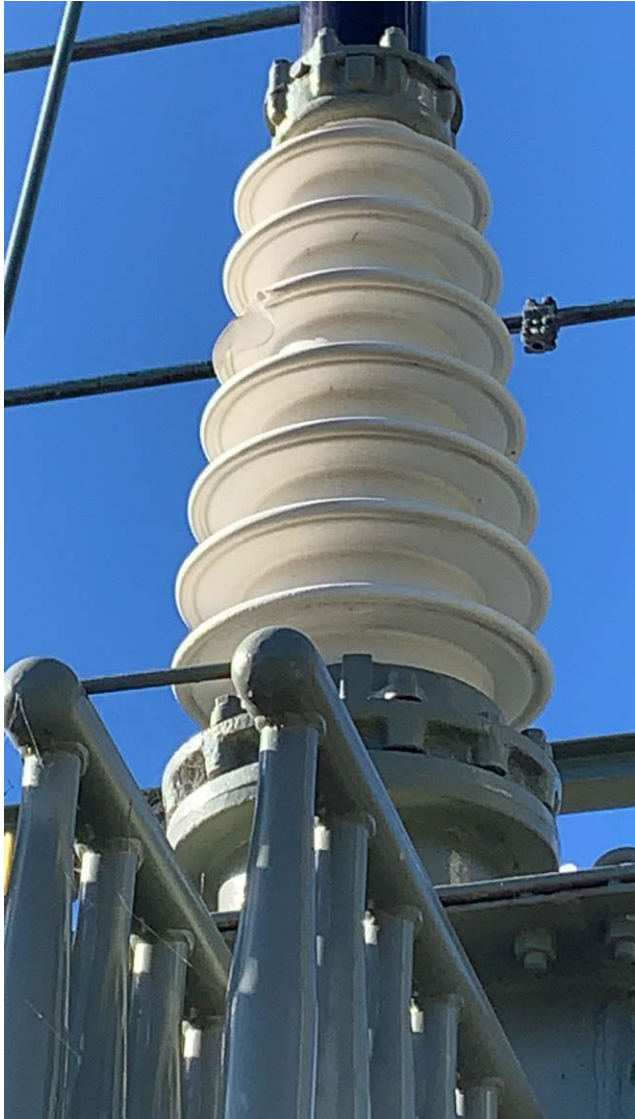
A close-up photograph of a white ceramic insulator on a power line. The insulator consists of several stacked, rounded, disc-like segments. The top segment shows a small, dark chip or mark on its surface. The insulator is mounted on a metal structure, and power lines are visible in the background against a clear blue sky.

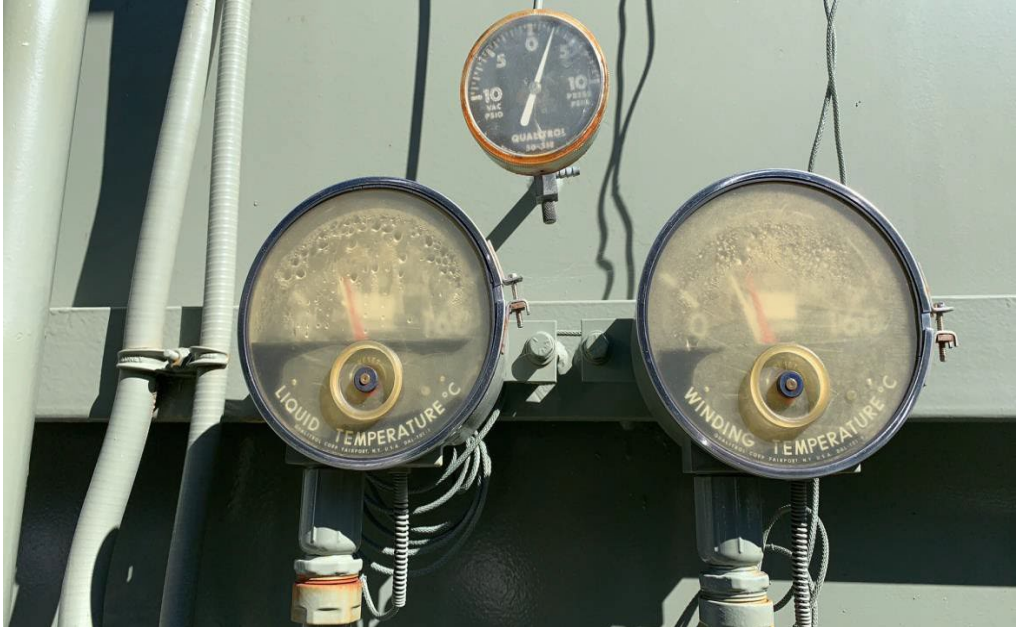
4 The C-Phase temperature gauges are not legible. PG&E stated that there is already a corrective tag #127143757.

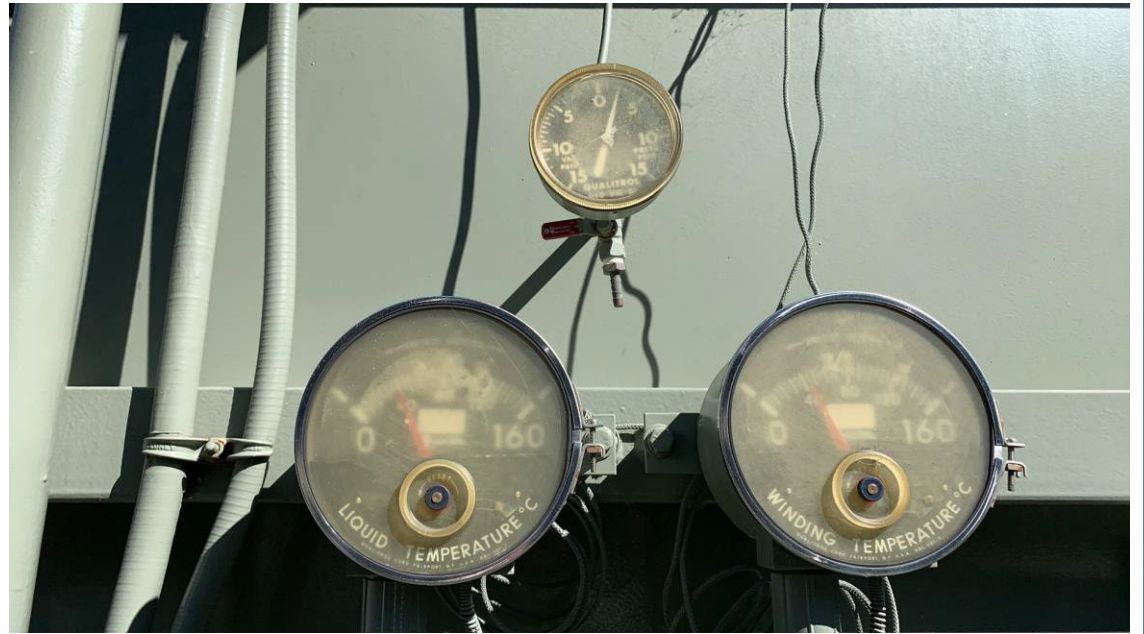
- 7 There is corrosion at the back of a meter panel. PG&E stated that there was an existing tag #127143598 for the corrosion.

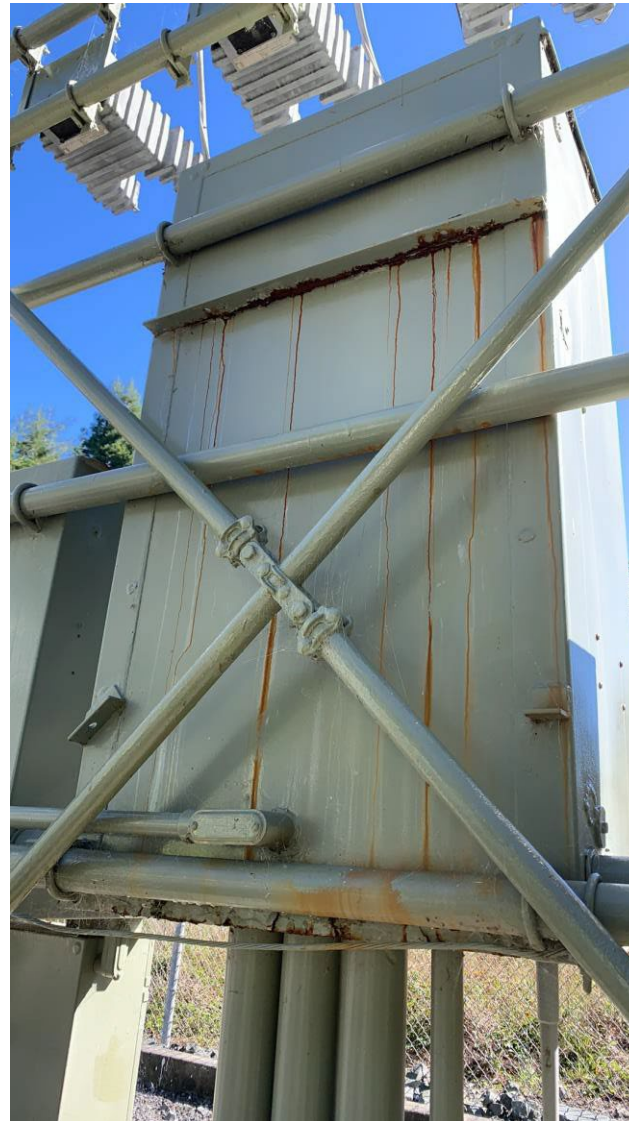
- 8 There is spare aluminum conductor by a transformer. There is an existing tag #126500663 to store the conductor elsewhere.

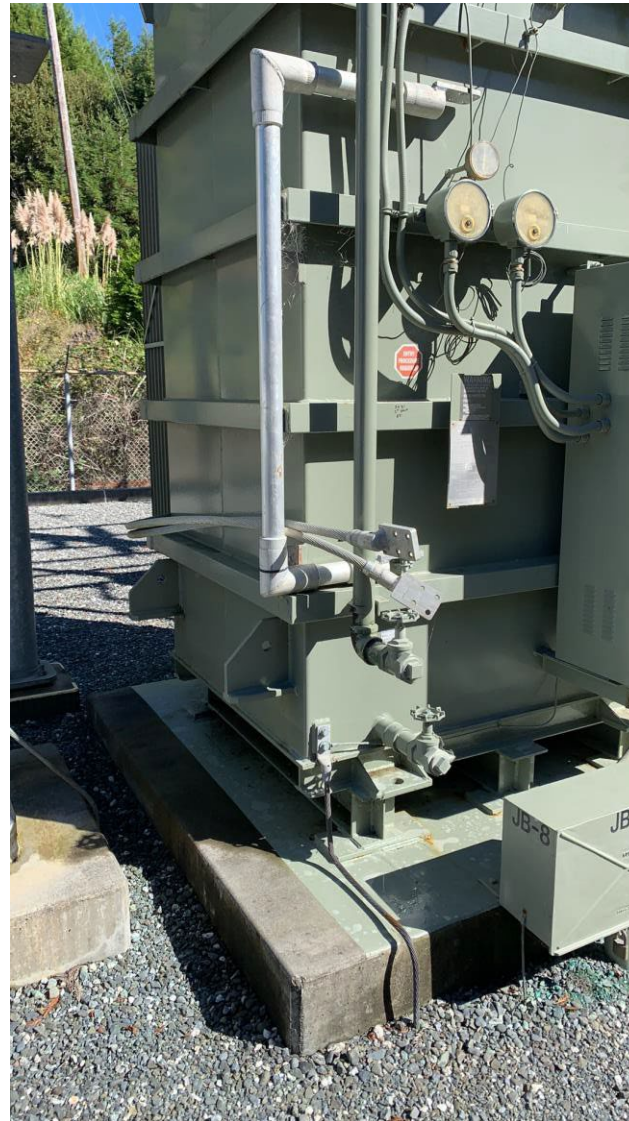
Violation #	Violation Description	Image
9	<p>There is a rusted potential transformer on A-Phase on Fairhaven #1 line. There is an existing tag #127135346.</p> <p>PG&E Response: We agree with the finding that there is rust on the potential transformer on A phase at Fairhaven Substation, but do not agree that the finding qualifies as a violation of GO 174, Rule 12. Our QEW identified this issue prior to the CPUC field audit and documented it in our system of record as a priority E notification, 127135346. We completed the work on 10/19/2023.</p>

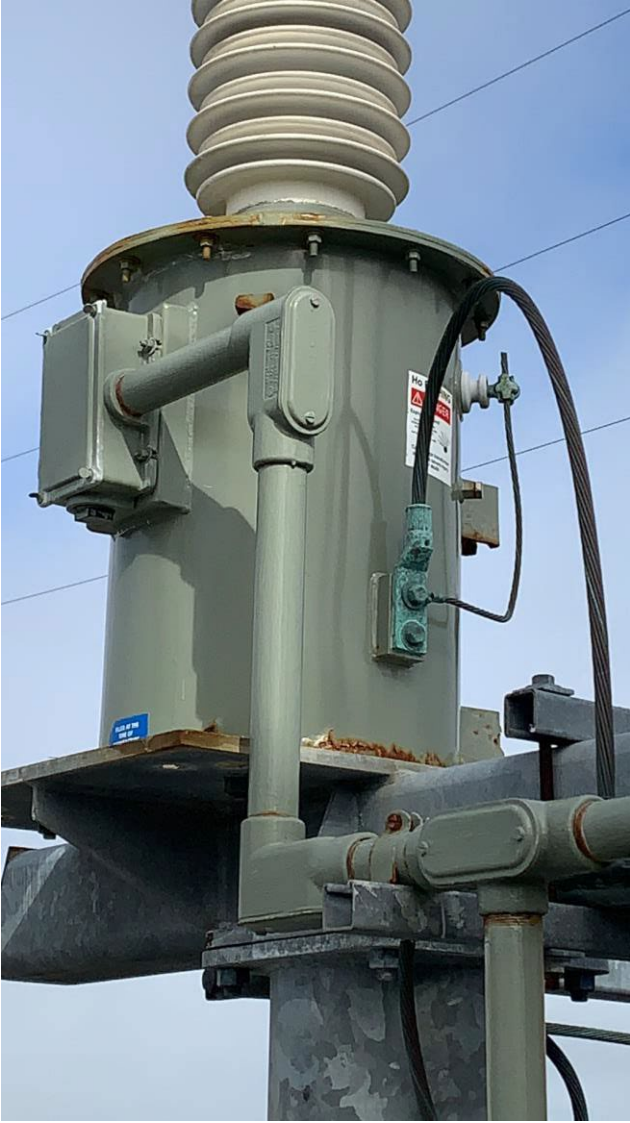
- 10 There is a rusted potential transformer on the C-Phase on Fairhaven #1 line. There is an existing tag #127135560.

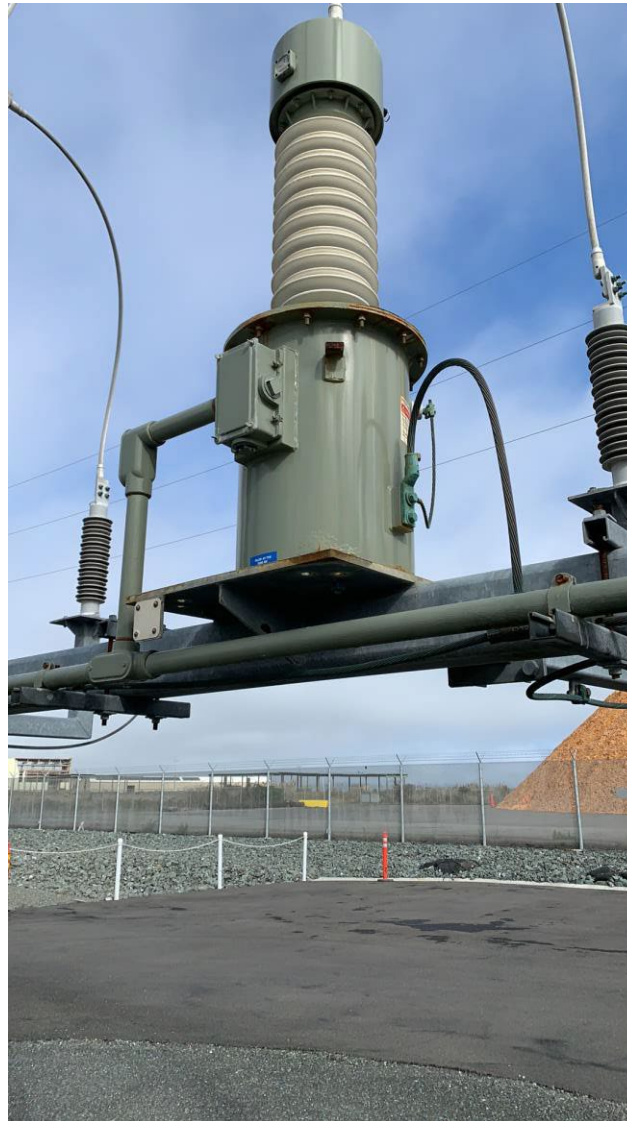
- 11 There is a rusted potential transformer on the B-Phase on Fairhaven #1 line. There is an existing tag #127135349.

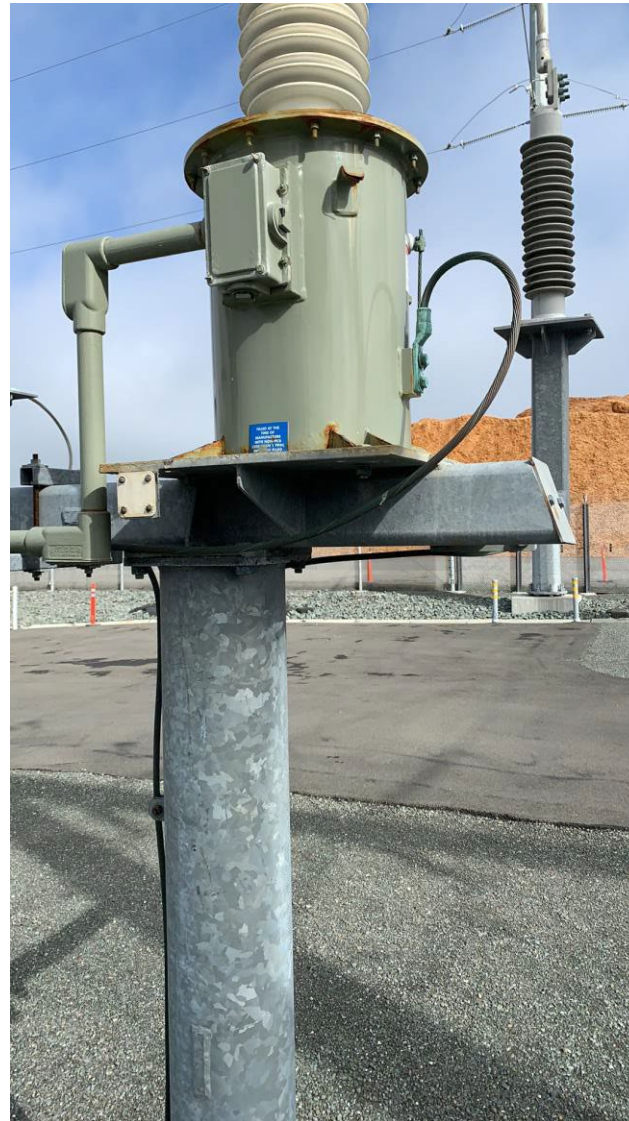
- 12 There is faded signage at the A-Phase potential transformer.

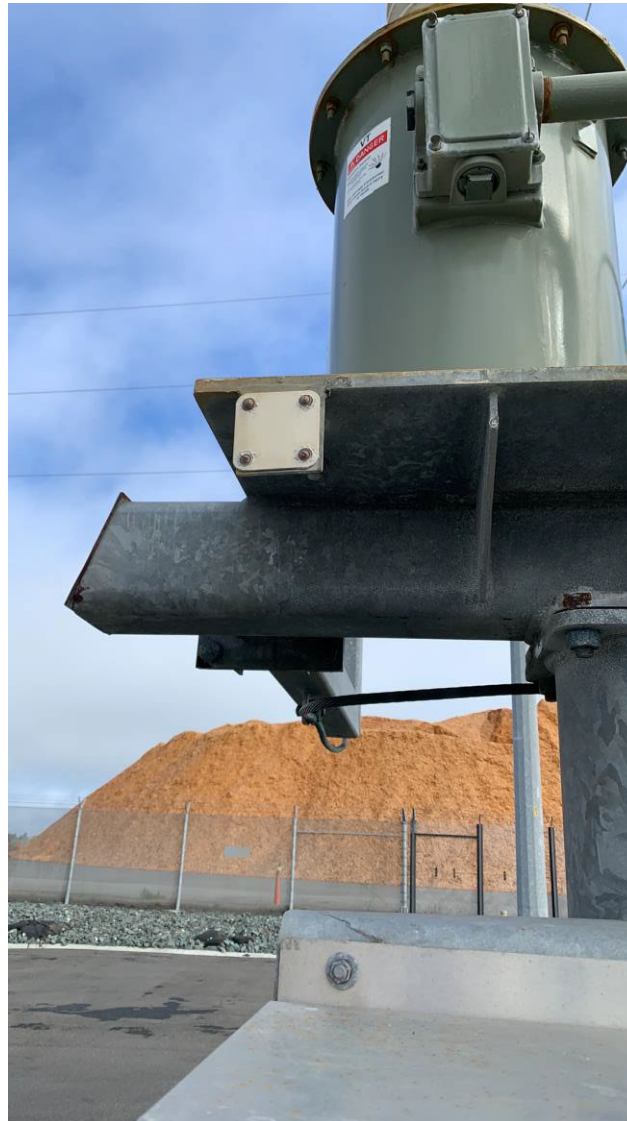
13 C-Phase potential transformer signage is worn out.

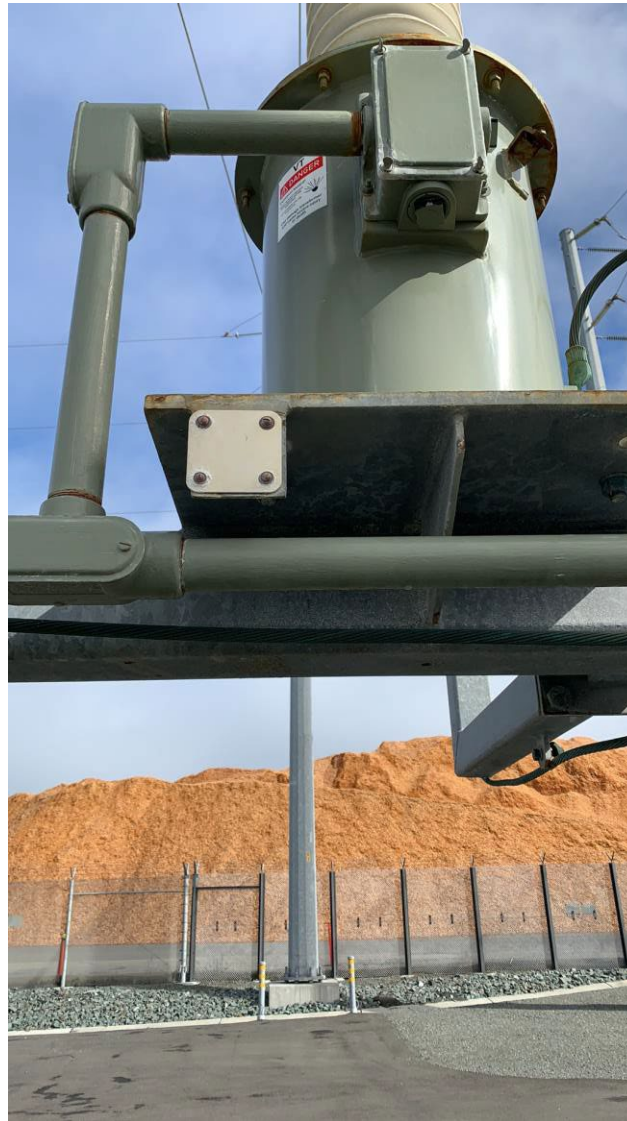
14 B-Phase potential transformer signage is worn out.

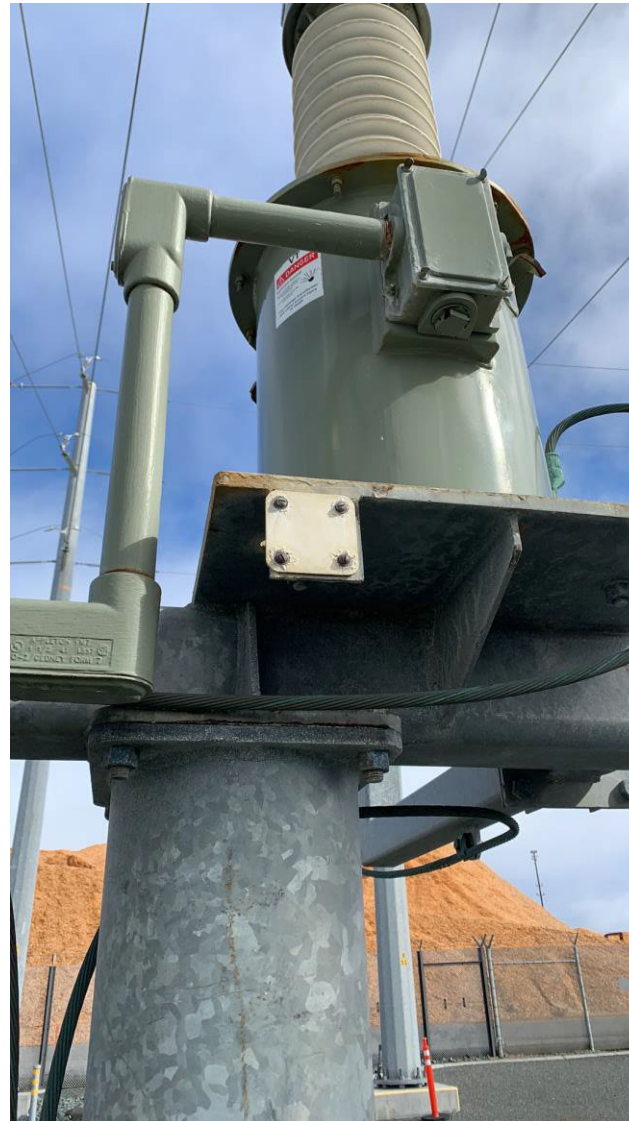
15 The signage for Essex junction Arcata-Fairhaven line is worn out. Each phase already has a tag.

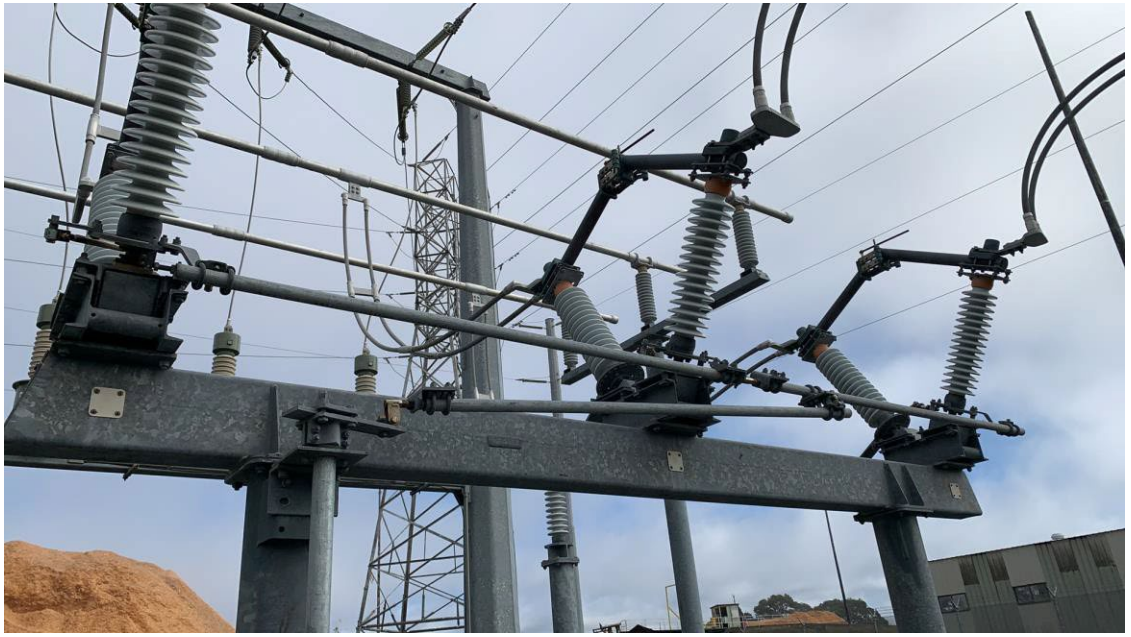
A photograph of an electrical switch assembly at a substation. The switch is mounted on a metal structure and features several insulators and conductors. The signage on the switch is faded and difficult to read. The background shows a clear sky and some industrial structures.
<p>18 Switch 6023 signs are worn out.</p> <p>PG&E Response: We agree with the finding that the signage is faded on switch 6023 at Fairhaven Substation. We created priority E bundled notification 127294346 and added it to the workplan. We will complete the work on current work prioritization and material availability.</p>

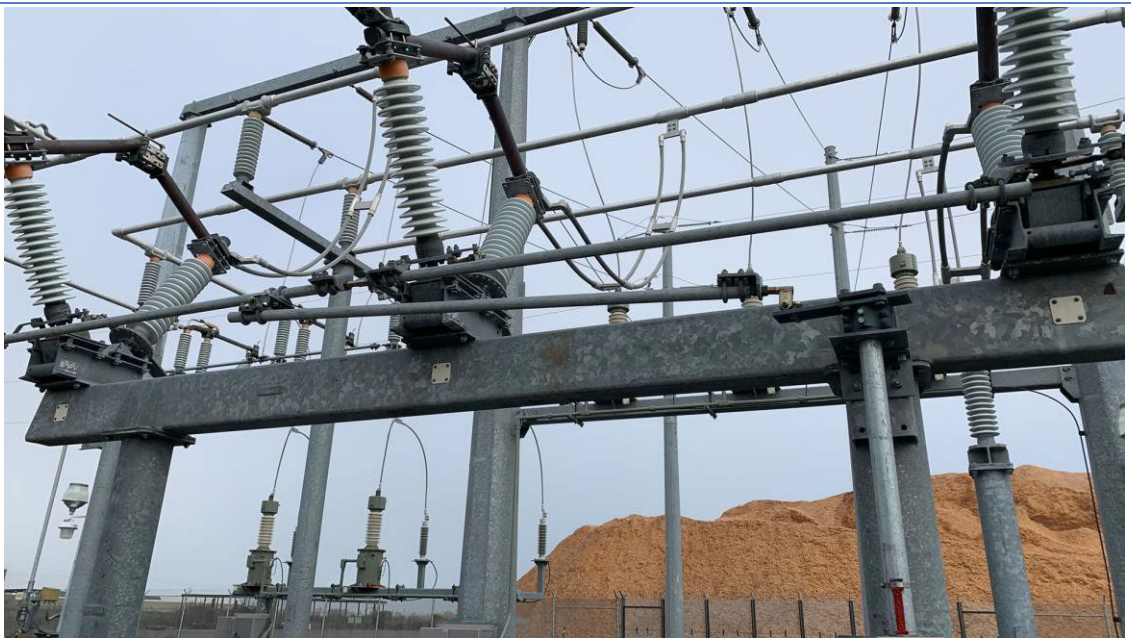
A photograph of an electrical switch assembly at a substation, similar to the one in the first image. The switch is mounted on a metal structure and features several insulators and conductors. The signage on the switch is faded and difficult to read. The background shows a clear sky and some industrial structures.

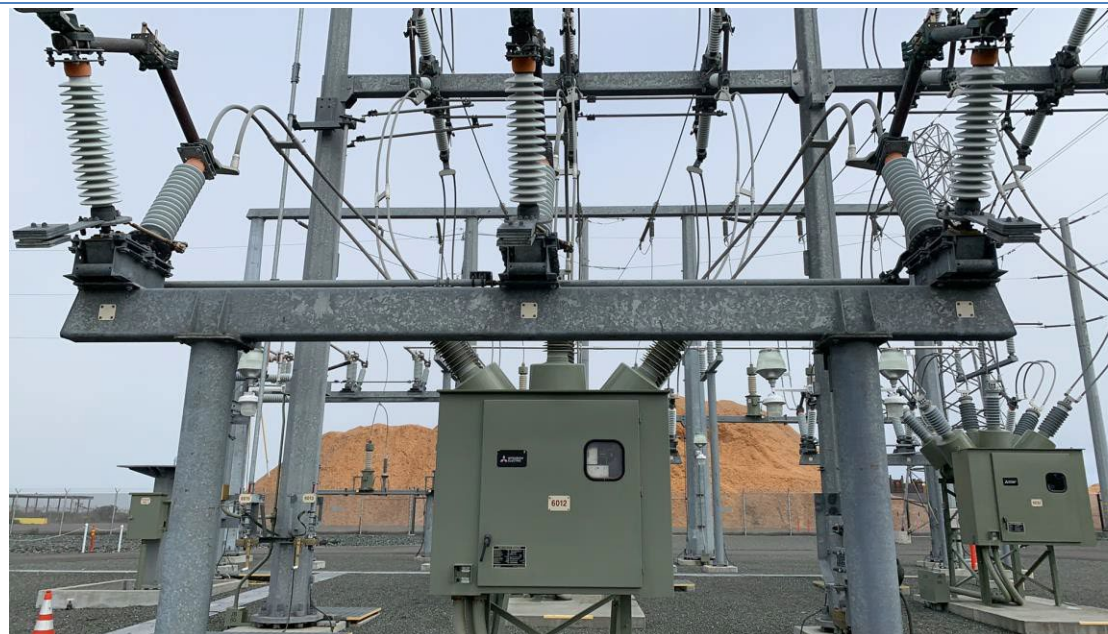
20 6043 switch signs are faded.

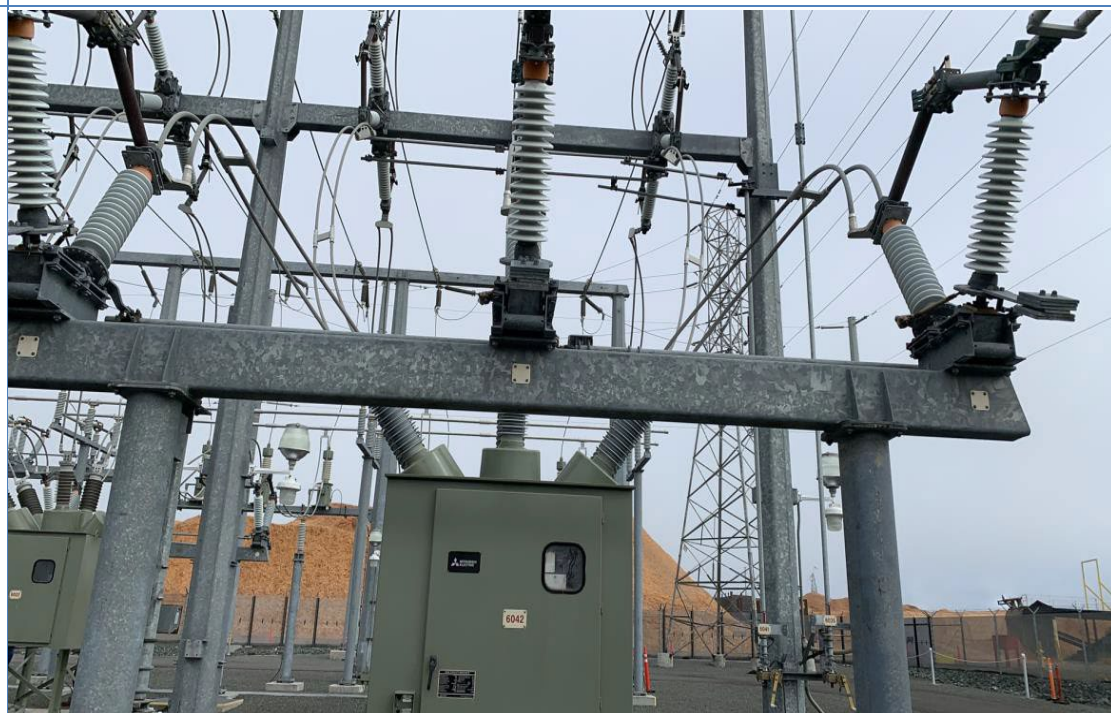
21 Transformer #1 phase-C potential transformer is rusting.

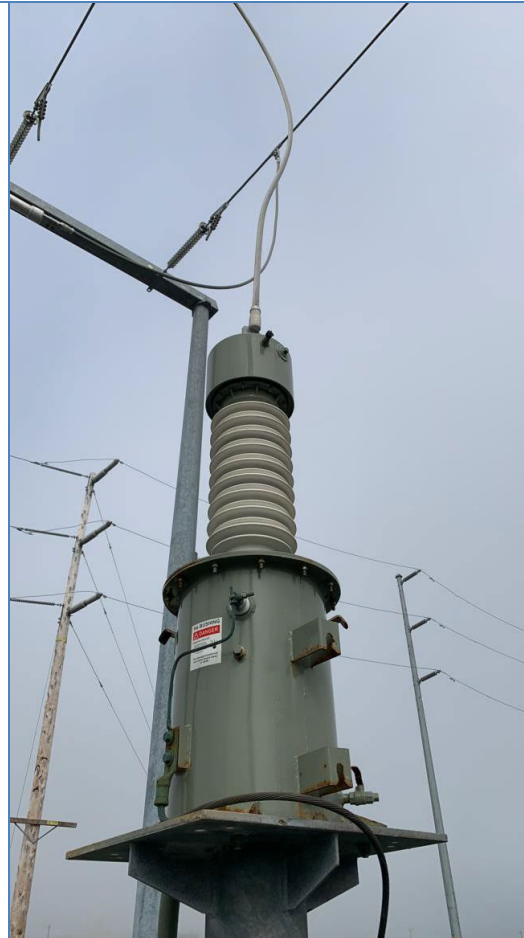
22 There is rust on Transformer 1. There is an existing tag #127135562.

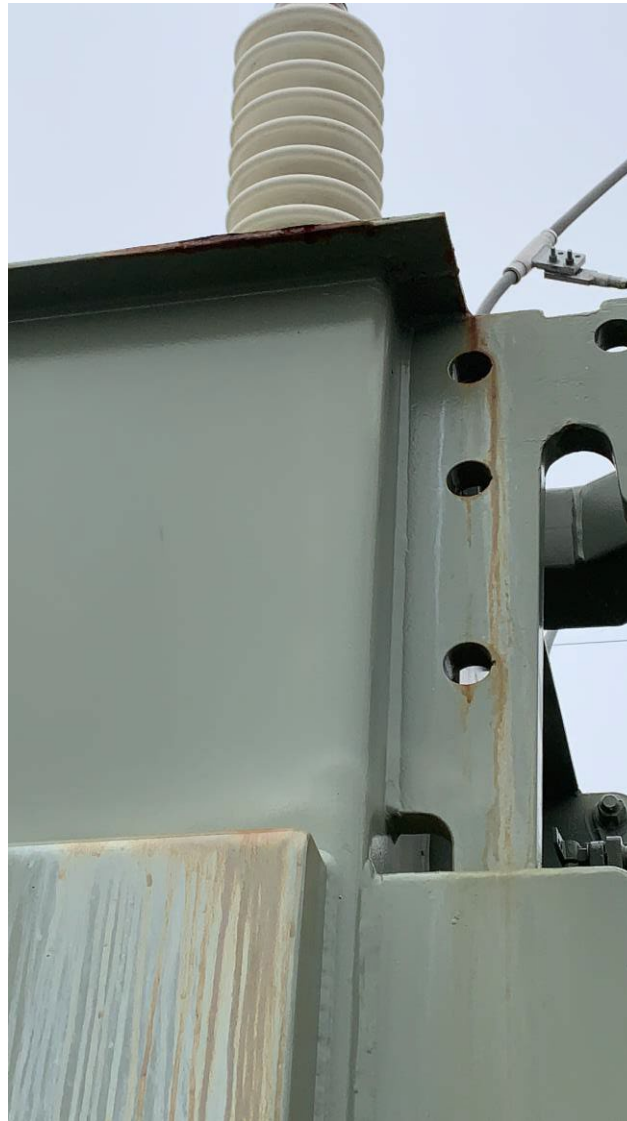
<p>23 CB1103 signs are rusted over. PG&E has an existing tag for all the rusted signs.</p> <p>PG&E Response: We agree with the finding that the signage is rusted on CB1103 at Fairhaven Substation. We created priority E bundled notification 127294346 and added it to the workplan. We will complete the work based on current work prioritization and material availability.</p>

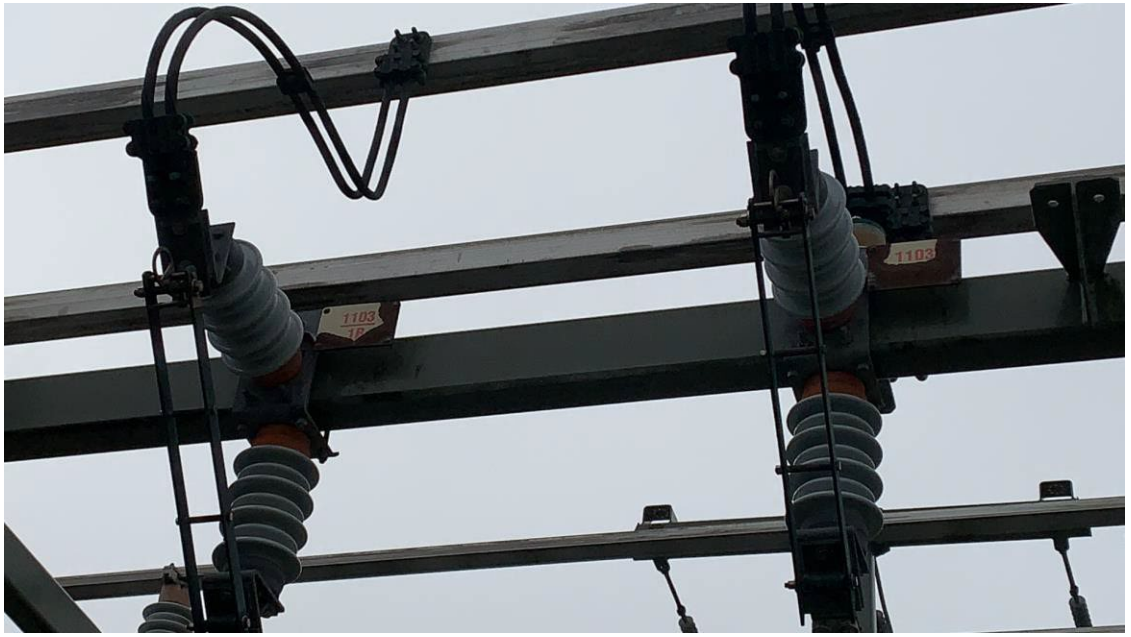
A close-up photograph of electrical equipment at Fairhaven Substation. The image shows several horizontal metal cross-arms supported by vertical insulators. Two signs are visible, one labeled '1103' and another labeled '1105'. The signs appear to be made of metal and show signs of rust. The background is a clear, light sky.
<p>24 Reg 1 has rusted signs. PG&E has an existing tag for those signs.</p> <p>PG&E Response: We agree with the finding that the signage is rusted on Reg 1 at Fairhaven Substation. We created priority E bundled notification 127294346 and added it to the workplan. We will complete the work based on current work prioritization and material availability.</p>

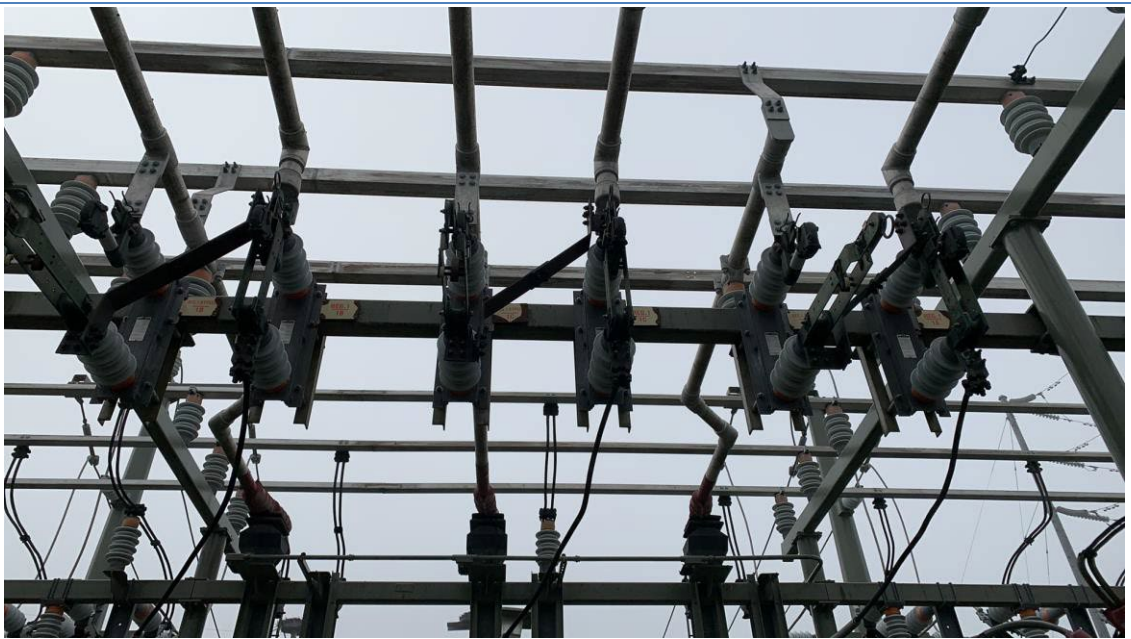
A wide-angle photograph of electrical equipment at Fairhaven Substation. The image shows a complex arrangement of metal cross-arms, insulators, and electrical components. Several signs are visible, some of which appear to be rusted. The background is a clear, light sky.

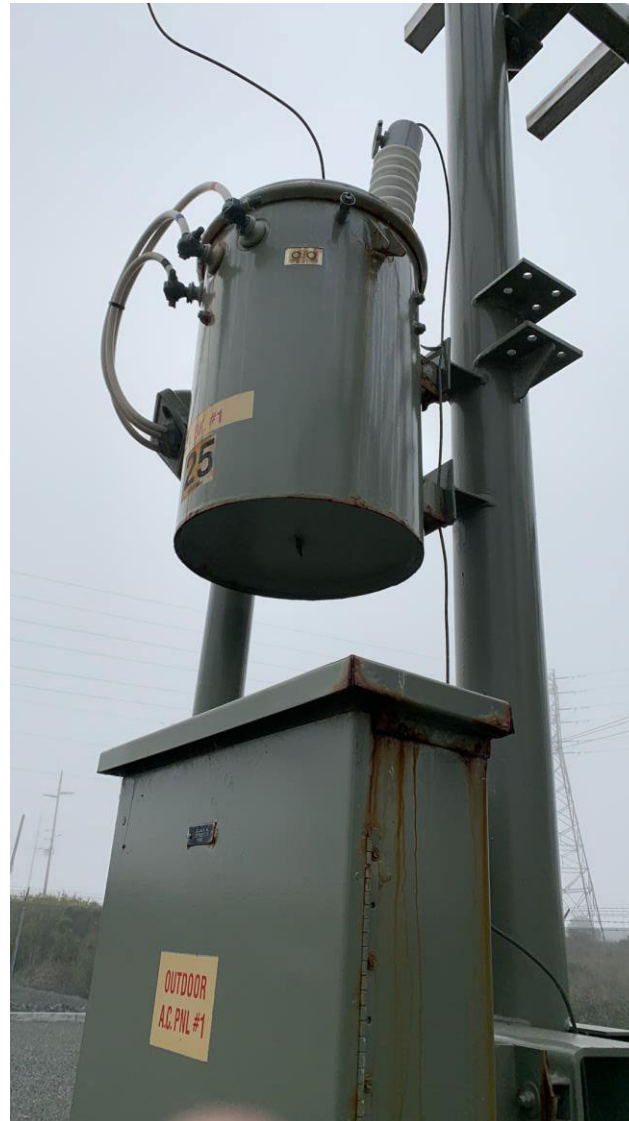
26 Potential transformer at 1103 PT 1C has damage. PG&E stated that there is already a capital work order.

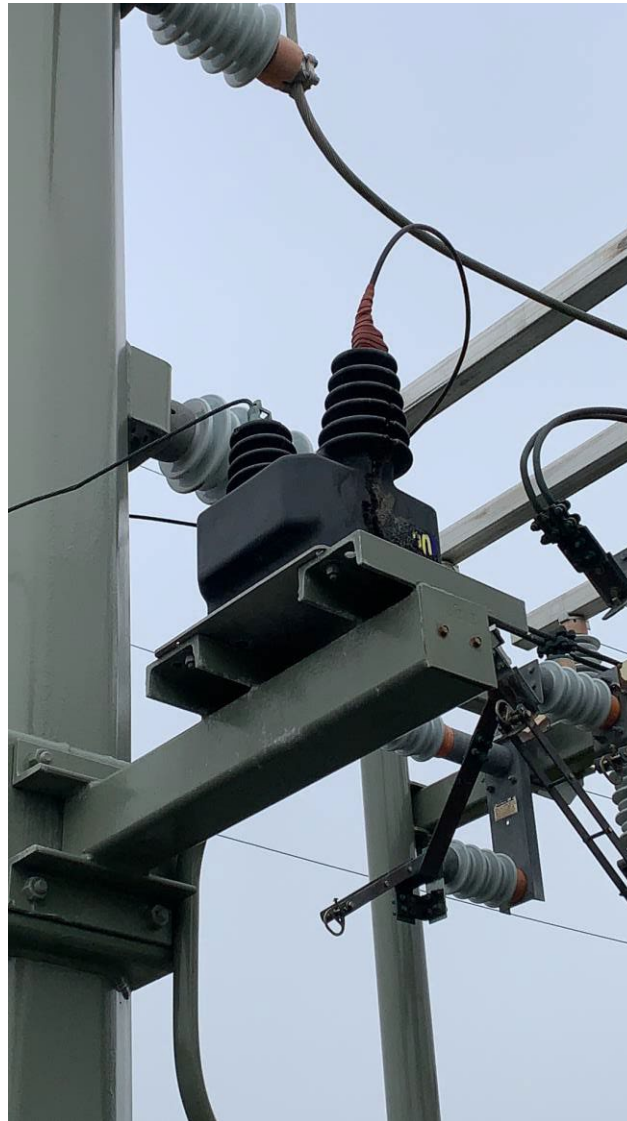
27 Potential transformer at 1104PT 1C is damaged. There is an existing capital project #122507600.

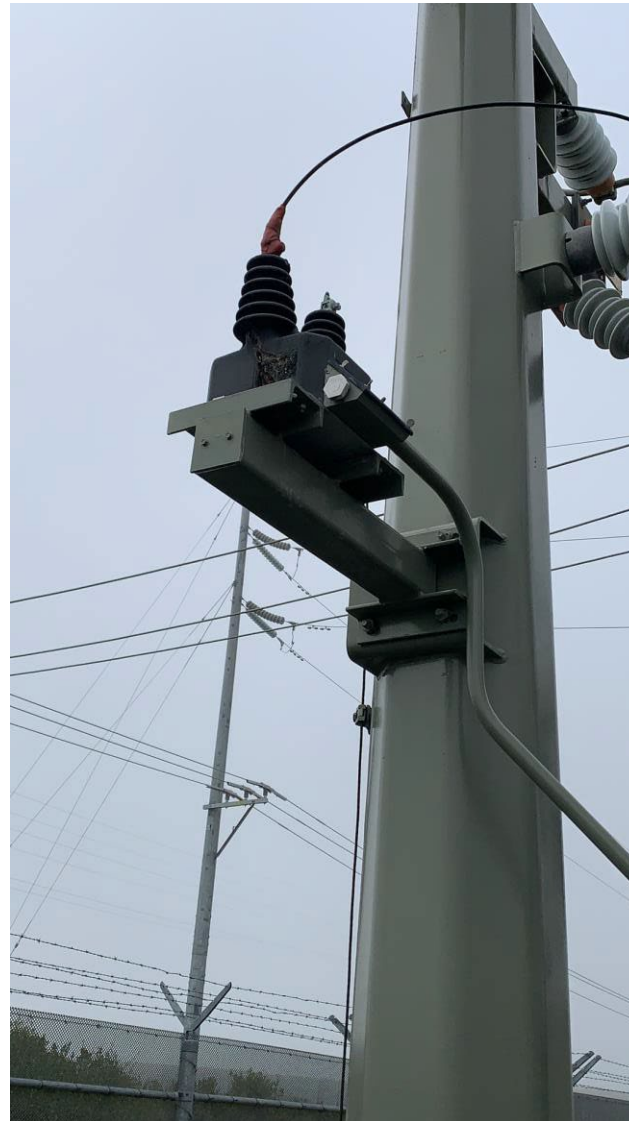
Violation #	Violation Description	Image
28	<p>There is an oil leak at Reg 1 by the top oil gauge. There is an existing tag #127140063.</p> <p>PG&E Response: We agree with the finding that the oil leak on Reg 1 at Blue Lake Substation. However, we inadvertently provided ESRB the incorrect notification. This work will be performed on priority a B notification 128045416 and has been added it to the workplan. We will complete the work based on current work prioritization and material availability.</p>

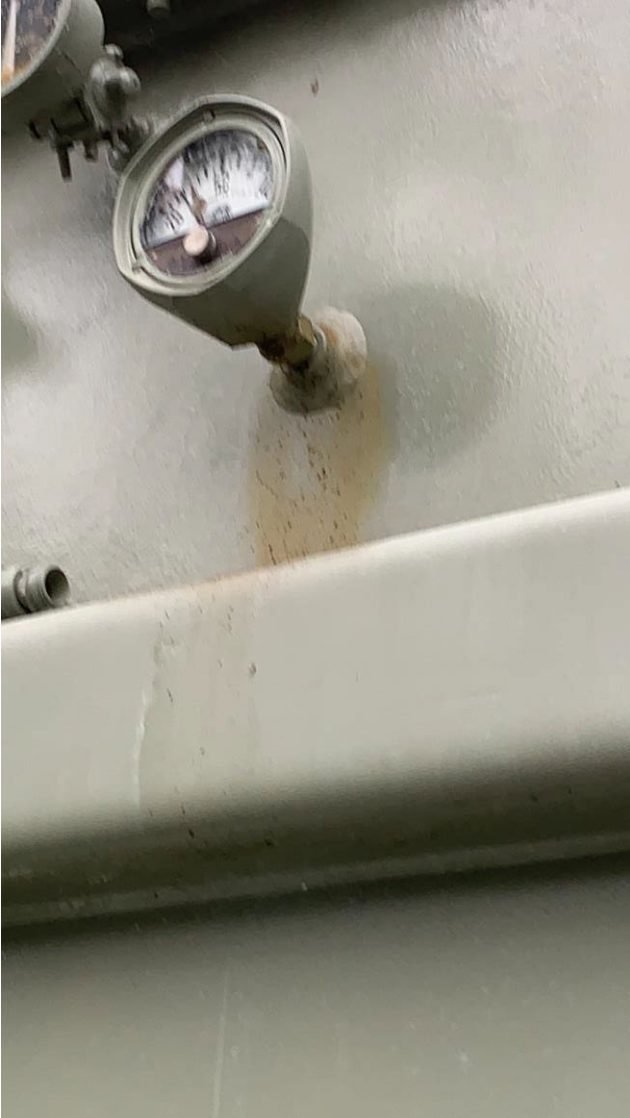
A close-up photograph of a white oil gauge mounted on a grey metal surface. The gauge has a circular window with a needle and a red oil level indicator. Below the gauge, there is a significant yellowish-brown stain on the metal surface, indicating an oil leak. The background shows other parts of the equipment.

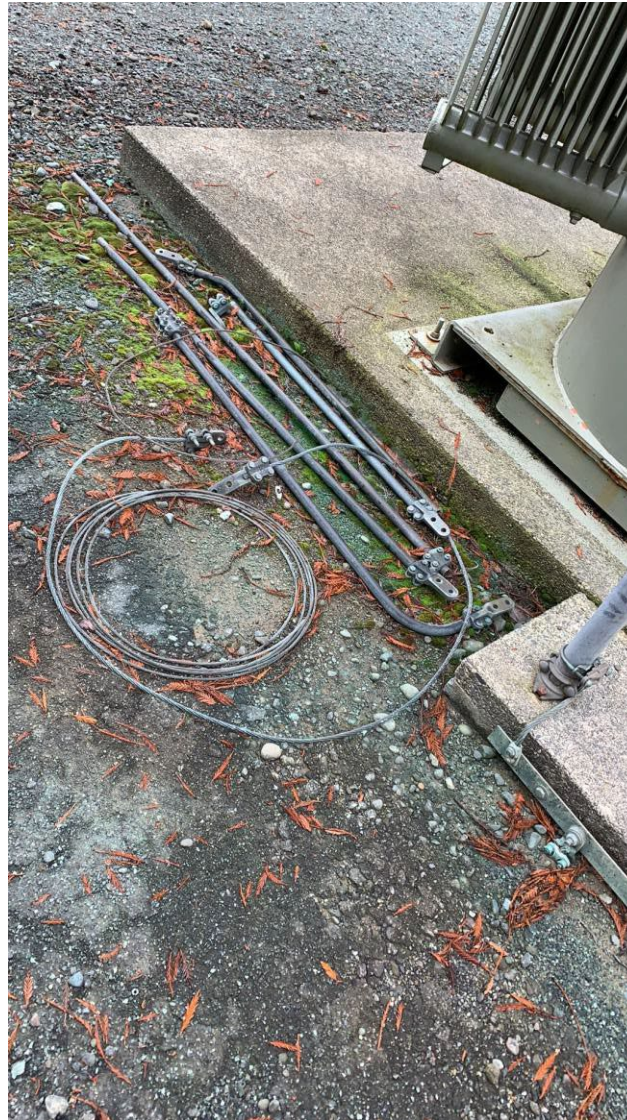
30 There is corrosion on the frame by MET POT phases A, B, and C.

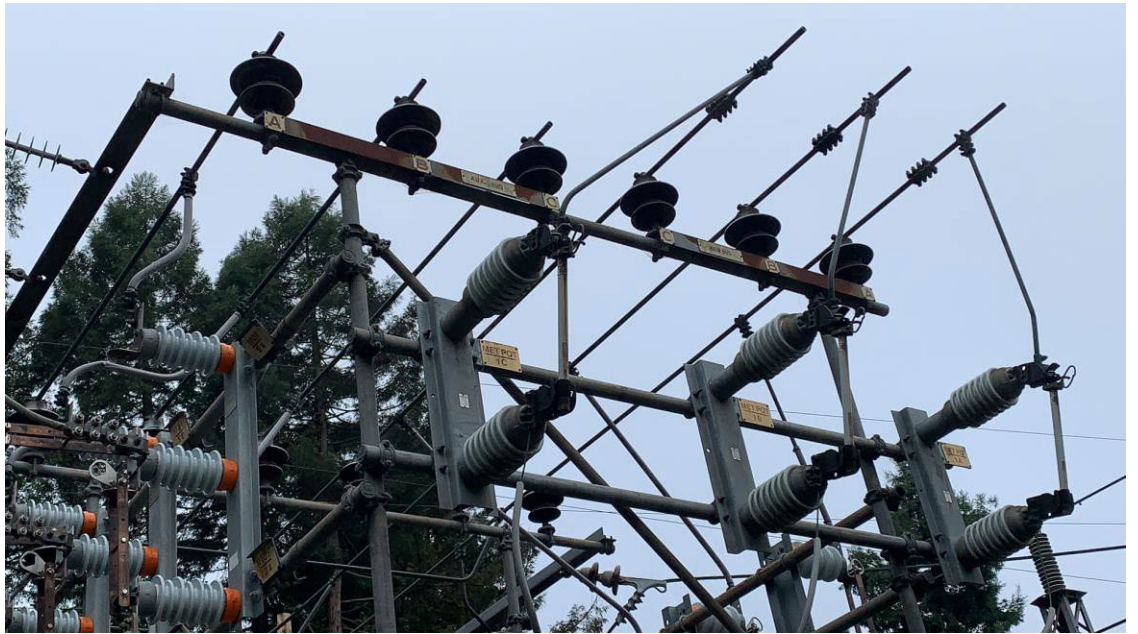
31 The insulators by MET POT 1A,1B, and 1C are contaminated. There is an existing tag #127140060.

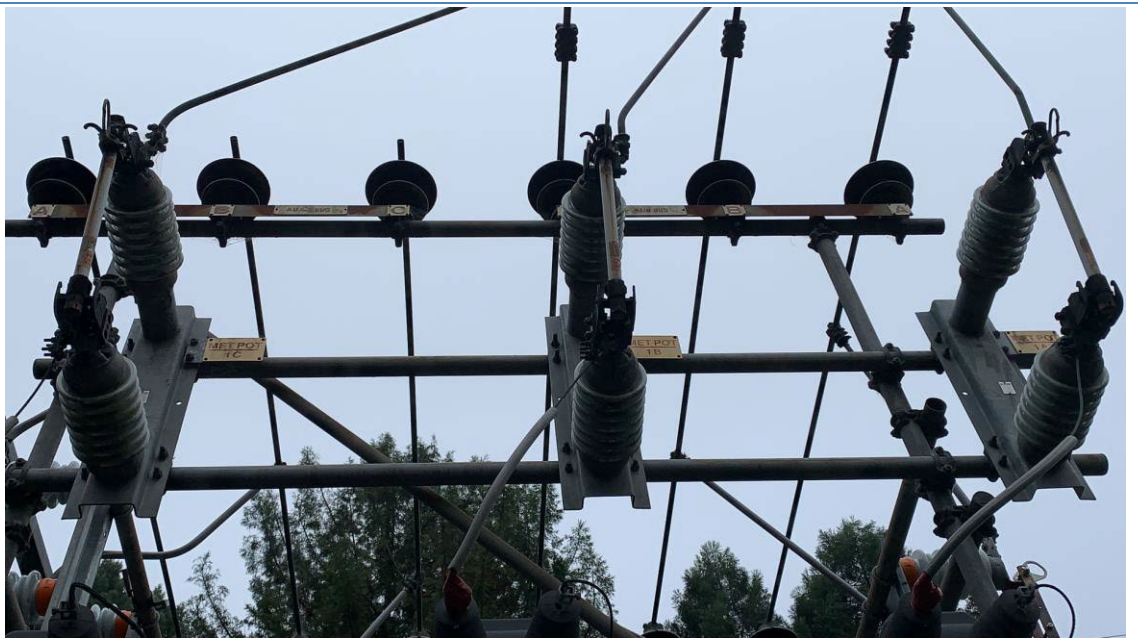
32 There is paint flaking off spare bank 1.

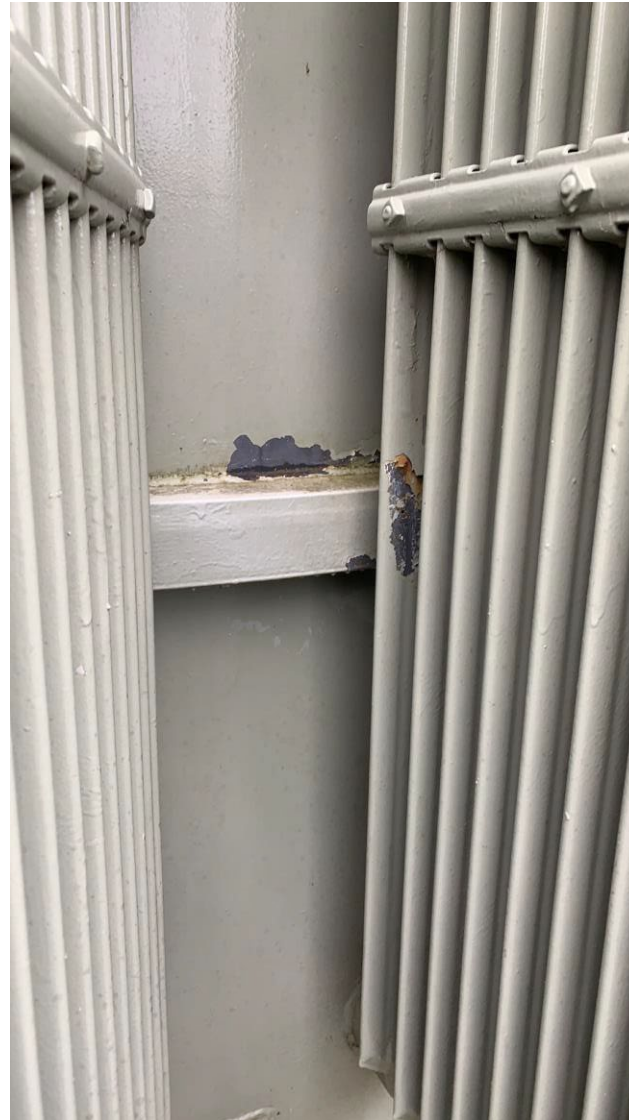
Violation #	Violation Description	Image
33	<p>The top nitrogen gauge for spare bank 1 transformer is illegible.</p> <p>PG&E Response: We agree that the top nitrogen gauge for the spare bank 1 transformer is illegible at Willow Creek Substation, but do not agree that the finding qualifies as a violation of GO 174, Rule 12. The nitrogen is read by the gauge in the lower nitrogen cabinet, or the electrician would use a calibrated portable gauge. This top nitrogen gauge is installed by the manufacturer and is an unsafe location that could potentially cause harm should an electrician need to read it, so it is not utilized.</p>

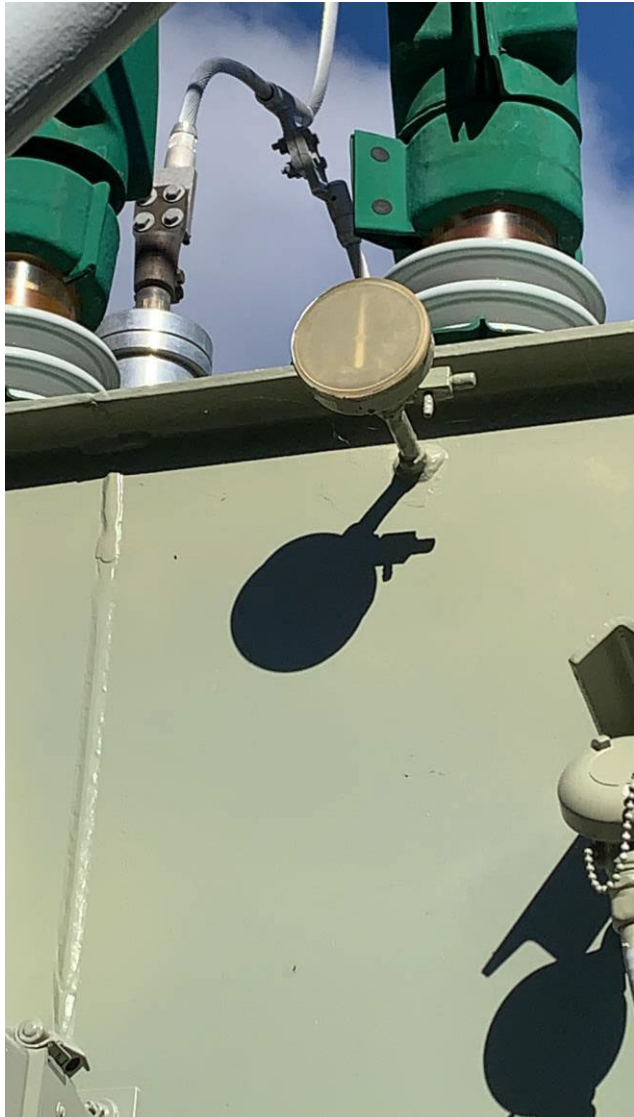
34 The nitrogen gauge at top of C phase bank 1 transformer is illegible.

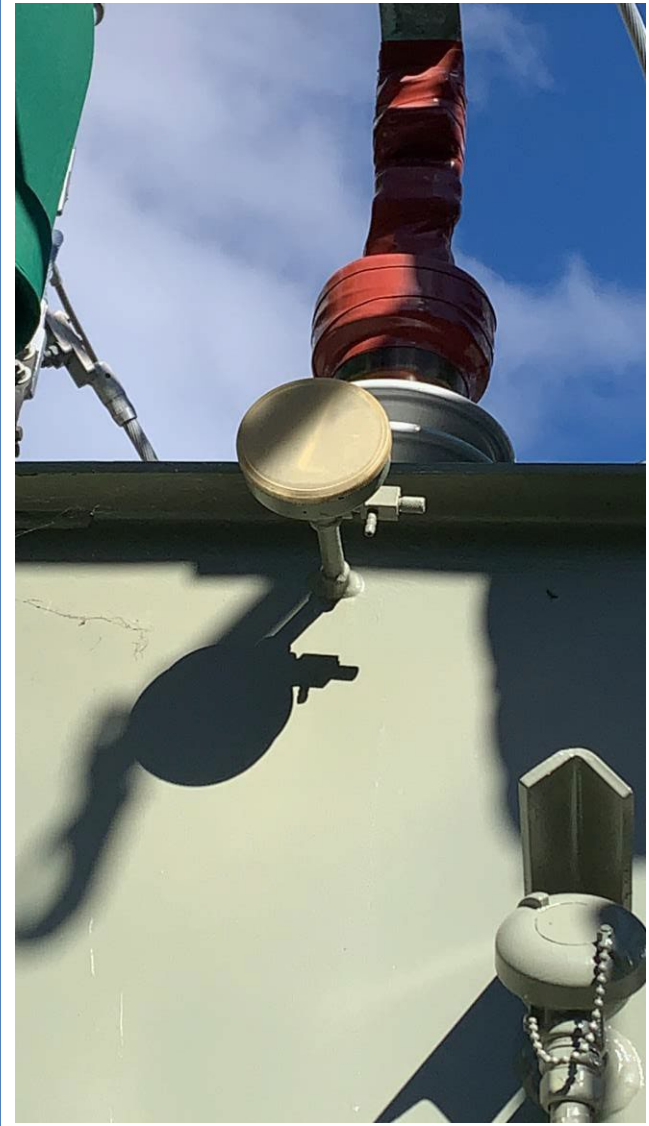
35 Top pressure gauge at B phase bank 1 transformer is illegible.
