CPUC SUBSTATION AUDIT
FINDINGS PG&E Eureka
Headquarters October 16 –
October 20, 2023

I. Records Review

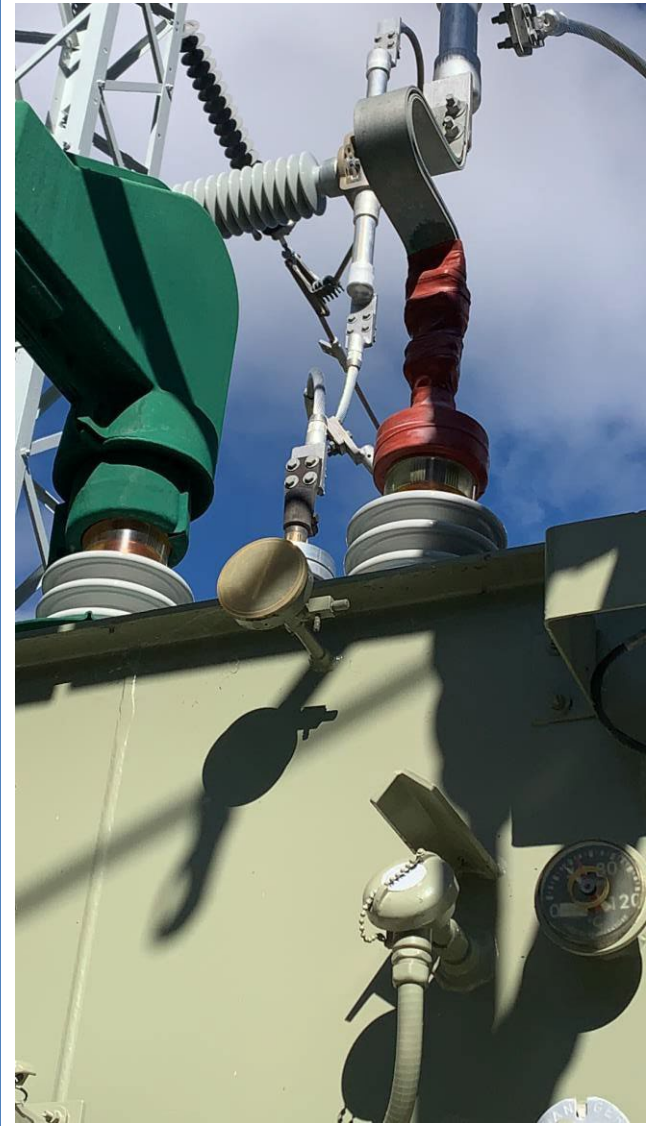
36 Nitrogen gauge at top of phase a bank1 transformer is illegible.

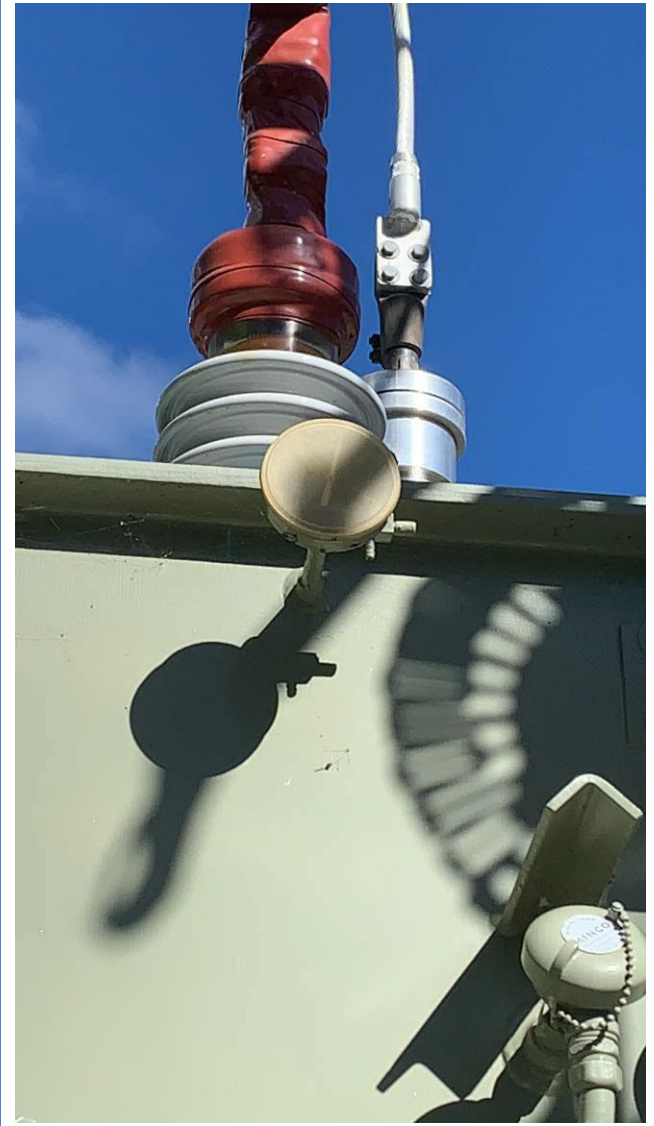
Violation #	Violation Description	Image
37	<p>The footing at switch 43 is rusting.</p> <p>PG&E Response: We agree with the finding that there is rust on the footing on switch 43 at Maple Creek Substation. We created priority B notification 127473741. We completed the work on 12/12/23.</p>

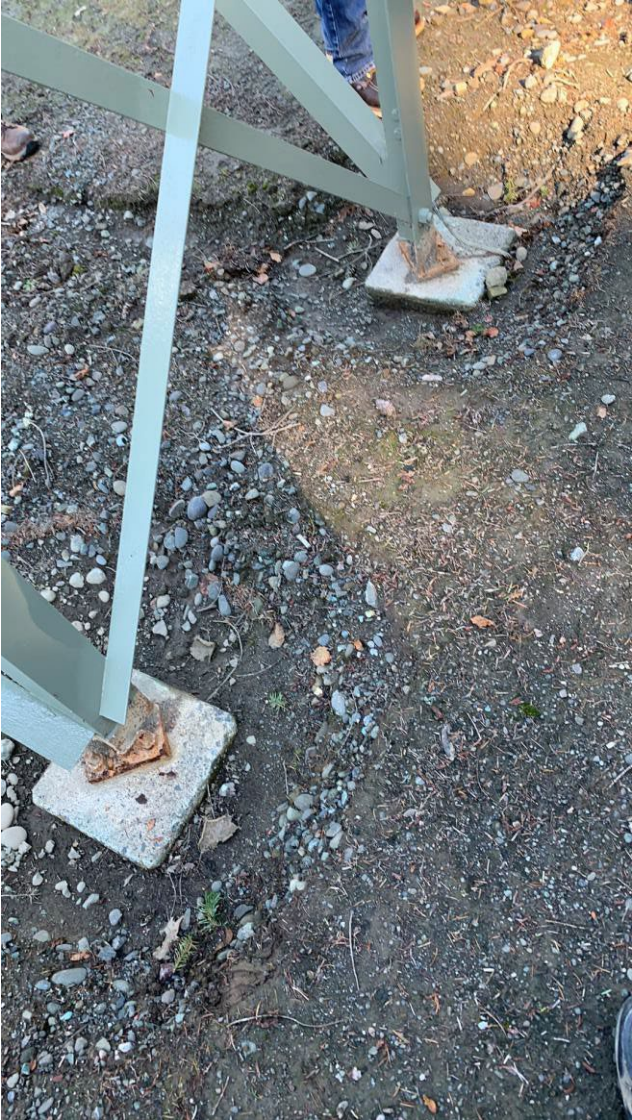
A photograph showing a close-up of a metal structure's footing. The metal beam is painted a light blue or grey color. It is mounted on a square concrete footing. The area where the metal meets the concrete is heavily corroded, with a thick, brown, flaky layer of rust. The ground around the footing is dark, damp soil with some small rocks and debris. In the background, another similar metal structure is visible, and a person's leg in blue jeans is partially seen.

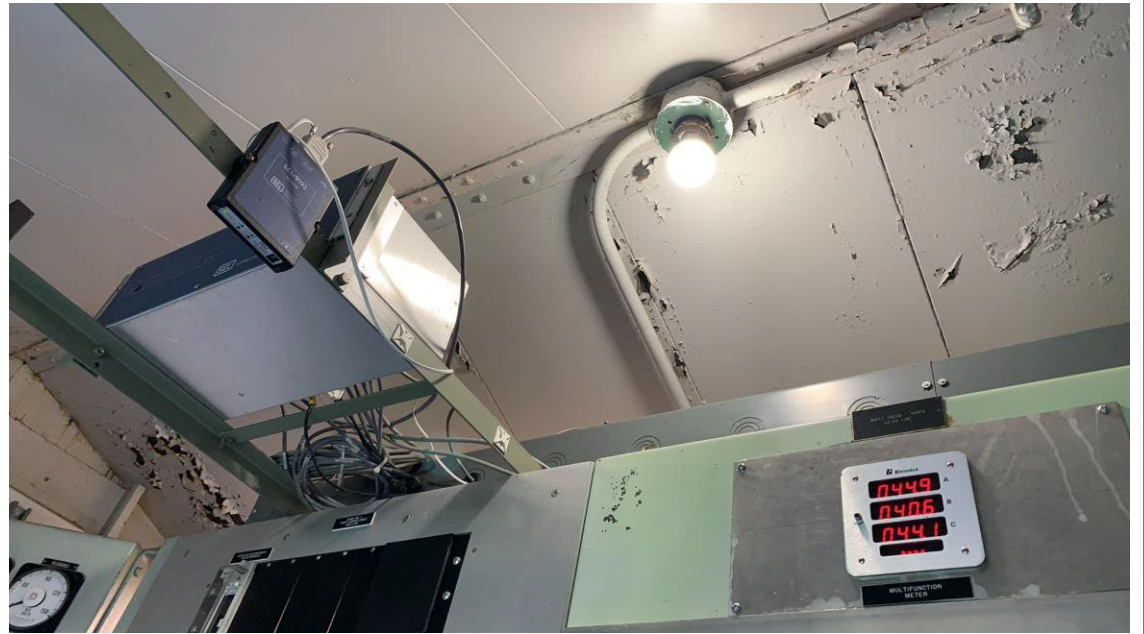
Fort Seward Substation

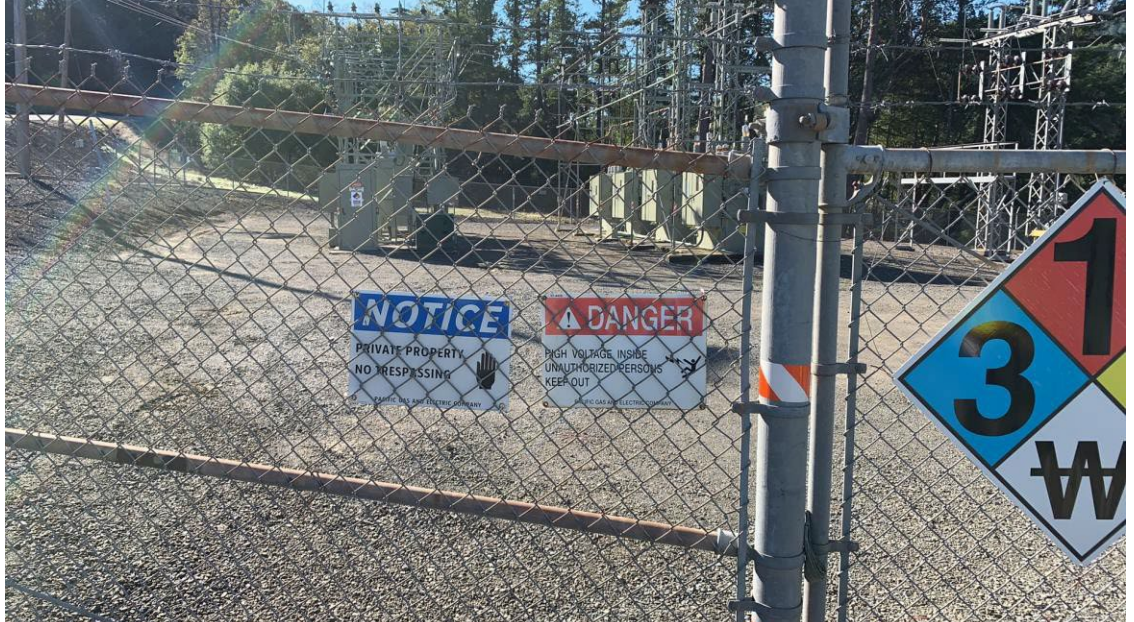
41 There is spare conductor kept inside the frame of a support structure.

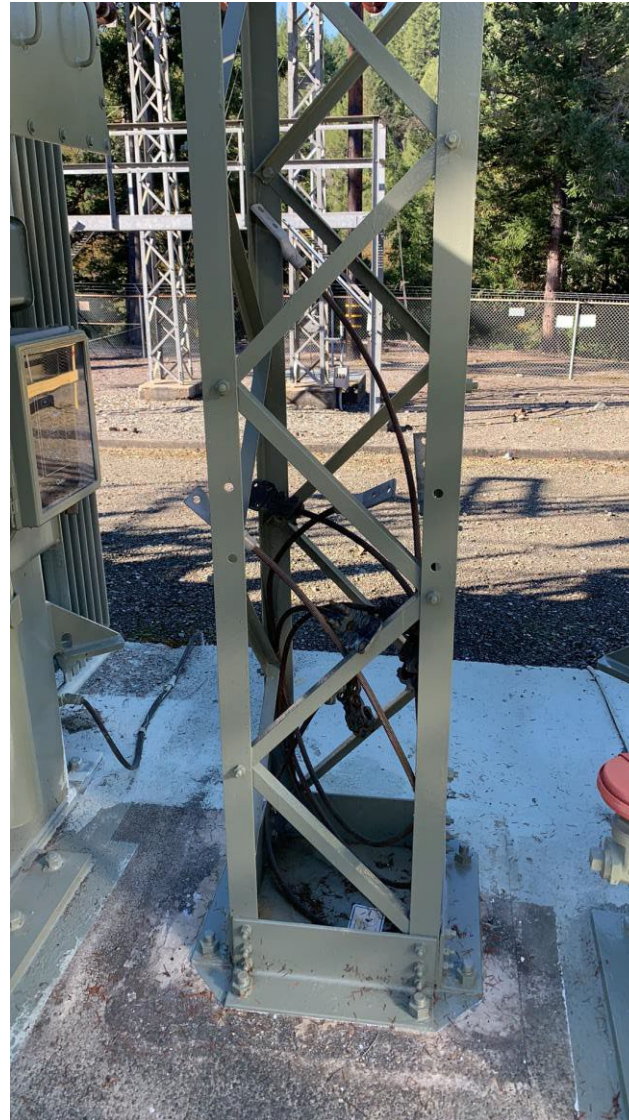
Garberville Substation

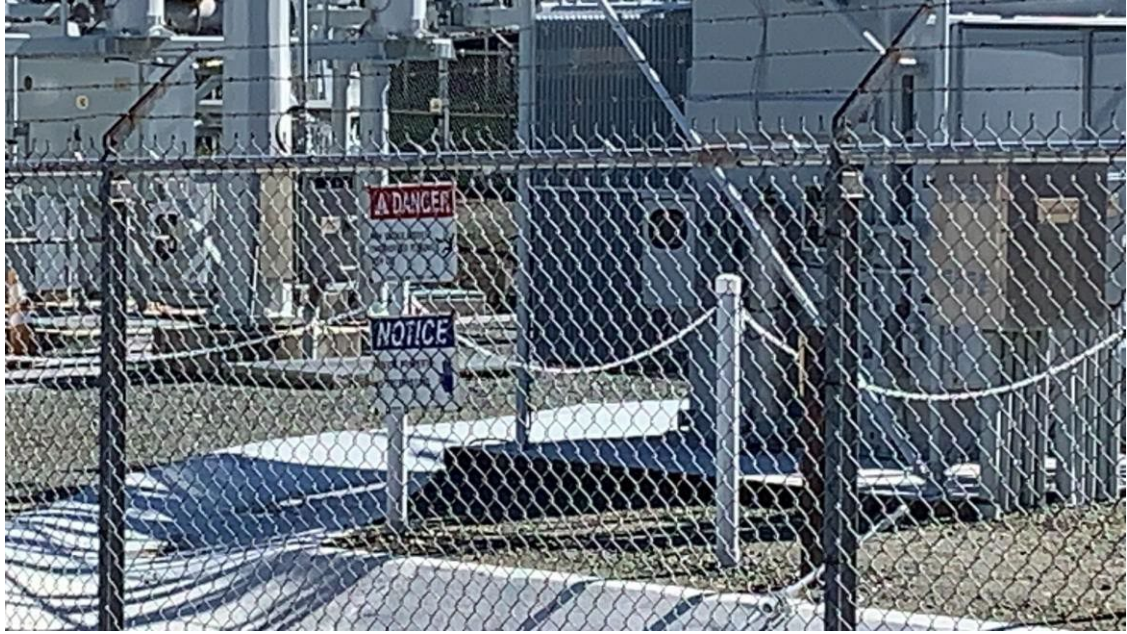
44 There is a second instance of batteries missing caps.

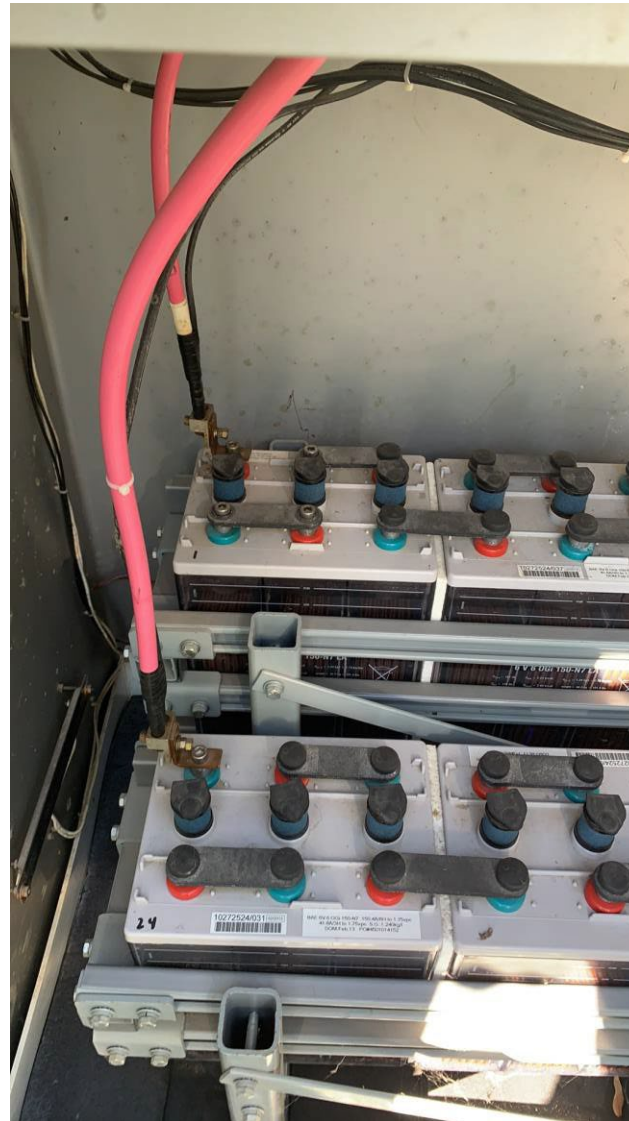
Violation #	Violation Description	Image
45	<p data-bbox="310 219 1083 251">There is a bolt broken off of the back panel of the regulator.</p> <p data-bbox="310 305 1234 568">PG&E Response: We agree with the finding of a broken bolt at the Regulator at Fruitland Substation, but do not agree that the finding qualifies as a violation of GO 174, Rule 12. Our QEW identified this issue prior to the CPUC field audit and documented it in our system of record as a priority E notification, 127132810. We will complete the work based on current work prioritization and material availability.</p>

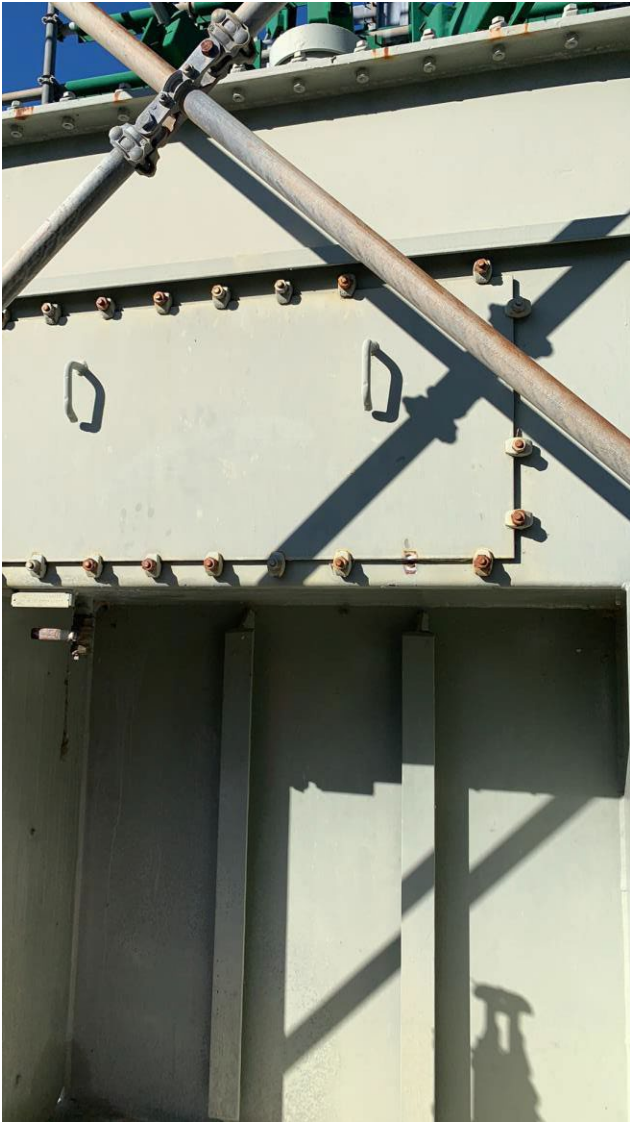
A close-up photograph of a metal regulator assembly. The image shows a grey metal panel with several bolts along its edge. A diagonal metal rod is attached to the top of the panel. One of the bolts on the right side of the panel is broken, with the head and part of the shaft missing. The background shows other parts of the substation structure under a clear sky.

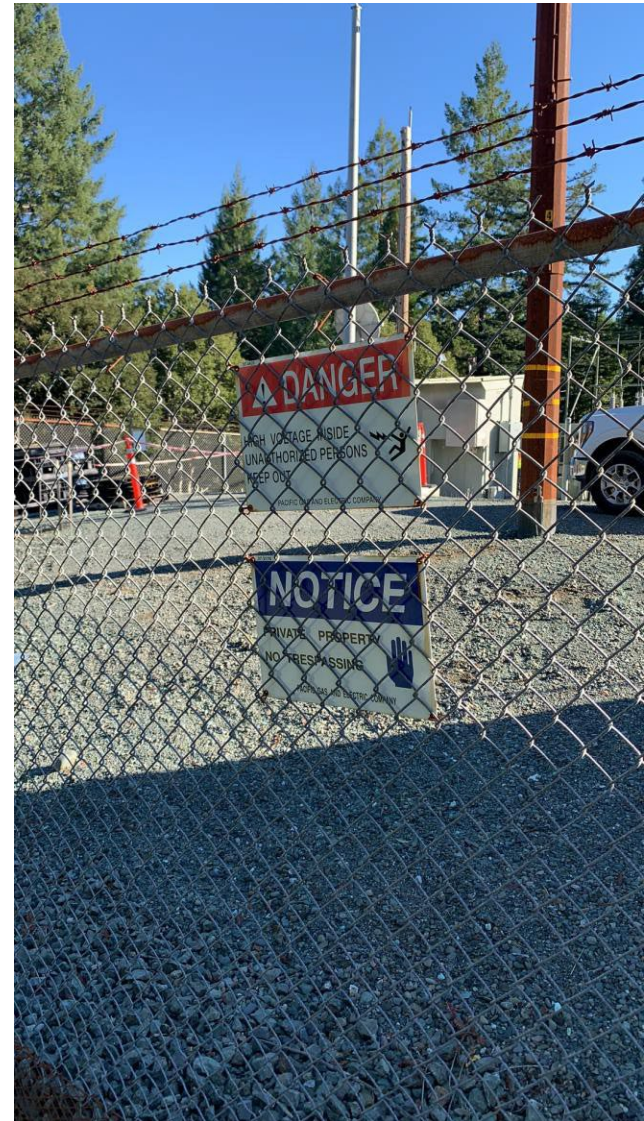
We agree with the finding the signs are on the inside of the perimeter fence at Fruitland Substation. We created priority B notification 128045441 and added it to the workplan. We will complete the work based on current work prioritization and material availability.

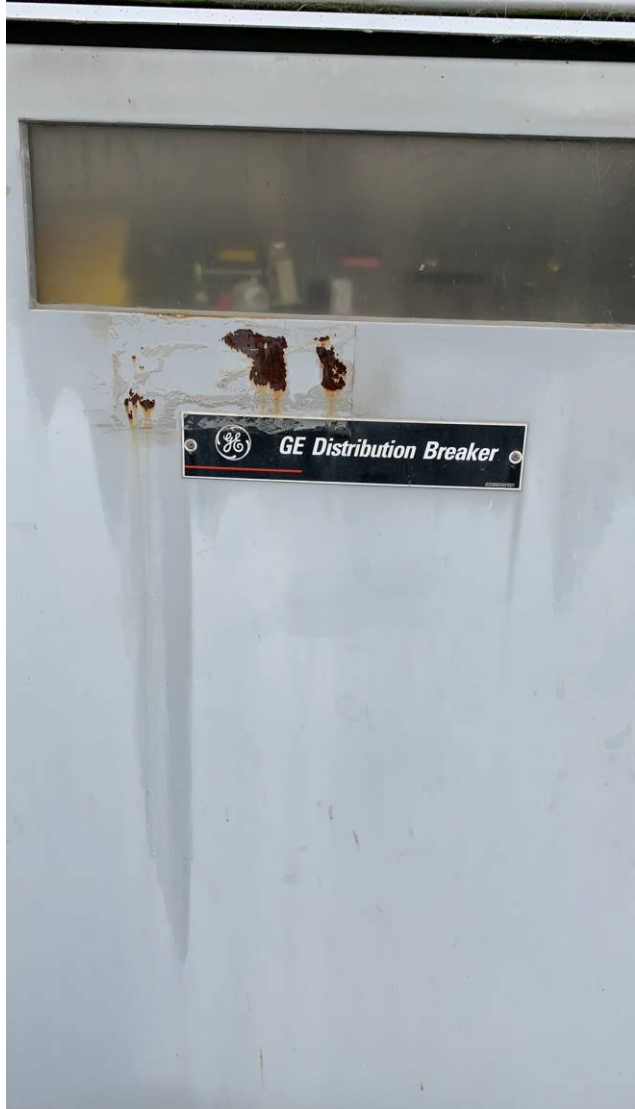
48 There is a light out at CB 1108/2. There is an existing tag #126606872

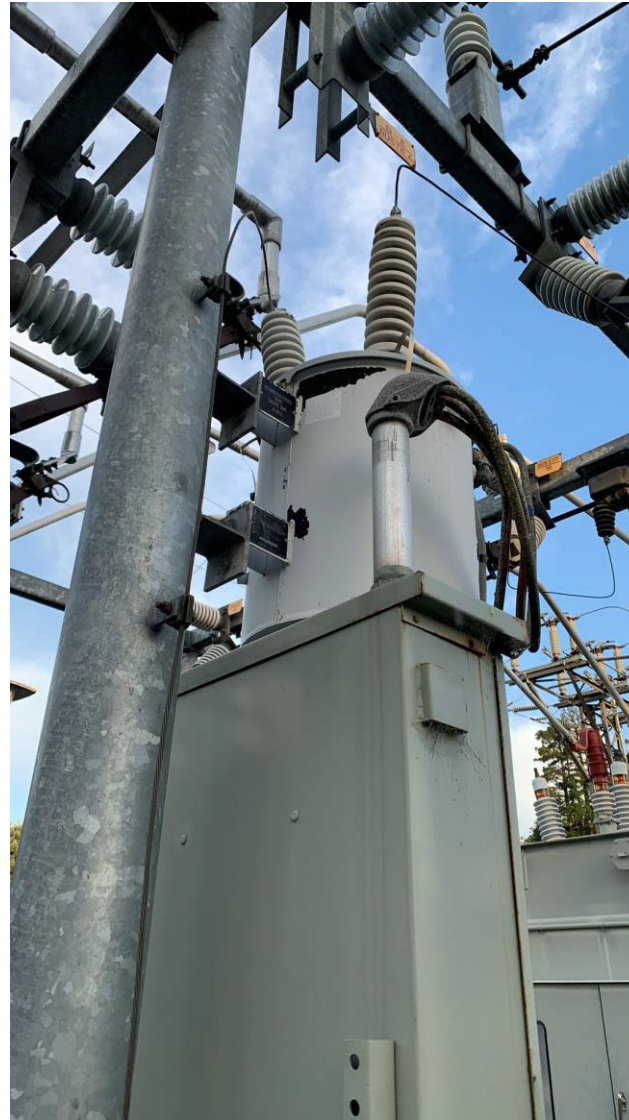
50 C phase PT has rust. There is an existing tag #126607211.

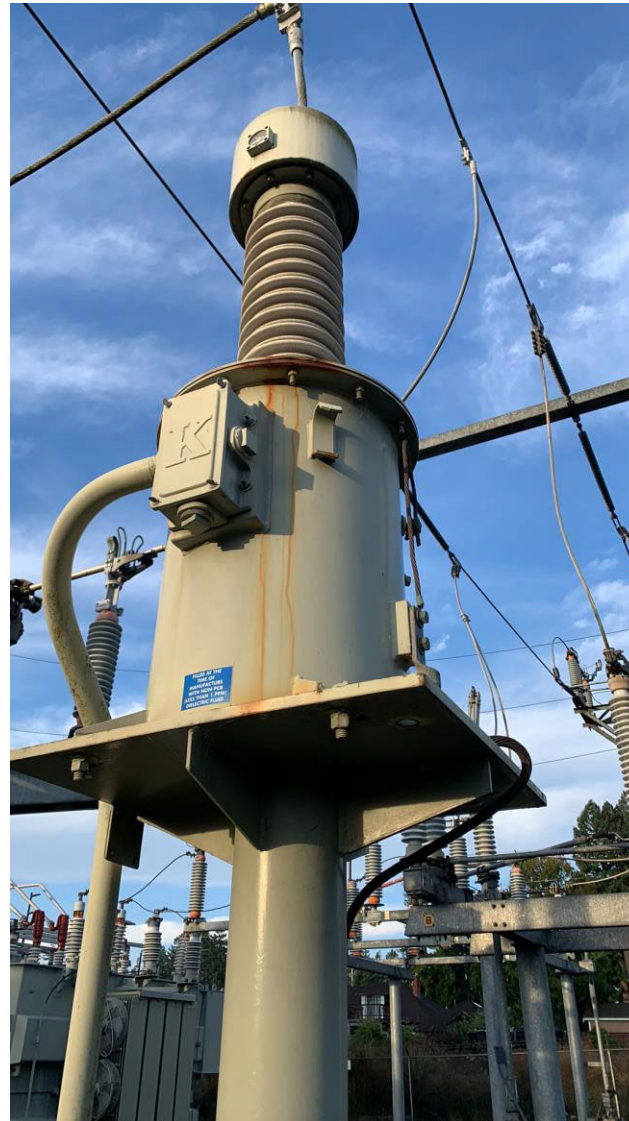
51 There is a sign on inside side of fence.
