CPUC SUBSTATION AUDIT FINDINGS
PG&E Vaca Dixon Headquarters
December 4 – 8, 2023

I. Records Review

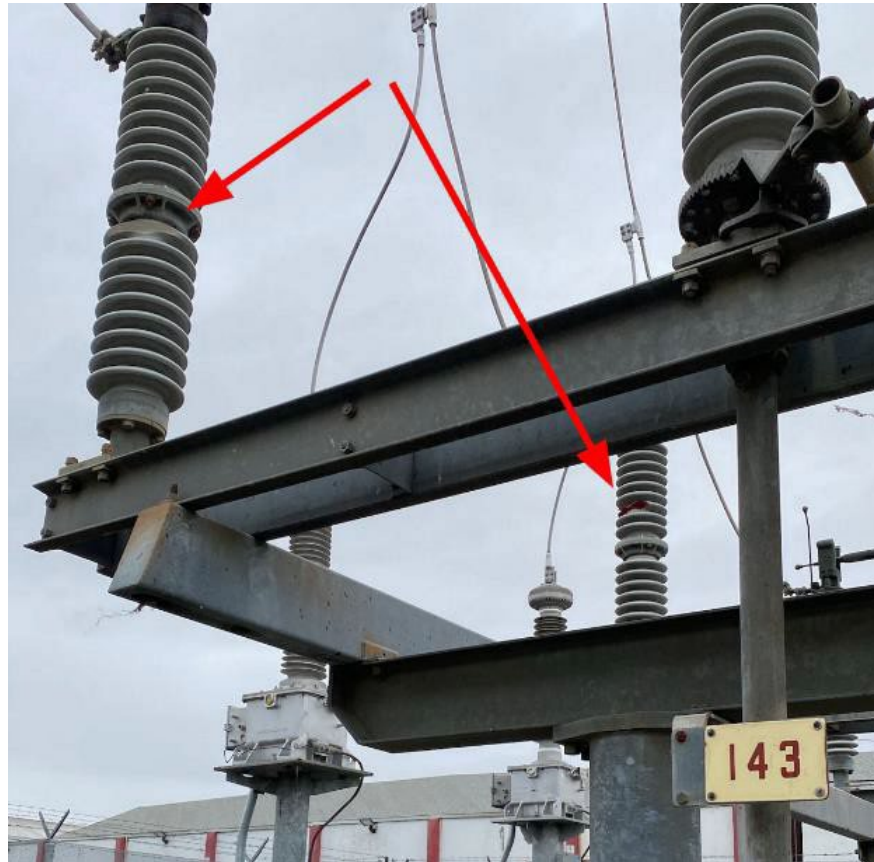
13.1. There are cracked insulator skirts on Air Switch 143. PG&E has an existing Notification #127475603 for this issue.

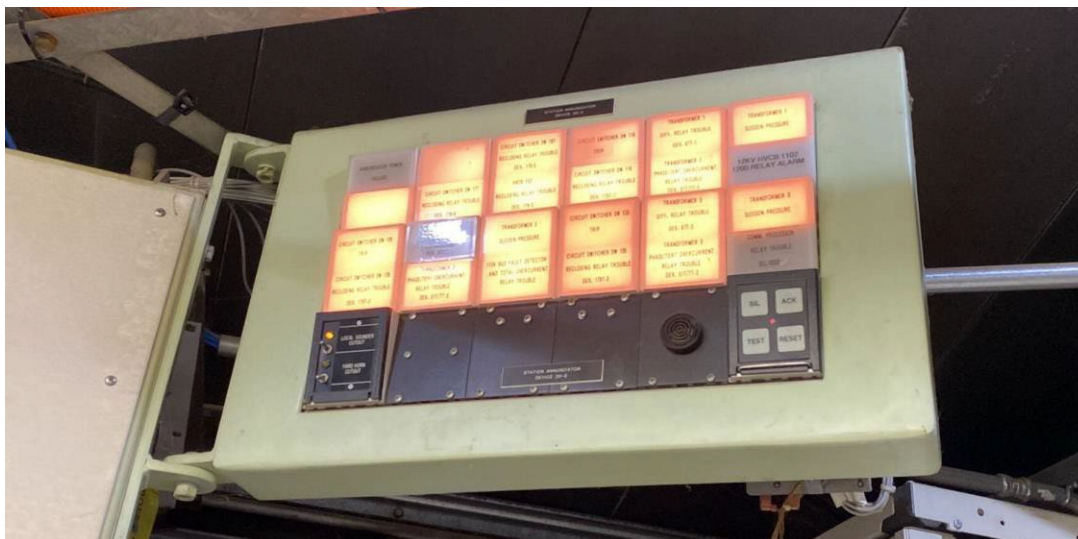
13.2. During a lamp test, ESRB observed burned out lights on the substation alarm annunciator panel.

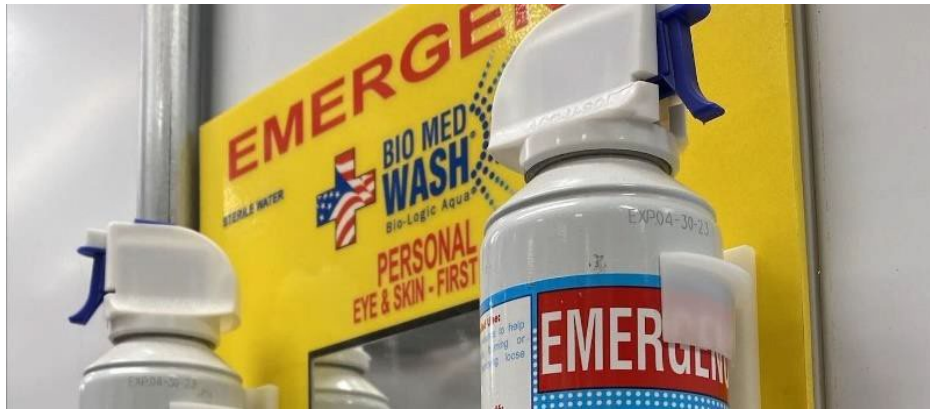
13.3.The emergency first aid solutions expired on April 30, 2023.

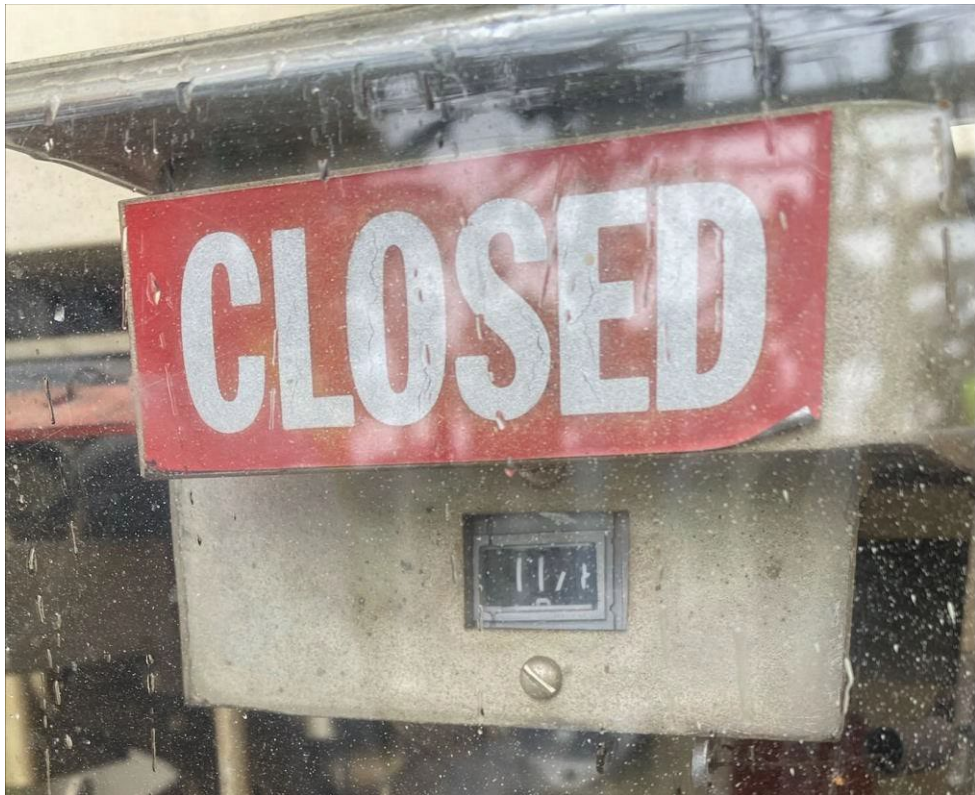
13.4.The breaker operations counter on Circuit Breaker 1100/2 is faded. PG&E has an existing Notification #127476309 for this issue.

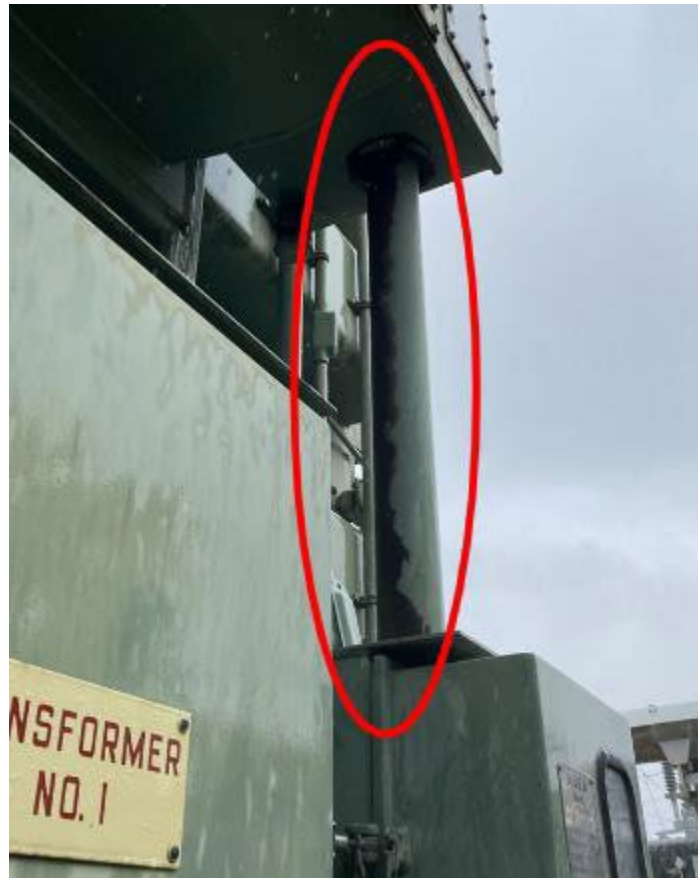
13.5. There is a leak on the Transformer Bank 1 LTC. PG&E has an existing Notification #127477505 for this issue.

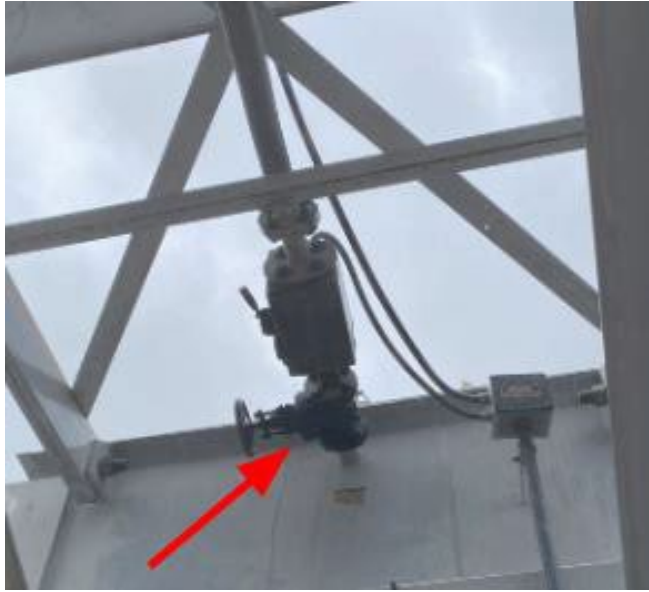
13.6. There is a leak on the flange to the oil conservator tank on Transformer Bank 2. PG&E has an existing Notification #127477501 for this issue.

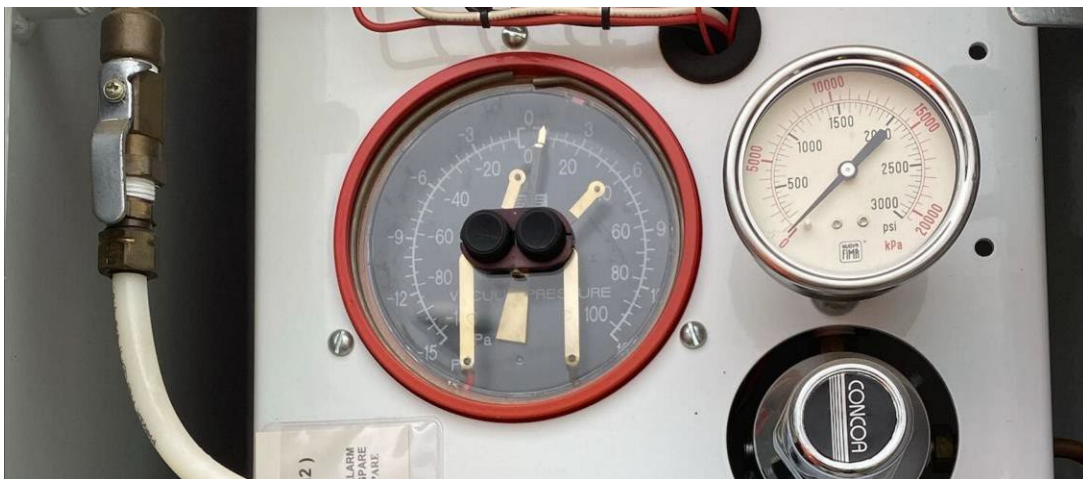
13.7. The nitrogen bottle on Transformer Bank 3 is empty. PG&E installed a new nitrogen bottle on site during the audit to correct the issue.

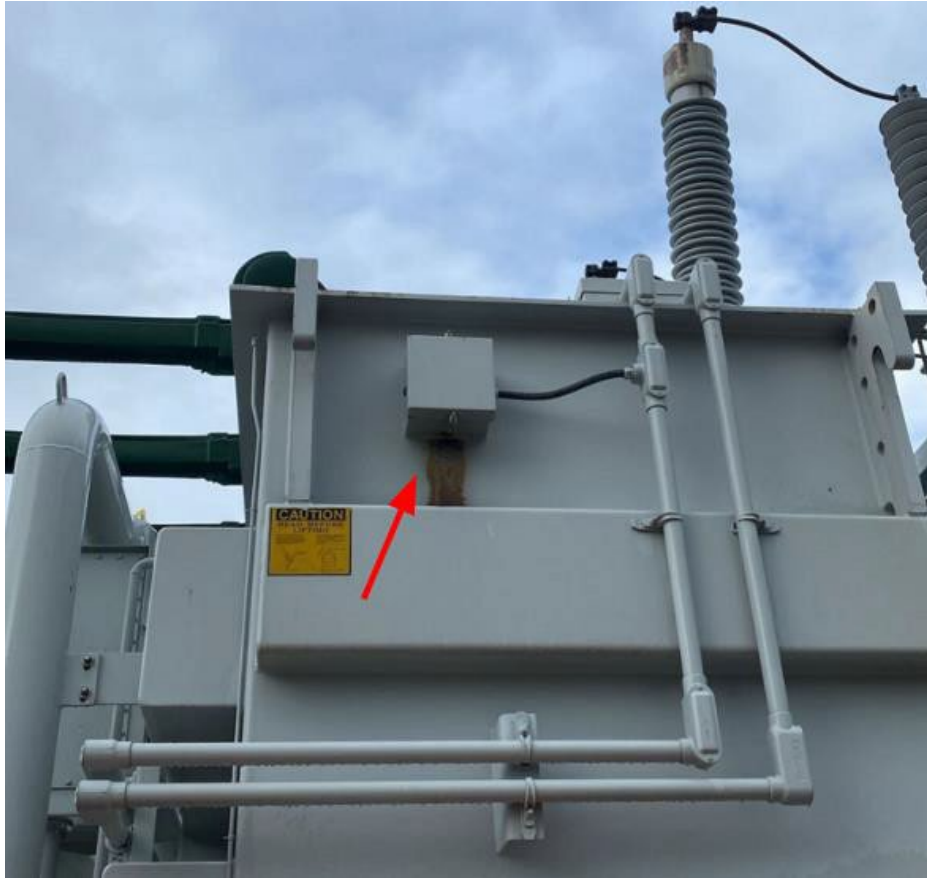
#127477504 for this issue.

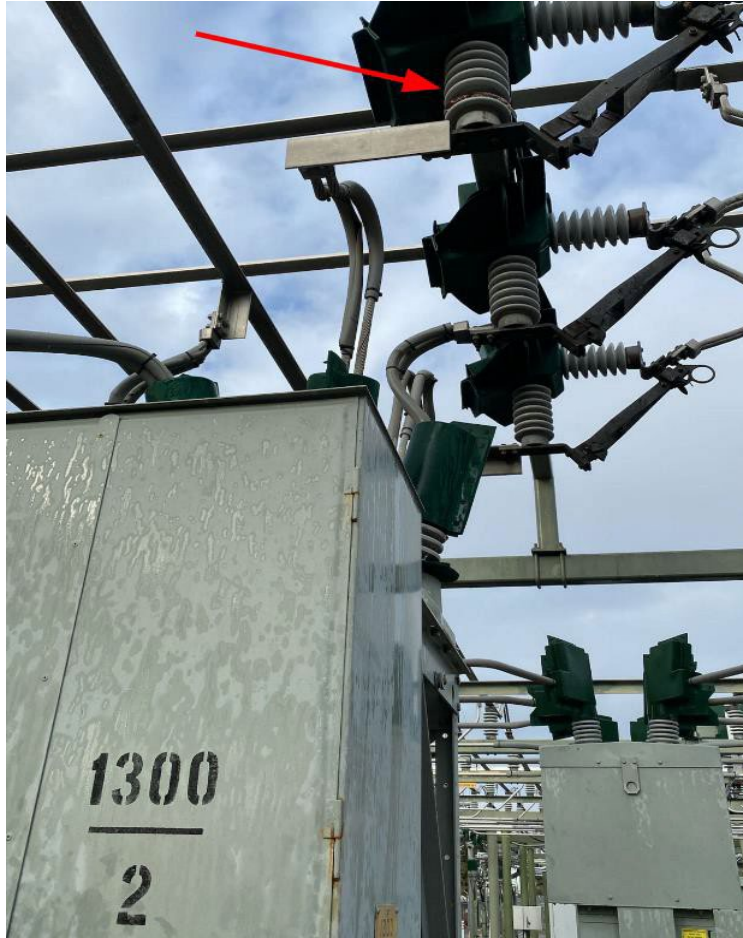
13.9.The insulator skirt on Switch 1300/1B is chipped.

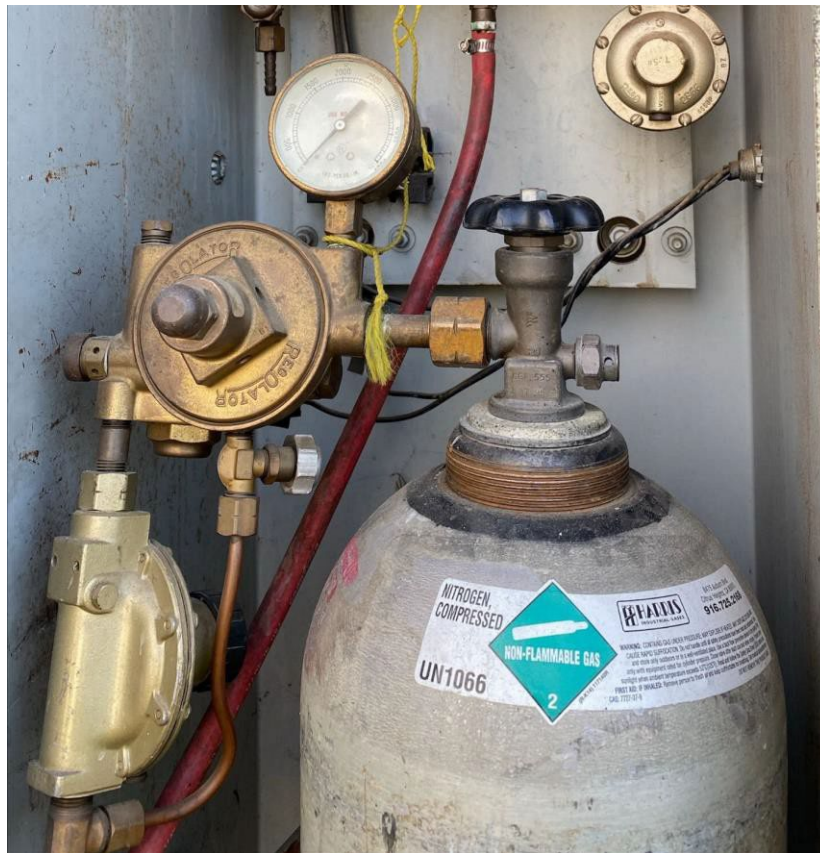
14.1. The nitrogen bottle on Transformer Bank 2 is empty. PG&E has an existing Notification #127429767 for this issue. PG&E installed a new nitrogen bottle on site during the audit to correct the issue.

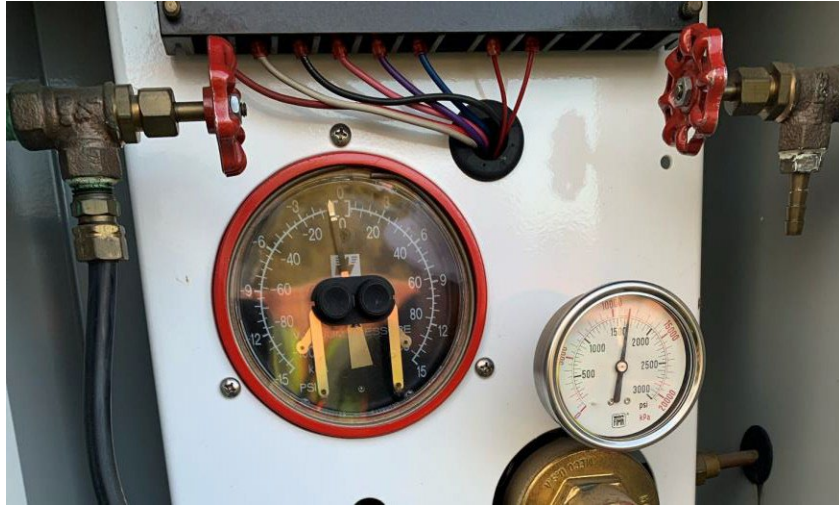
14.2. The pressure inside Transformer Bank 3 is negative. PG&E began repressurizing the transformer on site during the audit to correct the issue.

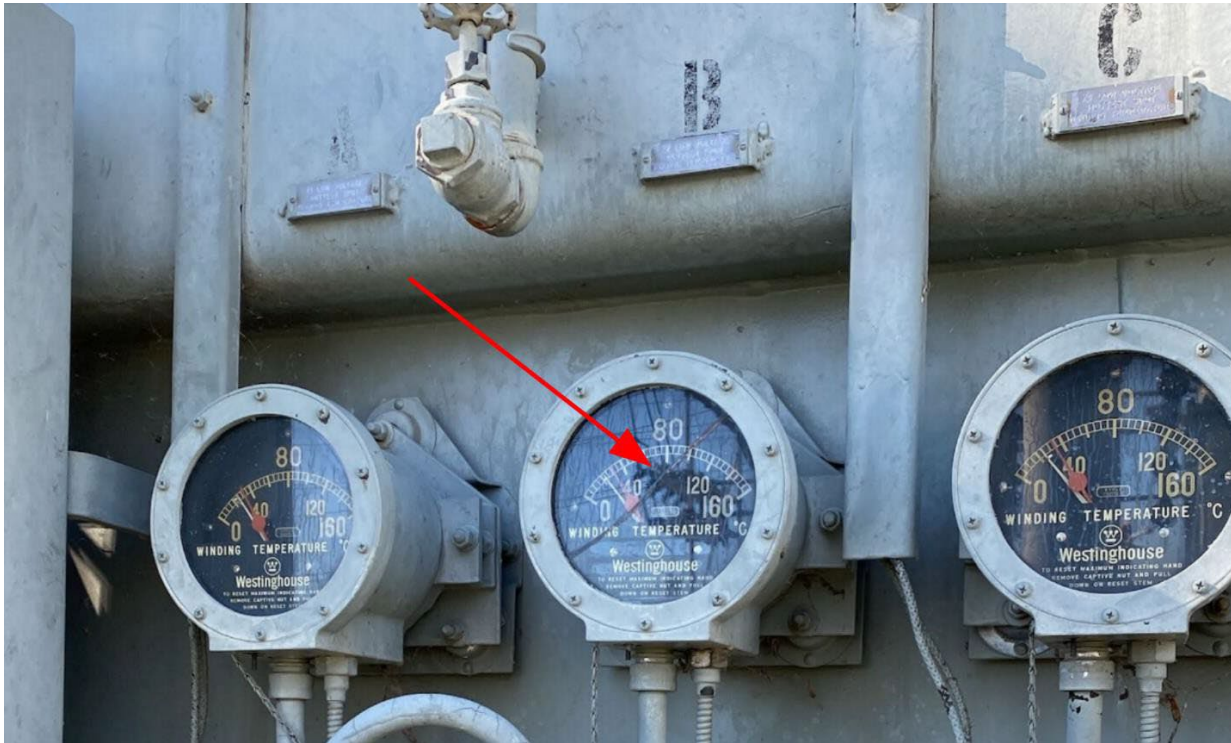
16.2. The cover on the Transformer Bank 2, B phase winding temperature gauge is cracked.
