# Site Visits Report

## Emergency Disaster Relief Program Years 2021, 2022 and 2023

### NETWORK PERFORMANCE AND PUBLIC SAFETY

Communications Service Providers Network Resiliency Requirements in Tier 2 and 3 High Fire Threat Districts pursuant to Decisions (D.) 20-07-011 and (D.) 21-02-029

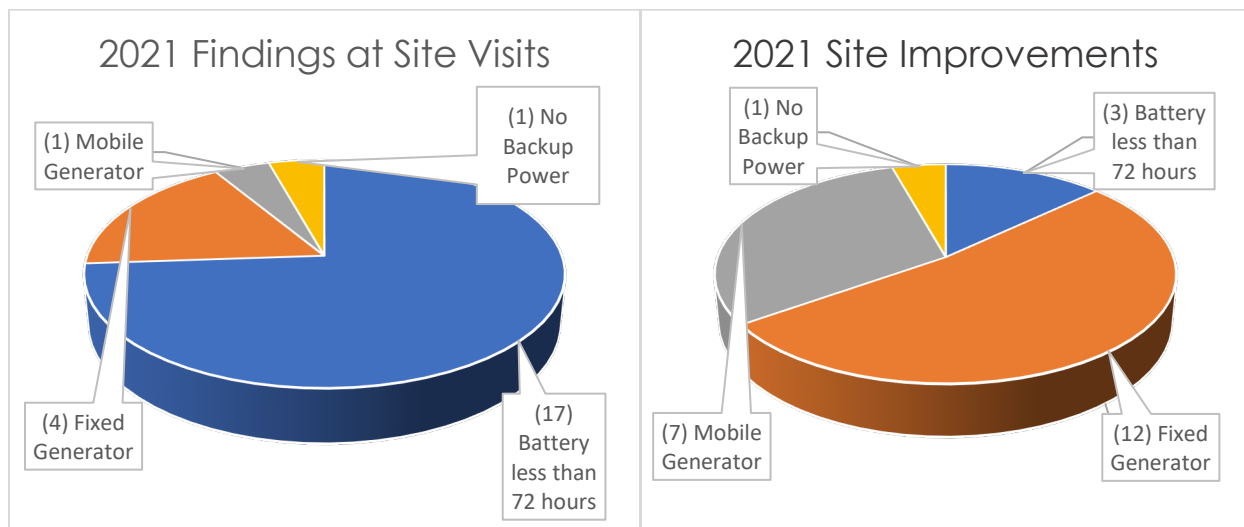
Figure 7: 2021 Site Visit Findings by Type of Backup Power\*

In 2021, Engineers visited sites in the counties of Alameda, Butte, Contra Costa, Placer, and Plumas. Of the twenty-four (24) total sites visited in 2021, the Engineers found that only six (6) of them had sufficient backup power to comply with the EDRP Decisions. Thus, eighteen (18) sites were found to be lacking sufficient backup power, and one (1) of these eighteen (18) sites had no backup power at all. The other seventeen (17) sites relied solely on batteries for their backup power, leaving each of these facilities with less than eight (8) hours of backup power.

Staff asked the service providers responsible for the eighteen (18) sites lacking sufficient backup power to install either fixed or mobile generators. Staff also recommended to service providers that they install the “hook-ups” necessary to readily connect to mobile generators and to ensure their generator refueling schedules were designed to meet the 72 hours backup power requirement.

As a result of these site visits, service providers made some resiliency-related improvements. Staff analyzed service providers’ Plans submitted in 2023 to determine whether any resiliency improvements were made to the sites visited in 2021 that had been found to be lacking sufficient backup power at the time of the site visit. See the ‘before-and-after’ depiction of network resiliency improvements in Figure 7 below. Service providers reported improvements in their 2023 Plans indicating the addition of seven (7) fixed generators and the assignment of seven (7) mobile generators since the 2021 site visits.

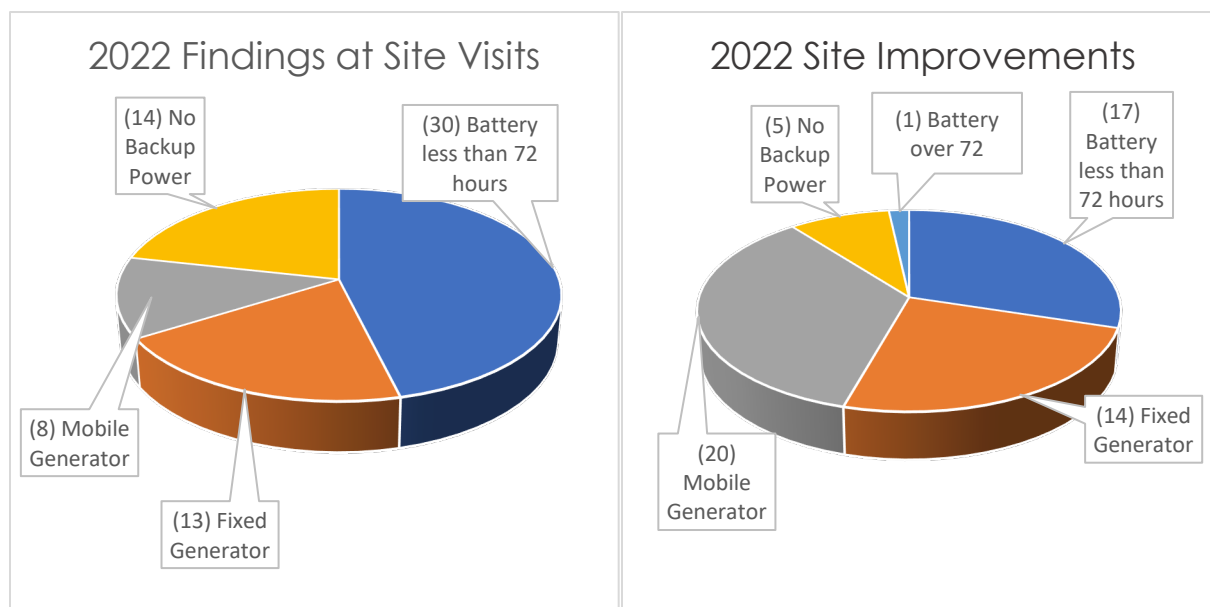
Figure 8: 2022 Site Visit Findings by Type of Backup Power

Engineers found that forty-four (44) of the sixty-five (65) sites visited did not have sufficient backup power at the time of the site visits. Specifically, thirty (30) sites had less than 72 hours of battery backup power, and fourteen (14) sites had no backup power at all. Staff recommended that providers install fixed generators or camlock connections for hooking up to mobile generators. Staff also reminded service providers that generator refueling schedules should be designed to meet the 72-hour backup power requirement.

Staff analyzed service providers' Plans submitted in 2023 to determine what improvements had been made to sites visited in 2022. Fourteen (14) of the original forty-four (44) sites that were found to be lacking backup power at the time of 2022 site visits are now equipped with 72 hours of backup power. See the before-and-after depiction of network resiliency improvements after 2022 site visits in Figure 8 below.

Staff found, however, that twenty-two (22) sites visited in 2022 still do not have 72 hours of backup power.<sup>16</sup> (Also, Staff learned that one (1) site was decommissioned and seven (7) were not reported<sup>17</sup> in the Plans that service providers submitted in 2023.)

Staff continue to request that service providers explore creative ways to install sufficient backup power, transport diversity, and/or harden these sites.

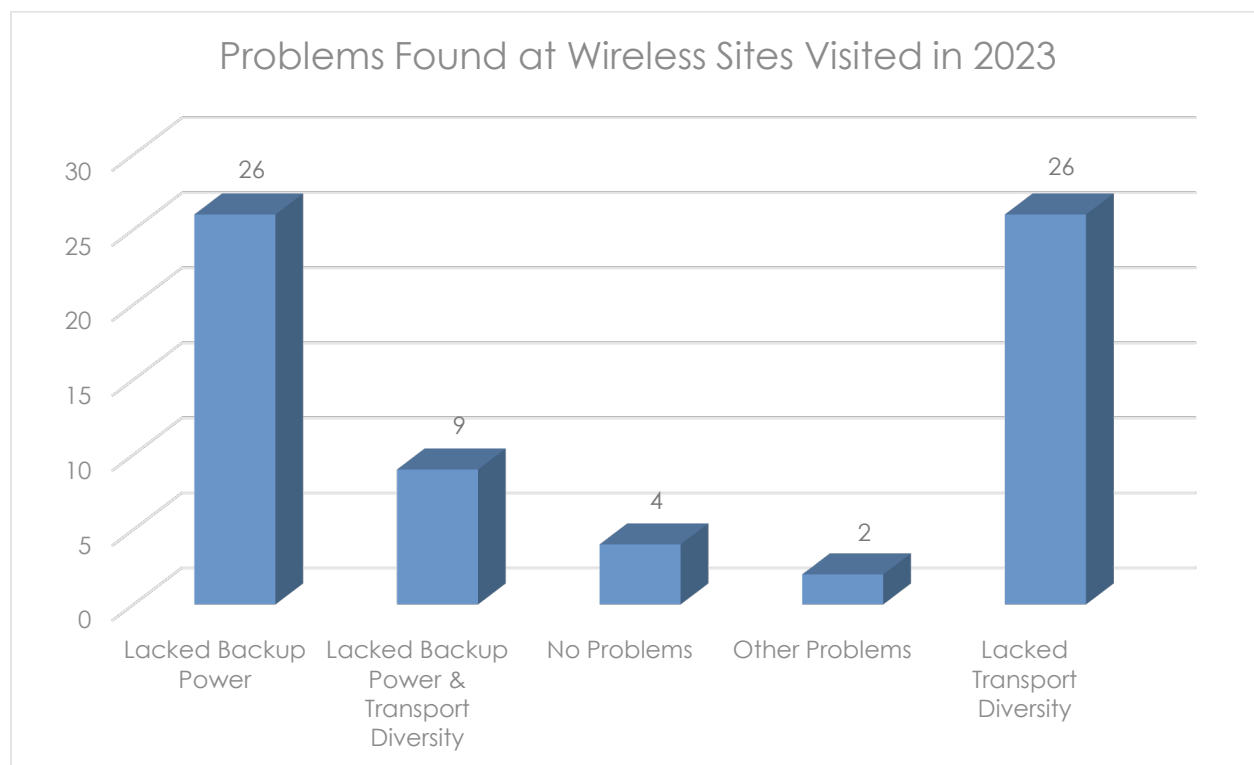
Figure 15: Problems Found at Wireless Sites Visited in 2023\*

Thirty-five (35) of the sixty-seven (67) total wireless sites visited in 2023 lacked 72 hours of backup power. The wireless sites visited in 2023 that were found to lack 72 hours of backup power are T-Mobile, AT&T Mobility and Verizon. In addition, nine (9) of the (35) thirty-five sites that were found to lack sufficient backup power *also* lacked transport diversity. Also noted, twenty-six (26) sites visited lacked transport diversity.

Site visits categorized as “No Problems” indicate that Engineers found these four (4) sites to be compliant with the resiliency strategies in the Decision at the time of the site visit, and no further discussion with the service providers was required. Two (2) of the sites visited in “No Problems” category were mobile storage warehouses that Staff examined for readiness to deploy mobile generators.

“Other Problems” were sites that were found to have 72 hours of backup power and transport diversity at the time of the site visit, yet Engineers found other issues to address with service providers. For example, Engineers made recommendations for service providers to take special measures to protect backup power on site from becoming inaccessible due to heavy snowfall, and at another location Engineers recommended the service provider take precautionary measures to protect equipment from flooding.

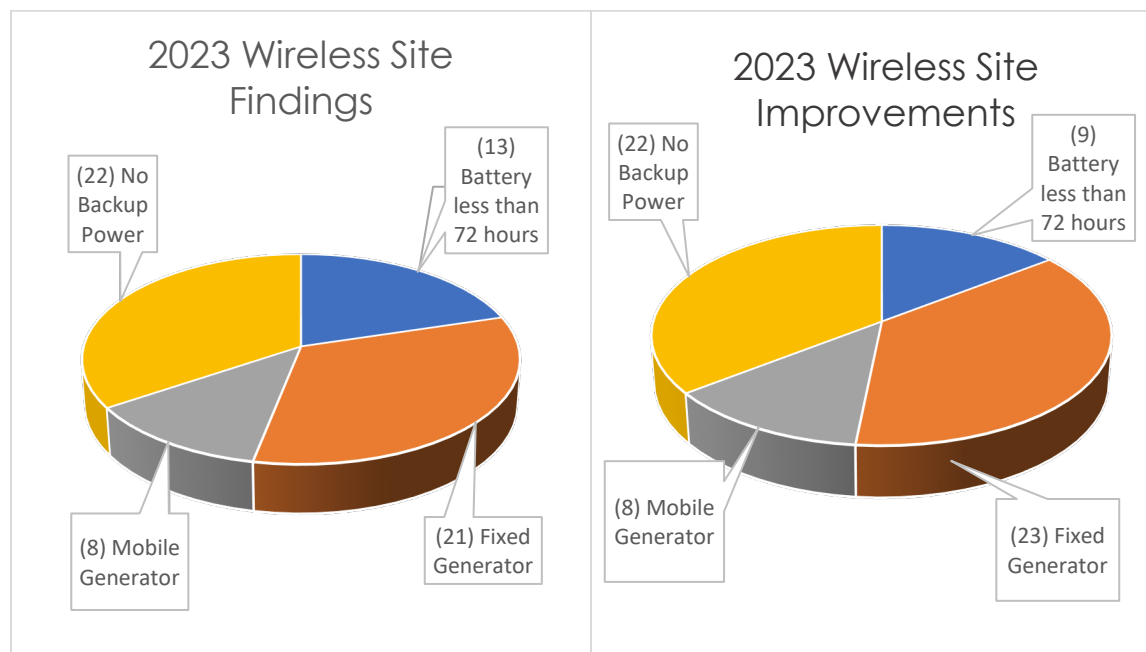
Figure 16: 2023 Wireless Site Visit Findings by Type of Backup Power\*

Based on follow-up conducted by Staff, wireless service providers have resolved just four (4) of the thirty-five (35) sites visited that were found to be lacking 72 hours of backup power.<sup>29</sup>

See the ‘before-and-after’ depiction of network resiliency improvements by wireless service providers in Figure 16 below. Although improvements are still needed, there has been a notable increase in fixed generators installed at sites which previously relied solely on batteries (which rarely meet 72 hours of backup power when used alone).<sup>30</sup>

- **AT&T Mobility:** All eleven (11) sites found to lack 72 hours of backup power at the time of the site visit still do not have sufficient backup power. AT&T Mobility did install two new camlock connections which is an improvement since the 2023 site visits.
  - Staff requested data on two (2) macrocell sites and three (3) oDAS sites that are assigned mobile generators to confirm these facilities are equipped with camlock connections. AT&T Mobility confirmed that the two (2) macrocells are equipped with camlock connections, but the three (3) oDAS are not. Staff continues to follow-up regarding AT&T Mobility's progress installing camlock connections at these three (3) oDAS facilities.

- **T-Mobile:** Fifteen (15) of the nineteen (19) sites found to lack 72 hours of backup power at the time of the site visit have not improved.
    - T-Mobile resolved four (4) of its nineteen (19) facilities lacking 72-hours of backup power by assigning mobile generators.

- **Verizon Wireless:** All five (5) sites found to lack 72 hours of backup power at the time of the site visit have not improved.
    - The five (5) sites lacking sufficient backup power were not resolved. They are small cells and oDAS facilities installed in the right-of-way. Staff have since learned that radio units are not installed at this oDAS location, and therefore the antennas are considered “passive.”

- Staff have recommended that Verizon Wireless ensure these five (5) sites have the proper “hook-up” for mobile generators. Verizon Wireless has met with Staff and CD Management regarding its challenges equipping small cells and oDAS with 72 hours of backup power. Verizon Wireless has agreed to refile its Plan with more data regarding each of these sites that continue to lack 72 hours of backup power.

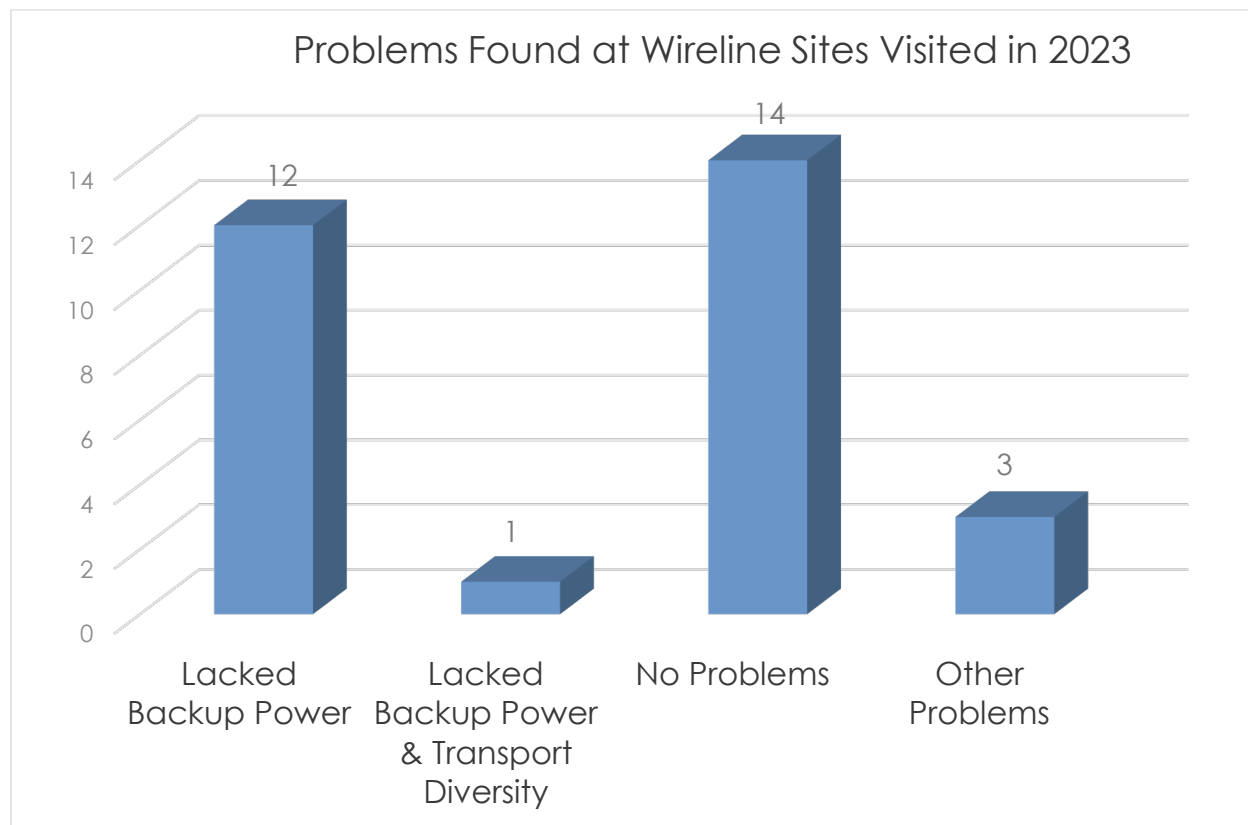
Figure 17: Problems Found at Wireline Sites Visited in 2023\*

Engineers found that a total of thirteen (13) of the thirty (30) wireline sites visited in 2023 lacked sufficient backup power to comply with the EDRP Decisions, and one (1) of these thirteen (13) sites *also* lacked transport diversity.

See Figure 17 below for a breakdown of the problems found at wireline sites visited in 2023. “No Problems” are fourteen (14) total sites that Engineers found to be compliant with the resiliency strategies in the EDRP Decisions at the time of visit. Three (3) of the sites in the “No Problems” category were mobile storage warehouses being examined for the readiness to deploy mobile generators.

“Other Problems” sites were found to have 72 hours of backup power and transport diversity at the time of the site visit; however, Engineers found other issues to address with service providers. Specifically, Staff found that the service providers had not reported these three (3) sites in their Plans even though all three (3) had been impacted by actual outages.<sup>31</sup>

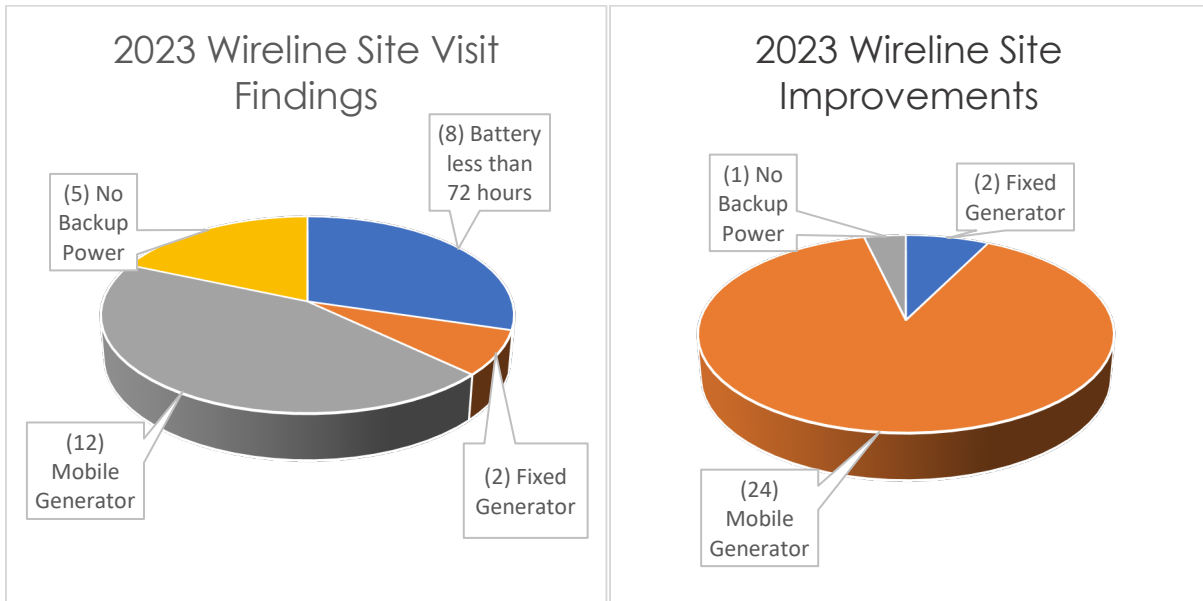
Figure 18: 2023 Wireline Site Visit Findings by Type of Backup Power

Based on the follow-up from Staff with the wireline service providers, all but one (1) of the thirteen (13) facilities found to be lacking 72 hours of backup power at the time of the visit are now equipped with 72 hours of backup power.<sup>32</sup>

That one (1) site still lacking 72 hours of backup power is an AT&T California site. Engineers noted that AT&T Mobility is collocated at this location and operates a fixed generator. Staff recommended that AT&T California approach AT&T Mobility regarding sharing its fixed generator.

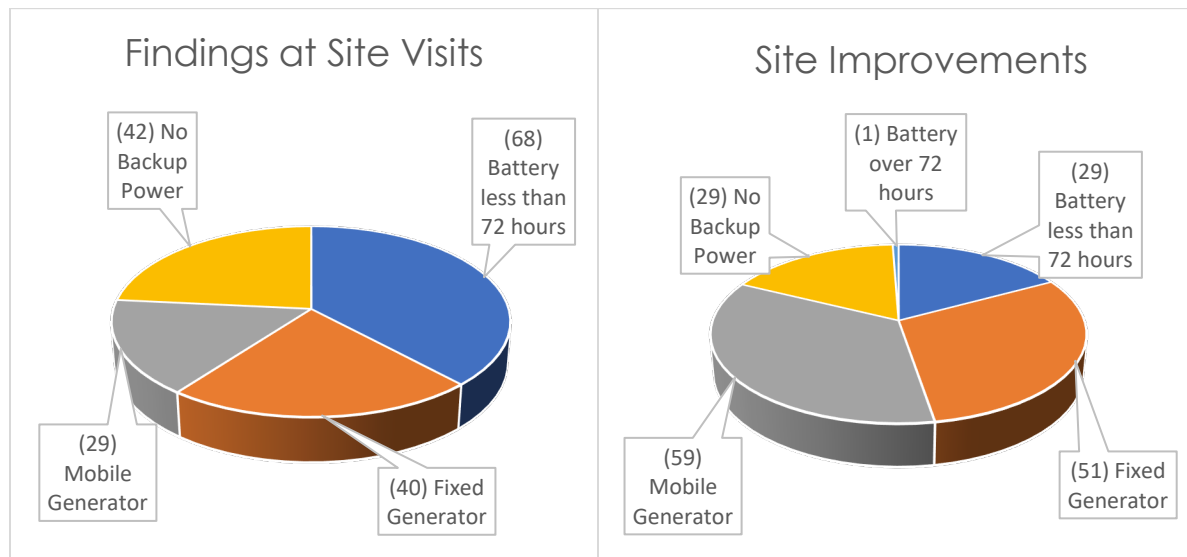
Figure 19: Overall Site Visit Findings by Type of Backup Power\*

Engineers found nearly 60% of the sites visited between 2021 and 2023 lacked 72 hours of backup power. Service providers responded to these site visit findings by reducing that number down to 31%.

Engineer field presence and recommendations clearly motivated service providers to improve network resiliency. These swift changes to a small sample of sites indicate to Staff that with focused efforts service providers could comply with the EDRP Decisions.
