**SUBJECT: Generation Audit of American Kings Solar (American Kings) - Audit Number
GA2024-04AKS**

**CPUC AUDIT FINDINGS OF
AMERICAN KINGS SOLAR
FEBRUARY 26 – FEBRUARY 29, 2024**

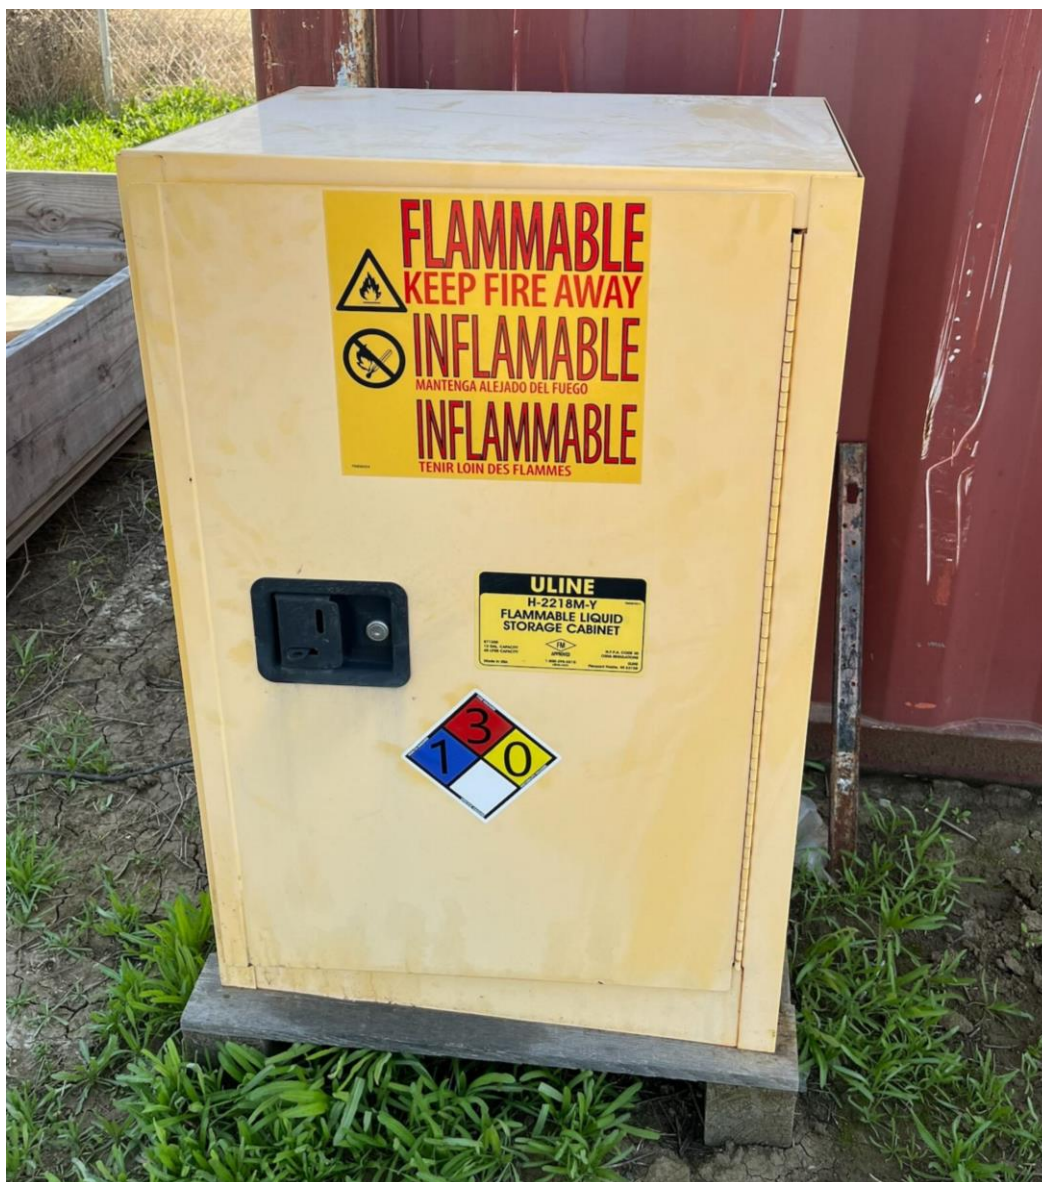
Figure 1 Flammable Storage Cabinet with NFPA Hazard Diamond

At American Kings Solar (“the Plant”) hazardous material is stored outside of the O&M building in a flammable storage cabinet. All hazardous materials stored in the flammable cabinet have corresponding Safety Data Sheets (SDS), easily accessible to the Plant staff and contractors. Located on the outside of the flammable cabinet is an NFPA hazard diamond used to communicate the presence of hazardous materials and their potential effects. The NFPA hazard diamond at American Kings Solar, seen in Figure 1, shows potential hazard ratings of; Health-1, Fire-3, Instability-0. The Plant violated NFPA 704 because the maximum potential hazard of all materials stored are not accurately shown on the NFPA hazard diamond. The purpose of NFPA hazard diamond is for efficient recognition of the potential hazard of all stored chemicals in an emergency. Klear HD Degreaser cleaner was stored in the cabinet which has a health hazard rating of two (2). The NFPA hazard icon, shown in Figure 1, does not exhibit the maximum potential hazard of the stored materials.

Plant staff should update the NFPA diamond, verifying all chemicals stored on-site have the appropriate hazard indication, including but not limited to the material presented in Finding 1. When new chemicals are introduced to the Plant and stored in the cabinet, the existing NFPA diamond should be reviewed and if necessary, updated. The accuracy of the NFPA hazard diamond is critical for the day-to-day safety of Plant staff and for the use of emergency responders to help determine the appropriate response in the case of an emergency.

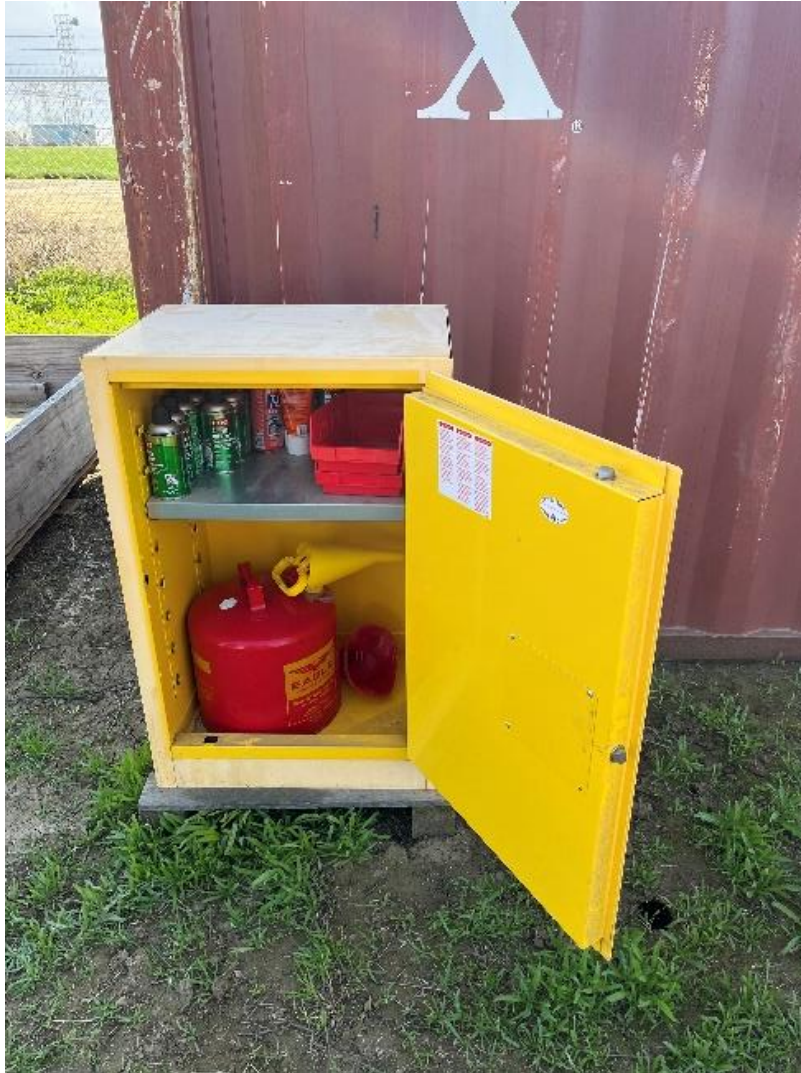
Figure 2 Flammable Storage Door Ajar

Additionally, upon inspection, when the flammable storage cabinet was opened, ESRB discovered the cabinet was not equipped with a self-closing and self-latching door. Figure 2 shows the cabinet door ajar. NFPA 1, section 66.9.4.3 requires a self-closing and latching door when flammable material is stored.

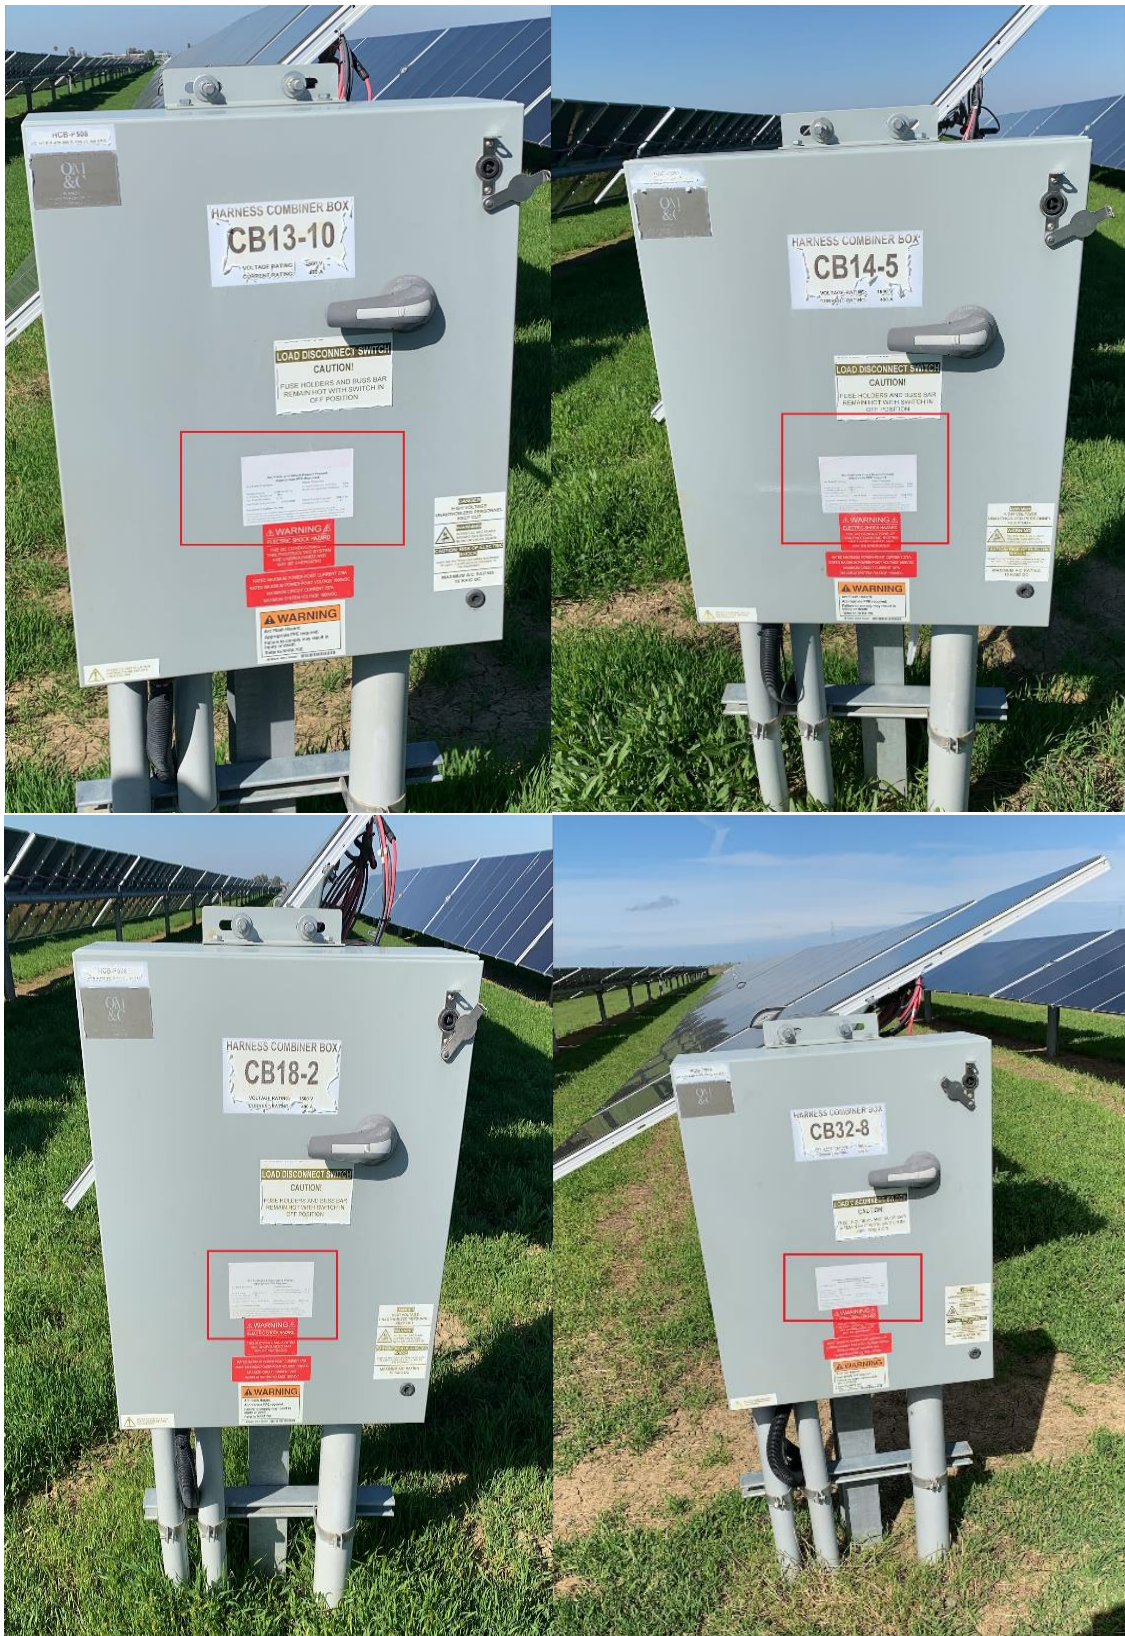
Figure 4 Combiner Box Deteriorated Danger Labels

At the time of the audit, ESRB inspected the solar arrays, inverters, and combiner boxes. All combiner boxes at the facility have a sticker indicating “Danger Arc Flash.” Throughout the facility there are several faded and illegible signs, assumed to be due to sun exposure or other environmental conditions. Examples of deteriorated signage at the Plant are shown in Figure 4, however the extent of the occurrence is not limited to combiner boxes shown. Maintaining signage indicating danger or safety hazards is critical for the safety of day-to-day operations, site visitors, and contractors. The Plant must maintain signage and perform routine inspections to identify and replace deteriorated or missing signage immediately after the issue is identified.

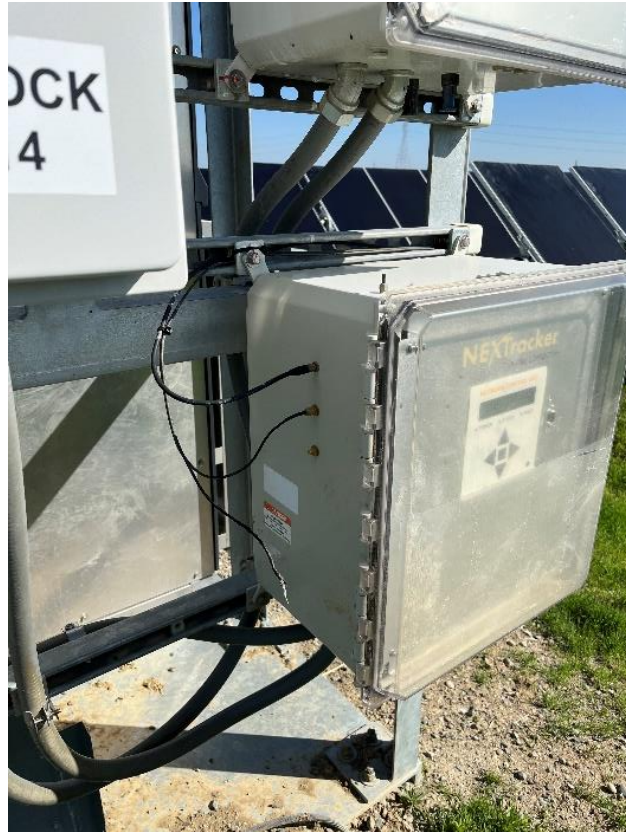
Figure 5 Broken connection on inverter communication device

At the time of ESRB's audit of the Plant, there were several cables and ground connections that were disconnected or broken. Examples and descriptions of the damaged cables can be seen in Figures 5, 6 and 7. The cables disconnected or broken are seen on grounds, ethernet cables, and communication with the inverters. Completing corrective maintenance on cables is critical to the safe and reliable operation of the facility. Plant staff attributed the disconnected cables in the solar fields to the recent vegetation control work, which brought sheep into the area. The sheep often brush up against equipment and move quickly which can cause cables to disconnect. It is a reasonable assumption that the sheep can be the cause of the disconnected cables. The staff should complete routine inspections following vegetation control to ensure the Plant remains in proper condition following sheep being in the area. The routine inspections should be an ongoing effort, with added emphasis following livestock roaming in the area.

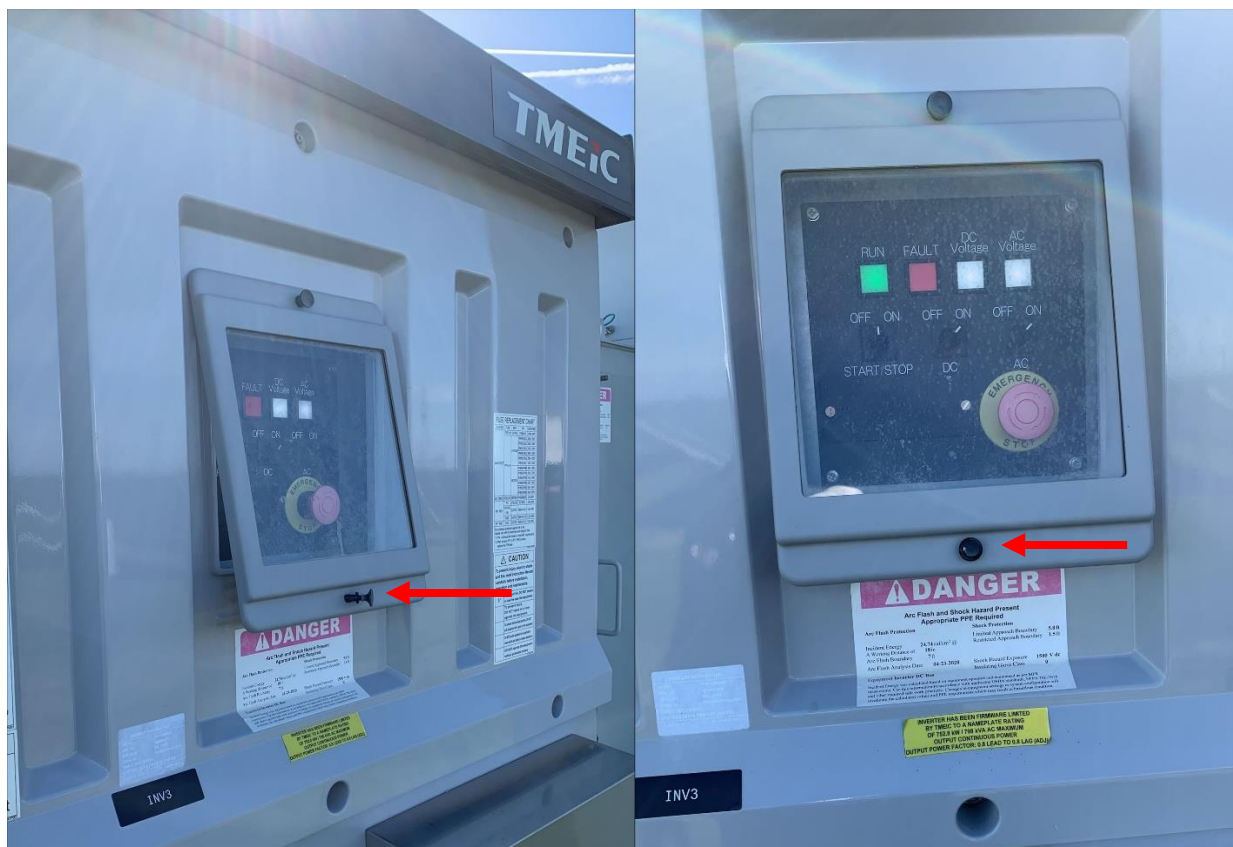
Figure 8 Inverter 21(Left) and Inverter 34(Right) Cover Ajar with broken Pin

Inverters at the facility have a control panel which is protected with a plastic covering. At several of the inverters, the pins holding the cover were broken, resulting in the control panel being exposed and vulnerable. With animals present in the vicinity, including sheep and dogs, the inverter control panel is vulnerable to incidental operation. The exposed control panels are also subjected to environmental concerns. The broken covers or pins were seen on inverters number 21 and 34. The Plant should include the control panel covers as a part of their routine inspections for the inverters and correct issues promptly after they are identified.

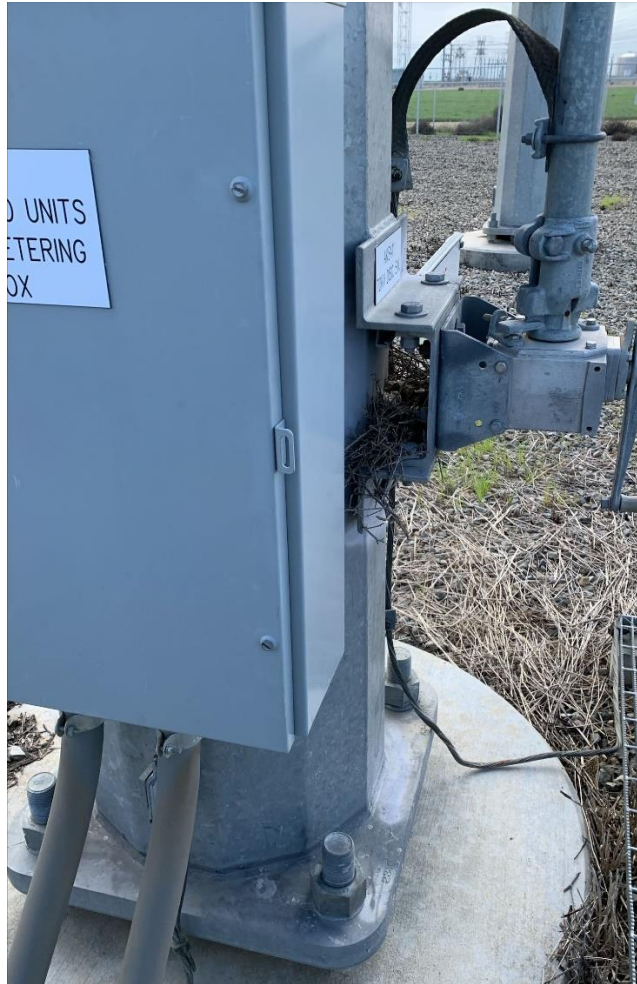
Figure 9 Bird's Nest in Switchyard

ESRB discovered an active bird’s nest within the fenced perimeter of the switchyard. Birds and birds’ nests pose several risks to Plant operations. Birds’ nests are composed of debris that could contain flammable or conductive material, all of which needs to be mitigated in the switchyard. An active birds nest also brings the risk of birds flying near operating equipment that can result in bridging between phase-to-ground or phase-to-phase caused by the wingspan of the bird when flying. The possible effects of bridging due to animal presence can range from brief occurrences to extensive power interruptions. Additionally, the presence of an active bird’s nest introduces the possibility of attracting predatory animals. The nest should be removed from the switchyard when deemed appropriate by the Plant, and preventative measures should be taken to prevent future nests from being made.

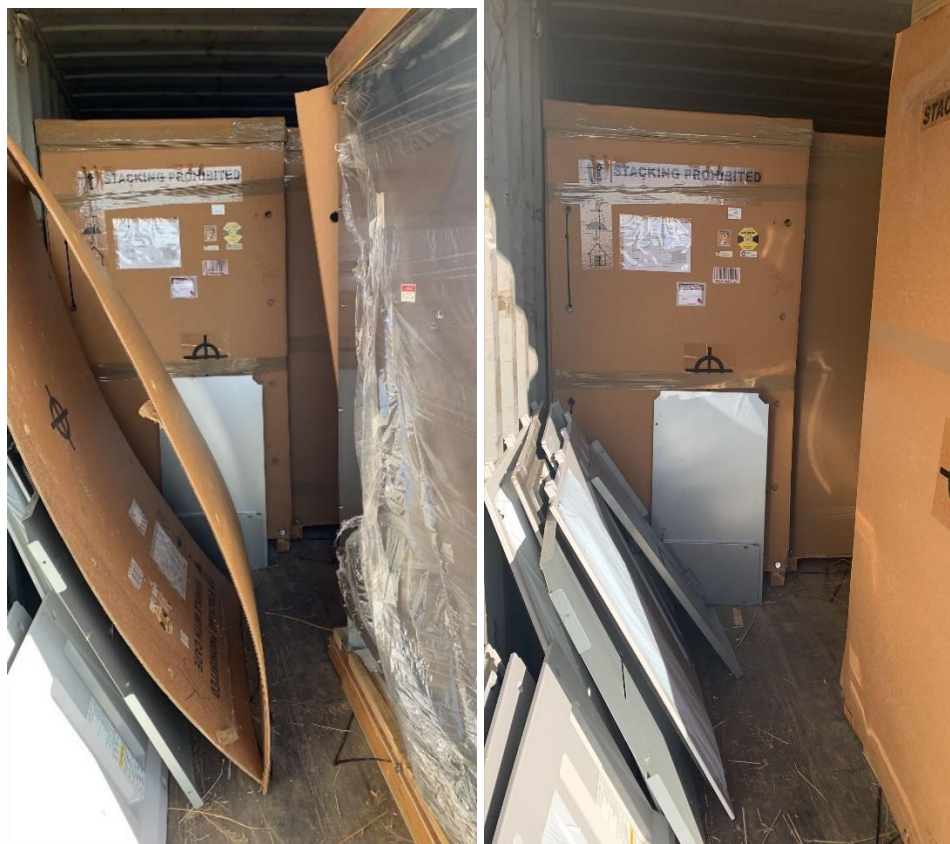
Figure 10 Storage Container

At the Plant, there are several Conex containers in the O&M yard that are used for the storage of equipment like spare inverters. Plant staff needs access to the interior of the Conex container for Plant operations. Upon inspection of the containers, trash in the form of cardboard and packaging materials were stored in the unit. The waste material stored in the storage unit can be seen in

Figure 10 on the left. The Plant staff corrected the issue and removed the waste during the audit. The area showing removed waste can be seen in Figure 10 on the right.
