RESPONSE TO THE CPUC AUDIT FINDINGS OF: PANOCH VALLEY SOLAR

Audit Date: May 12-15, 2025
Audit Number: GA2025-05PA

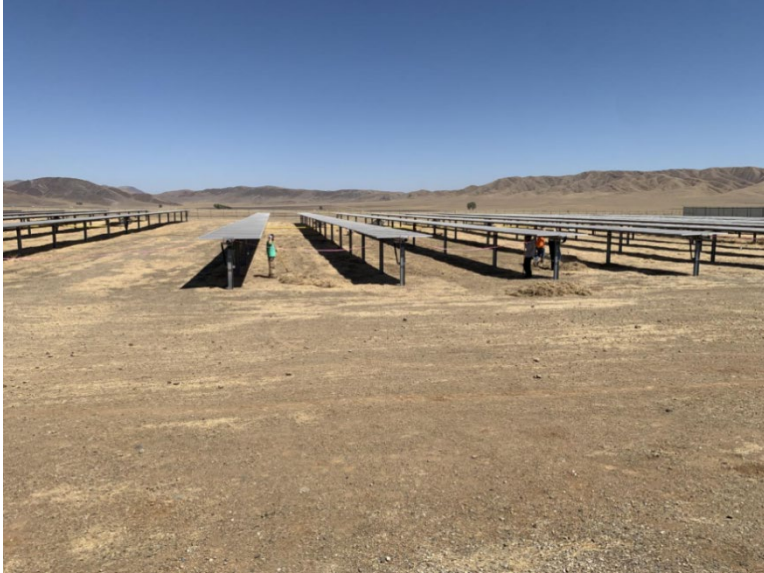
Response to Figure 1: Current vegetation near Solar PV Arrays (9/17/25)

3. **Between Arrays:** Harrow drags and string trimmers have been used on “rows” or informal roads between arrays (rows are approximately 13 ft to 15 ft wide) and approximately 20 ft around arrays to reduce vegetation in those areas to a height of one (1) inch or less immediately following such work. 95% of the rows and area around arrays had vegetation height reduced as described as of this Audit Response; 100% of such areas are expected to have had vegetation heights reduced by October 3, 2025.

4. **Under Arrays:** Panoche Valley has been using string trimmers and Brush Hogs (walk-behind string trimmers) to reduce vegetation under arrays to a height of approximately one (1) inch following such vegetation management efforts. As of this Audit Response, vegetation under approximately 40% of the arrays has been reduced

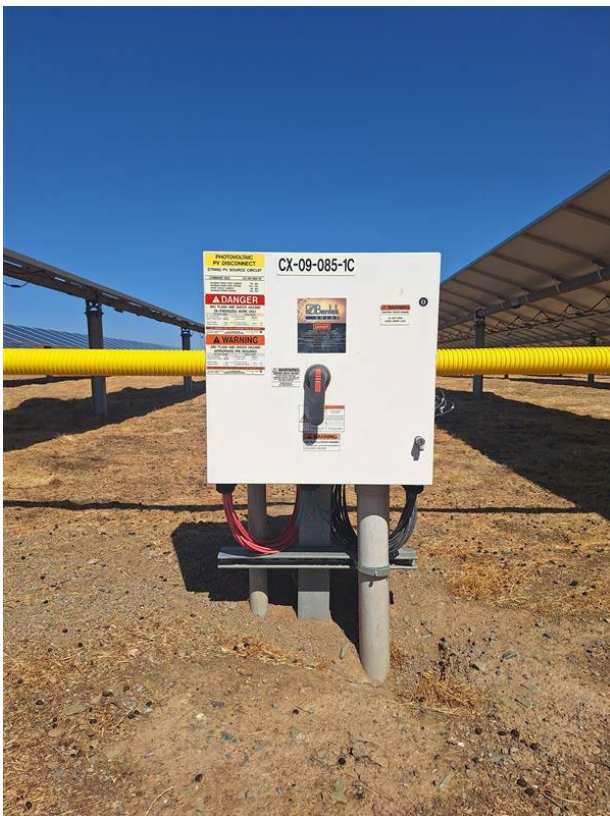
Response to Figure 2: Current vegetation near DC Combiner Boxes (9/17/25)

5. **Around Inverter Skids, Combiner Boxes, Switchgears and Junction Boxes (“Equipment”):** Panoche Valley has used string trimmers to reduce vegetation within five (5) ft of Equipment to a height of one (1) inch or less immediately following such trimming, with the work completed in August 2025.

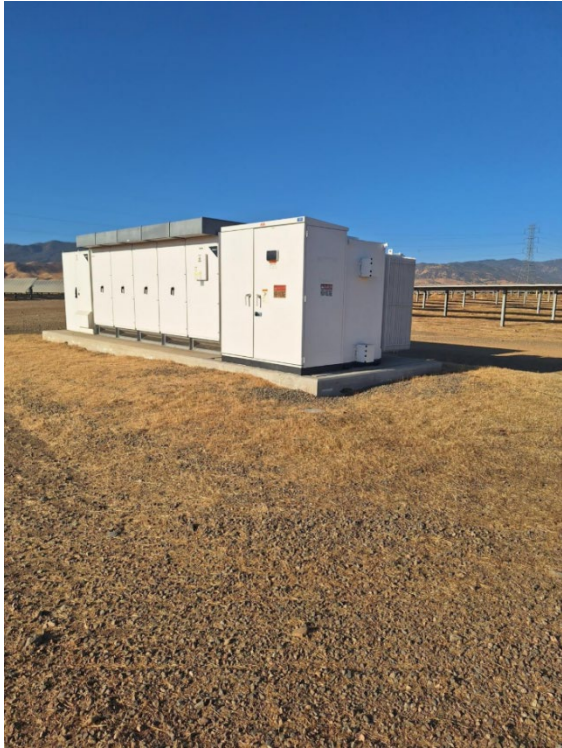
Response to Figure 3: Current vegetation near Inverter Skid (9/17/25)

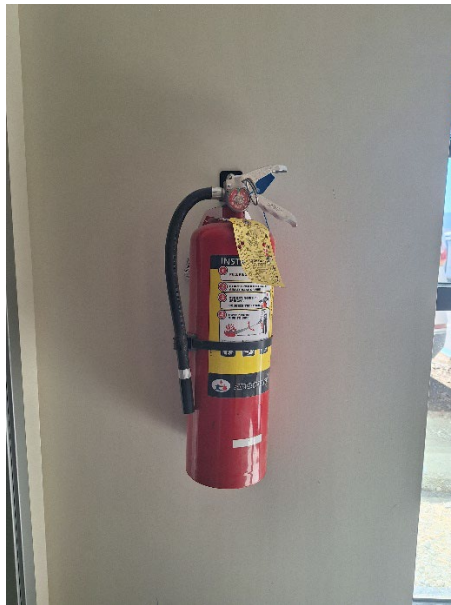
The fire extinguisher identified in the Audit as missing from its designated location inside the O&M building was onsite but not placed back into its appropriate location. The extinguisher was returned to its designated location in the O&M building on May 15, 2025, immediately upon the Audit finding.

Response to Figure 1: Fire Extinguisher in O&M Building (9/26/25)
