## PUBLIC UTILITIES COMMISSION

E20220901-01

**RE: Notice of Violation - Border Fire Incident 220901-15253**

**Border 32 Fire**  
**Summary of Violations**

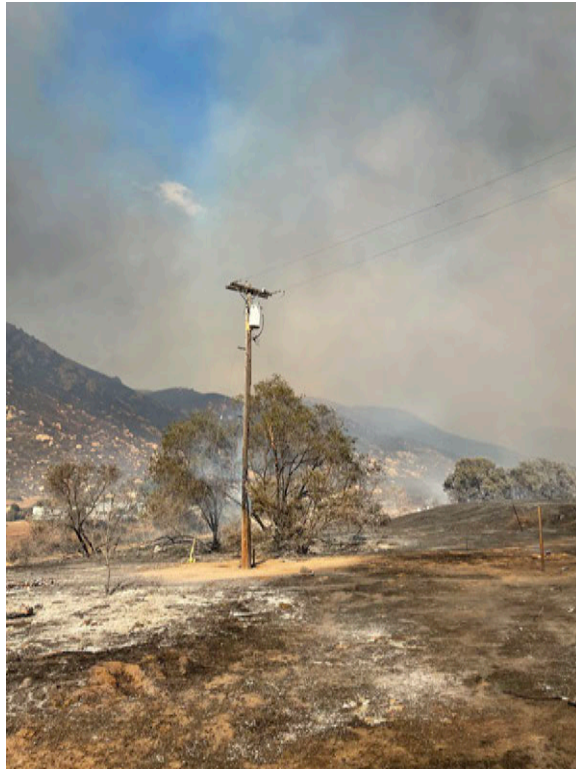
2.

Description of the photo: SDGE POLE

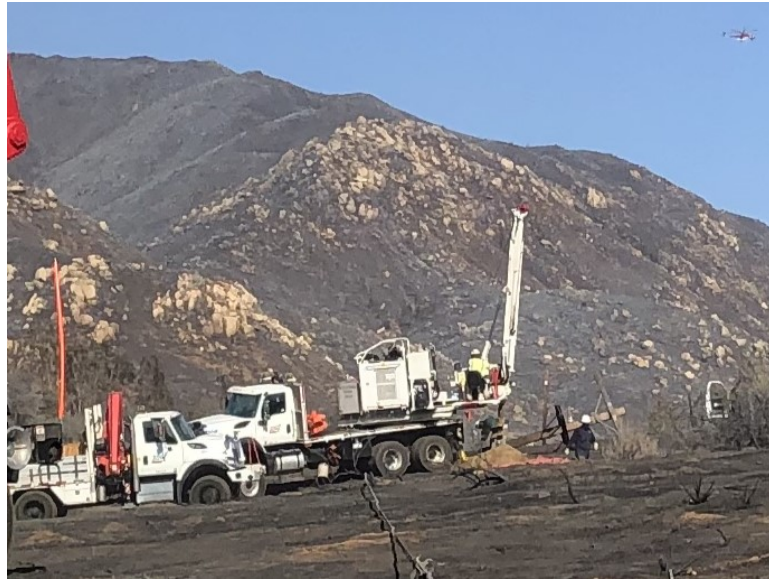
6.

Description of the photo: SDGE VEHICLES
